AN INVESTIGATION OF DISTRESSES FOUND IN CONCRETE AND ASPHALT  
PAVEMENTS FOR GEORGIA FORENSIC GUIDE RECOMMENDATION

CATHERINE ELIZABETH JOHNSON

A Thesis Submitted to the Graduate Faculty of The University of Georgia in Partial Fulfillment  
of the Requirements for the Degree

2016

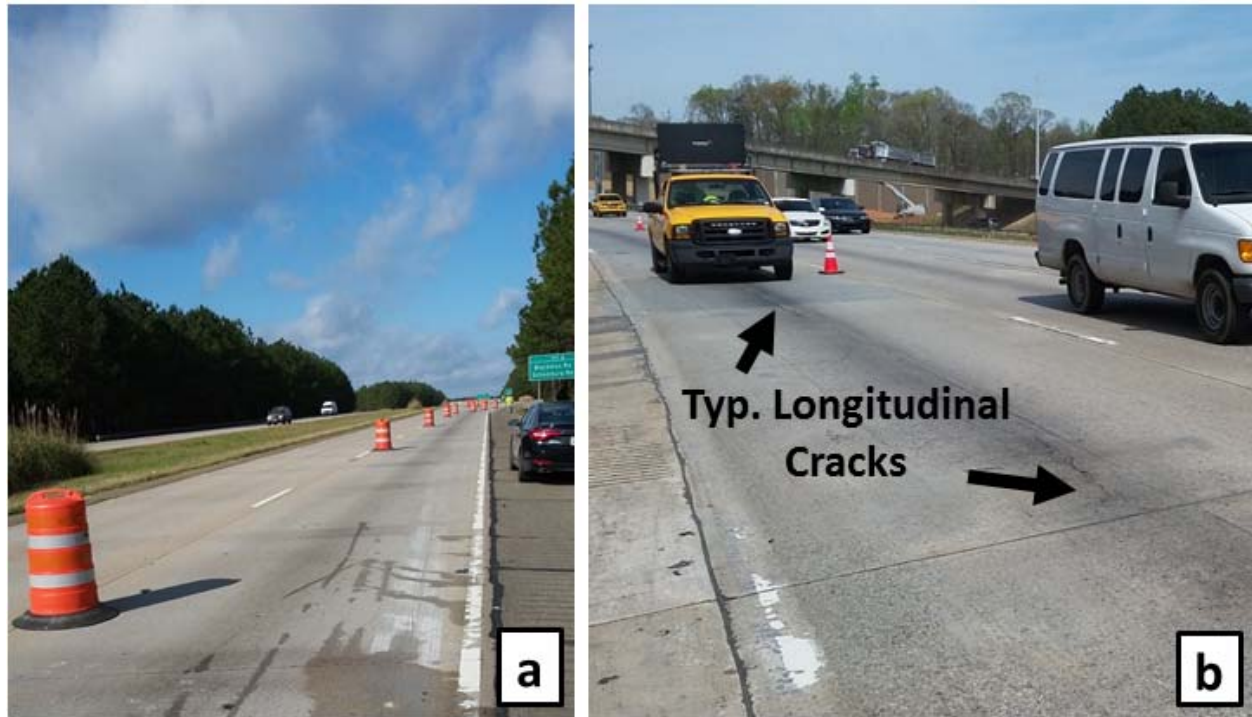
I-75 was believed to have been constructed in 1968 with the earliest documented rehabilitation occurring in 1989. This section was composed of an existing road that was widened from 2 lanes to 3 lanes in one direction with a design speed of 55 miles per hour. The outside lane (lane #3) was designed to have 10.5 inches of Portland Cement Concrete (PCC) over a layer of 6.5 inches of unbonded concrete with GAB underneath. The inside lane (lane #1) was composed of 10 inches of PCC over an Asphalt Concrete (AC) layer of 4 inches with GAB underneath. The inside lane consisted of a different concrete composition than the outside lane. The AADT for the site is 115,000 vehicles with about 8,050 trucks (7%). During visual inspection, the inside lane was observed to have fewer signs of failure. In addition, inside lane experienced a lower volume of trucks.

Figure 6.2 - JPCP General Site Conditions  
(a) SR 22 (good condition); (b) I-75 (poor condition)

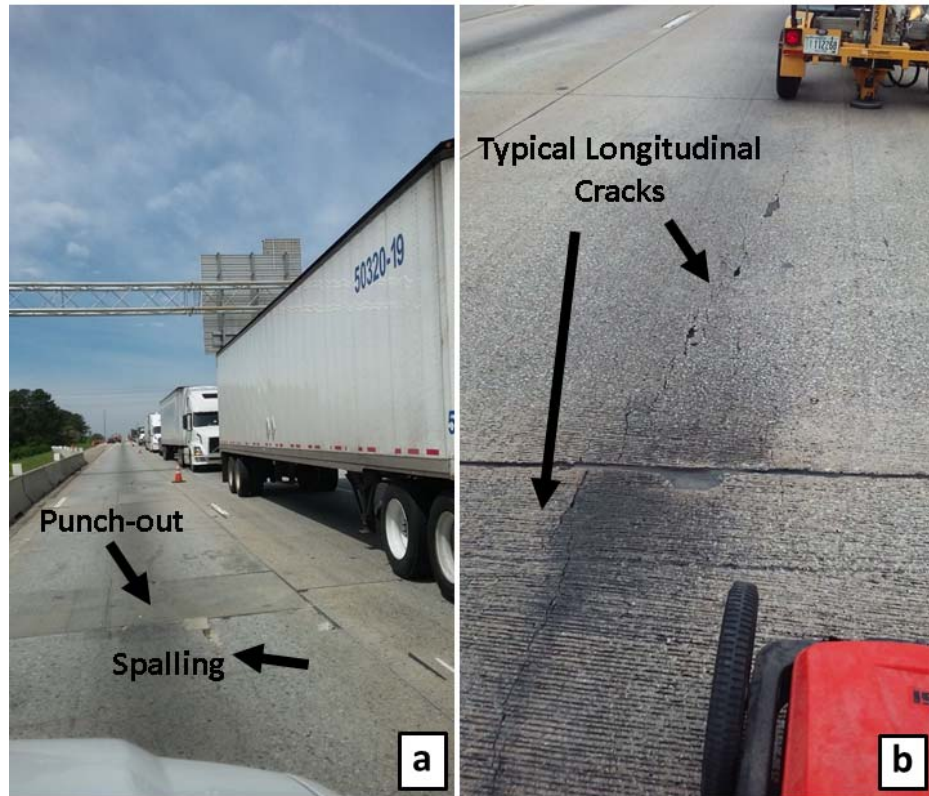
Figure 6.3 - I-75 Typical Distress (Poor Condition)  
 (a) Spalling Repairs and Longitudinal Cracking; (b) Longitudinal Cracking through joints.

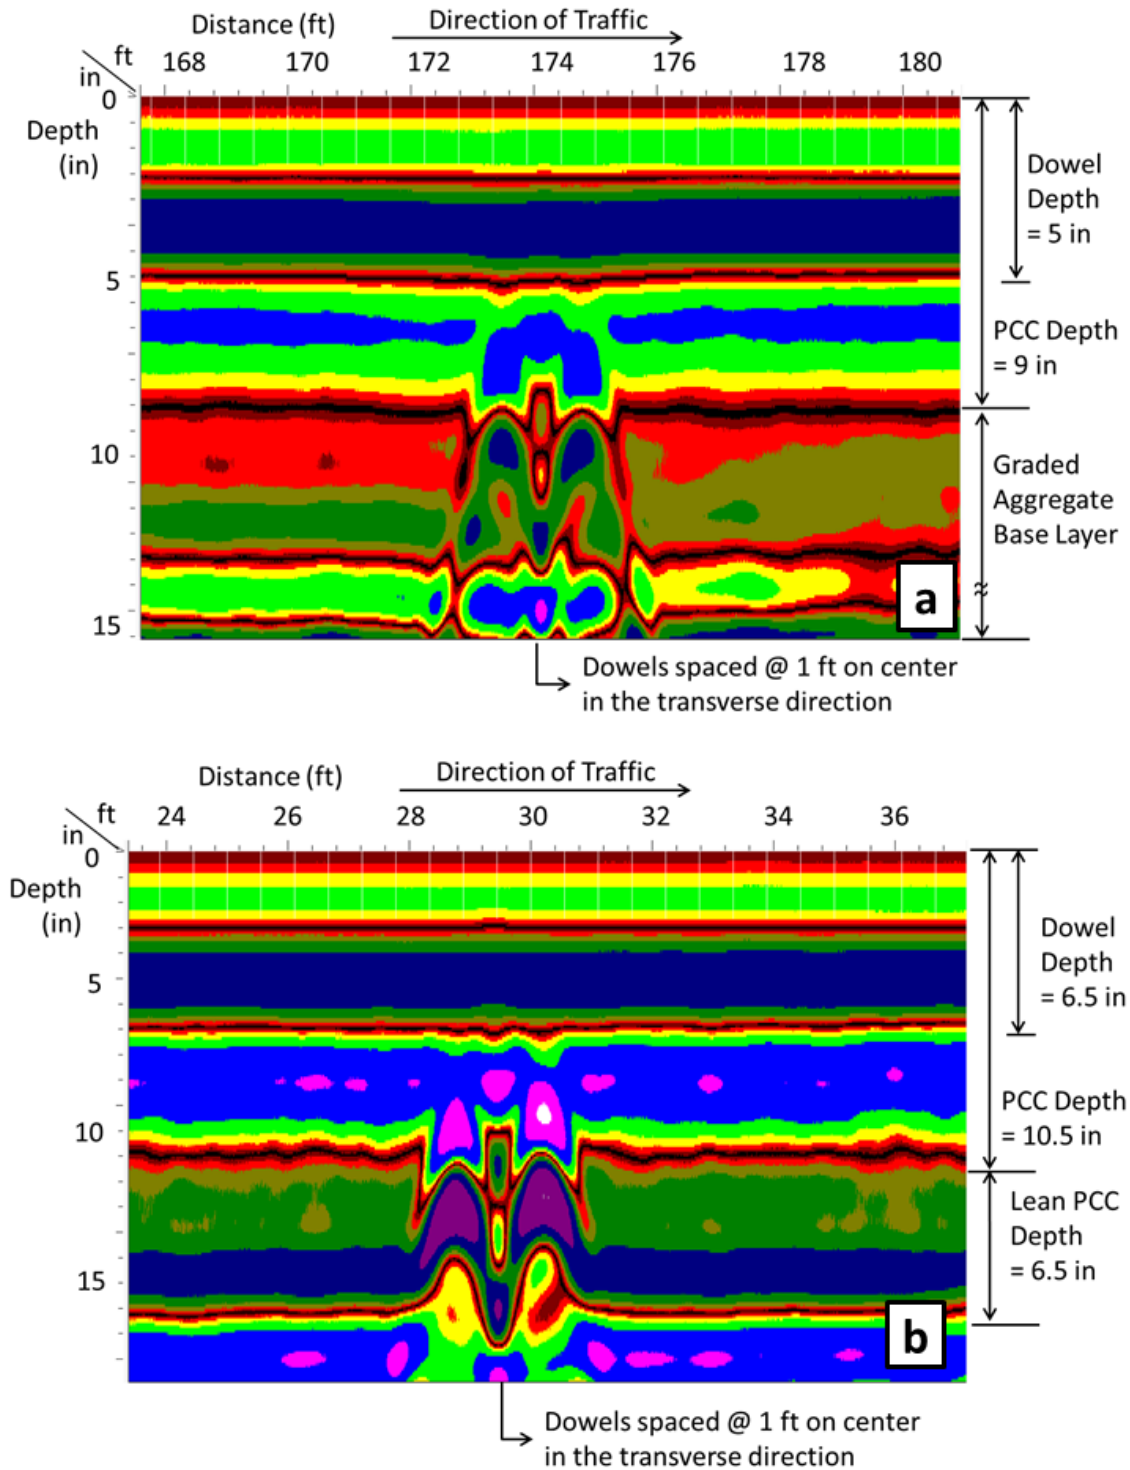
Figure 6.4 - Typical GPR scans showing single joint  
 (a) JPCP scan of SR 22 (good condition); (b) JPCP scan of I-75 (poor condition) in the direction of traffic.

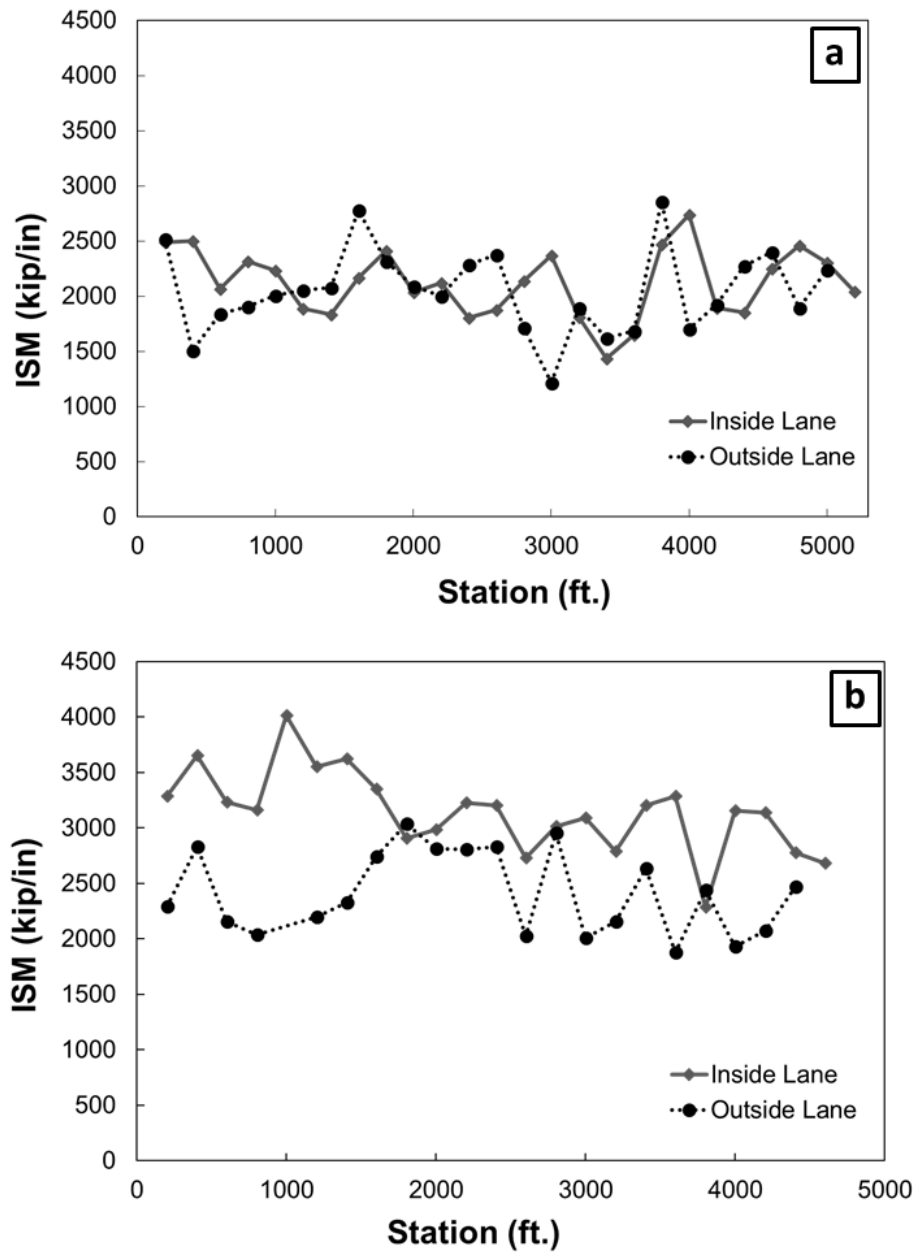
The ISM plots created from the FWD testing are shown in Figure 6.5. Compared to the ISM plot SR-22, I-75 shows a certain degree of variation along with distance, that might be

interpreted as a construction variability. Using the FWD data, a modulus of subgrade reaction,  $k$  was back-calculated based on the 1993 AASHTO design guide (AASHTO, 1993) and is summarized in Table 6.2. These results show that I-75 had a stronger ISM value than compared to SR-22. However, concrete pavements are not dependent on a strong subgrade soil.

Figure 6.5 - Selected ISM Plots determined from FWD tests  
(a) SR-22 (good condition); (b) I-75 (poor condition)

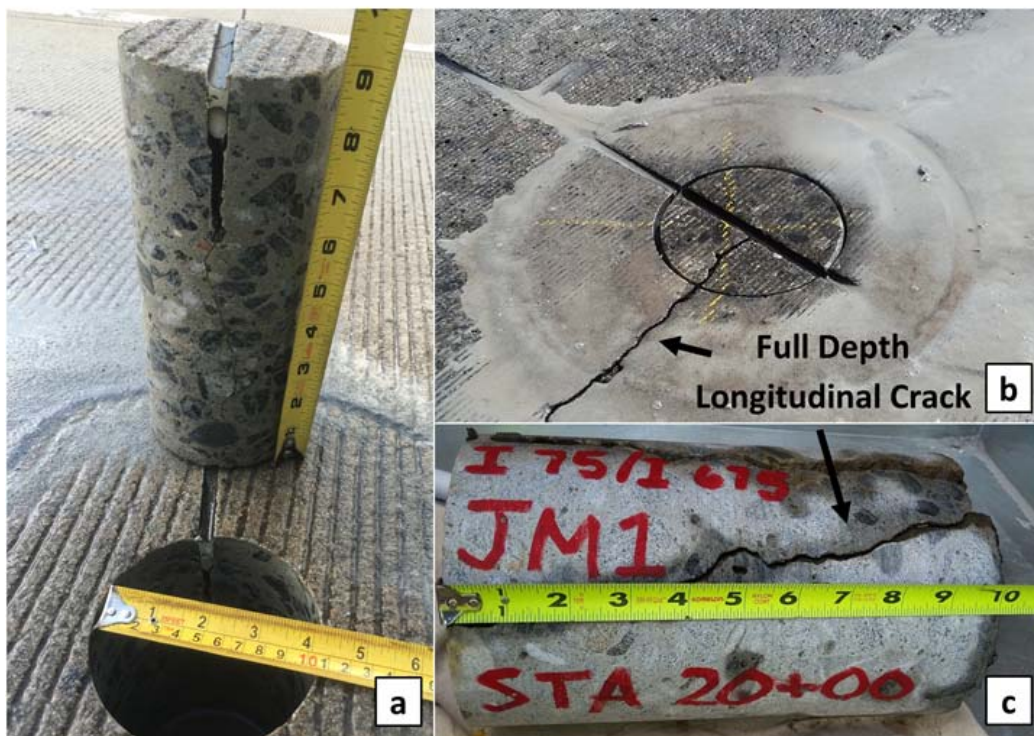
Figure 6.6 - Typical Cores at Joints

(a) SR 22 core at the joint (good condition); (b) I-75 core (poor condition); (c) I-75 core (poor condition) showing a full-depth longitudinal crack.

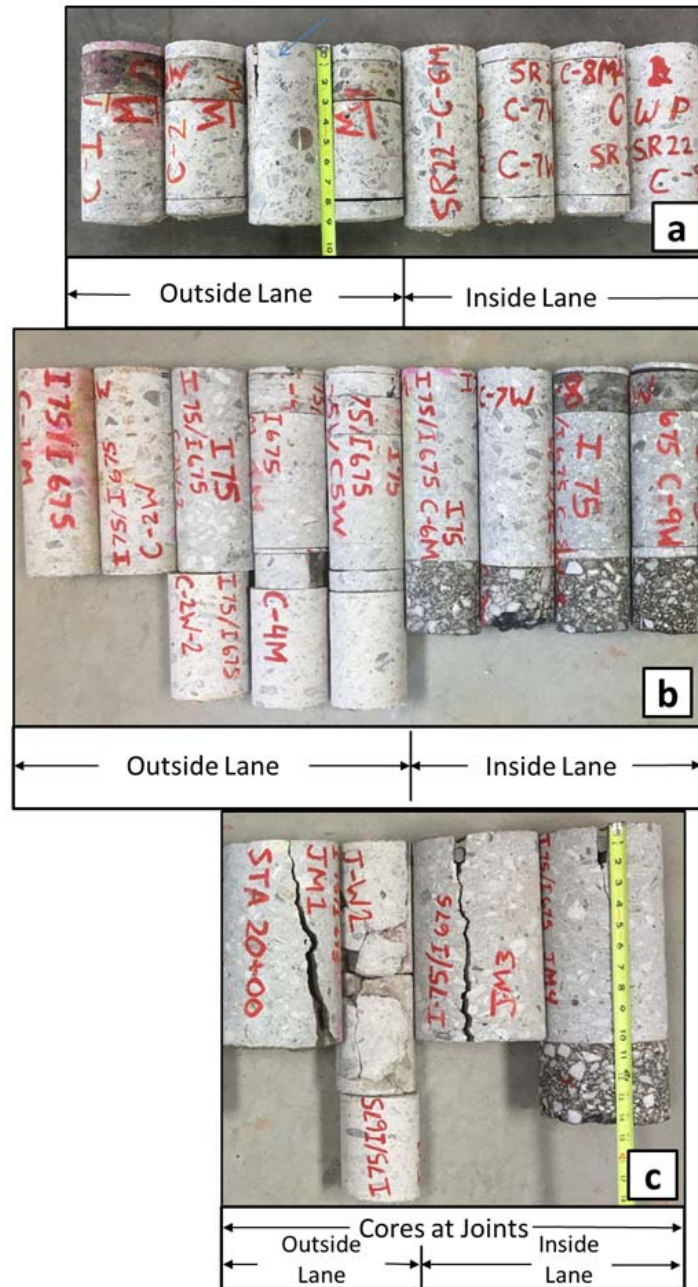
Figure 6.9 - All cores retrieved from JPCP sections  
 (a) SR 22 cores (good condition); (b) I-75 cores (poor condition);  
 (b) (c) I-75 cores at joints (poor condition).

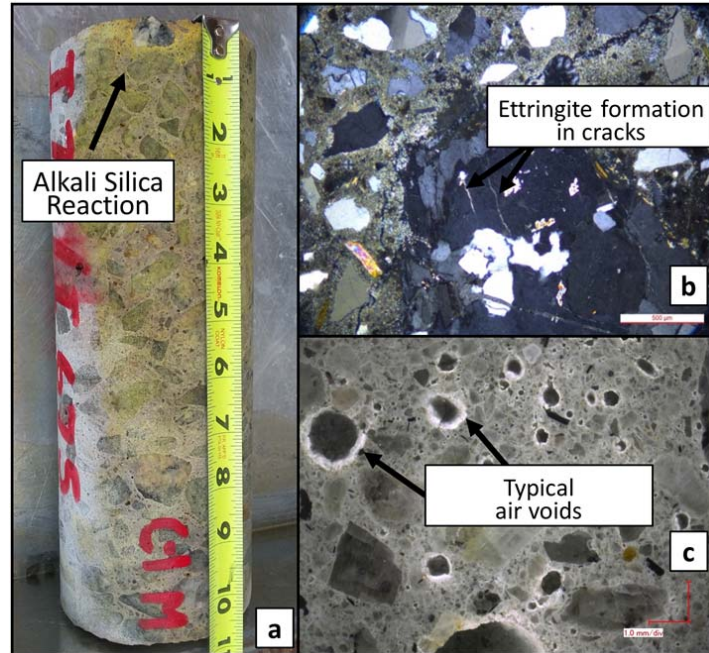
At the I-75 site, the inside lane showed less signs of joint failure, as opposed to outside lane, which showed many deficiencies. In addition, the two lanes show a visible difference in mixture design, which strongly indicates that they were constructed at different times. As indicated in Figure 6.9 (c), the saw cut on the sample measured 2 inches. The second core sample taken in the middle of the outside lane (C-1M) was tested for an Alkali-Silica Reaction (ASR). There was a bright yellow reaction around aggregates as shown in Figure 6.10 (a), and thus on site testing revealed that there was evidence of ASR. This core sample was selected for a petrographic analysis. A core sample (C-2W-2) was taken from a rehabilitation patch and 6.5 inches of existing PCC was discovered underneath the new PCC. Sample J-W2 was tested for carbonation, which indicated positive on the surface of cracks. As shown in Figure 6.9 (b), cores taken from the inside lane were discovered to have approximately 4 inches of an asphalt concrete layer beneath the PCC layer. The reinforcement began at a clear-cover depth of approximately 3.5 in. below the pavement surface. Small particle delamination was observed on the site. The dowel (sample J-M4) was epoxy coated and did not show carbonation.

Figure 6.10 - ASR damage found in I-75 section (poor JPCP)  
 (a) On-site field test; (b) Photomicrograph of ASR gel and a crack filled with ettringite in thin section; (c) Photomicrograph of the typical air void structure from a core.

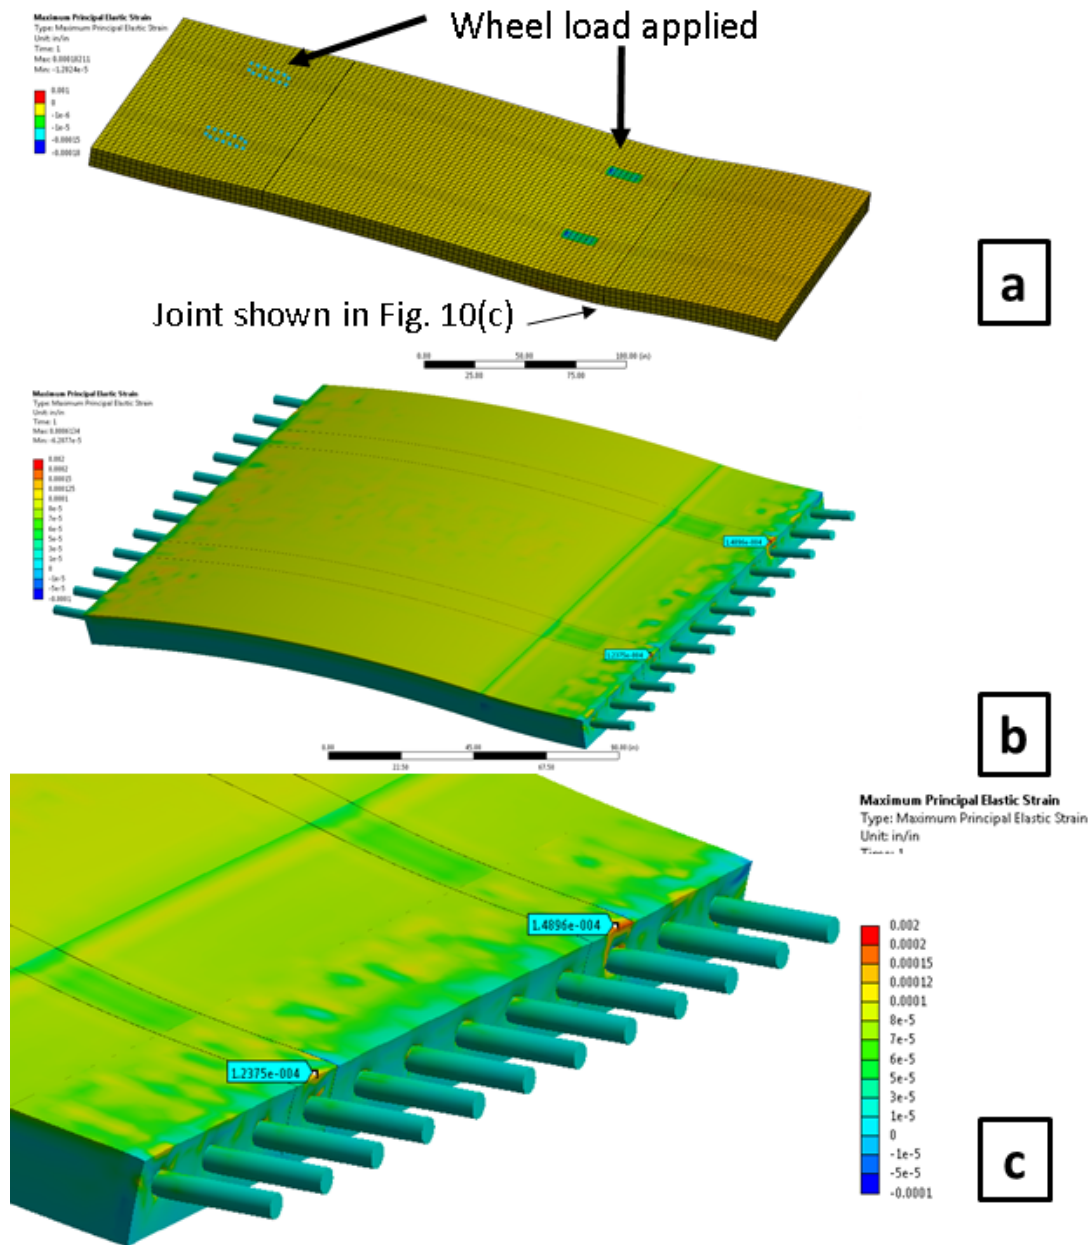
Figure 6.11 - FEA strain results

Based on the FEA analysis, it was ascertained that thermal deformation combined with structural deformation from the wheel loads caused longitudinal cracks at joints parallel to the centerline of the concrete slabs. The analysis did not account for the microcracks developed during the concrete placement, minor ASR damage in the concrete material, or an increased cover depth during construction found in the I-75 site investigations. The extent of cracking may have been exacerbated if these effects were taken into consideration in the material model. Many of these problems are not common in Georgia pavements, therefore these conclusions apply only to I-75. A full report of conclusions and recommendations are presented in Section 10 – Conclusions.

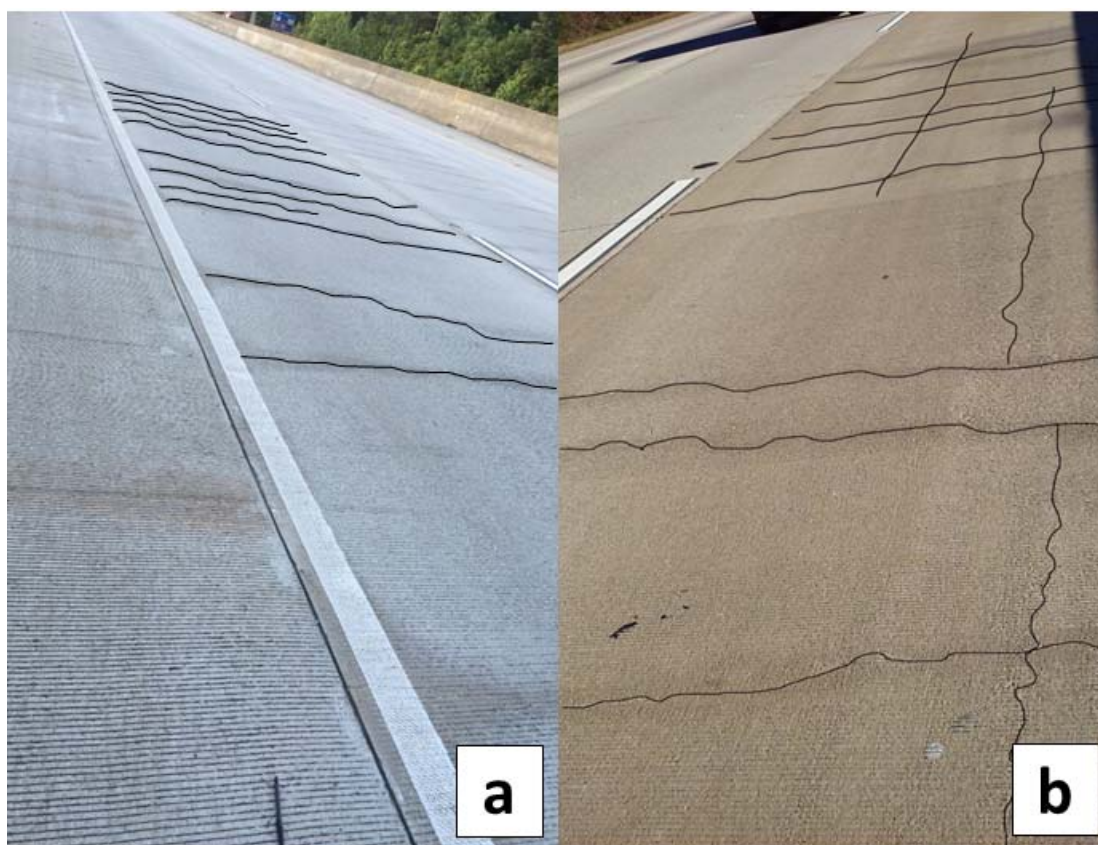
Figure 7.2 - Site Photos of CRC Pavement  
 . (a) I-85 MP 45-44 (Fair Condition) (b) I-85 MP 55-54 (Poor Condition).  
 Note: Cracks enhanced for clarity.

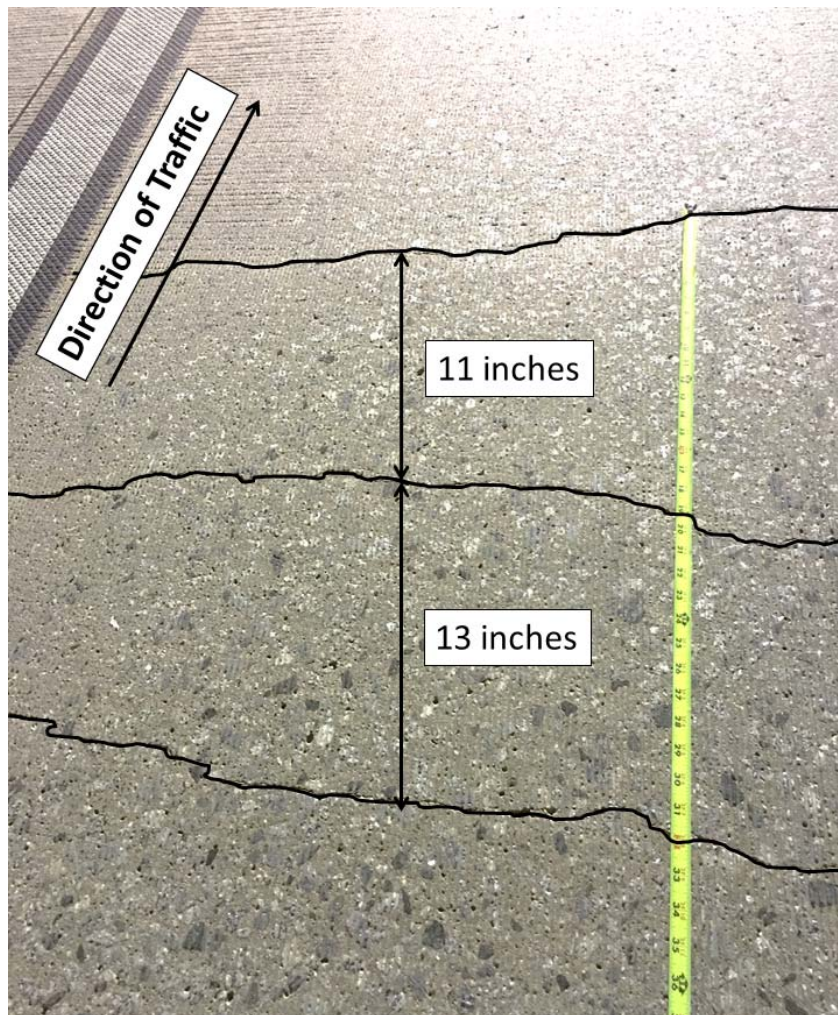
observed. In the MP 55 section, crack spacing was observed to be very similar to MP 45, in that most of the cracks were located 3.5 inches to 13 inches apart. Neither pavement sections meet the recommended crack spacing from other DOT's, but they are not seen as a sign of distress in Georgia pavements.

Figure 7.3 - I-85 Typical Transverse Crack Pattern (Cluster Cracking)

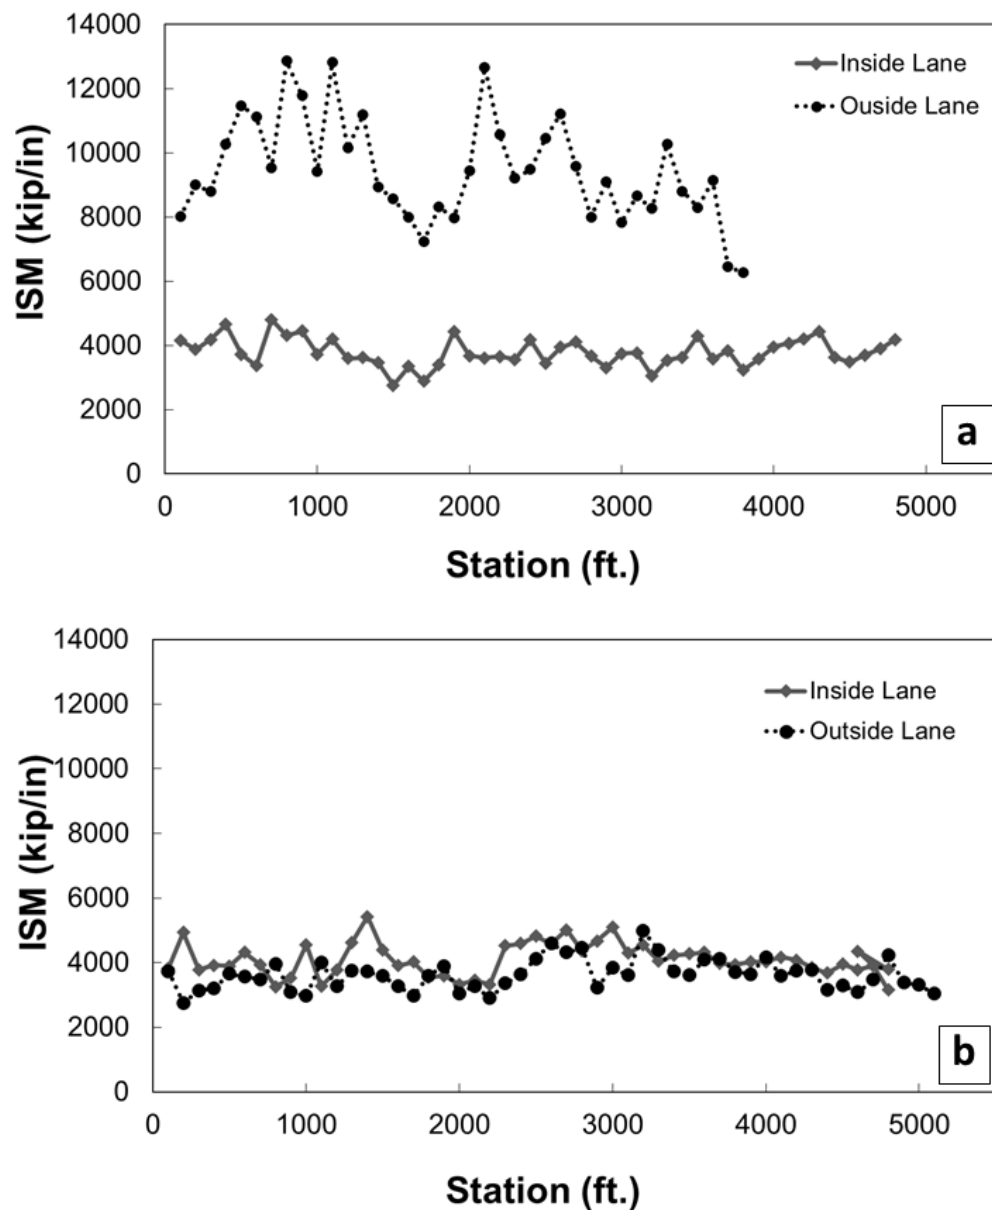
unusually high ISM value and irregular variation, which might be interpreted as a possible structural variation. After taking coring samples, a very stiff subgrade was located underneath the outside lane. This results in an abnormally high ISM value, as seen in Figure 7.5. The ISM test is dependent on the soil strength, although soil strength does not affect pavement performance.

Figure 7.5 - ISM Plots for CRC Pavements  
(a) I-85 MP 45 (b) I-85 MP 55

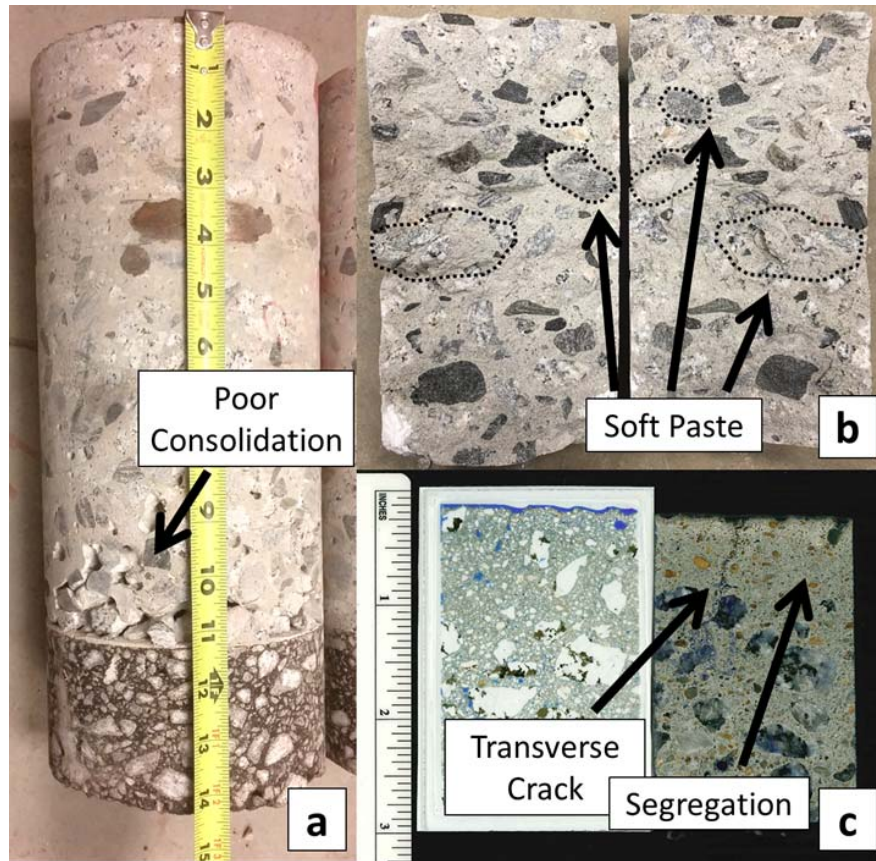
attributed to poor consolidation, as shown in Figure 7.10(a). Although the paste was reported to be of fair quality, it was much softer than the aggregate, as seen in Figure 7.10(b). Also, segregation issues are often attributed to excessive vibration, as seen in Figure 7.10(c).

Figure 7.10 - Construction Signs of Distress\* on I-85 MP 55-54 (Poor Condition)

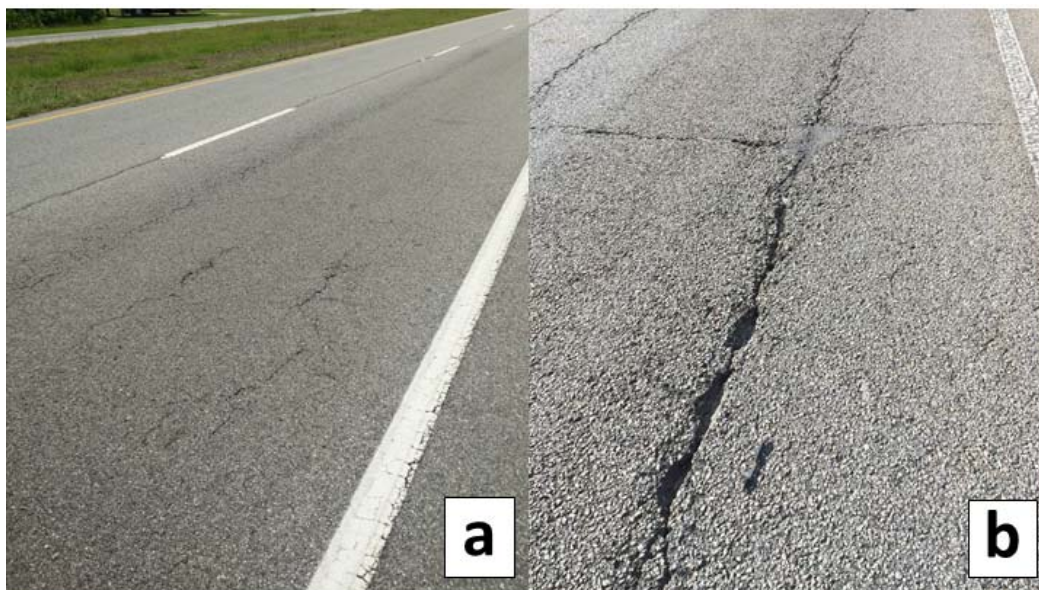
Figure 8.2 - Site Photos (AC pavements)  
 (a) SR 38 (fair condition) (b) SR 54 (poor condition)

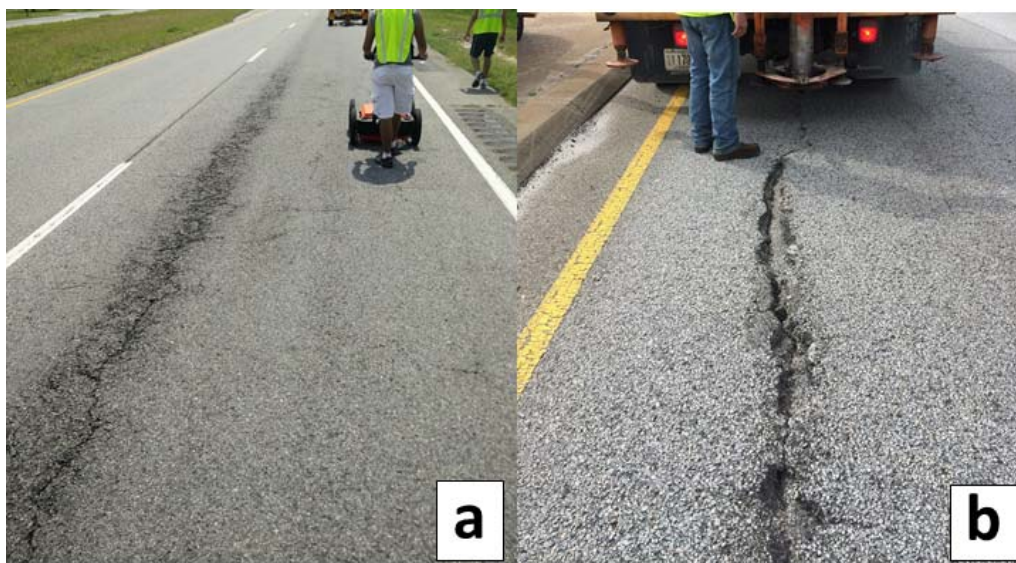
Figure 8.3 - Typical Distress  
(a) SR-38 (b) SR-54

As previously mentioned, SR-38 exhibited moderate raveling and fatigue cracking on the left side of the outside lane (Figure 8.3(a)). Due to the unique location of longitudinal cracking, it was suspected that the distress was initiated by reflective cracking and deteriorated further due to traffic. Observation of cored specimens from SR-38 confirmed that cracking was reflected from soil cement. Reflective cracking is a common distress among pavements when a soil cement is used, because the soil cement typically experiences shrinkage cracks, which is reflected upward to the pavement surface (Adaska, 2004).

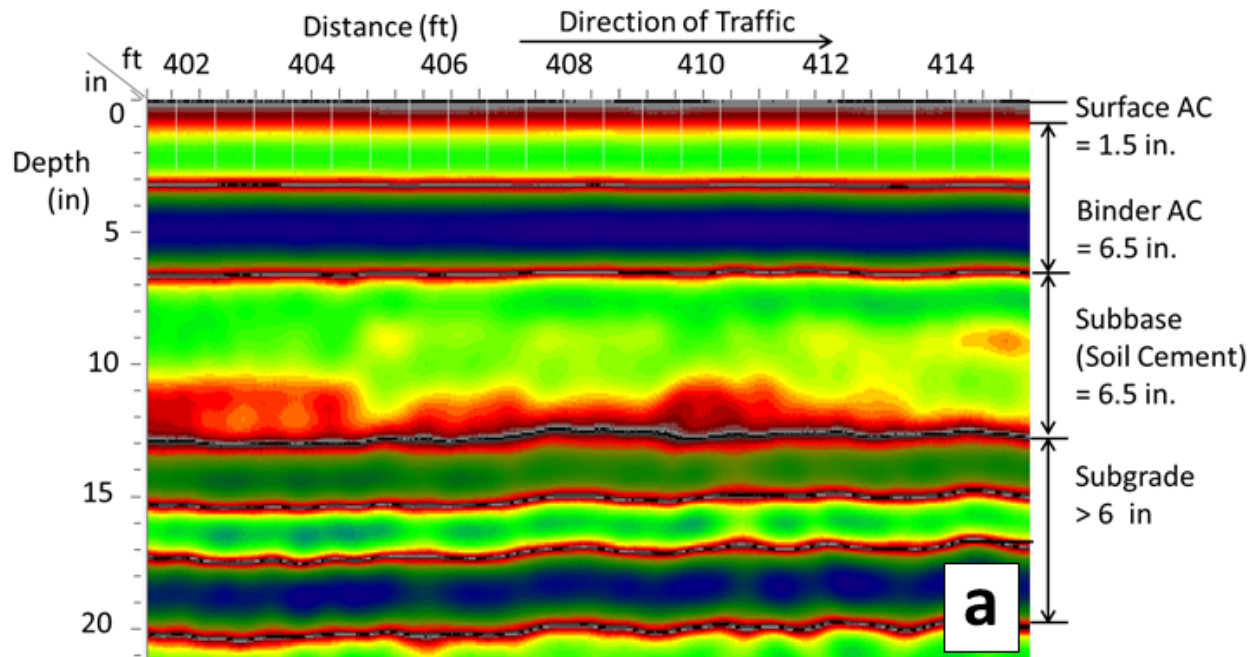
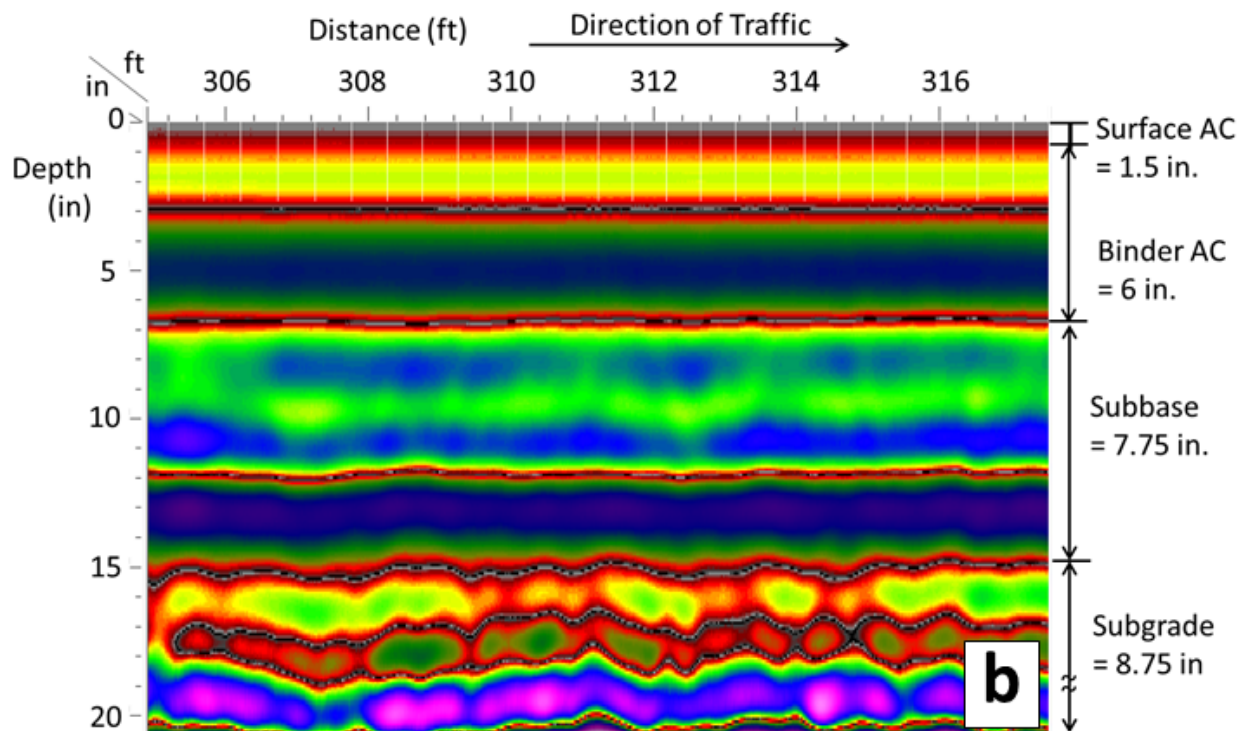
from 12 inches to 23. These irregular cores contained very thick binder and base mixtures, with no GAB below. The most logical explanation is that the previous roadway underwent a full-depth rehabilitation that left some pieces of the existing roadway in place. It is assumed that the road was most likely widened at that time, which explains why the outside lane has a steady ISM value. The average ISM value for the outside lane is 900 kip/in, which is lower than the value of pavement from SR-38 (around 1100 kip/in).

Figure 8.4 - SuperPave pavement scan  
(a) SR-38 and (b) SR-54

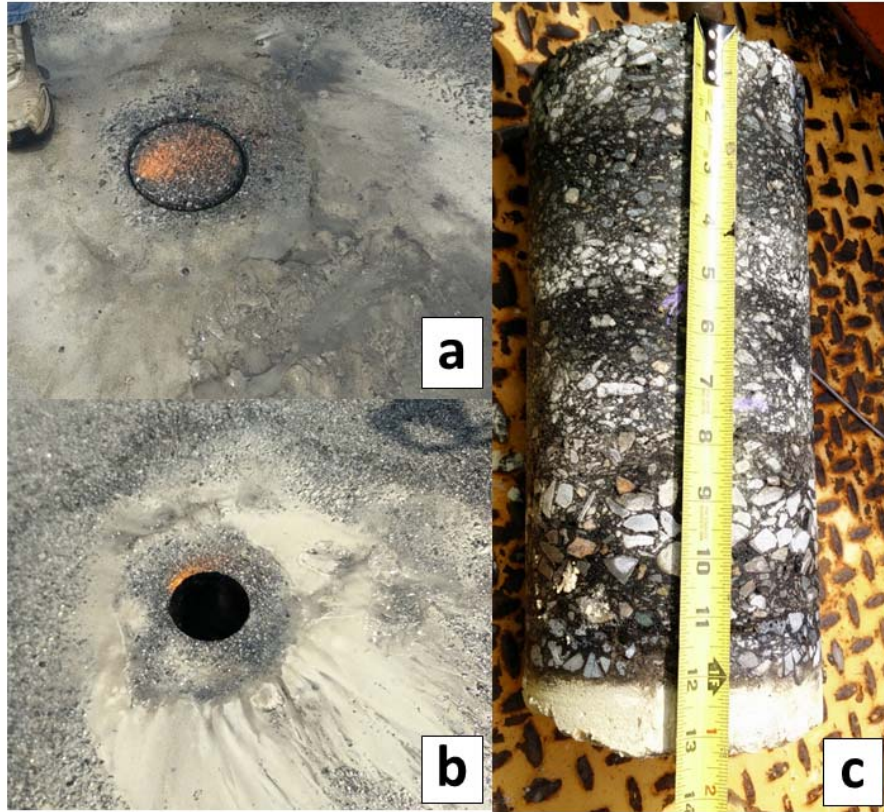
Figure 8.6 - Typical Cores at Joints (SR-38)

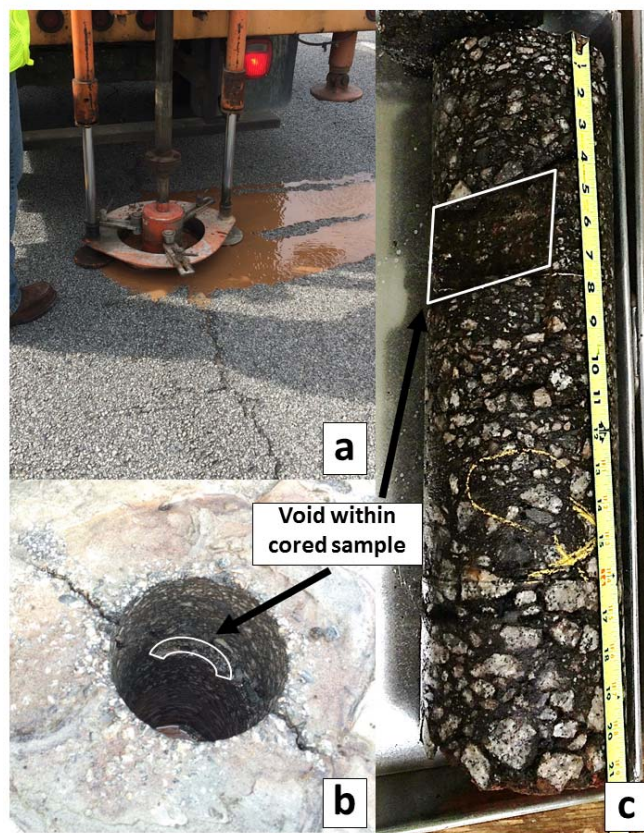
Design drawings were not available for SR-54. The irregular length of coring samples from the inside lane of SR-54 lead to the conclusion that, the inside lane was composed of an existing pavement that contained an asphalt base (Figure 8.7c). The existing road underwent a full-depth rehabilitation on partial sections of the road. The two pavements are joined at the wheel path locations in the pavement. The large cracks shown in Figure 8.3 (b) initiated from the two pavement layers.

Figure 8.7 - Typical Cores at Joints (SR-54)

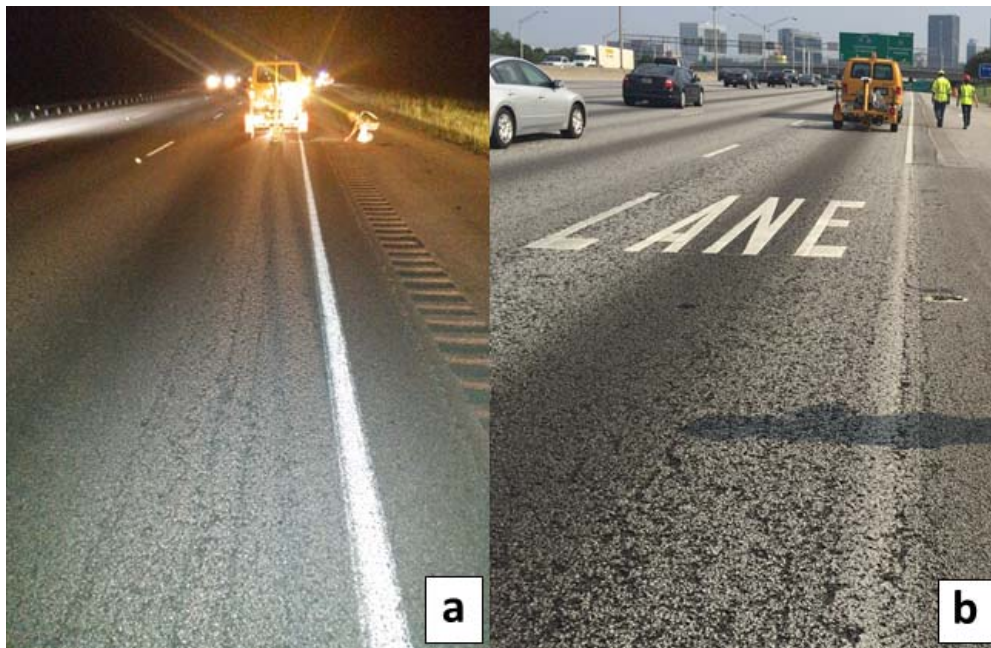
Figure 9.2 - Site Photos (PEM pavements)  
 (a) I-95 (good condition) (b) I-75/I-85 (poor condition)

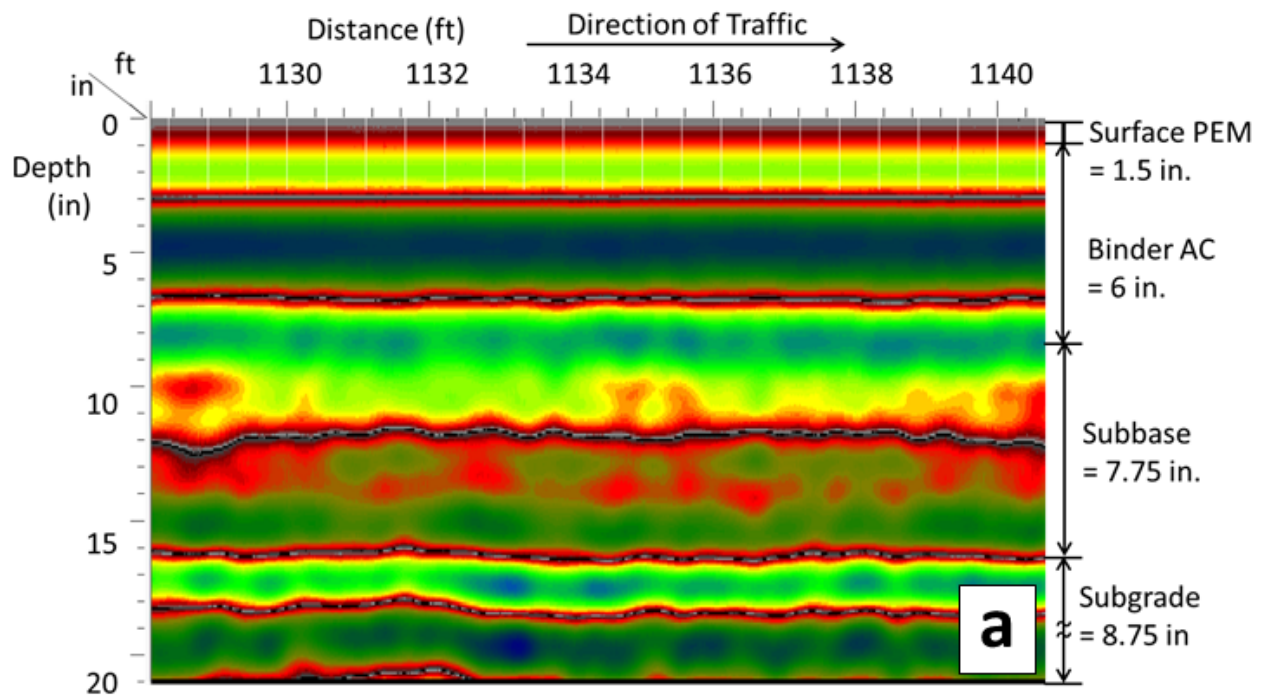
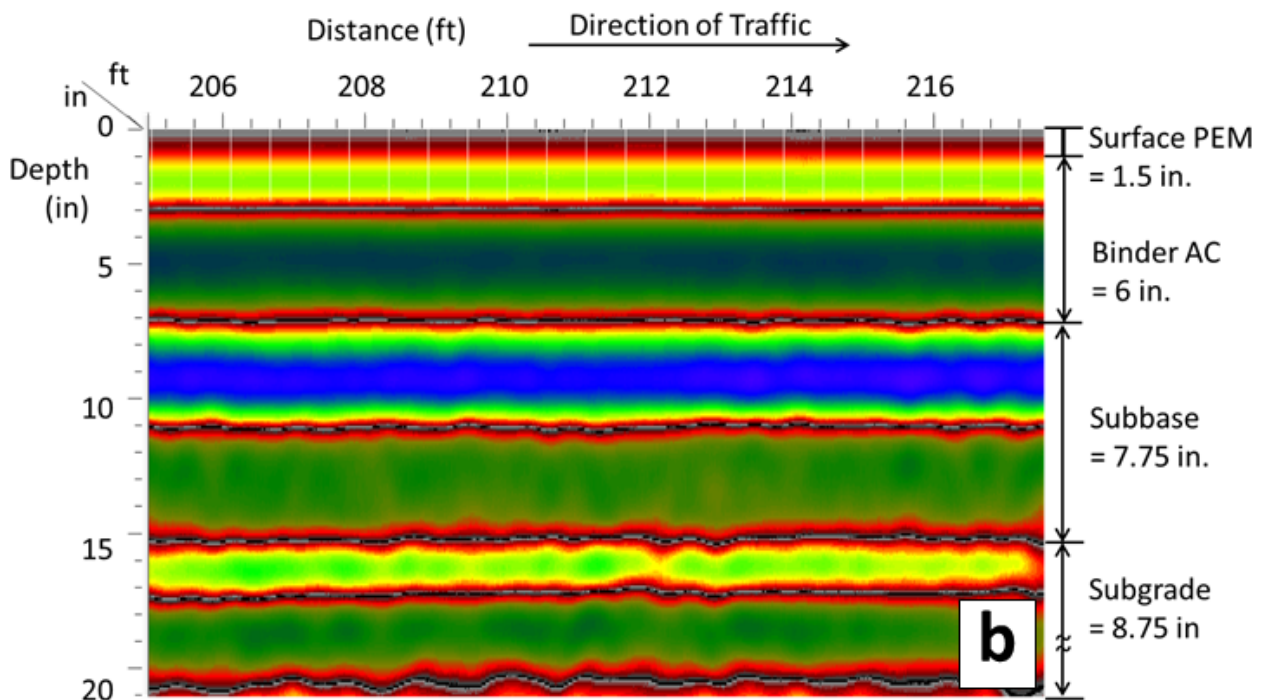
Non-destructive testing was carried out by using a Falling Weight Deflectometer (FWD) and Ground Penetration Radar (GPR). More information on these technologies is shown in Section 3.3 - Review of Pavement Forensic Technologies – Non-destructive. A representative scan from I-95 and I-75/I-85 with labels denoting PEM surface, base, and subgrade profiles is shown in Figure 9.3. Both scans showed consistently level layers with no air voids.

Figure 9.3 - PEM pavement scan  
(a) I-95 and (b) I-75/I-85
