The Rock House

Historic Structure Report
Fall 2011

Forward

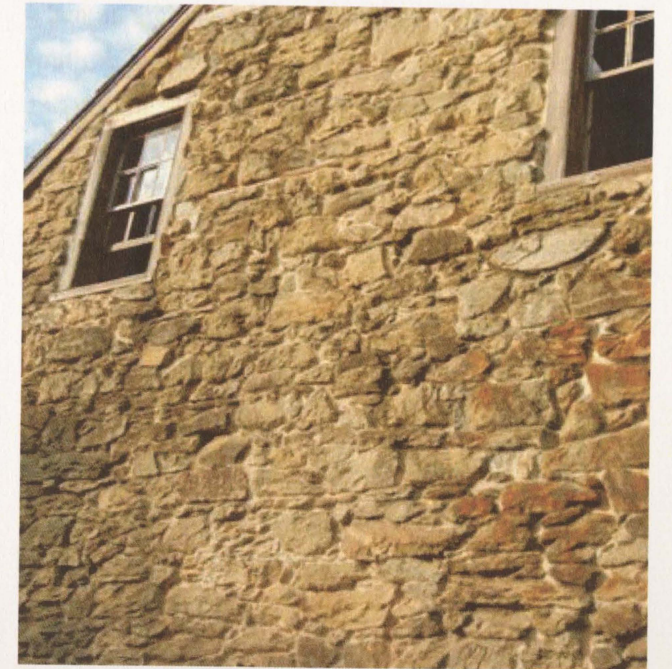
The water drainage on the south facade has impaired the cellar entrance retaining walls,

and caused the south cellar windows to rot. Previous attempts to drain excess water from the cellar are evident, with the placement of drain pipes in the corners of the basement. However, the system is not successful since the floor is not graded to move water towards the drains.

- Regrade around the foundation to establish positive drainage so that water flows away from the structure.
- Install french drain around the base of the building to remove water trying to work its way under the foundation wall.

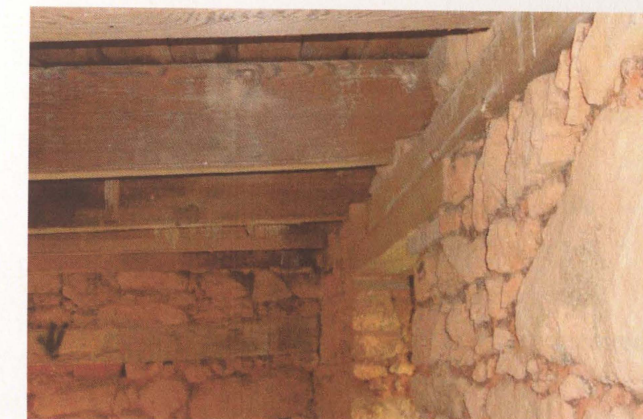
The rubble stone basement walls have been repointed only on the chimney support walls. The east chimney's left corner shows a definite slant to the left and has cement repointing placed over the original

clay mortar. It is unclear at this point, whether this slant was an original feature of the wall or if it has shifted over time.

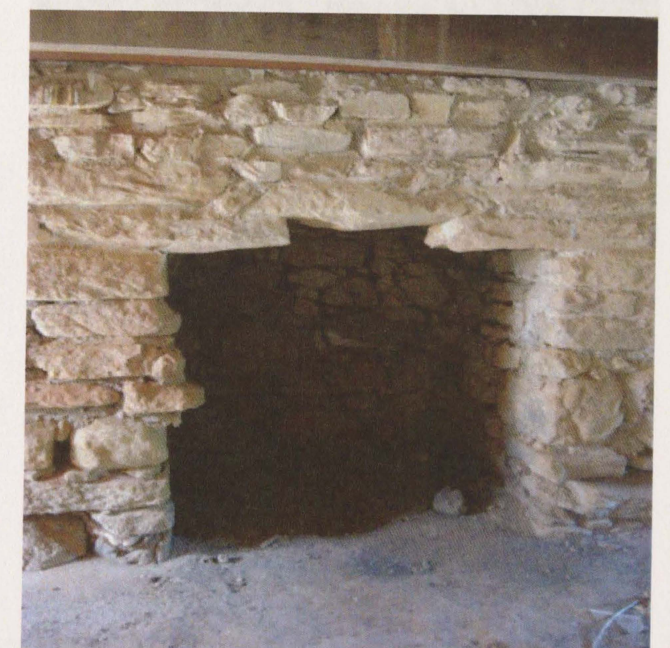
The fireplace on the west wall is missing its key stone, but it has been missing since at least the 1960s

when an archival photo was taken. The mortar on the southwest corner of the fire place has been eroded and will need repointing. The stone work above the west wall window is showing signs of settling and cracking due to termite damage in the window header (discussed in *Framing*), and the cracks are expressed through to the exterior as well.

The large fireplace hearths were replaced during the Askins renovation and show signs of cracking due to rusting of the metal plates installed behind. The fireplace boxes themselves (especially the east chimney) show signs of settling and repairs made to the inside of the flu. The chimneys do not have caps on them which allows water to run down the inside of the structure.

- Remove loose interior stucco.
- Appropriately assess the historic mortar mixture. Then repoint eroded and missing mortar

segments around the basement fireplaces with the appropriate mortar mixture.

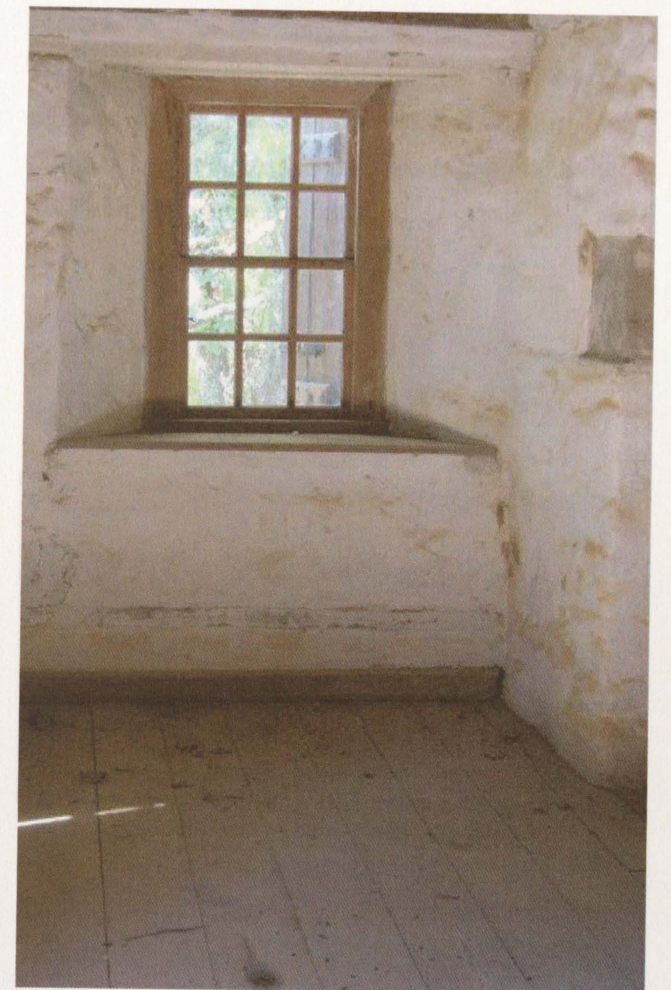
The first floor sags toward the main support beam running parallel to the north wall of the building. However, the floors appear to be in generally good condition. The flooring appears to be relatively new

except for a small section in the northwest corner which appears to be older, more narrow wood. The interior partitions from the Askins restoration, and are in good shape. There seems to be no major structural issues with any of them.

- Assess the main beam and screw jack support to see if it is structurally sound for the weight of future visitors and can be used to level out the first floor.

- Work to level the floor using the existing jack if possible. If this is not possible, brace and support the main beam to level out the floor.
- Remove graffiti and repair vandalism.

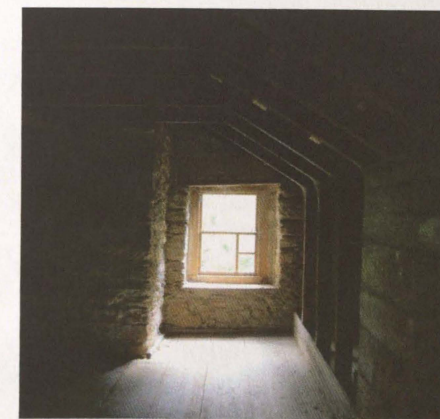
The attic floor is wide tongue and groove boards that appear to be similar except for three in the southeast quadrant of the attic that display circular saw marks. The brace roof structure is in good shape with older wood shingle nailer boards still in place. These are covered with plywood for the current roof and show signs of moisture leakage. The roof structure shows signs of both straight and circular cut marks, suggesting the roof structure is a replacement.

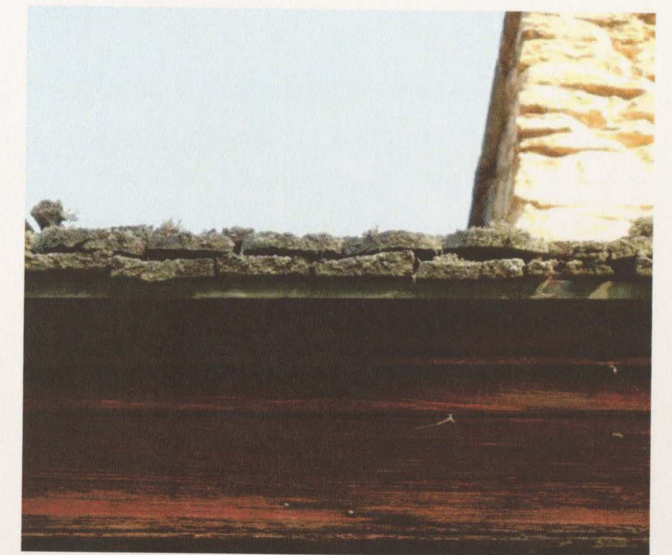
The roof is sheathed in wood shingles that show signs of failure. Missing, cupped, and broken shingles appear across the roof surface on both the front and the rear of the building.

At this time we are unable to tell if there are fur strips under the shingles or tar paper on the plywood. The current shingles also appear to be too narrow to provide adequate off set of the joints. There is also a low overhanging tree rubbing against the roof on the southwest corner of the building.

- Assess the roof and identify necessary repairs.
- Repair the roof before significant leaks occur that may damage other parts of the structure.

- Replace the existing roof with a properly ventilated wooden shingle roof.
