IMPACT OF WEATHER STRESSORS TO IDENTIFY VULNERABLE BRIDGE ELEMENTS  
IN GEORGIA TOWARDS DATA DRIVEN ASSEST MANAGEMENT

by SPENCER KOPF

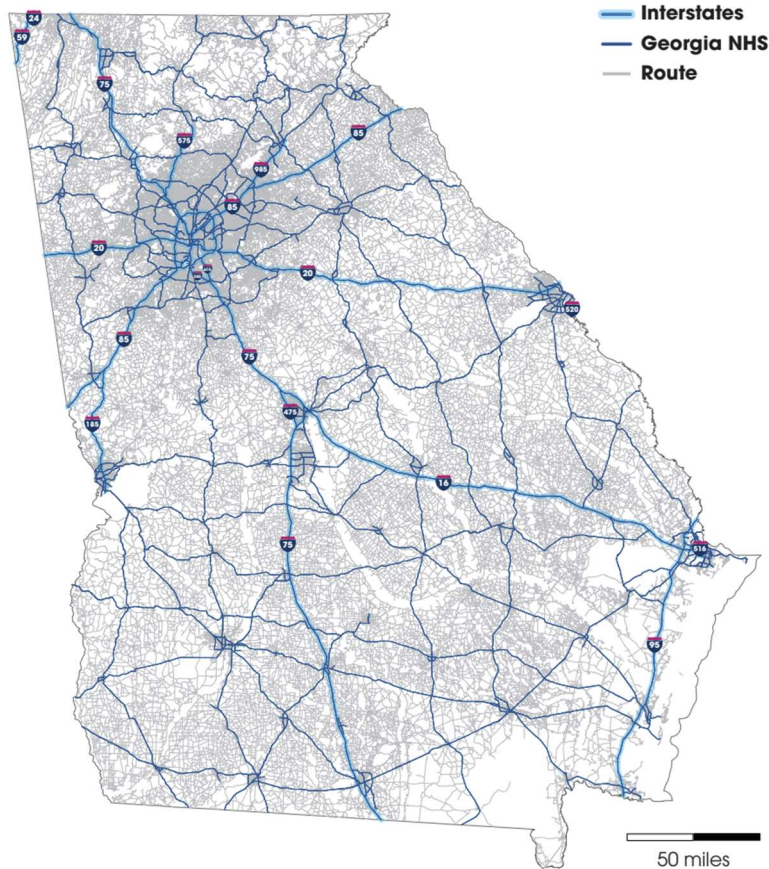
**Figure 1 - National Highway System in Georgia \*NTS (GDOT, 2019).**

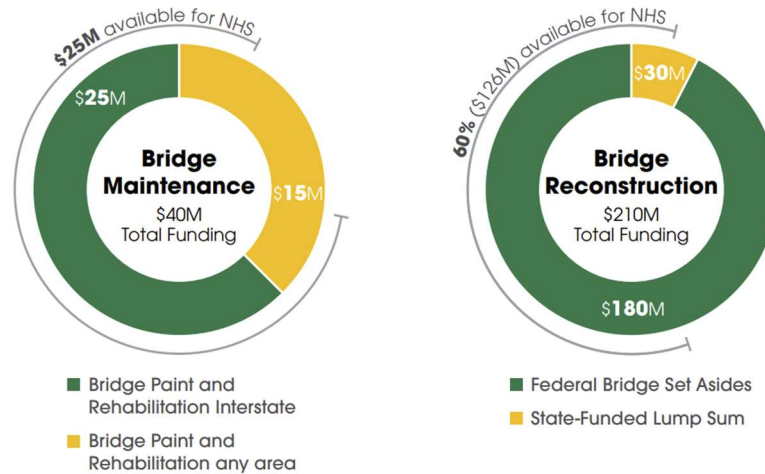
**Figure 2 - Funds Available for SRS Maintenance and Reconstruction (GDOT, 2019)**

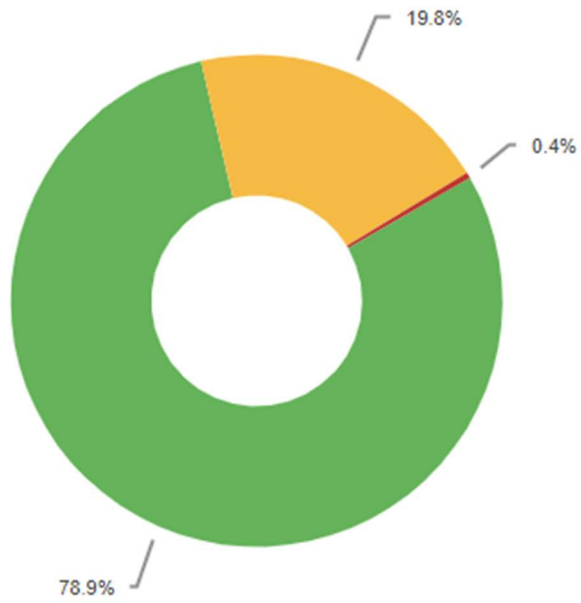
**Figure 3 – Current Georgia State-Owned Bridge Condition (Good, Fair, Poor)**

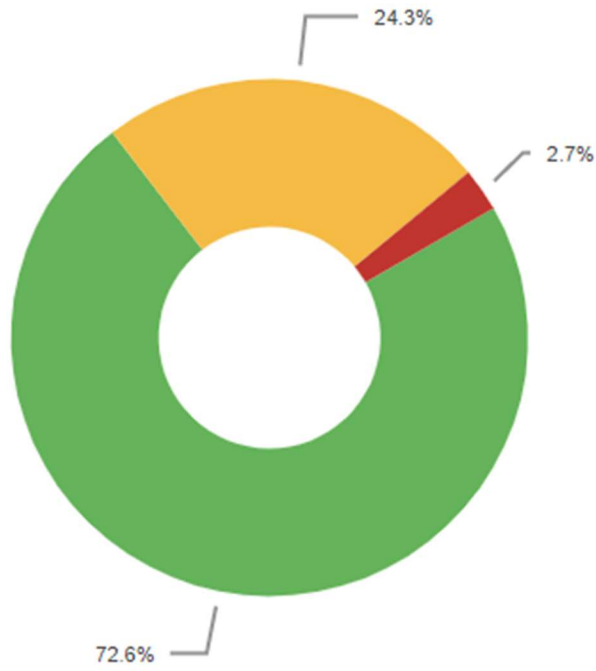
**Figure 4 – Current County-Owned Bridges Condition (Good, Fair, Poor)**

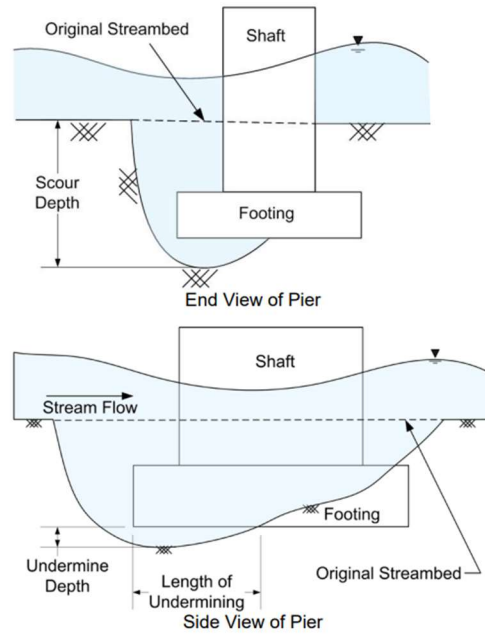
**Figure 5 – Scour and Undermining (FHWA, 2012)**

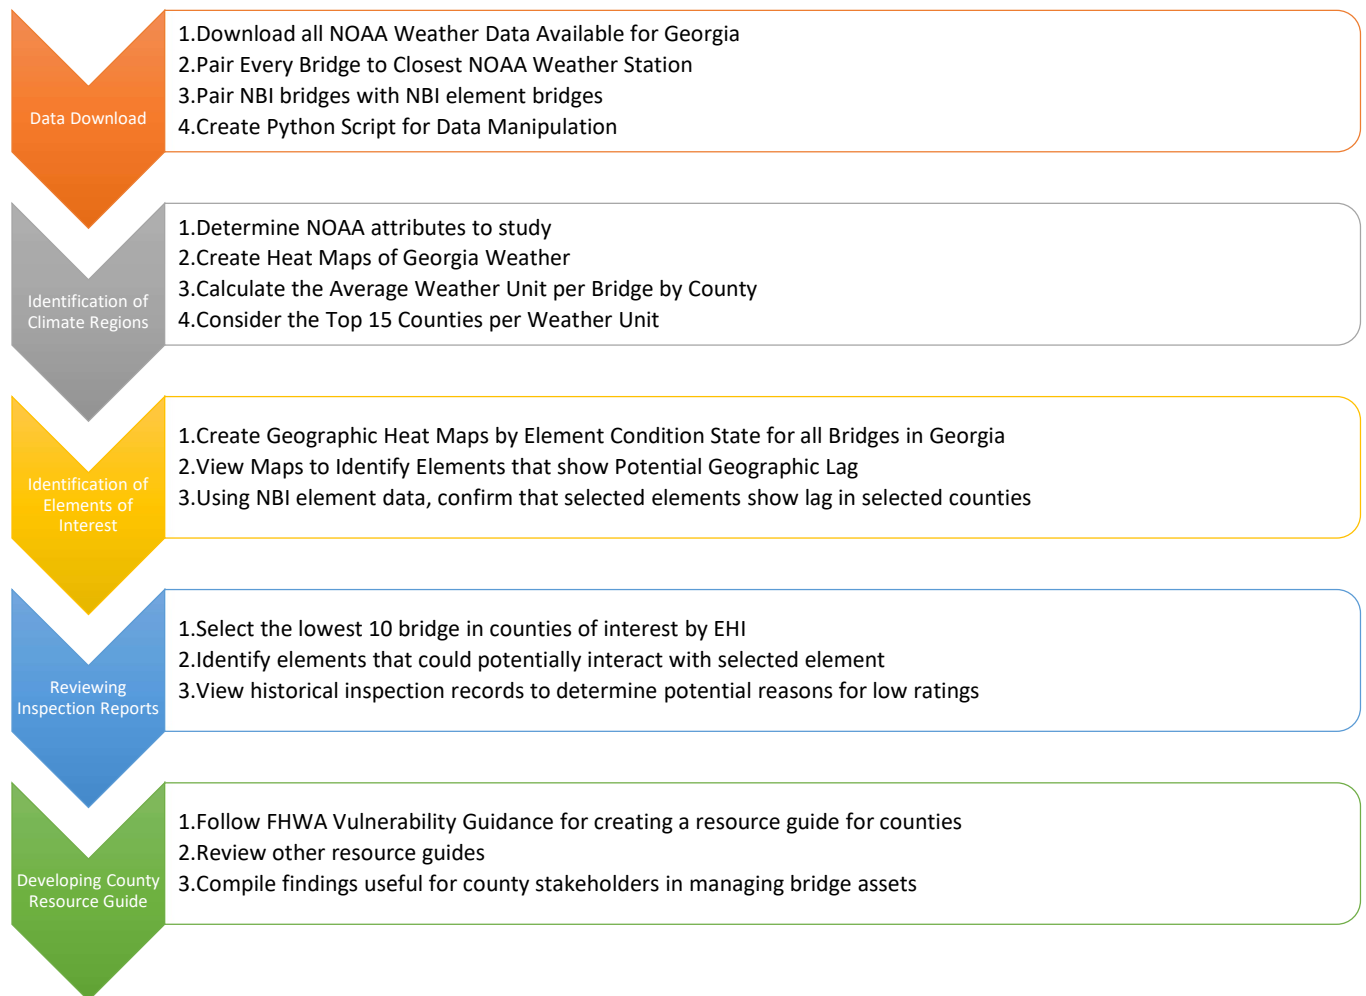
## Download NOAA Data

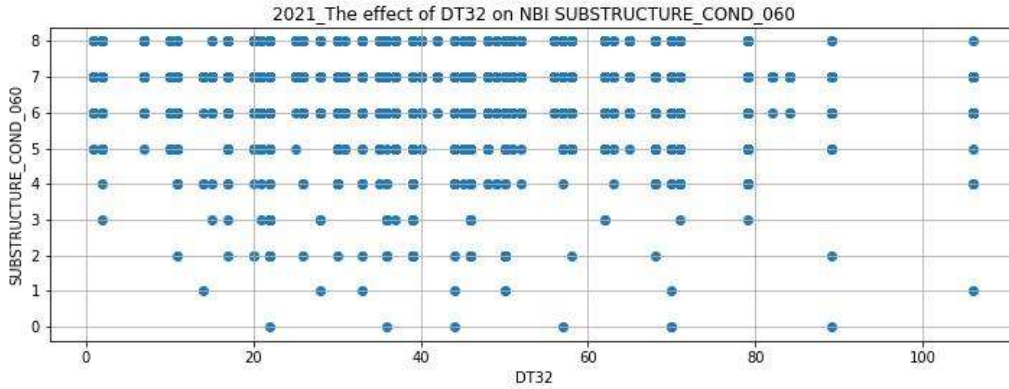
**Figure 10 – Days Under 32° F vs NBI Substructure Condition**

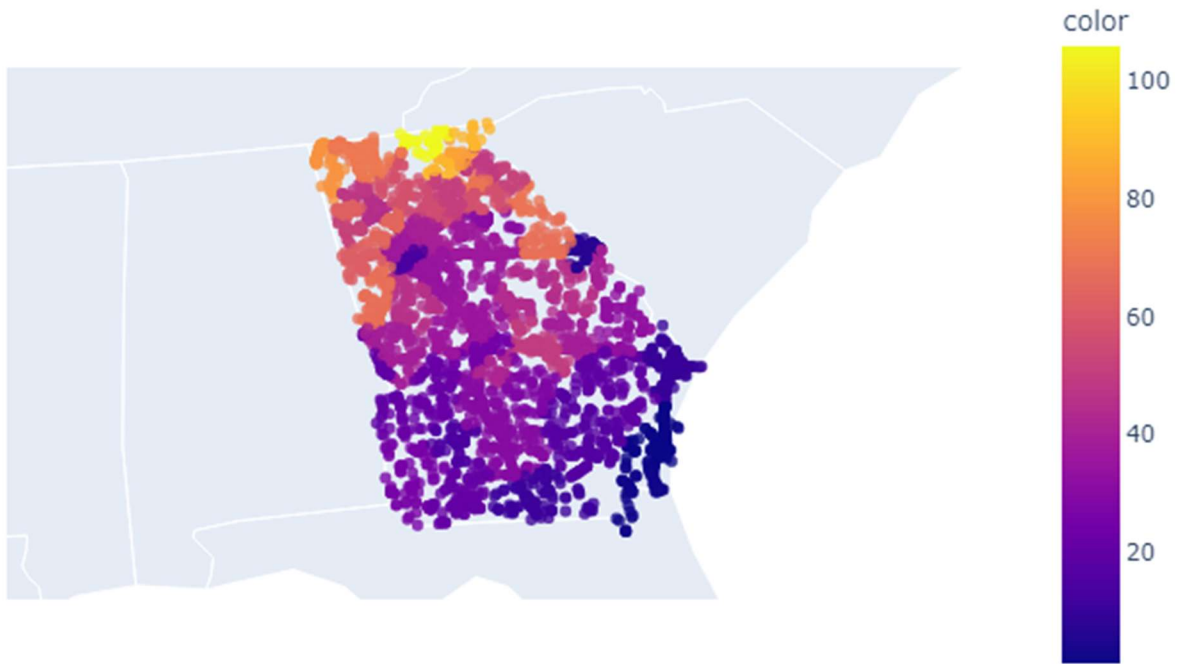
**Figure 11 – State Owned DT32 Bridge Heat Map (color = days)**

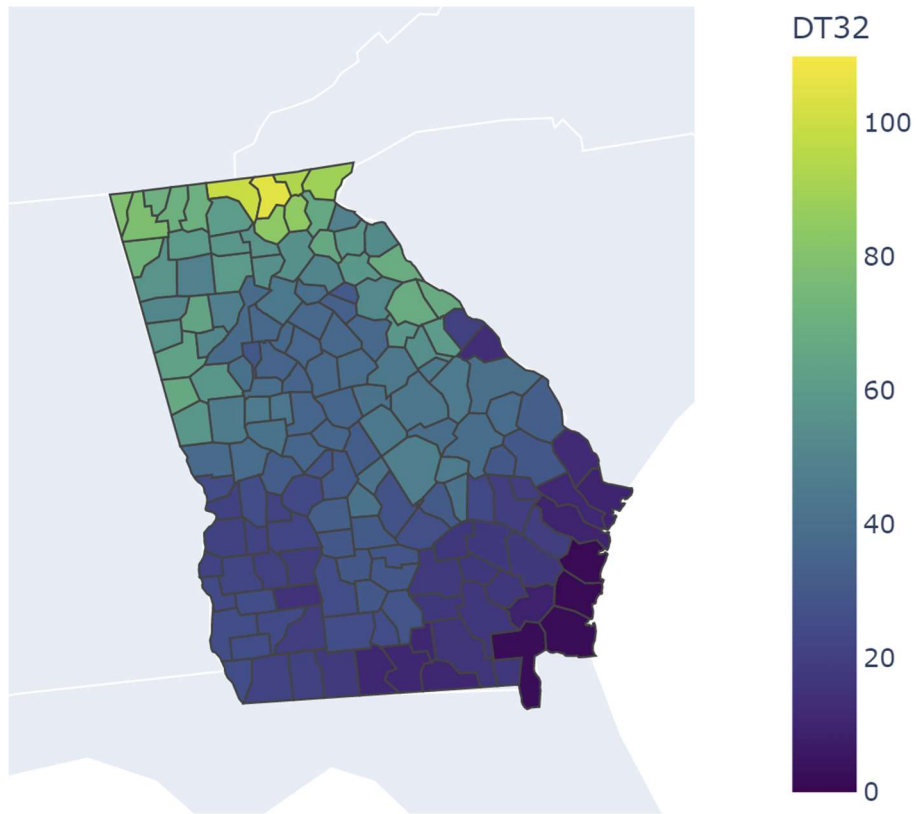
**Figure 15: Average DT32 per bridge by County, 2021**

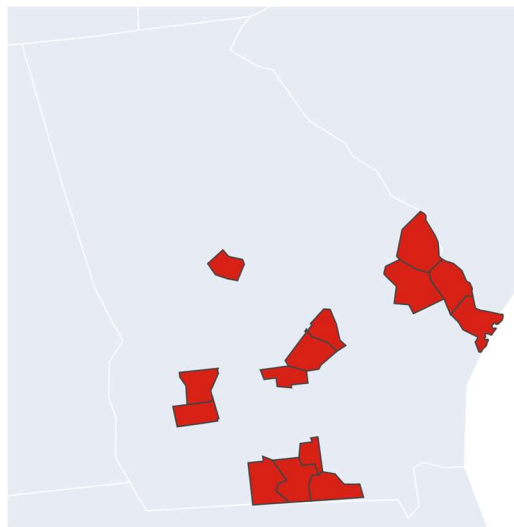
**Figure 17 - Counties of Interest DX90**

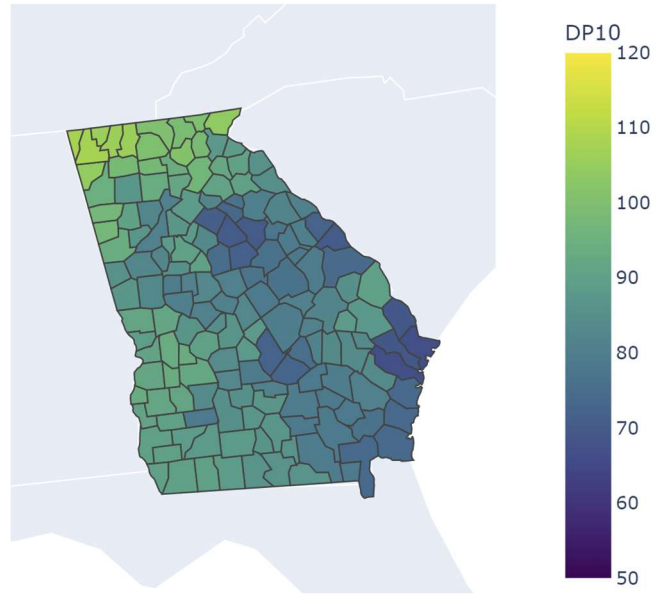
**Figure 19 – Average DP10 per bridge by County, 2021**

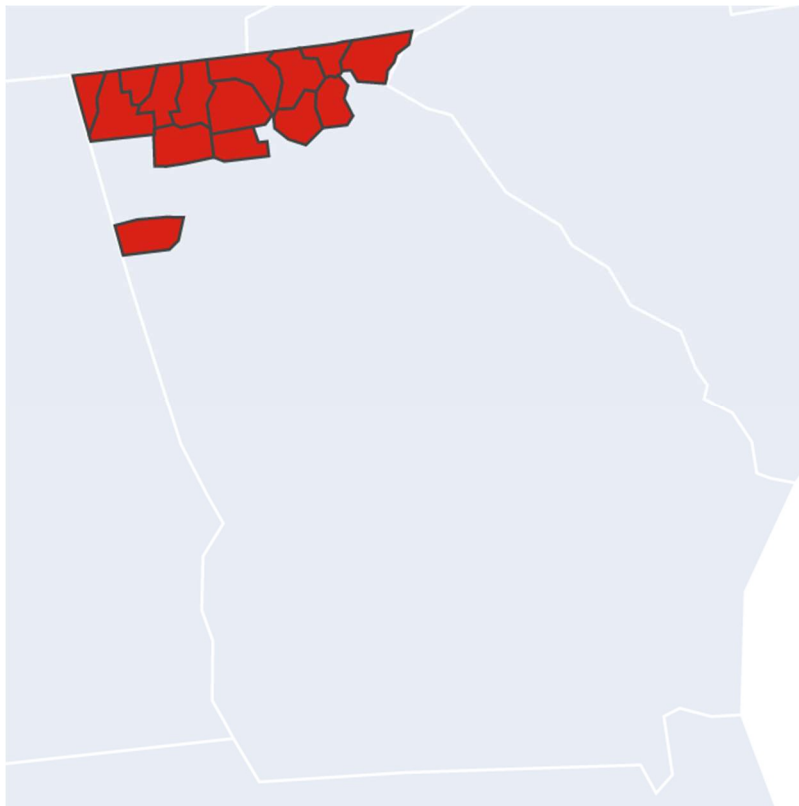
**Figure 20 - Counties of Interest DP10**

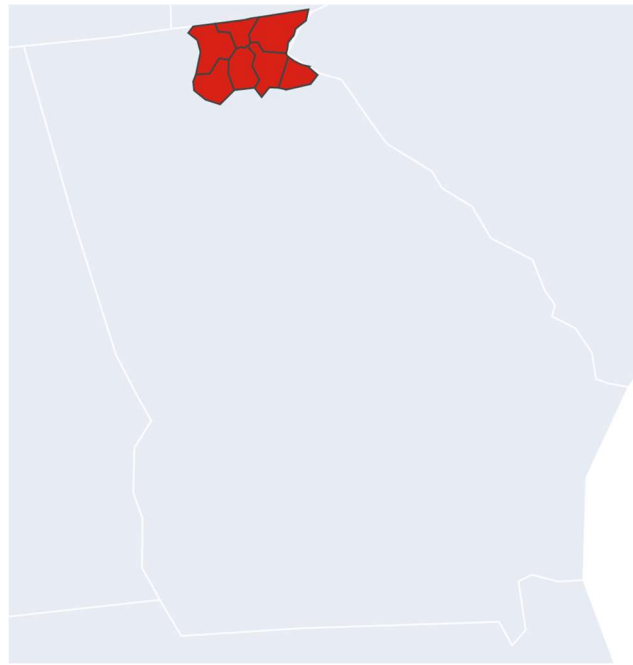
**Figure 21 - Counties of Interest SNOW**

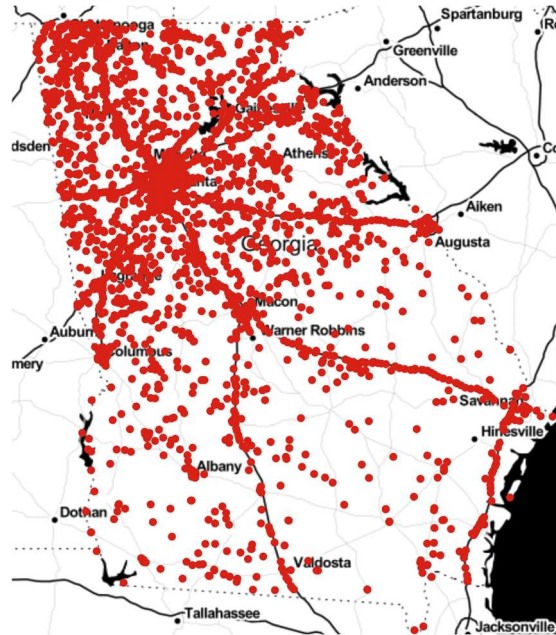
**Figure 22 – Bridges Containing EN107 Steel Girder, 2021**

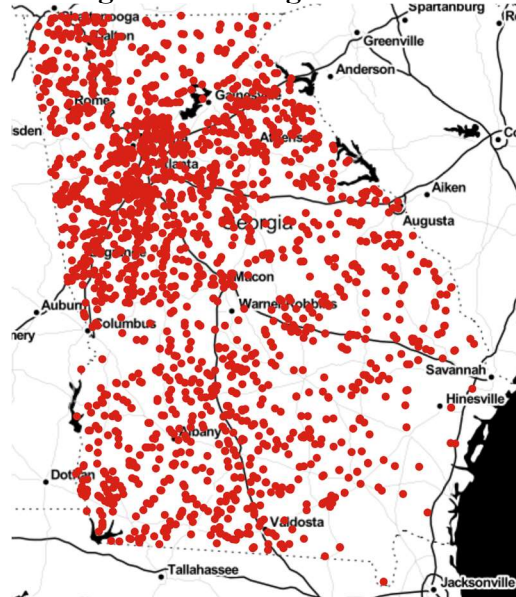
**Figure 23 – Bridges Containing EN225 Steel Pile, 2021**

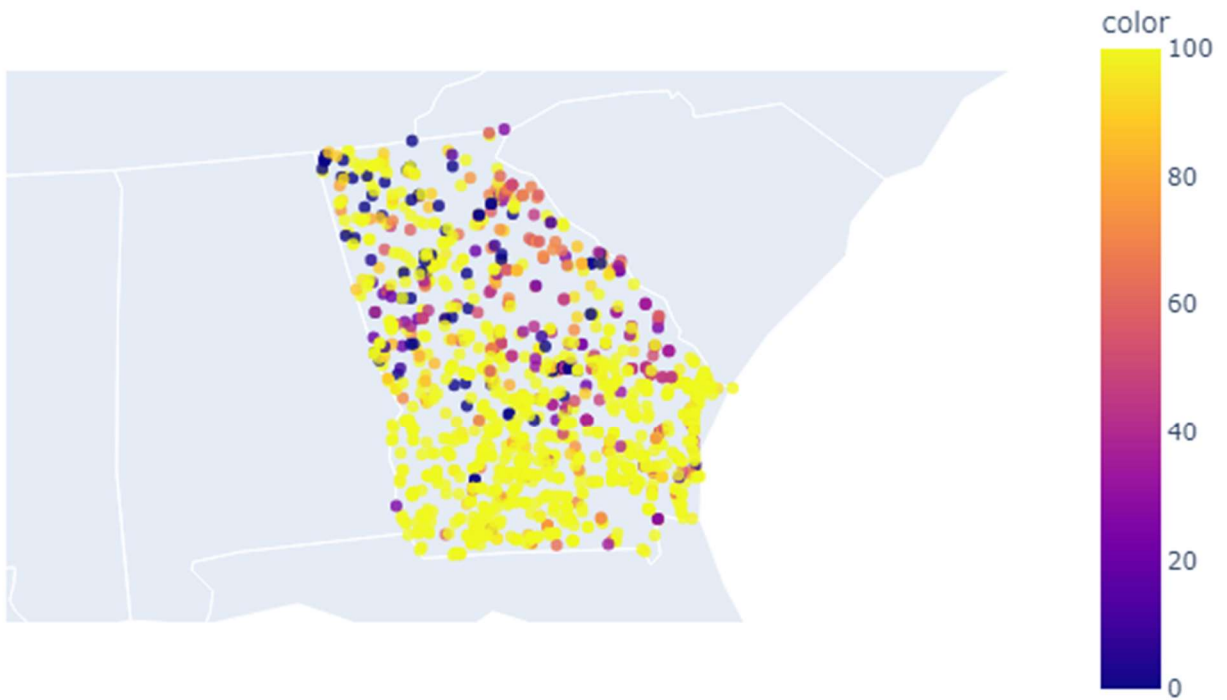
**Figure 25 – EN16 State Owned Bridges Percentage in Condition State One**

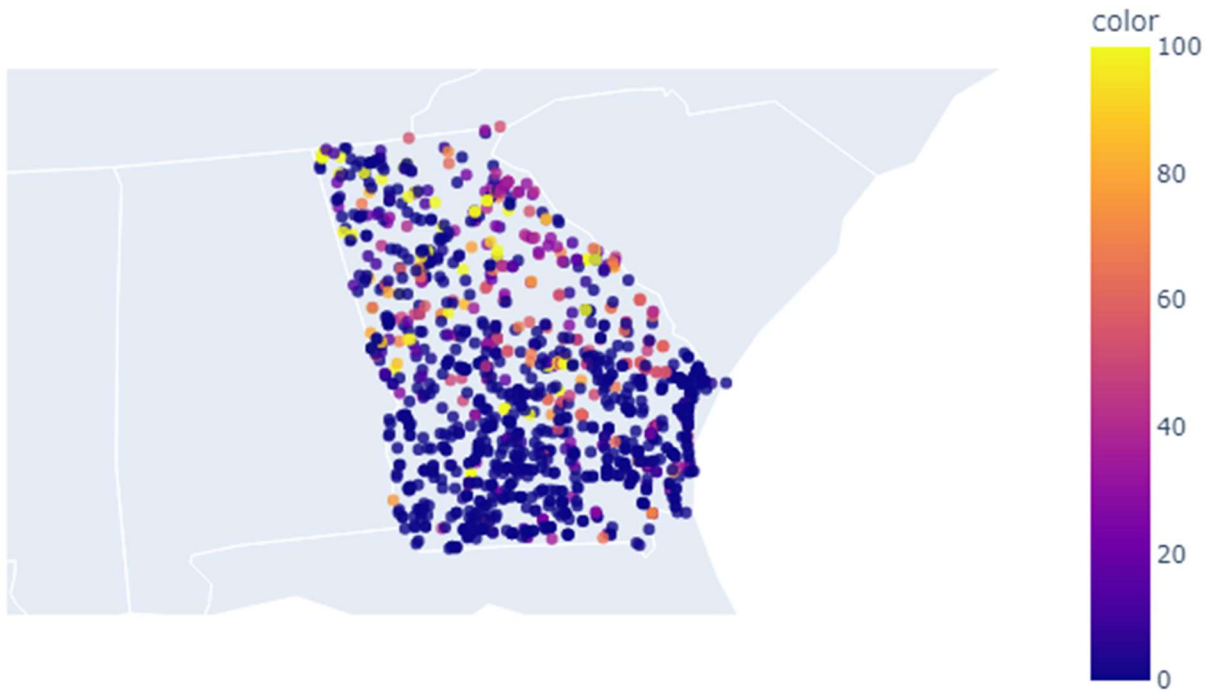
**Figure 26 – EN16 State Owned Bridges Percentage in Condition State Two**

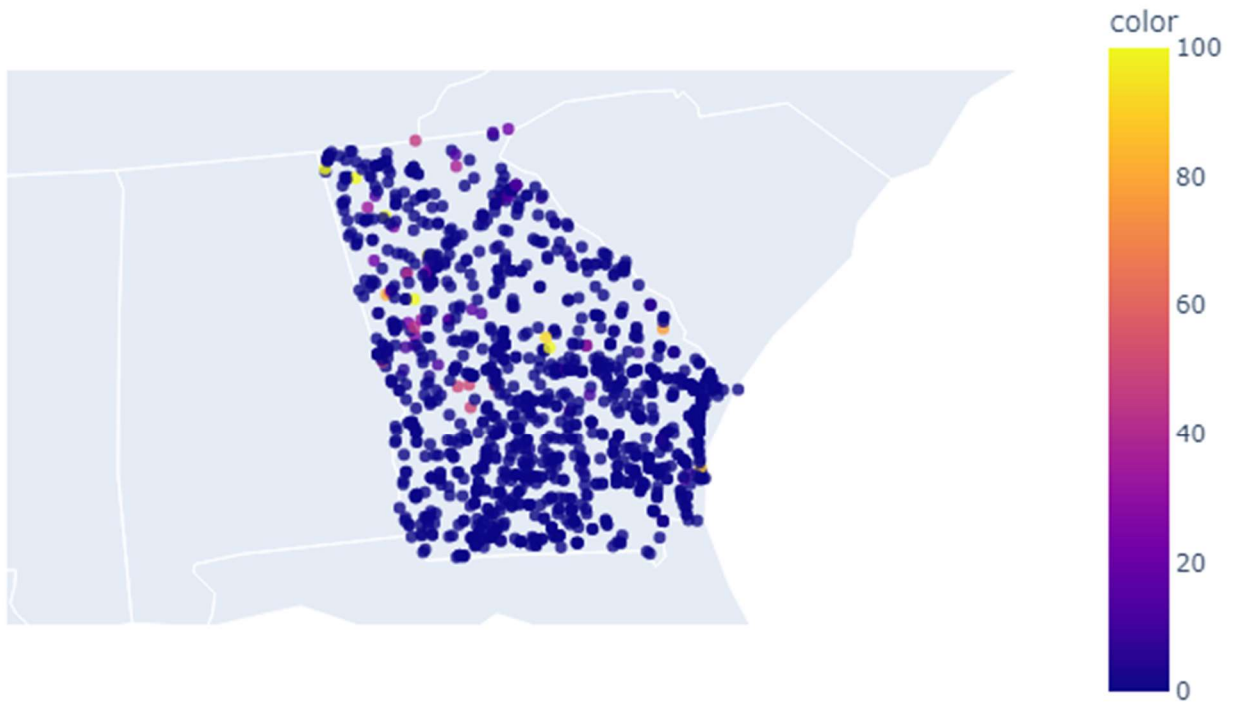
**Figure 27 – EN16 State Owned Bridges Percentage in Condition State Three**

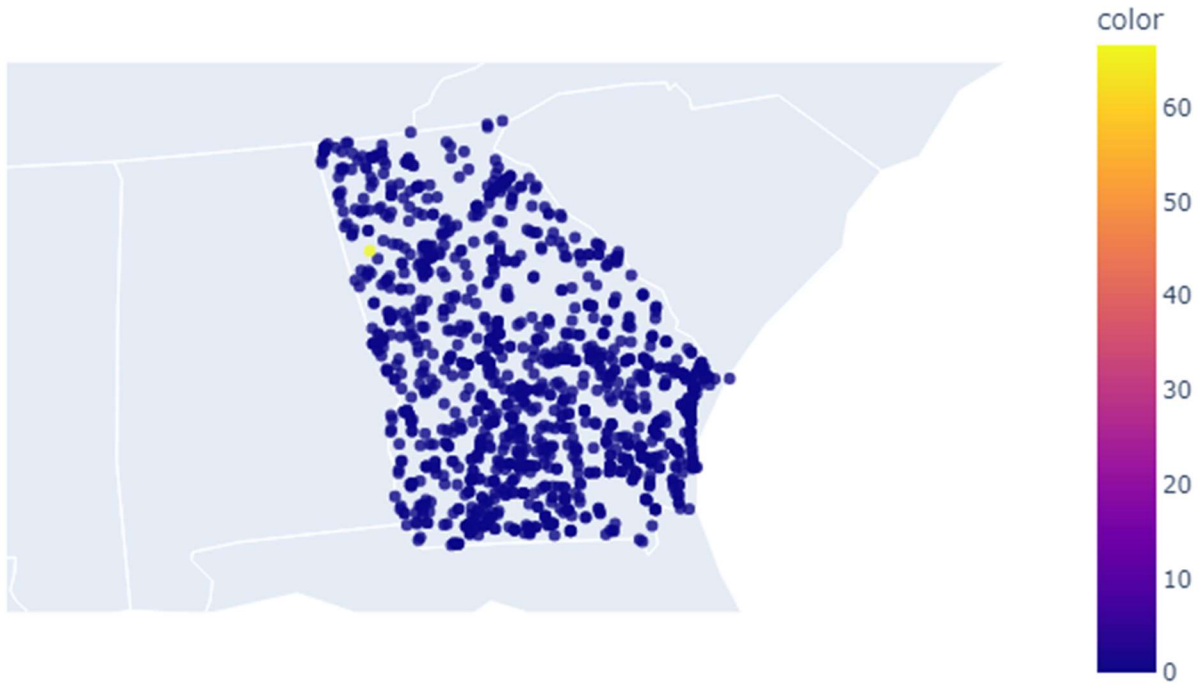
**Figure 28 – EN16 State Owned Bridges Percentage in Condition State Four**

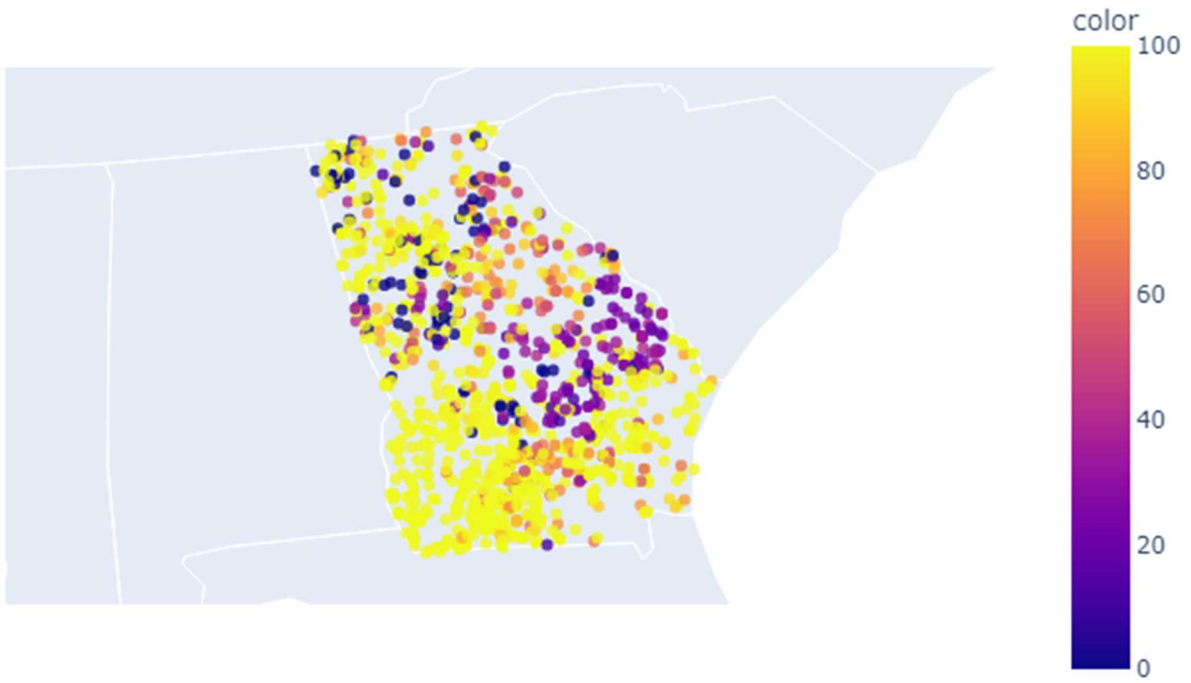
**Figure 29 – EN16 County Owned Bridges Percentage in Condition State One**

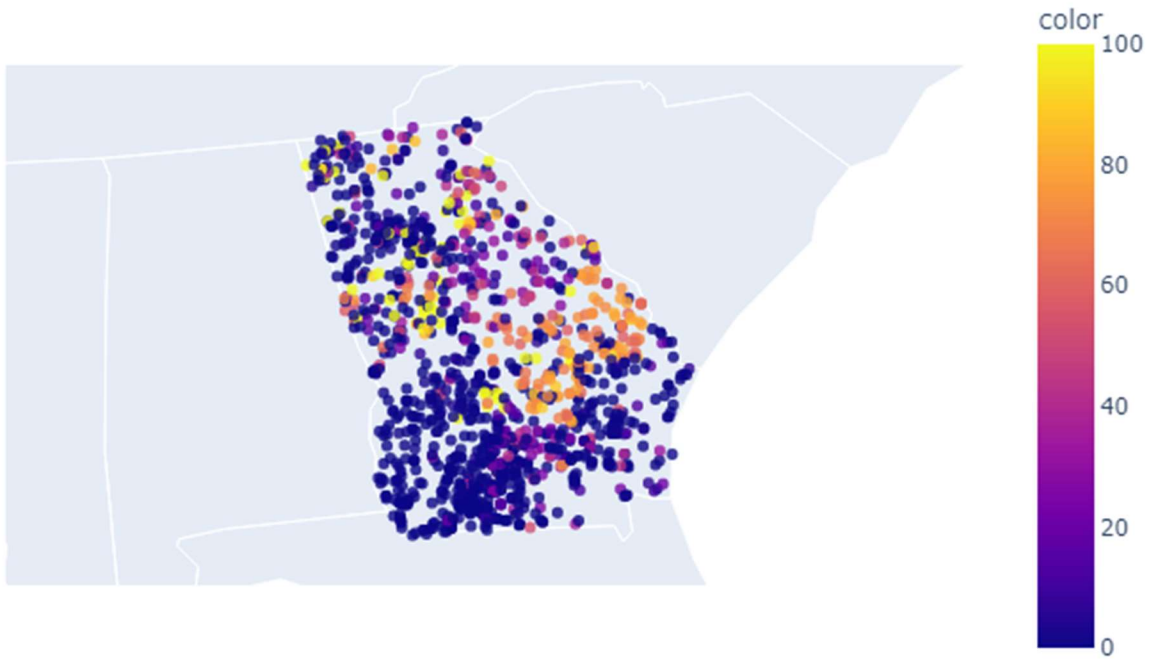
**Figure 30 – EN16 County Owned Bridges Percentage in Condition State Two**

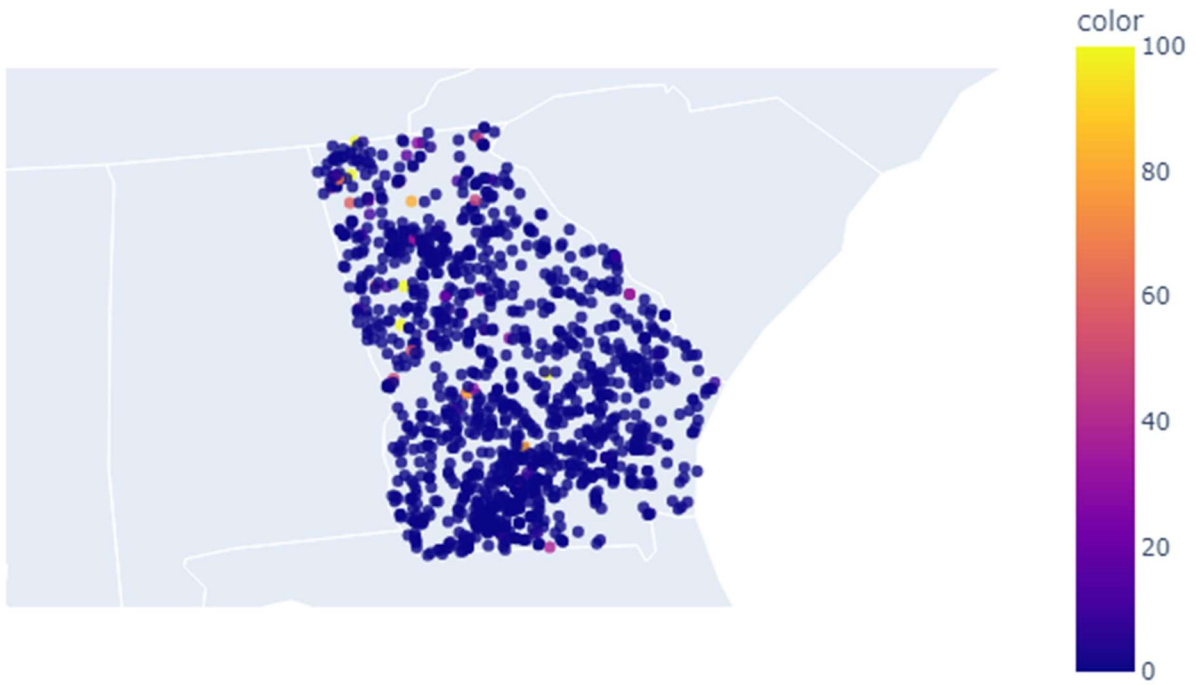
**Figure 31 – EN16 County Owned Bridges Percentage in Condition State Three**

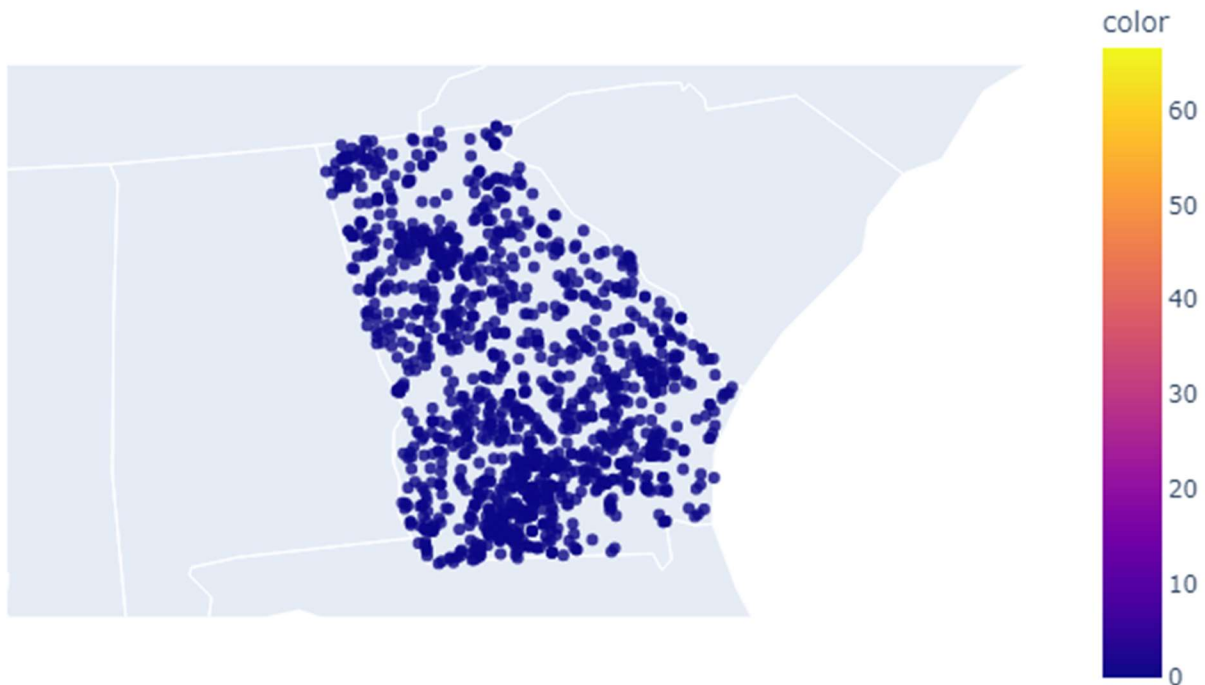
**Figure 32 – EN16 County Owned Bridges Percentage in Condition State Four**

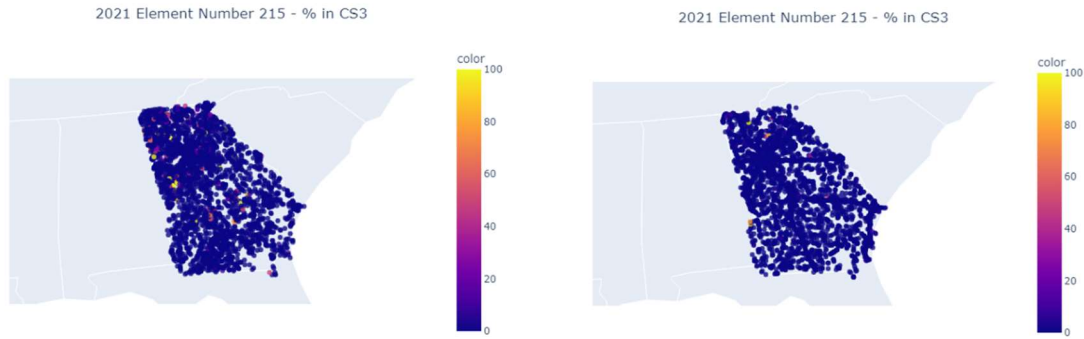
**Figure 33: Percent of EN215 in CS3 by location, 2021. County-Owned (Left) vs State-Owned (Right)**

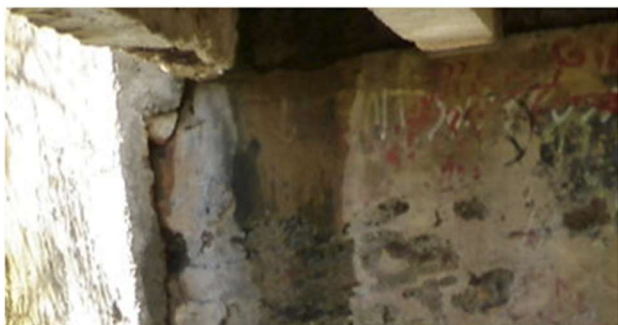
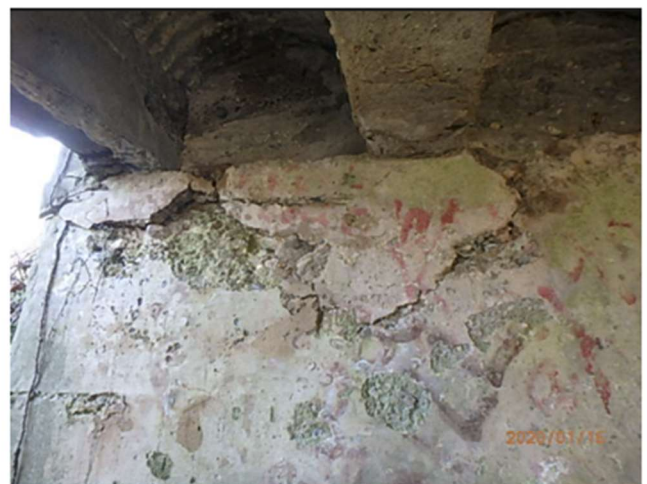
**Figure 37 - EN215 in 2014 (Left) and 2020 (Right)**

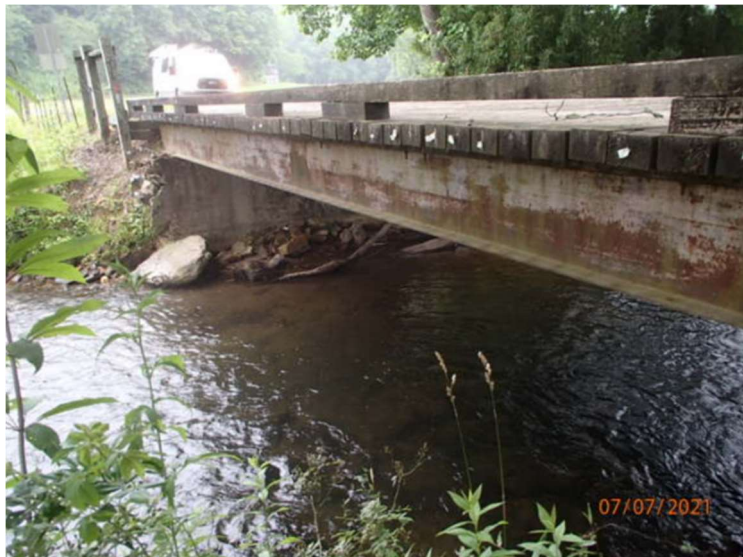
**Figure 39: Bridge 291-5028-0 Side View (GDOT, 2021)**

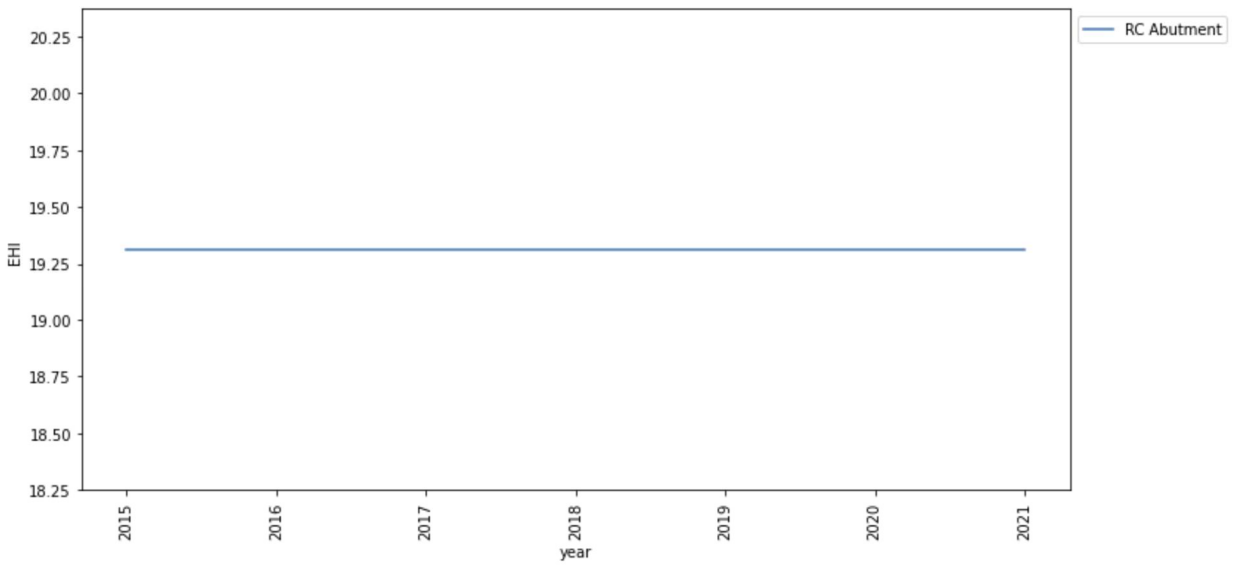
**Figure 40: , Bridge 291-5028-0 Reinforced Concrete Abutment EHI by Year**

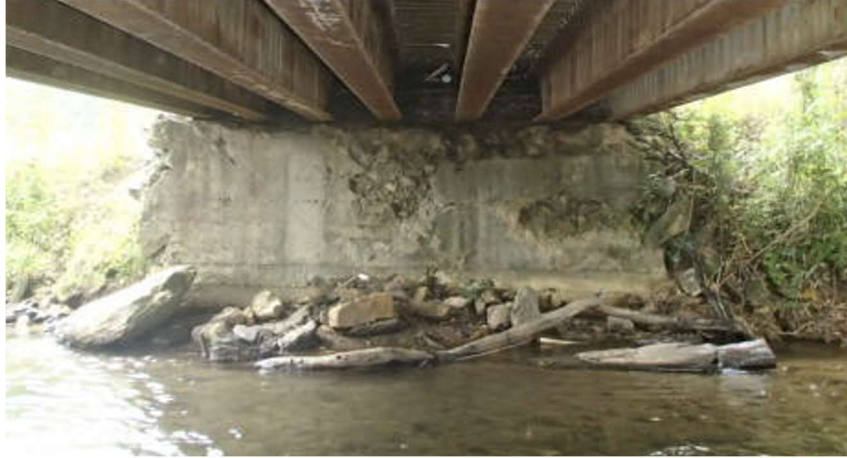
**Figure 41: Concrete Spalling in Abutment 1 in 2014 (Left) and 2021 (Right)**

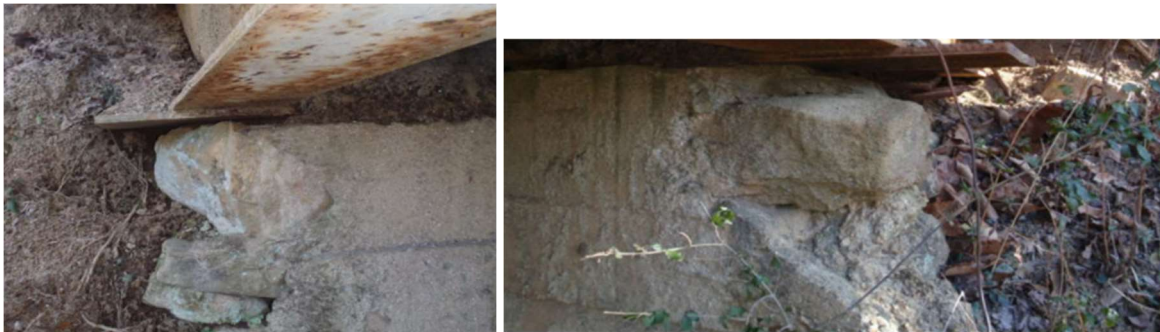
**Figure 42: Reinforced Concrete Abutment Area Loss (GDOT, 2021)**

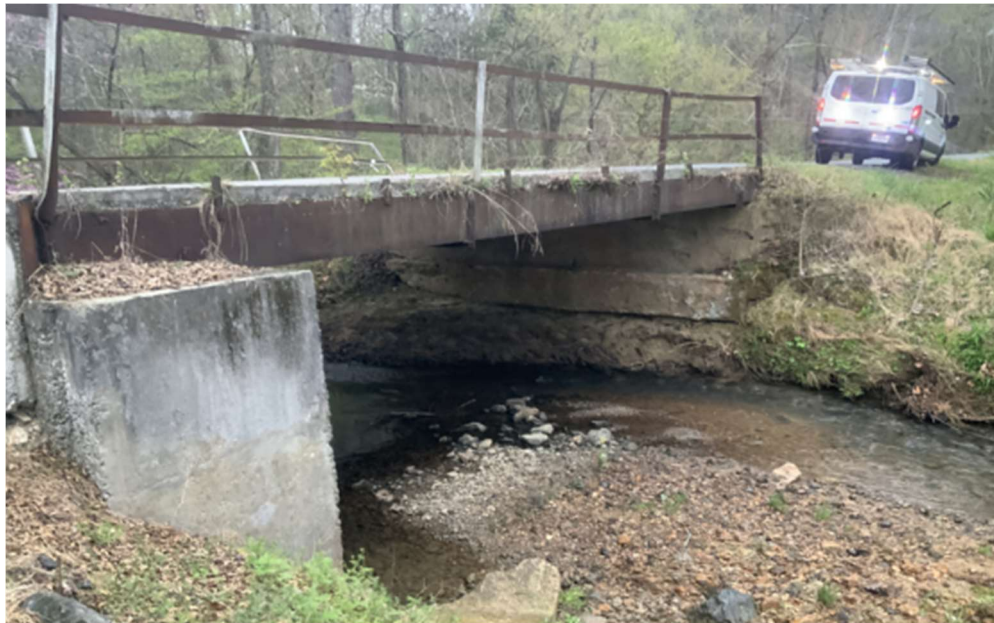
**Figure 43: Bridge 055-5009-0 Side View (GDOT, 2022)**

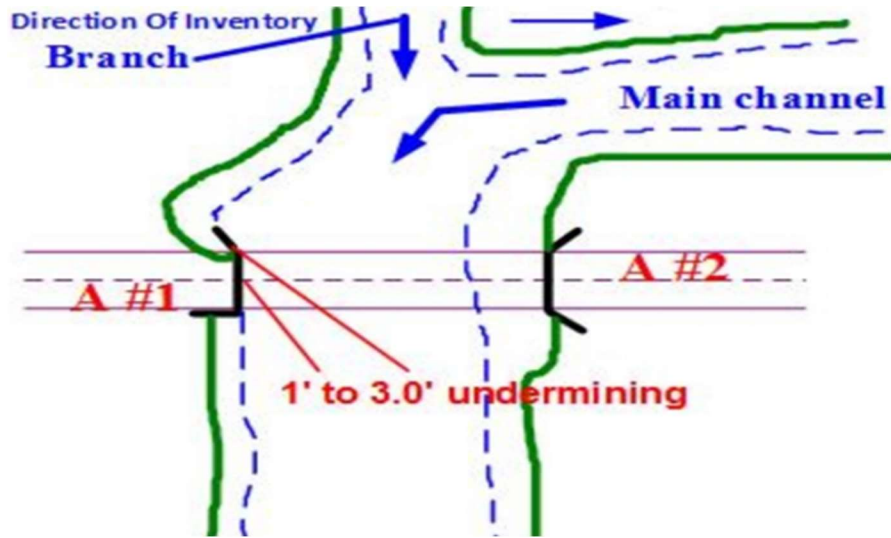
**Figure 44: Bridge 055-5009-0 Top View (GDOT, 2022)**

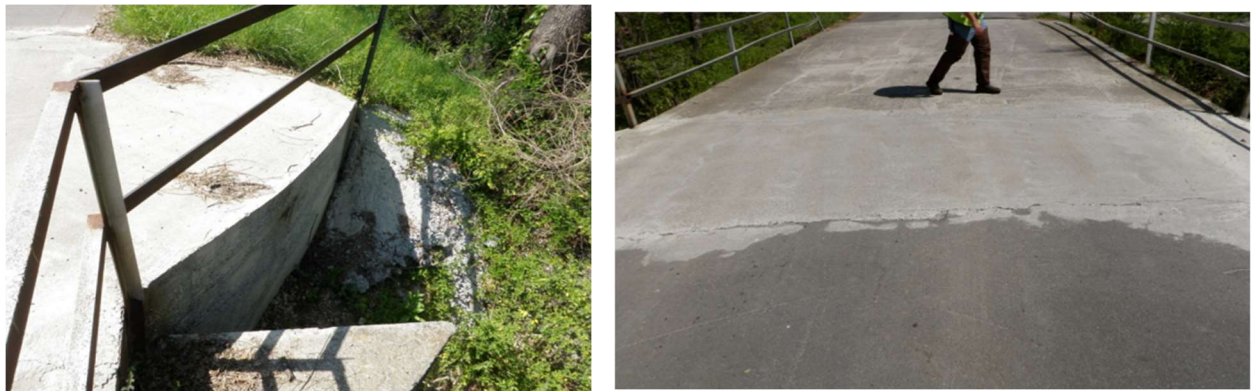
**Figure 45: Bridge 055-5009-0 Void Repair Side View(Left) and Top View (Right)**

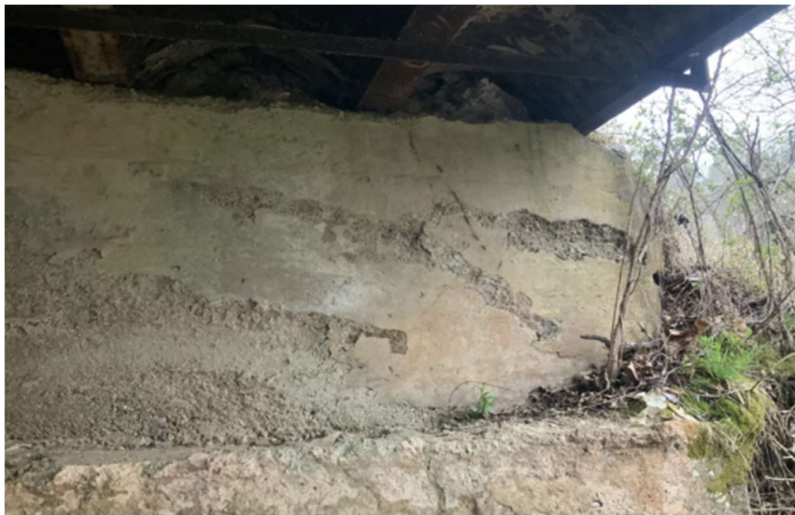
**Figure 46: Spalling in Abutment 2 (GDOT, 2022)**

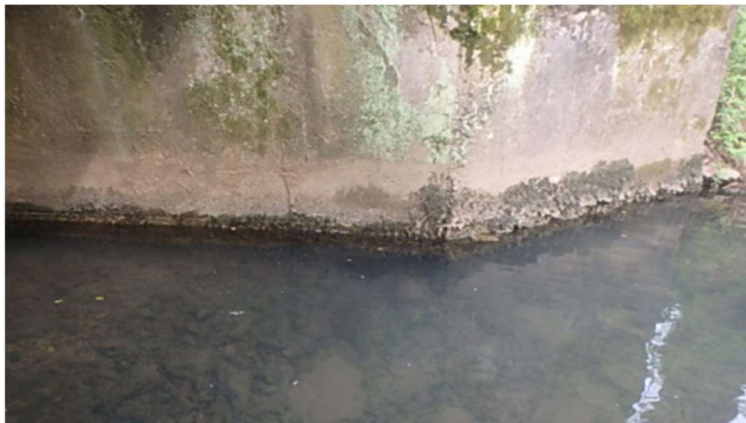
**Figure 47: Undermining in Abutment 1 (GDOT, 2020)**

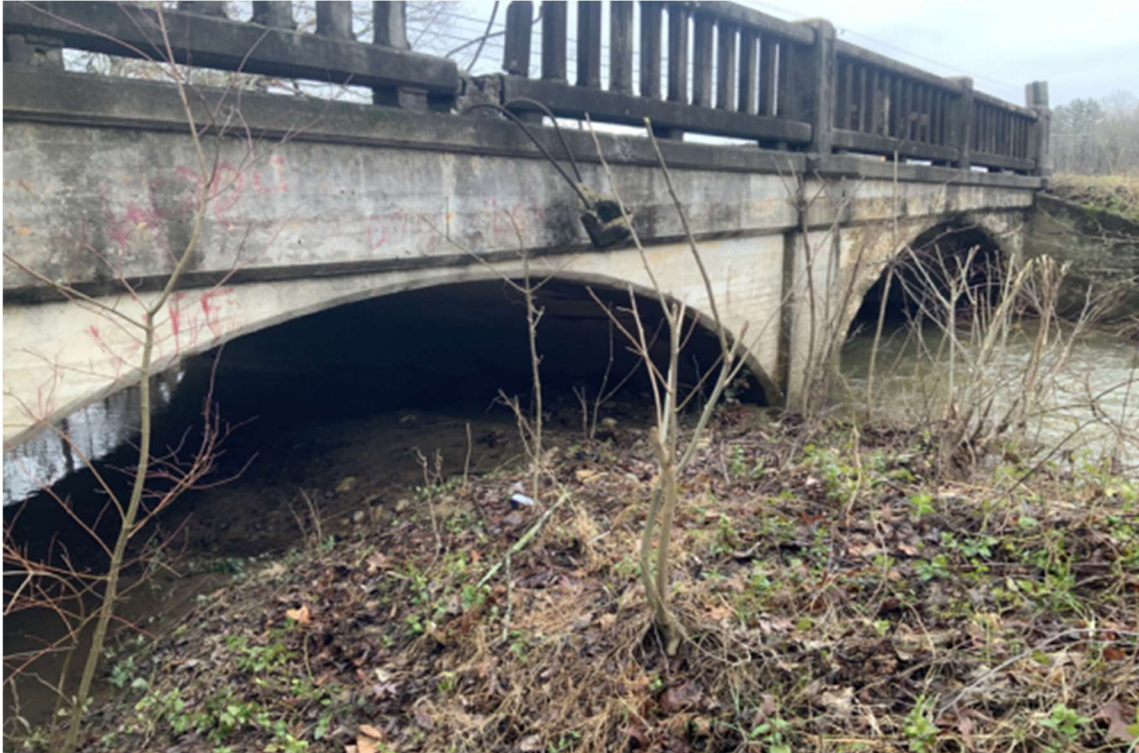
**Figure 48: Left Side View of Bridge 213-0045-0 (GDOT, 2022)**

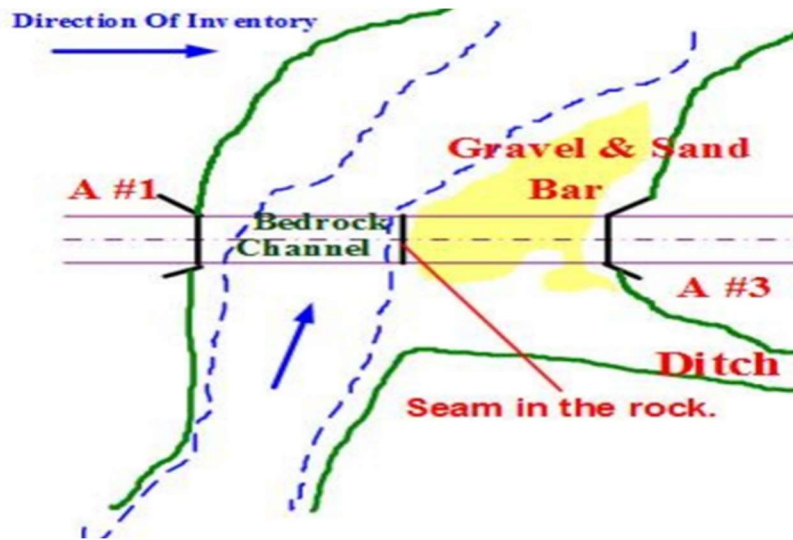
**Figure 49: Top Waterway View of Bridge 213-0045-0 (GDOT, 2022)**

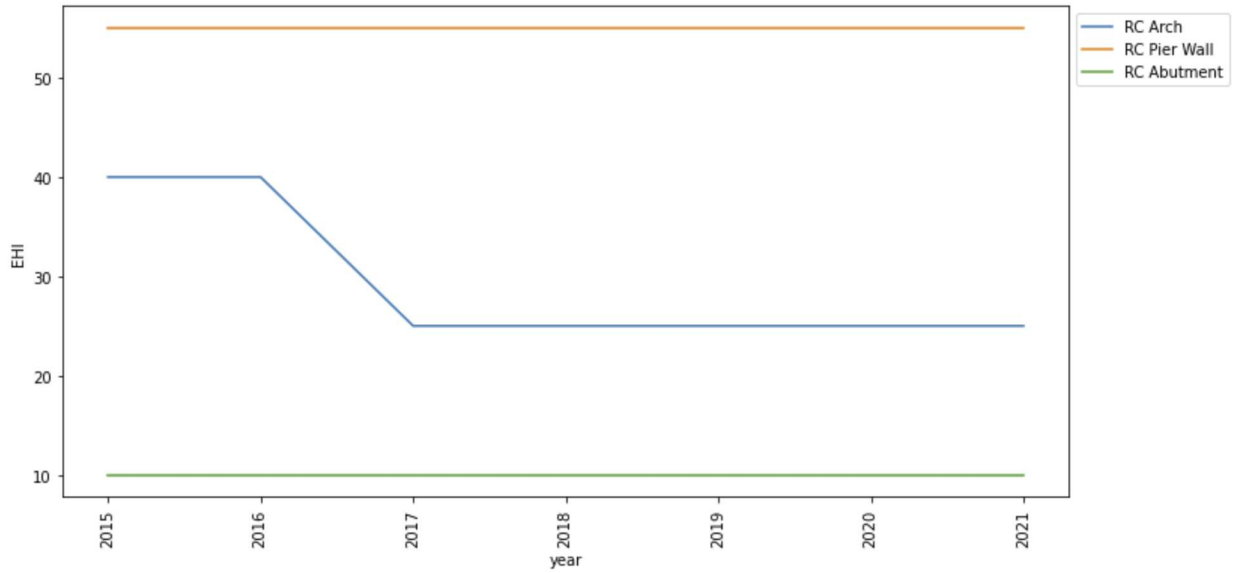
**Figure 50: Bridge 213-0045-0-0 EHI by Year**

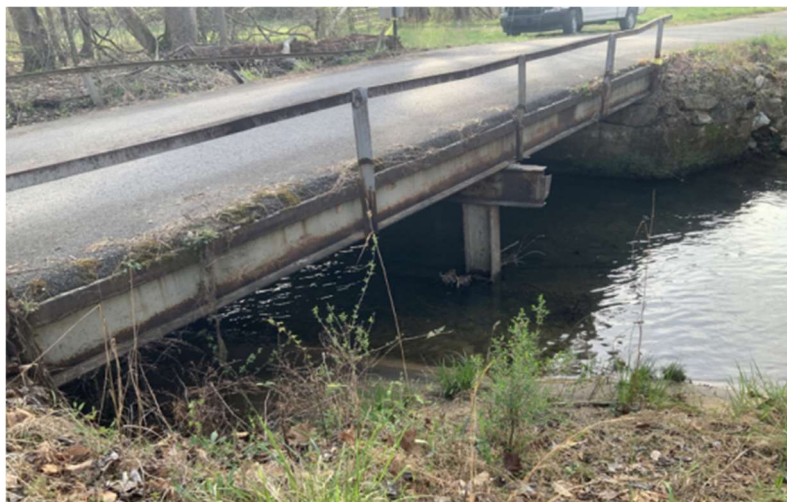
**Figure 51: Bridge 055-5045-0 Right Side View (GDOT, 2020)**

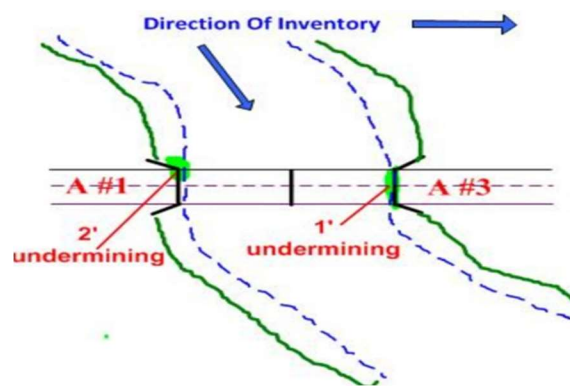
**Figure 52: Bridge 055-5045-0 Top View Sketch (GDOT, 2018)**

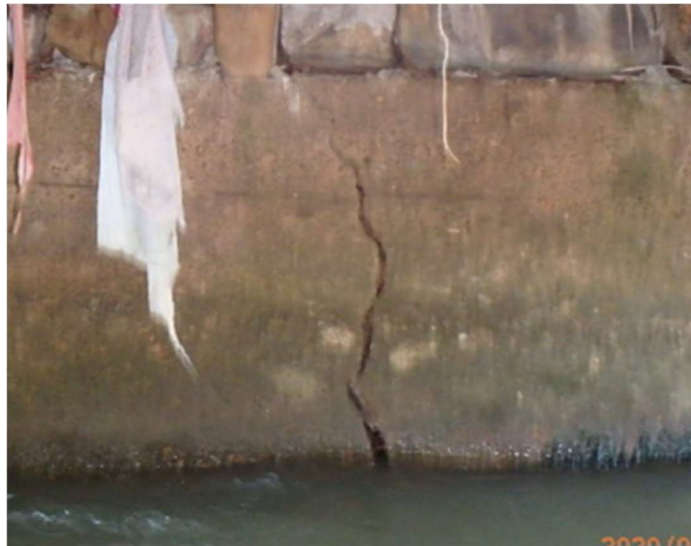
**Figure 54: Bridge 055-5045-0 Abutment 1 Settlement Crack (GDOT, 2020)**
