IMPACT OF WEATHER STRESSORS TO IDENTIFY VULNERABLE BRIDGE ELEMENTS  
IN GEORGIA TOWARDS DATA DRIVEN ASSEST MANAGEMENT

by SPENCER KOPF

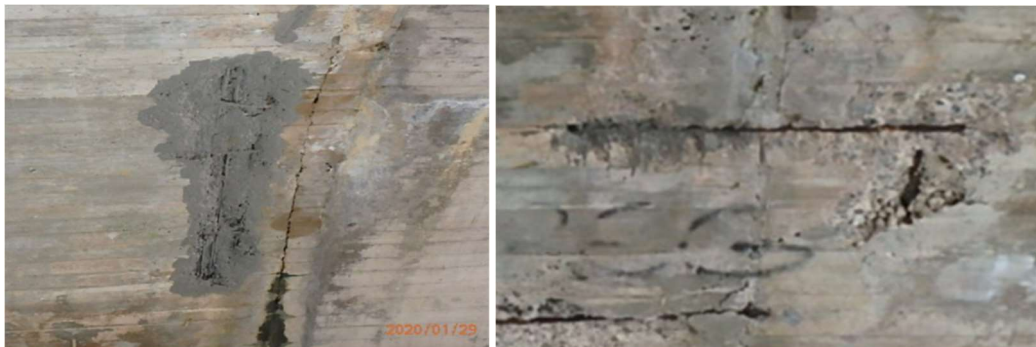
**Figure 55: Arch Span with Exposed Rebar Covered with Epoxy vs Rebar with No Epoxy**  
(GDOT, 2020)

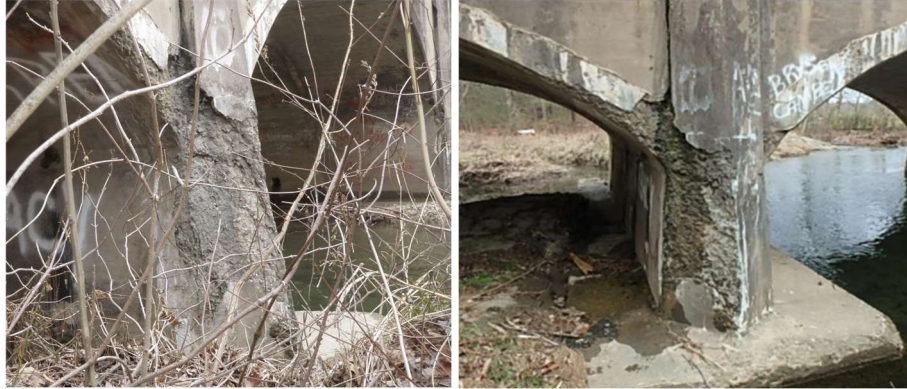
**Figure 58: Progression of Pier Degradation 2014(Left) to 2020(Right)**

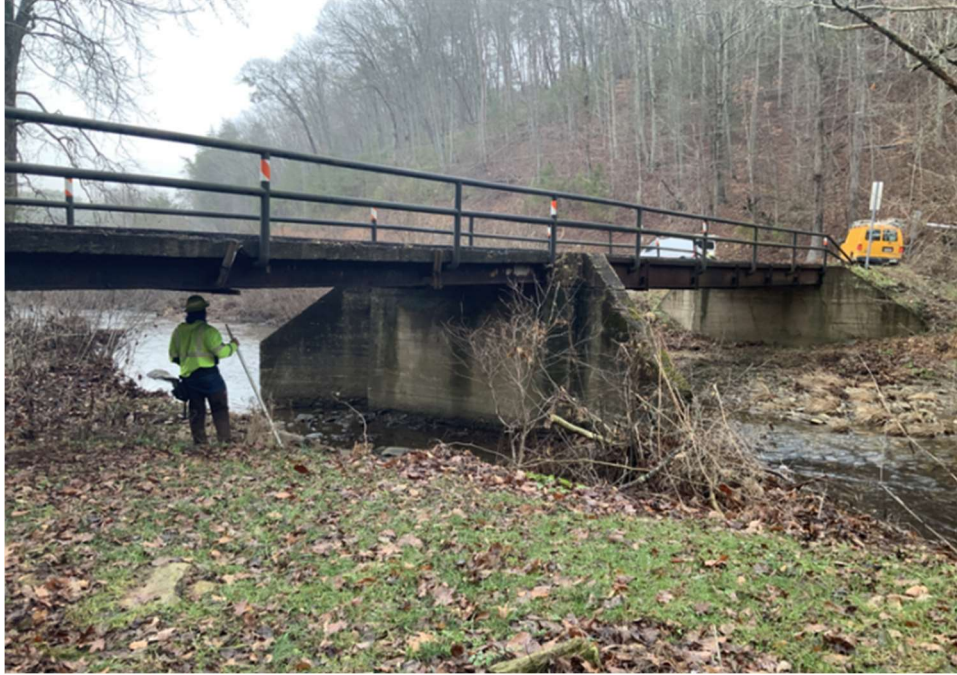
**Figure 59 - Bridge 213-5004-0 Side View (GDOT, 2021)**

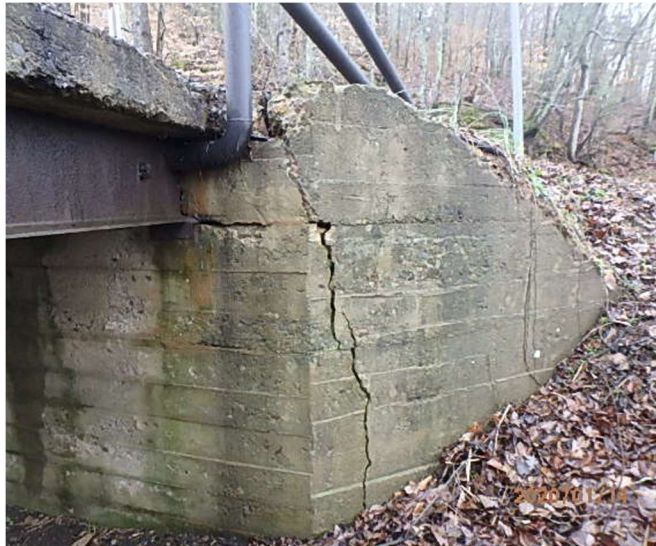
Figure 62 - Large Crack on Abutment 1 Discovered (GDOT, 2019)

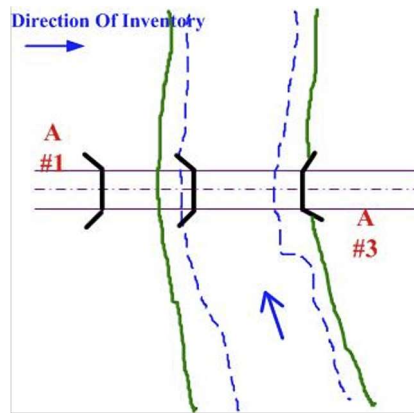
**Figure 63 - Bridge 213-5004-0 Top View (GDOT, 2019)**

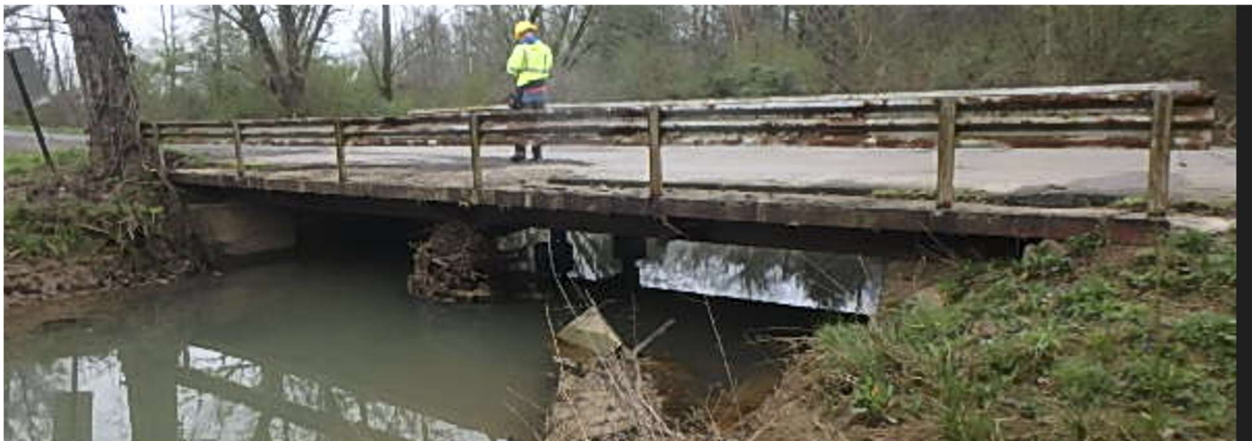
**Figure 65: Bridge 055-5026-0 Side View (GDOT, 2020)**

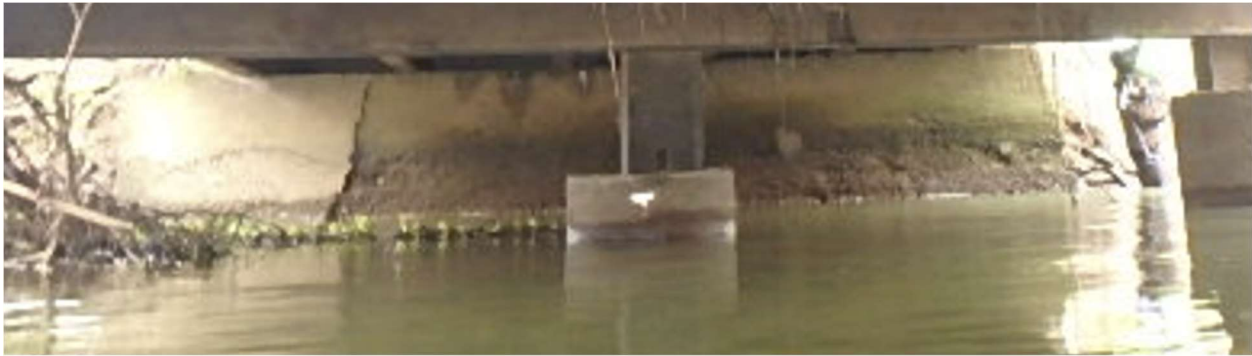
**Figure 66: Reinforced Concrete Abutment on Bridge 055-5026-0 (GDOT, 2020)**

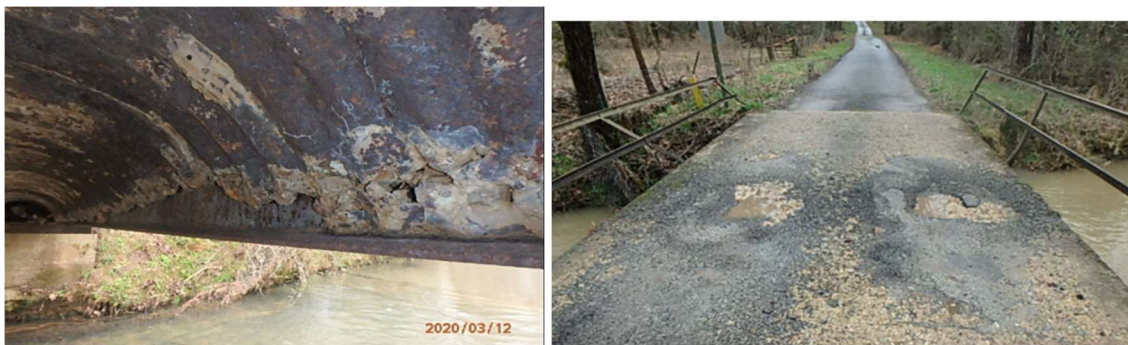
**Figure 67: Bridge 055-5041-0 Deck Bottom (Right) and Top (Right) Deterioration (GDOT, 2020).**

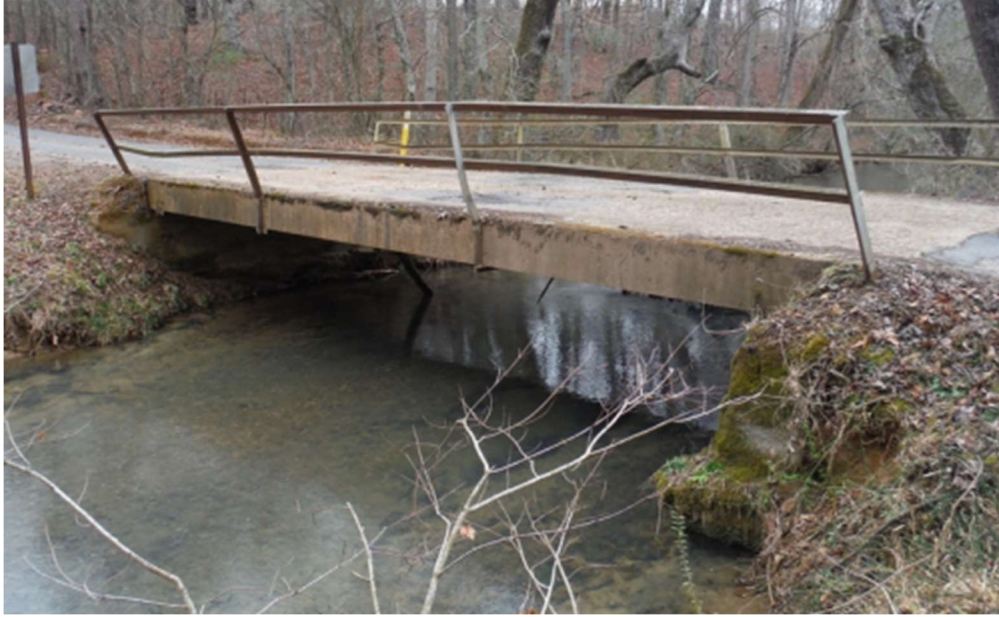
**Figure 68: Scour at Abutment 1 (GDOT, 2014)**

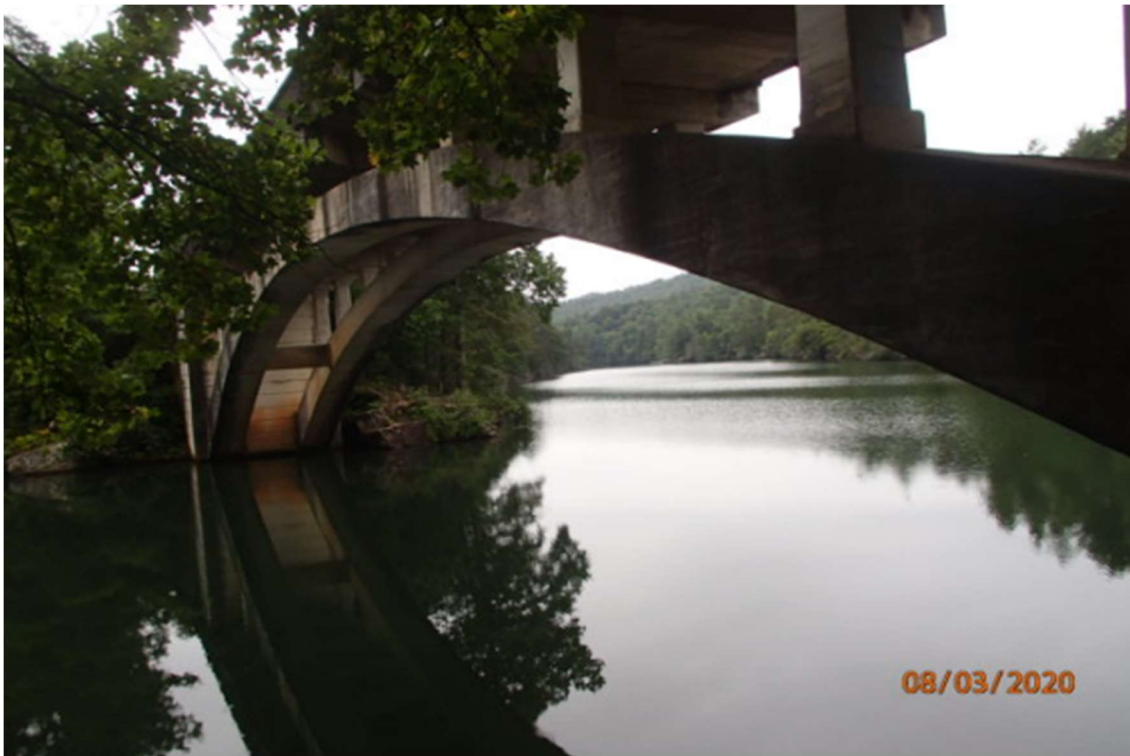
**Figure 70: Side View of Bridge 241-5024-0 (GDOT, 2020)**

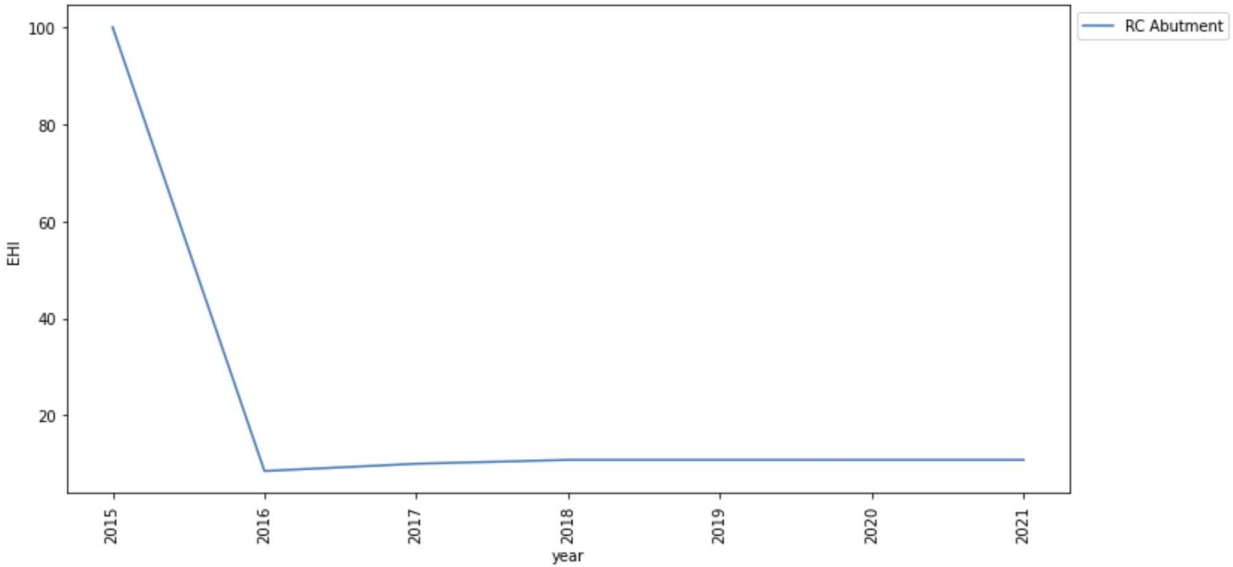
**Figure 71: Bridge 241-5024-0 Reinforced Concrete Abutment EHI by Year**

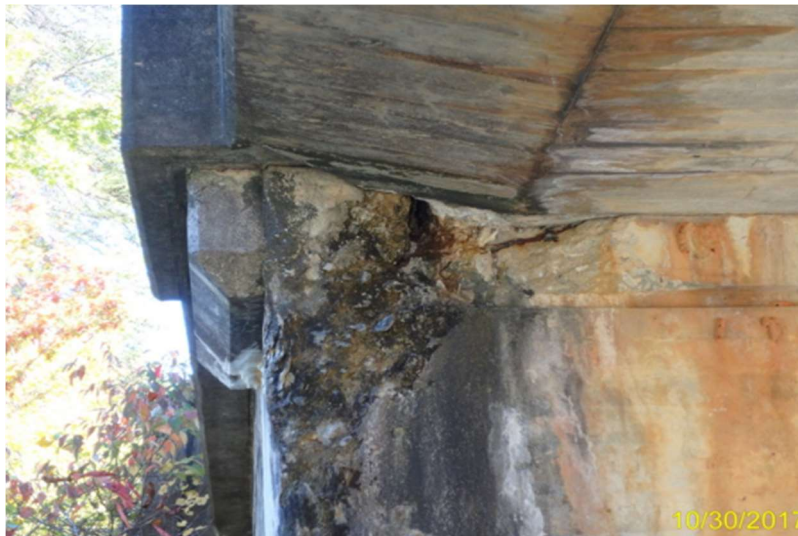
**Figure 72: Concrete Spalling and Exposed Rebar in Abutment 1 of Bridge 241-5024-0, 2017**

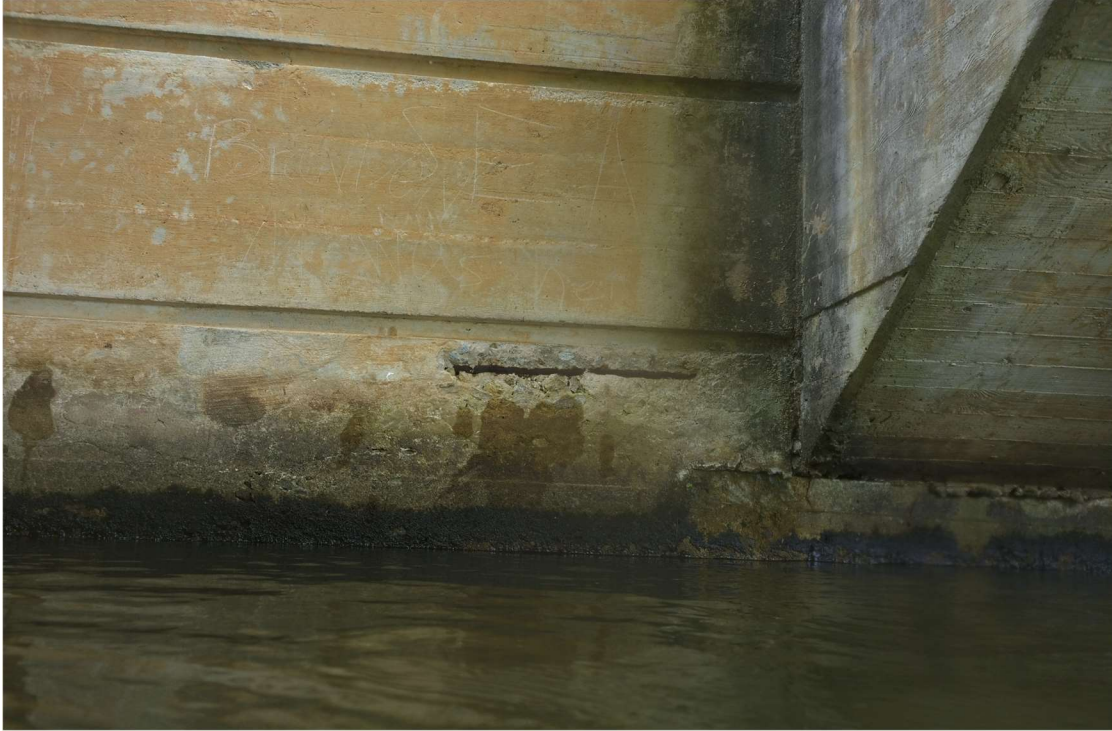
**Figure 73: Concrete Degradation and Exposed Rebar at Waterline in Abutment 1 of Bridge 241-5024-0 (GDOT, 2018)**

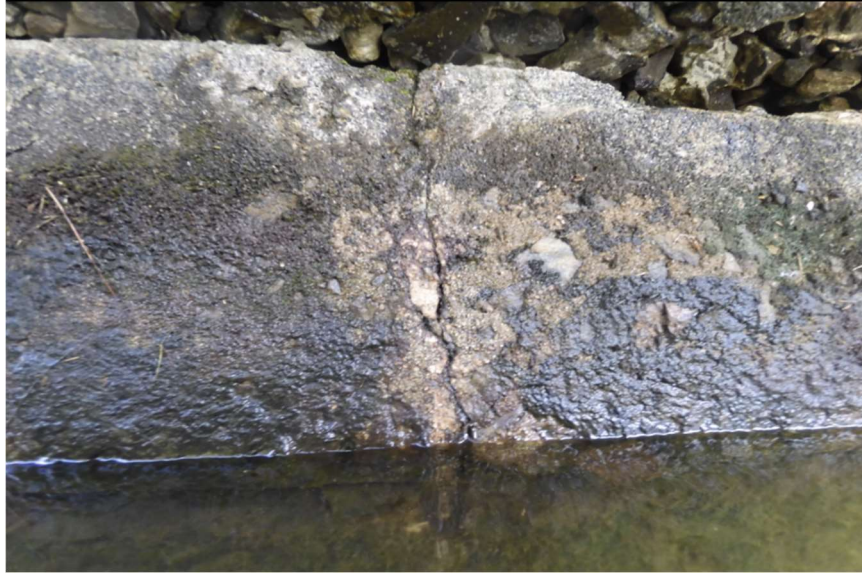
**Figure 74: Concrete Cracking and Honeycombing in Abutment 1 of Bridge 241-5024-0 (GDOT, 2022)**

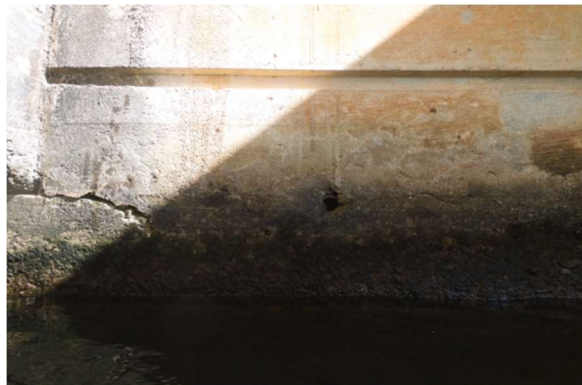
**Figure 75: Honeycombing Patch in Abutment 1 of Bridge 241-5024-0 (GDOT, 2022)**

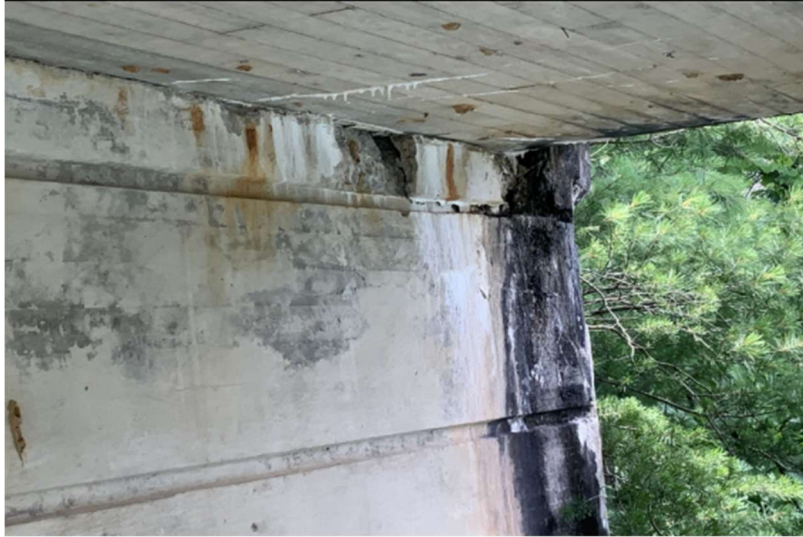
**Figure 76: Concrete Spalling in Abutment 1 of Bridge 241-5024-0 (GDOT, 2022)**

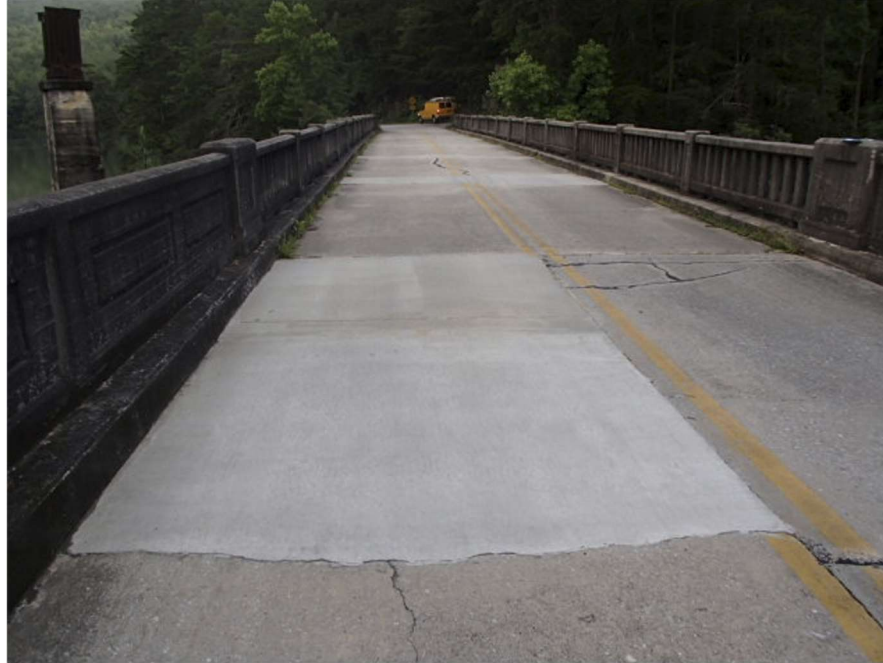
**Figure 77: Reinforced Concrete Deck Patching on Bridge 241-5024-0 (GDOT, 2022)**

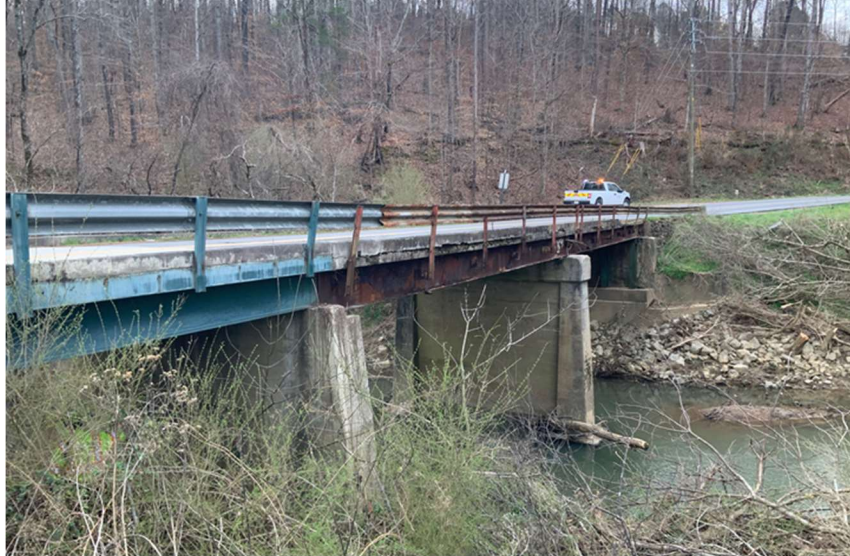
**Figure 78 - Bridge 055-5030-0 Side View (GDOT, 2022)**

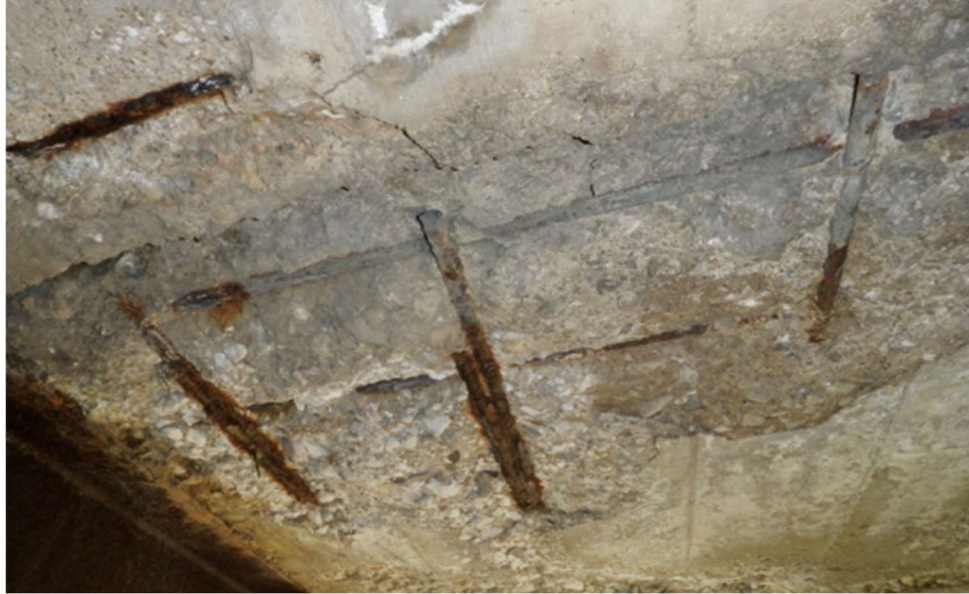
**Figure 79 – Bridge 055-5030-0 Deck Spalling (GDOT, 2022)**

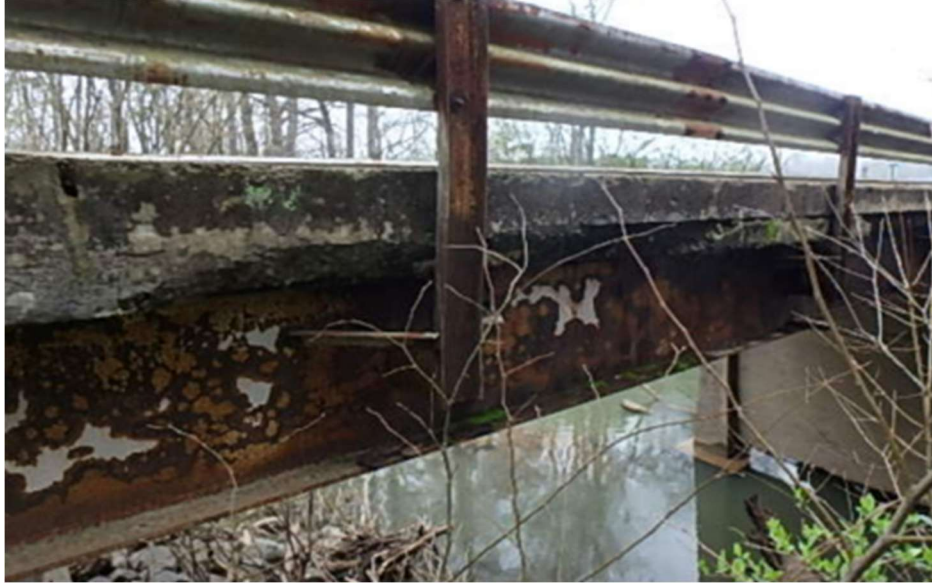
**Figure 80 – Bridge 055-5030-0 Wide Flange 100% Section Loss (GDOT, 2022)**

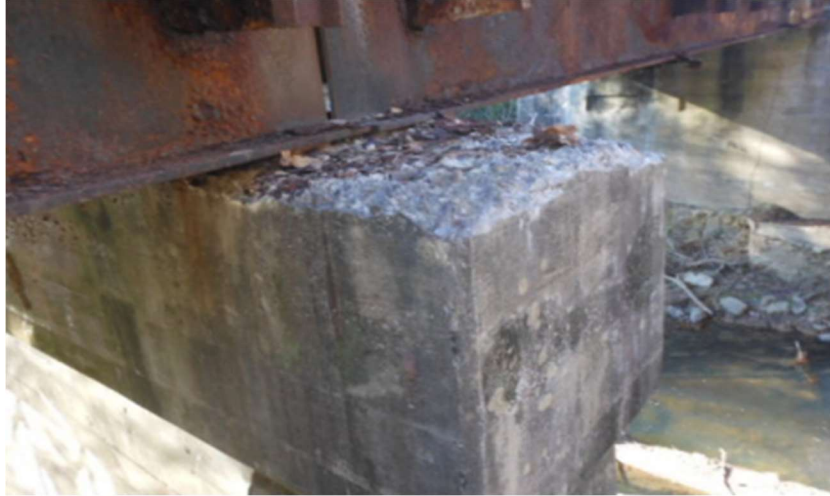
**Figure 81 – Reinforced Concrete Pile Cap Wear on Bridge 055-5030-0 (GDOT, 2017)**

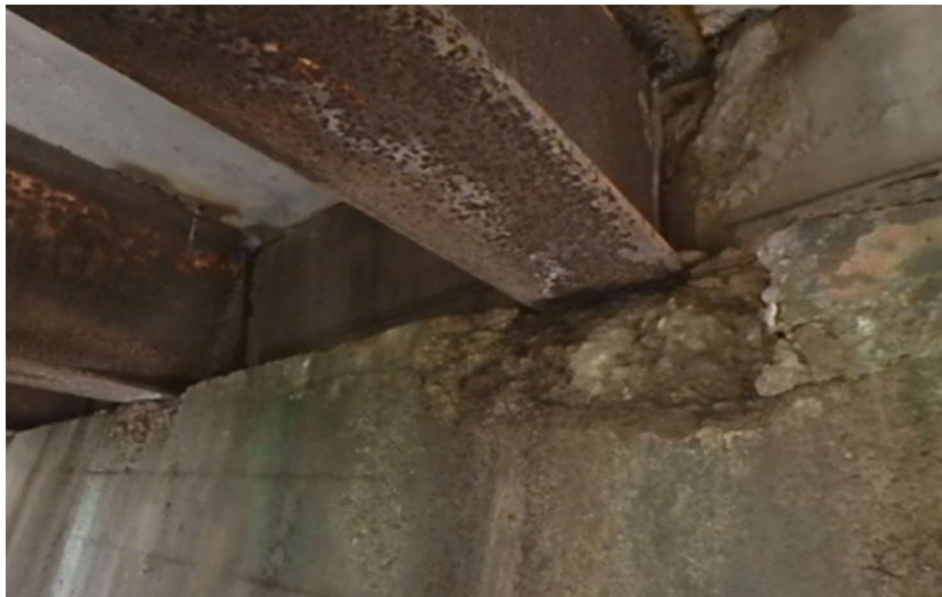
**Figure 82 – Spalling in Reinforced Concrete Abutment on Bridge 055-5030-0 (GDOT, 2020)**

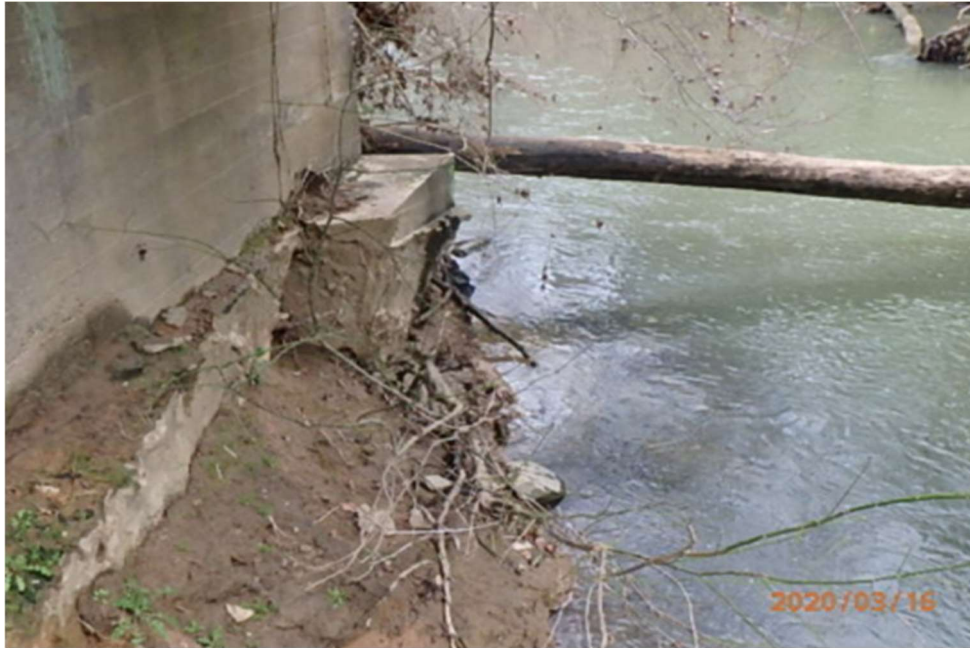
**Figure 83 – Scour at Reinforced Concrete Pier Wall on Bridge 055-5030-0 (GDOT, 2020)**

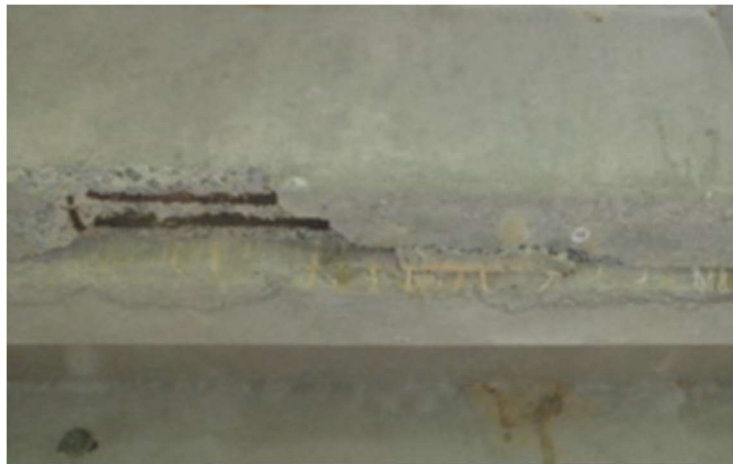
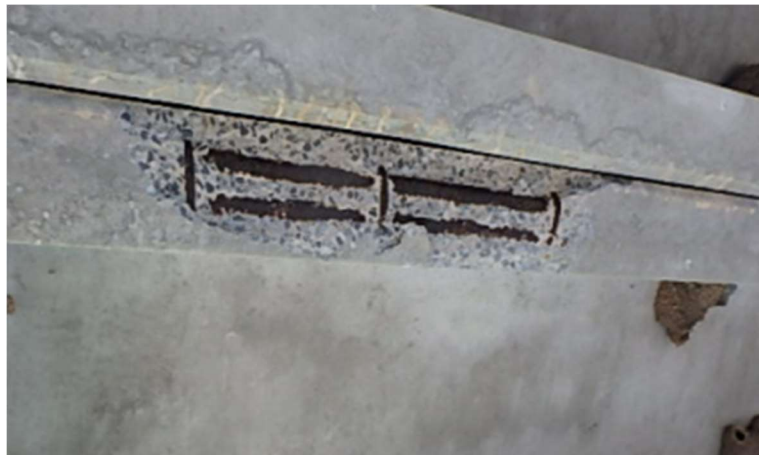
**Figure 84 – Bridge 313-5028-0 Reinforced Concrete Girder Spalling 2014 (Top) vs 2020 (Bottom)**

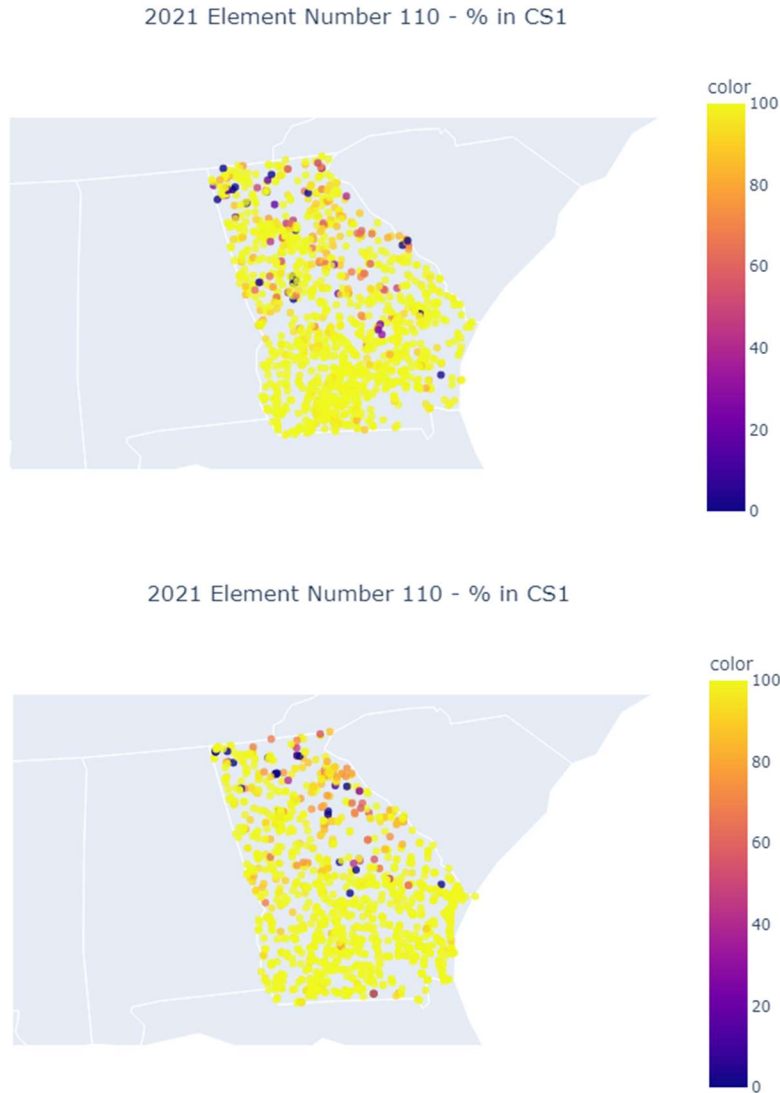
**Figure 85: Percent of EN110 in Condition State One by Location, 2021. County-Owned (Top) vs State-Owned (Bottom)**

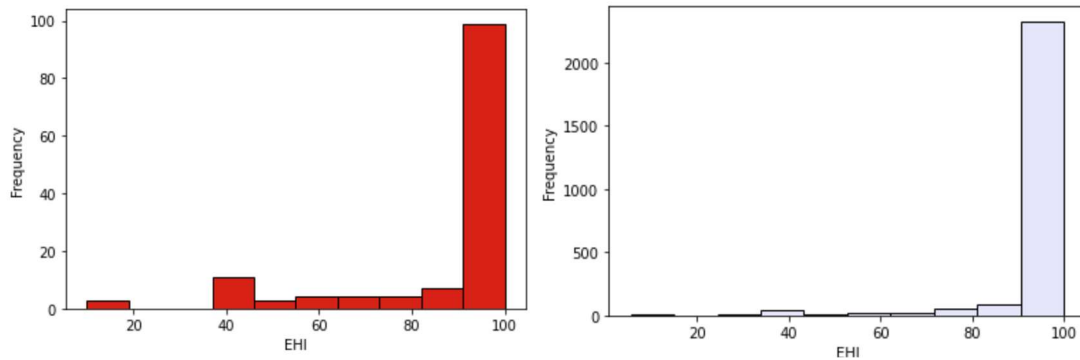
**Figure 86 – EHI of EN110 DT32 Counties (Left) vs NonDT32 Counties (Right)**

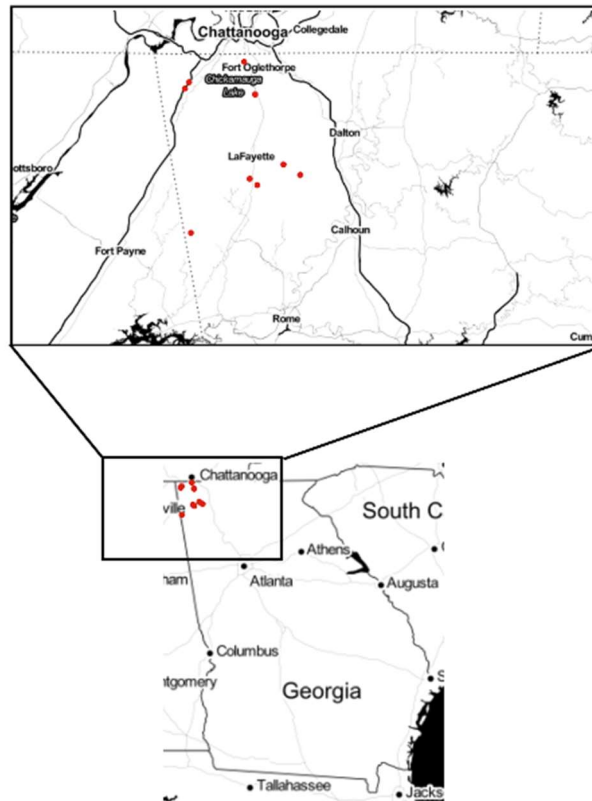
**Figure 90 - Location of Selected DT32 Bridges for EN110**

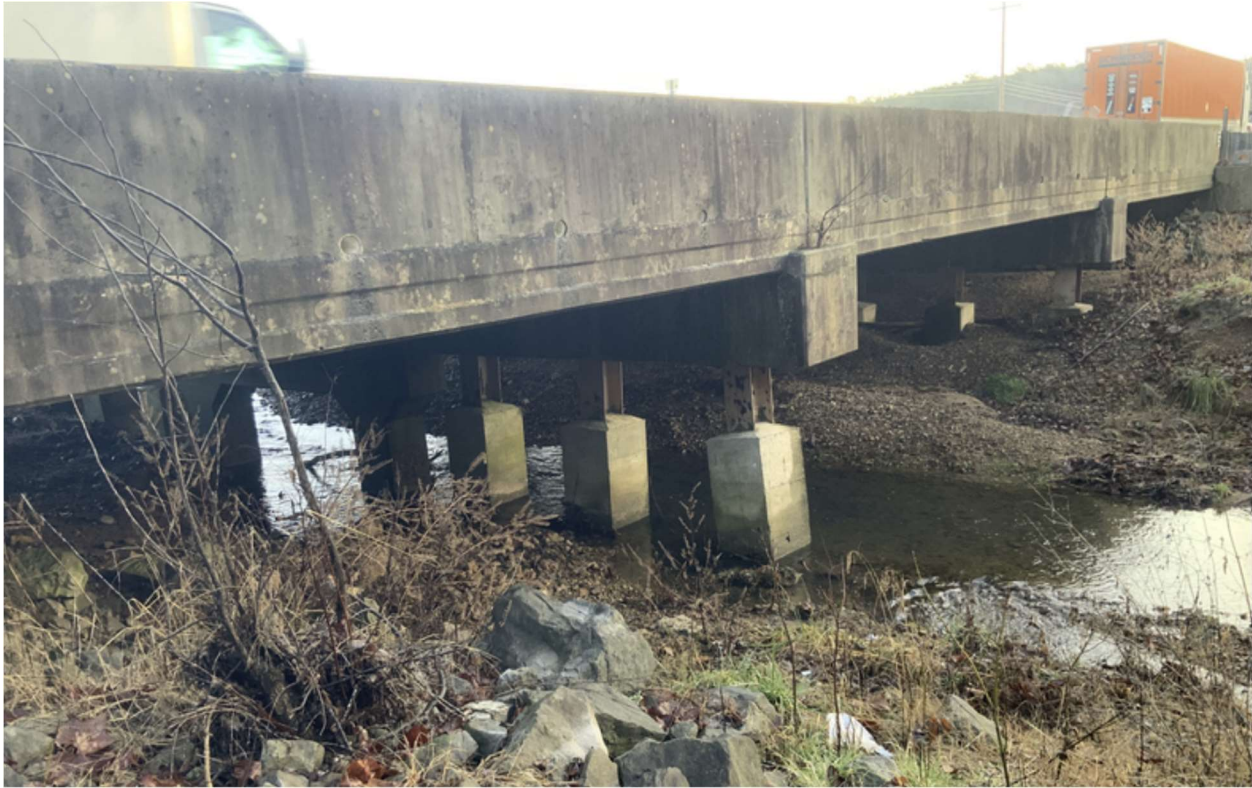
**Figure 91 – Bridge 295-0015-0 Side View (GDOT, 2021)**

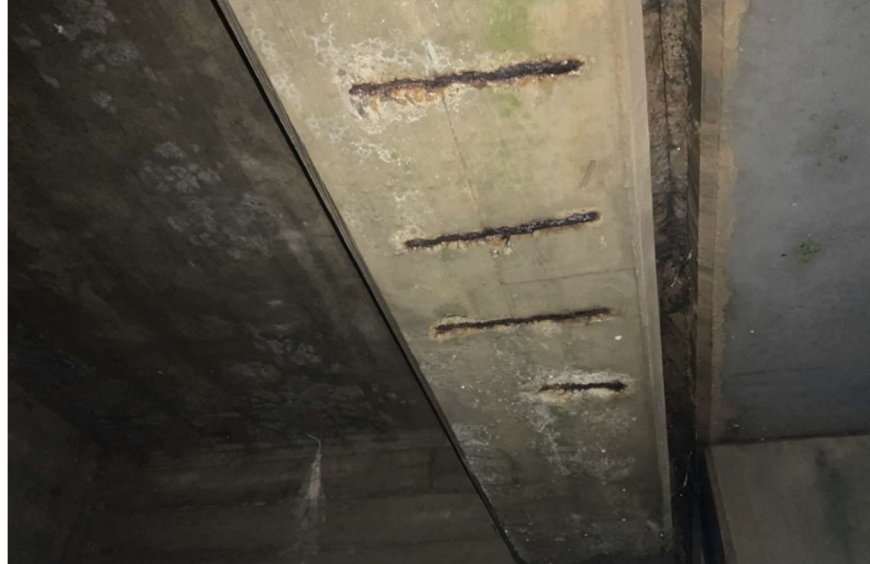
**Figure 92 – Bridge 295-0015-0 Typical Girder Spalling (GOT, 2021)**

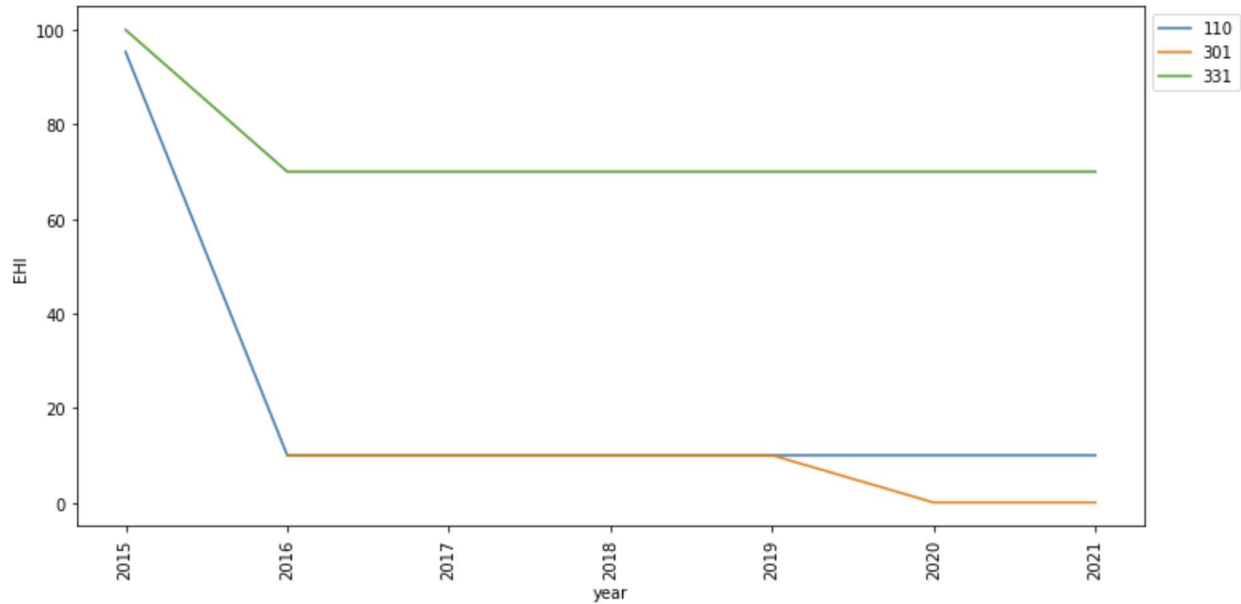
**Figure 93 – Bridge 295-0015-0 EHI by Year**

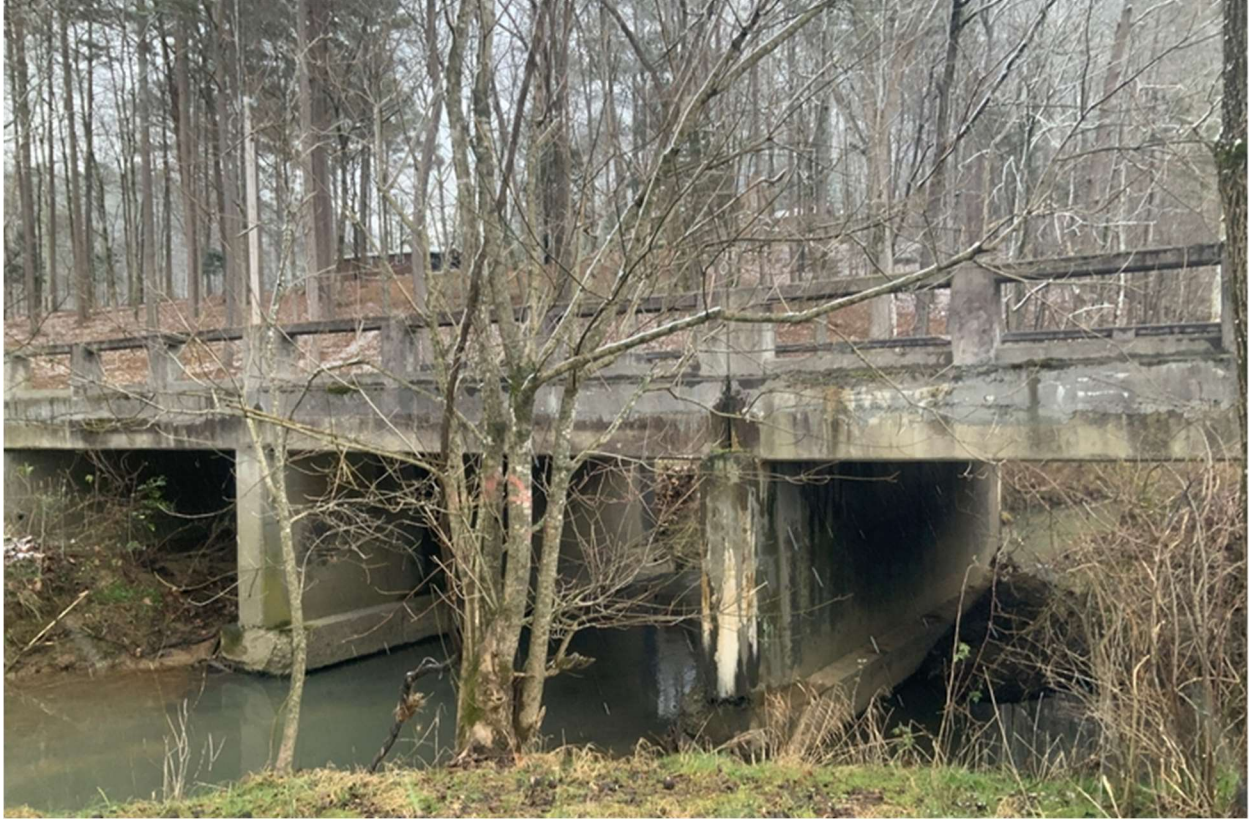
**Figure 94 – Bridge 295-0039-0 Side View (GDOT, 2021)**

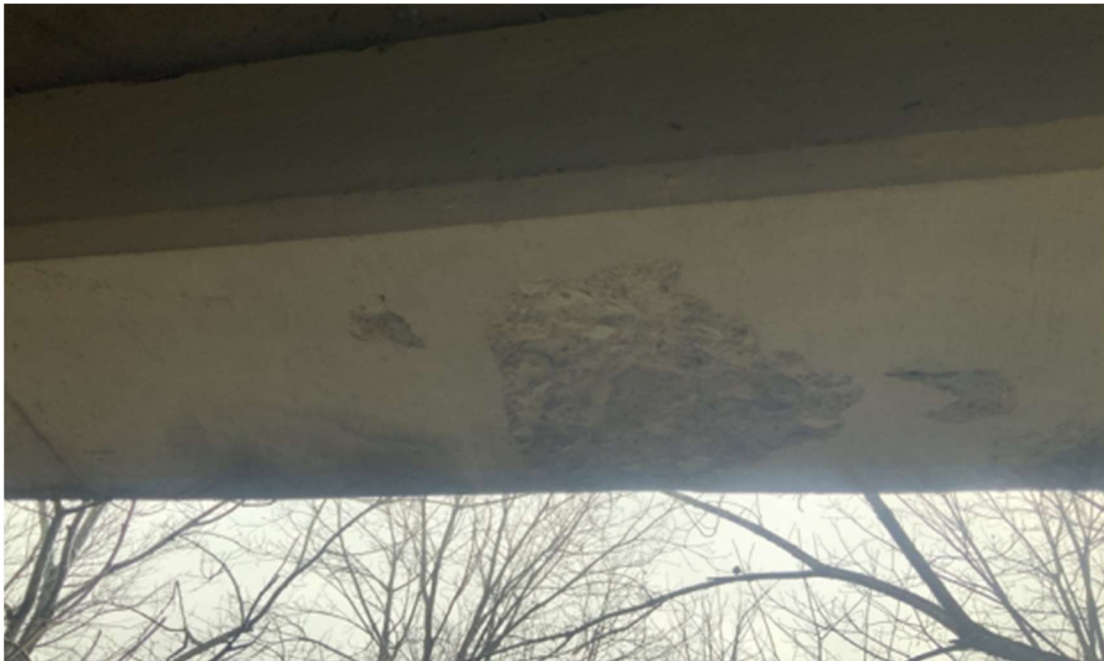
**Figure 95 – Bridge 295-0039-0 Concrete Spalling (GDOT, 2021)**

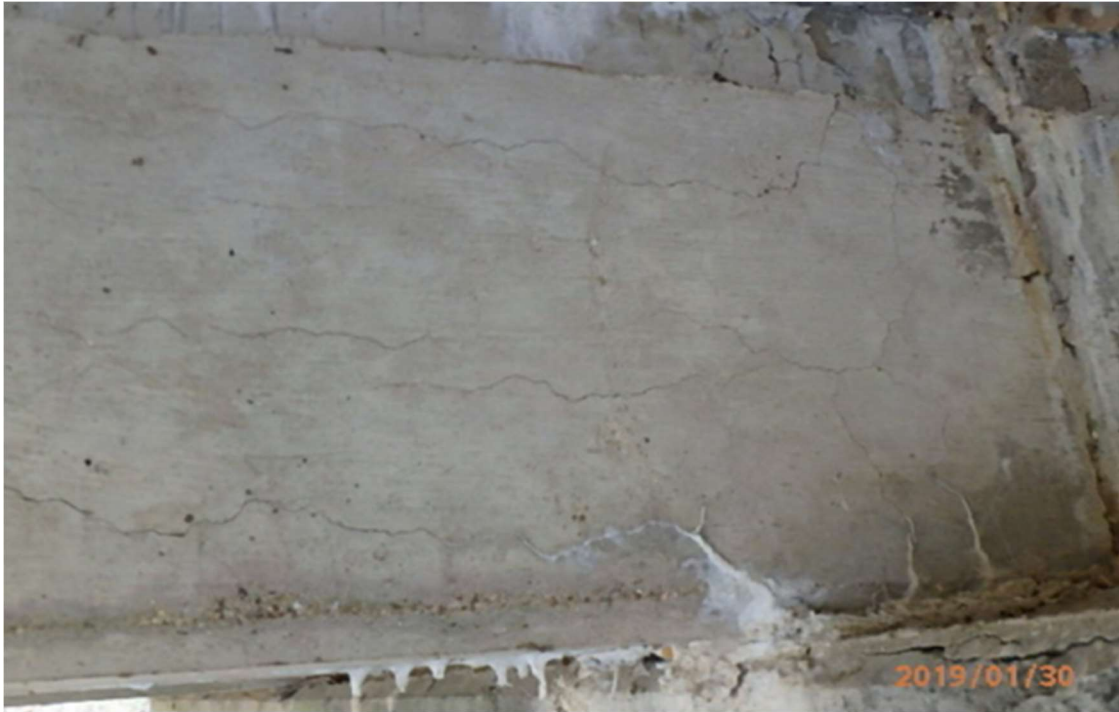
**Figure 96 – Bridge 295-0039-0 Concrete Cracking (GDOT, 2019)**

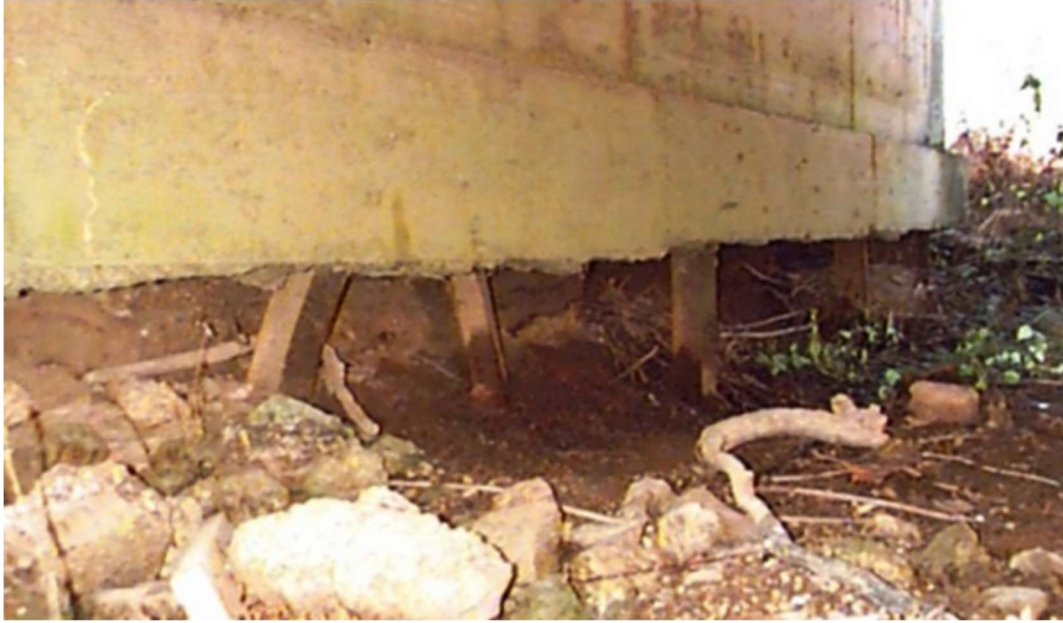
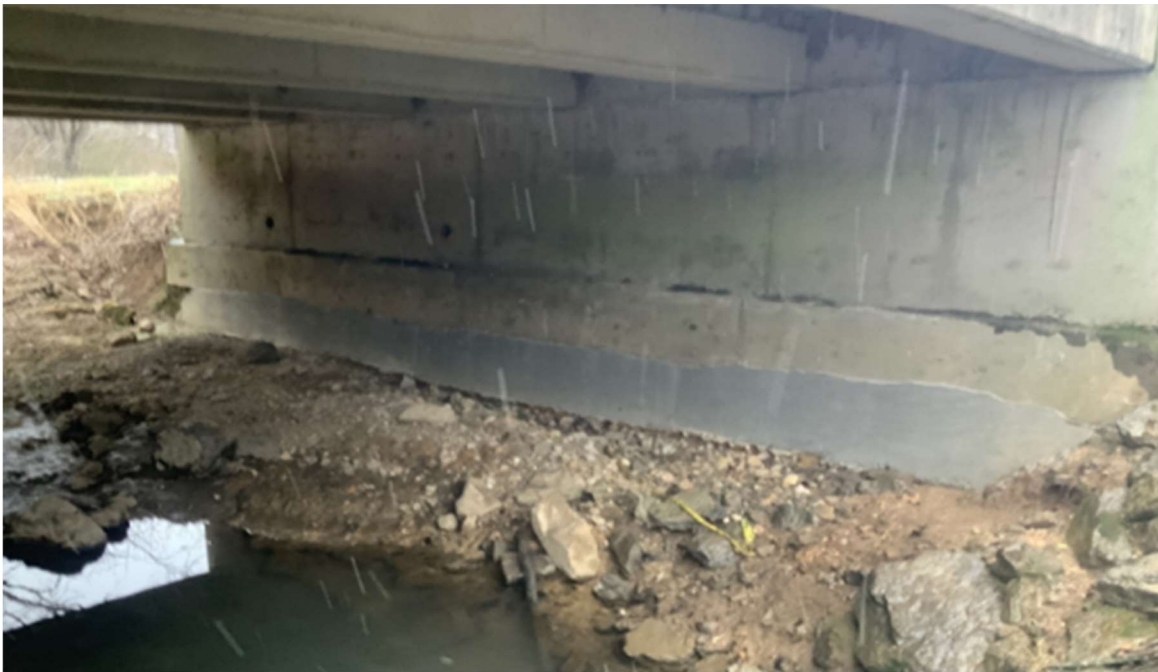
**Figure 97 – Bridge 295-0039-0 Reinforced Concrete Abutment 2015 (Top) vs 2021 (Bottom)**

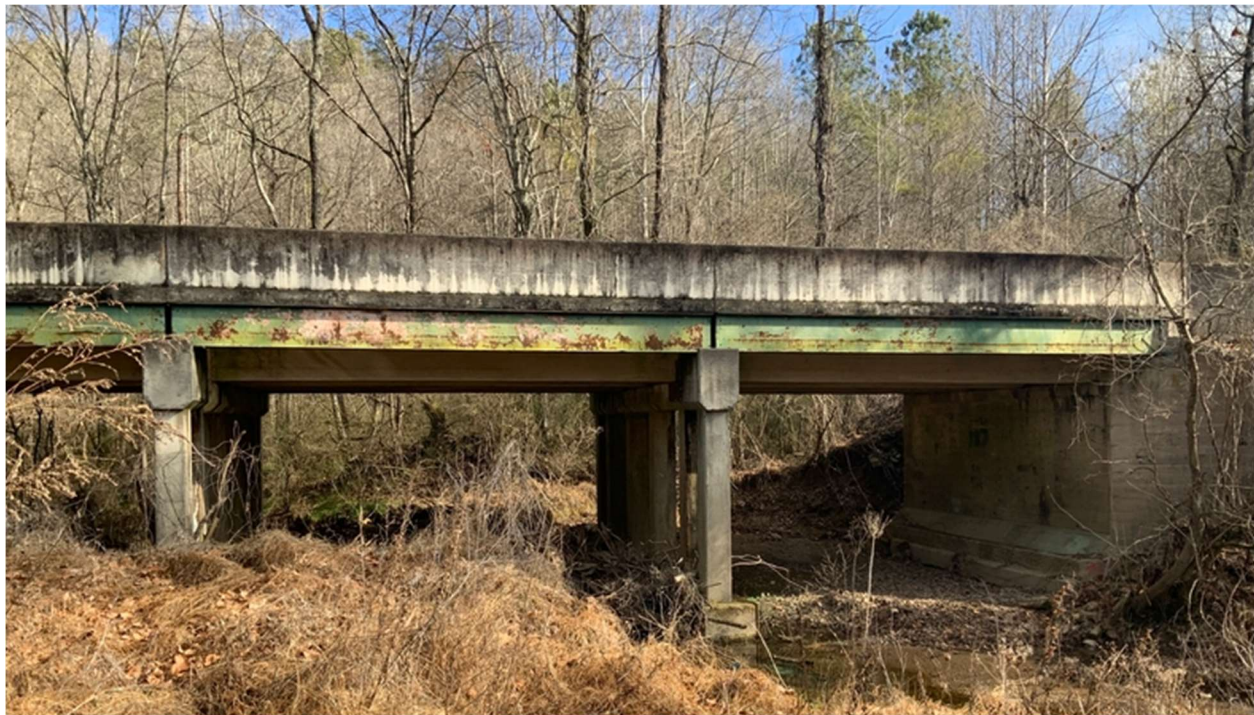
**Figure 98 – Bridge 295-0041-0 Side View (GDOT, 2021)**

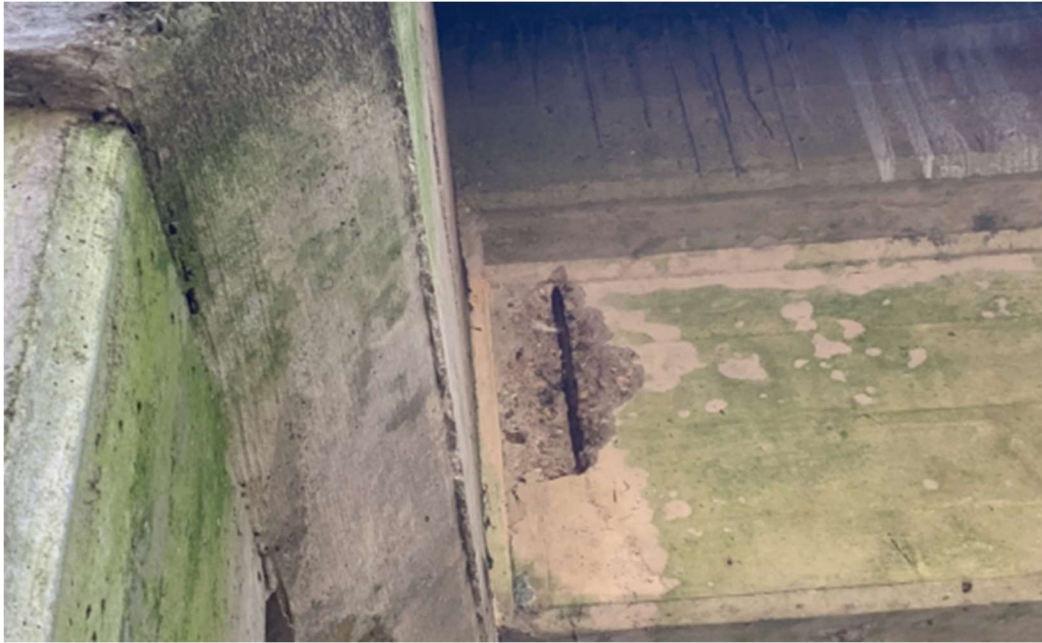
**Figure 99 – Bridge 295-0041-0 Reinforced Concrete Girder Spalling (GDOT, 2021)**
