IMPACT OF WEATHER STRESSORS TO IDENTIFY VULNERABLE BRIDGE ELEMENTS  
IN GEORGIA TOWARDS DATA DRIVEN ASSEST MANAGEMENT

by SPENCER KOPF

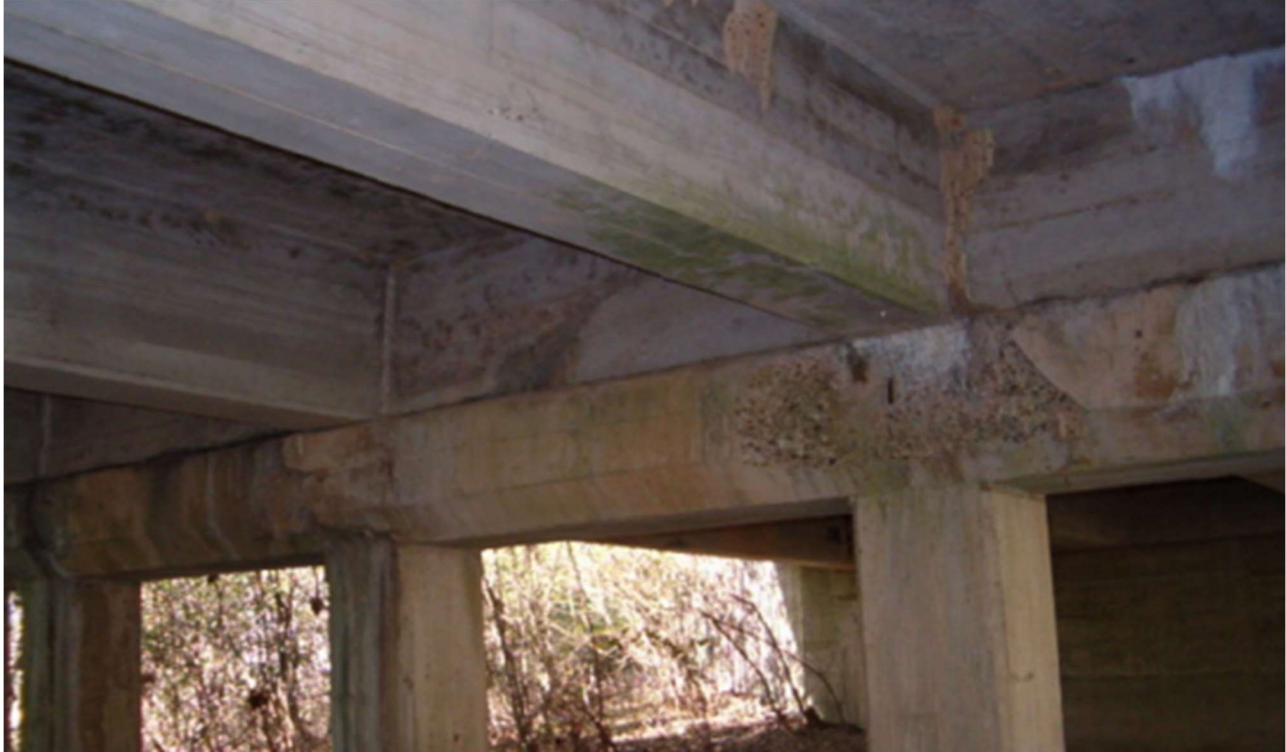
**Figure 100 – Bridge 295-0041-0 Reinforced Concrete Pier Cap (GDOT, 2021)**

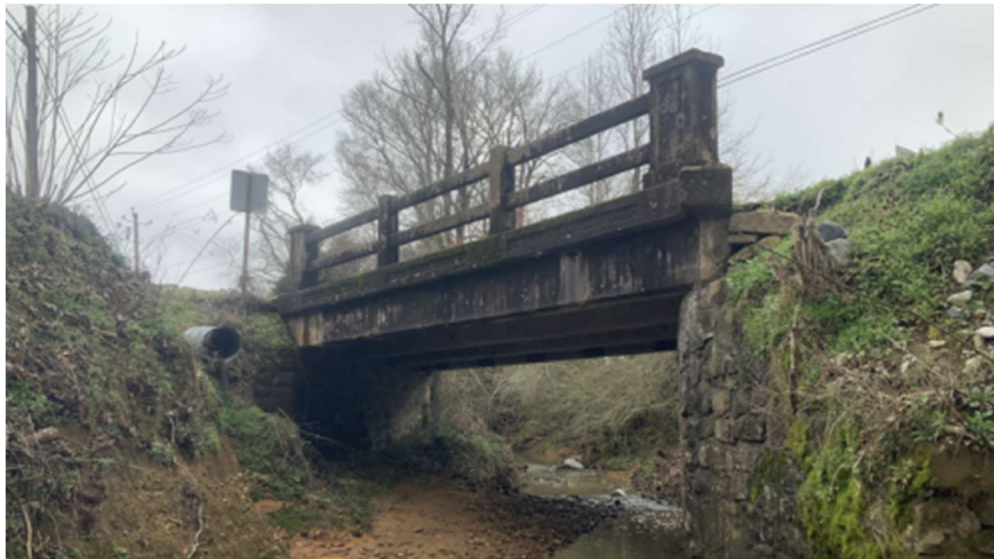
**Figure 101 – Bridge 055-5037-0 Side View (GDOT, 2022)**

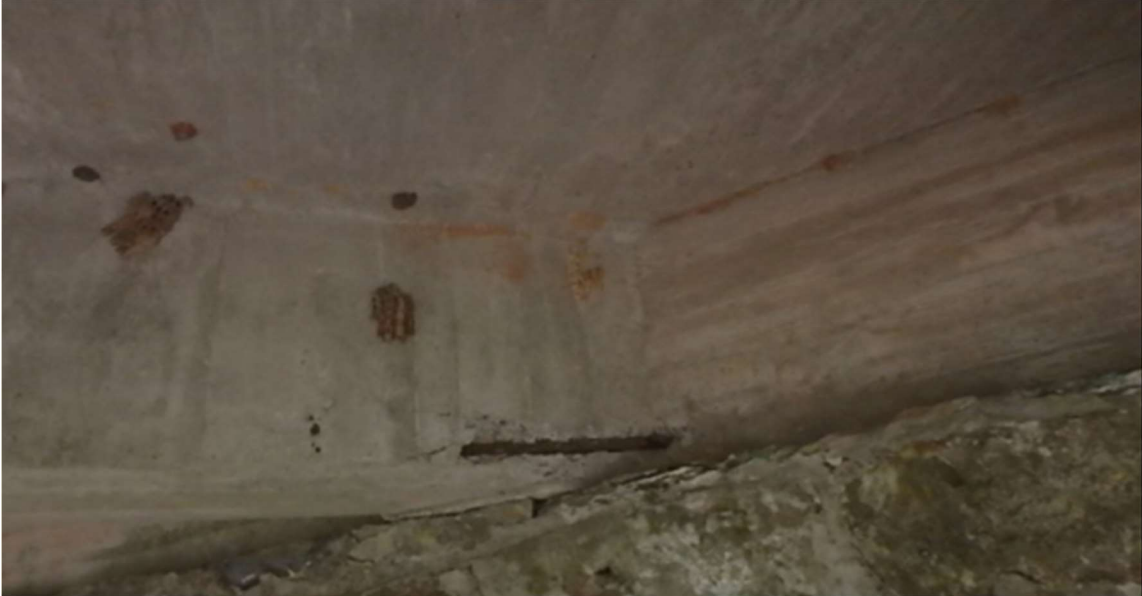
**Figure 102 – Bridge 055-5037-0 Reinforced Concrete Girder Spalling (GDOT, 2020)**

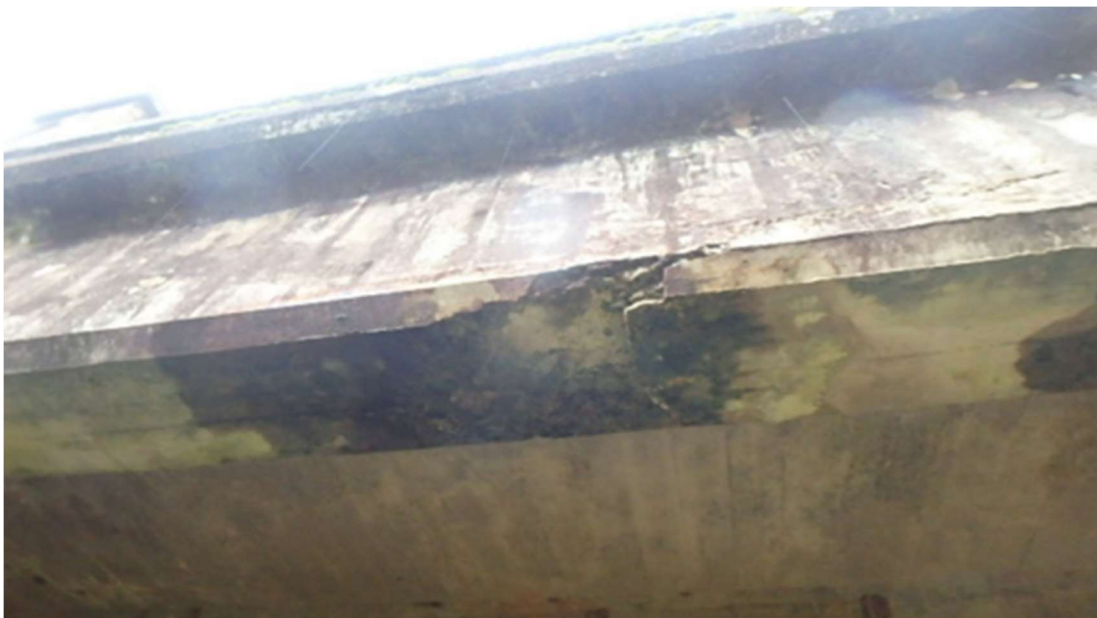
**Figure 103 – Bridge 055-5037-0 Reinforced Concrete Girder Spalling (GDOT, 2020)**

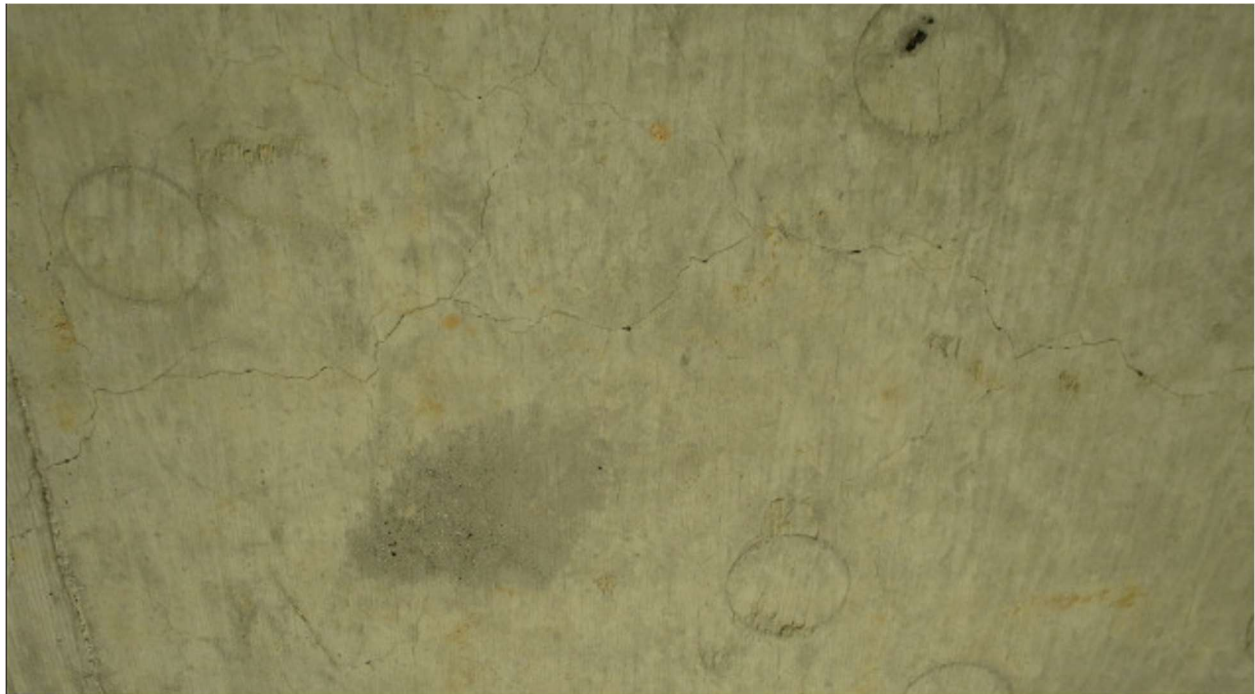
**Figure 104 – Bridge 083-0026-0 Reinforced Concrete Girder Typical Cracking (GDOT, 2019)**

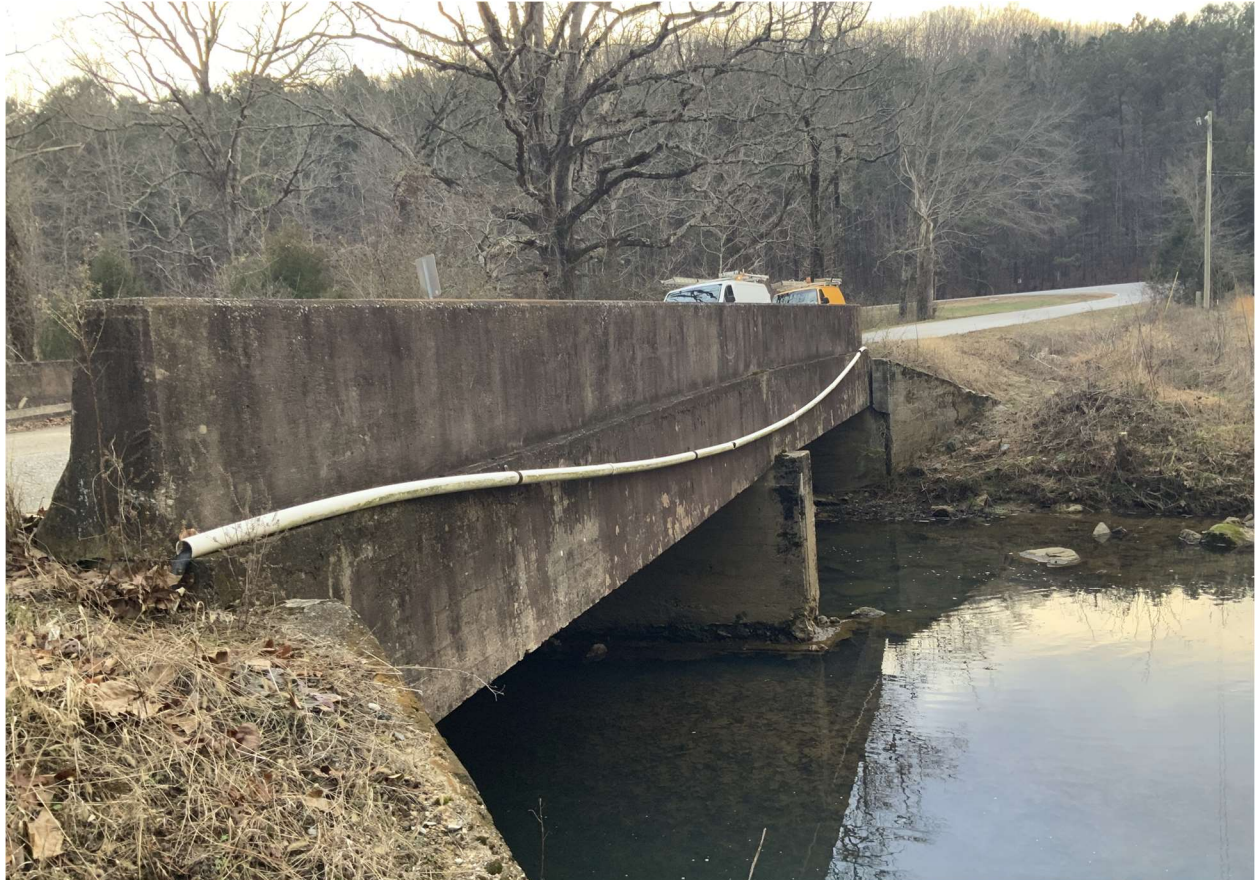
**Figure 105 – Bridge 295-5011-0 Side View (GDOT, 2022)**

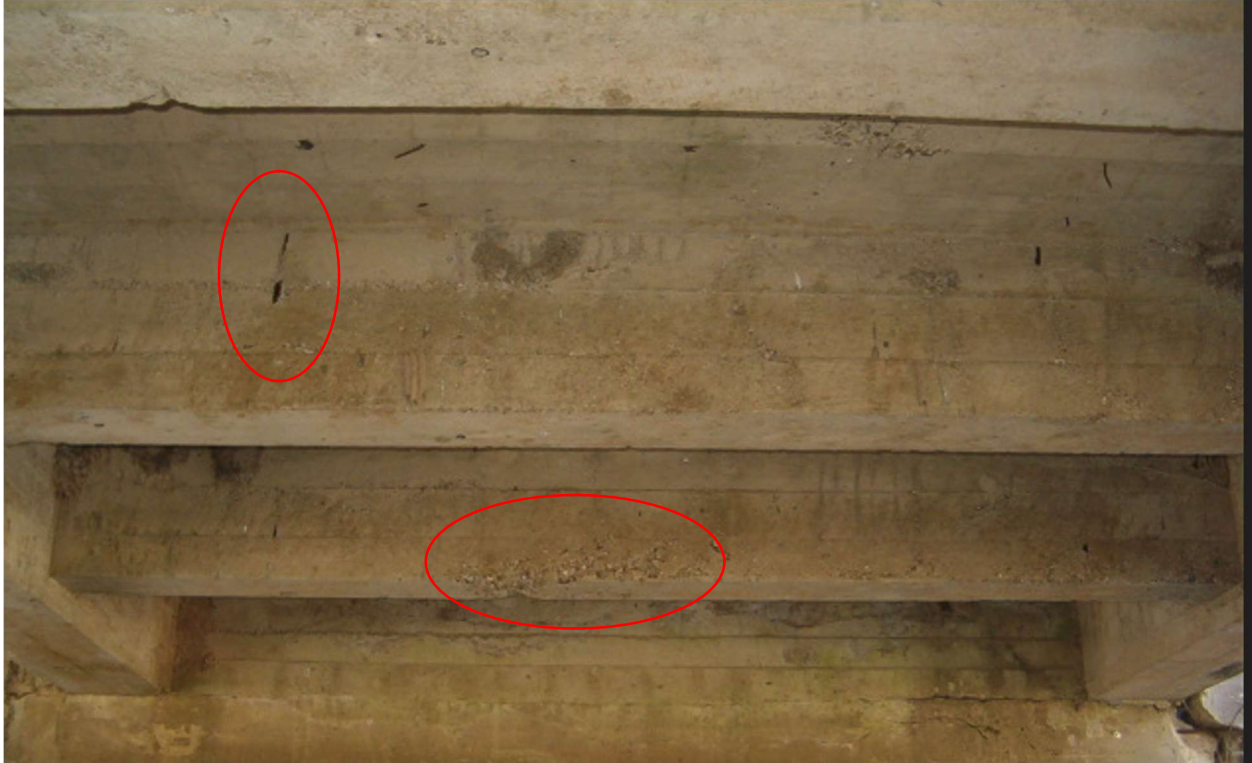
**Figure 106 – Bridge 295-5011-0 Reinforced Concrete Girder Typical Spalling (GDOT, 2022)**

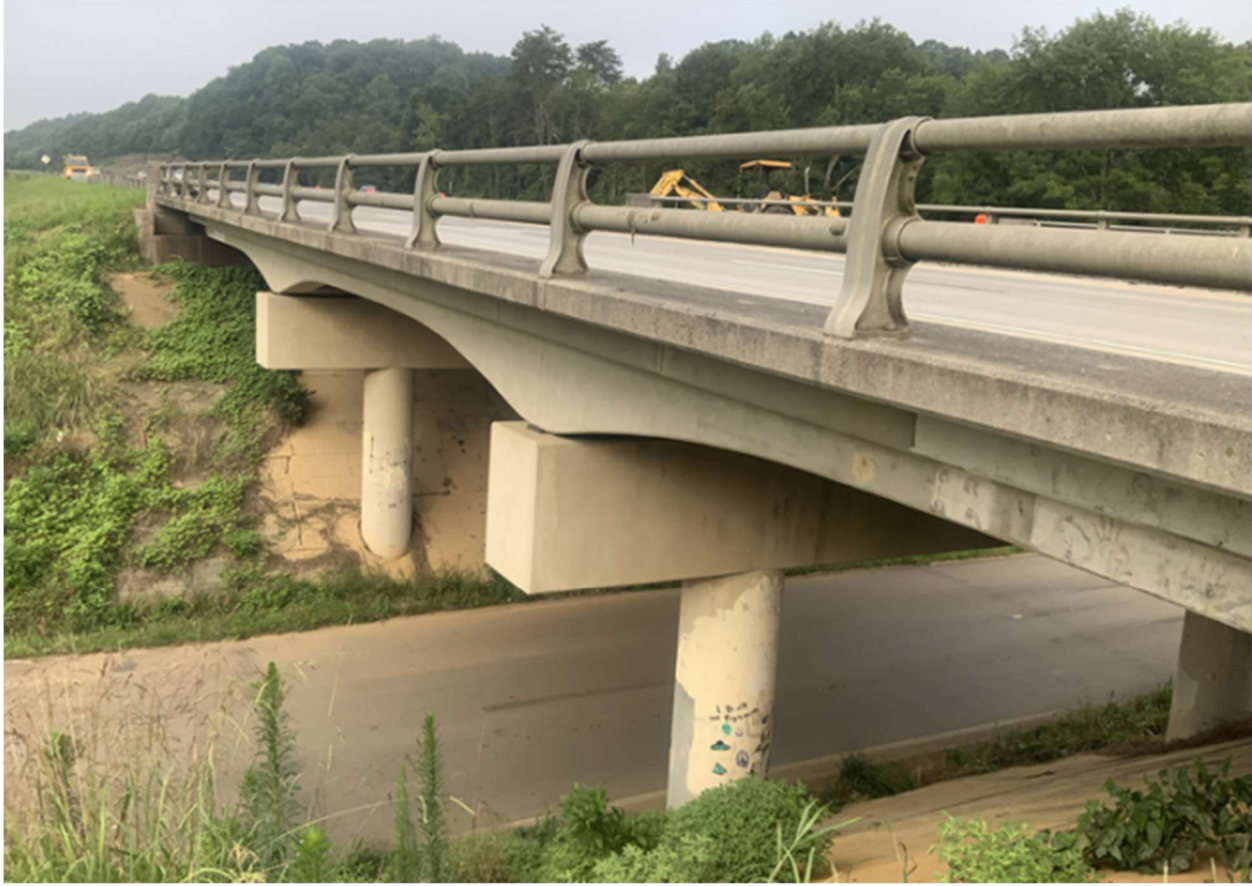
**Figure 107 – Bridge 083-0027-0 Side View (GDOT, 2022)**

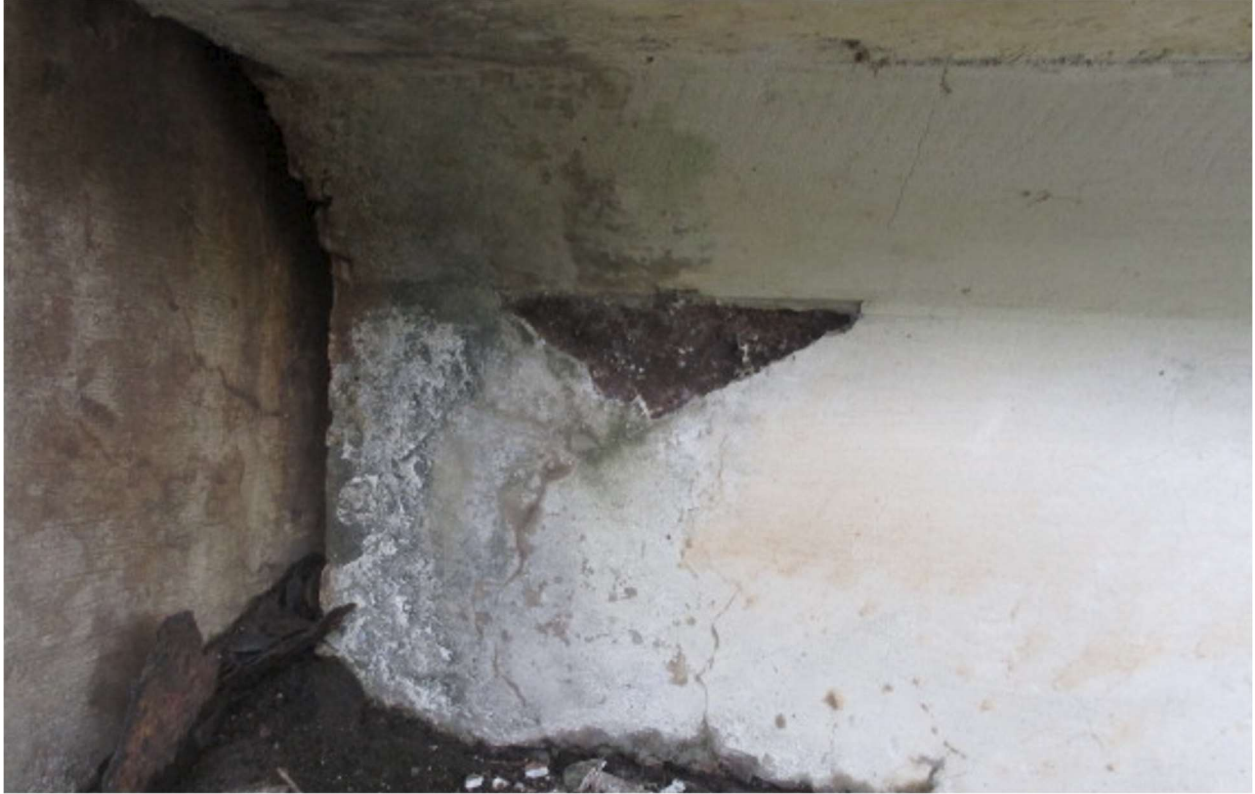
**Figure 108 – Bridge 083-0027-0 Reinforced Concrete Girder Spalling (GDOT, 2019)**

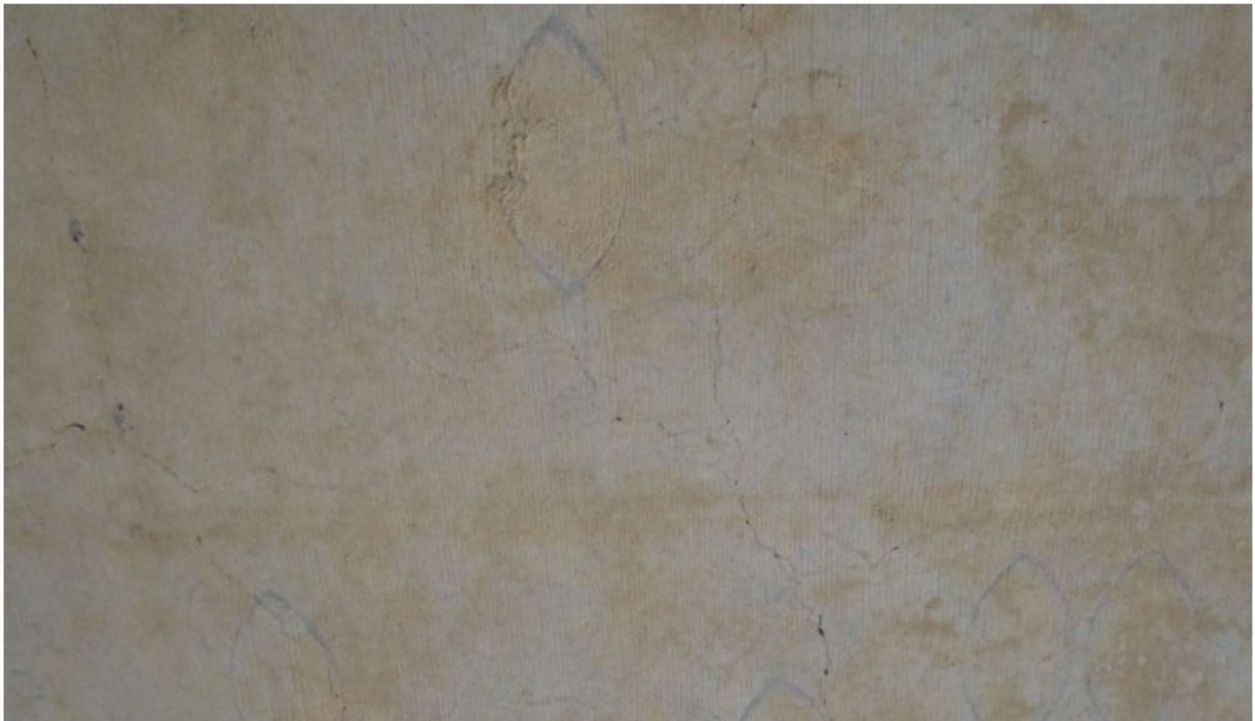
**Figure 109 – Bridge 083-0027-0 Reinforced Concrete Girder Cracking (GDOT, 2019)**

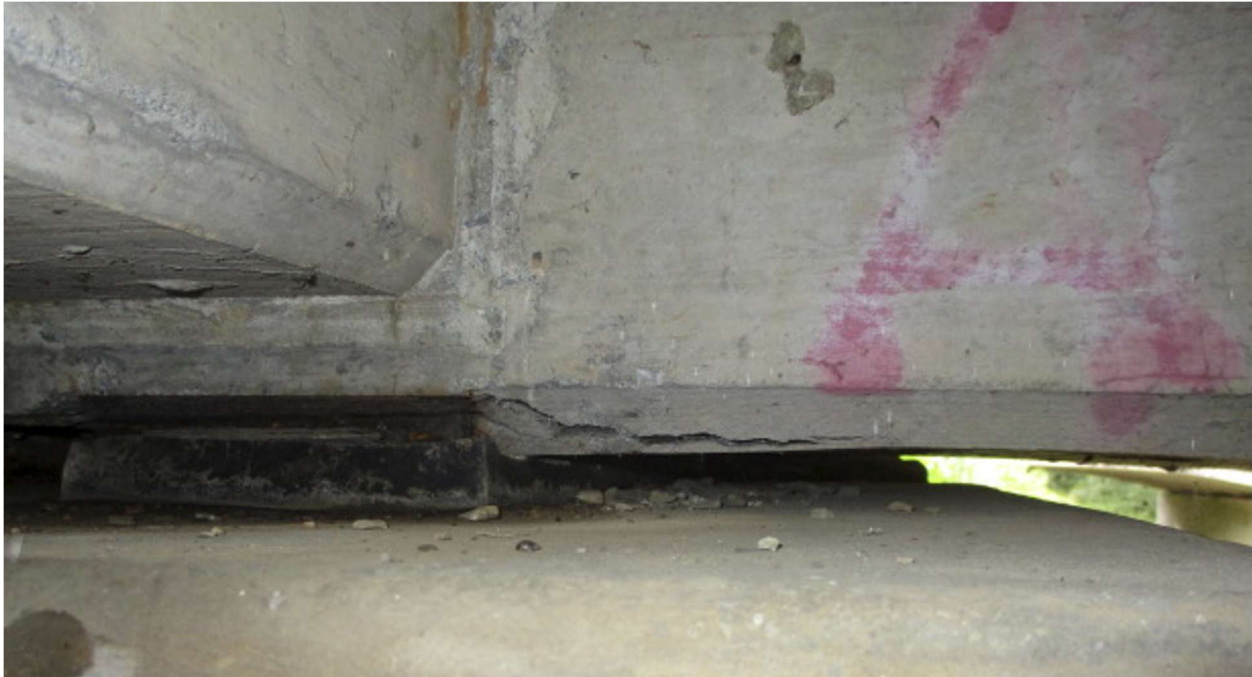
**Figure 110 – Bridge 083-0027-0 Reinforced Concrete Girder Spalling (GDOT, 2019)**

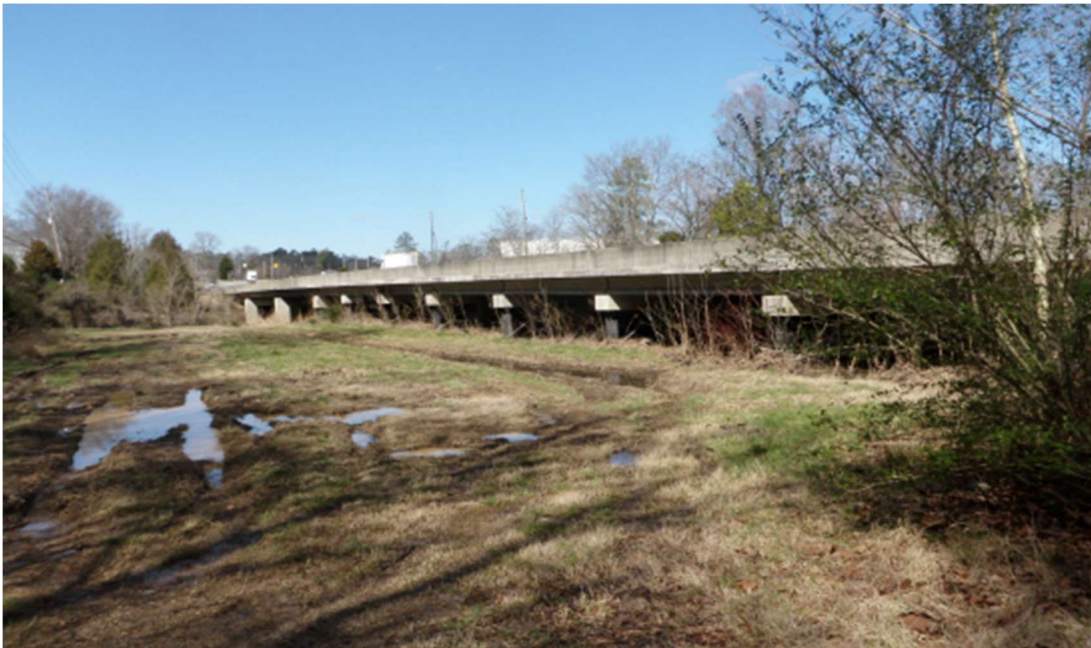
**Figure 111 – Bridge 295-0004-0 Side View (GDOT, 2015)**

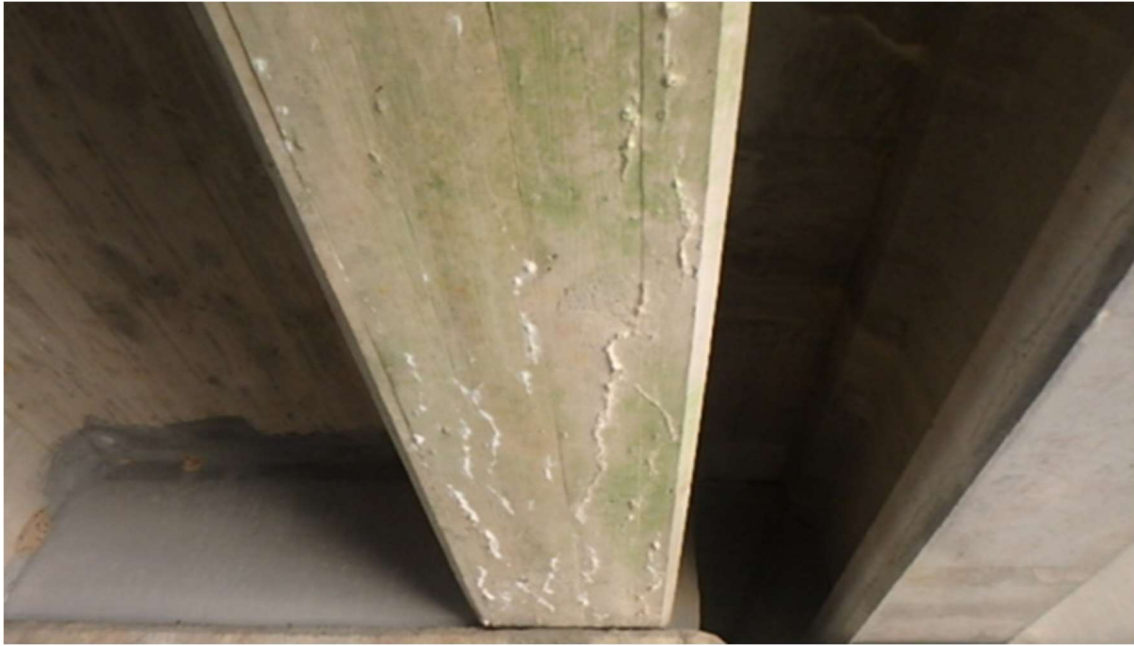
**Figure 112 – Bridge 295-0004-0 Reinforced Concrete Girder Cracking with Efflorescence  
(GDOT, 2020)**

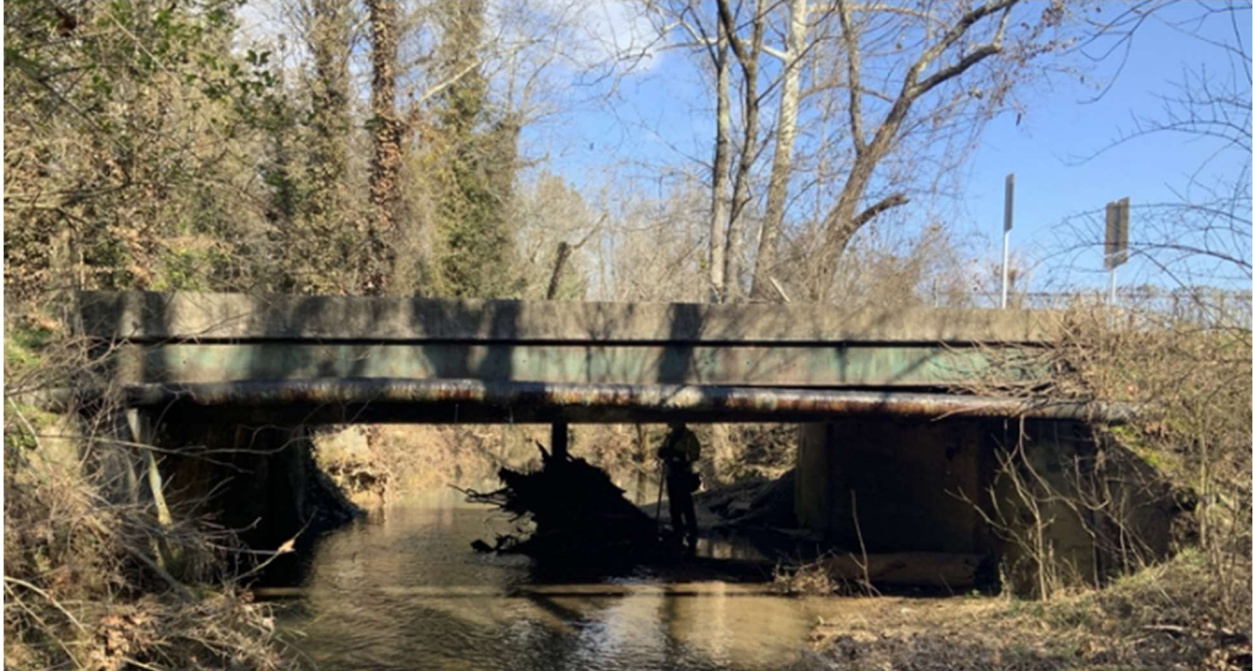
**Figure 113 – Bridge 295-0040-0 Side View (GDOT, 2021)**

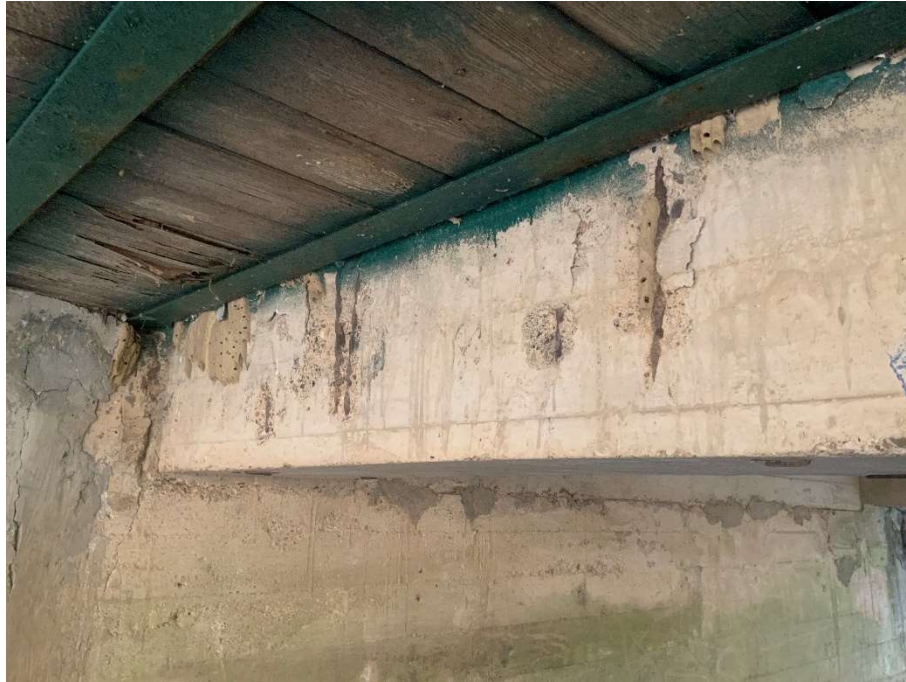
**Figure 114 – Bridge 295-0040 Reinforced Concrete Girder Spalling (GDOT, 2023)**

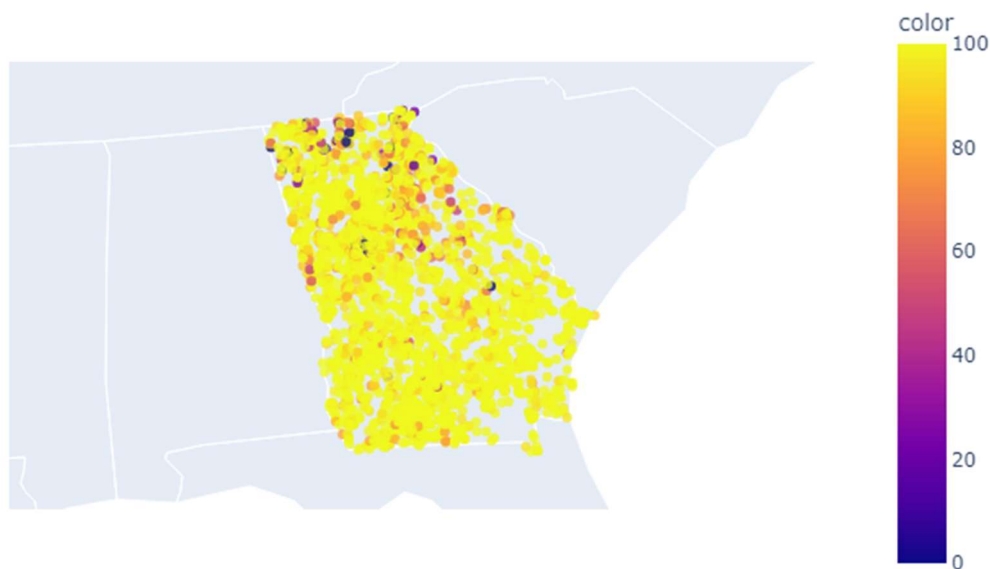
2021 Element Number 234 - % in CS1

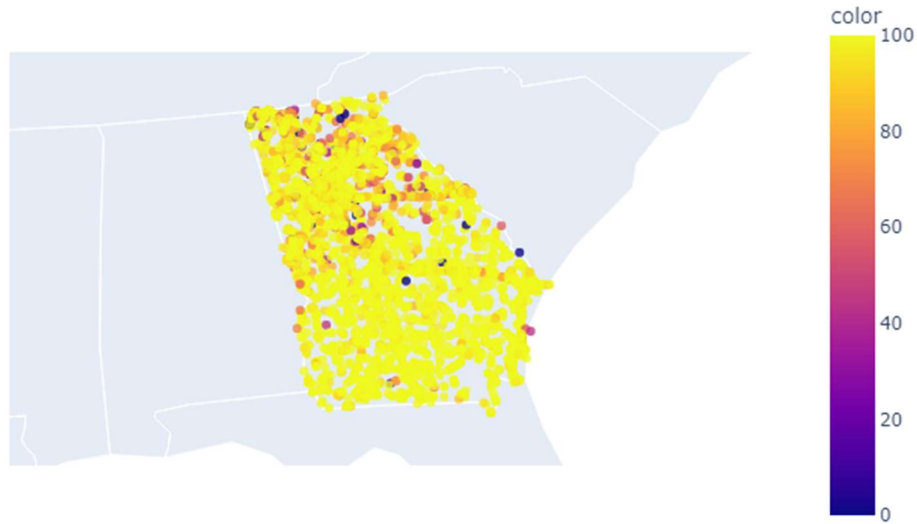
**Figure 115: Percent of EN234 in Condition State One by Location, 2021. County-Owned (Top) vs State-Owned (Bottom)**

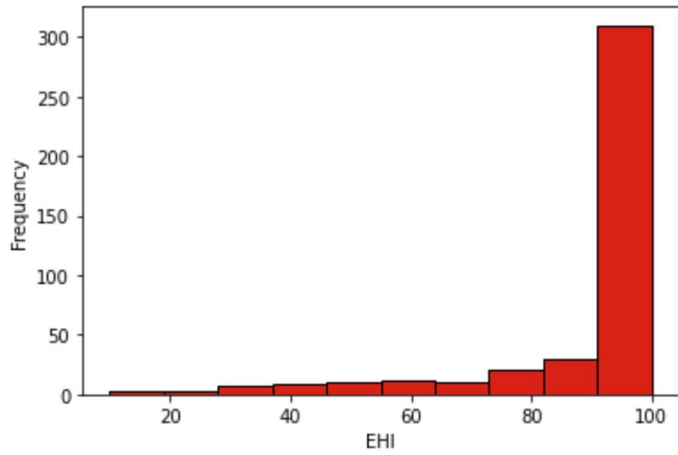
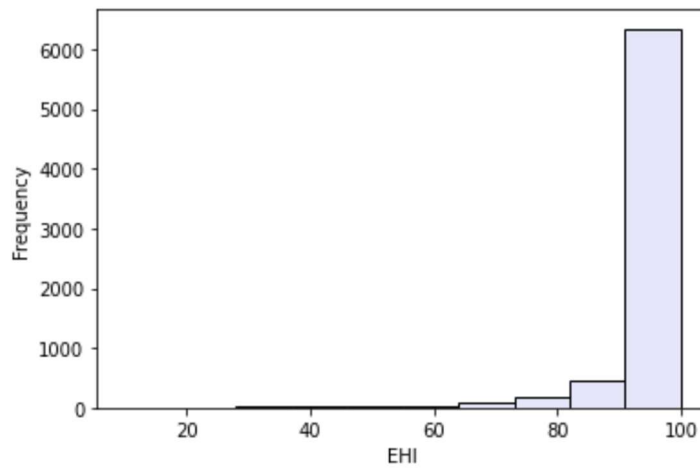
**Figure 116 – EHI of EN234 DT32 Counties (Top) vs NonDT32 Counties (Bottom)**

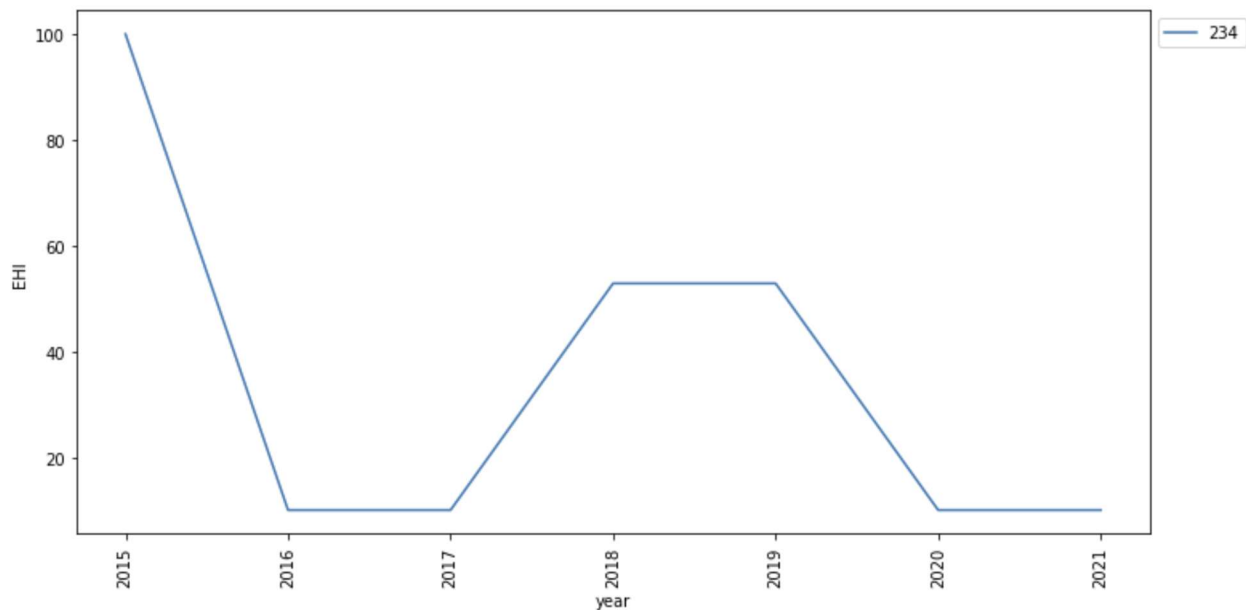
**Figure 119 – Bridge 295-5012-0 Reinforced Concrete Pier Cap EHI by Year**

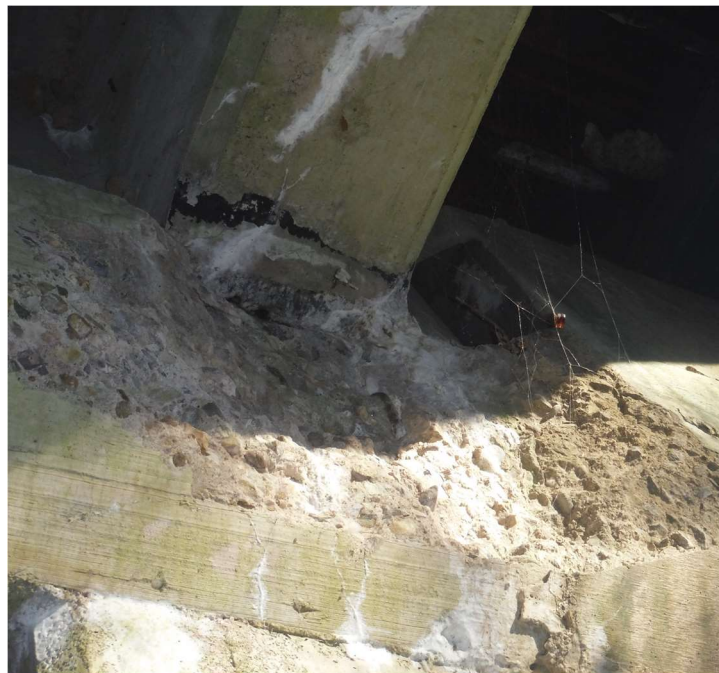
**Figure 120 – Bridge 295-5012-0 Reinforced Concrete Pier Cap Spalling (GDOT, 2017)**

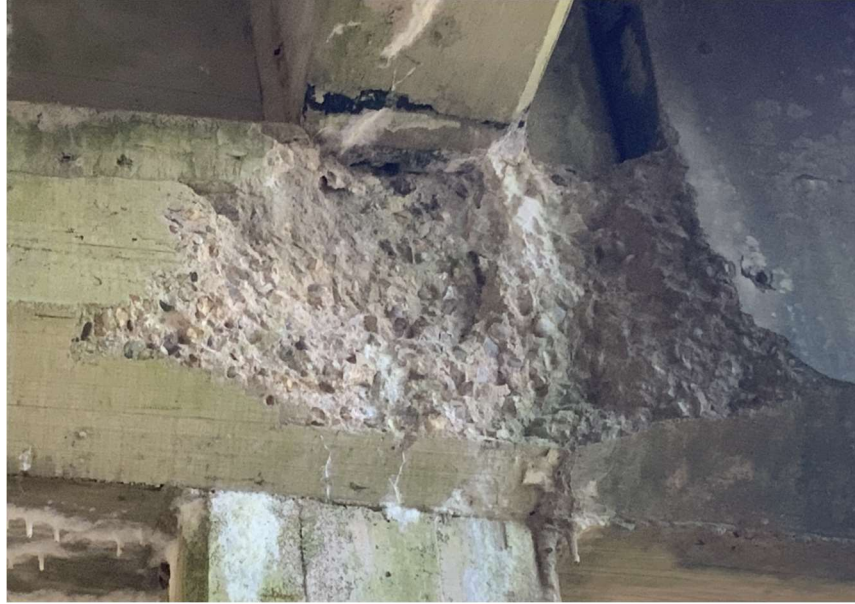
**Figure 121 – Bridge 295-5012-0 Reinforced Concrete Pier Cap Spalling (GDOT, 2021)**

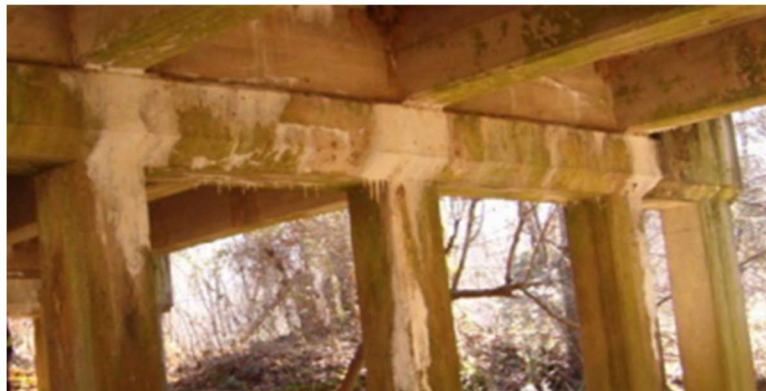
**Figure 122 – Bridge 295-5012-0 Reinforced Concrete Pier Cap Efflorescence (GDOT, 2017)**

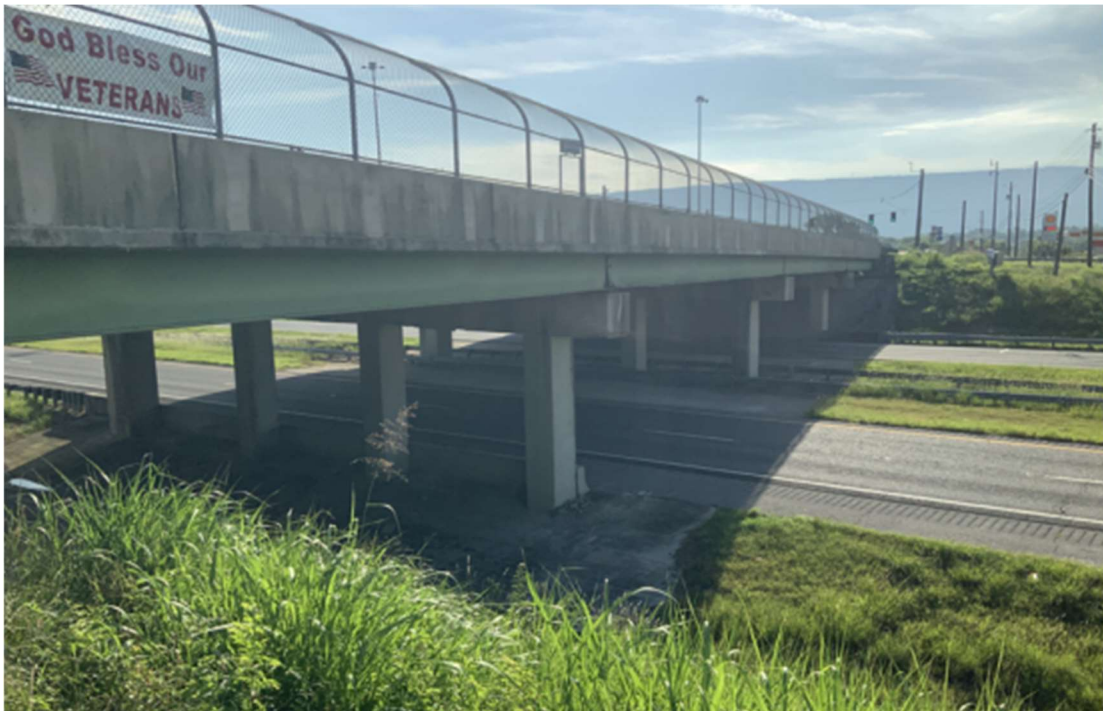
**Figure 123 – Bridge 083-0012-0 Side View (GDOT, 2021)**

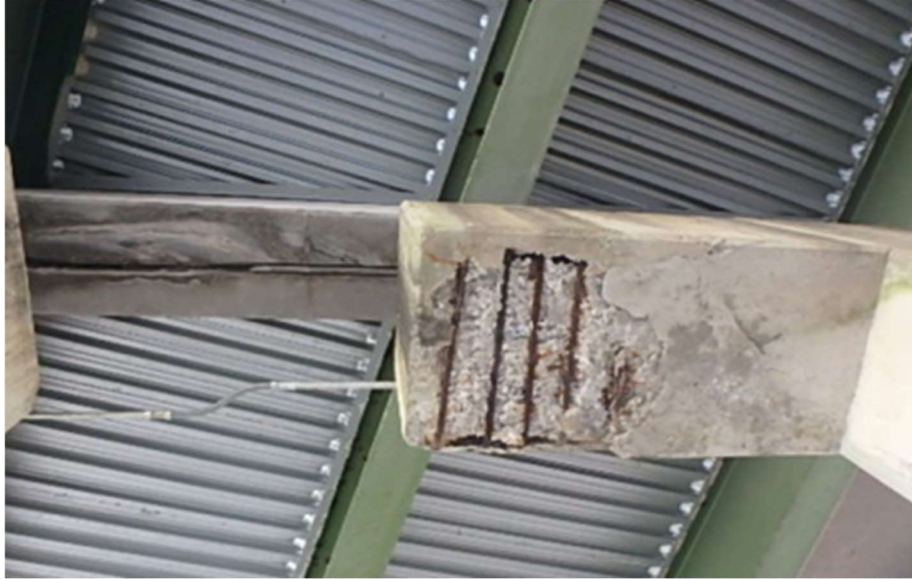
**Figure 124 – Bridge 083-0012-0 Reinforced Concrete Pier Cap Spalling with Exposed Rebar (GDOT, 2019)**

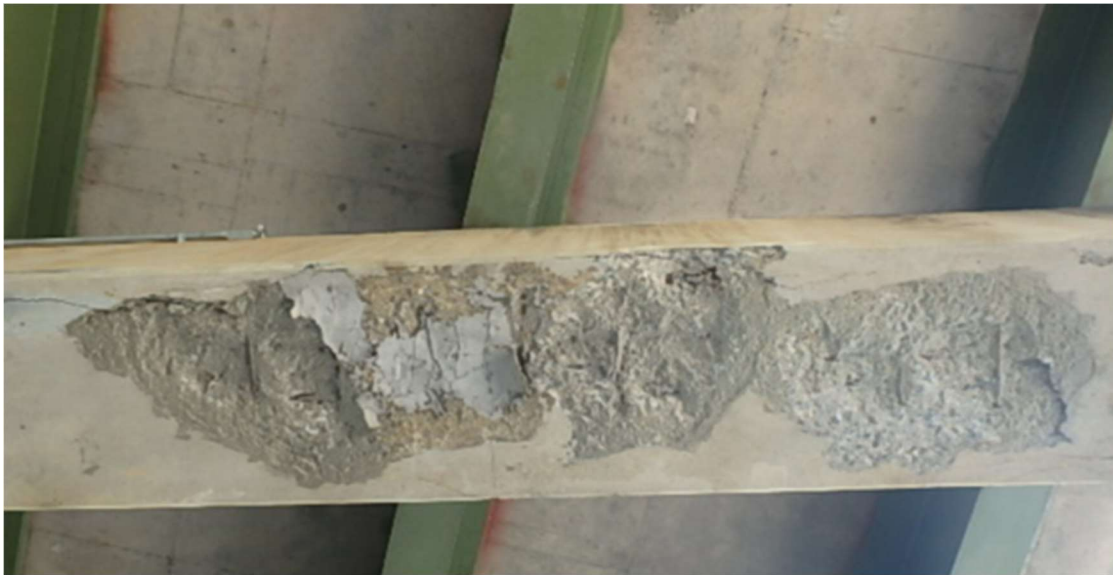
**Figure 125 – Bridge 083-0012-0 Reinforced Concrete Pier Cap Failed Spall Repair (GDOT, 2019)**

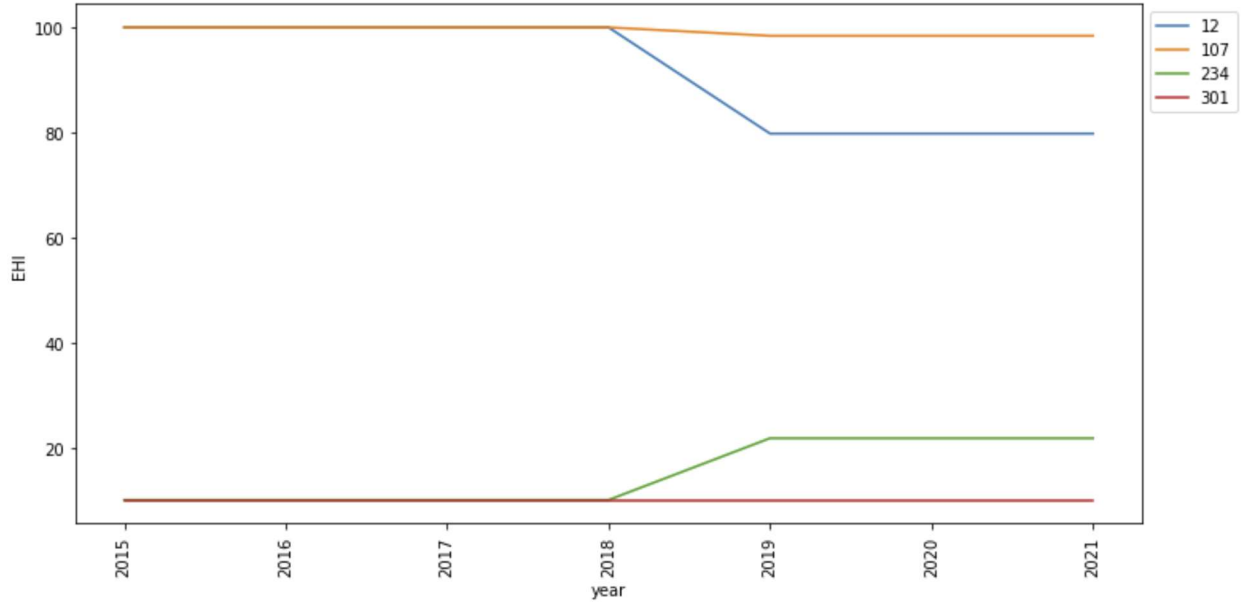
**Figure 126 – Bridge 083-0012-0 Element EHI by Year**

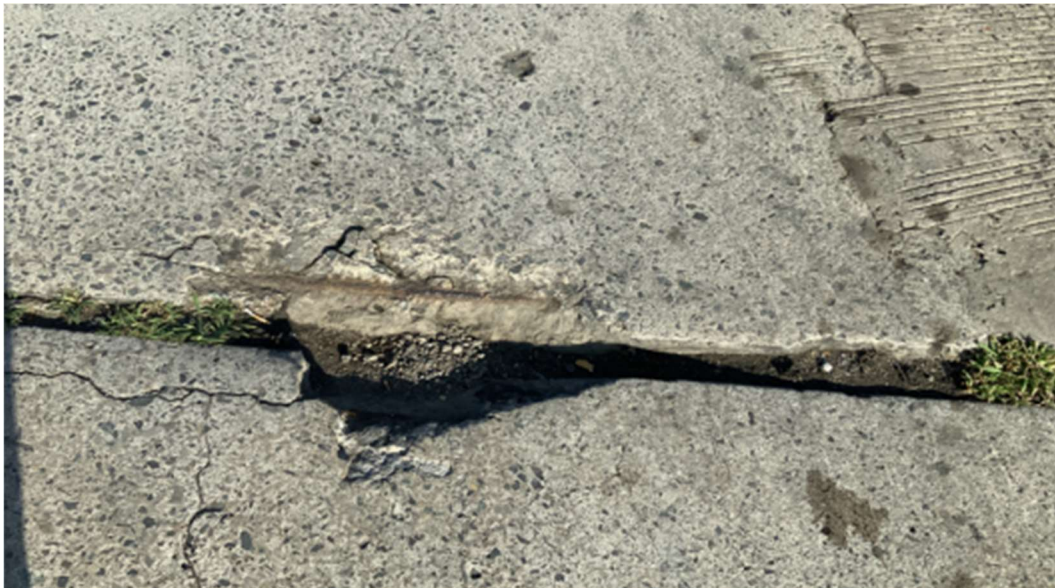
**Figure 127 – Bridge 083-0012-0 Joint Failure (GDOT, 2017)**

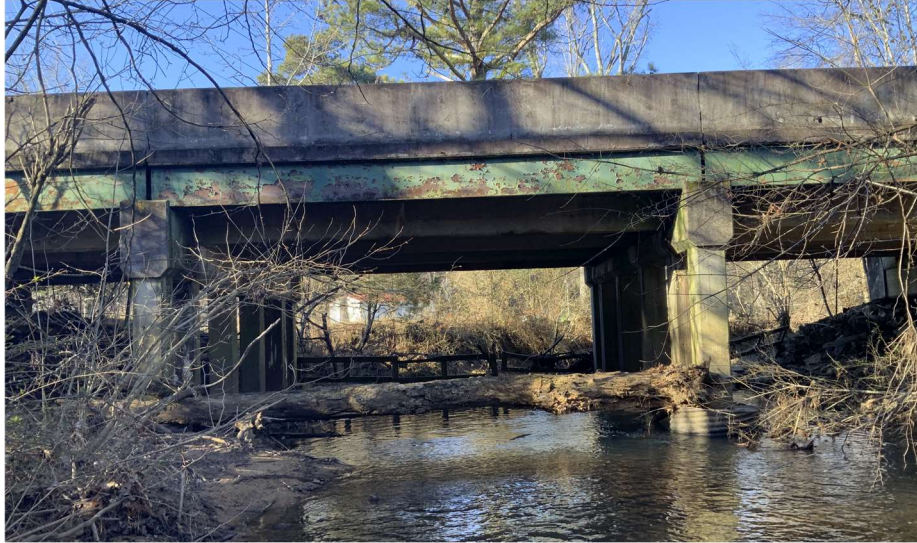
**Figure 128 – Bridge 295-5013-0 Bridge Side View (GDOT, 2021)**

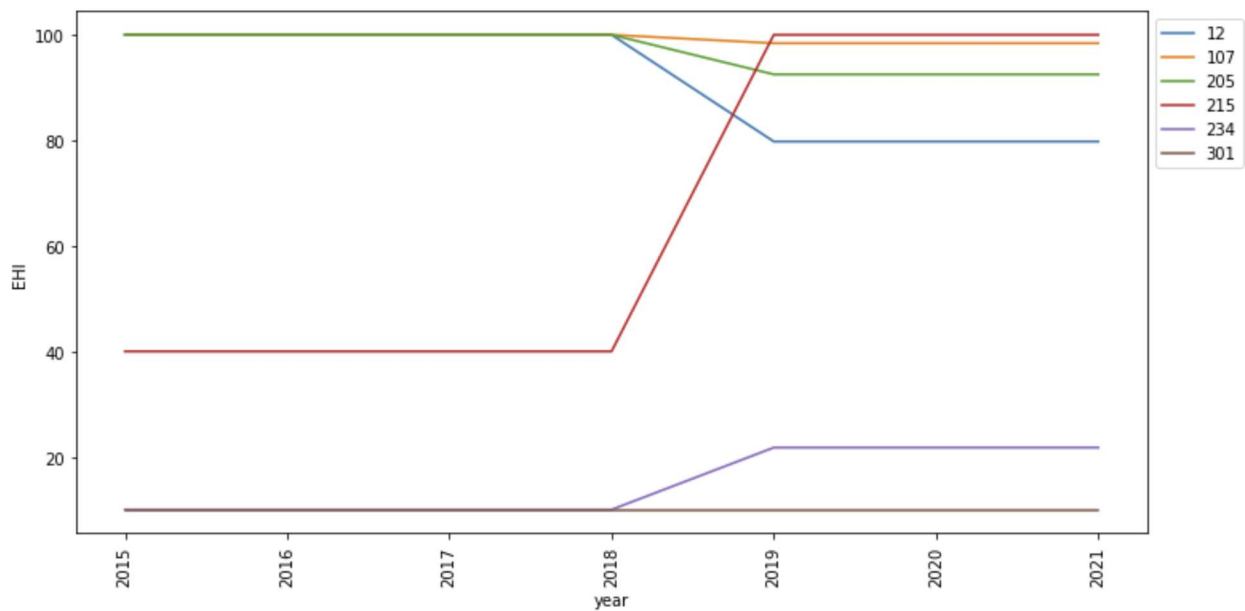
**Figure 129 – Bridge 295-5013-0 EHI by Year**

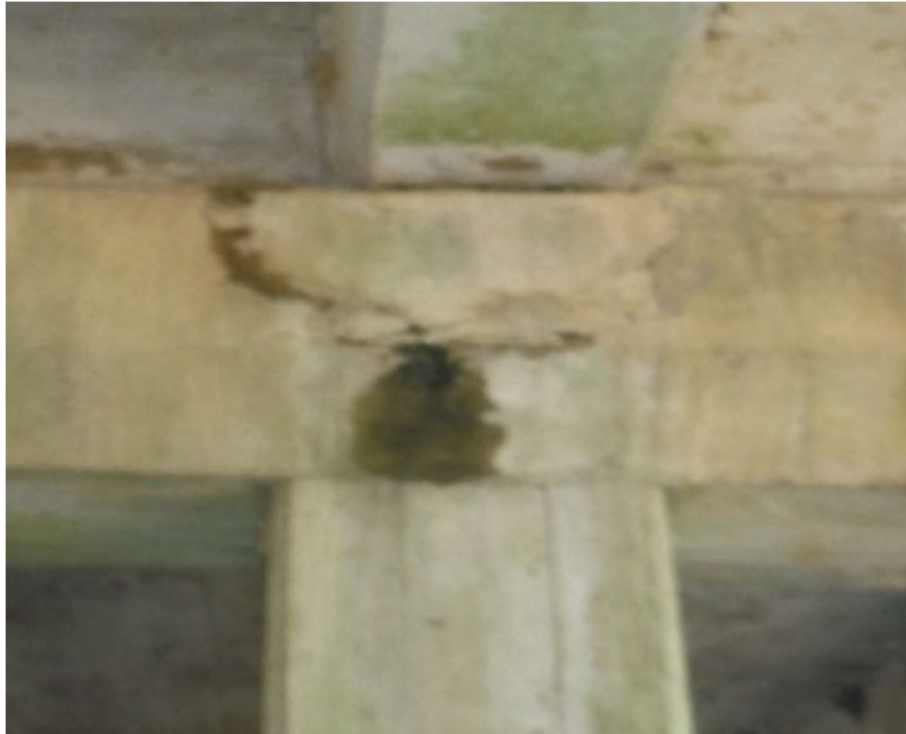
**Figure 130 – Bridge 295-5013-0 Reinforced Concrete Pier Cap Cracking (GDOT, 2021)**

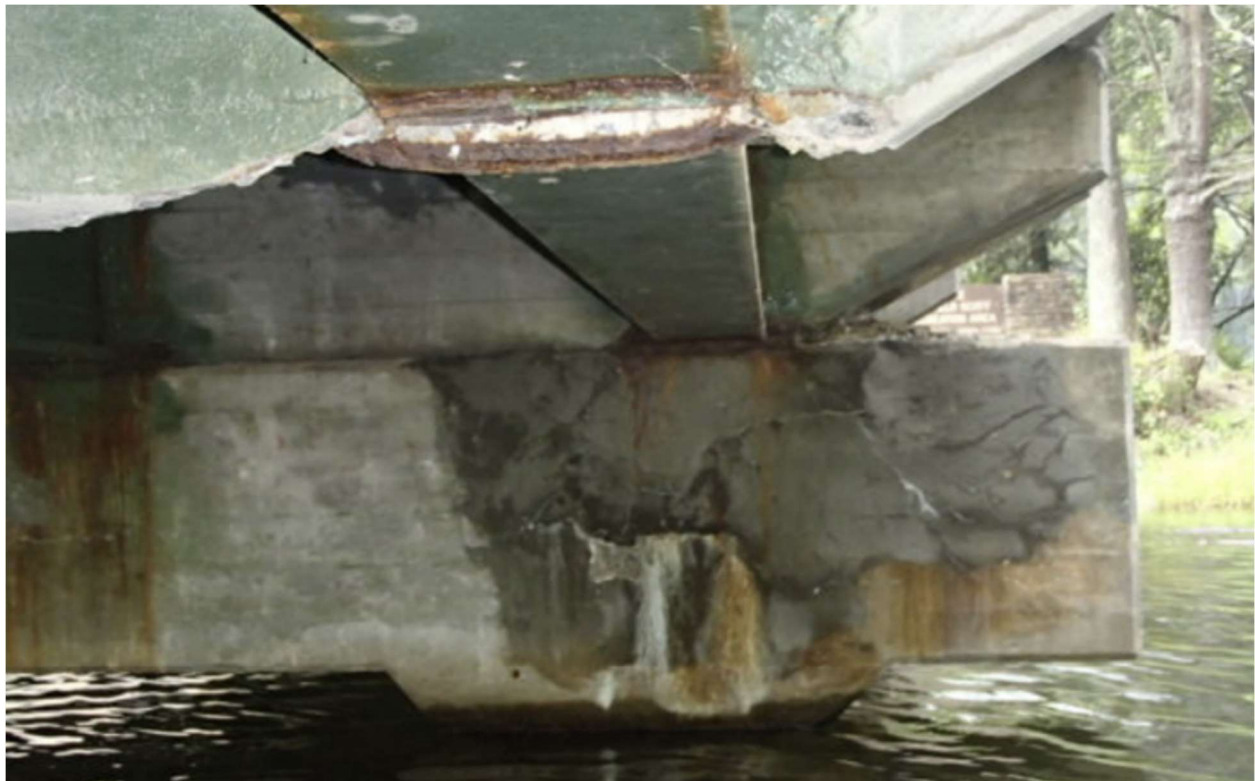
**Figure 131 – Bridge 291-0017-0 Reinforced Concrete Pier Cap (GDOT, 2021)**
