IMPACT OF WEATHER STRESSORS TO IDENTIFY VULNERABLE BRIDGE ELEMENTS  
IN GEORGIA TOWARDS DATA DRIVEN ASSEST MANAGEMENT

by SPENCER KOPF

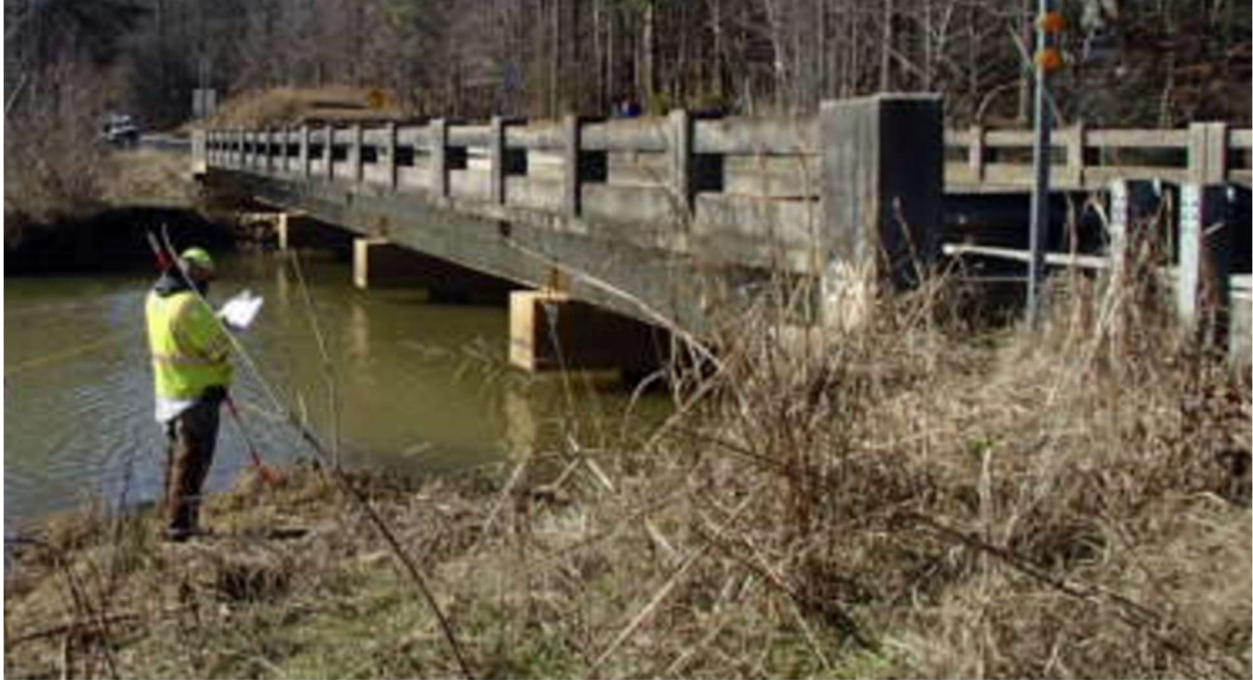
**Figure 132 – Bridge 311-5001-0 Side View (GDOT, 2021)**

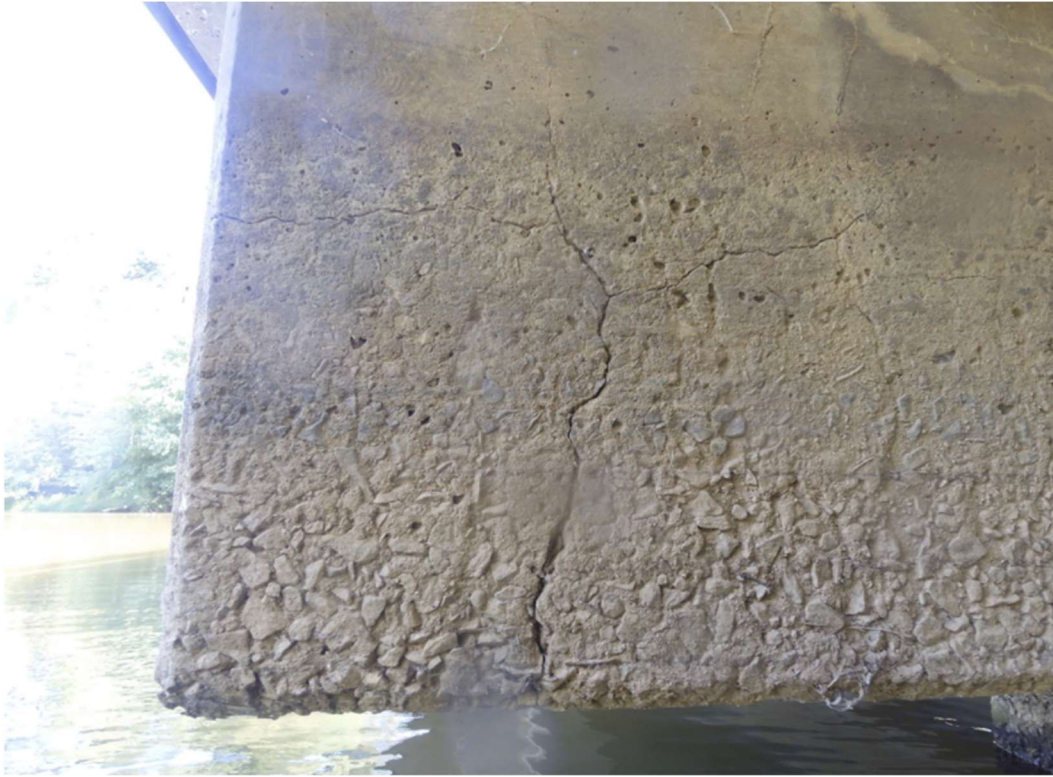
**Figure 133 – Bridge 311-5001-0 Pier Cap Cracking (GDOT, 2018)**

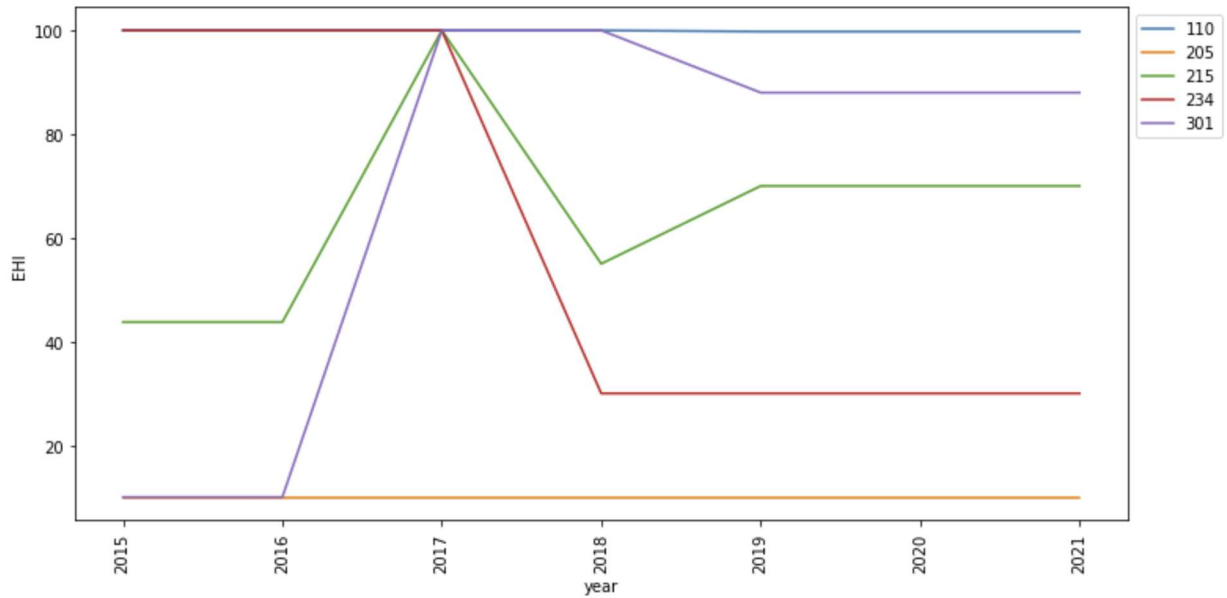
**Figure 134 – Bridge 311-5001-0 Element EHI by Year**

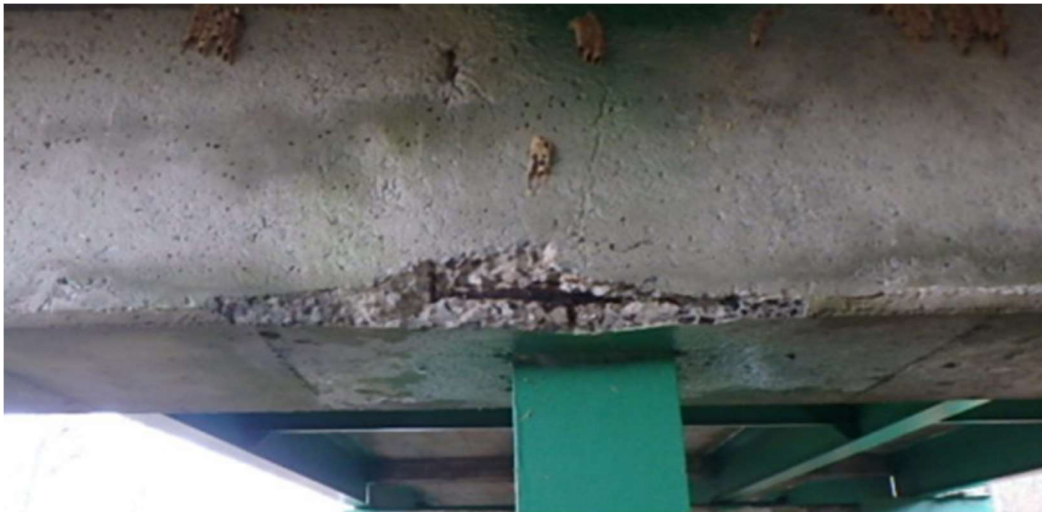
**Figure 135 – Bridge 213-0001-0 Reinforced Concrete Pier Cap Spalling with Rebar Section Loss (GDOT, 2020)**

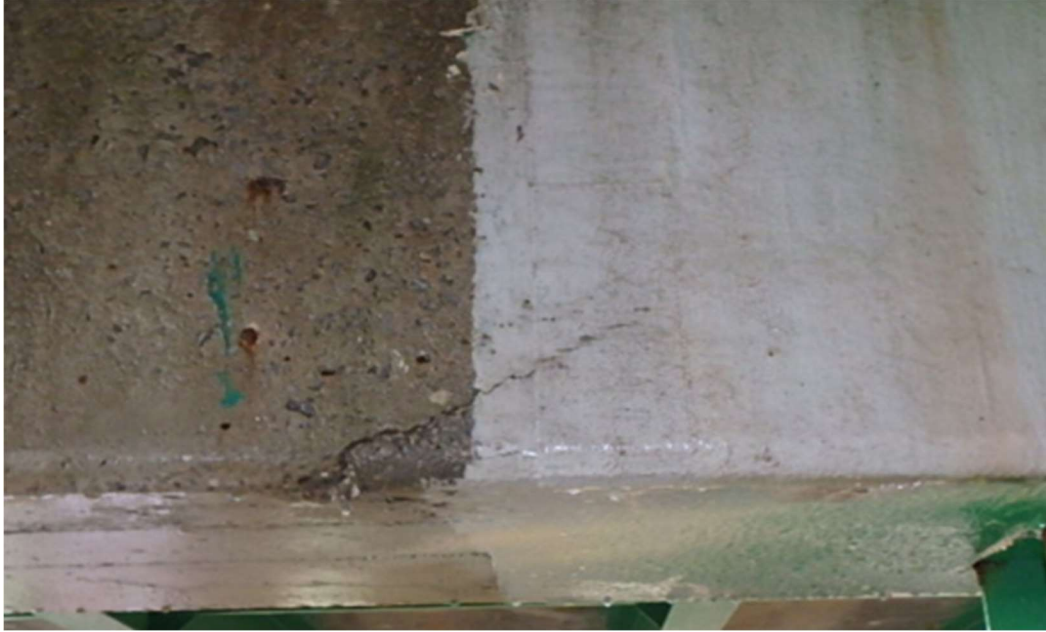
**Figure 136 – Bridge 213-0001-0 Reinforced Concrete Pier Cap Cracking in Wrap Repair  
(GDOT, 2020)**

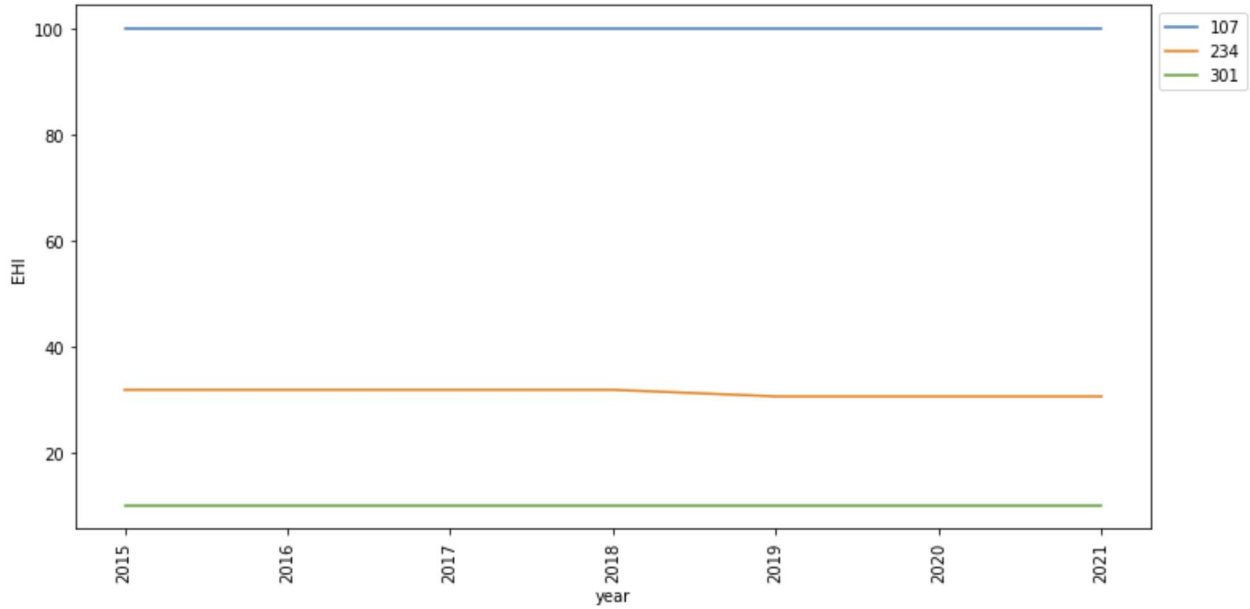
**Figure 137 – Bridge 213-0001-0 EHI by Year**

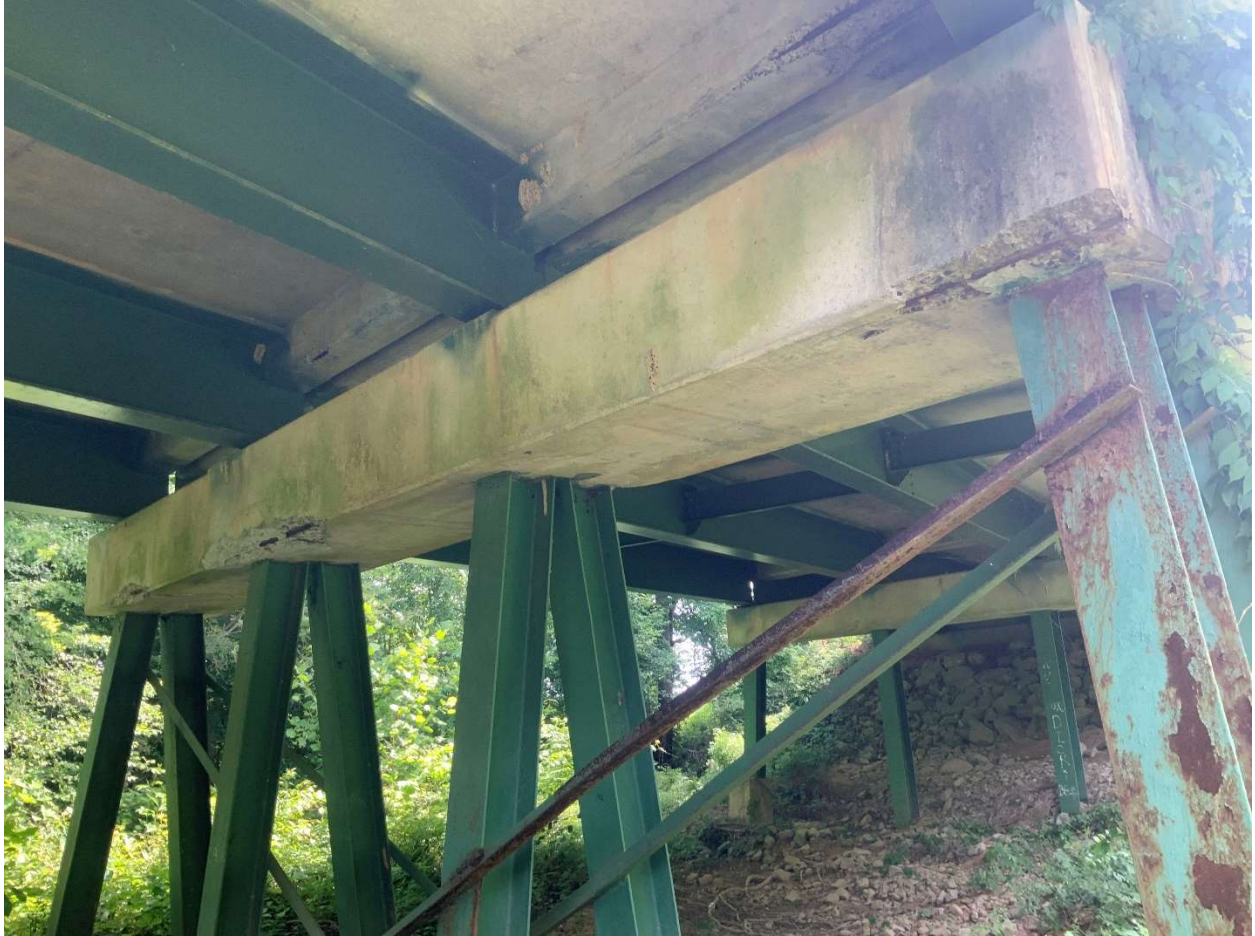
**Figure 138 – Bridge 313-0004-0 Reinforced Concrete Pier Cap Spalling, 2022**

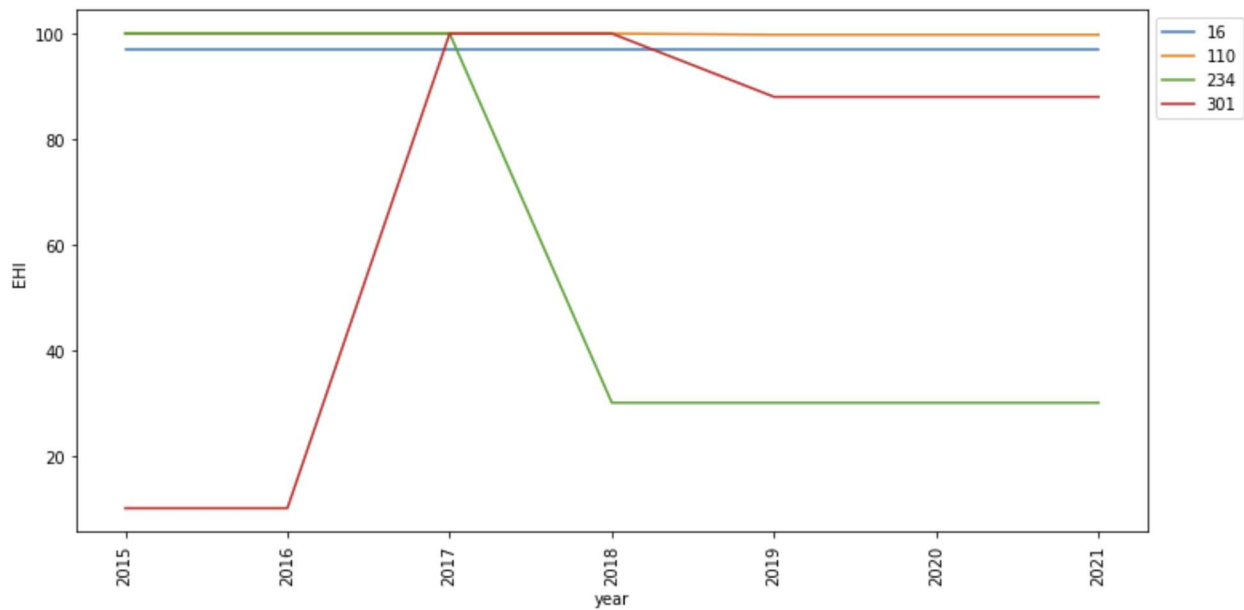
**Figure 139 – Bridge 291-0018-0 Element EHI by Year**

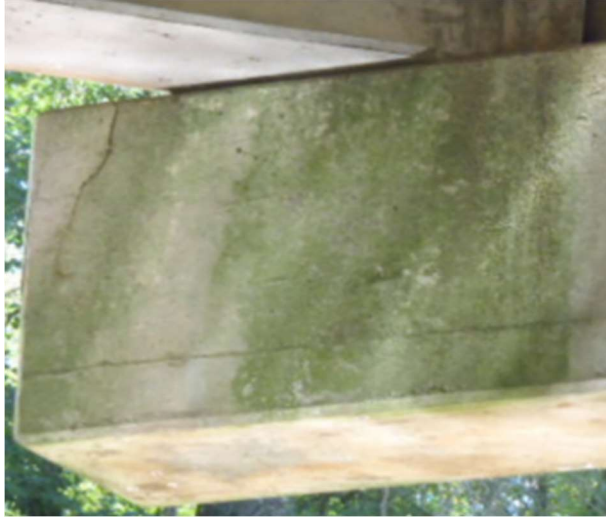
**Figure 140 – Bridge 291-0018-0 Reinforced Concrete Pier Cap Cracking (GDOT, 2018)**

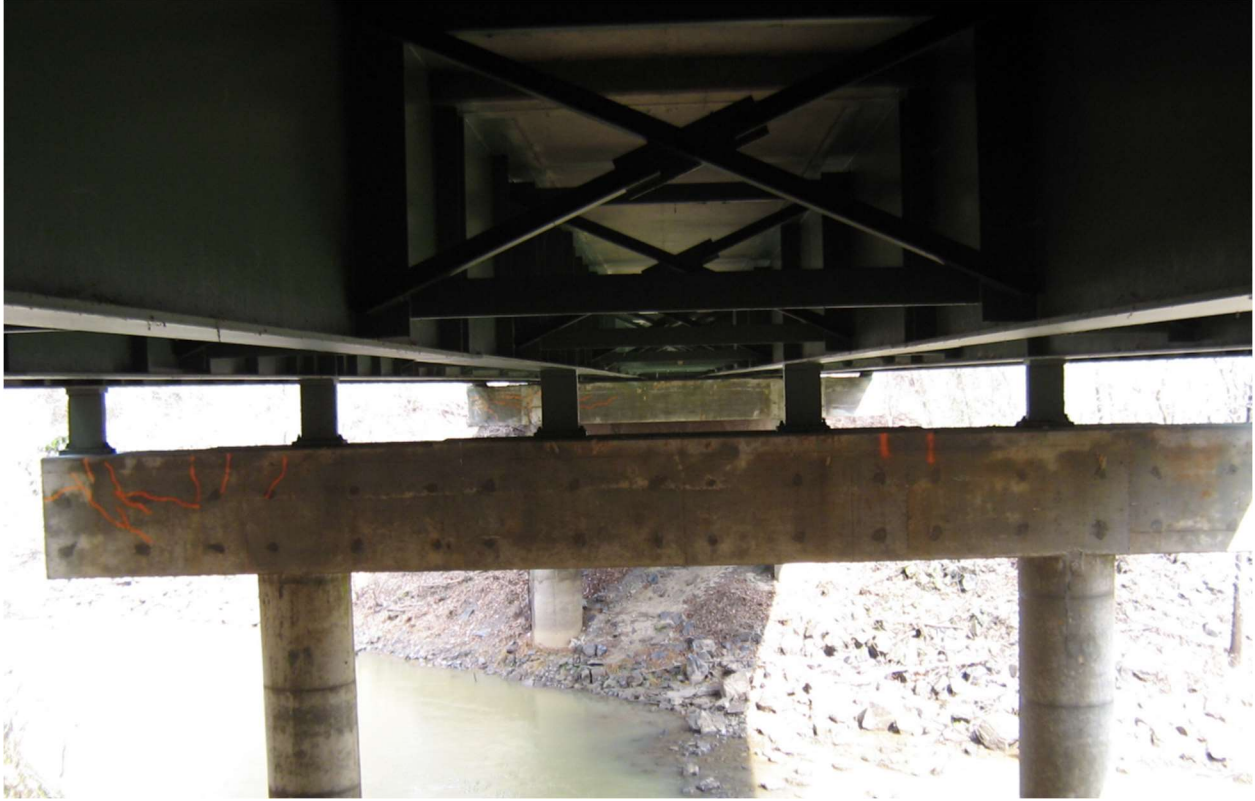
**Figure 141 – Bridge 213-0008-0 Pier Cap Concrete Cracking (GDOT, 2022)**

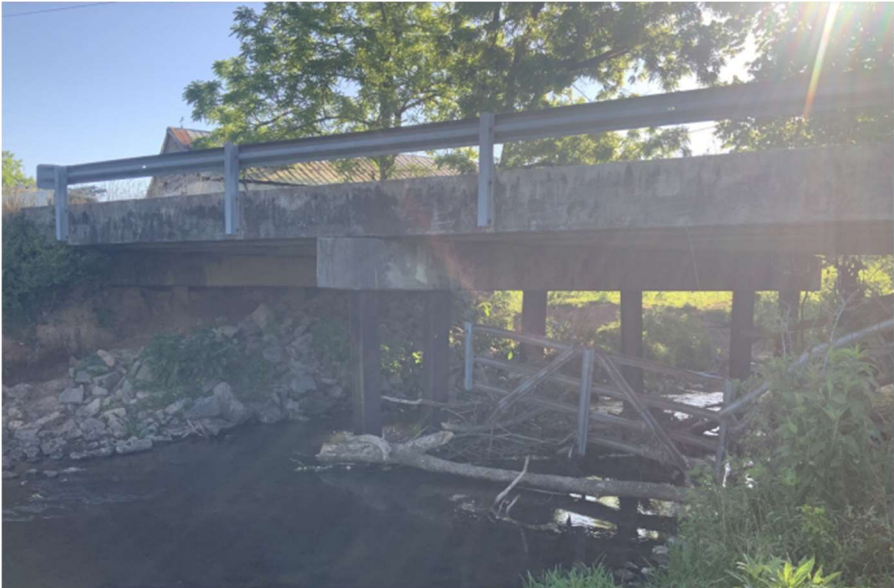
**Figure 142 – Bridge 313-5028-0 Bridge Side View (GDOT, 2022)**

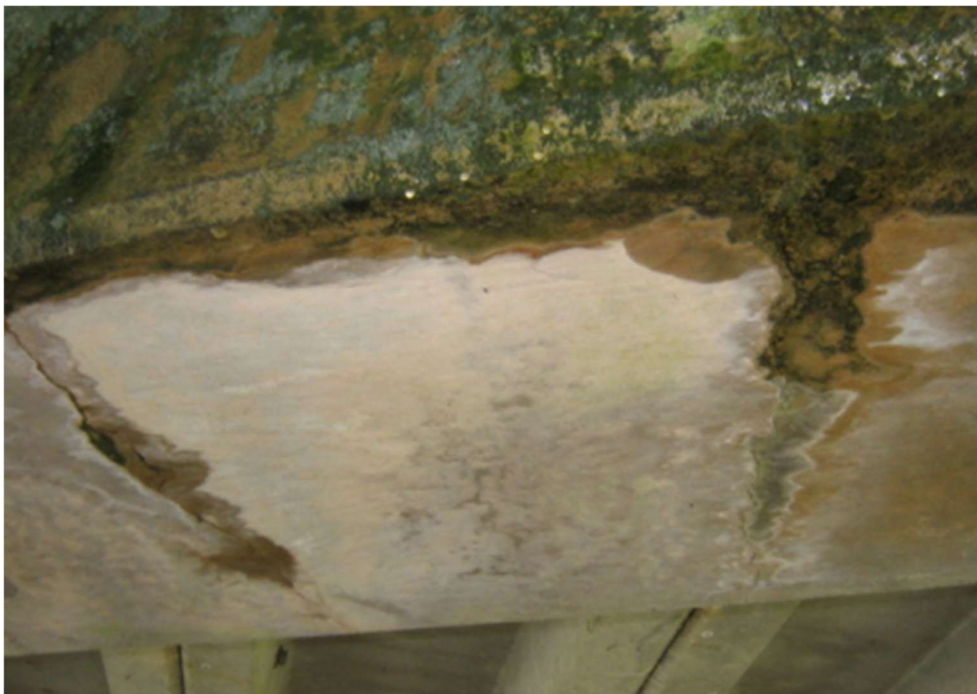
**Figure 143 – Bridge 313-5028-0 Pier Cap Cracking (GDOT, 2022)**

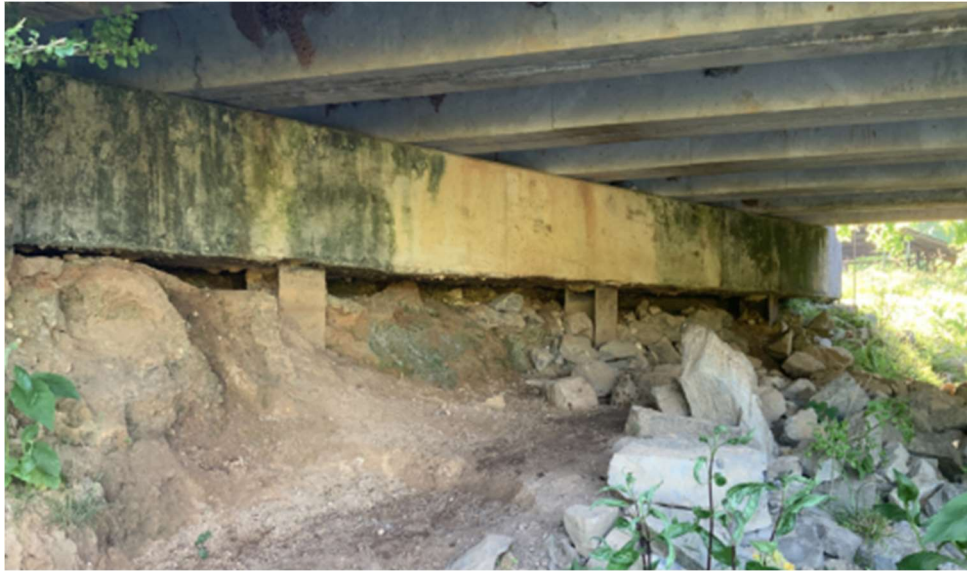
**Figure 144 – Bridge 313-5028-0 Abutment 3 Undermining (GDOT, 2022)**

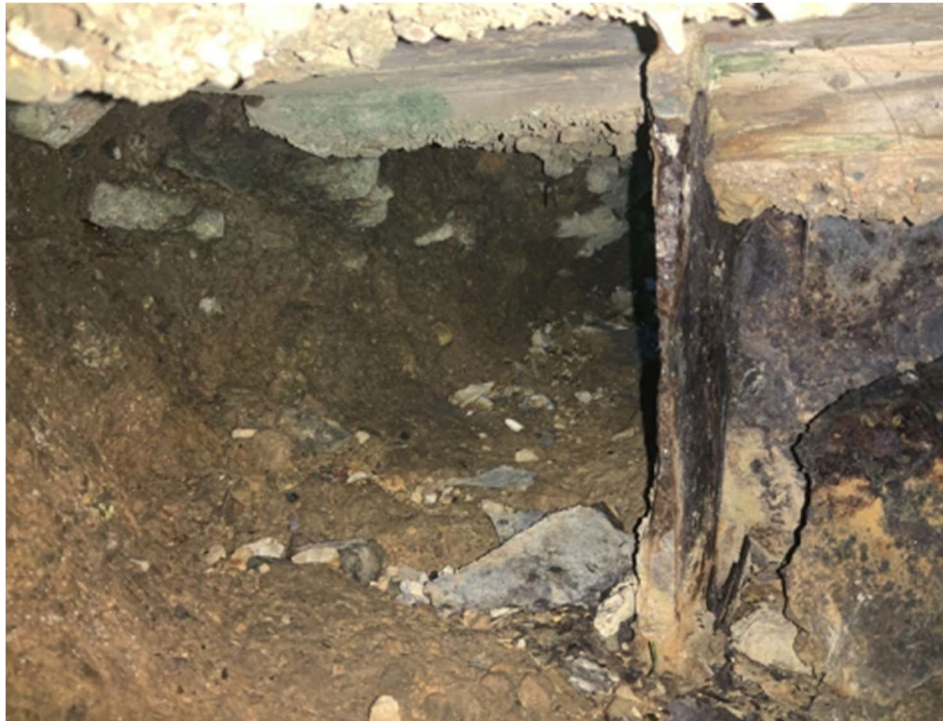
**Figure 145 – Bridge 313-5028-0 Abutment 3 Pile 1 Section Loss (GDOT, 2022)**

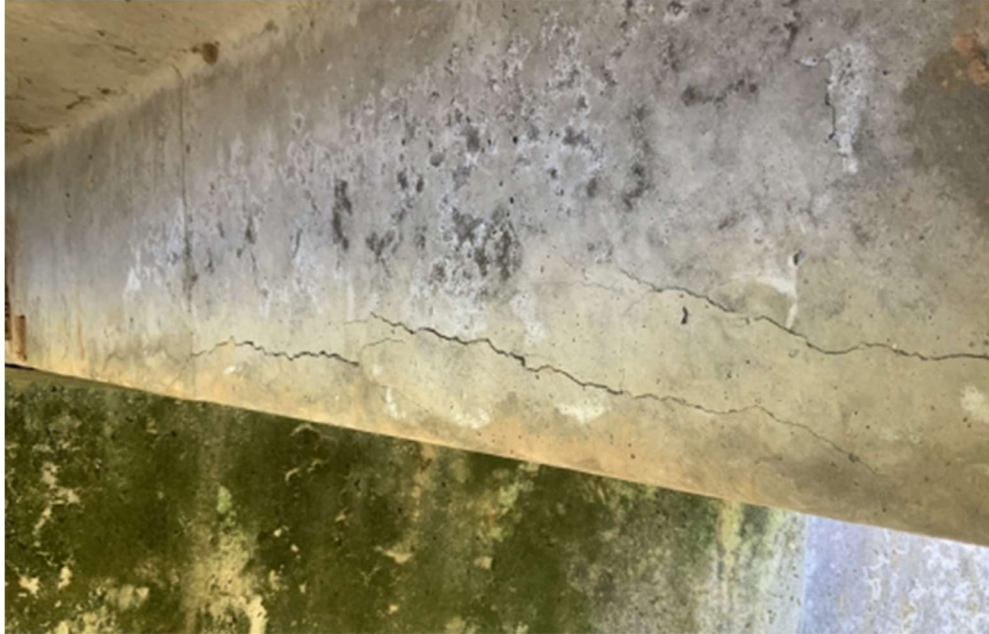
**Figure 146 – Bridge 313-5028-0 Span 2 Cracking (GDOT, 2022)**

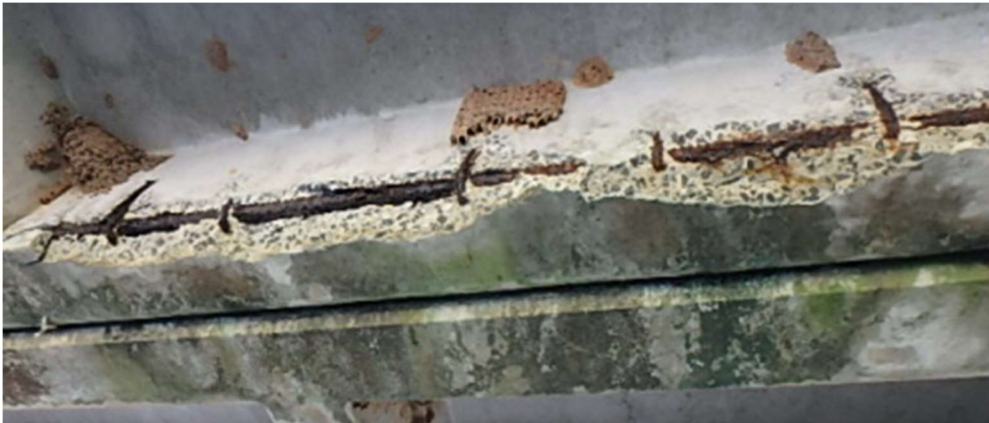
**Figure 147 – Bridge 313-5028-0 Span 1 Spalling (GDOT, 2020)**

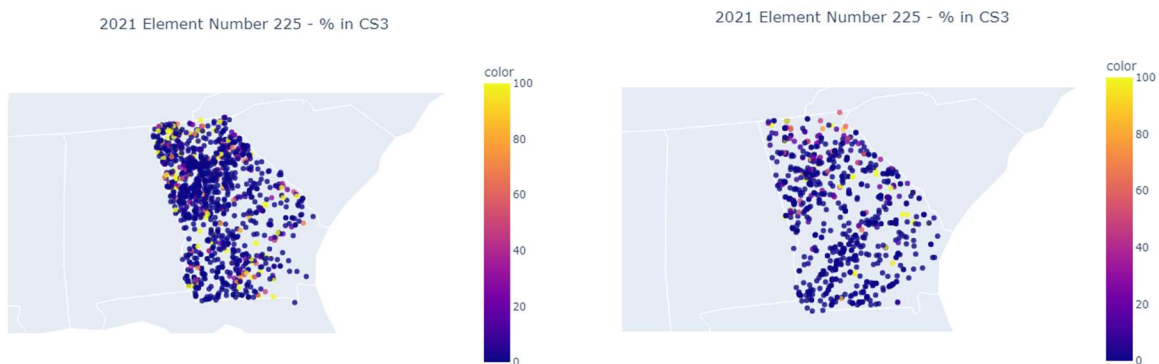
**Figure 148: EN215 Percent in CS3 by location, 2021 County-Owned (Left) vs State-Owned (Right)**

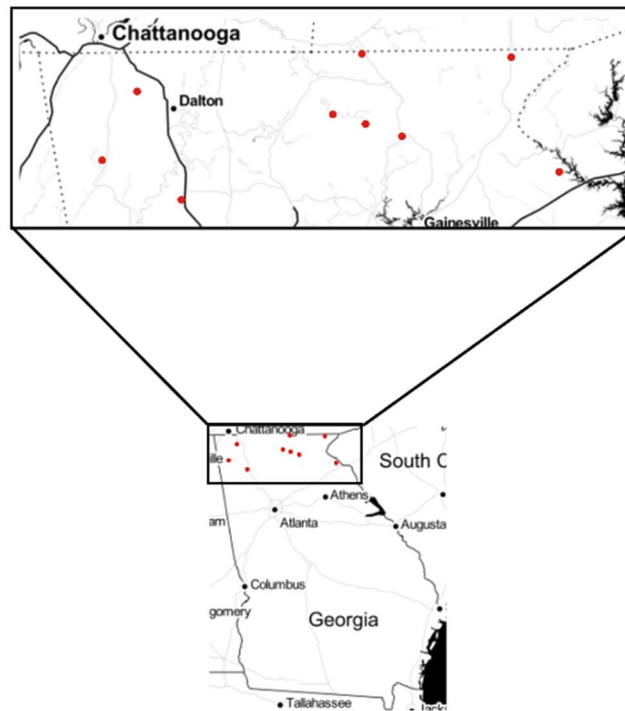
**Figure 149 - Location of Selected DP10 Bridges for EN225**

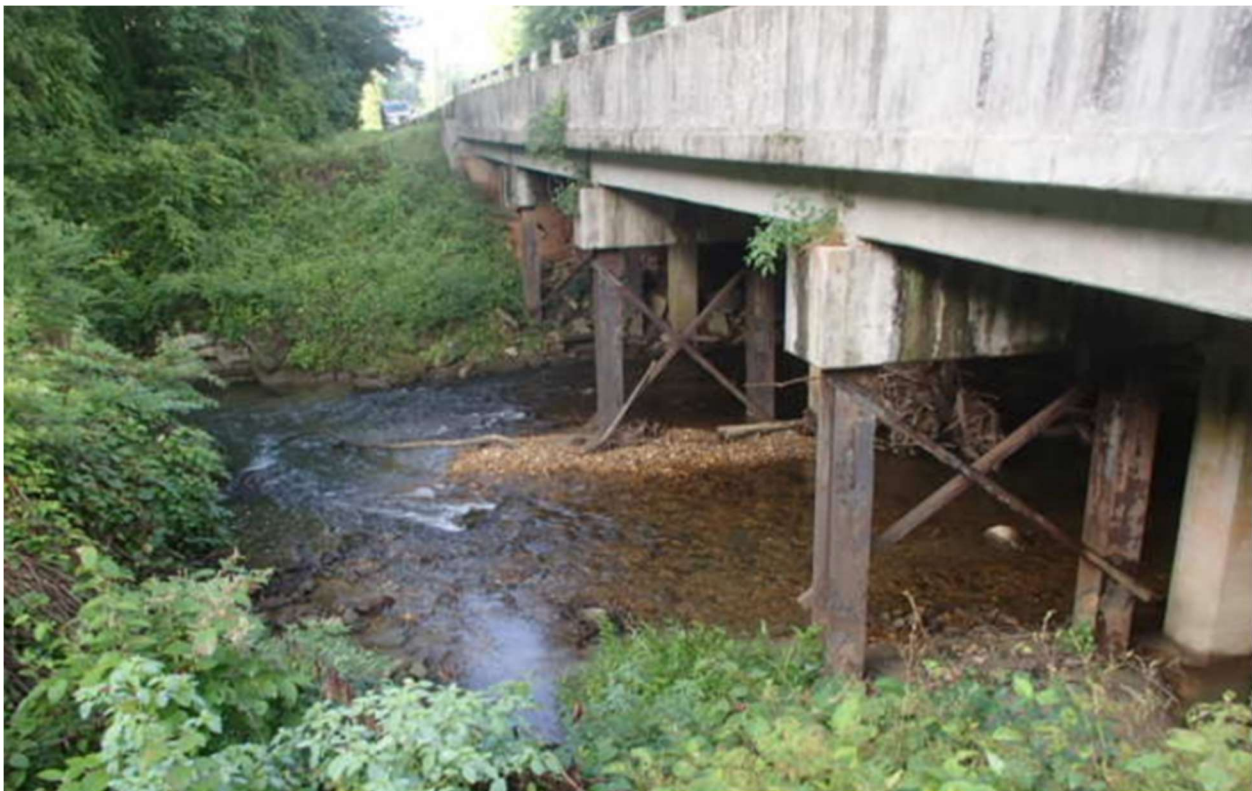
**Figure 150 – Bridge 241-0016-0 Side View (GDOT, 2022)**

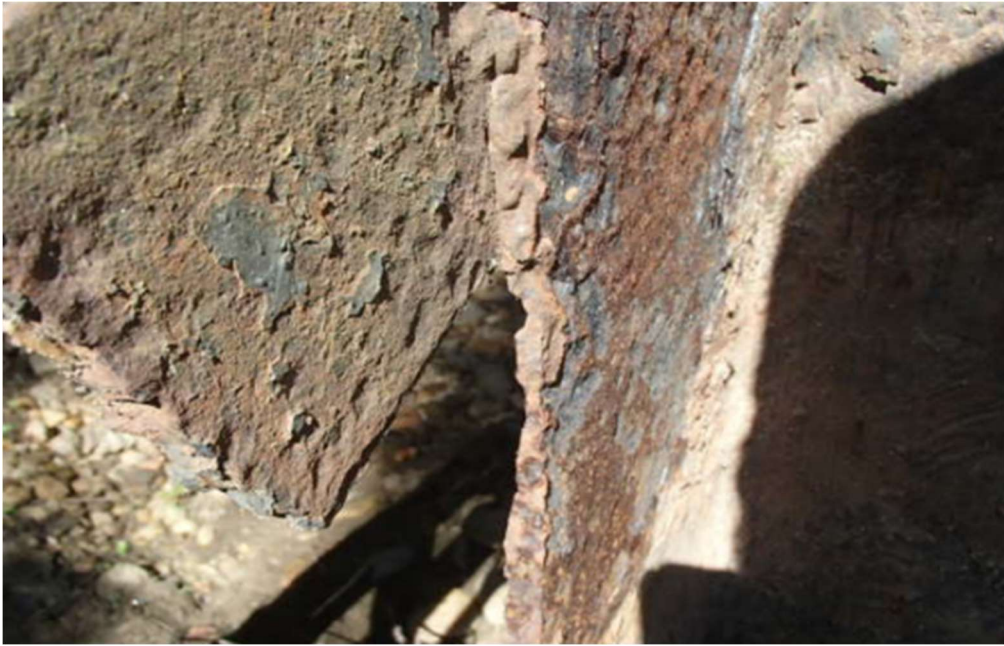
**Figure 151 – Bridge 241-0016-0 Steel Pile Section Loss at Ground Level (GDOT, 2022)**

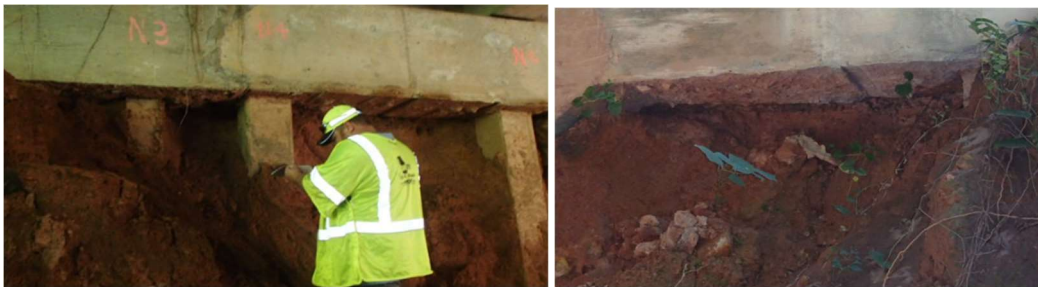
**Figure 152 – Erosion at Abutment 5 on Bridge 241-0016-0 (GDOT, 2020)**

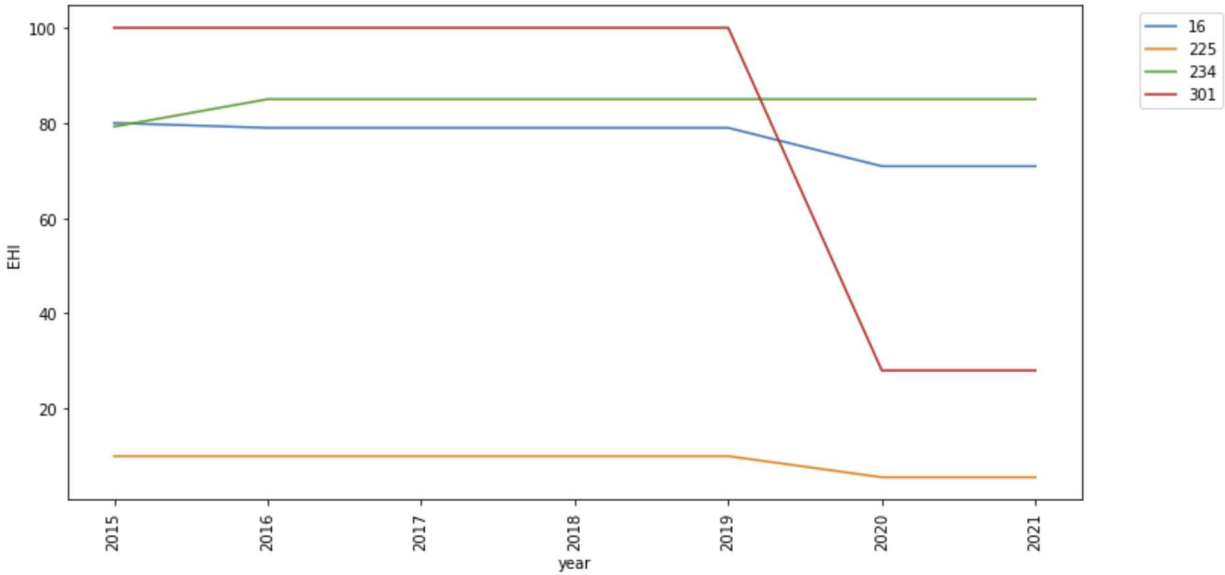
**Figure 153 – Bridge 241-0016-0 EHI by Year, 2015-2021**

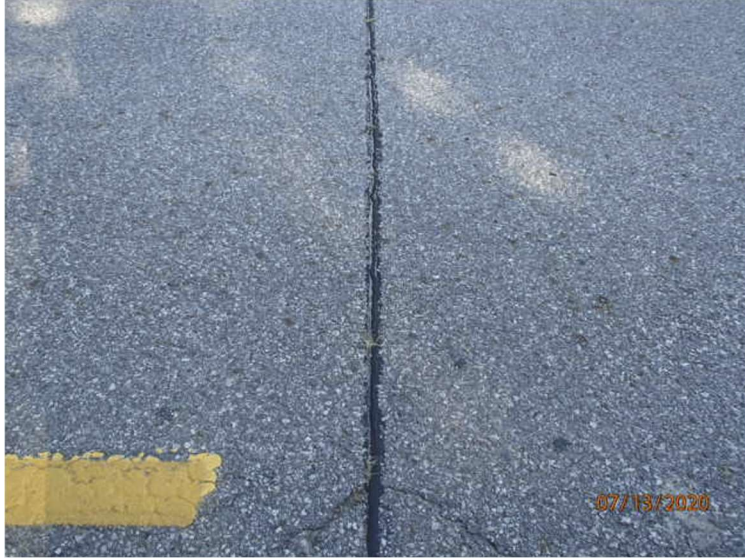
**Figure 154 – Bridge 241-0016-0 Failing Joint (GDOT, 2020)**

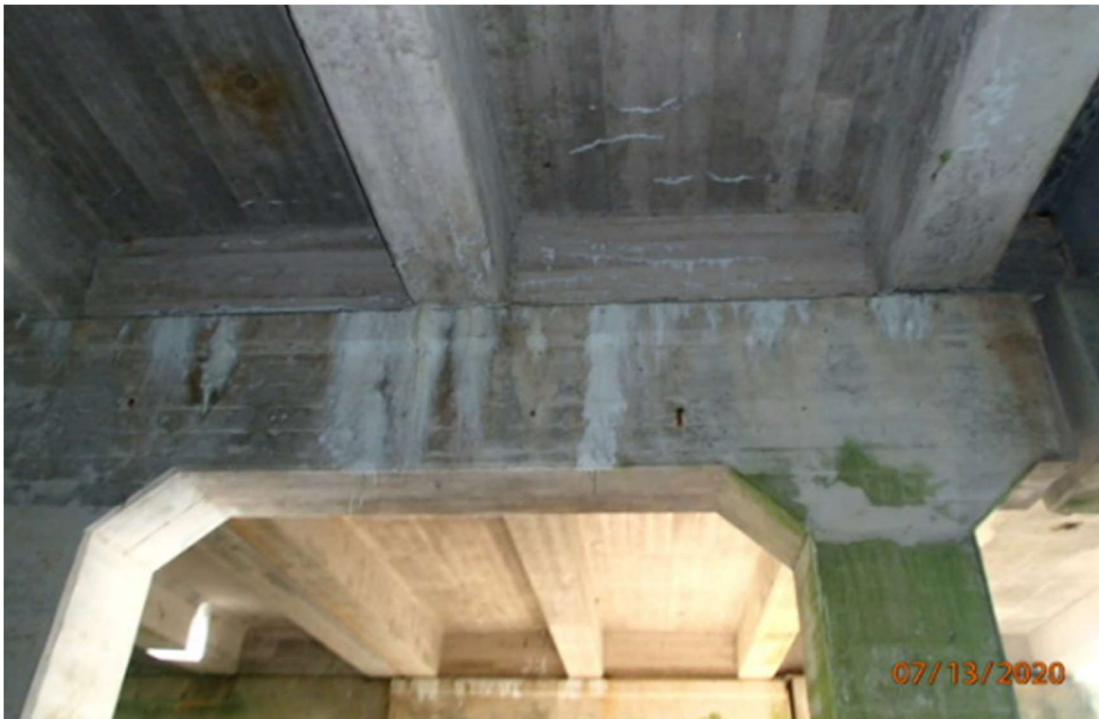
**Figure 155 – Bridge 241-0016-0 Efflorescence at Reinforced Concrete Top Flange (GDOT, 2020)**

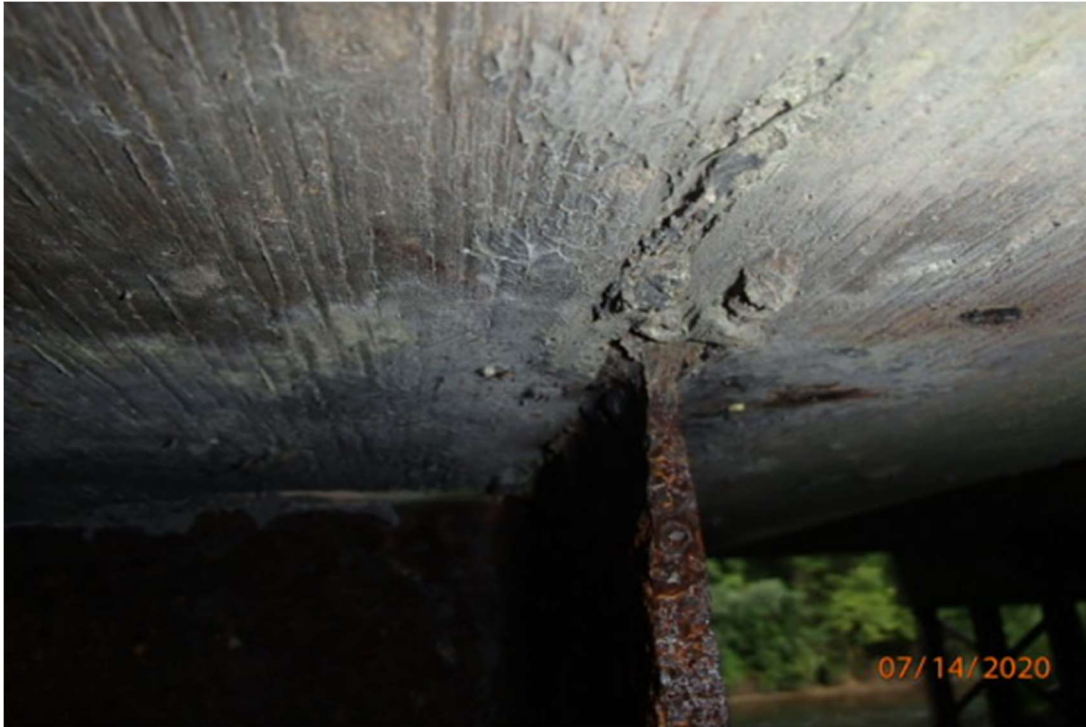
**Figure 156 – Bridge 241-0016-0 Steel Pile Section Loss at Deck (GDOT, 2020)**

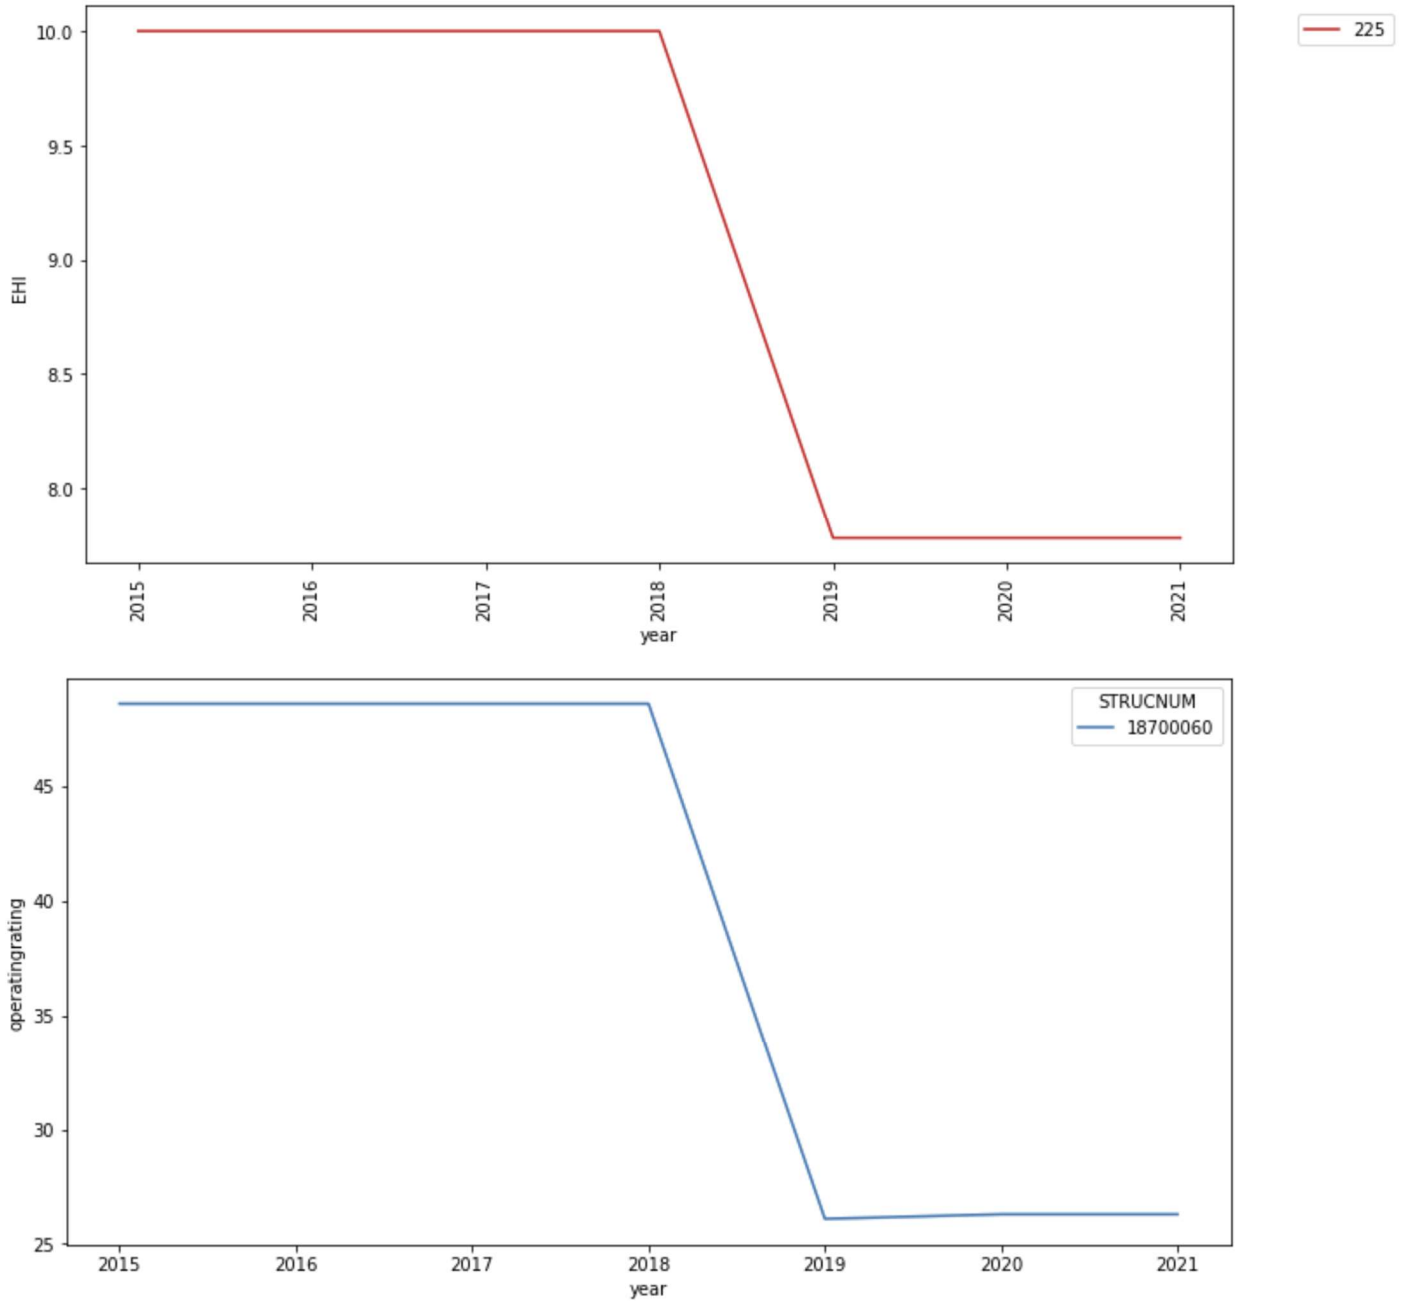
**Figure 157 – Bridge 187-0006-0 EN225 EHI (Top) and Operating Rating (Right) by Year**

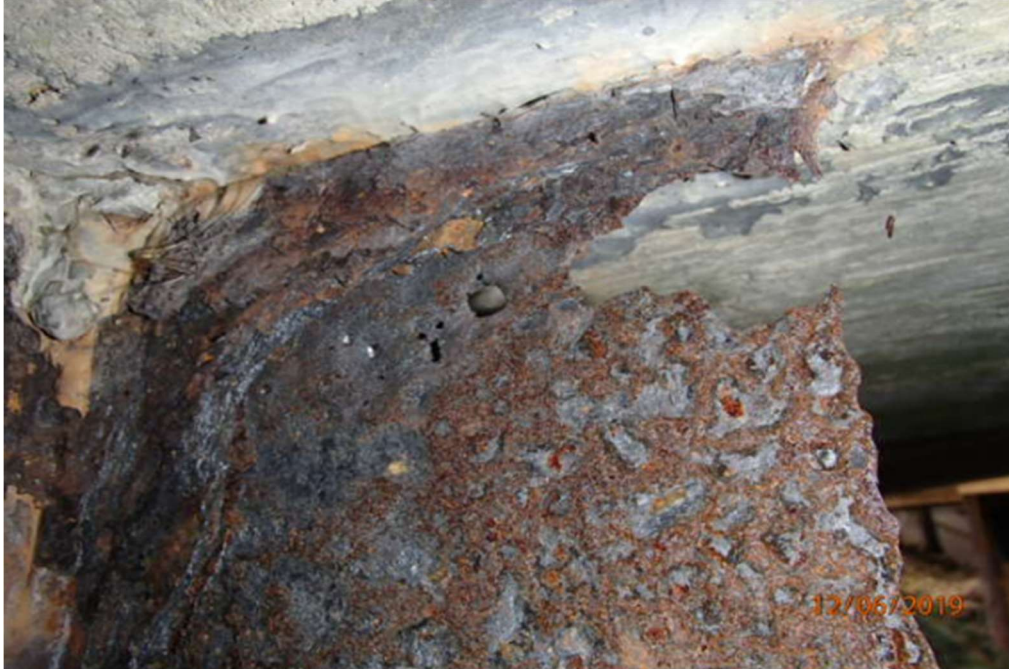
**Figure 158 – Bridge 187-0006-0 Pile Condition, 2019**

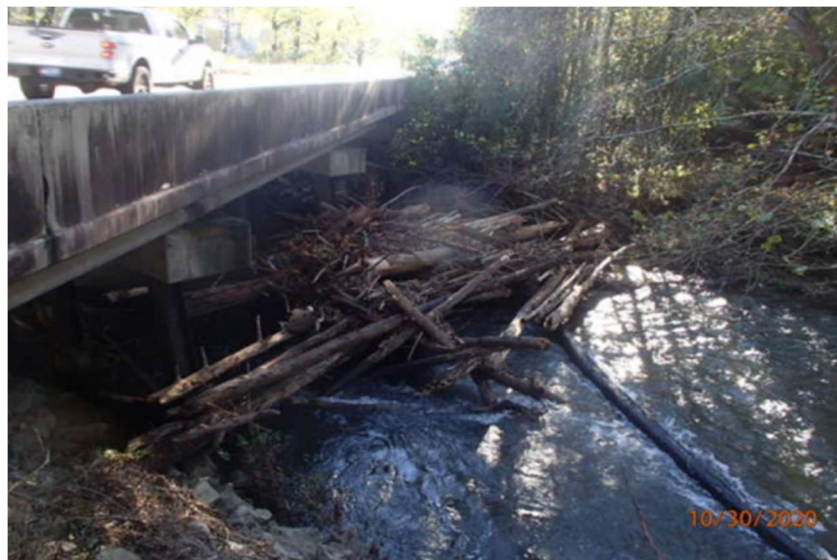
**Figure 159 – Logjam at Bridge 187-0006-0 (GDOT, 2020)**

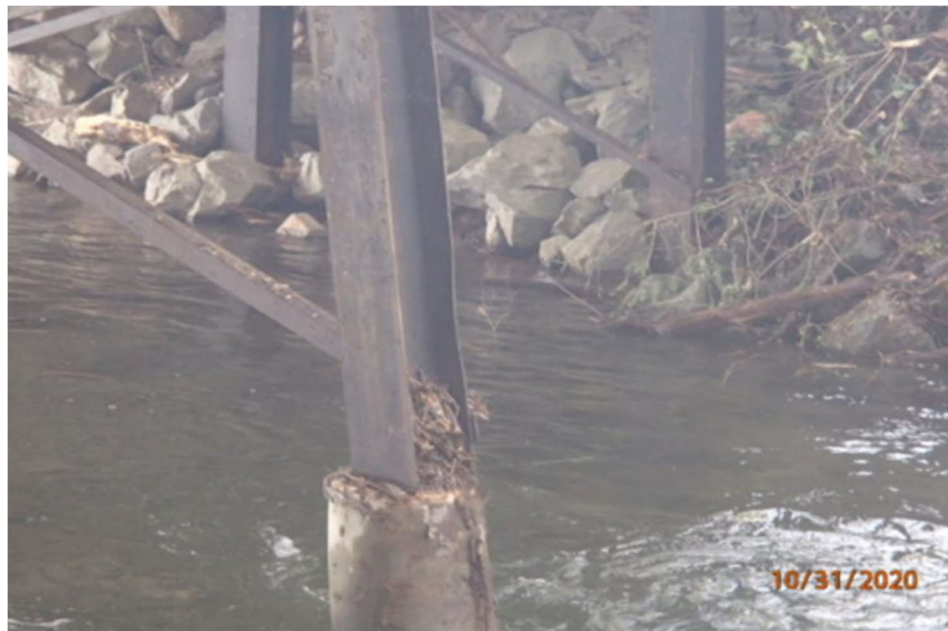
**Figure 160 – Minor Bending in Steel Pile in Bridge 187-0006-0 (GDOT, 2020)**

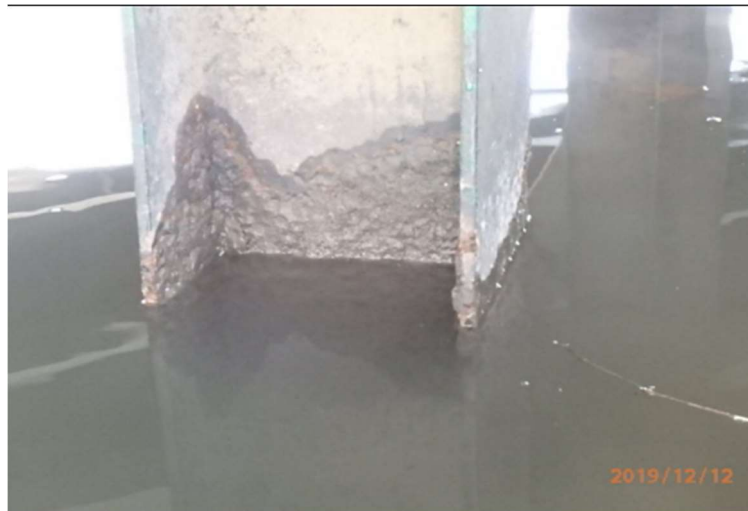
**Figure 161 – Bridge 0047-5012-0 Typical Steel Pile Section Loss (GDOT, 2019)**

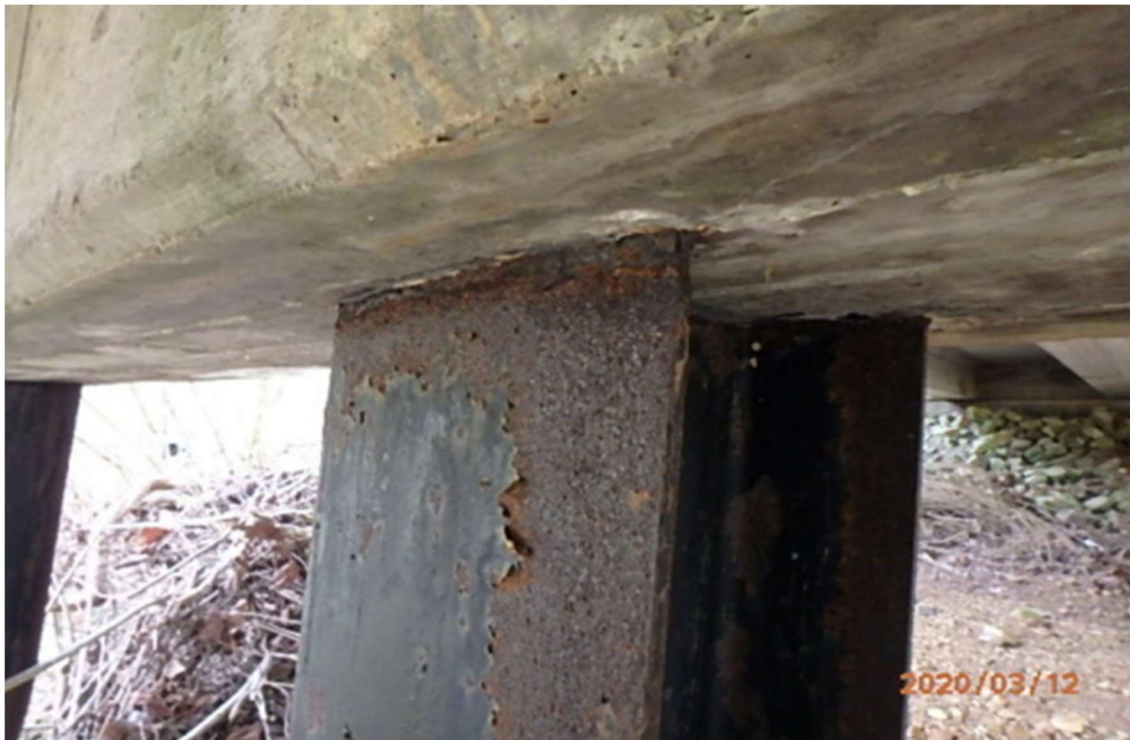
**Figure 162 – Bridge 055-5001-0 Typical Steel Pile Section Loss (GDOT, 2020)**
