IMPACT OF WEATHER STRESSORS TO IDENTIFY VULNERABLE BRIDGE ELEMENTS  
IN GEORGIA TOWARDS DATA DRIVEN ASSEST MANAGEMENT

by SPENCER KOPF

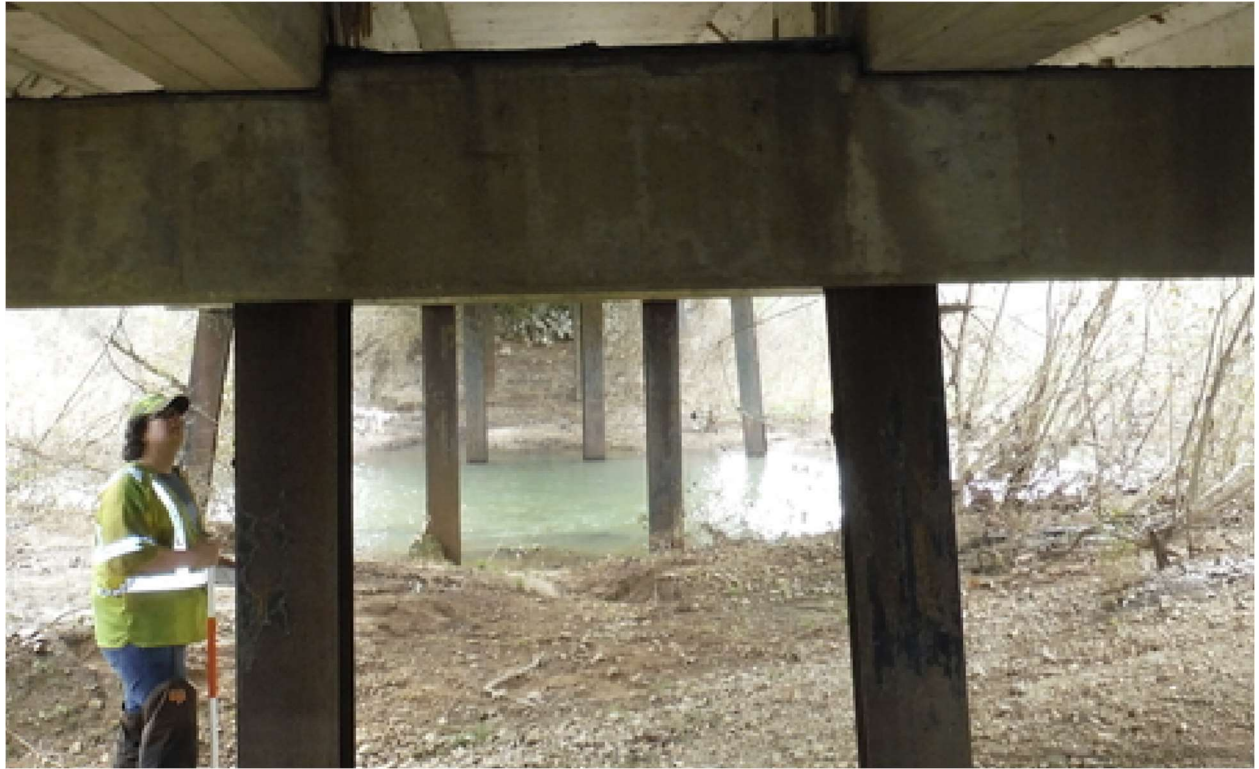
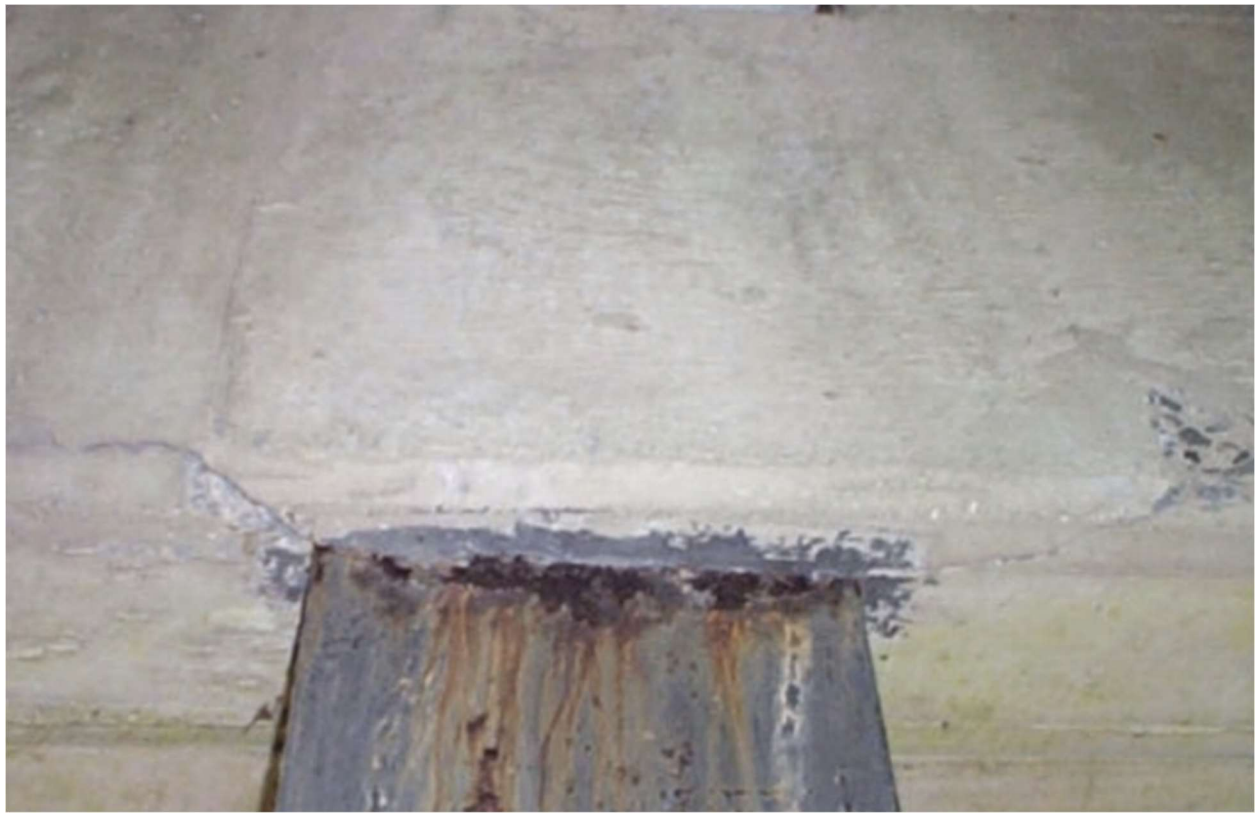
**Figure 163 – Bridge 055-5001-0 Steel Pile Connection 2016 (Top) vs 2022 (Bottom)**

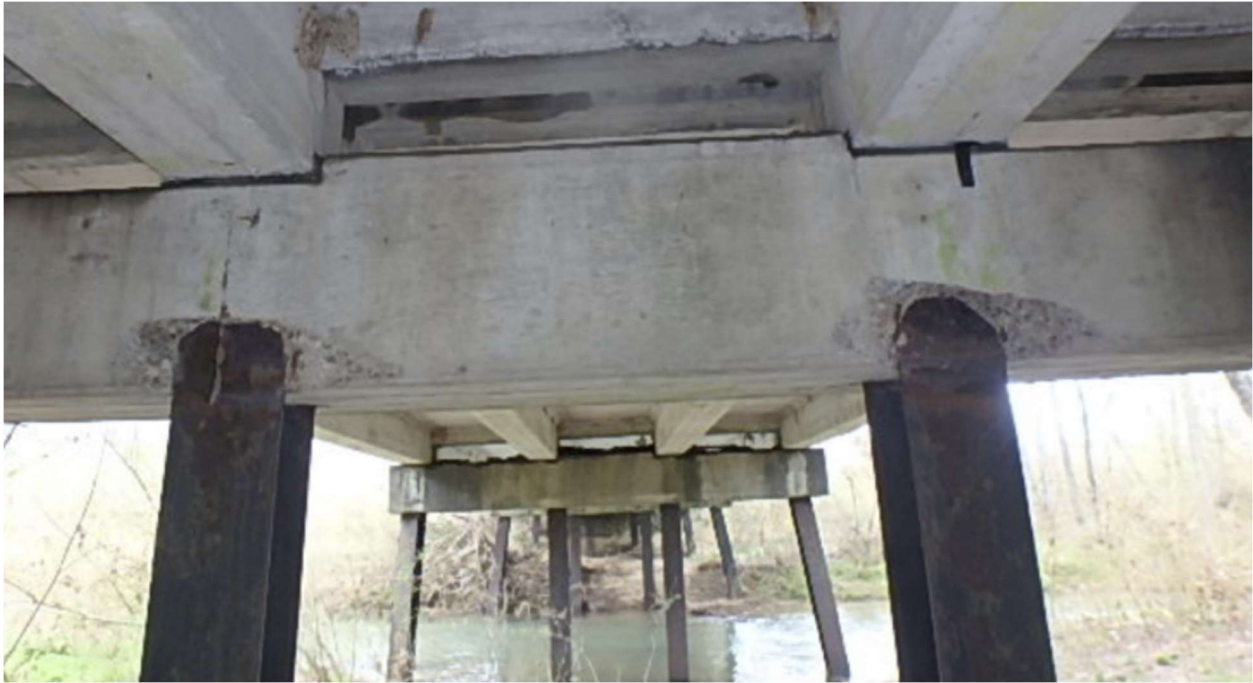
**Figure 164 – Bridge 055-5001-0 Steel Pile Connection 2016 (Top & Middle) vs 2022  
(Bottom)**

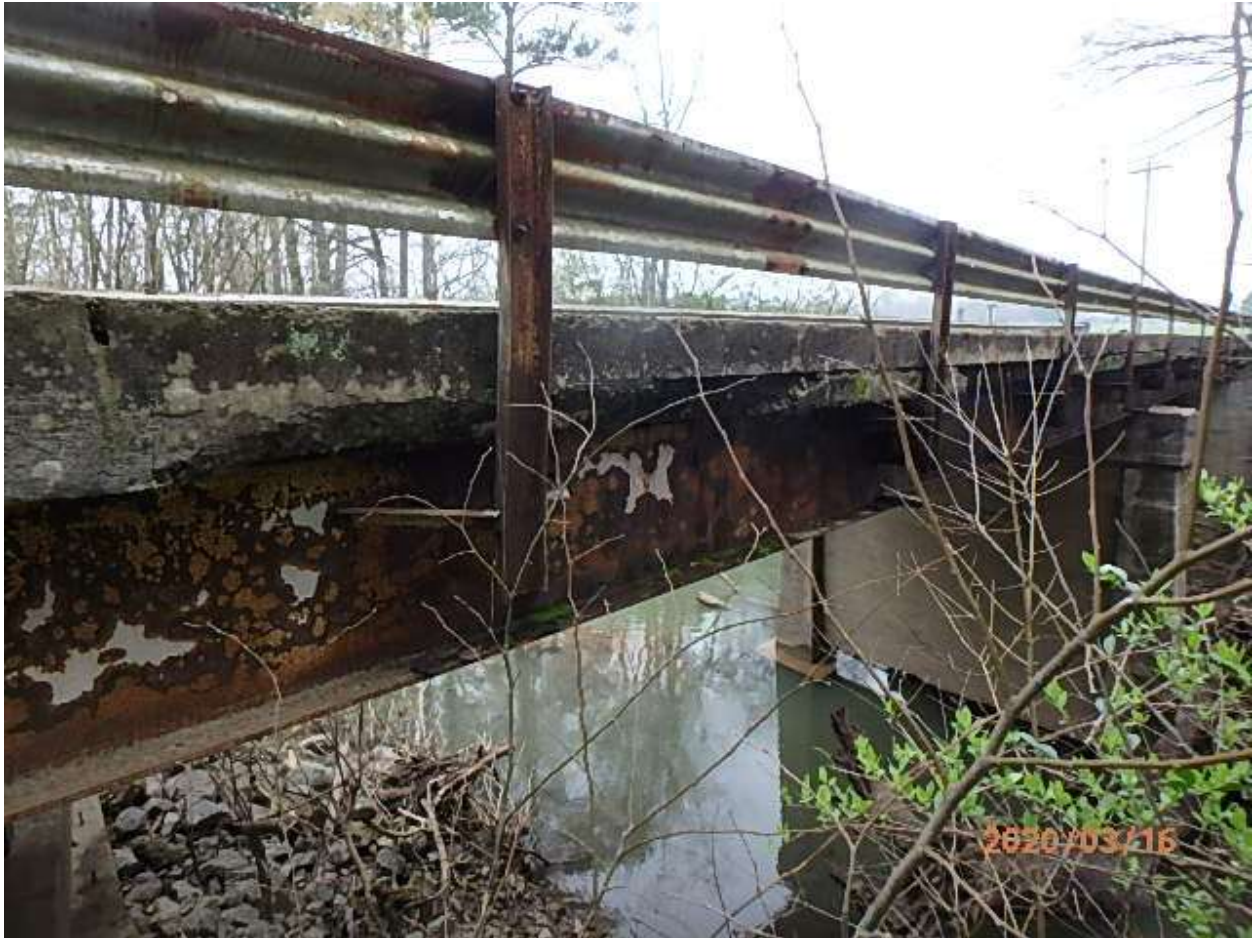
**Figure 165 – Bridge 055-5030-0 Steel Girder Condition (GDOT, 2020)**

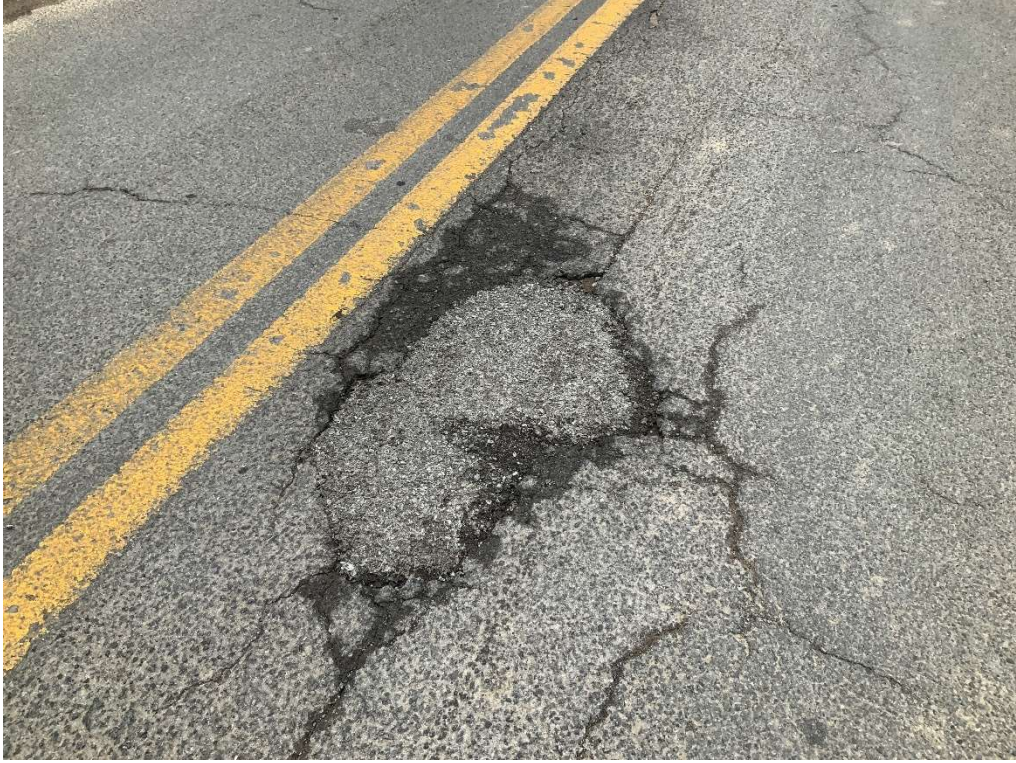
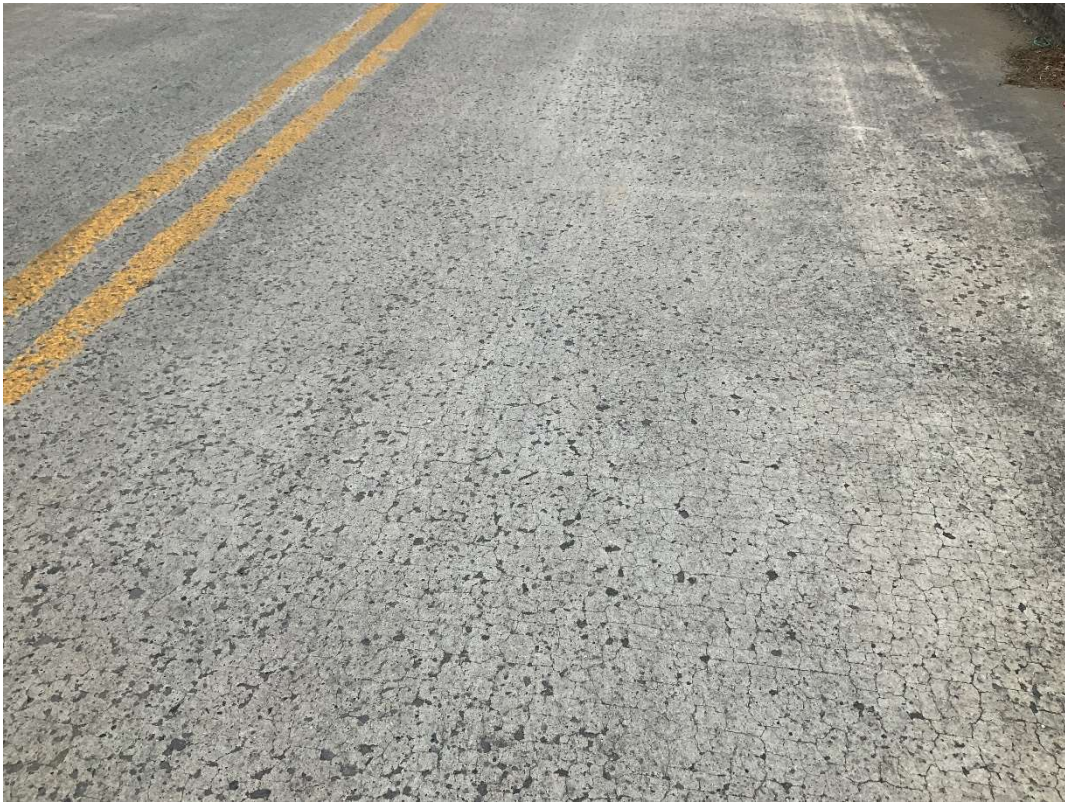
**Figure 166 – Bridge 055-5030-0 Deck Topside Condition (GDOT, 2022)**

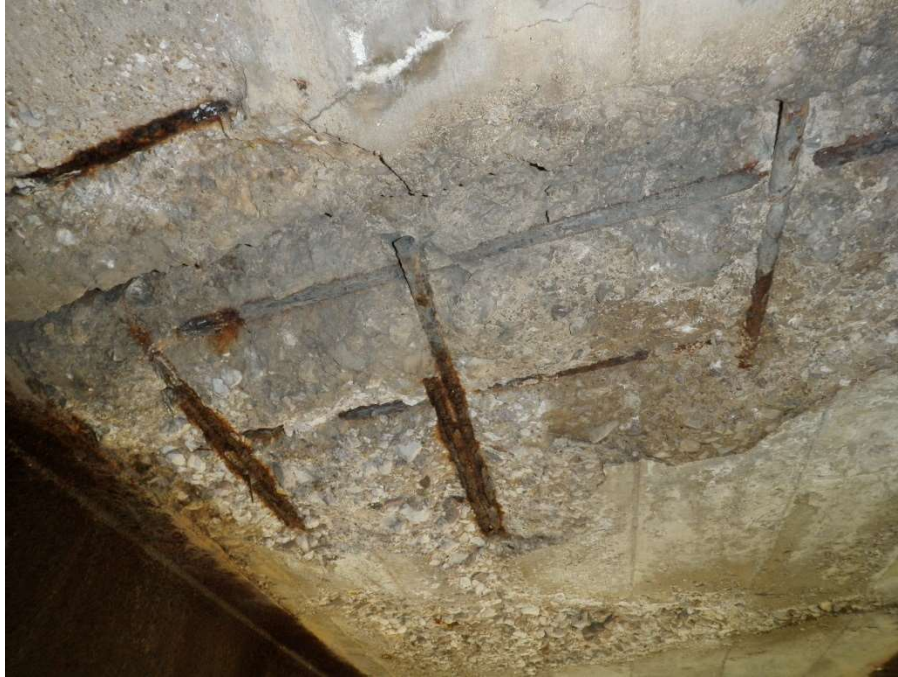
The cracking on the topside of the deck is minor when compared to the cracking that is visible on the underside and sides of the deck. Both have major spalls that have been identified in inspection reports as 2012. However, inspectors have done a poor job of tracking the progression of these spalls. The photos recorded are shown in **Figure 167**. These photos show the severity of the spalls.

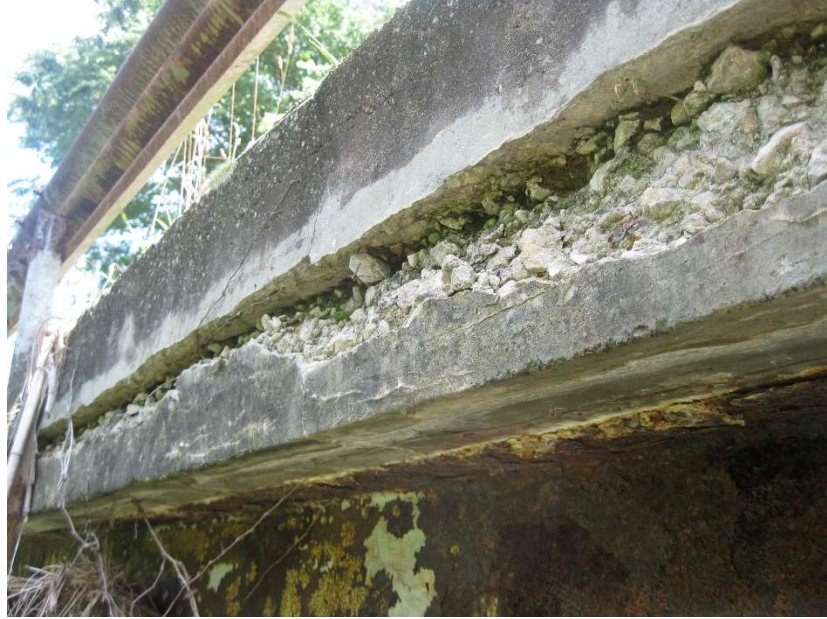
**Figure 167 – Bridge 055-5030-0 Deck Condition (GDOT, 2022)**

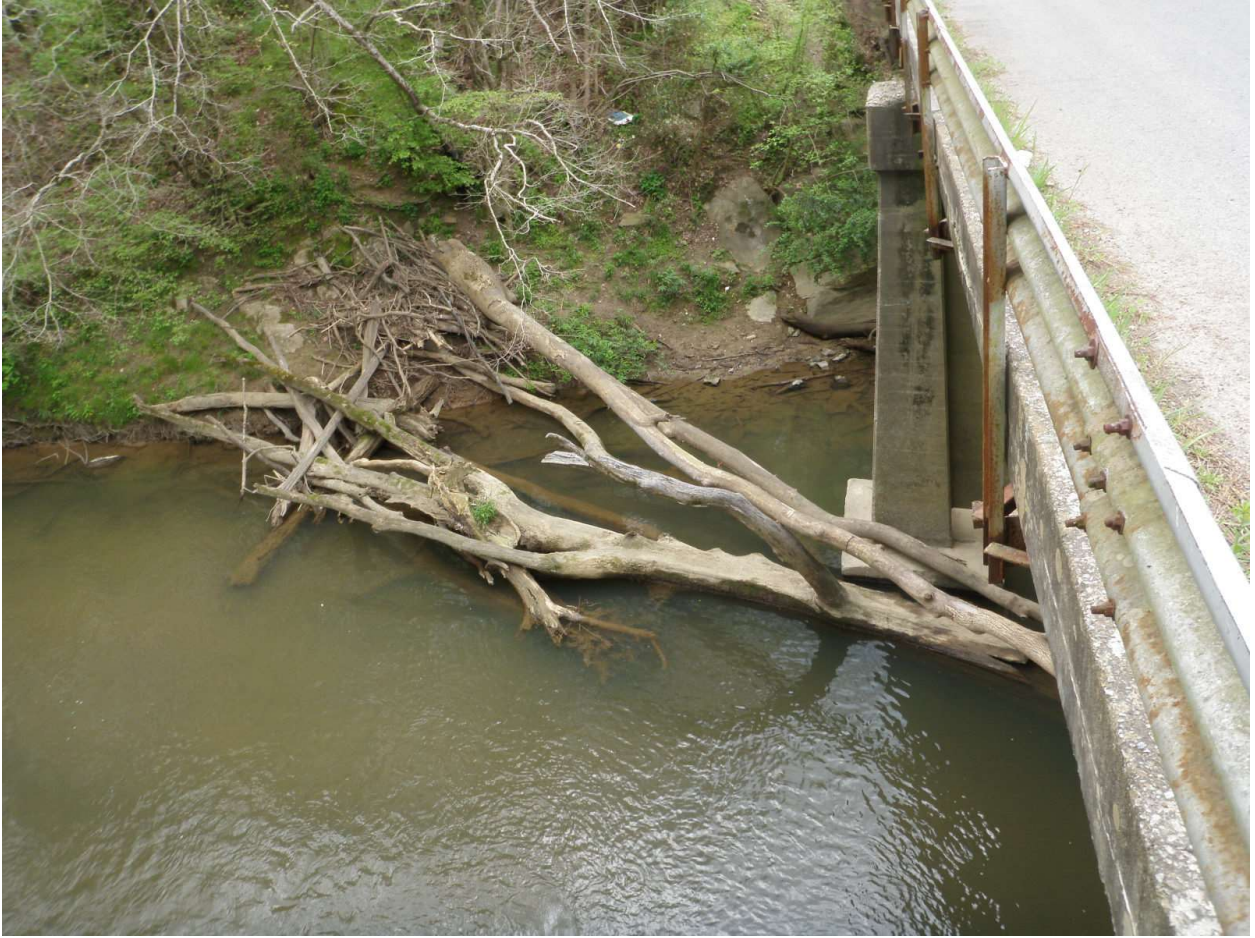
Additionally, there are concerns at the substructure. The first is a large drift accumulation. This can contribute to scouring. **Figure 168** shows the difference in drift accumulation at bent 3 over the years.

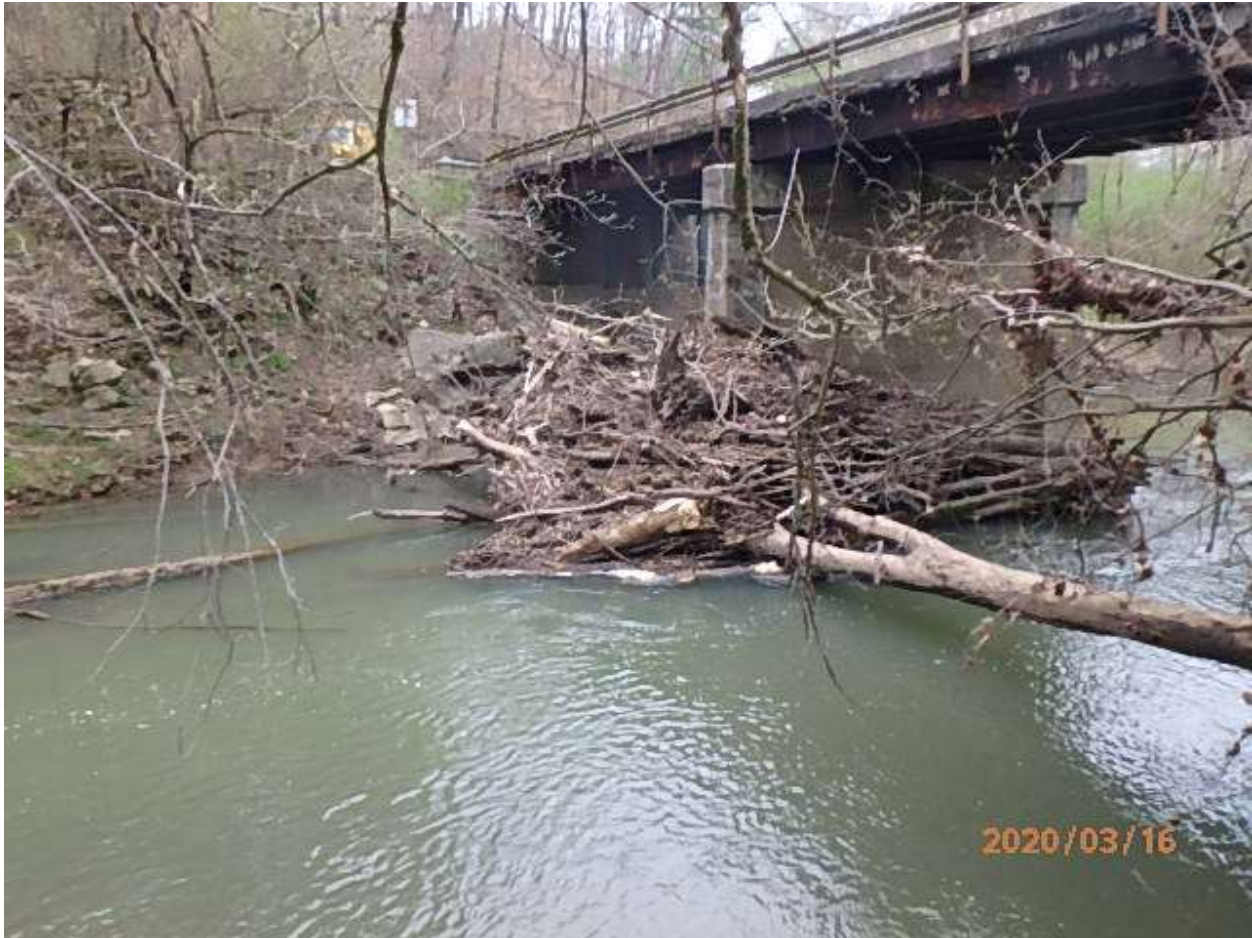
**Figure 168 – Bridge 055-5030 Drift at Bent 3 2012 (Top) vs 2020 (Middle & Bottom)**

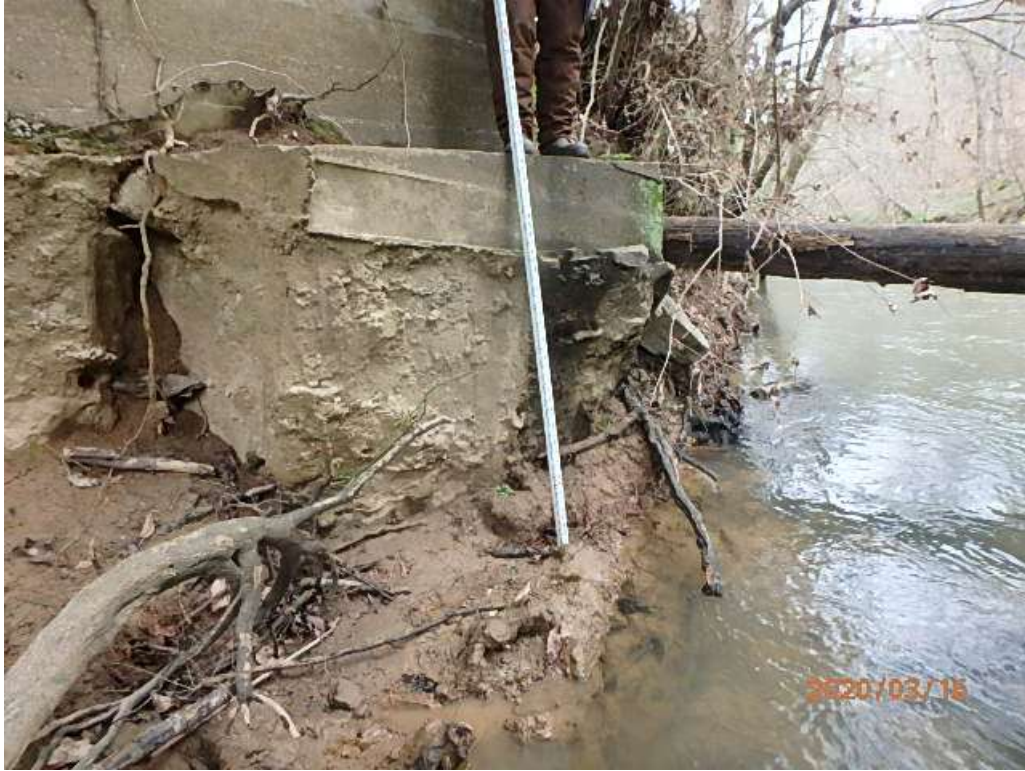
**Figure 169 – Bridge 055-5030-0 Bent 2 Scour (GDOT, 2020)**

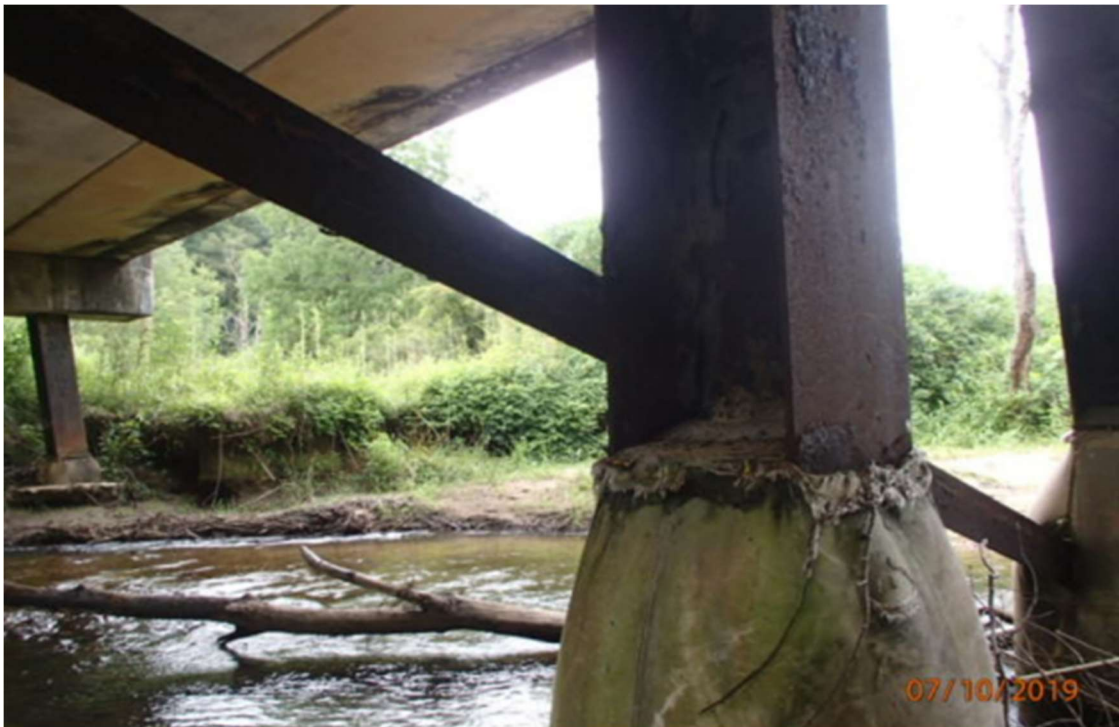
**Figure 170 – Bridge 291-5026-0 Steel Pile Condition (GDOT, 2019)**

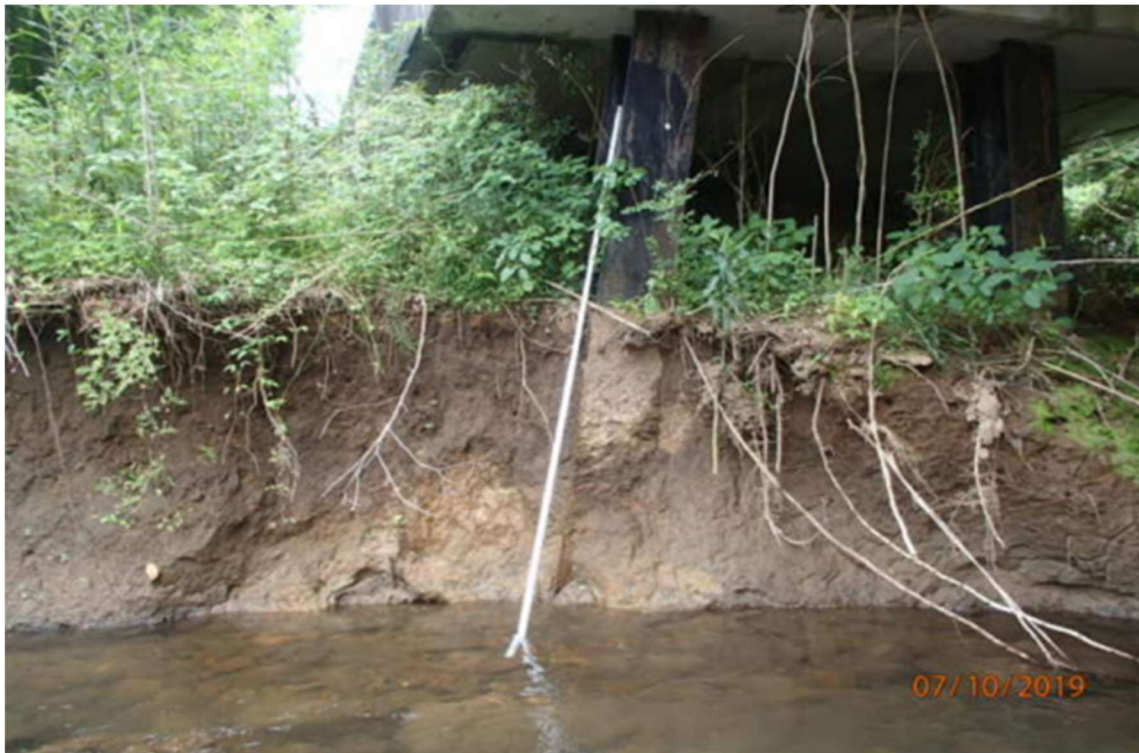
**Figure 171 – Bridge 291-5026-0 Scour (GDOT, 2019)**

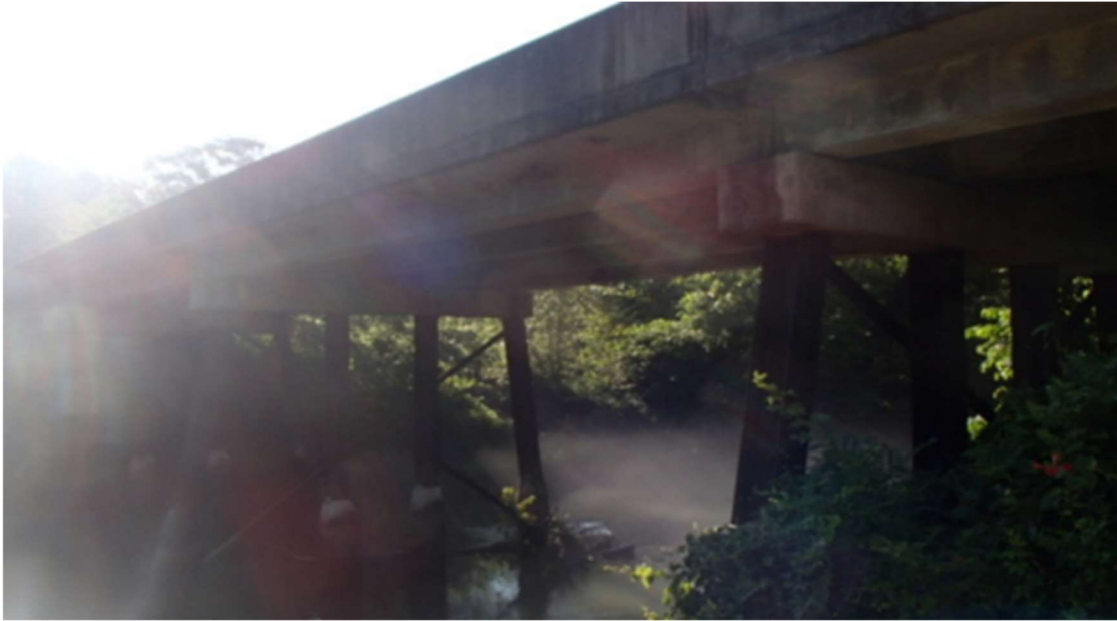
**Figure 172 – Bridge 291-5035-0 Side View (GDOT, 2019)**

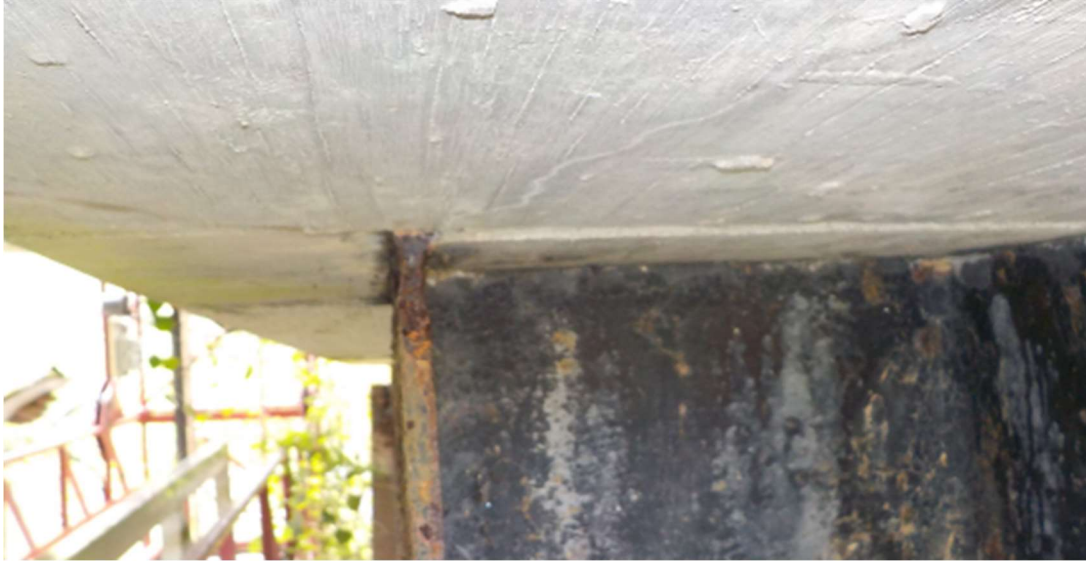
**Figure 173 – Bridge 291-5035-0 Steel Pile Corrosion (GDOT, 2020)**

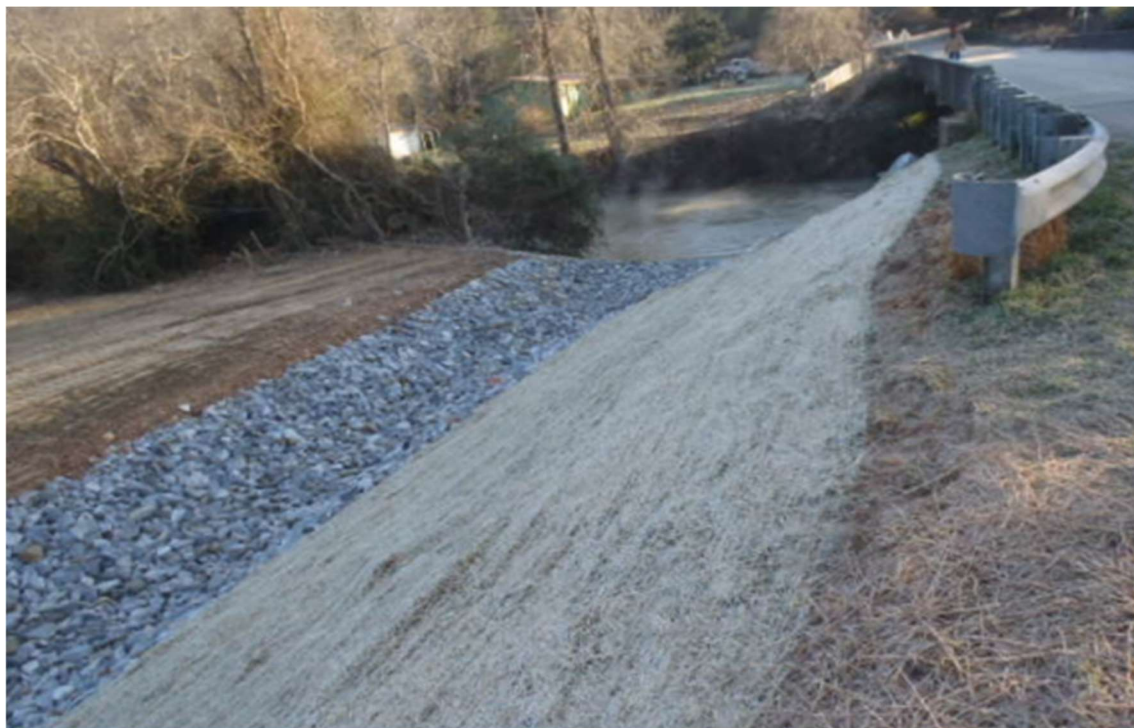
**Figure 174 – Bridge 291-5035-0 Erosion, 2015 (Top) and Erosion Repair, 2016 (Bottom)**

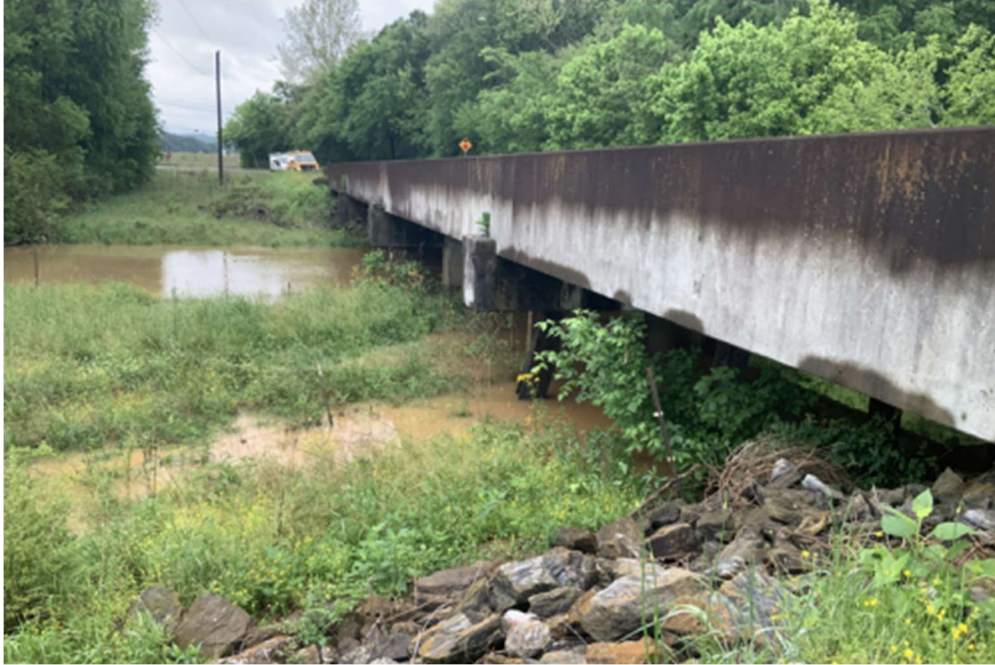
**Figure 175 – Bridge 129-5003-0 Side View, 2022**

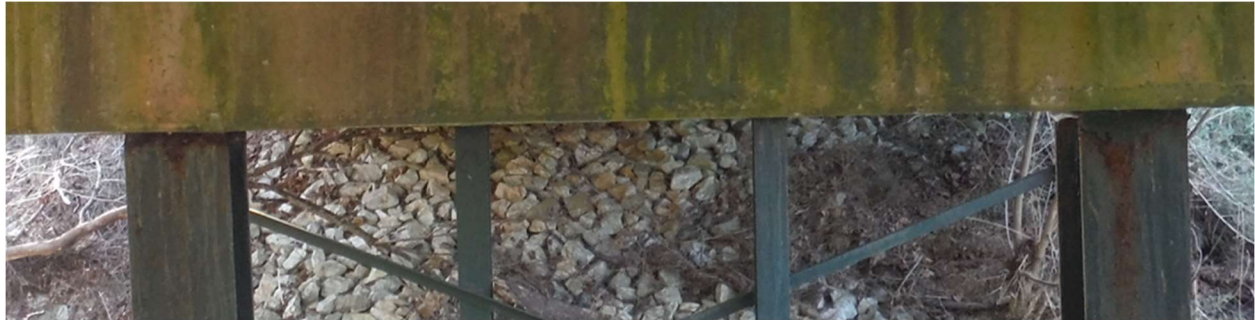
**Figure 176 – Bridge 111-5002-0 Steel Pile Condition at Bent 2 (GDOT, 2016)**

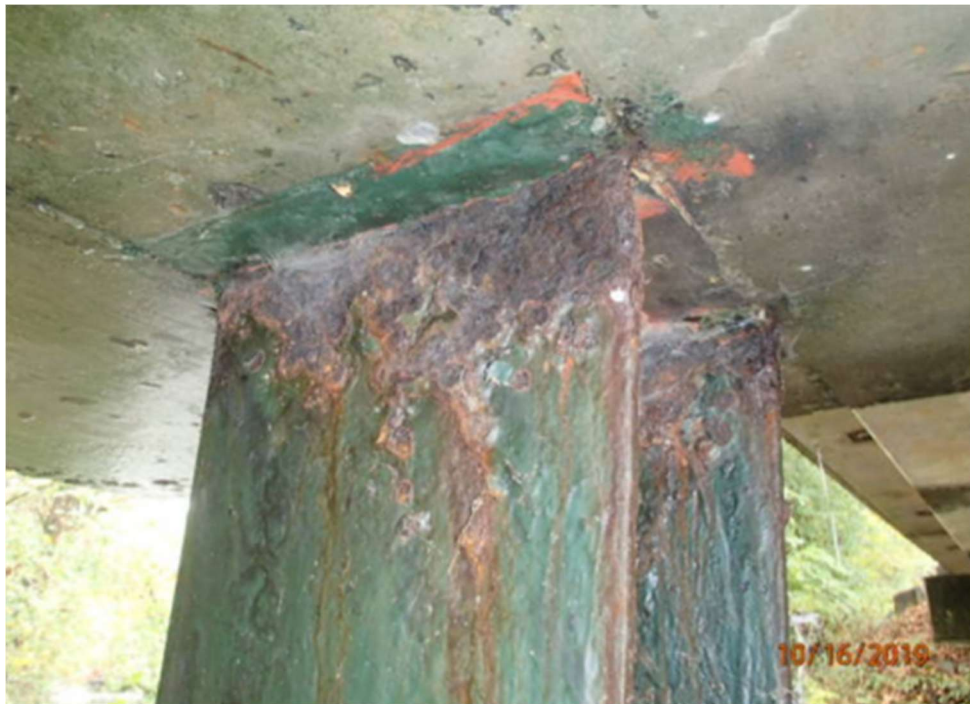
**Figure 177 – Bridge 111-5002-0 Typical Steel Pile Condition (GDOT, 2019)**

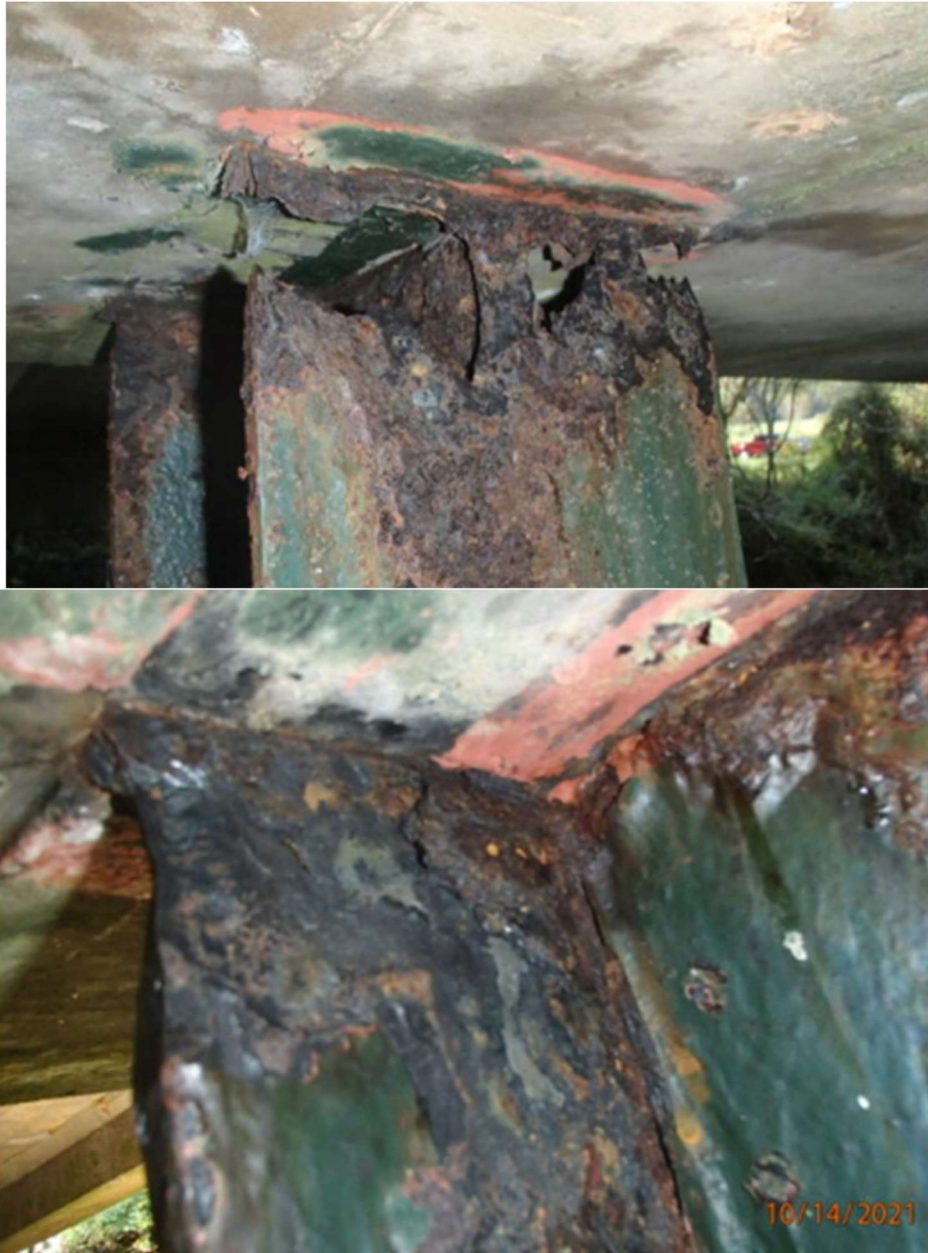
By 2021, the bridge was closed by inspectors because of the advanced section loss on the steel piles. The piles had 100% section loss in some areas, and heavy corrosion in other areas. Most flanges had just ¼” of flange remaining.

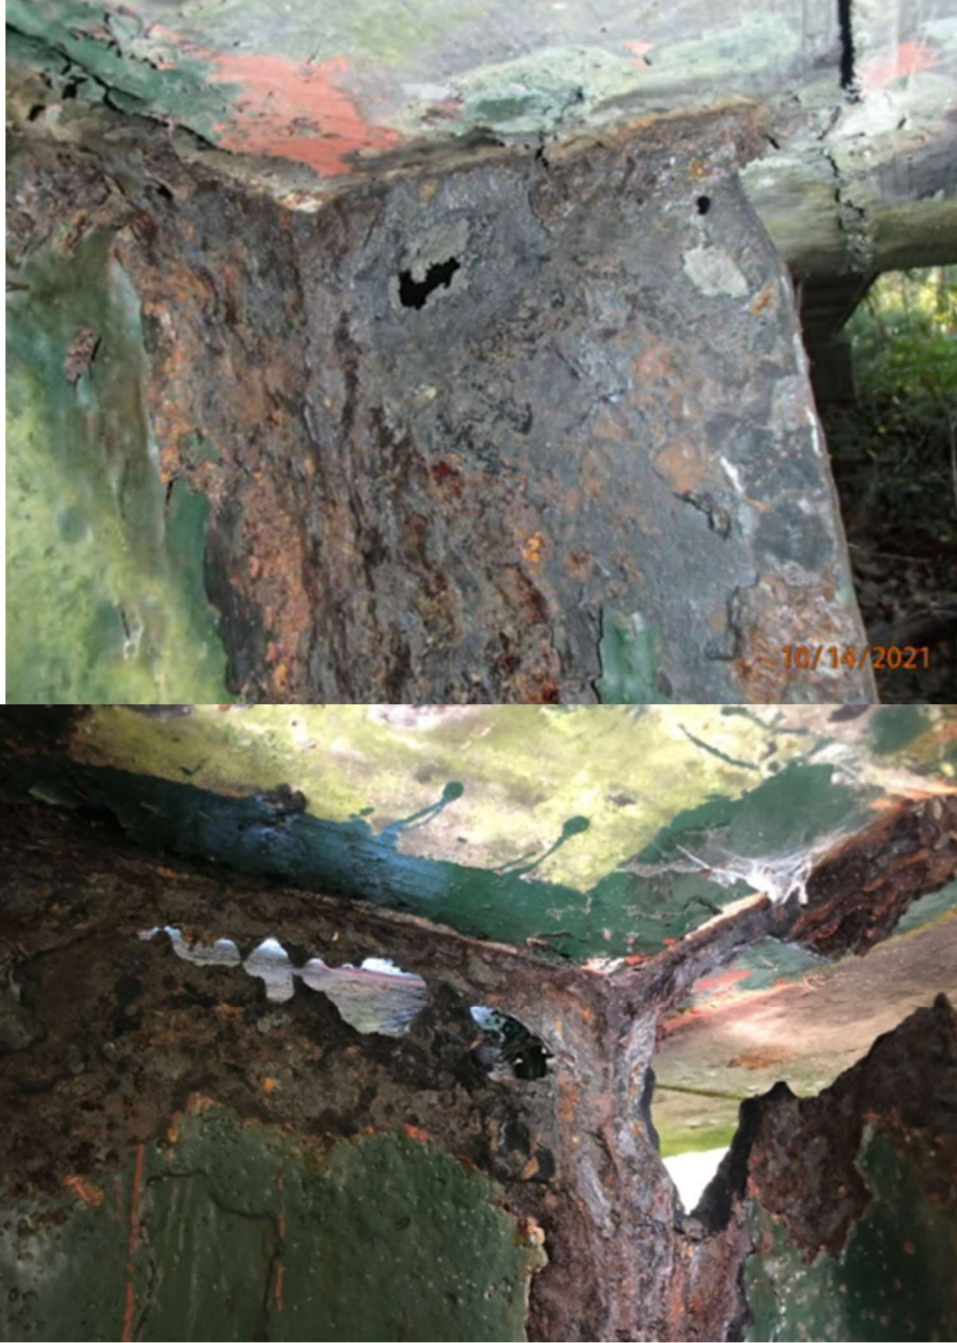
**Figure 178 – Bridge 111-5002-0 Steel Pile Conditions (GDOT, 2021)**

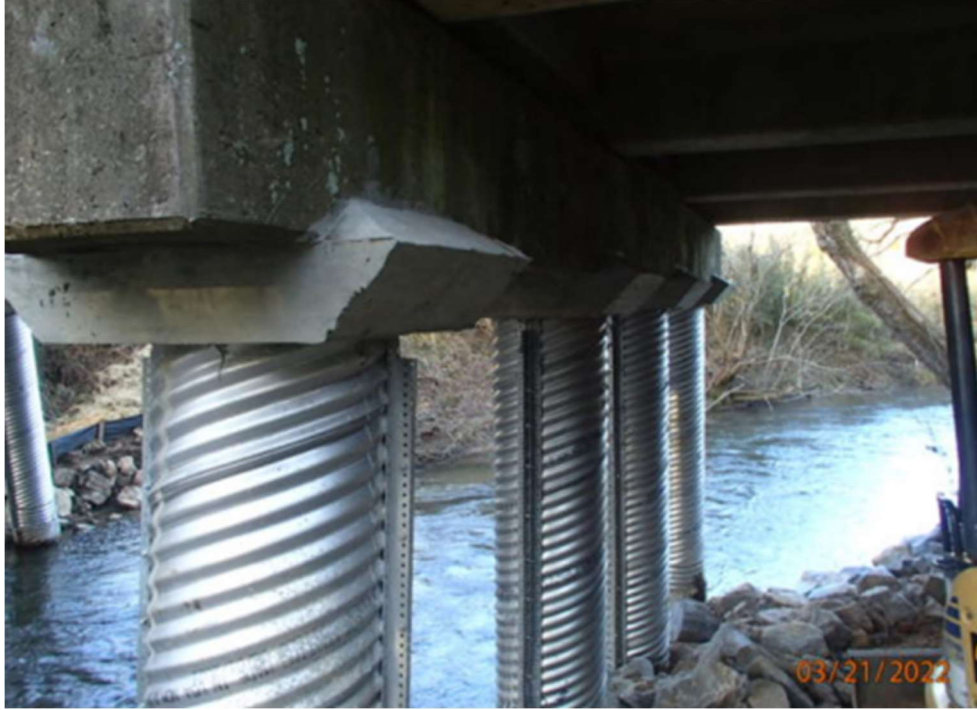
**Figure 179 – Bridge 111-5002-0 Steel Pile Repair (GDOT, 2022)**

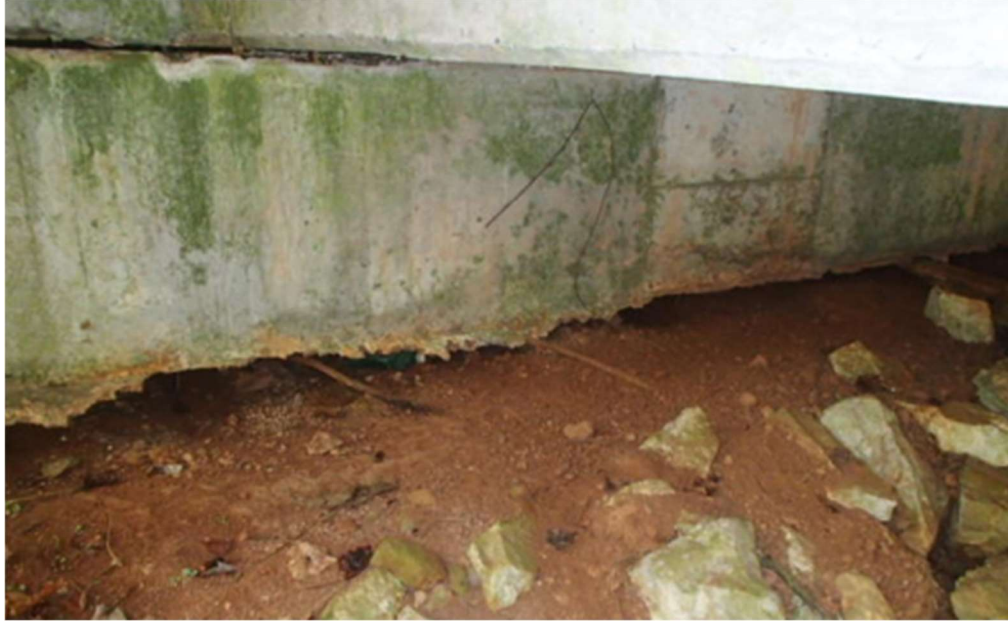
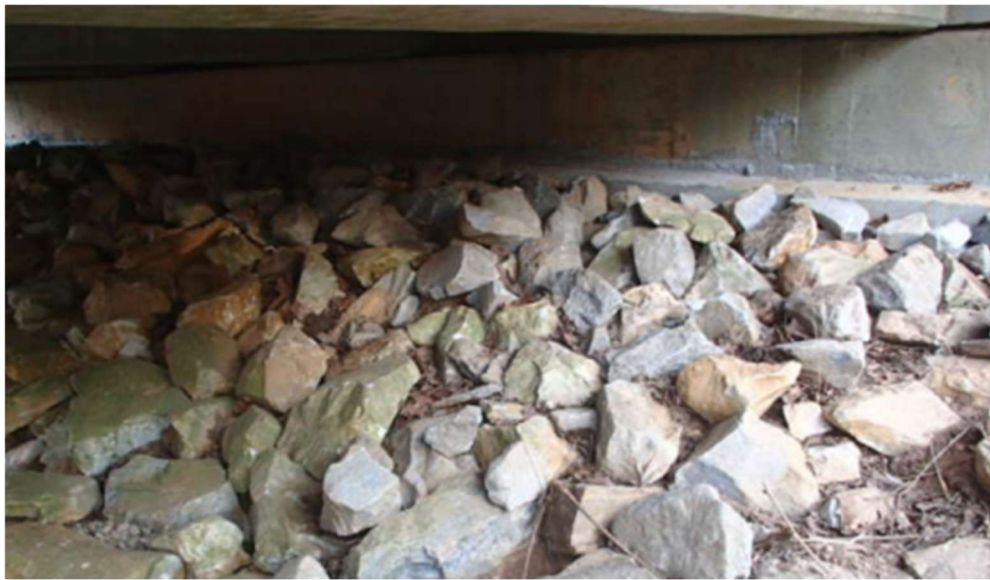
**Figure 180 – Bridge 111-5002-0 Abutment Repair 2019 (Top) vs 2022 (Bottom)**

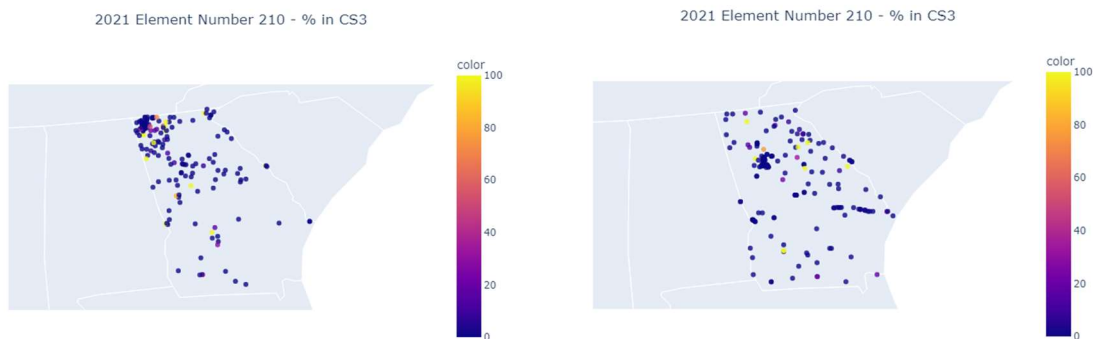
**Figure 181: EN210 Percent in CS3 by location, 2021. County-Owned (Left) vs State-Owned (Right)**

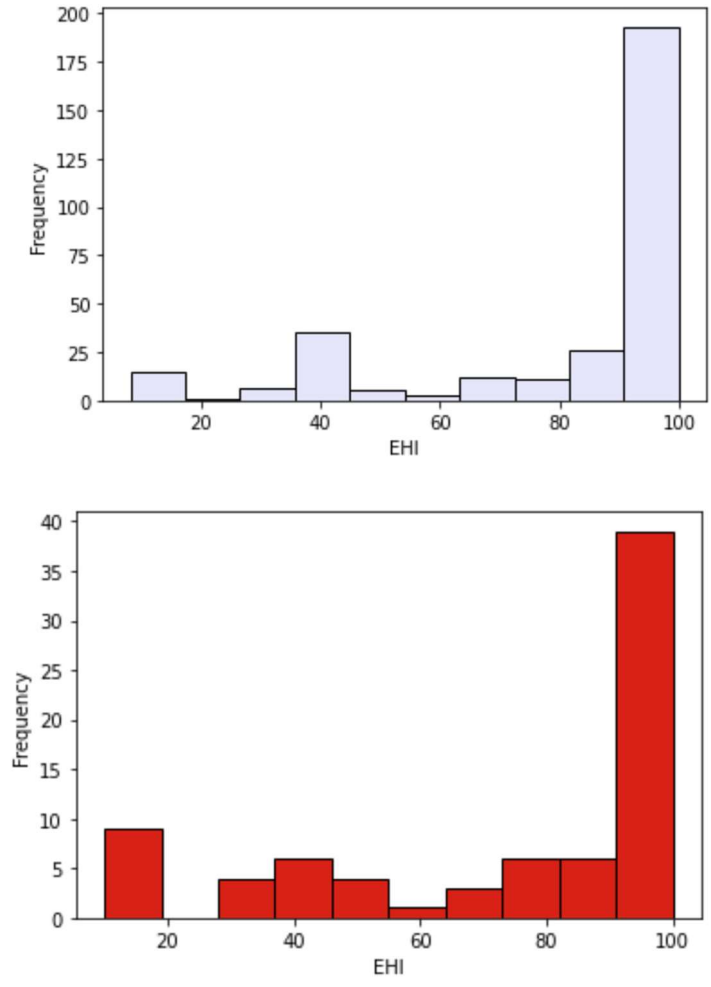
**Figure 182 – EHI of EN210 DP10 Counties (Bottom) vs NonDP10 Counties (Top)**

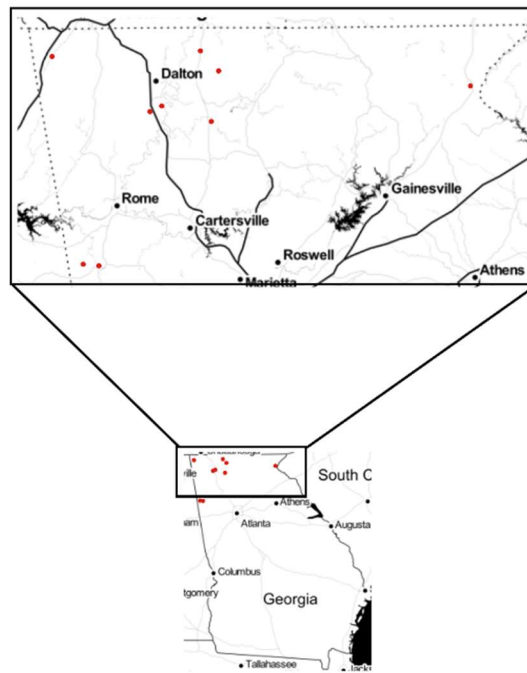
**Figure 183 - Location of Selected DP10 Bridges for EN210**

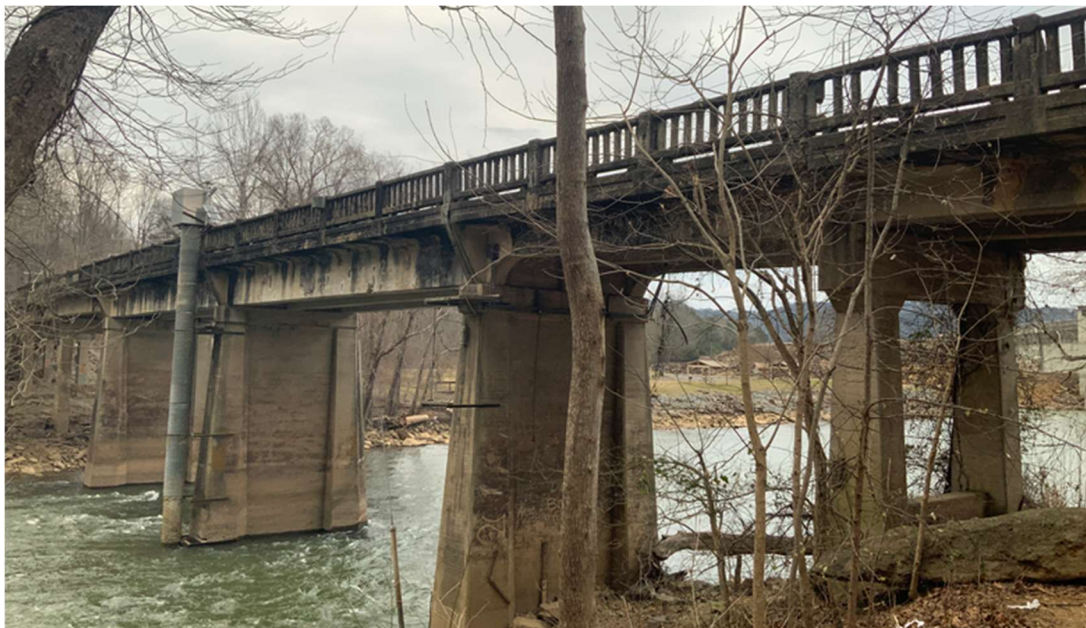
**Figure 184 – Bridge 213-0044-0 Sideview (GDOT, 2022)**
