IMPACT OF WEATHER STRESSORS TO IDENTIFY VULNERABLE BRIDGE ELEMENTS  
IN GEORGIA TOWARDS DATA DRIVEN ASSEST MANAGEMENT

by SPENCER KOPF

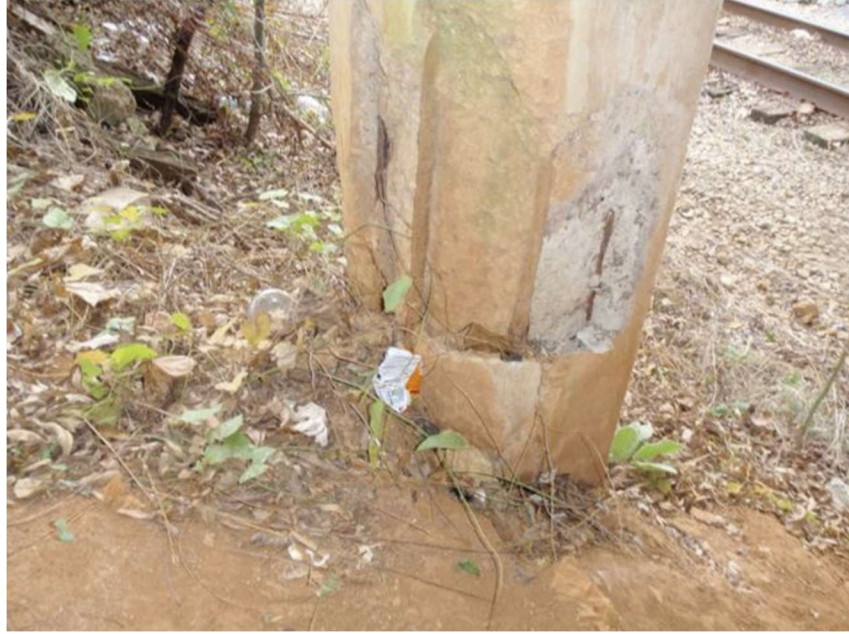
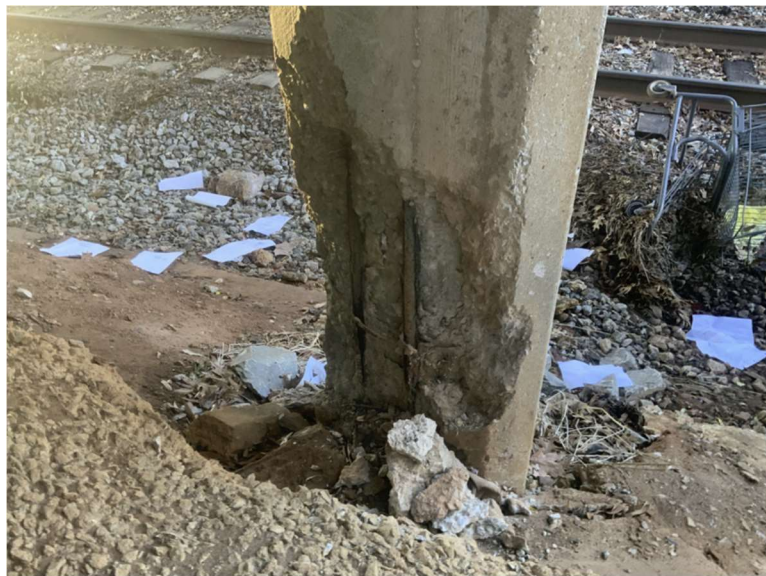
**Figure 186 – Bridge 233-055-0 Column 3-2 2016 (Top) vs 2022 (Bottom)**

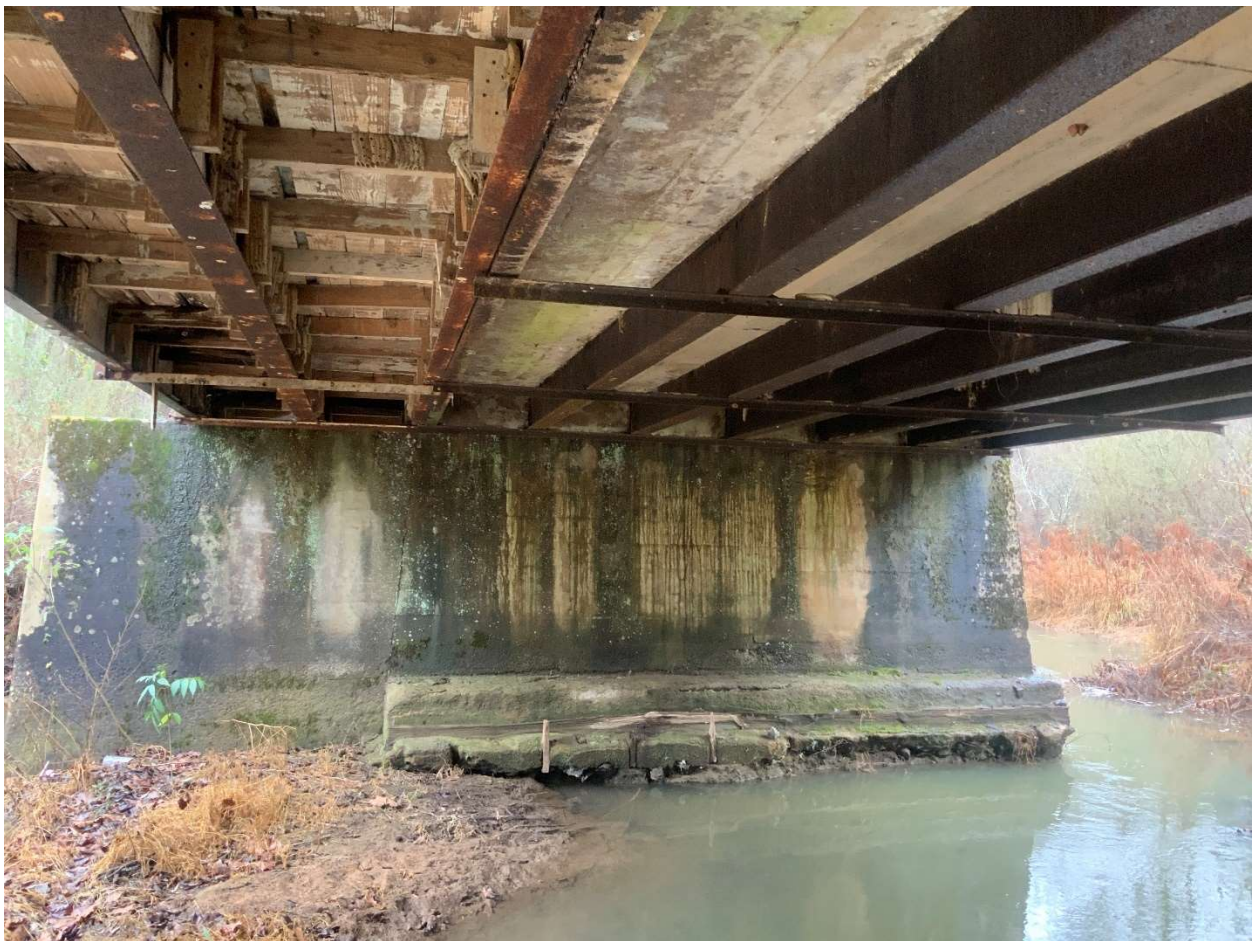
**Figure 187 – Bridge 233-5036-0 Pier Wall Scour (GDOT, 2021)**

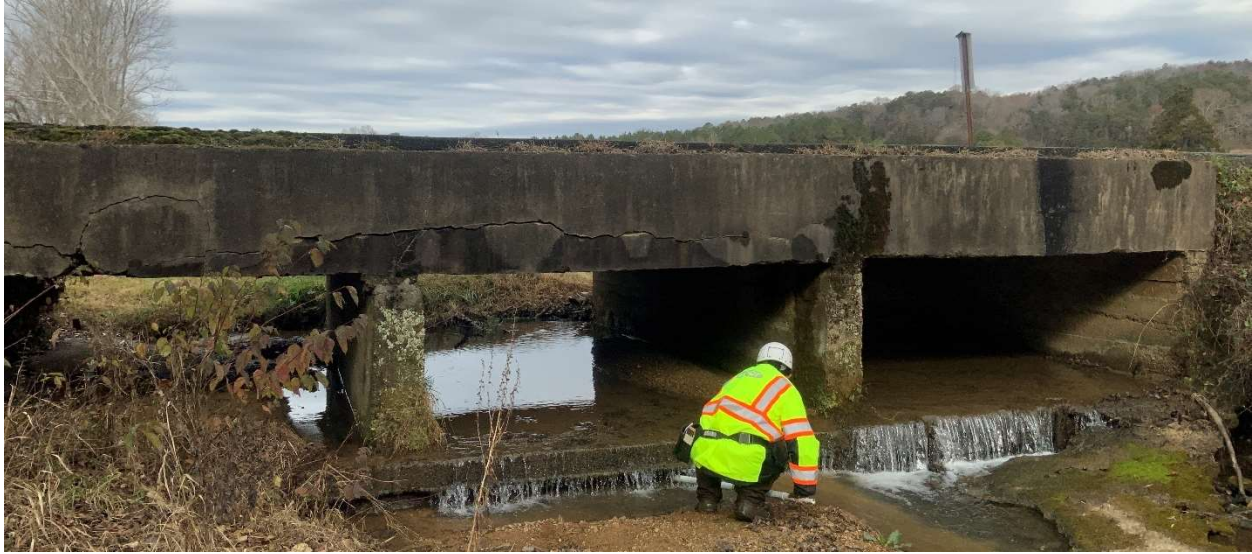
**Figure 188 – Bridge 233-5026-0 Side View (GDOT, 2022)**

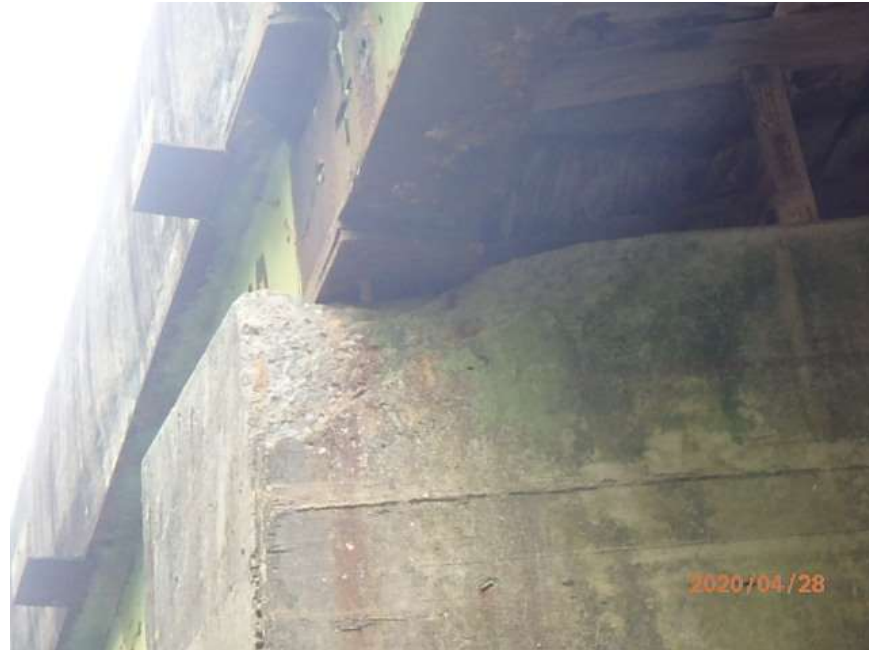
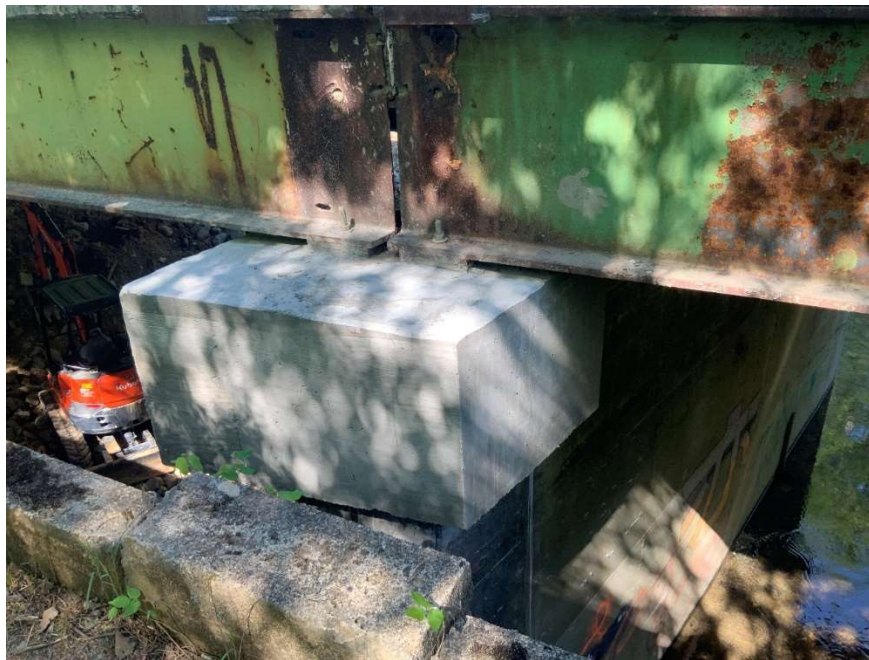
**Figure 189 – Bridge 313-5008-0 Pier Wall Spall (Top) vs Repaired (Bottom)**

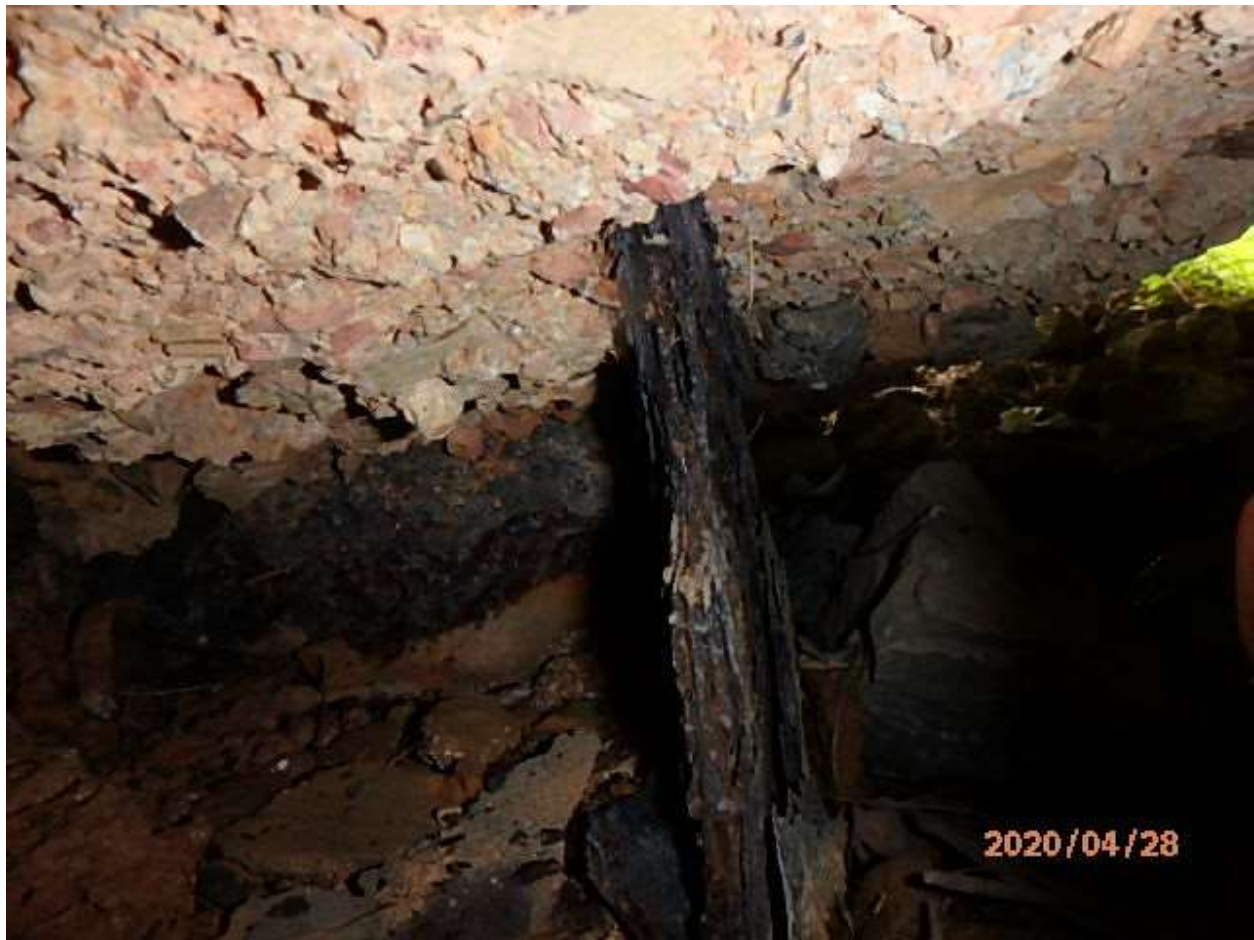
**Figure 190 – Bridge 313-5008-0 Abutment pile 100% Section Loss (GDOT, 2020)**

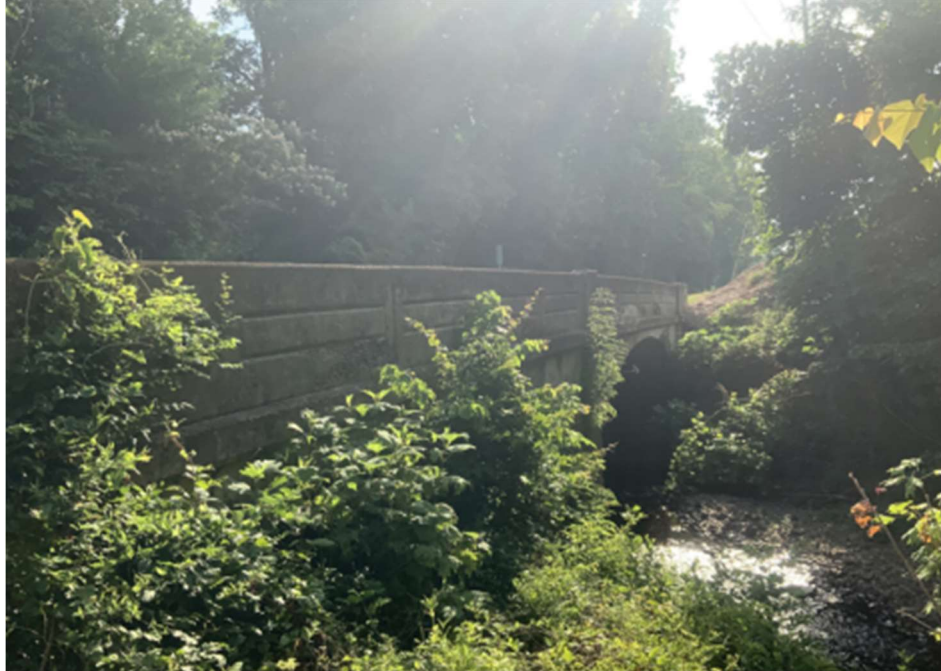
**Figure 191 – Bridge 313-5002-0 Side View (GDOT, 2022)**

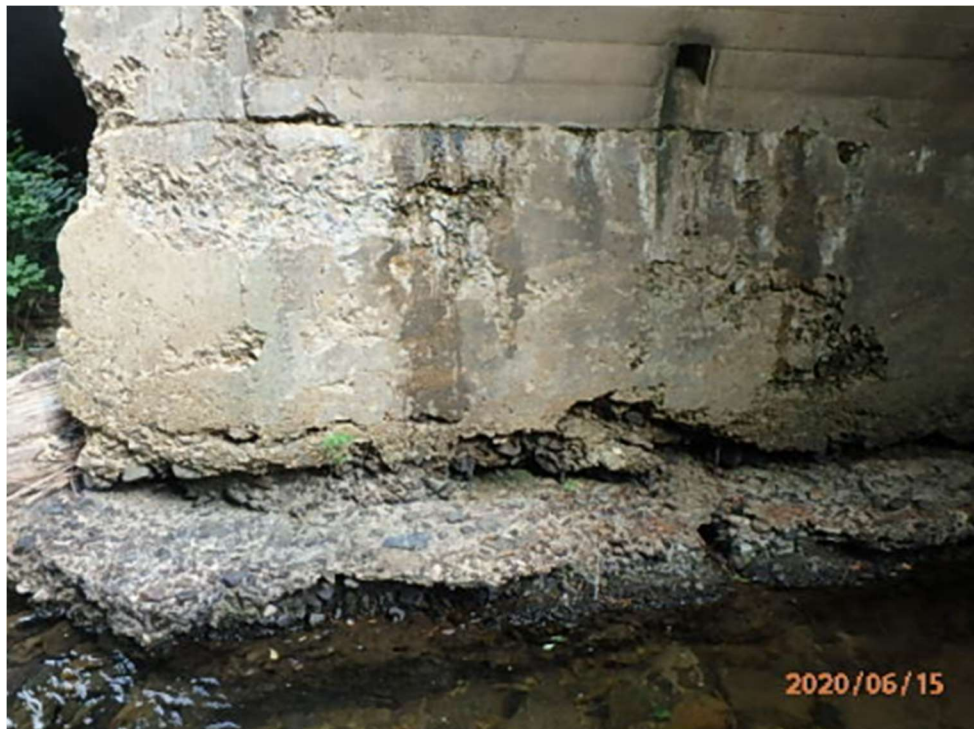
**Figure 192 – Bridge 313-5002-0 Reinforced Concrete Pier Wall Condition (GDOT, 2020)**

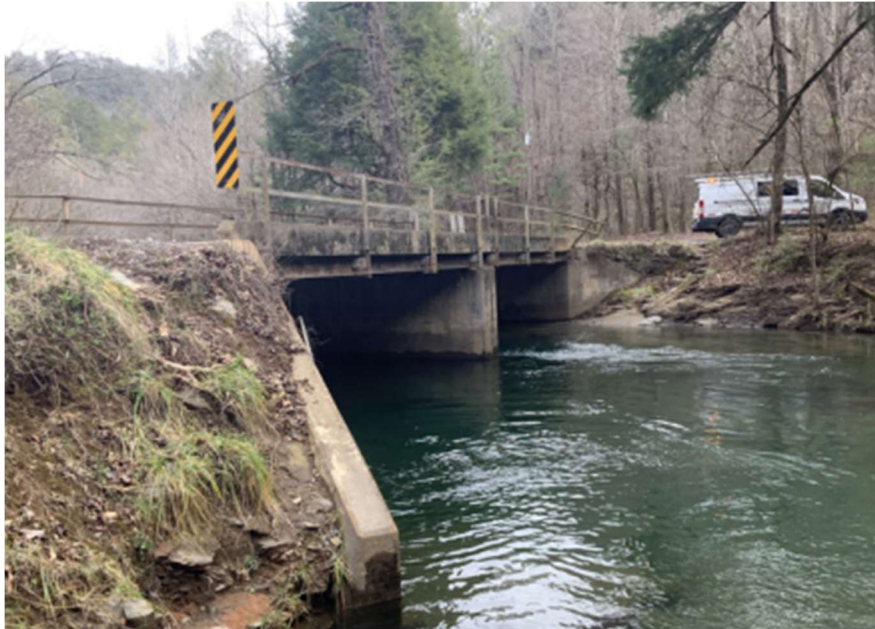
**Figure 193 – Bridge 213-0048-0 Side View (GDOT, 2022)**

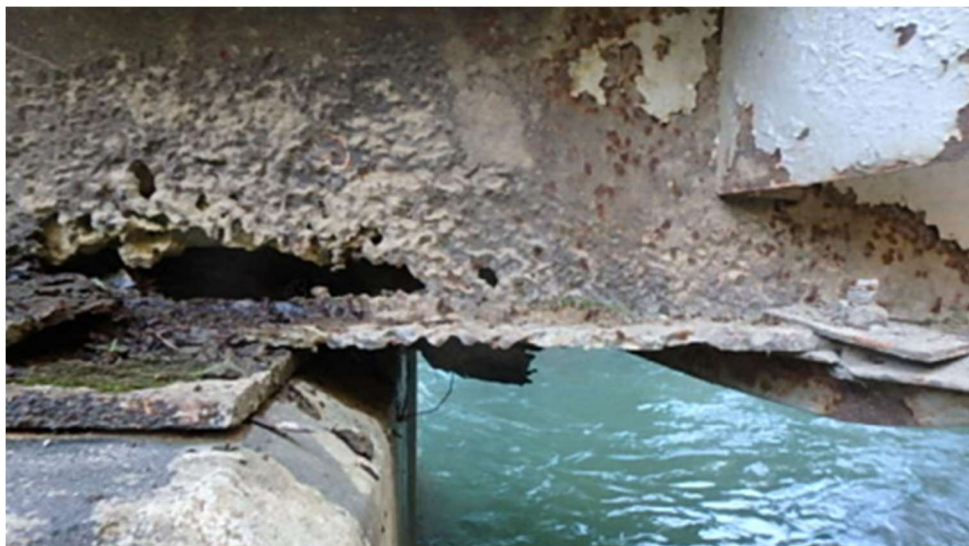
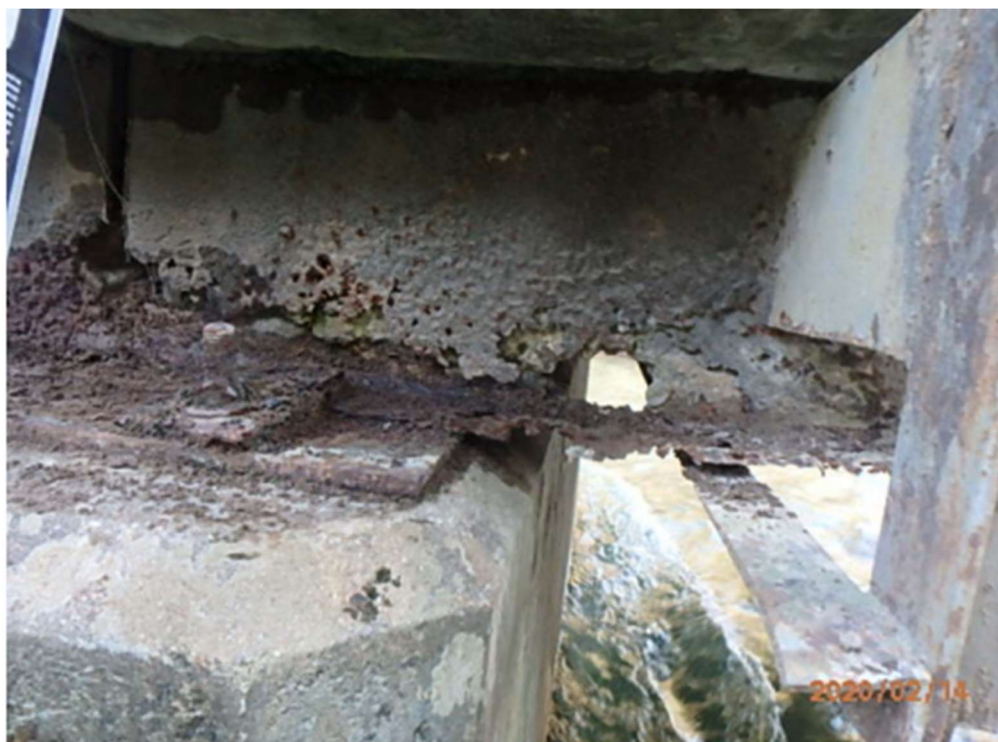
**Figure 194 – Bridge 213-0048-0 Steel Girder Corrosion (GDOT, 2020)**

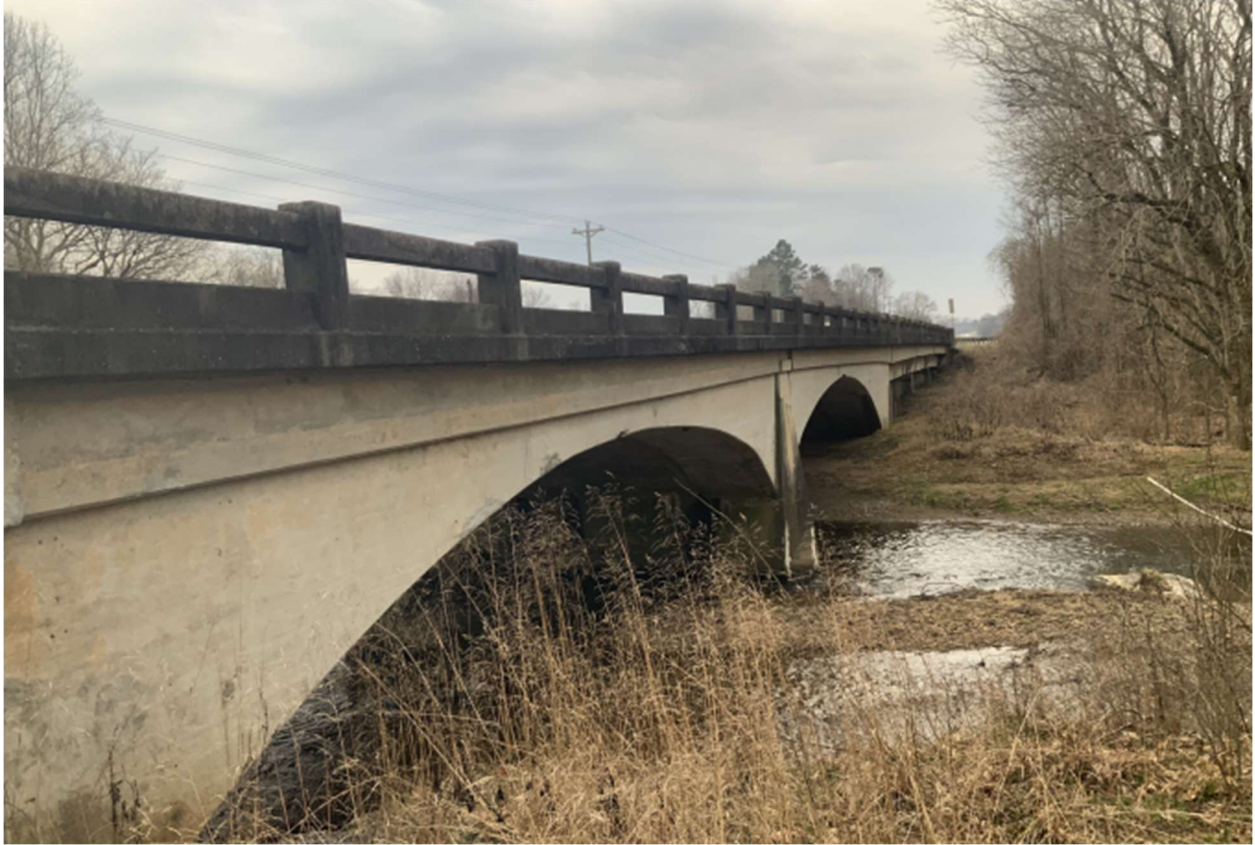
**Figure 195 – 213-0017-0 Side View (GDOT, 2022)**

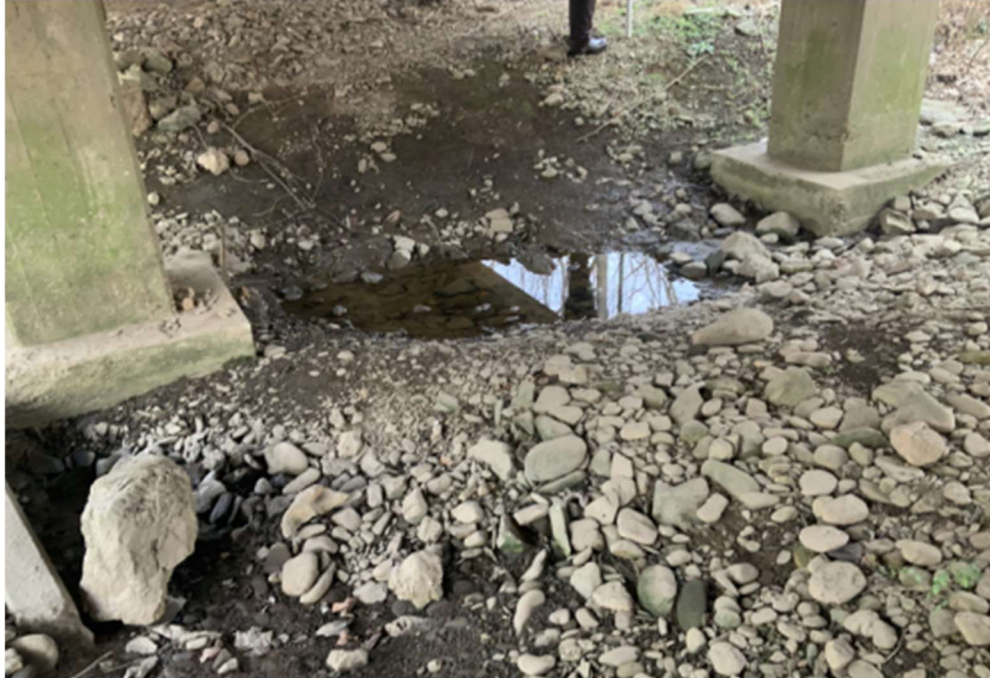
**Figure 196 – Bridge 213-0017-0 Scouring at Bent 4, 2022**

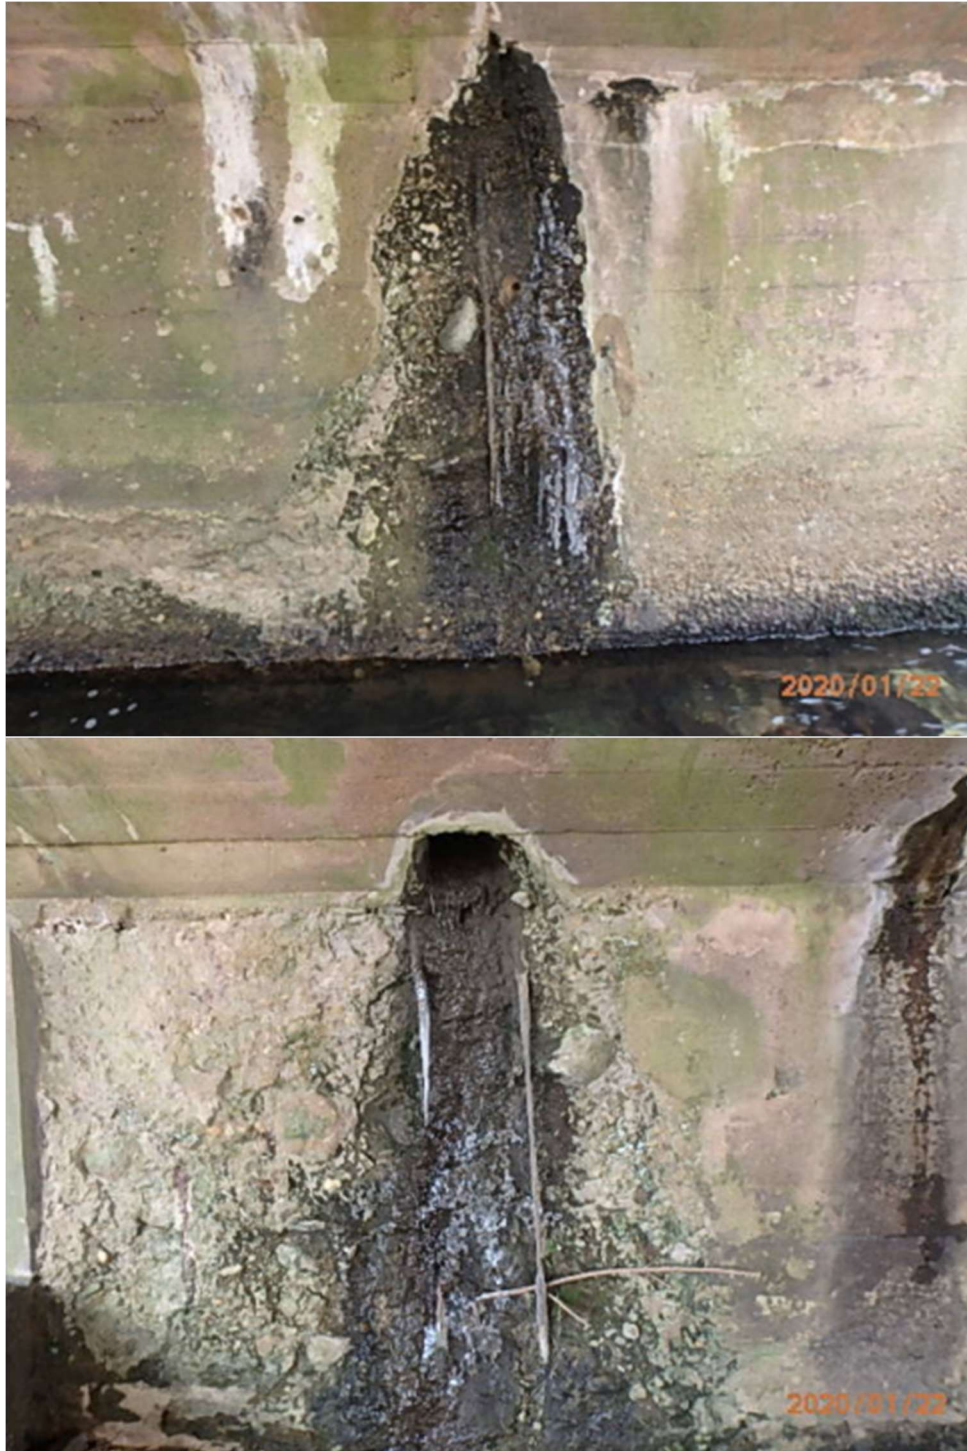
**Figure 197 – Bridge 213-0017-0 Pier Wall 2 Abrasion Area (GDOT, 2020)**

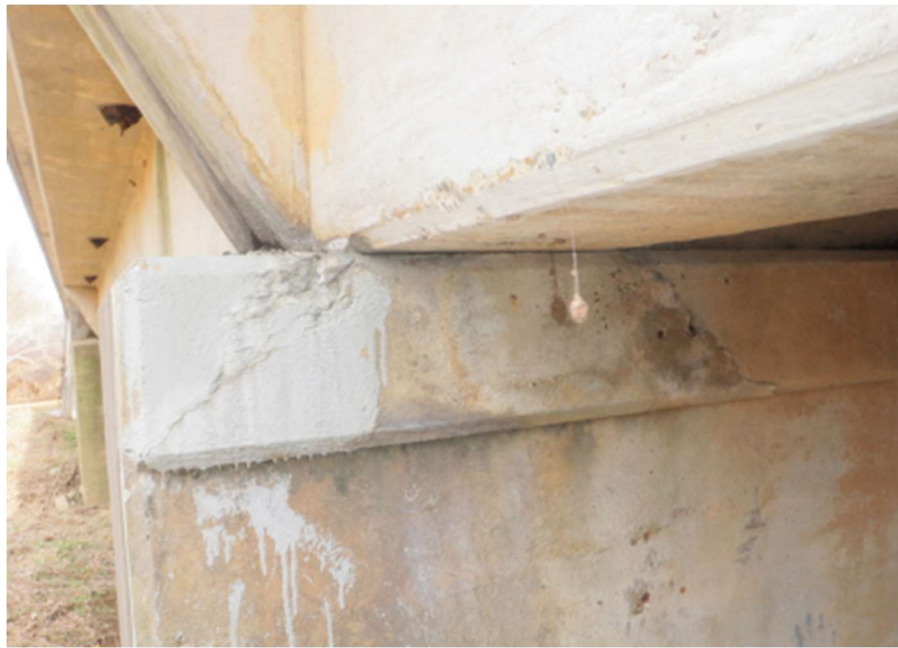
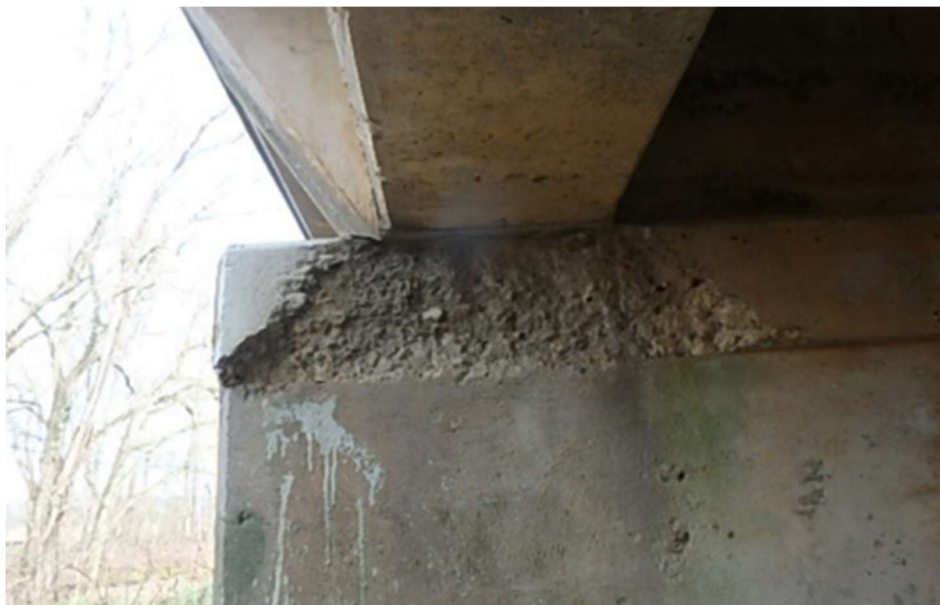
**Figure 198 – Bridge 213-0017-0 Bent Cap 4 Spall 2016 (Top) vs 2020 (Bottom)**

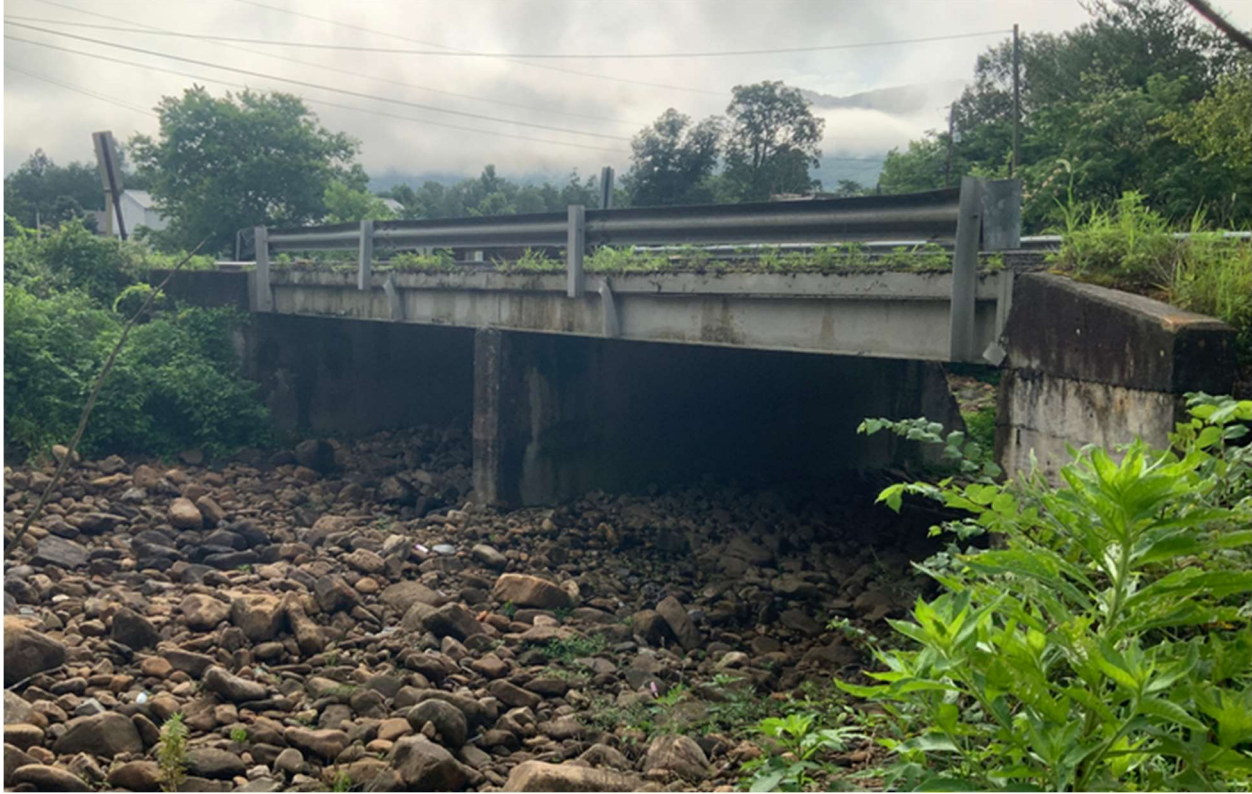
**Figure 199 – Bridge 083-0046-0 Side View (GDOT, 2022)**

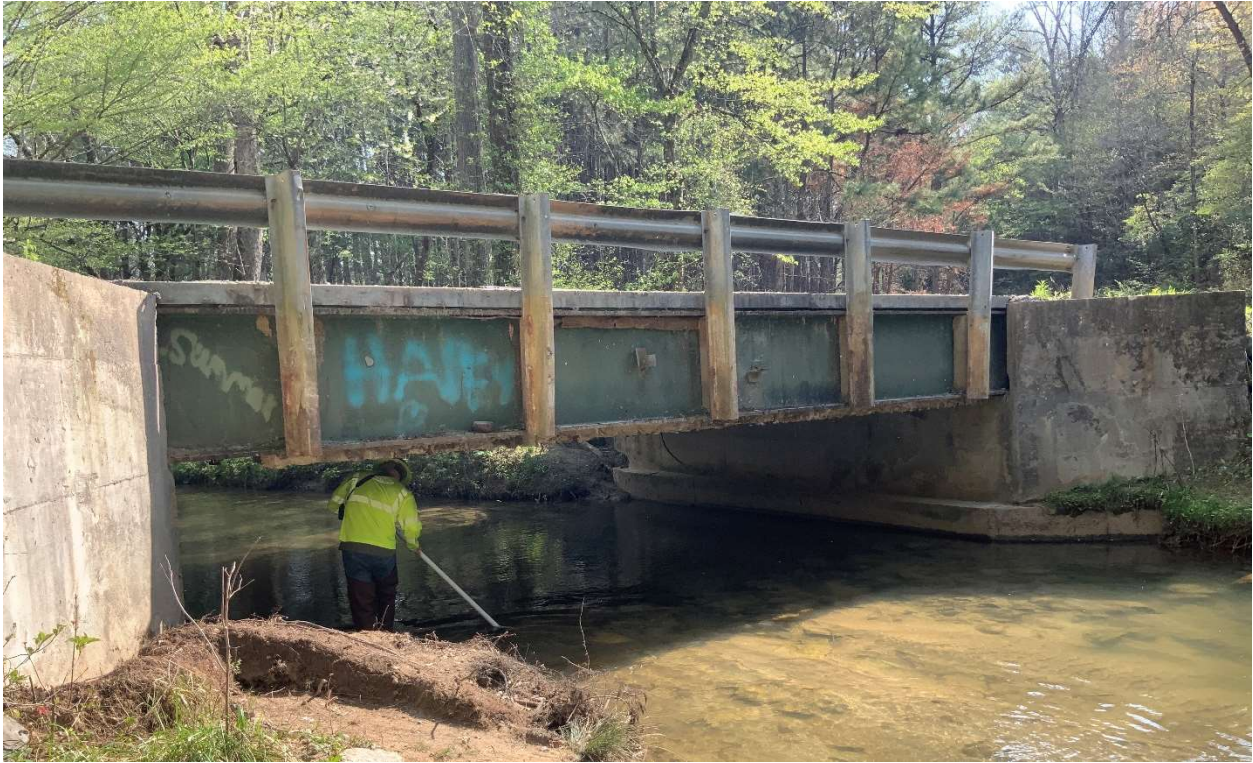
**Figure 201 – Bridge 123-5060 Side View (GDOT, 2021)**

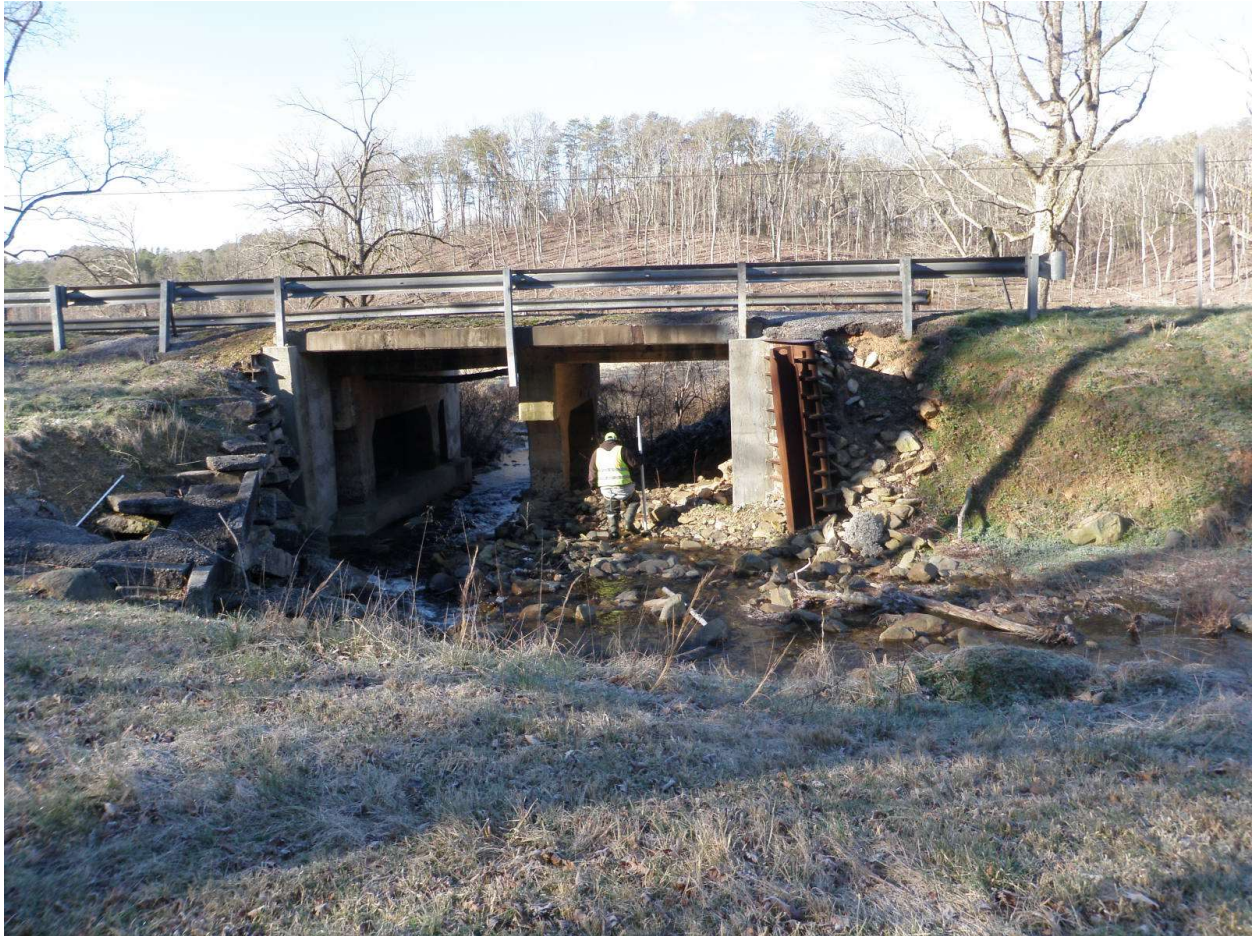
was reported in both abutments, with the area in abutment one being reported as 0.6'x1.4'x5.0', and the area in abutment three reported as 4.0 x 6.5'. The inspectors recorded the same measurements in 2022. However, this bridge shows how rapidly areas of undermining can grow. One interesting thing observed in the inspection photos was the difference in the creek flowrate when captured at different times.

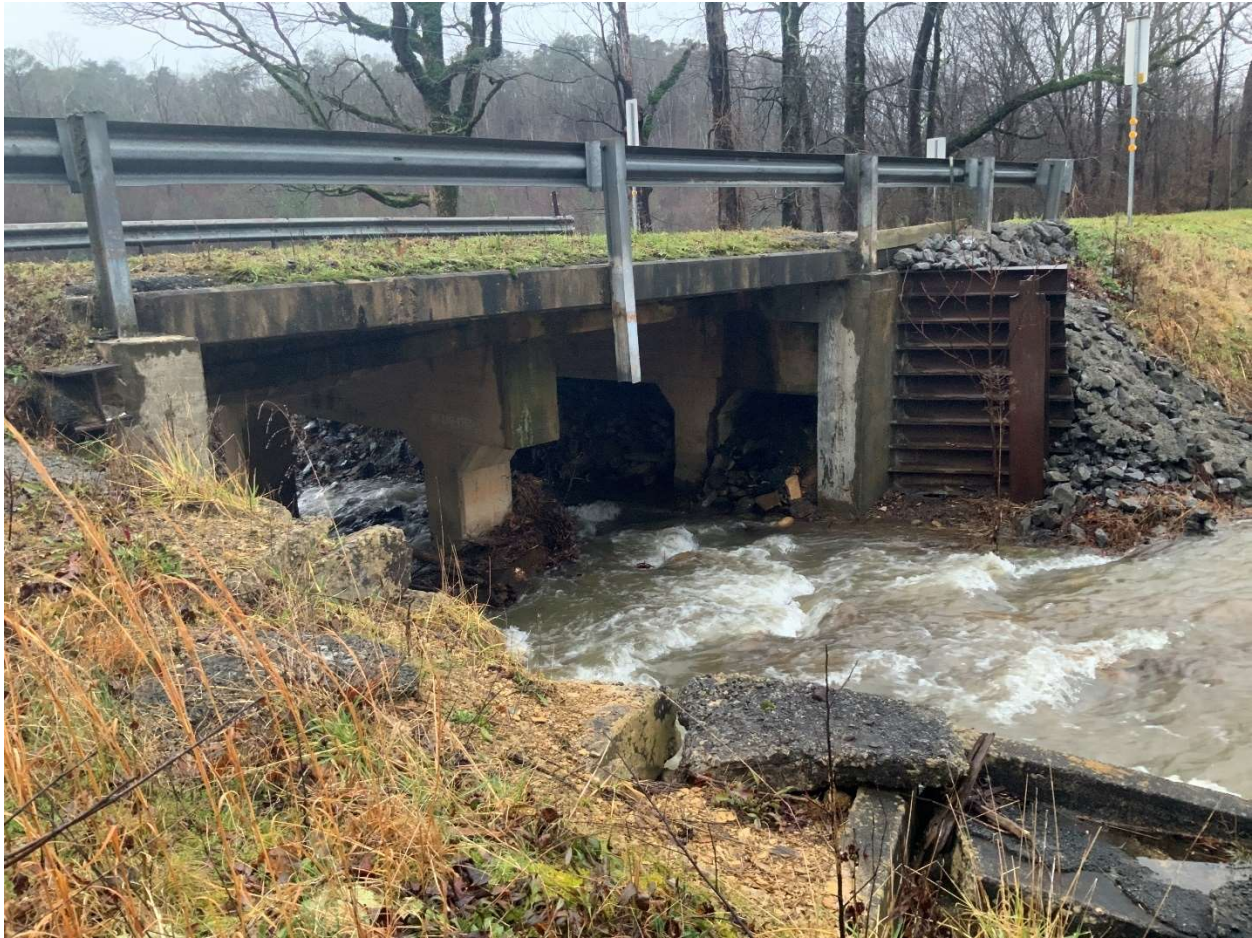
**Figure 202 – Bridge 213-0044-0 Volumetric Flowrate No Precipitation (Top) vs With Precipitation (Bottom)**

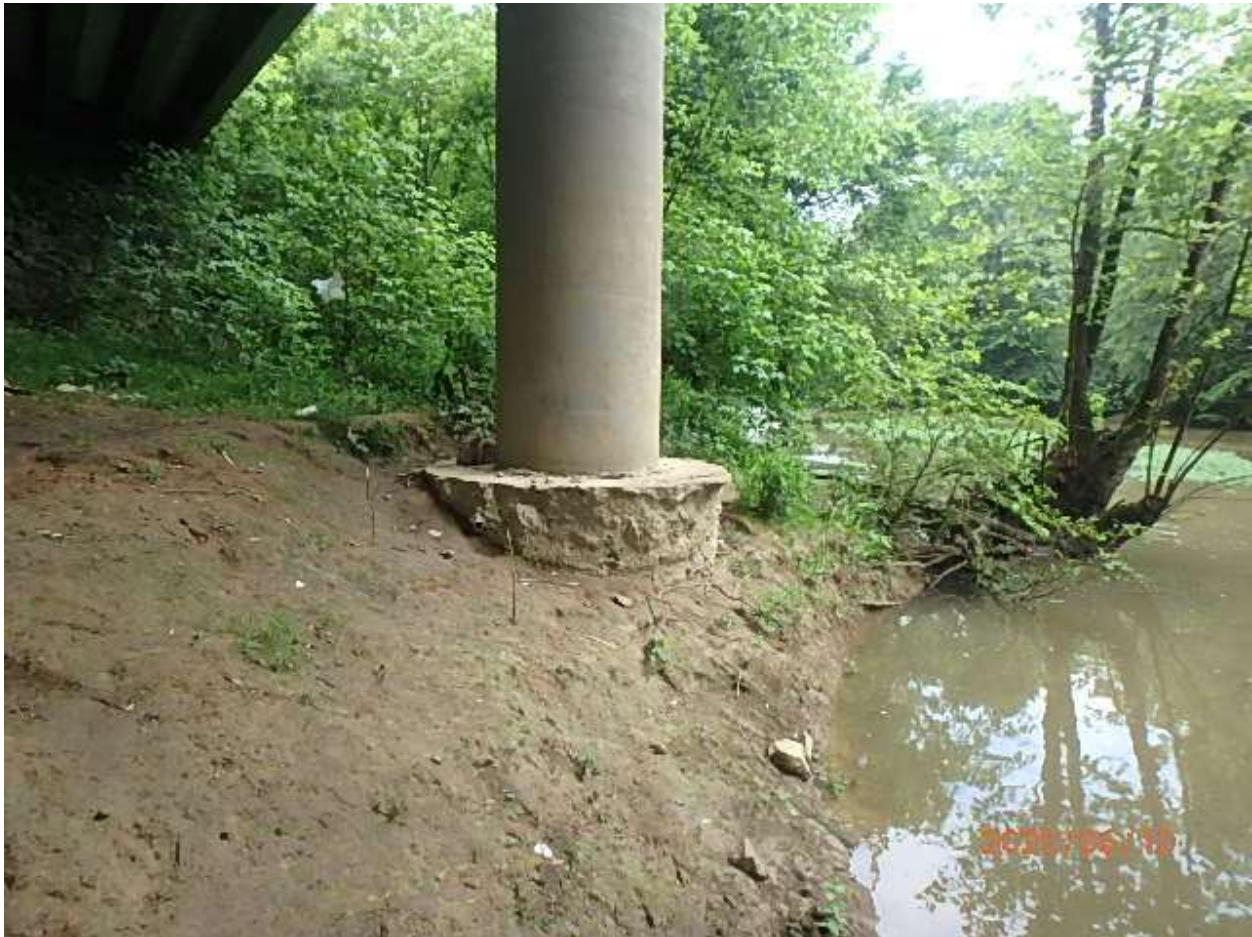
**Figure 203 – Bridge 313-5083-0 Bent 2 Scour (GDOT, 2020)**

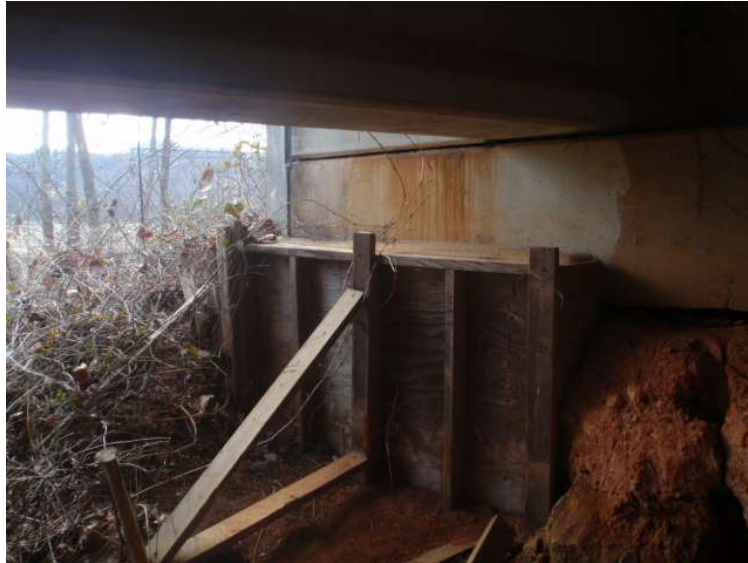
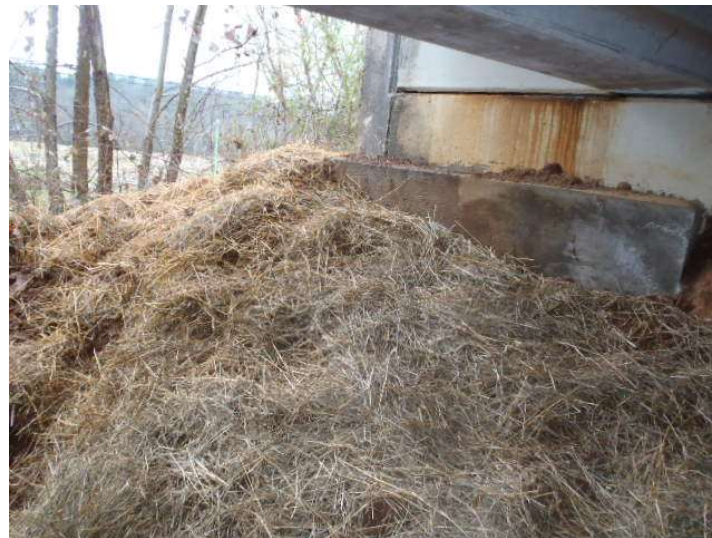
**Figure 205 – Bridge 311-0040-0 Abutment Repair (GDOT, 2020)**

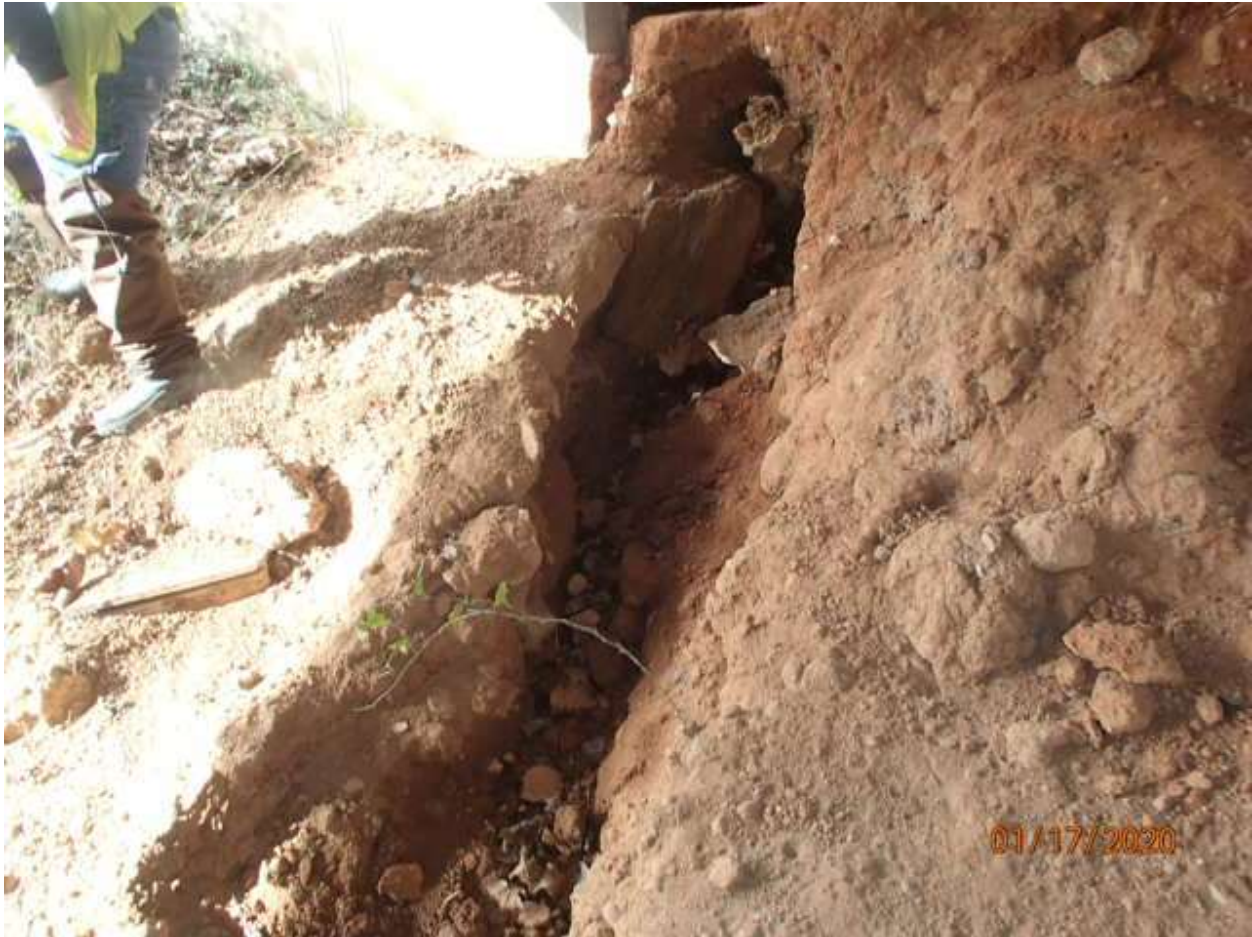
**Figure 206 – Bridge 311-0040-0 Erosion (GDOT, 2020)**

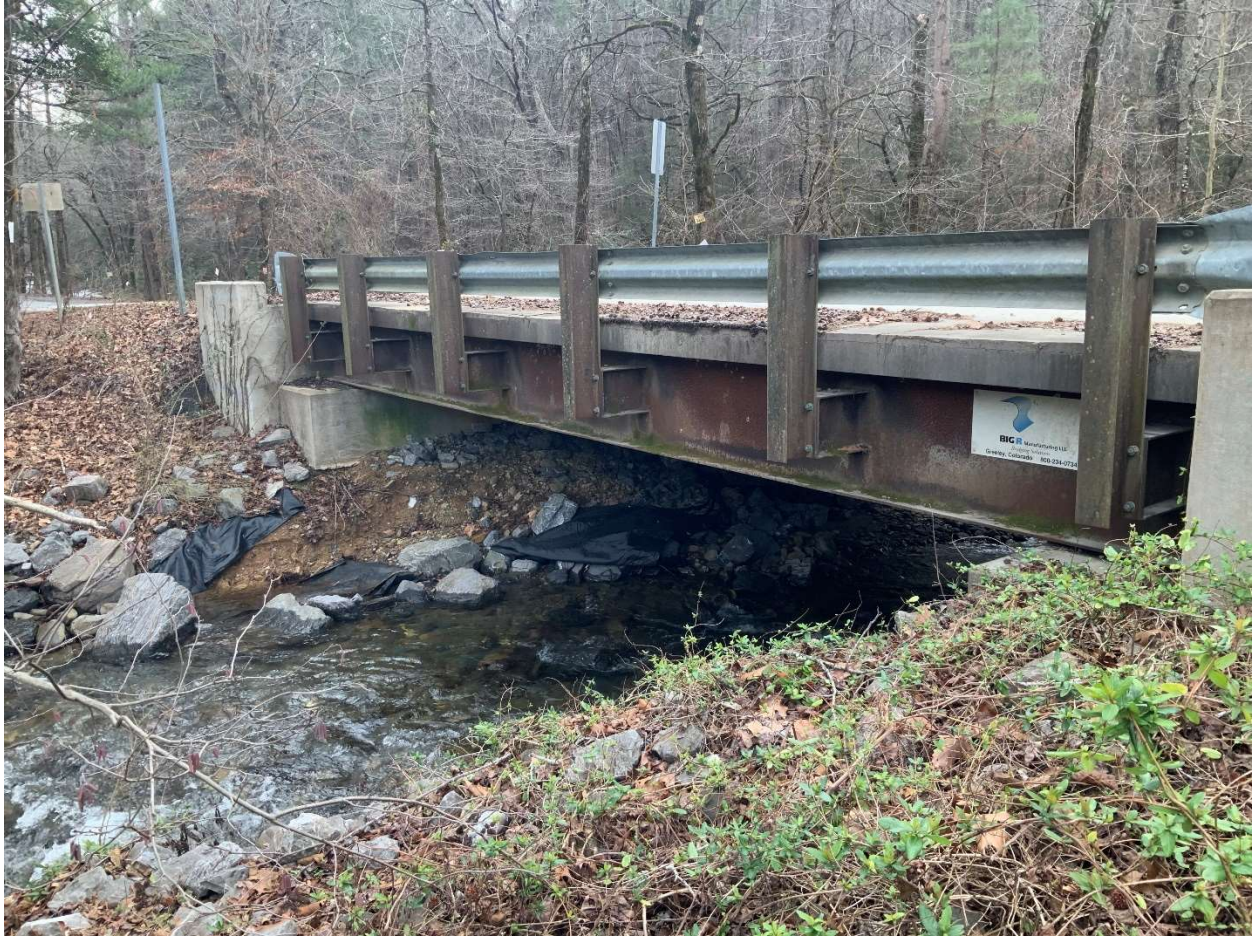
**Figure 207 – Bridge 213-5044-0 Bridge Side View (GDOT, 2022)**

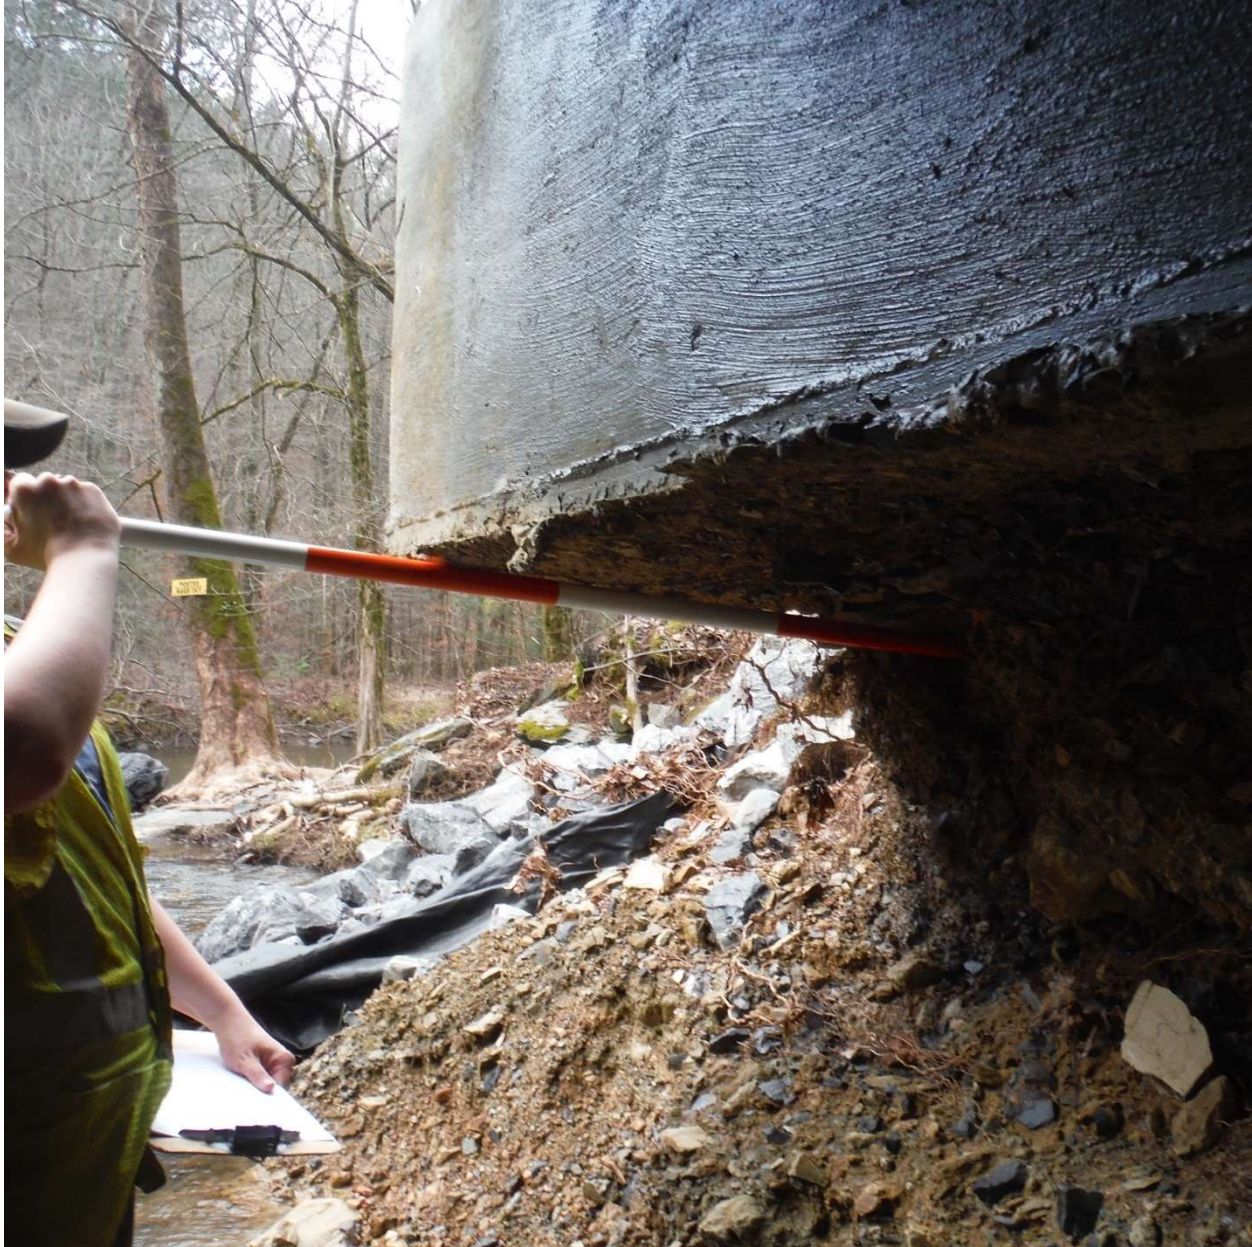
**Figure 208 – Bridge 213-5044-0 Abutment One Scour (GDOT, 2016)**
