IMPACT OF WEATHER STRESSORS TO IDENTIFY VULNERABLE BRIDGE ELEMENTS  
IN GEORGIA TOWARDS DATA DRIVEN ASSEST MANAGEMENT

by SPENCER KOPF

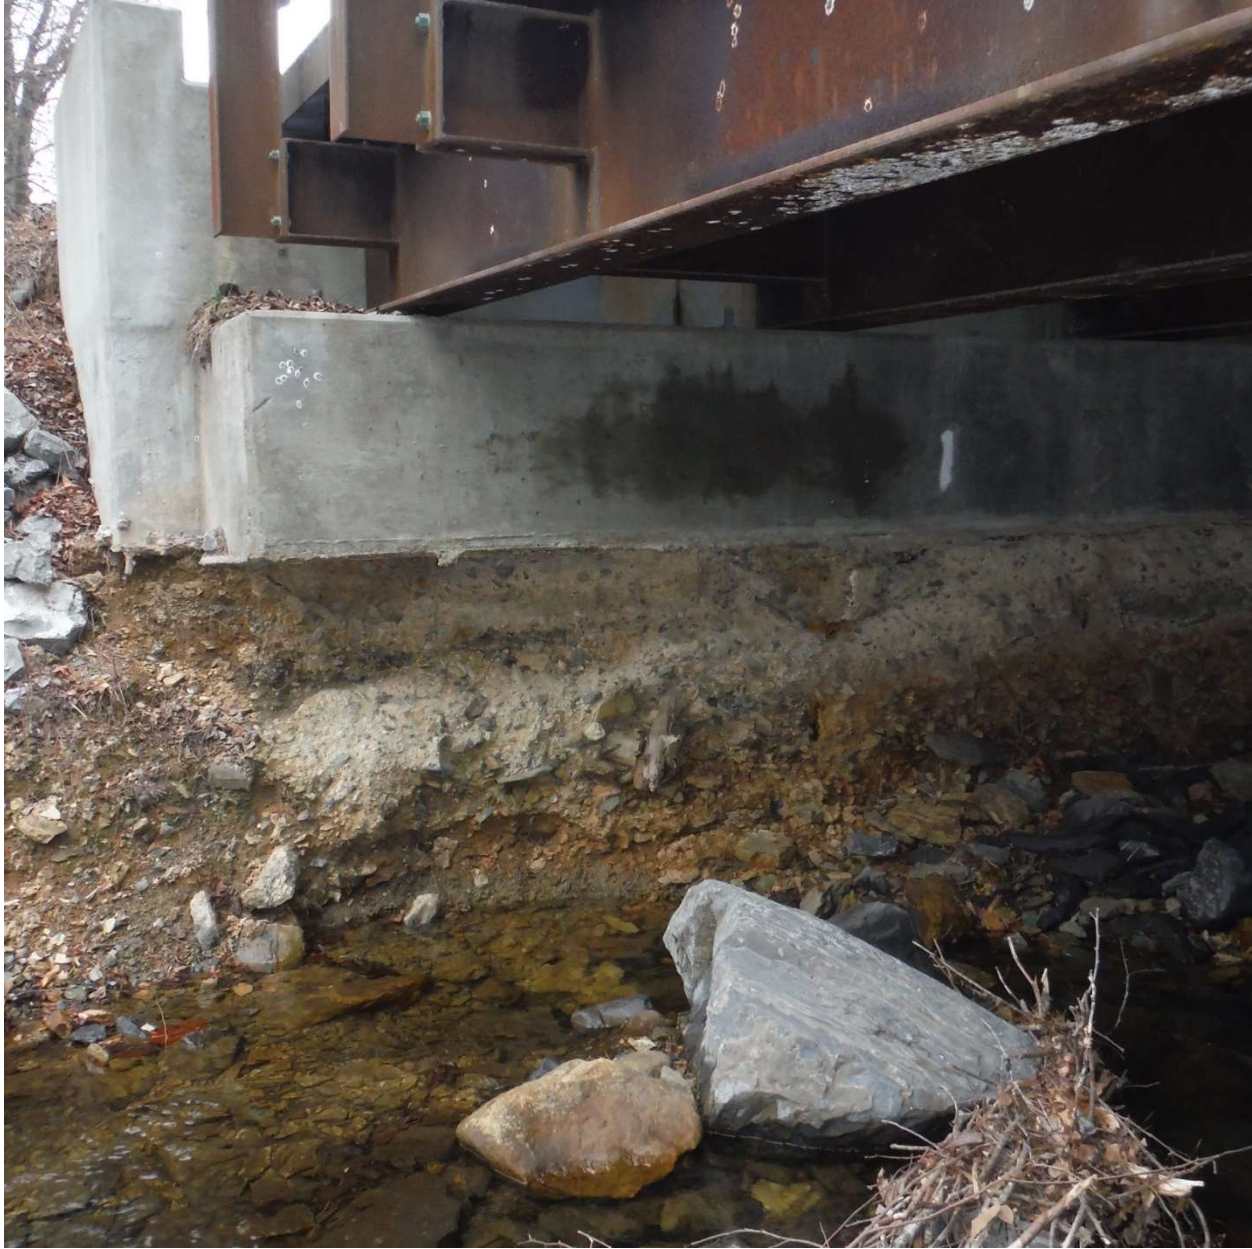
**Figure 209 – Bridge 213-5044-0 Abutment One Scour (GDOT, 2018)**

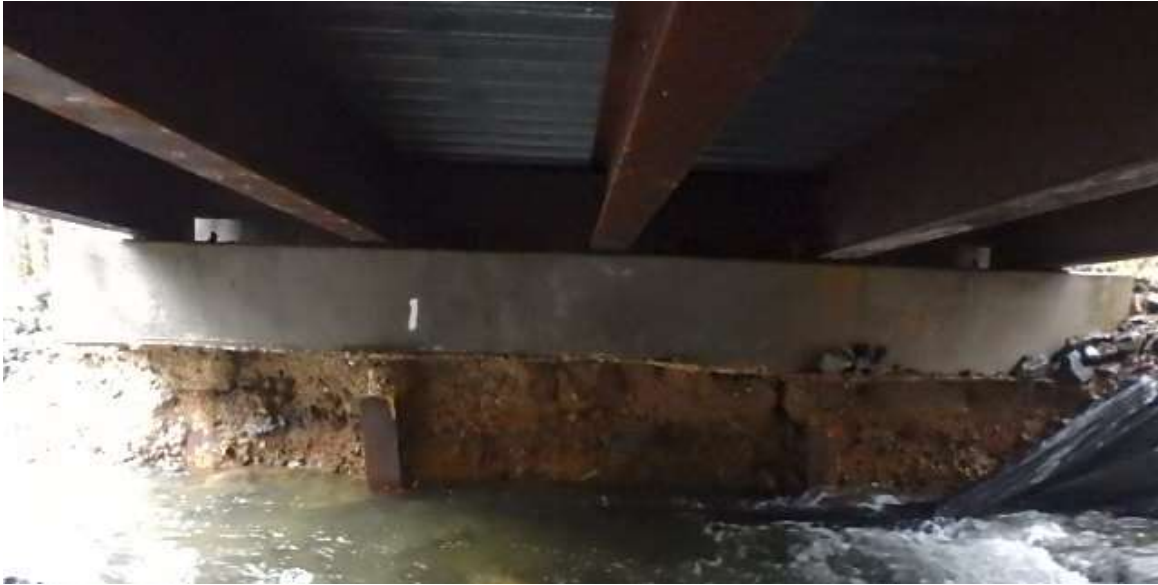
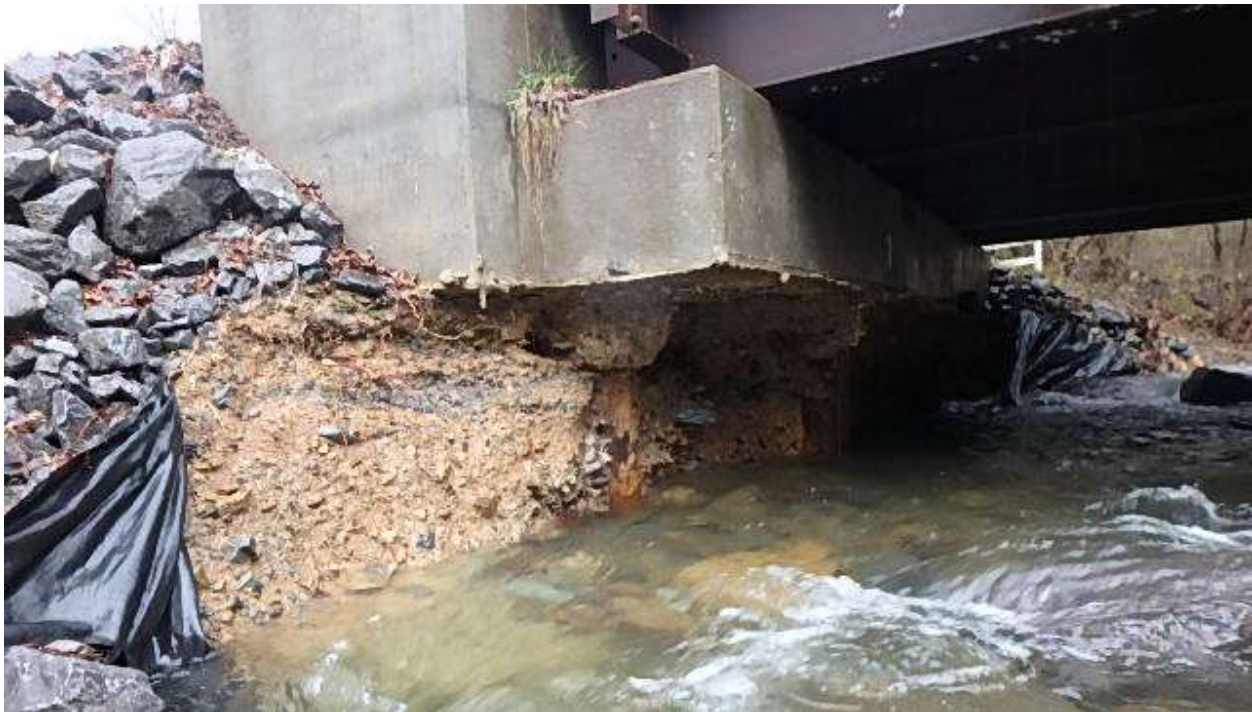
**Figure 210 – Bridge 213-5044-0 Abutment One Scour (GDOT, 2020)**

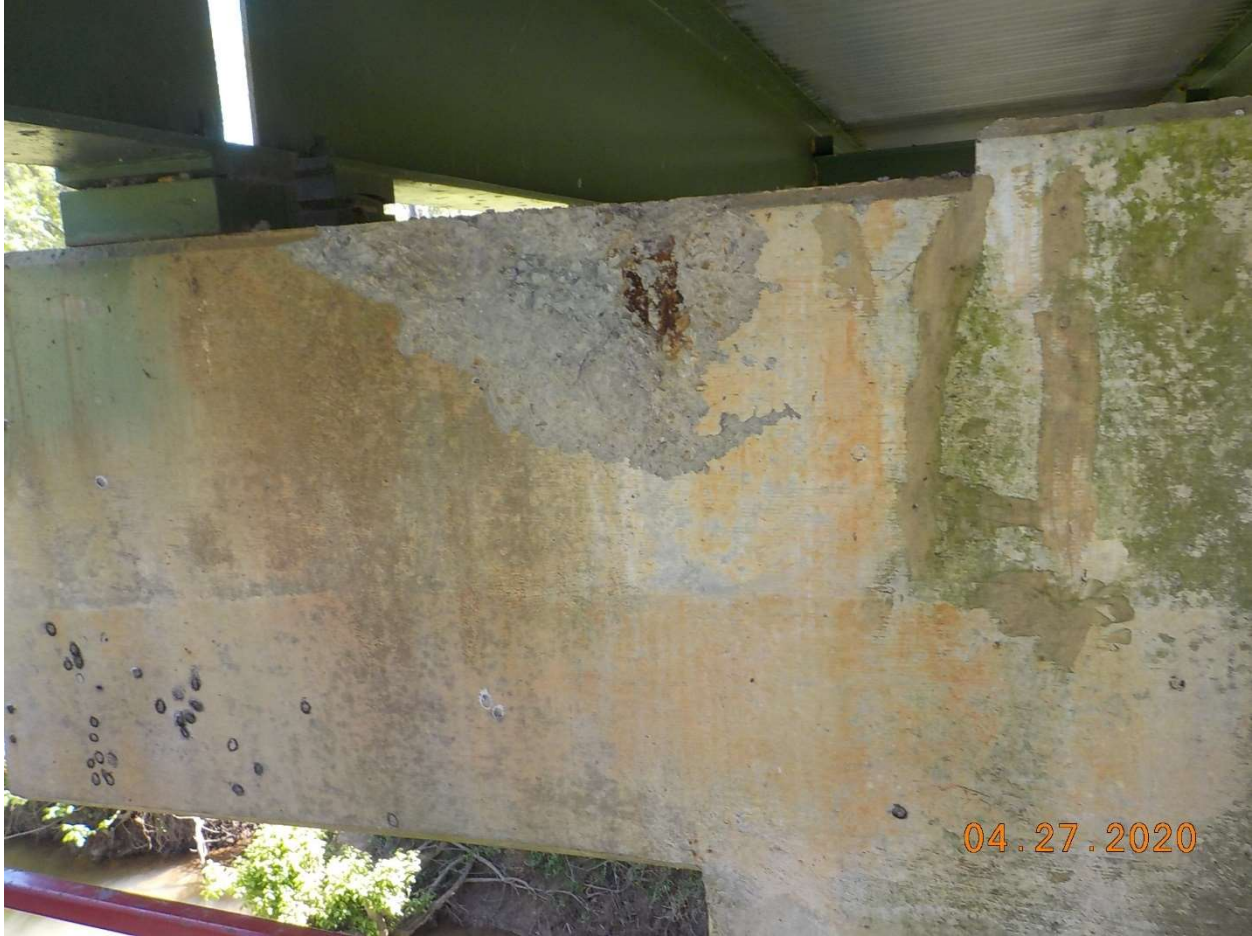
**Figure 211 – Bridge 187-0016-0 Bent Cap 5 Spalling (GDOT, 2020)**

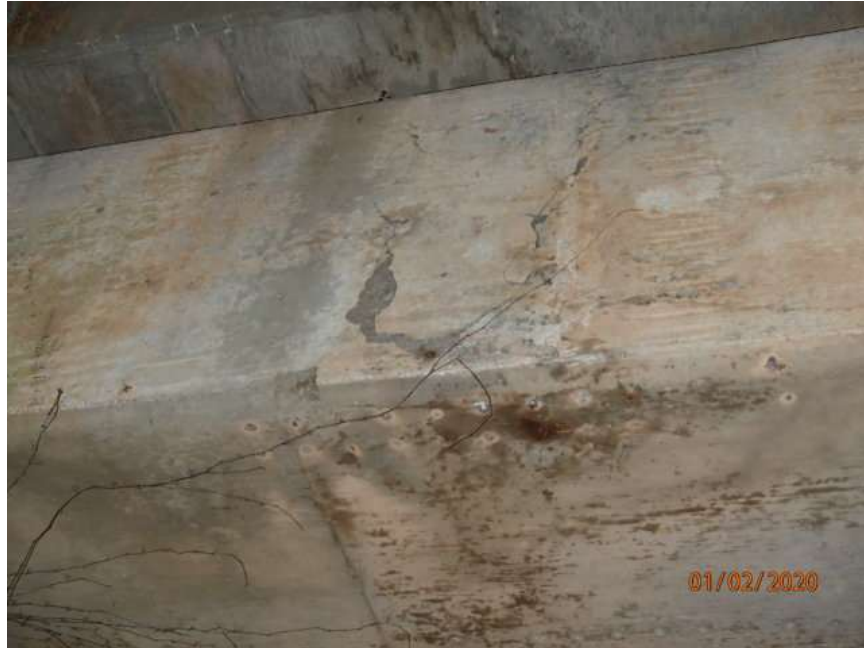
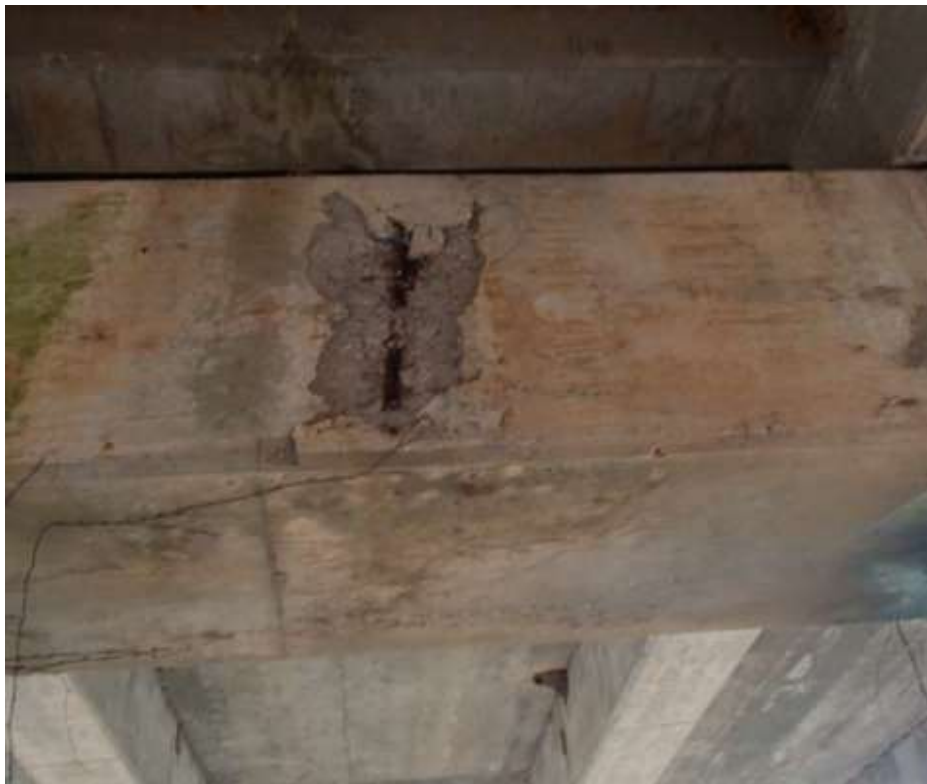
**Figure 212 – Bridge 187-0016-0 Bent Cap 9 Spalling 2020 (Top) vs 2022 (Bottom)**

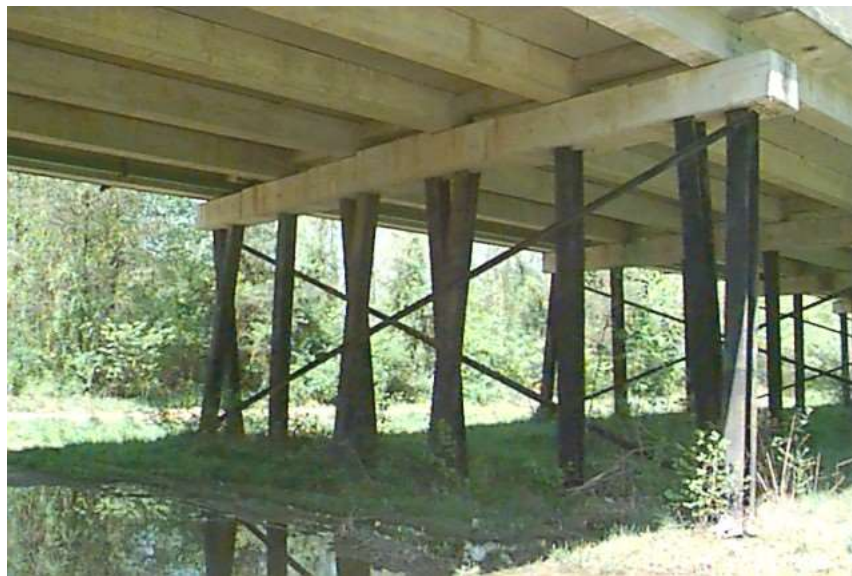
Bridge 129-0009-0 is a state-owned bridge that is in Gordon County. This 17-span bridge was originally constructed in 1930, but a majority of the bridge was constructed in 1980 as a part of a widening project. Overall, the bridge is in good condition with areas of concrete spalling and cracking in members of the superstructure and substructure. There is also some minor corrosion on the steel piles. However, the main weather-related issue with this bridge is scour. In 2015, inspectors noted “slight scour around columns.” Despite this note there was no maintenance items recommended by inspectors. By the 2019 inspection, scour had removed around 7.0’ of soil from around the base of the steel piles. **Figure 213** shows bent 15 in 2015 and 2019.

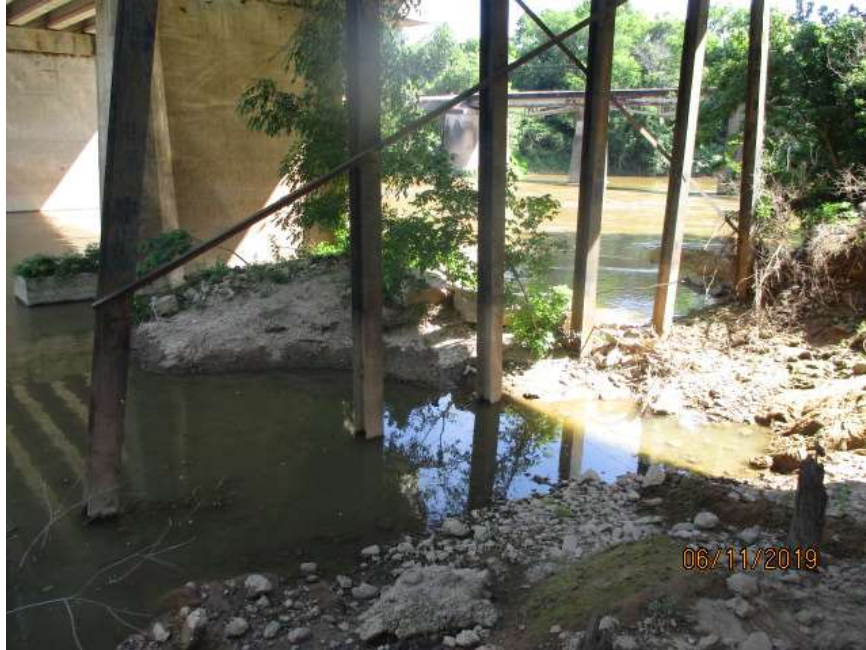
**Figure 213 – Bridge 129-0009-0 Scour at Bent 15 2015 (Top) vs 2019 (Bottom)**

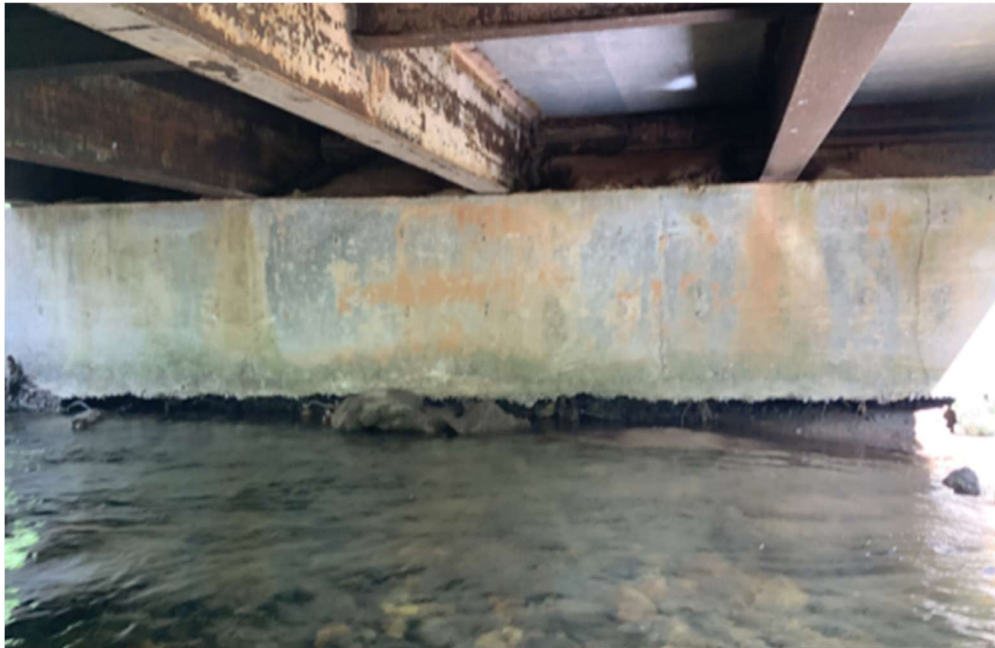
**Figure 214 – Bridge 123-5024-0 Abutment 2 Undermining (GDOT, 2021)**

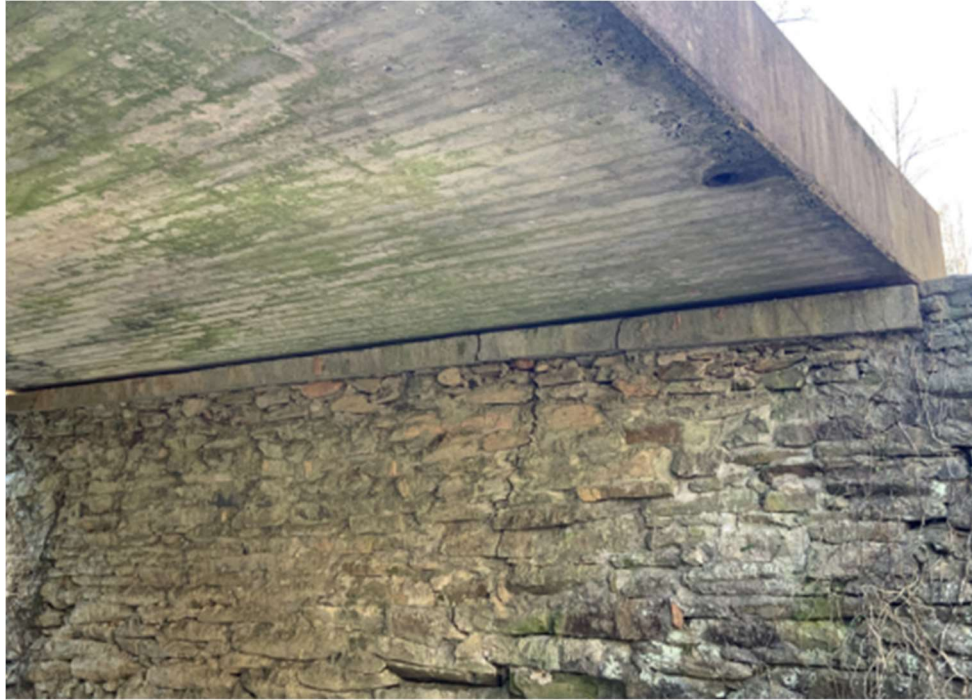
**Figure 215 – Bridge 123-0036-0 Settlement Cracking (GDOT, 2022)**

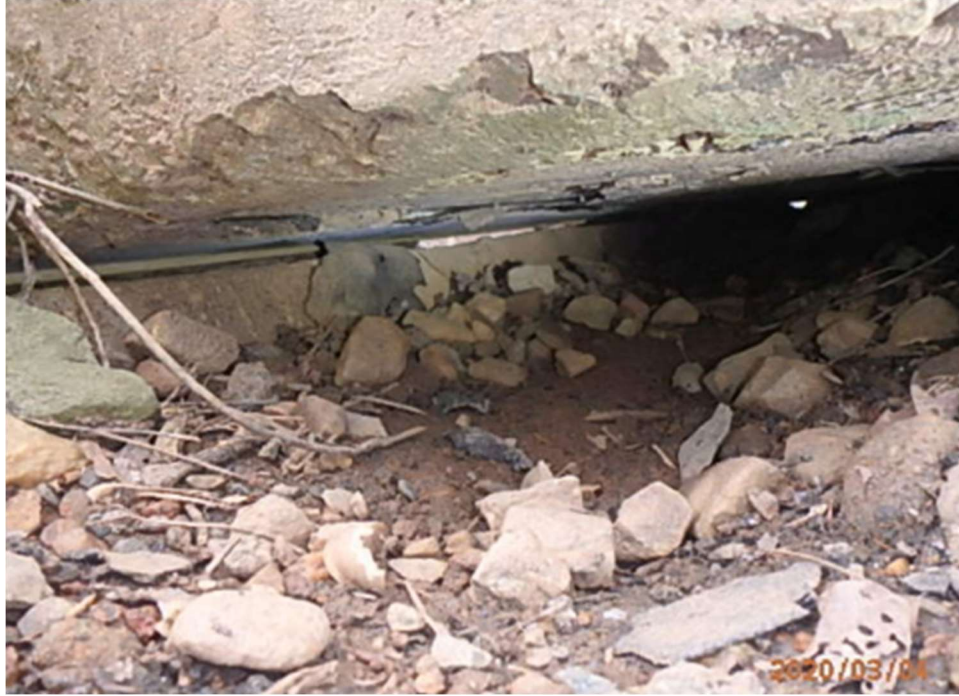
**Figure 216 – Bridge 123-0036-0 Abutment Void (GDOT, 2020)**

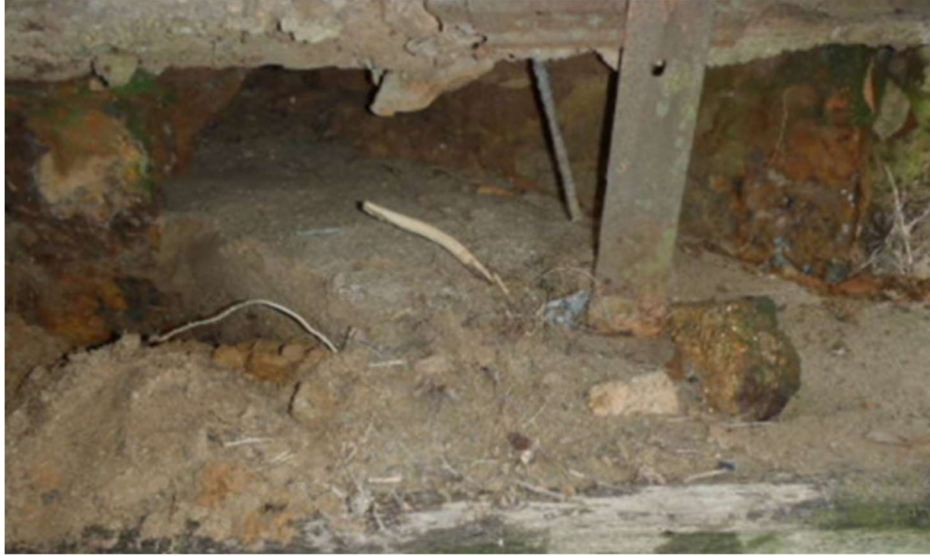
**Figure 217 – Bridge 147-5080-0 Typical Abutment Condition (GDOT, 2021)**

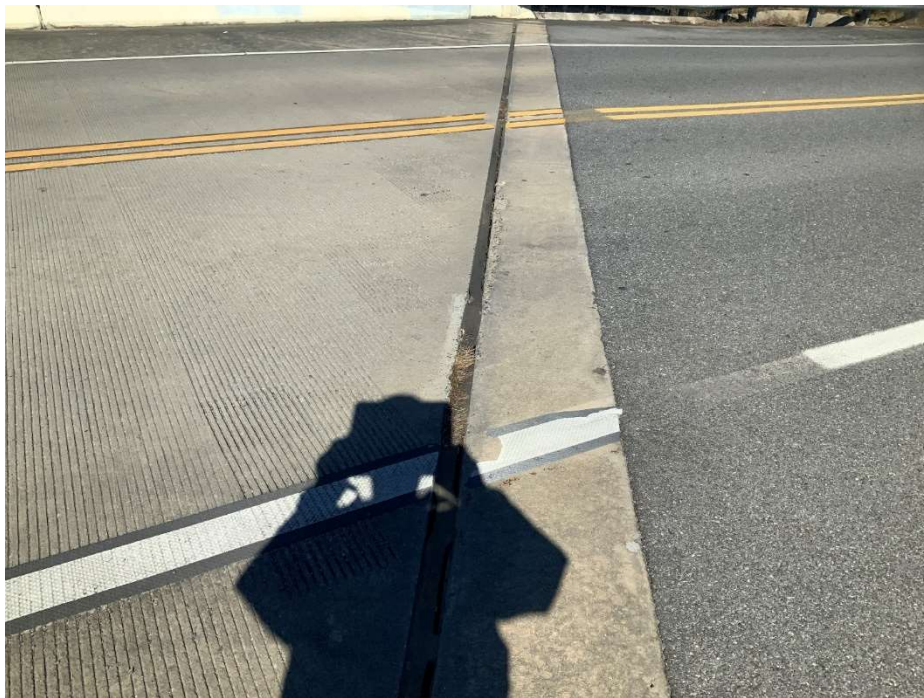
**Figure 218 – Bridge 213-5045-0 Failed Compression Joint (GDOT, 2022)**

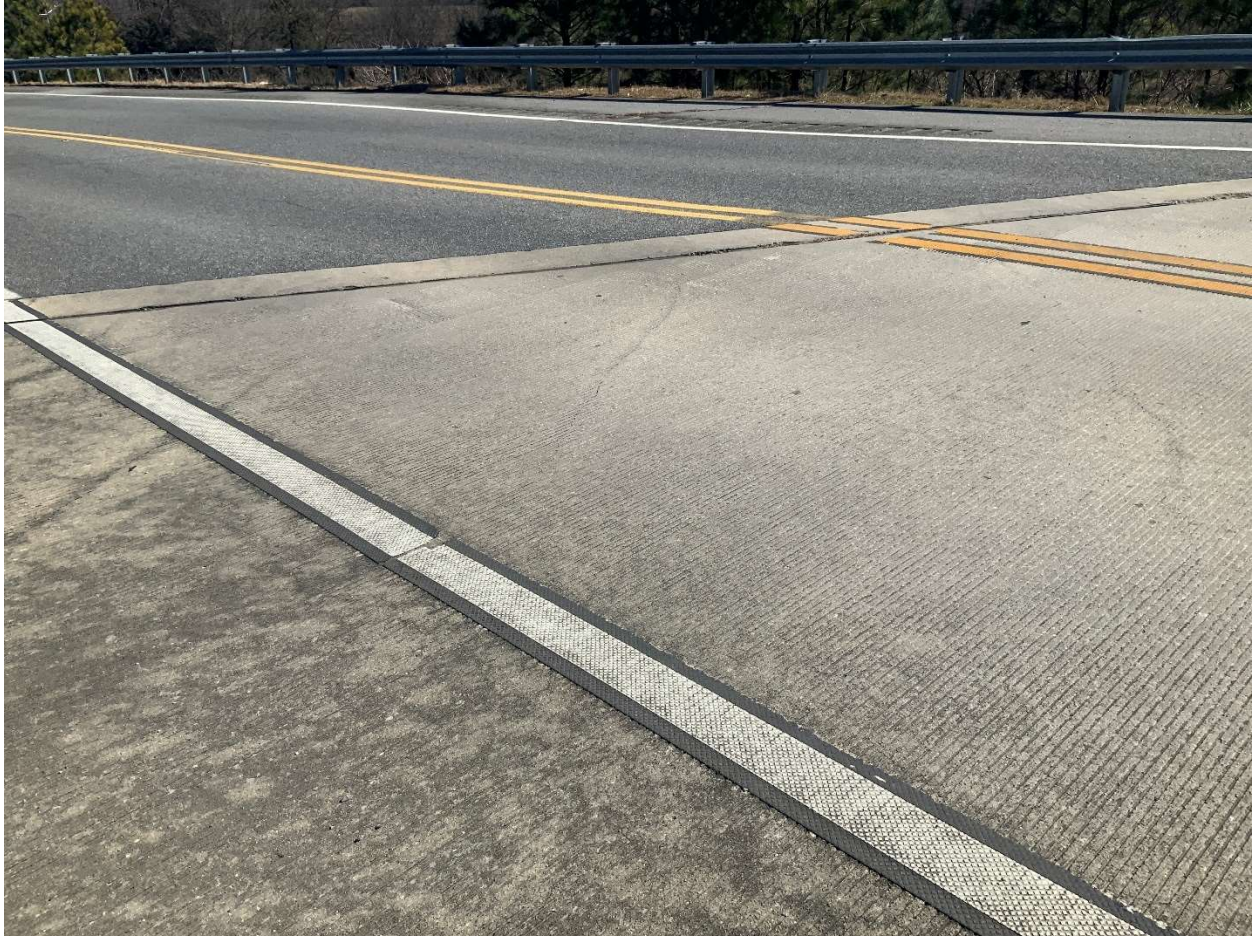
**Figure 219 – Bridge 213-5045-0 Bridge Deck Cracking at Abutment (GDOT, 2022)**

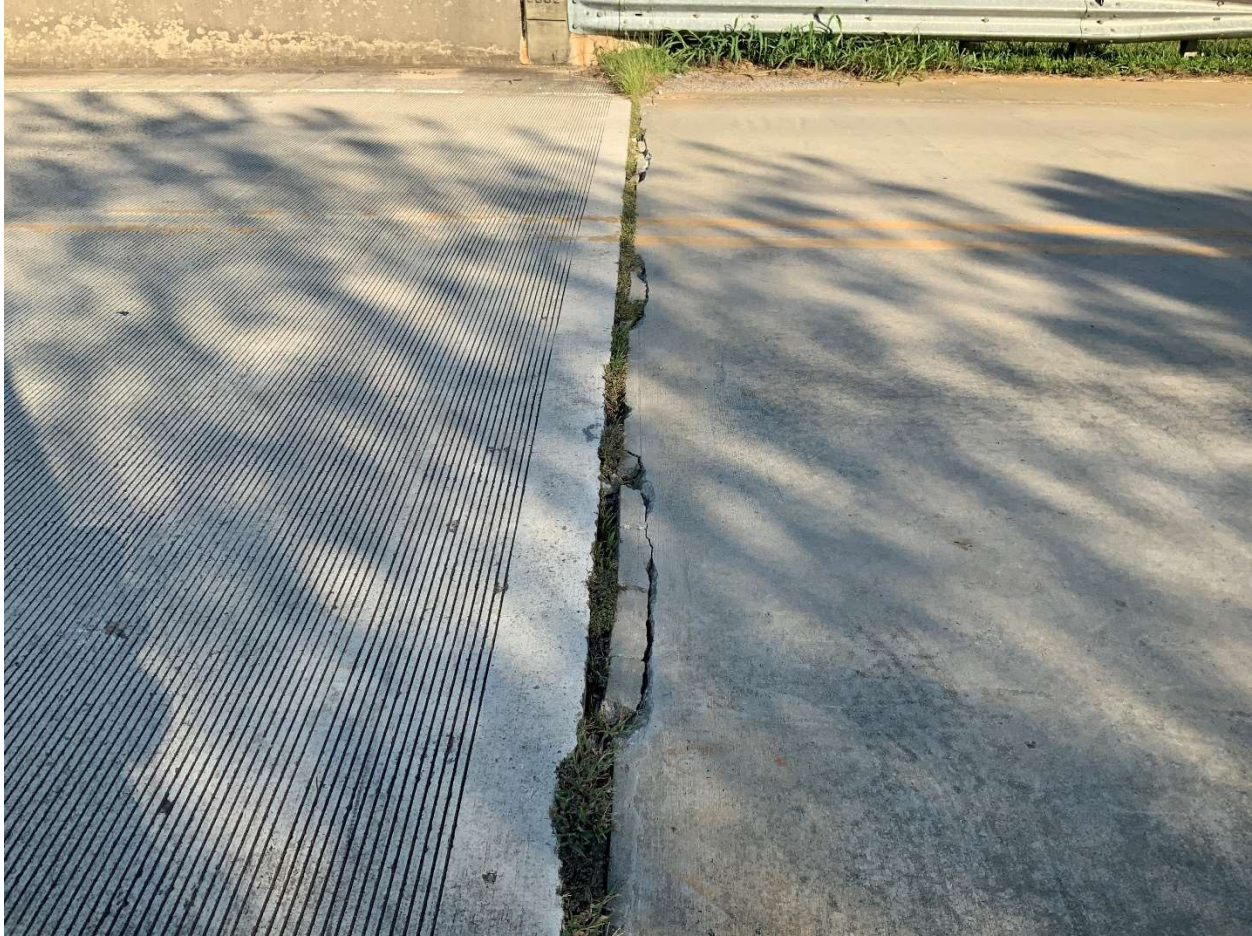
**Figure 220 – Bridge 157-5084-0 Failed Compression Joint (GDOT, 2022)**

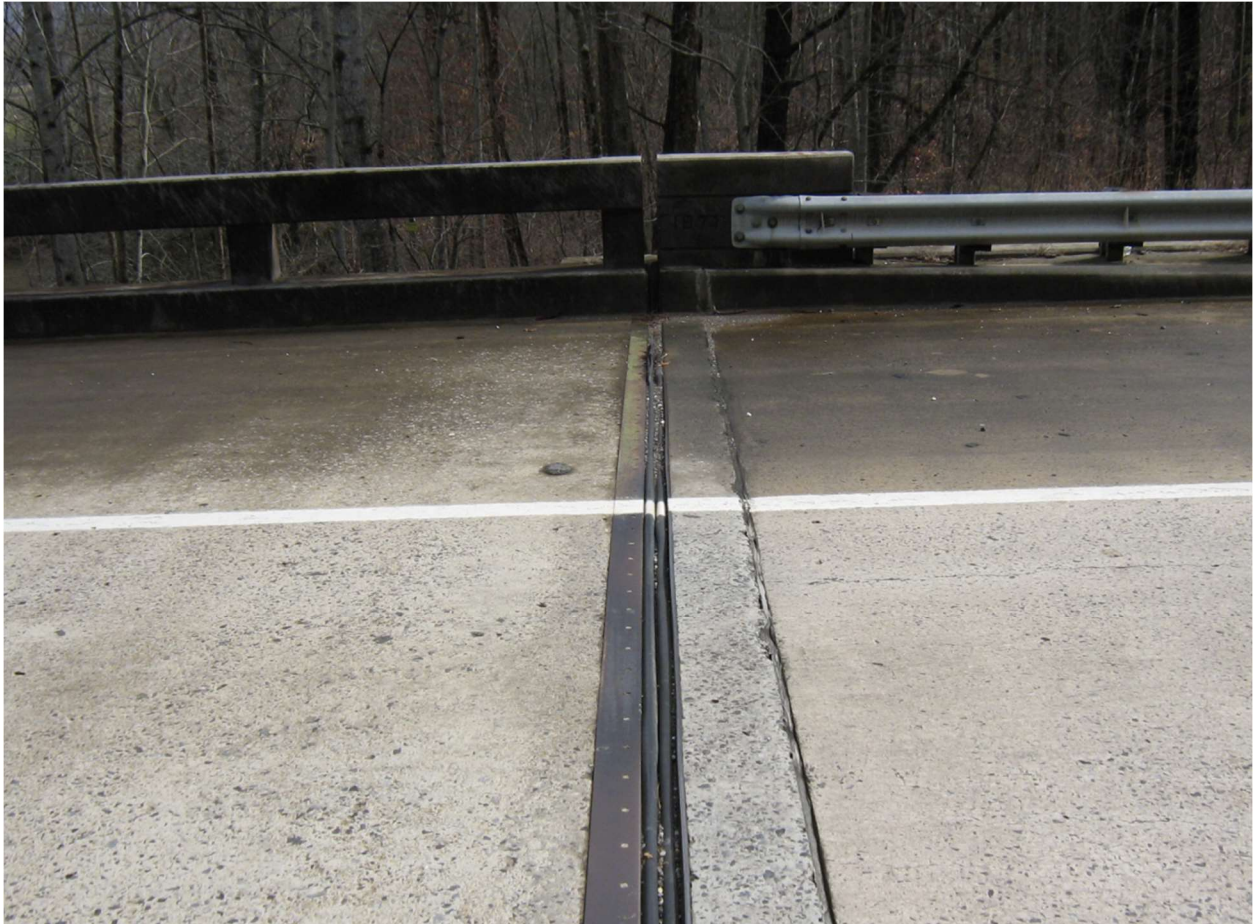
Bridge 213-0008-0 is a state owned and maintained bridge located in Murray County. The bridge was opened in 1974, and allows US411 to pass over the Coosawatte River. There is one compression joint at abutment one in this bridge. In 2015 inspectors noted that the joint was beginning to fail, as some of the rubber was loose, but the NBIE data still reflected an EHI of 100. Inspectors requested maintenance for the joint. In 2018 the joint condition visually had worsened, but the NBIE data was unchanged. By 2022 the compression joint at abutment one had entirely come out, and had an EHI of 0.0. **Figure 221** shows the progression of the joint deterioration.

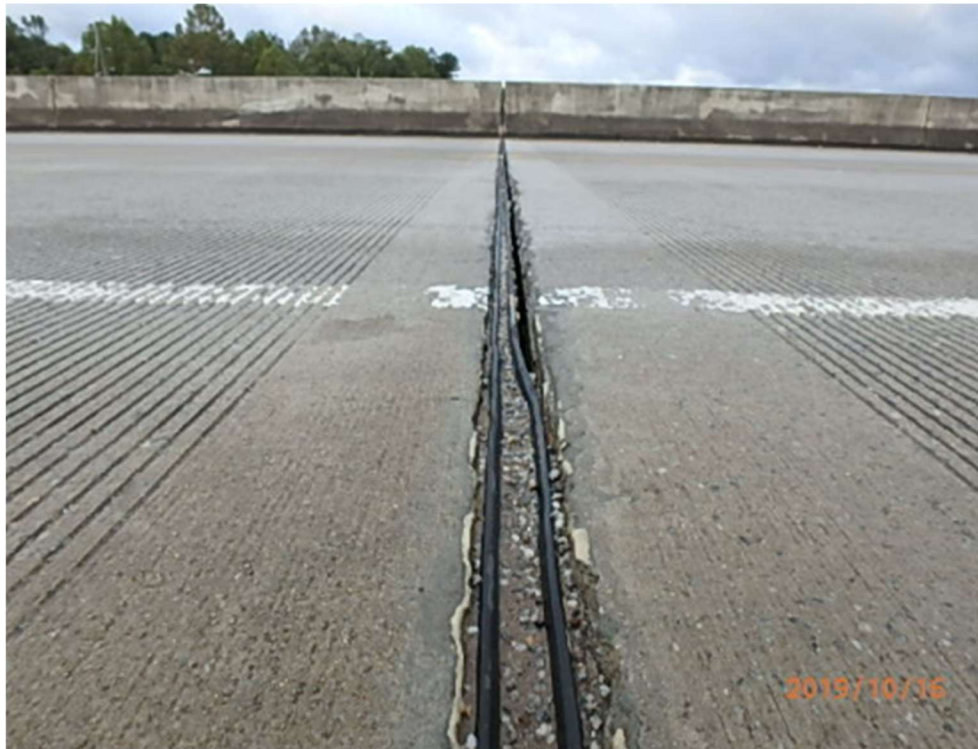
**Figure 222 – Bridge 097-5059-0 Failing Joint (GDOT, 2019)**

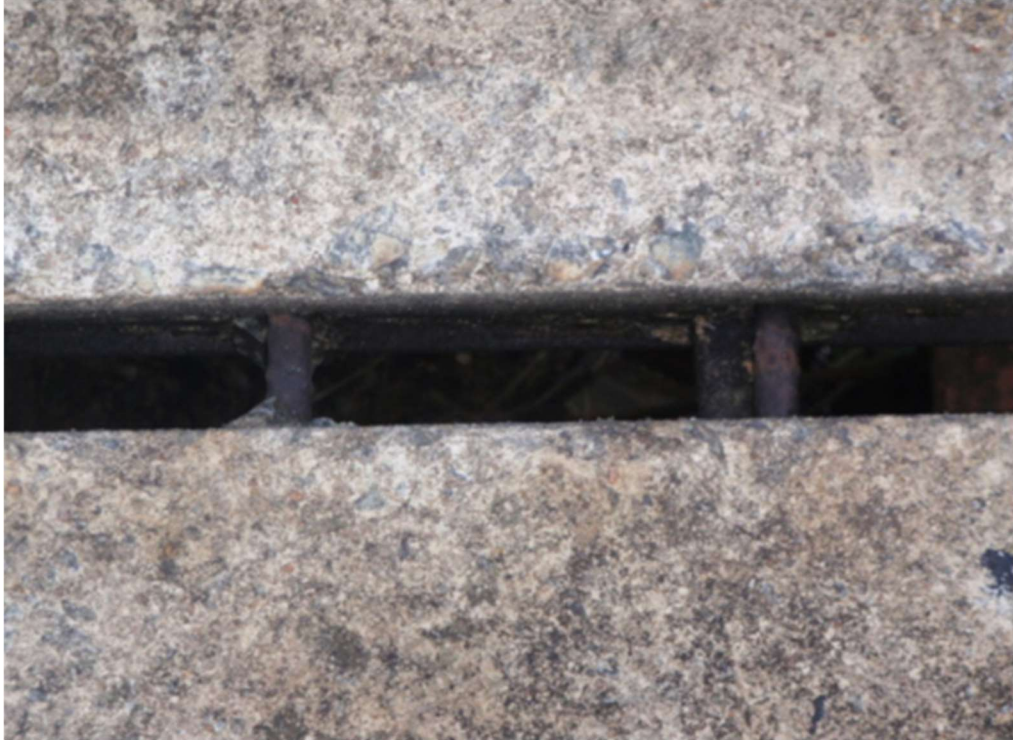
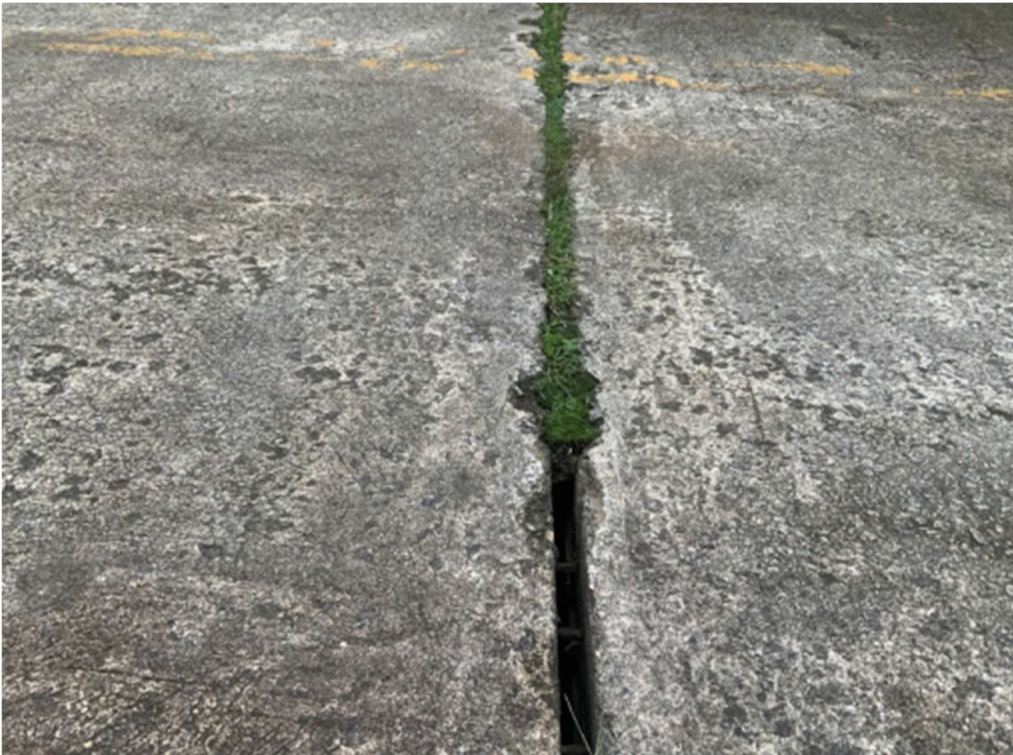
**Figure 223 – Bridge 045-5018-0 Joint Condition 2016 (Top) vs 2021 (Bottom)**

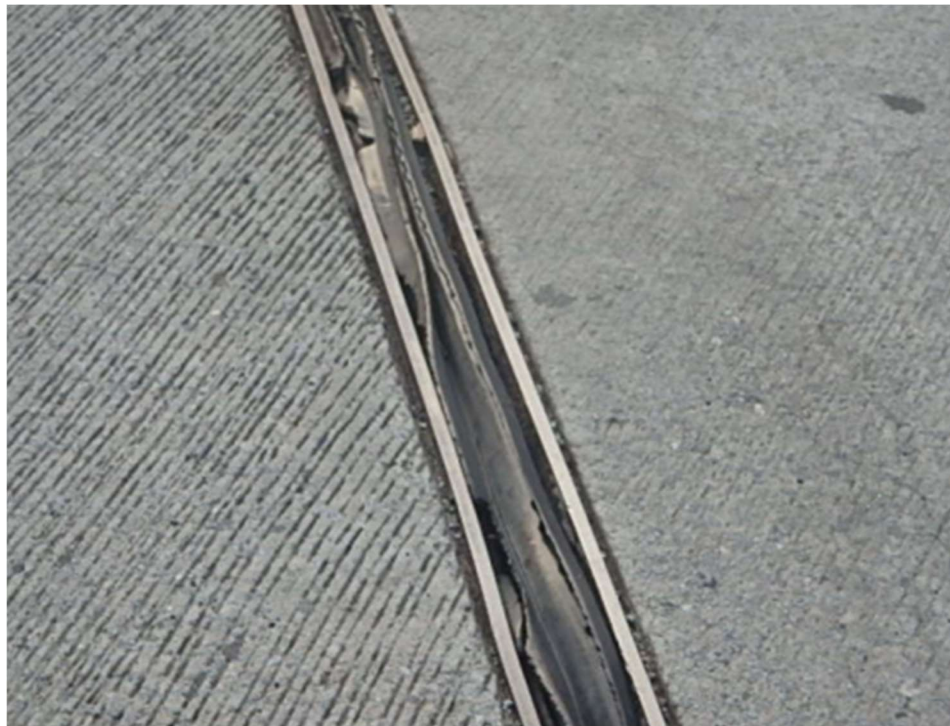
**Figure 224 – Bridge 089-0131-0 Strip Seal Expansion Joint Typical Condition (GDOT, 2016)**

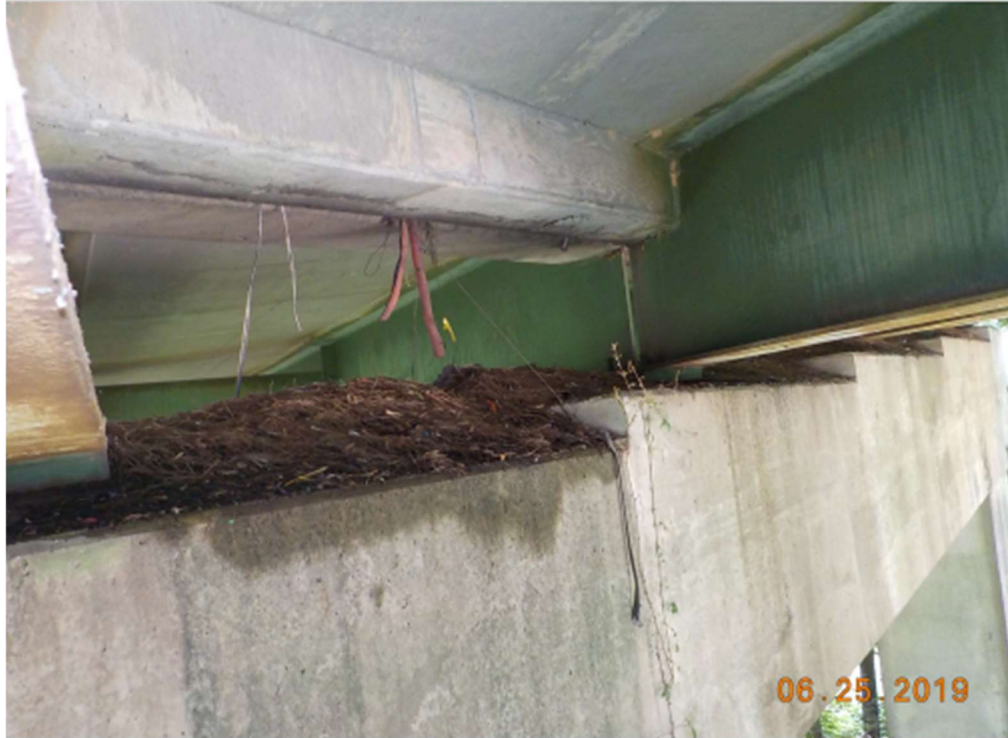
**Figure 225 – Bridge 089-0131-0 Debris Build Up on Bent Cap 3 (GDOT, 2019)**

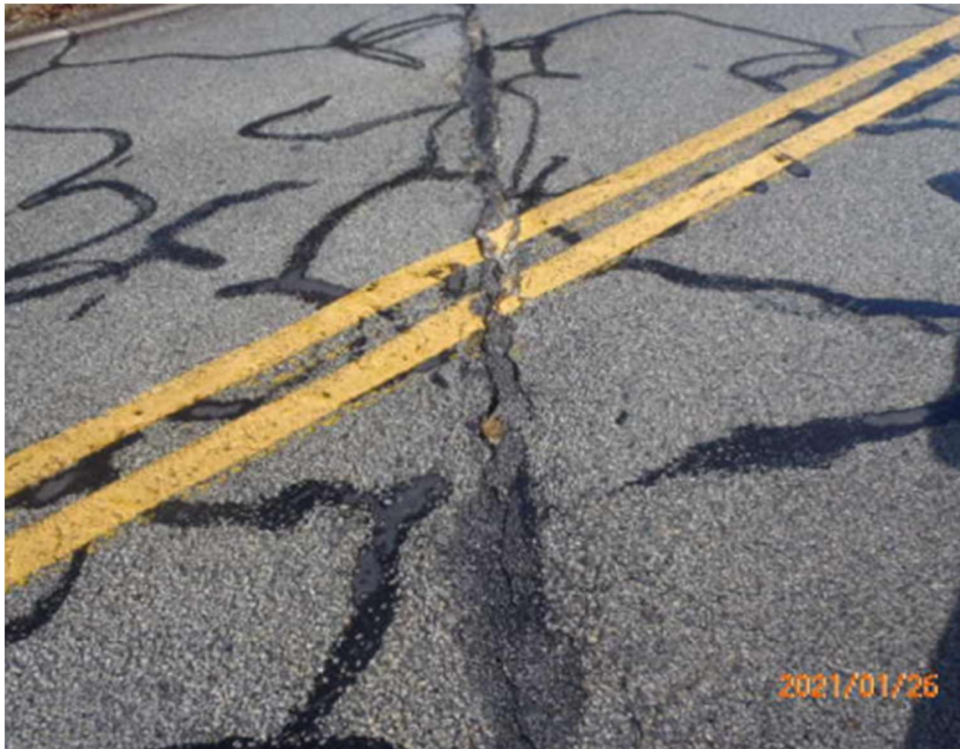
**Figure 226 – Bridge 257-0001-0 Typical Joint Condition (GDOT, 2021)**

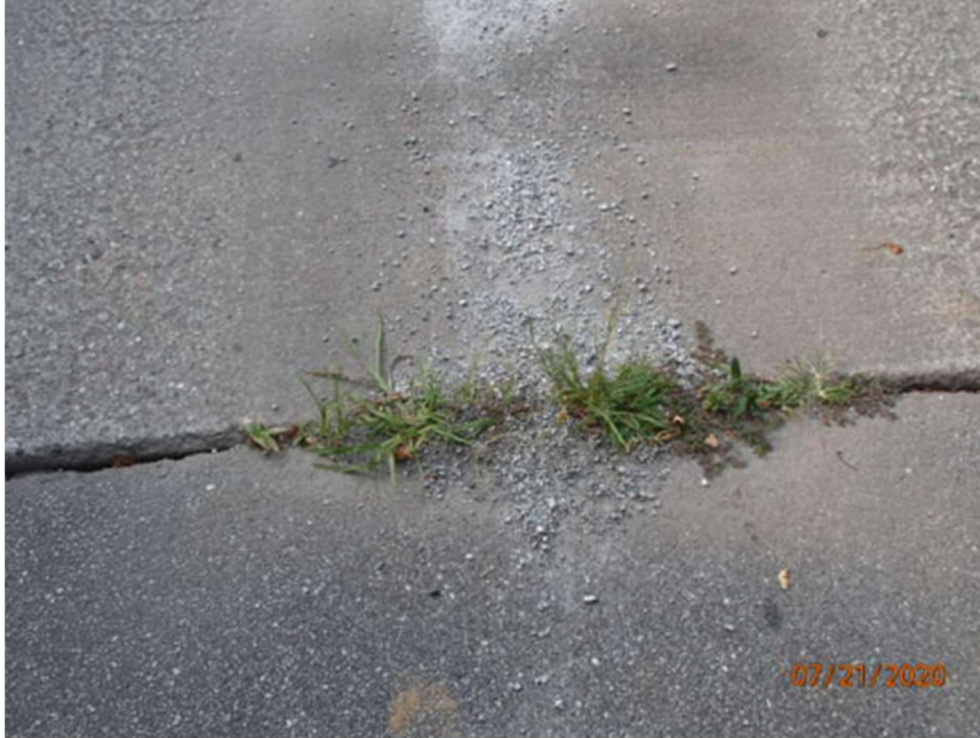
**Figure 227 – Bridge 241-5051-0 Joint Condition (GDOT, 2020)**

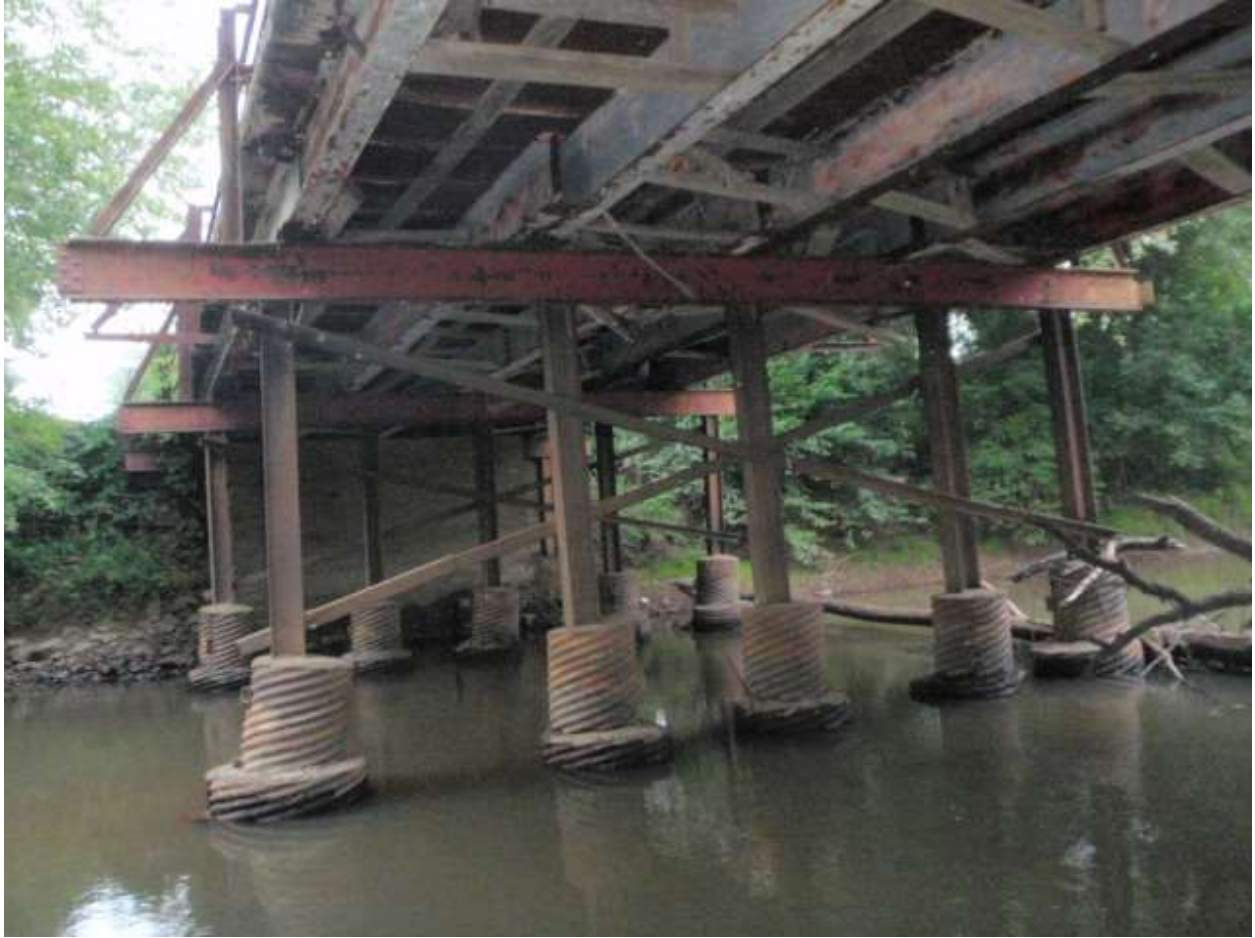
Bridge 045-009-0 was built in 1971, and is owned and maintained by Carroll County. The bridge was identified because of the poor condition of the steel pier caps. The steel pier caps were classified to be in condition state three because of the corrosion and the loss of the protective painting. **Figure 228** shows the change from 2014, when inspectors first recommended that this element be painted, to 2022.

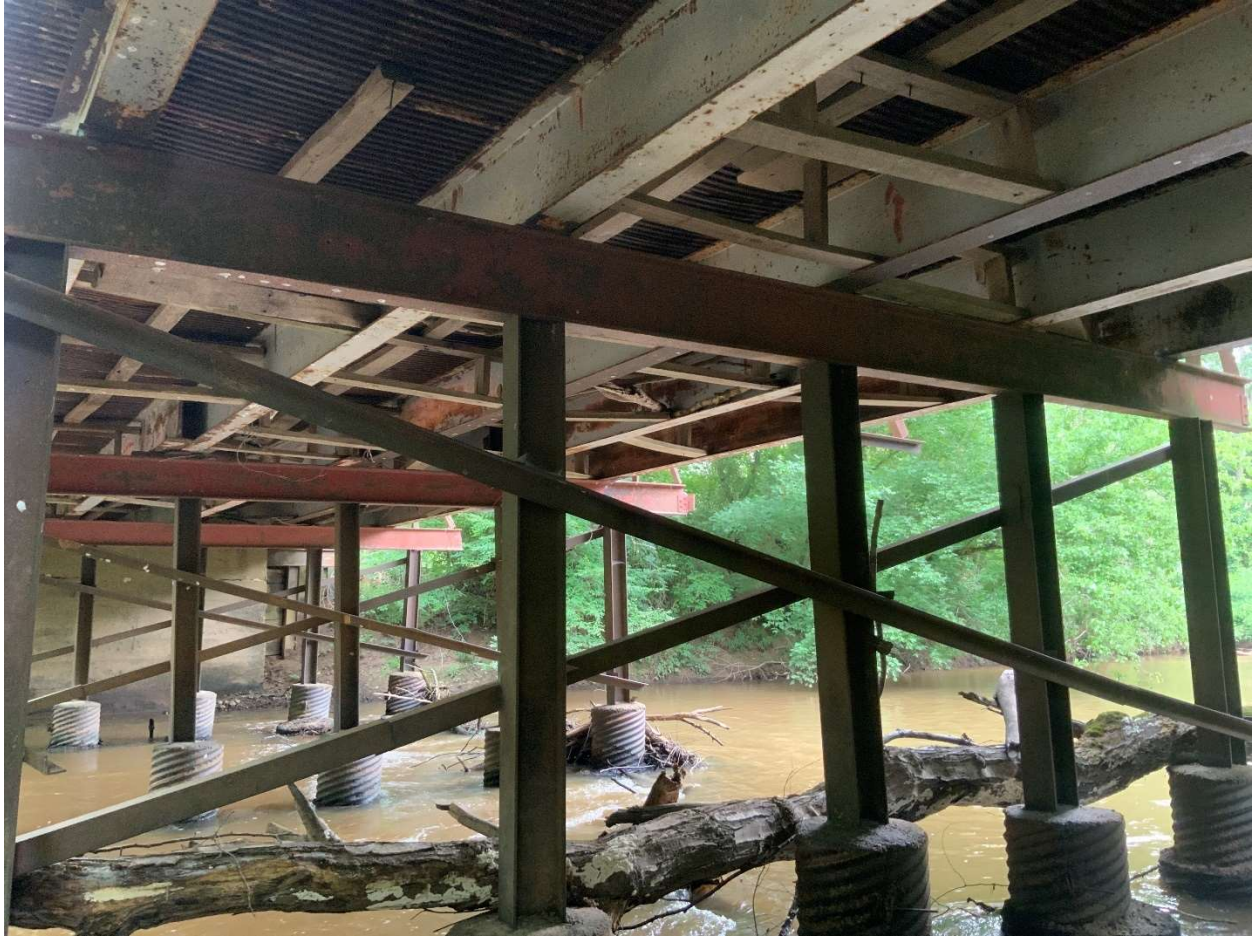
**Figure 228 – Bridge 045-0079-0 Steel Pier Cap 2014 (Top) vs 2022 (Bottom)**

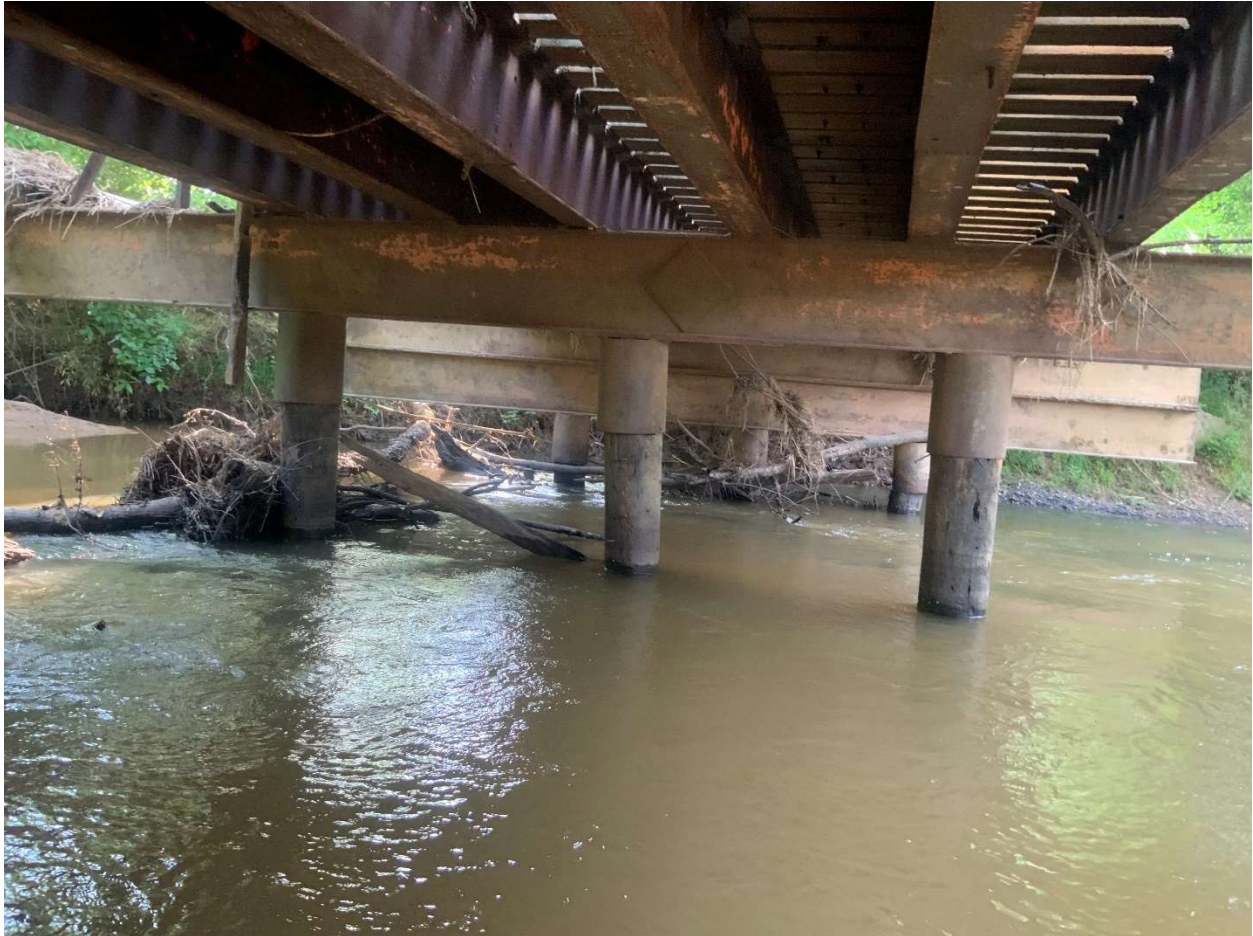
**Figure 229 – Bridge 045-5027 Steel Pier Cap Condition (GDOT, 2022)**
