IMPACT OF WEATHER STRESSORS TO IDENTIFY VULNERABLE BRIDGE ELEMENTS  
IN GEORGIA TOWARDS DATA DRIVEN ASSEST MANAGEMENT

by SPENCER KOPF

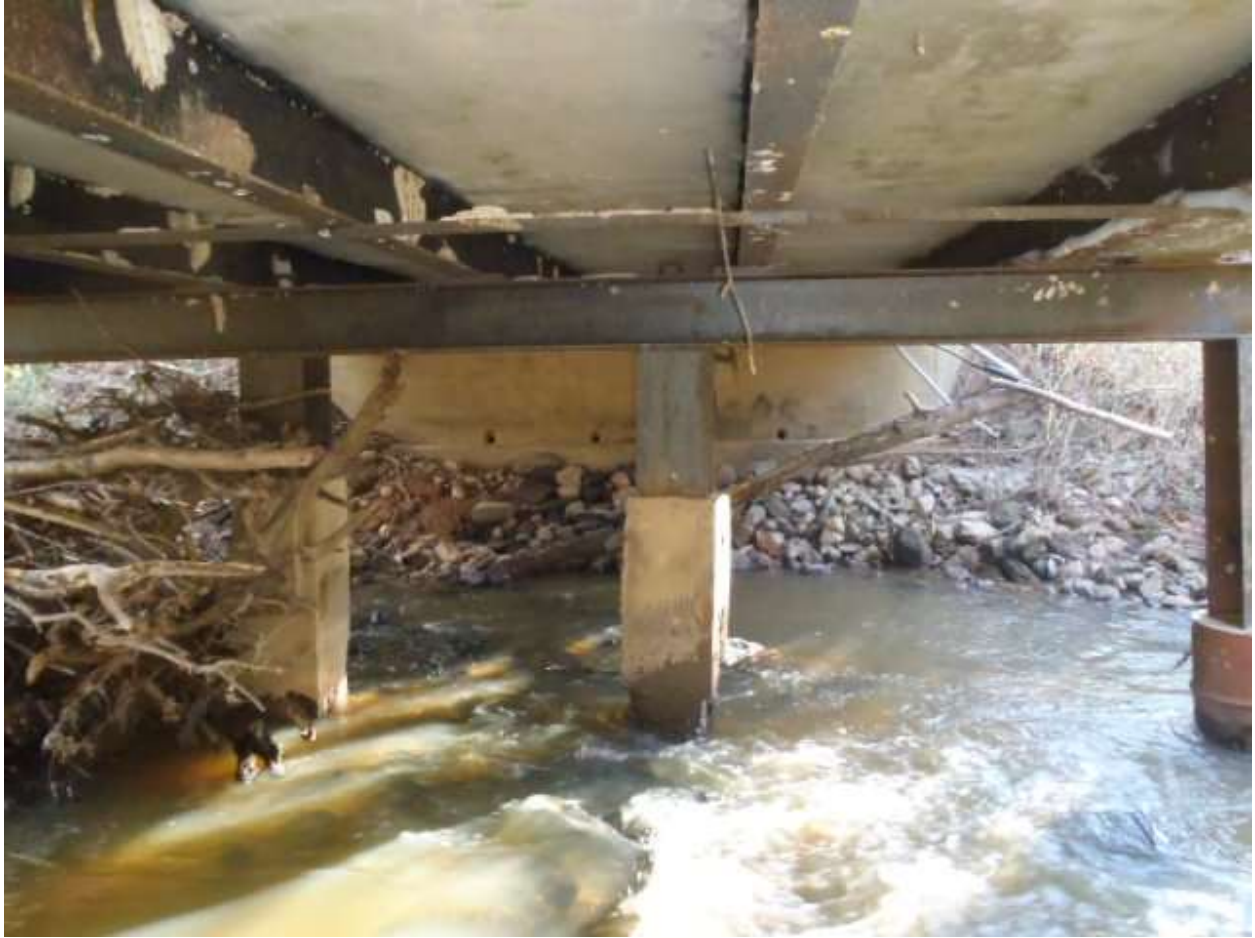
Bridge 531-5002-0 is a county owned and maintained bridge located in Pike County. It was originally built in 1970 and passes over Turnpike Creek. This bridge was identified to study the steel pier cap condition. Since the first inspection report the steel pier cap EHI has fallen from 40 to 10. The corrosion has worsened over the years, although it is difficult to observe visually through photos. **Figure 230** shows the progression of the steel corrosion from 2016-2022.

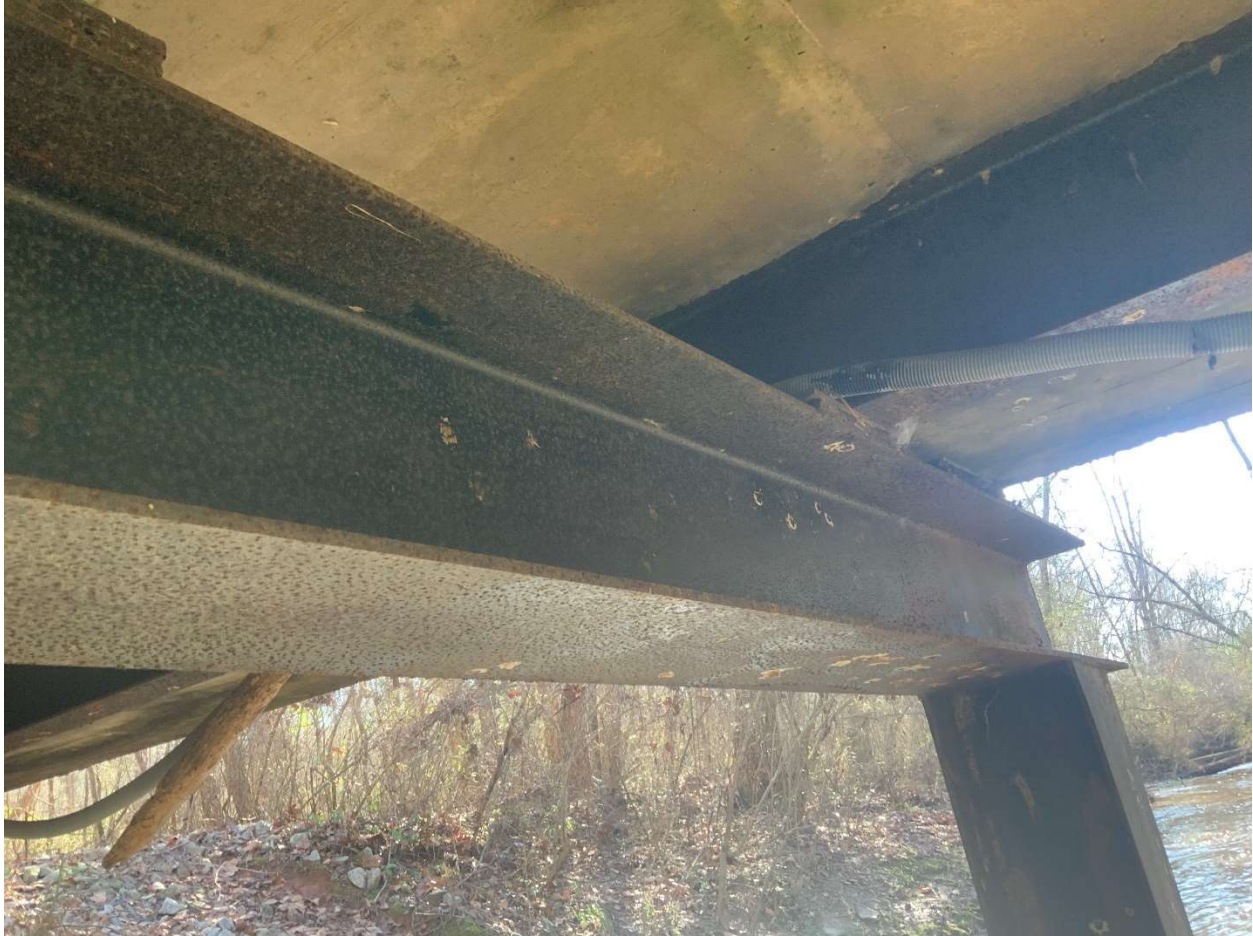
**Figure 230 – Bridge 231-5002-0 Steel Pier Cap Condition 2016 (Top) vs 2022 (Bottom)**

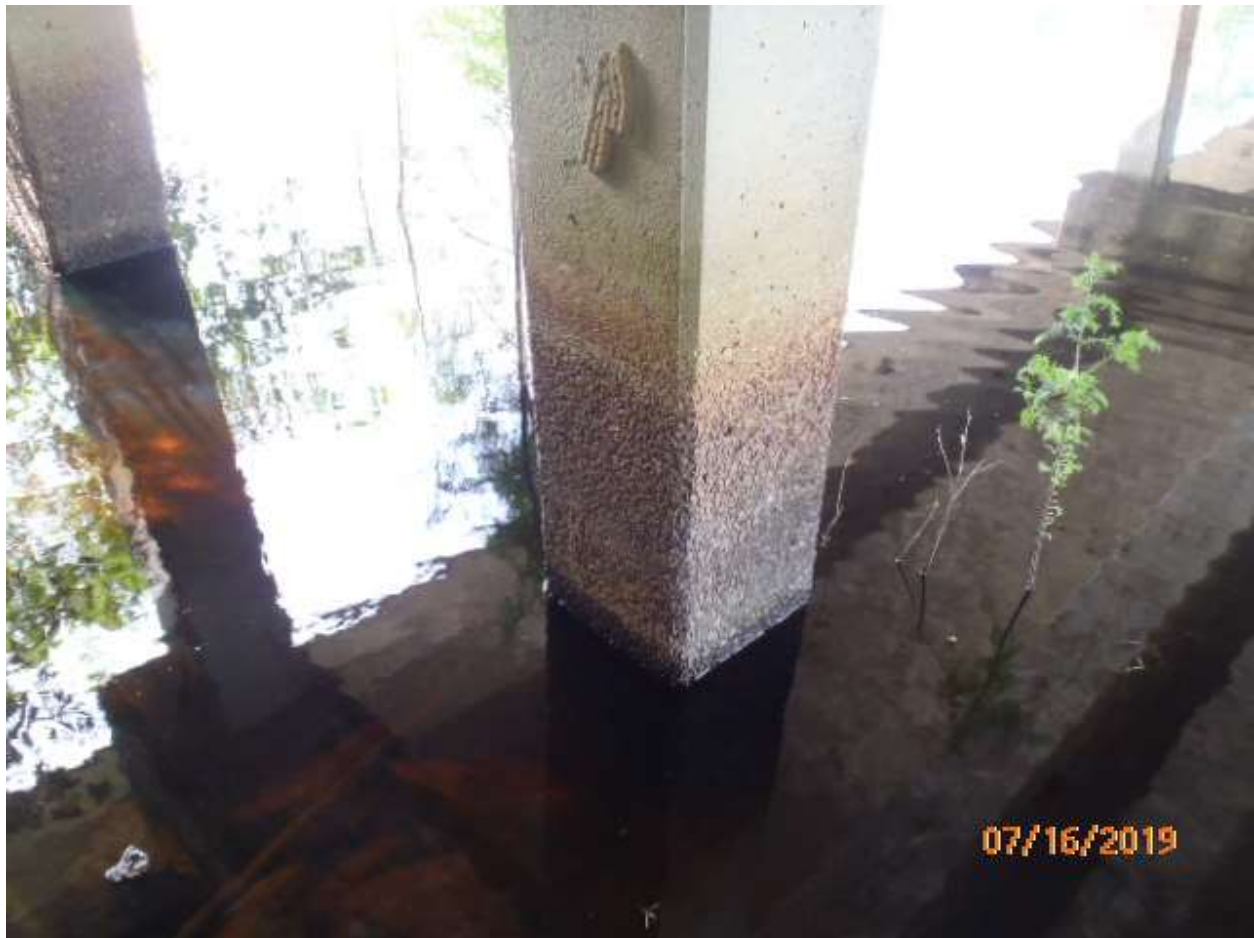
**Figure 231 – Bridge 283-5026-0 Typical Pile Condition (GDOT, 2019)**

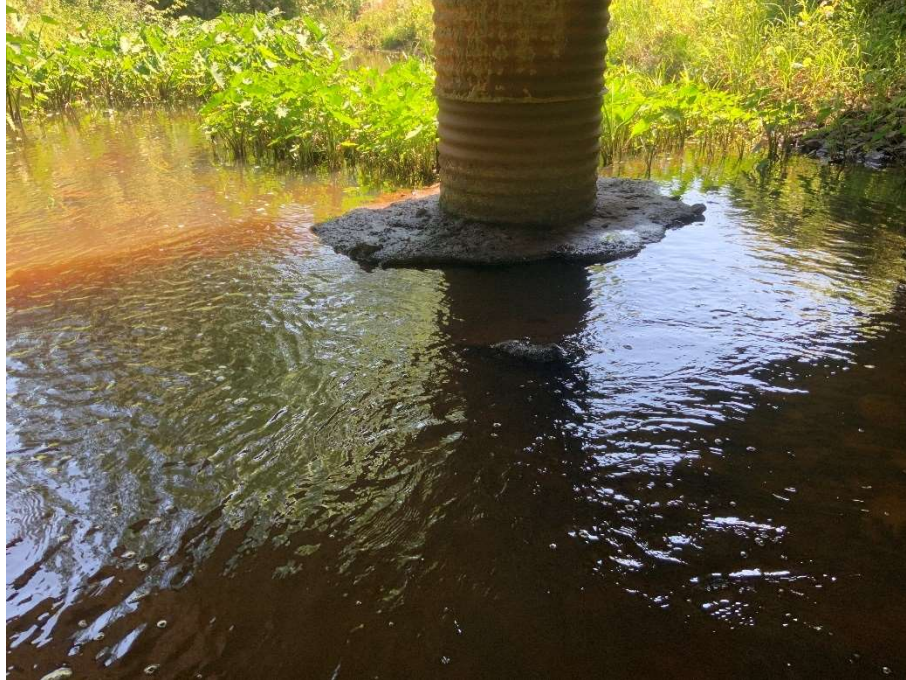
**Figure 232 – Bridge 175-5086-0 Scour (GDOT, 2021)**

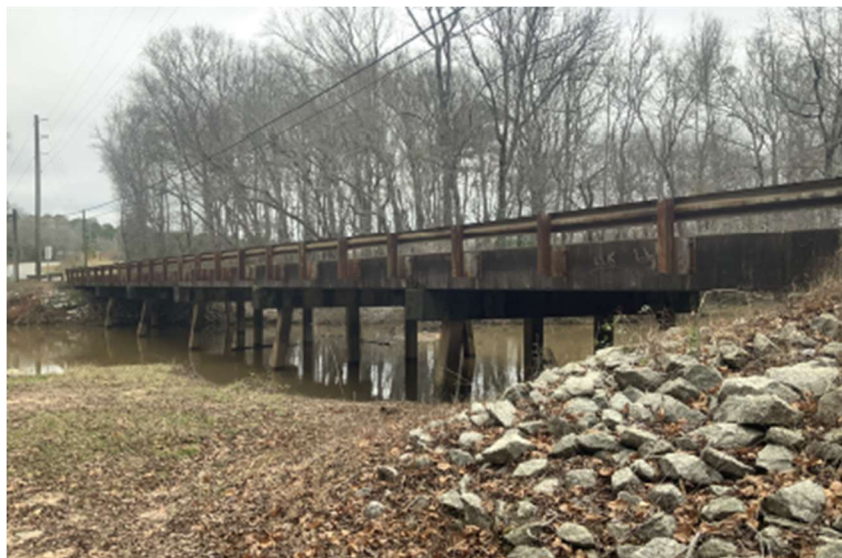
**Figure 233 – Bridge 231-5024-0 Side View (GDOT, 2021)**

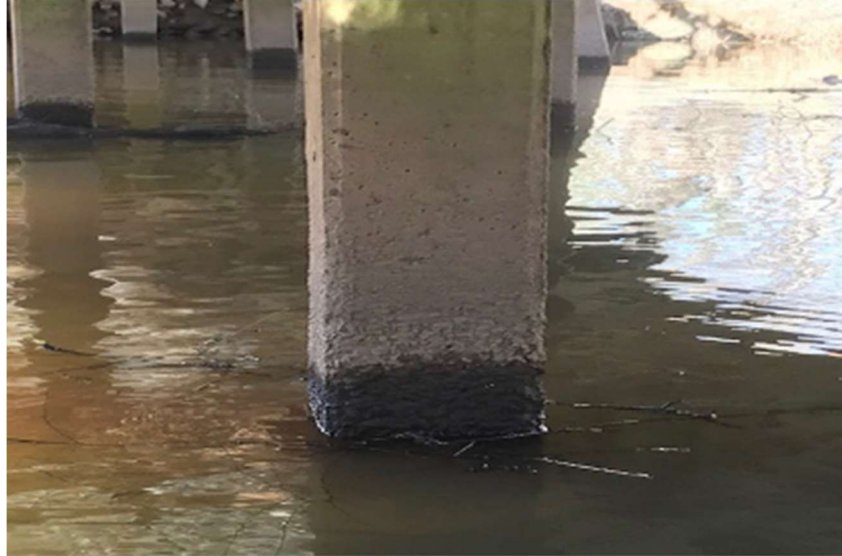
**Figure 234 – Bridge 231-5024-0 Typical Reinforced Concrete Pile Condition (GDOT, 2021)**

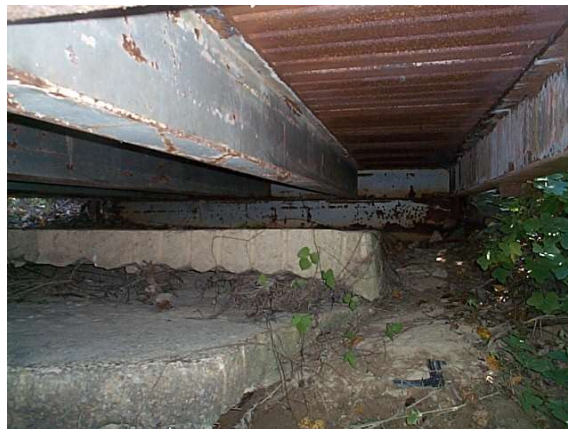
Bridge 297-5062-0 is a county owned and maintained bridge located in Walton County. It was identified because of the poor steel abutment condition, with an EHI of 10.0. The steel abutment has maintained this EHI since the initial inspection. It appears that the corrosion is the result of proximity to humidity and lack of maintenance painting. **Figure 235** shows the abutment condition from 2013 to 2021.

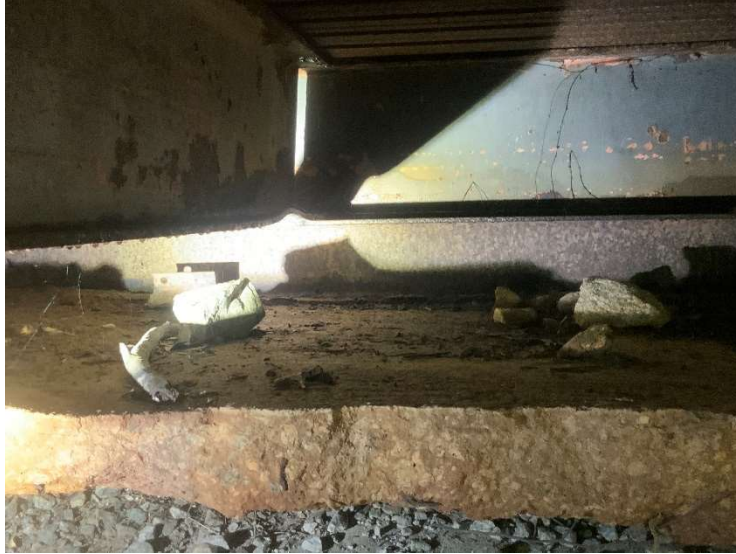
**Figure 235 – Bridge 297-5062-0 Steel Abutment Condition 2013 (Top) vs 2021 (Bottom)**

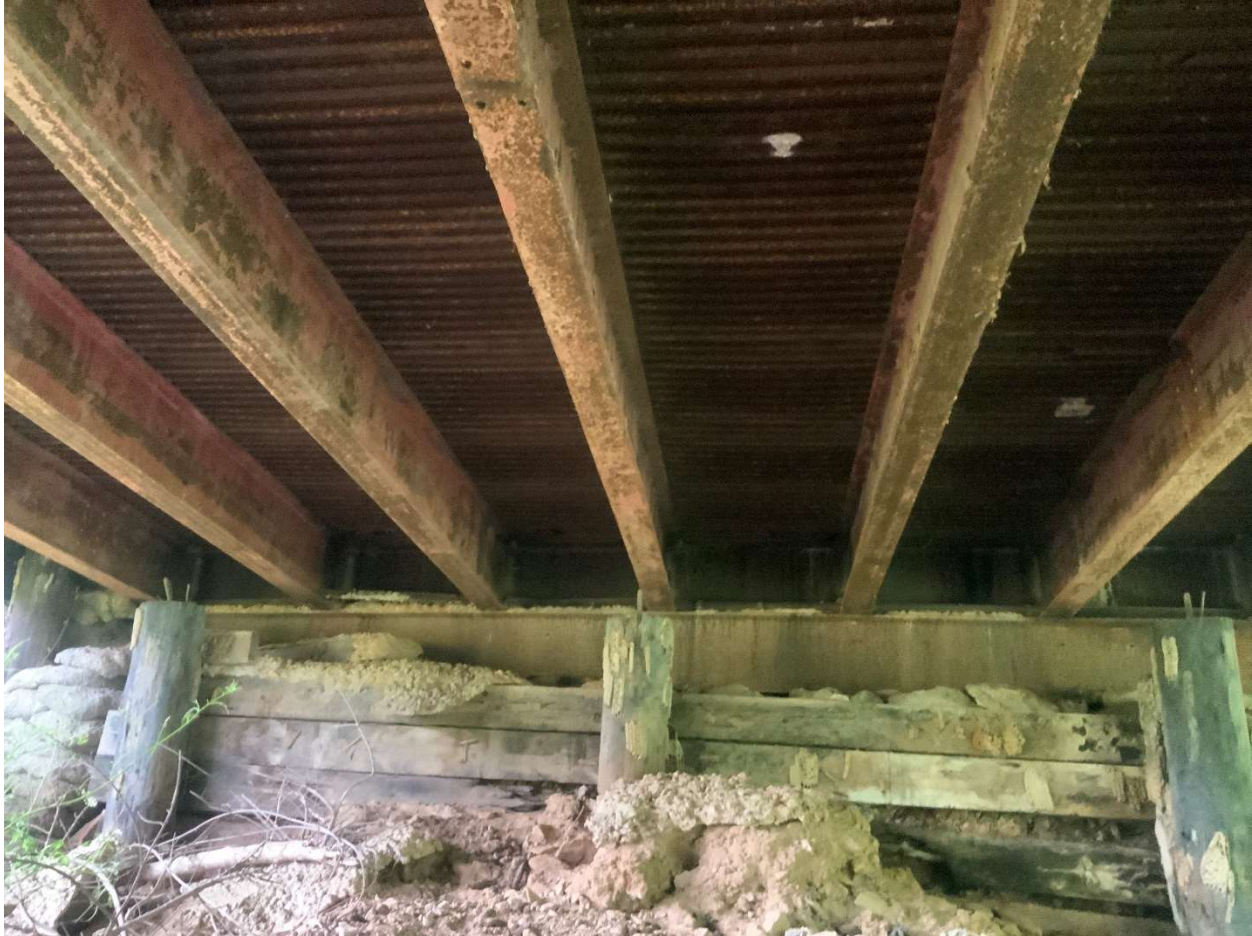
**Figure 236 – Bridge 045-5126-0 Steel Abutment Condition (GDOT, 2021)**

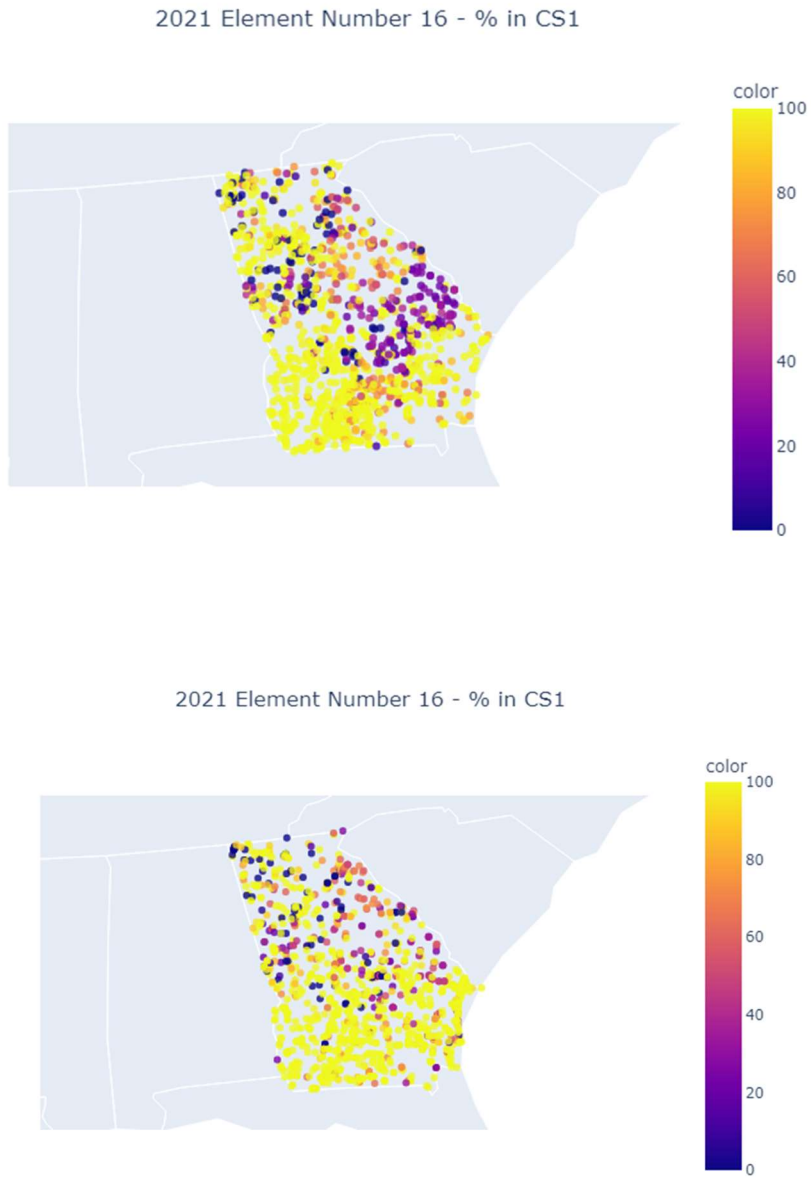
**Figure 237: Percent of EN16 in Condition State One by Location, 2021. County-Owned (Top) vs State-Owned (Bottom)**

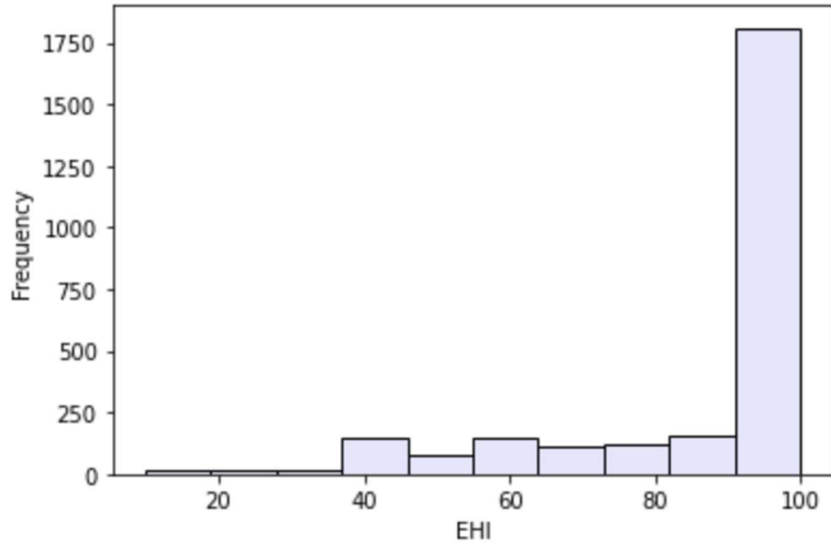
**Figure 238 – EHI of EN16 Snow Counties (Top) vs Non Snow Counties (Bottom)**

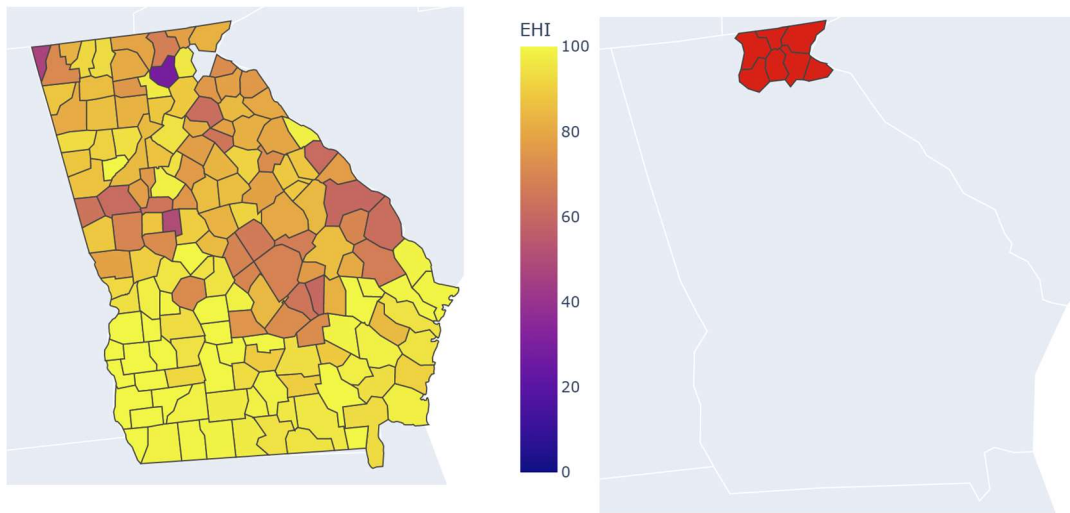
**Figure 239 – EHI of EN16 by County (Left) vs Snow Counties (Right)**

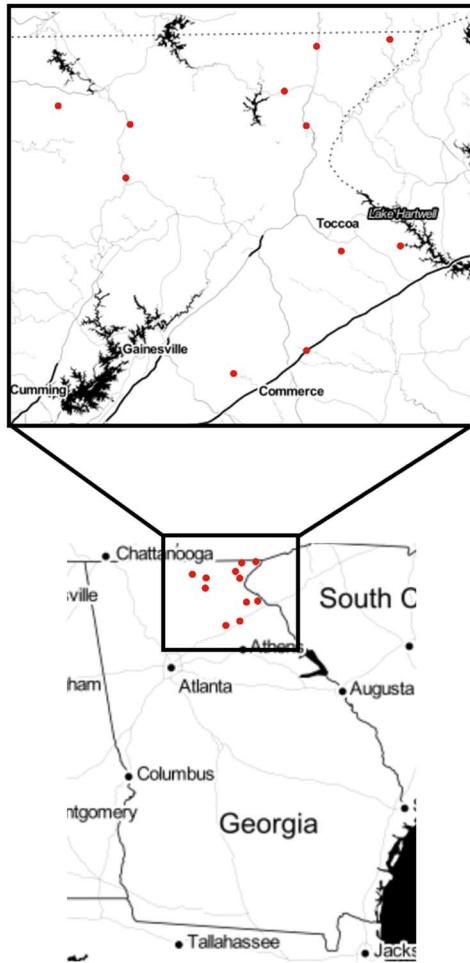
**Figure 240 - Location of Selected Snow Bridges for EN16**

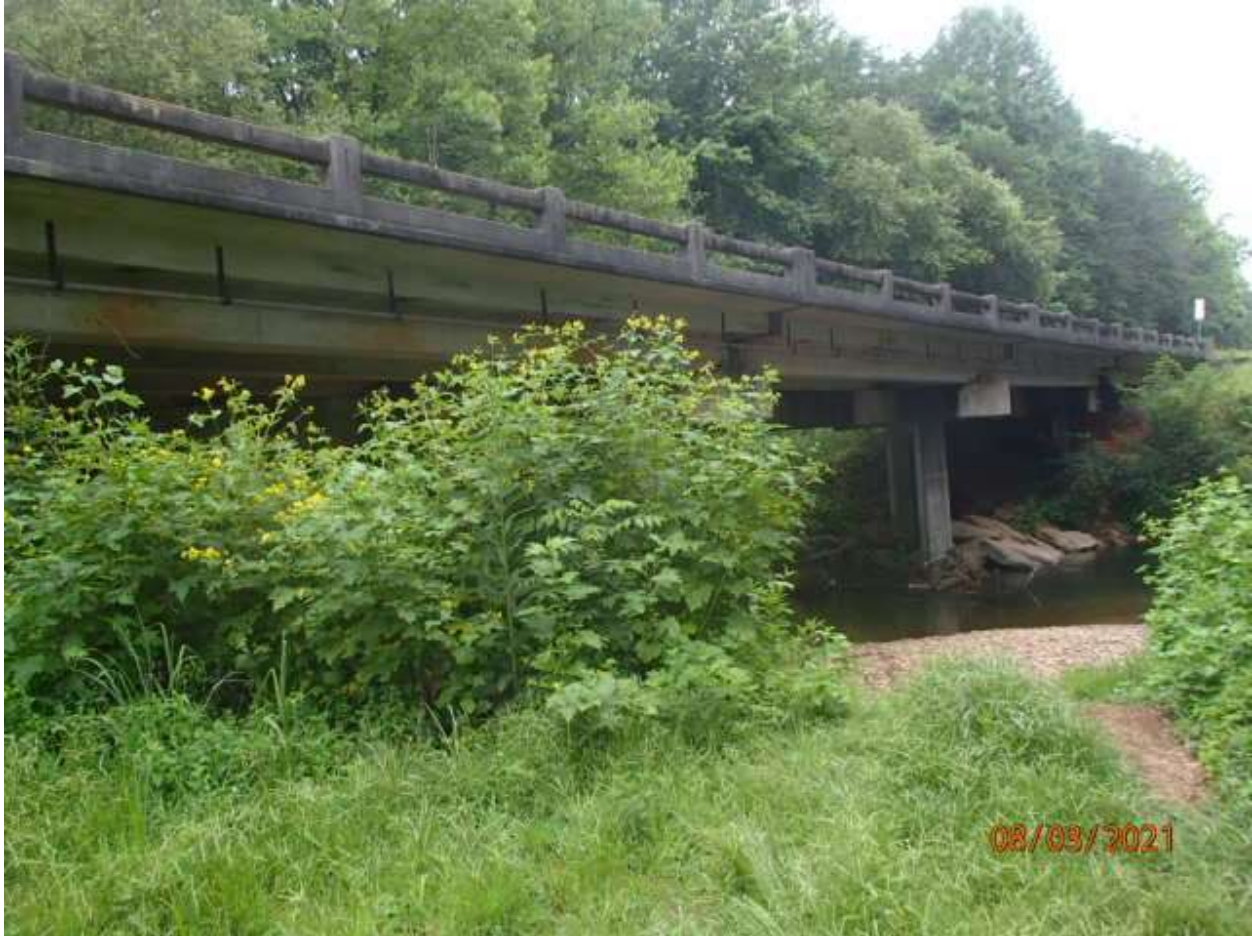
**Figure 241 – Bridge 291-0018-0 Side View (GDOT, 2021)**

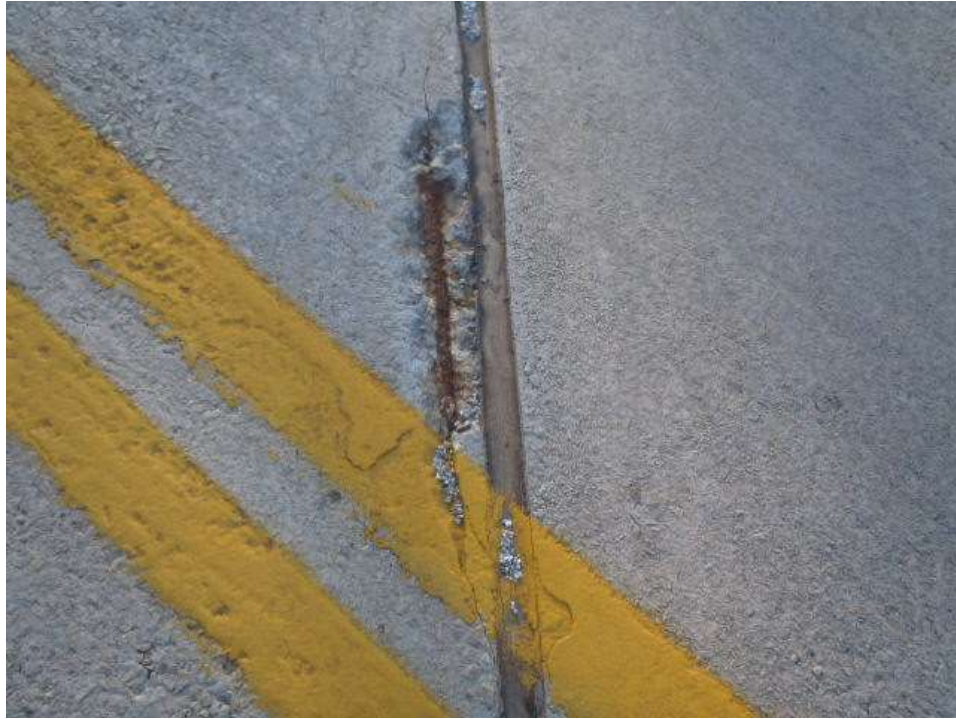
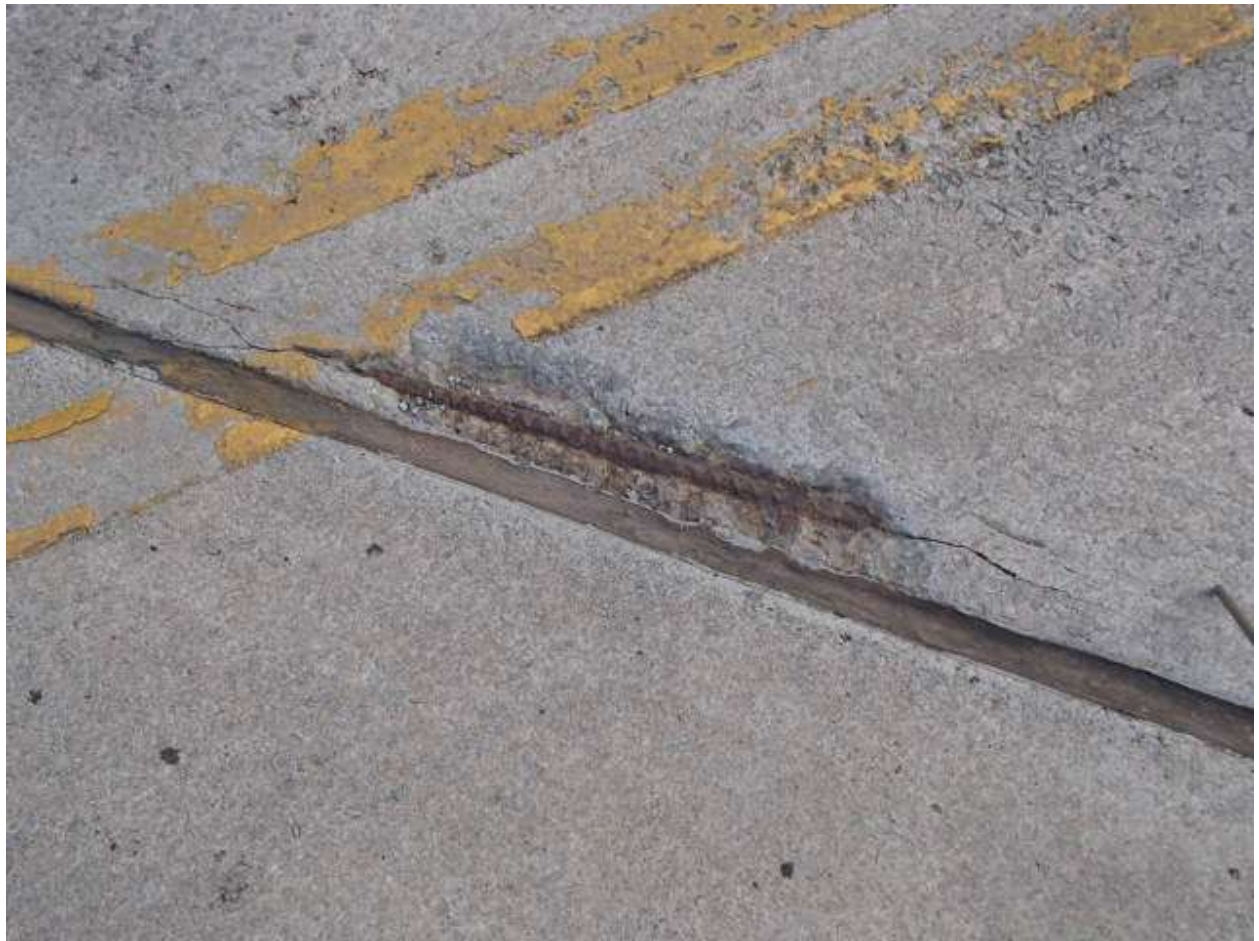
This bridge has several defects that could be attributed to weather stressors. The first is concrete spalling on the deck. There are several reasons why a concrete spall can occur on a deck, so it cannot be directly attributed to weather stressors, however knowing that Union County is located in an area of Georgia that experiences high snowfall totals, it is likely that weather had an influence on the spalling. **Figure 242** and **Figure 243** show the progression of one of the concrete deck spalls from 2014-2019.

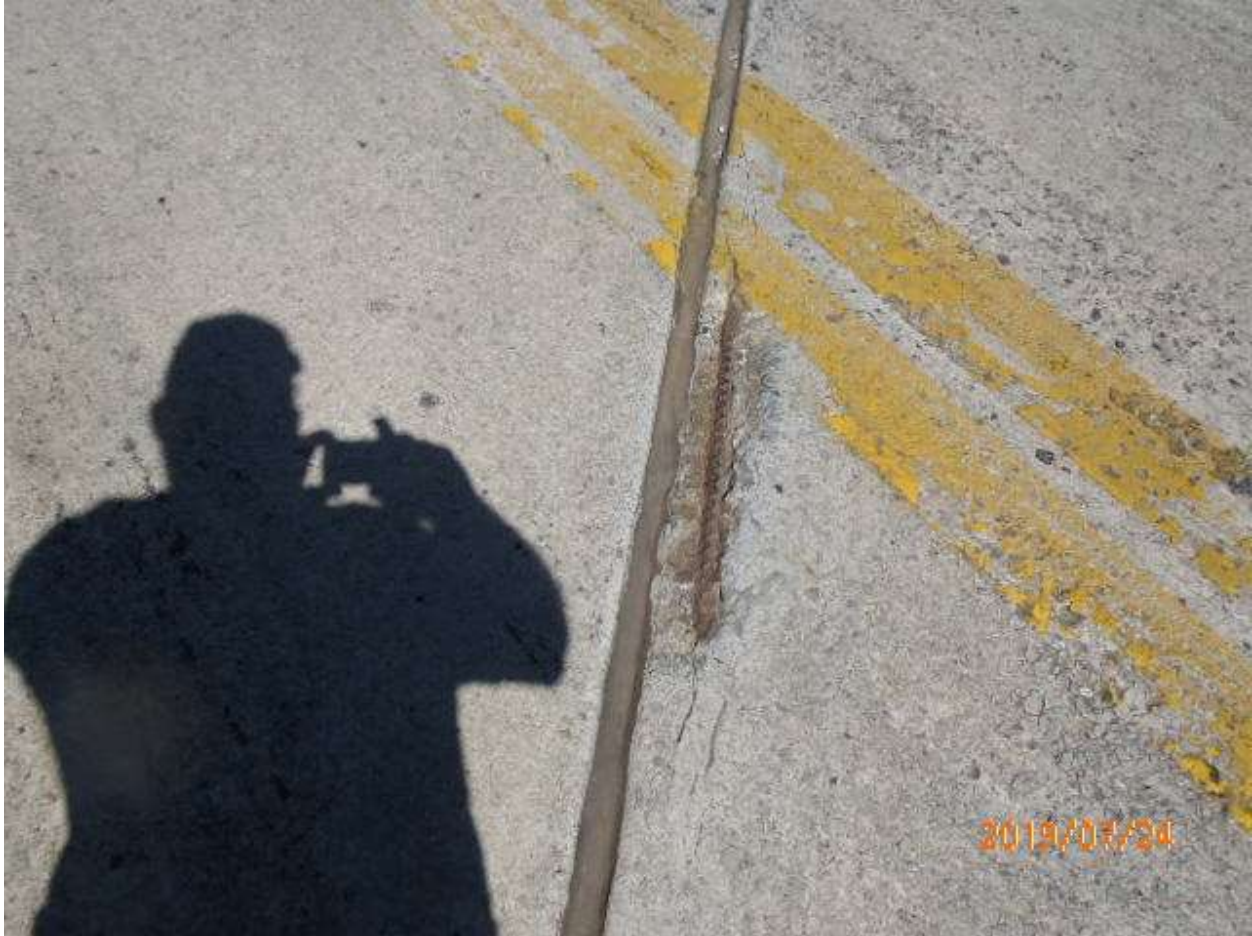
**Figure 242 – Deck Spall 2014 (Top) vs 2017 (Middle) vs 2019 (Bottom)**

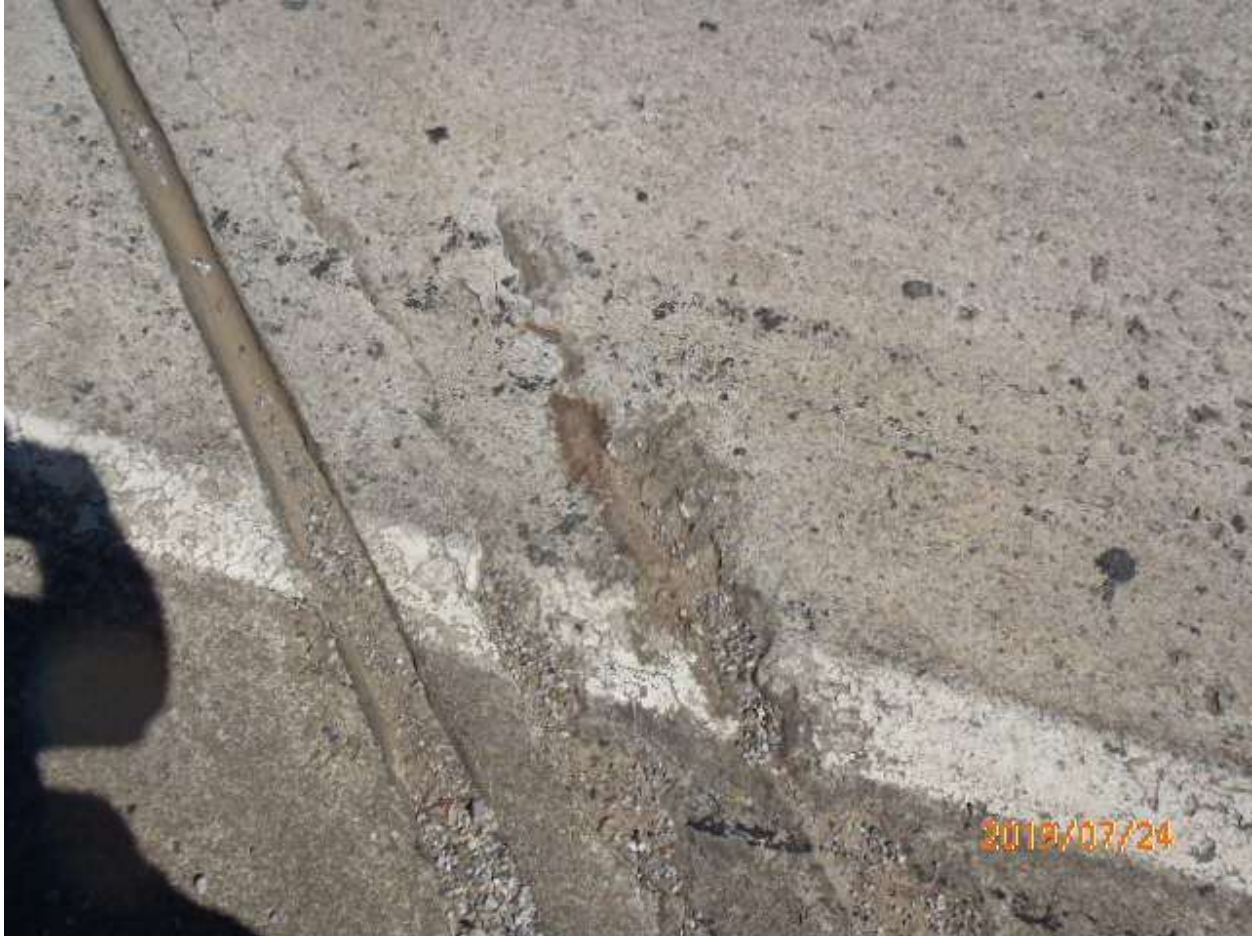
**Figure 243 – Deck Spalling 2014 (Top) vs 2019 (Bottom)**

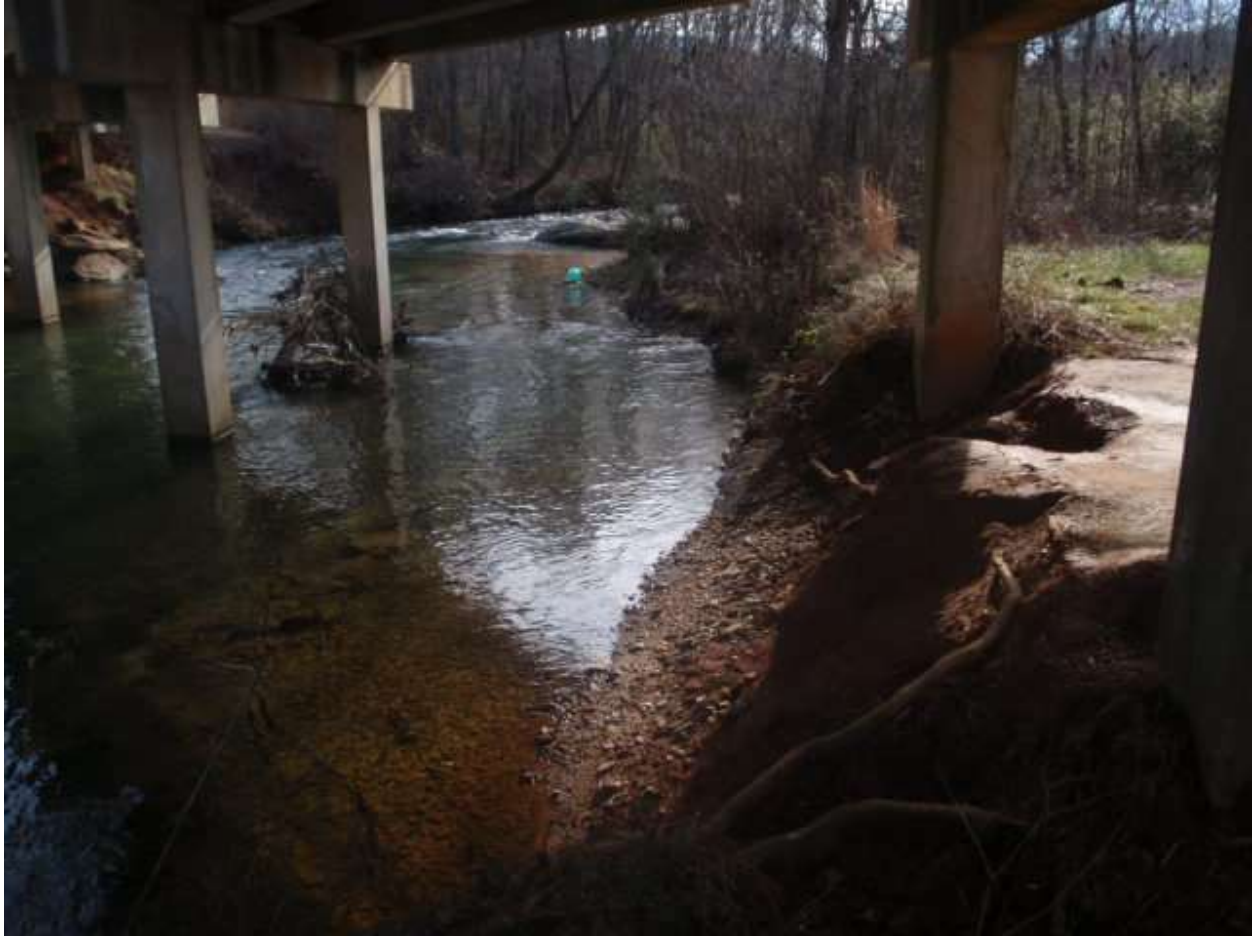
**Figure 244 – Bridge 291-0018-0 Bridge Erosion (GDOT, 2014)**

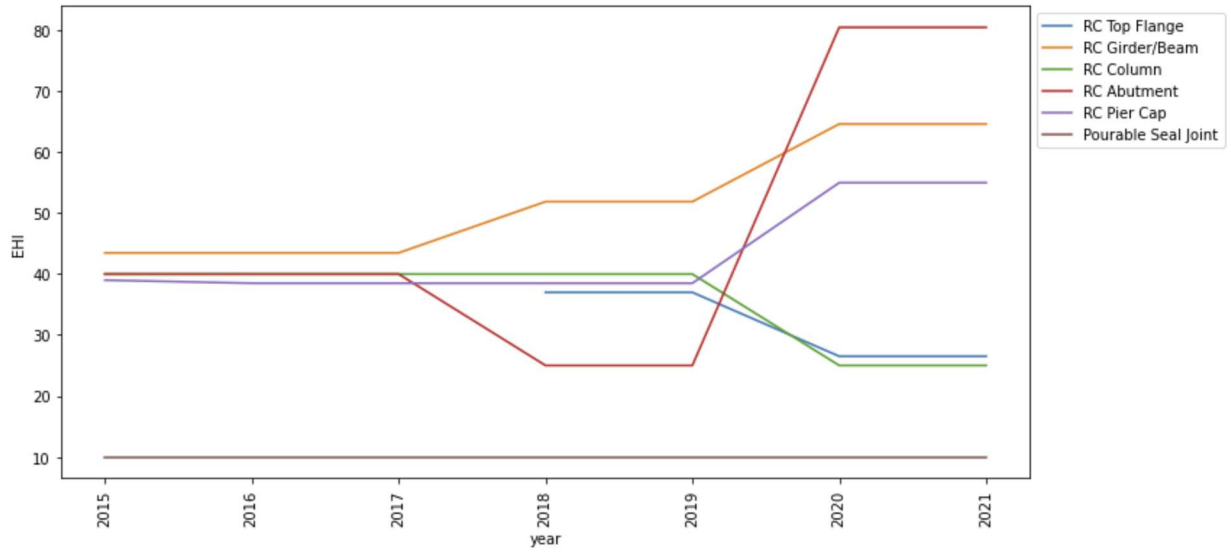
**Figure 245 – Bridge 241-5036-0 EHI by Year**

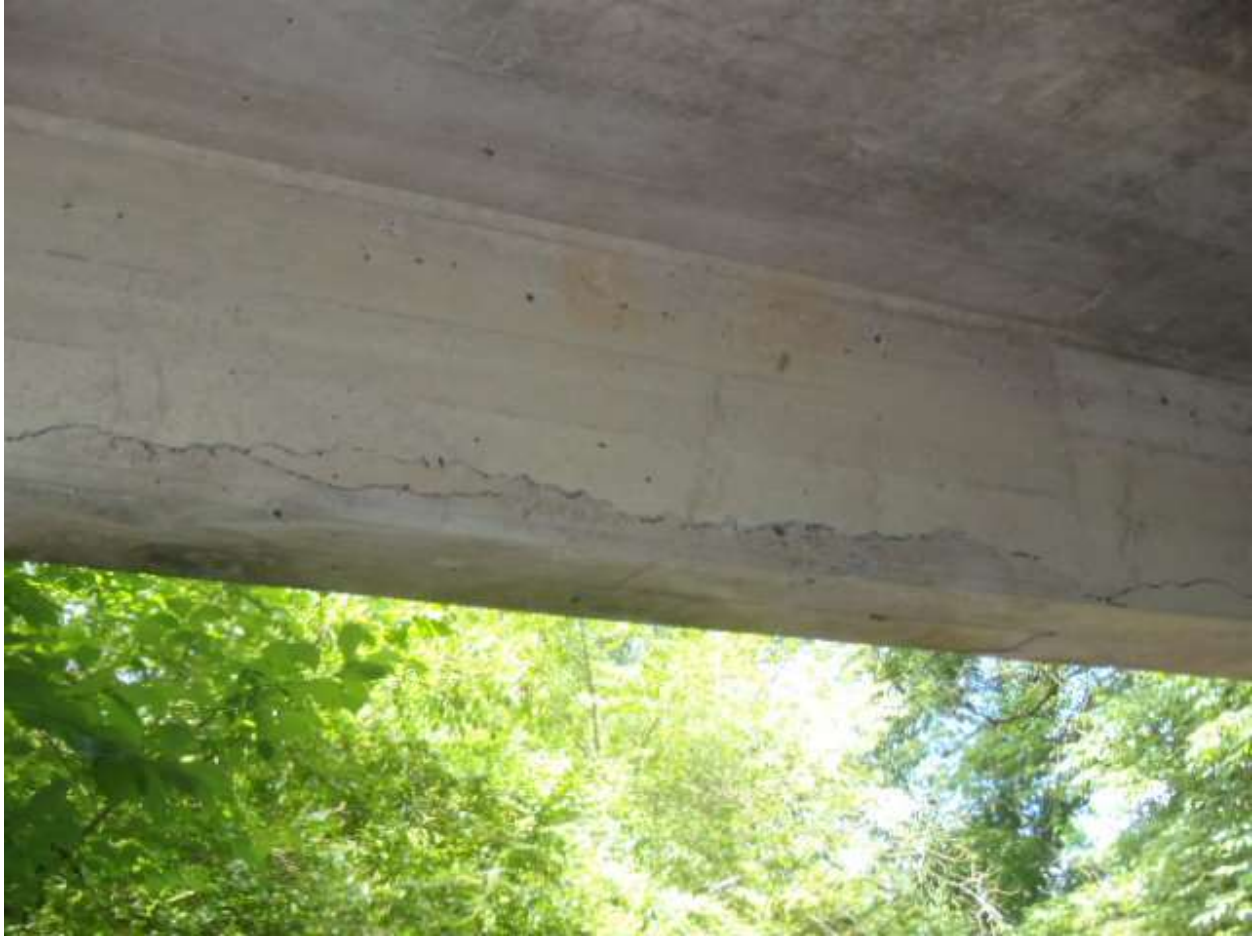
The superstructure of this bridge has experienced heavy cracking and spalling. The 2014 inspection report noted several cracks and spalls. At this time inspectors also noted the need to seal these cracks and spalls. As of 2022, these have not been fixed, and as a result the condition of these superstructure elements has worsened. **Figure 246 – Figure 248** show the progression of the degradation.

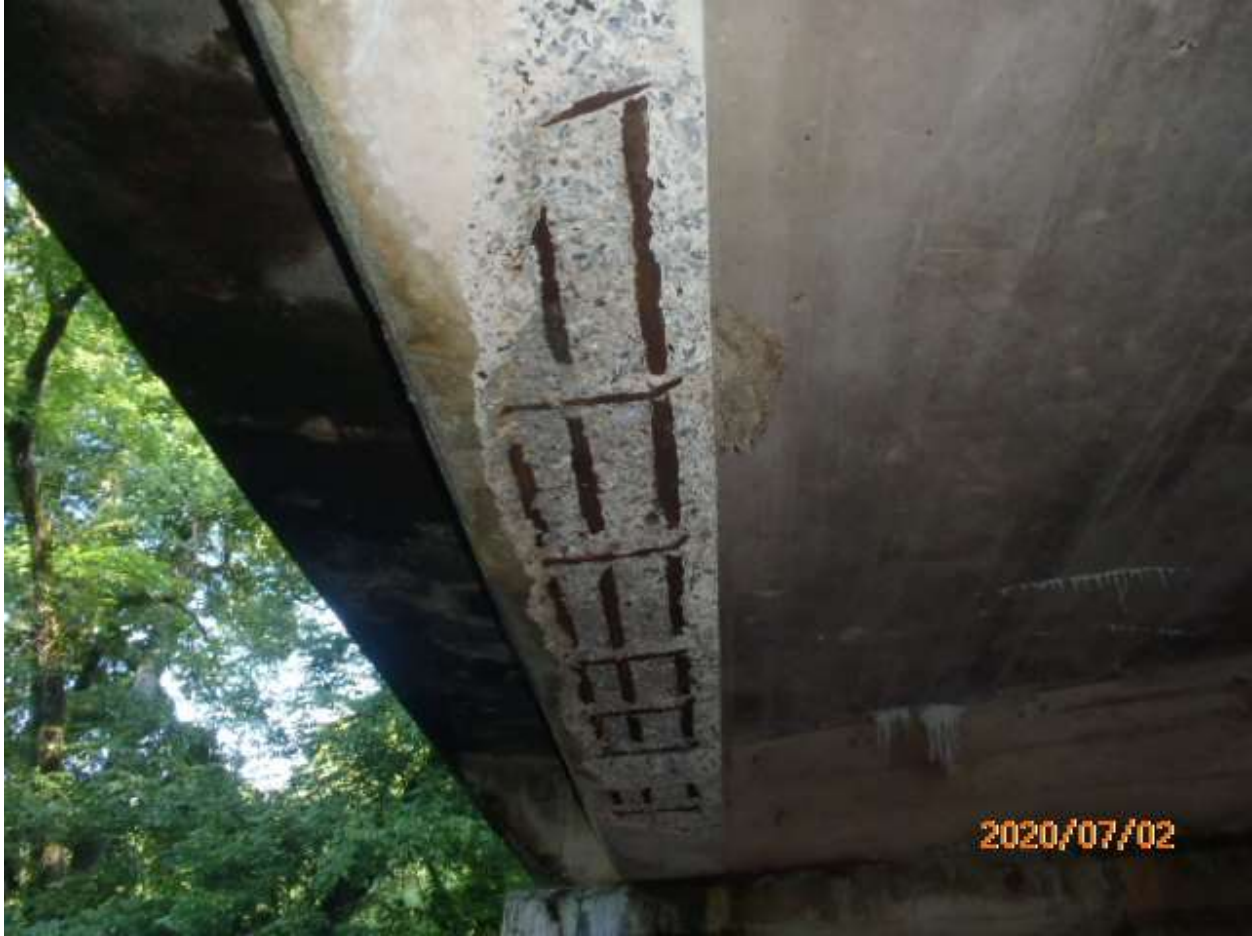
**Figure 246 – Bridge 241-5036-0 Span 3 Beam 3 Concrete Spall 2014 (Top) vs 2020 (Bottom)**

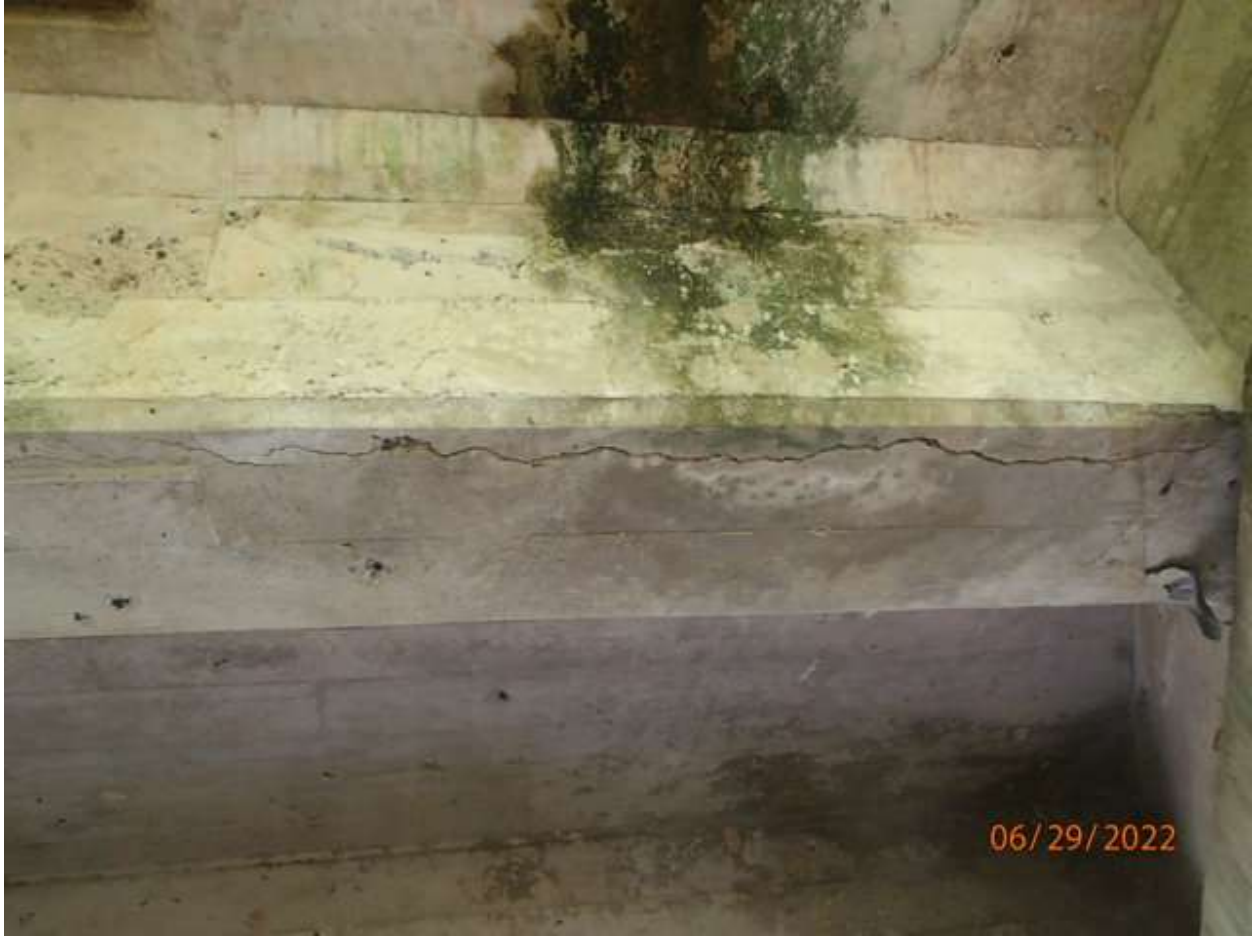
**Figure 247 – Bridge 241-5036-0 Span 3 Beam 1 Concrete Cracking 2014 (Top) vs 2022  
(Bottom)**

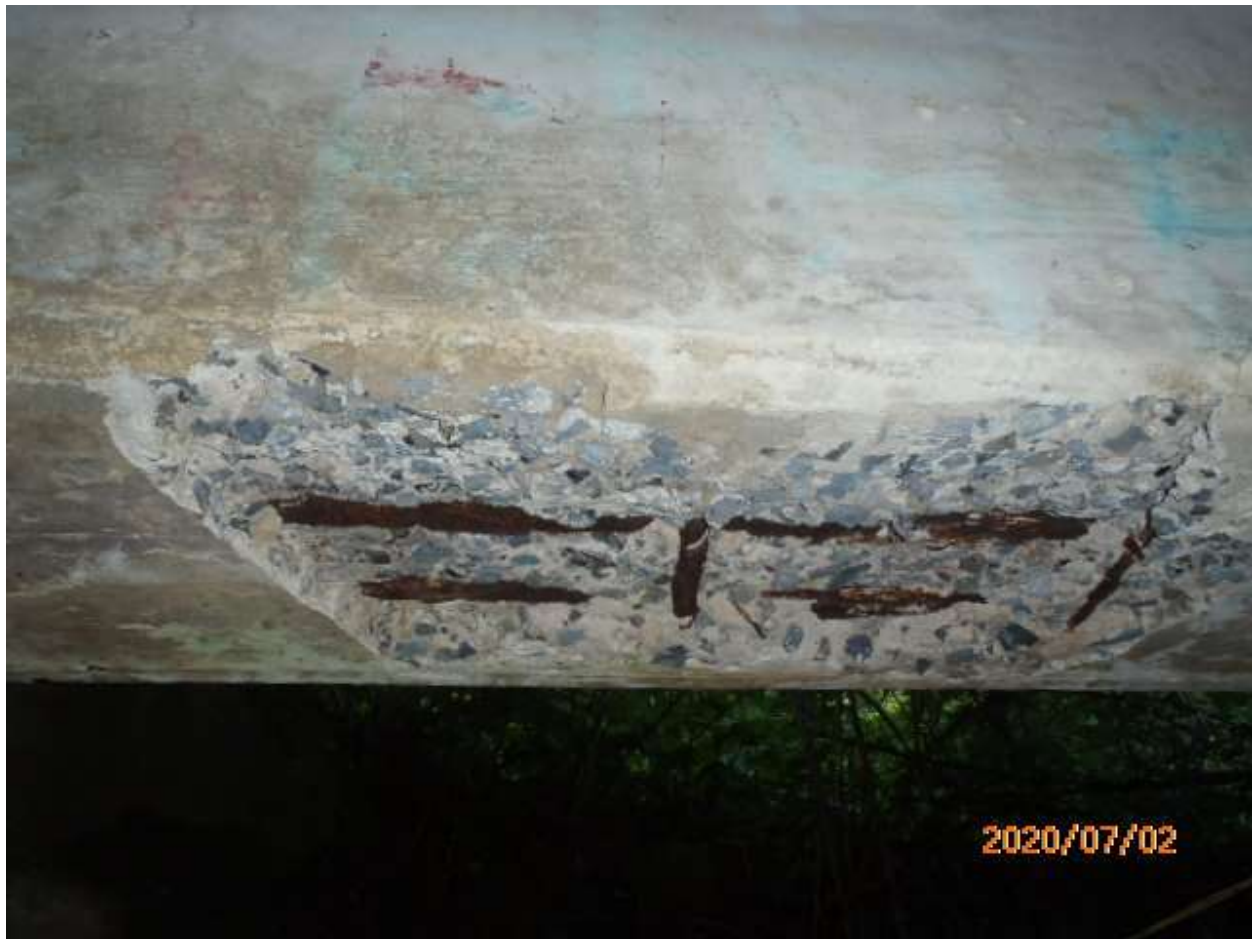
**Figure 248 – Bridge 241-5036-0 Span 1 Beam 1 Concrete Spalling 2014 (Top) vs 2020  
(Bottom)**

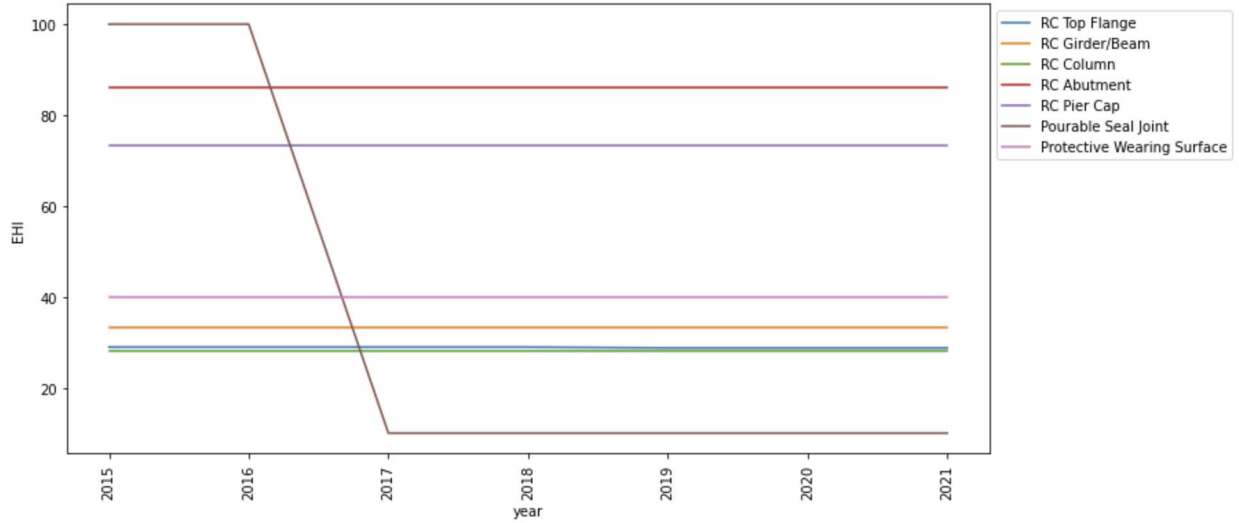
**Figure 249 – Bridge 187-0007-0 EHI by Year**
