IMPACT OF WEATHER STRESSORS TO IDENTIFY VULNERABLE BRIDGE ELEMENTS  
IN GEORGIA TOWARDS DATA DRIVEN ASSEST MANAGEMENT

by SPENCER KOPF

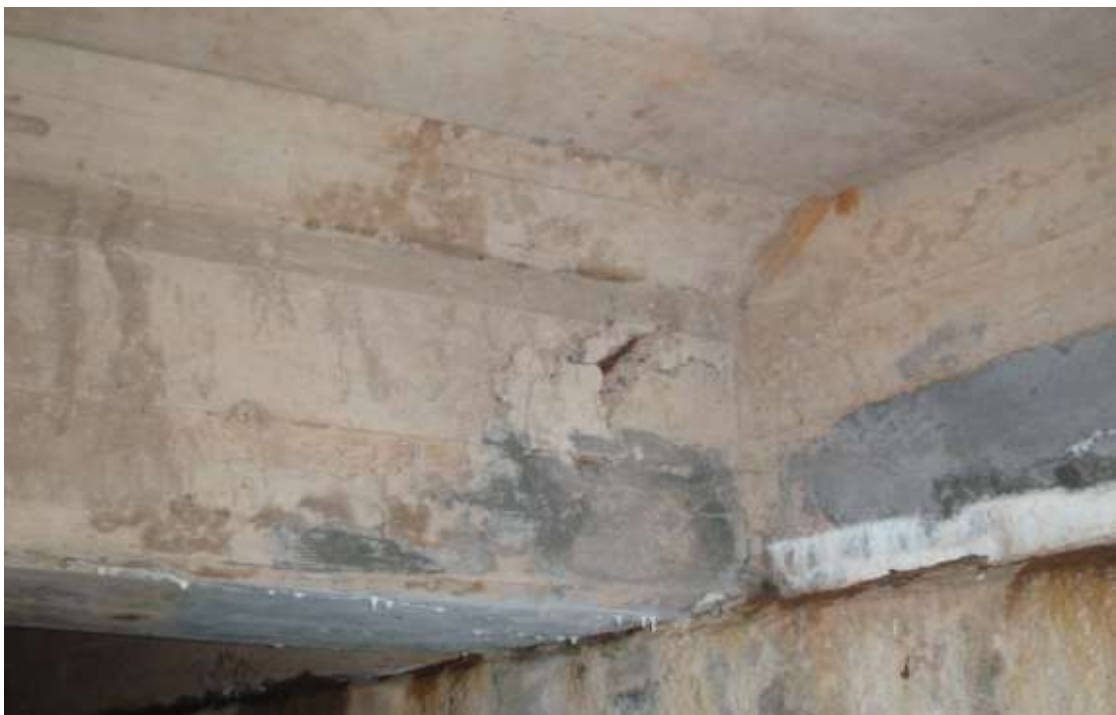
Since 2014 there have been many maintenance requests overlooked to patch spalling and cracking on the concrete elements of the bridge. A replacement bridge is projected to have completed construction in 2023, which explains why the state strategically chose not to invest in maintenance on this bridge.

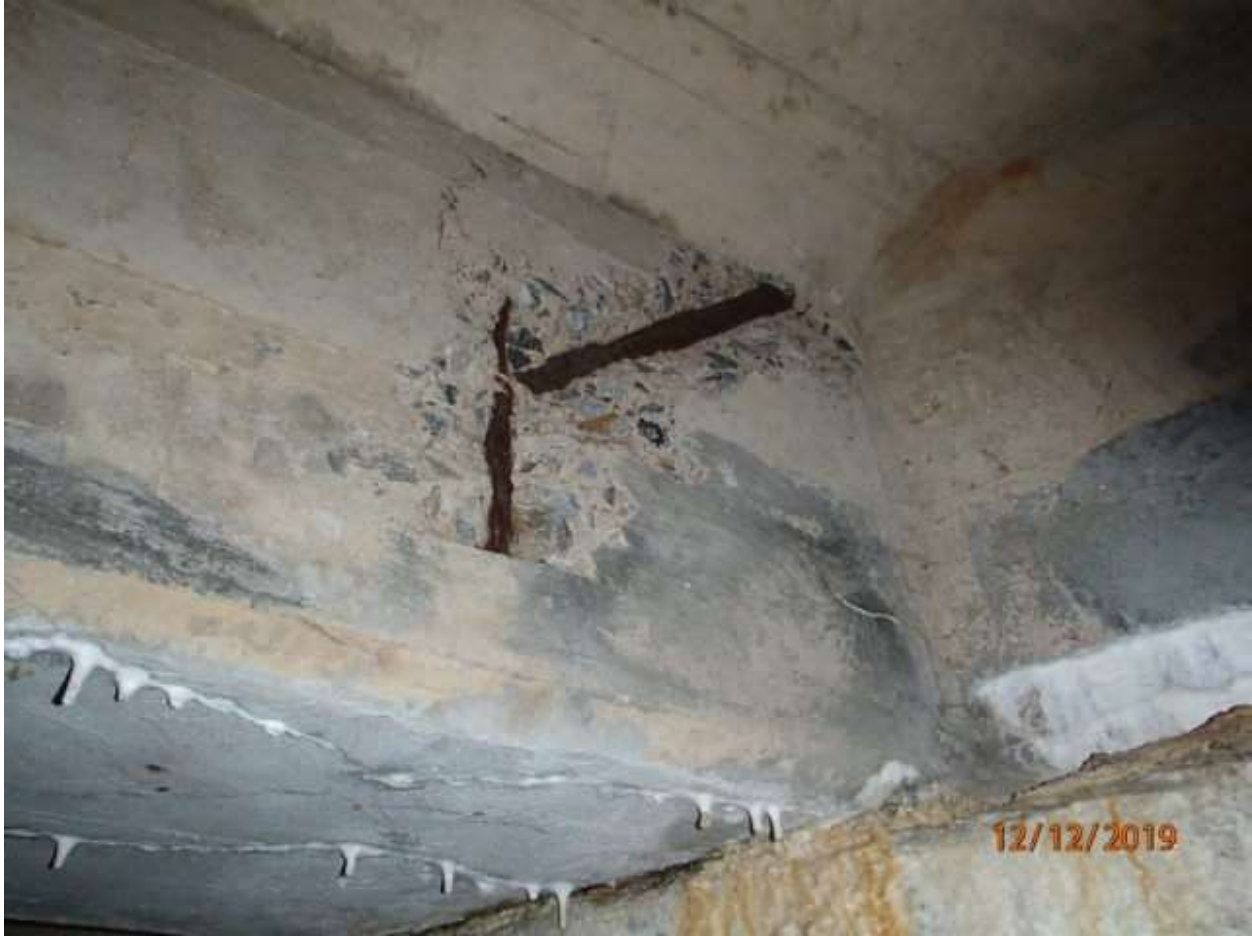
**Figure 250 – Bridge 187-0007-0 Concrete Spalling 2013 (Top) vs 2019 (Bottom)**

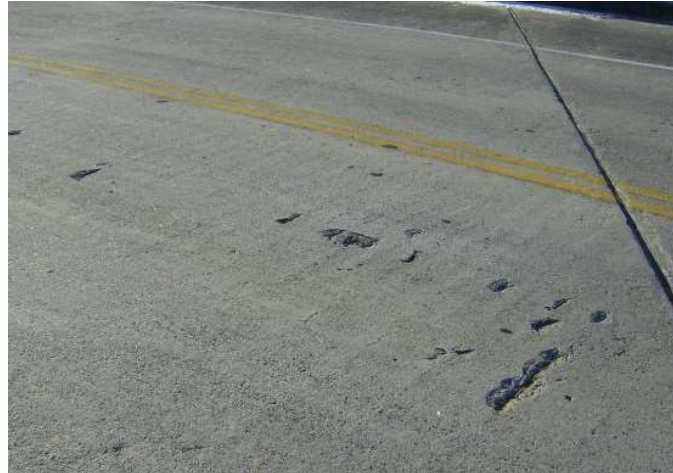
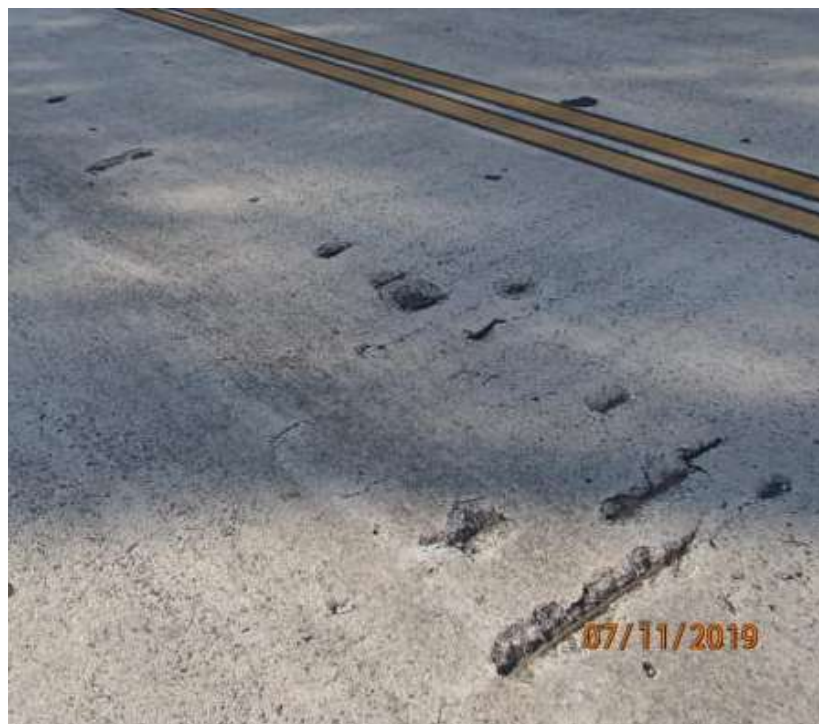
**Figure 251 – Bridge 291-0002-0 Bridge Deck Concrete Spall in Span 1 2014 (Top) vs 2019  
(Bottom)**

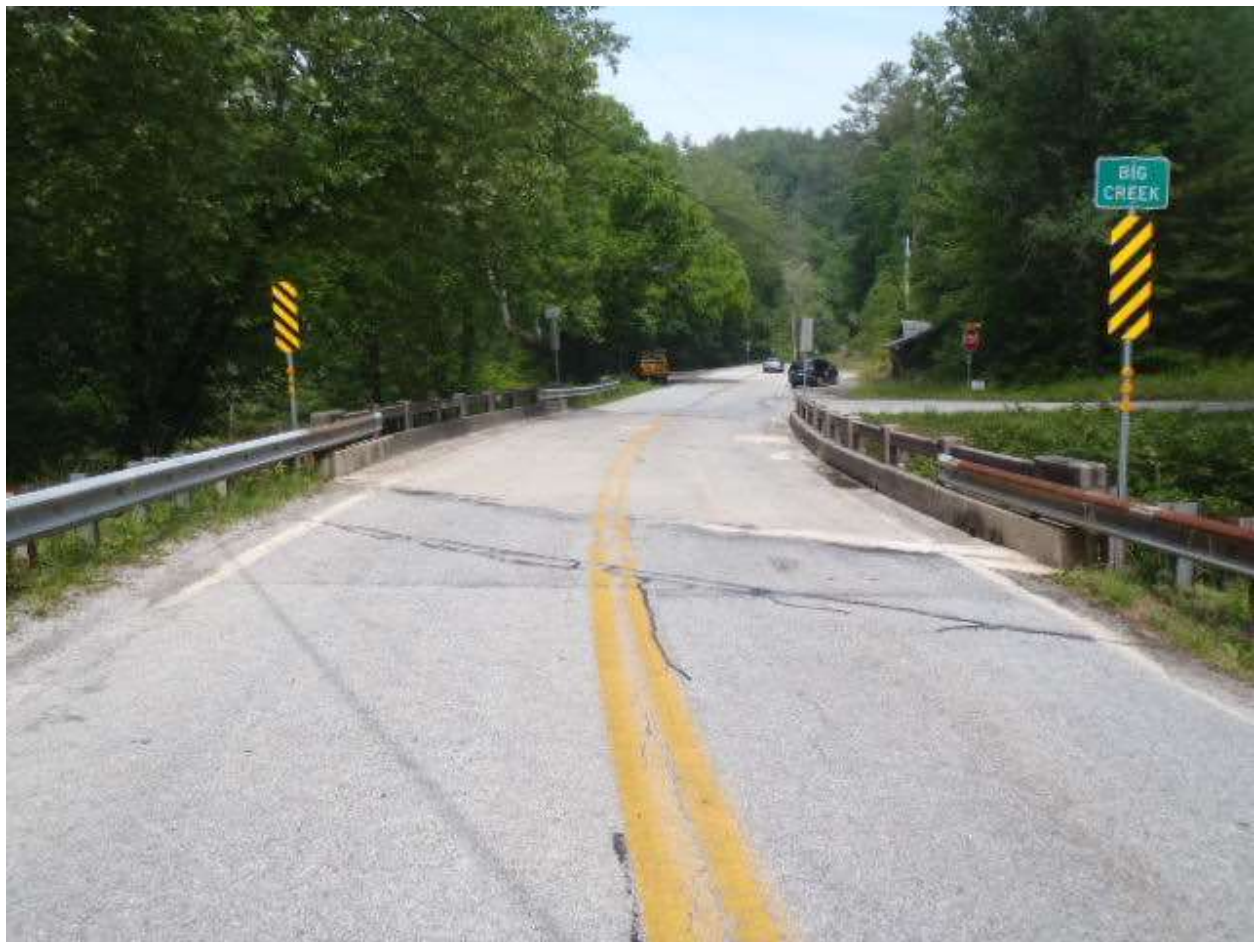
This is a state owned and maintained bridge located in Rabun County. It is a concrete bridge originally constructed in 1939, that passes over Big Creek. Inspector have noted that this bridge has experienced “moderate to heavy scaling and surface deterioration dur to age, salts, and freeze thaw cycles.” However, 20-30% of these deck areas have been repaired, mitigating some of the deck deterioration.

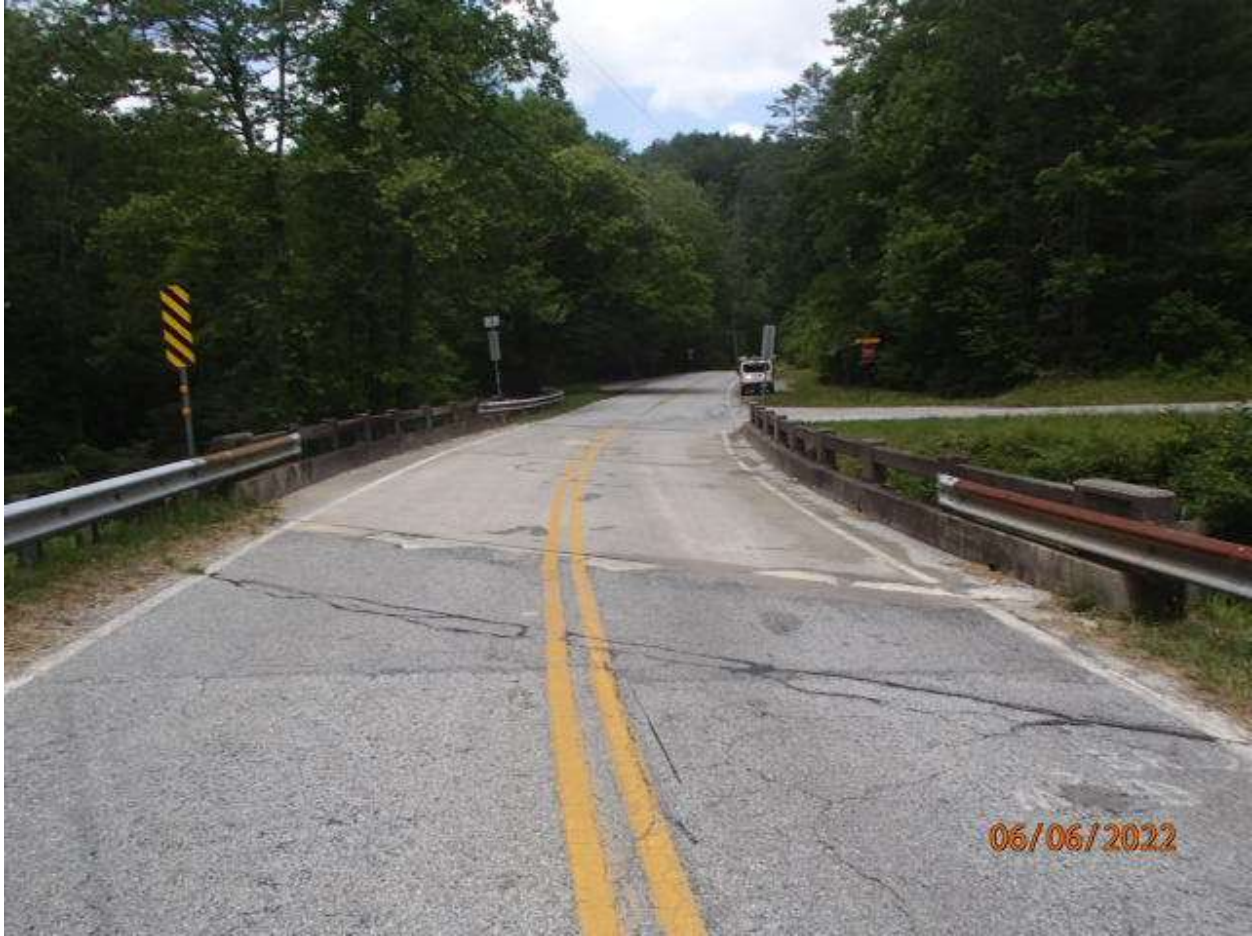
**Figure 252 – Bridge 241-0018-0 Deck Condition 2014 (Top) vs 2022 (Bottom)**

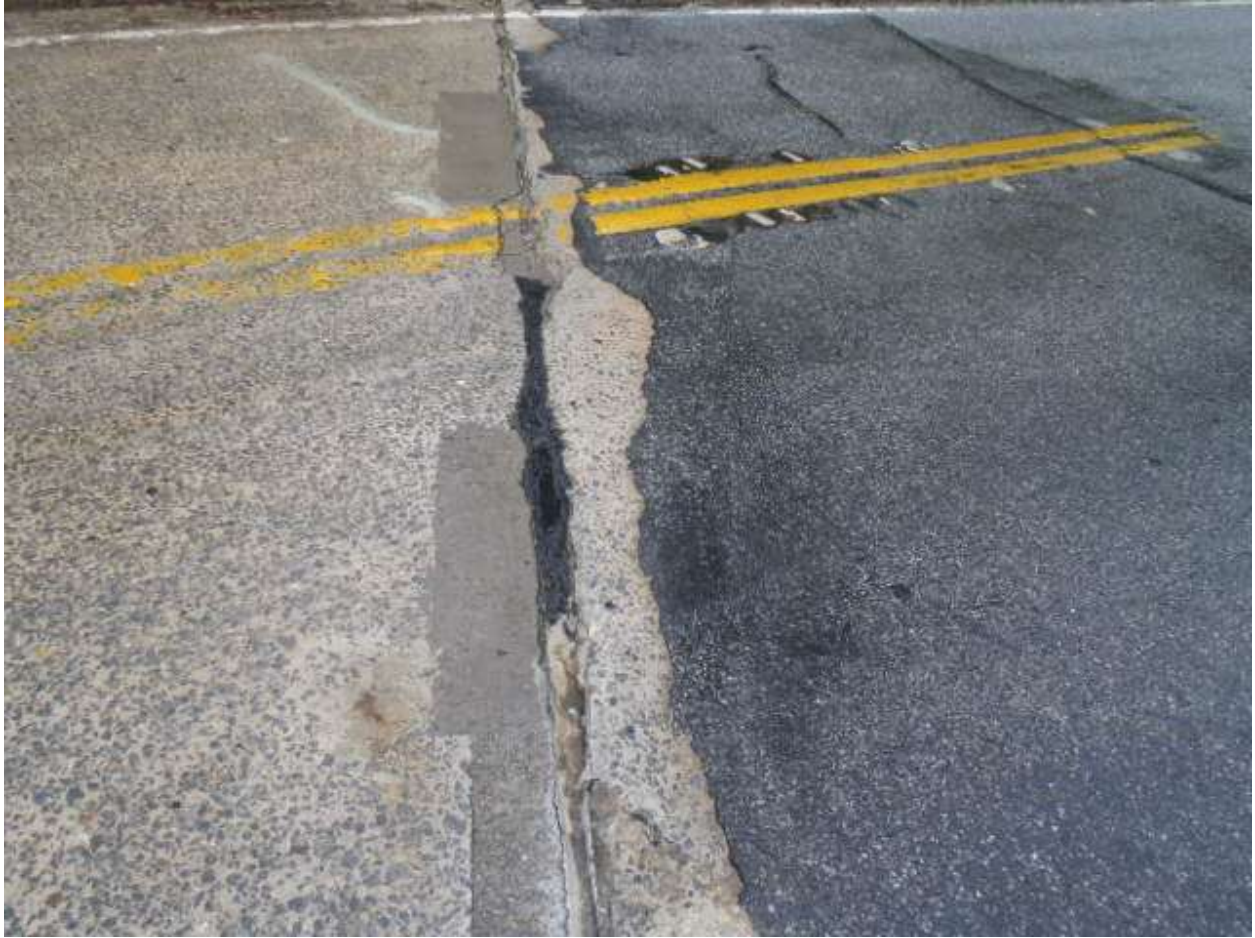
This bridge shows how snow, deicing salts, and freeze-thaw cycles can work to deteriorate a bridge deck in a vulnerable area.

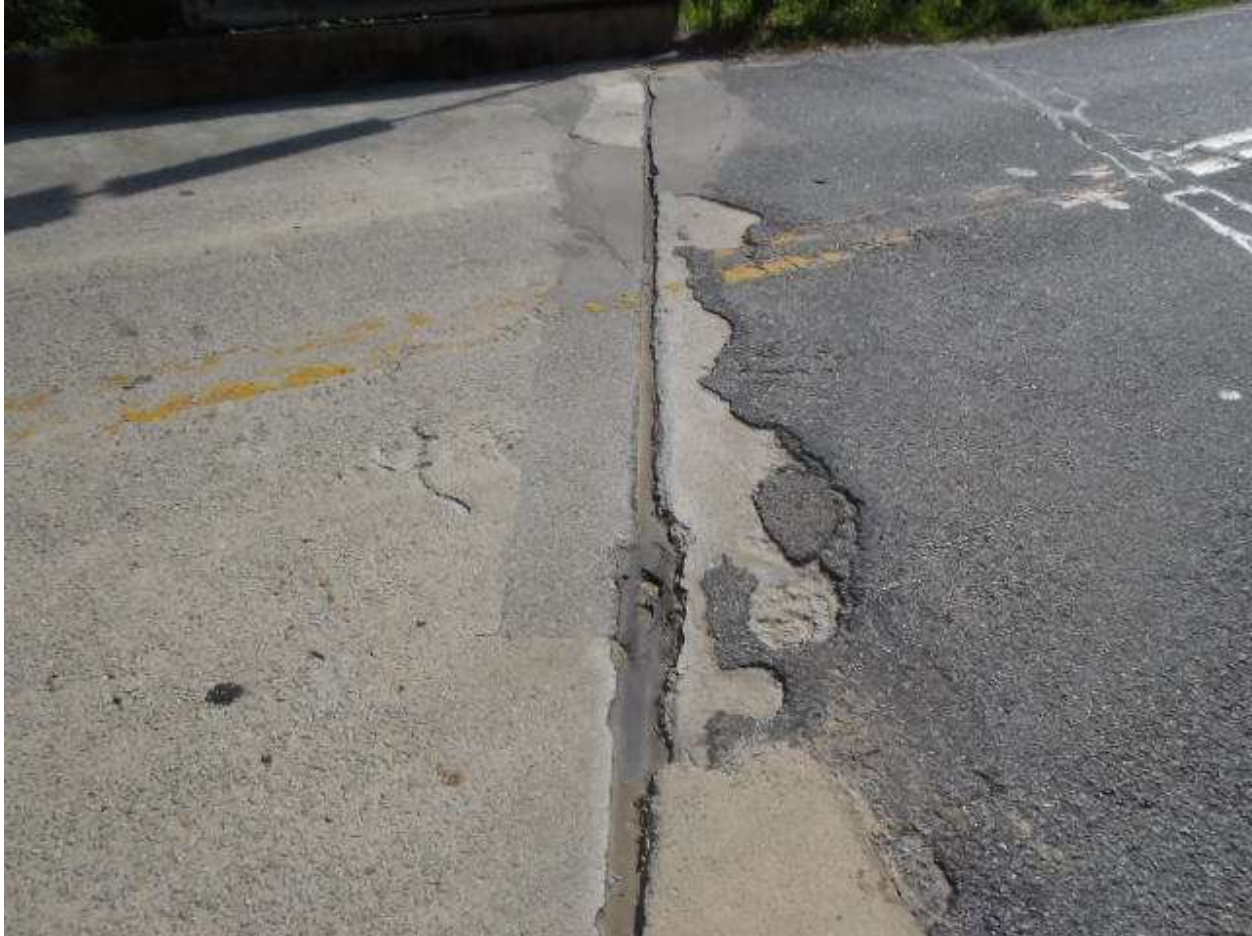
**Figure 253 – Bridge 241-0018-0 Bridge Deck Condition 2014 (Top) vs 2022 (Bottom)**

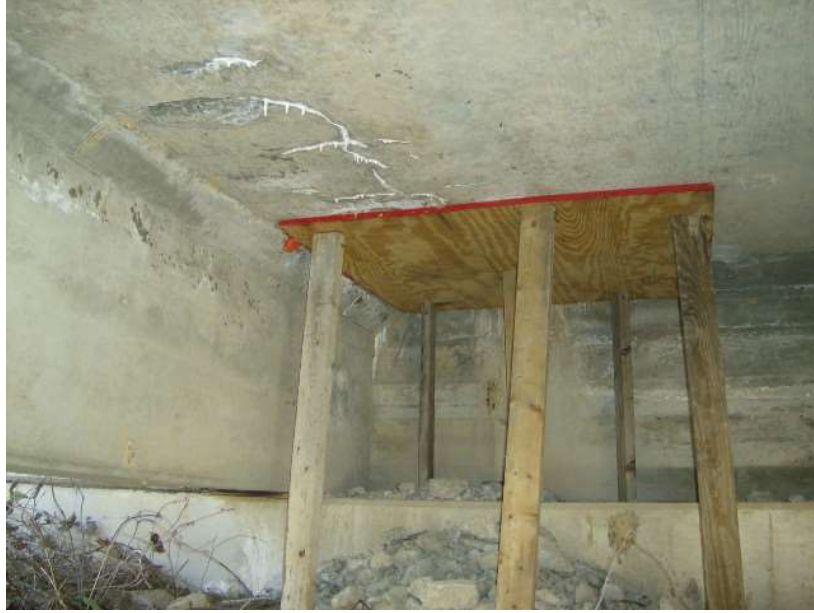
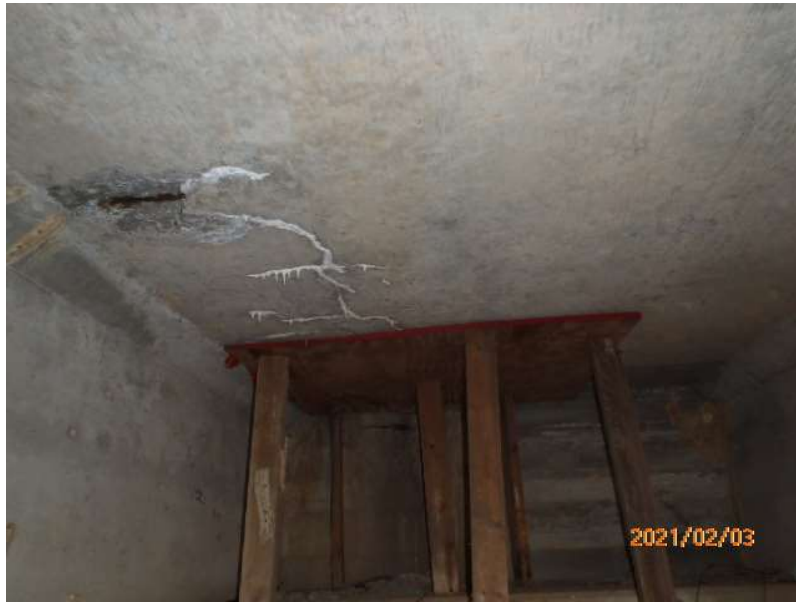
**Figure 254 – Bridge 257-0008-0 Bridge Spalling Under Span 3 2015 (Top) vs 2021 (Bottom)**

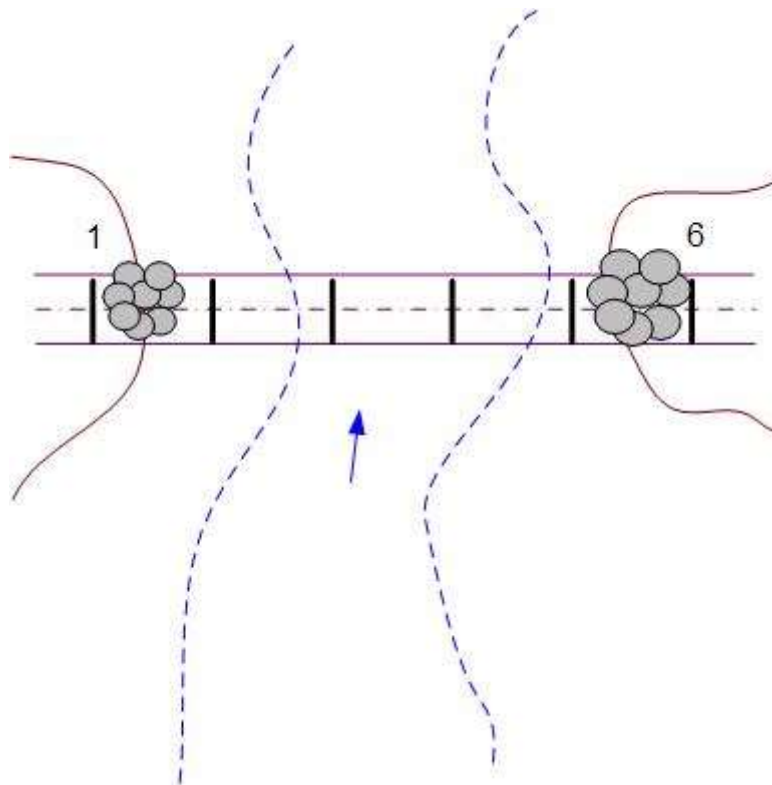
**Figure 255 – Bridge 257-0012-0 Plan View (GDOT, 2021)**

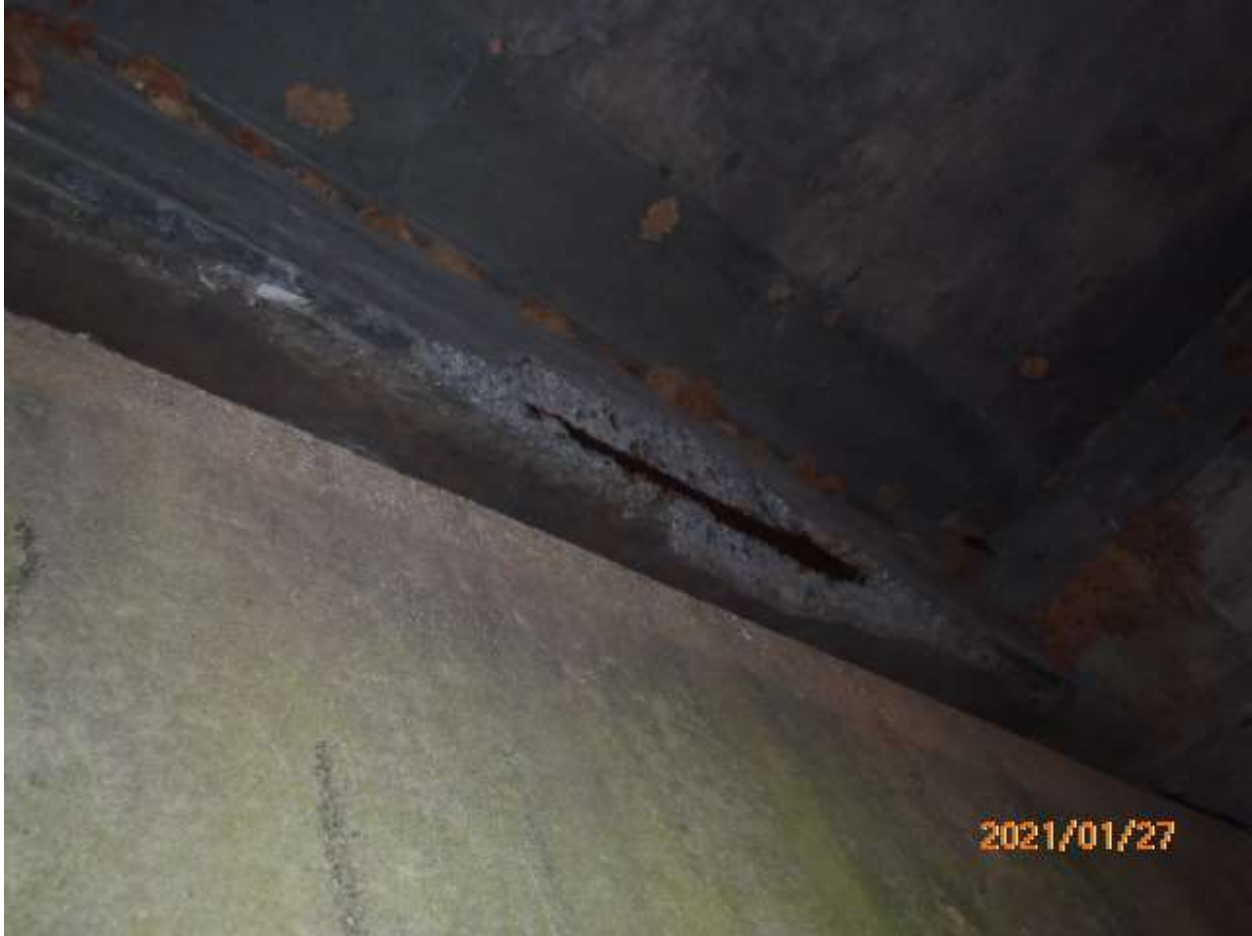
**Figure 257 – Bridge 257-0012-0 Concrete Spalling (GDOT, 2021)**

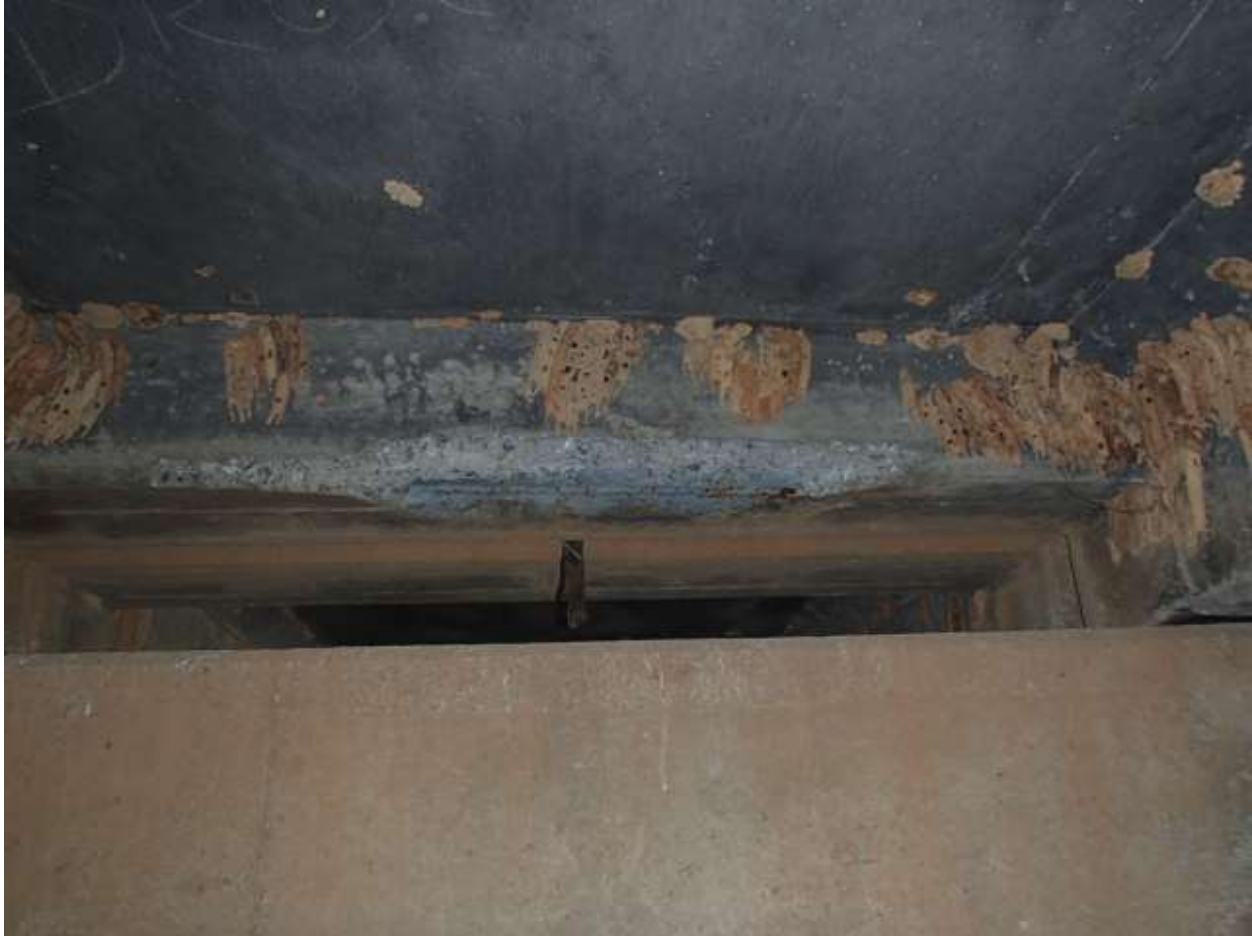
**Figure 258 – Bridge 257-0012-0 Concrete Spalling with Epoxy Painting (GDOT, 2021)**

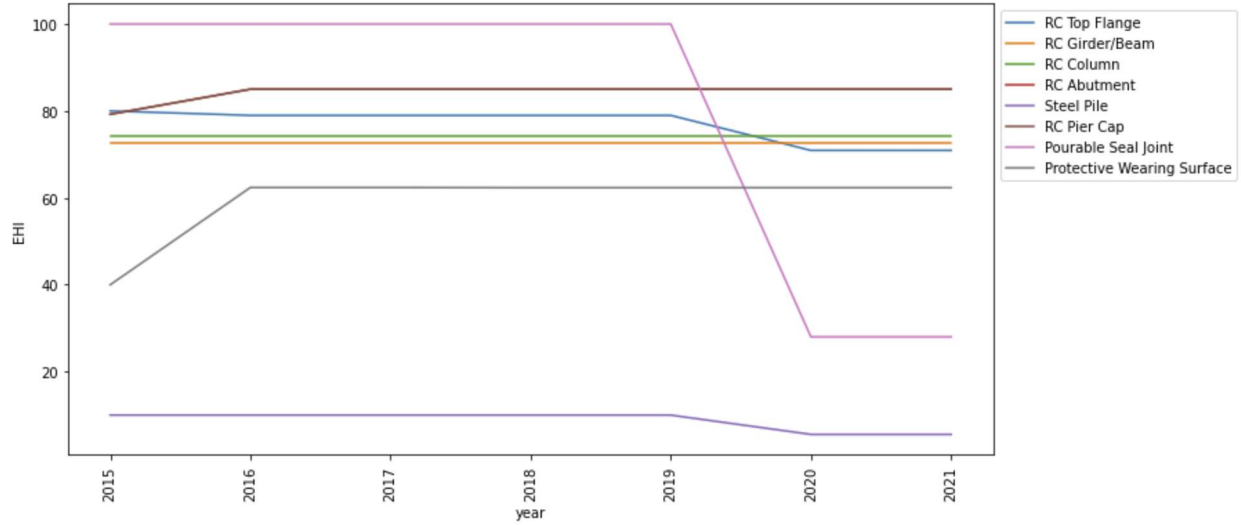
**Figure 259 – Bridge 241-0016-0 EHI by Year**

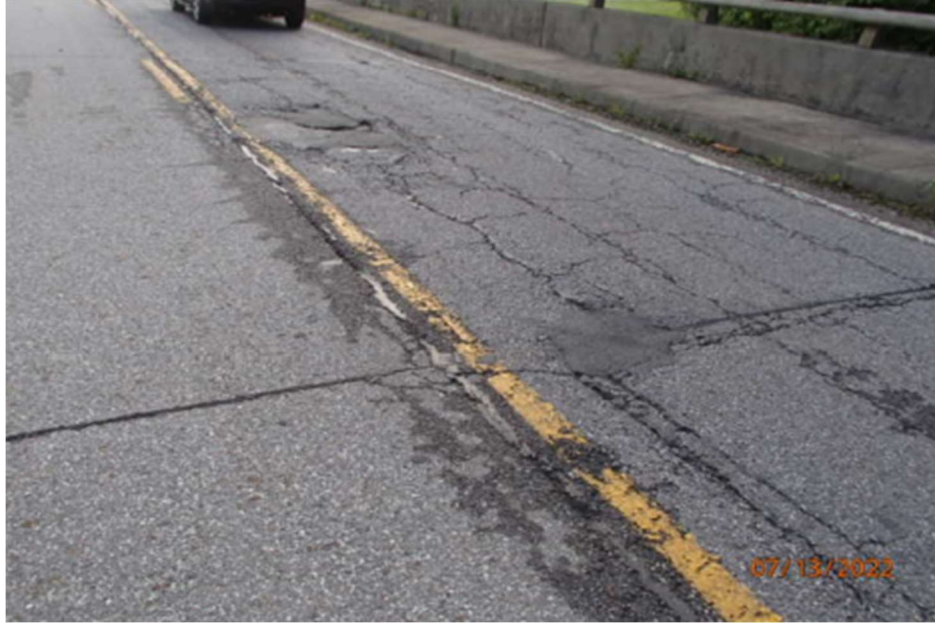
**Figure 260 – Bridge 241-0016-0 Typical Deck Cracking (GDOT, 2022)**

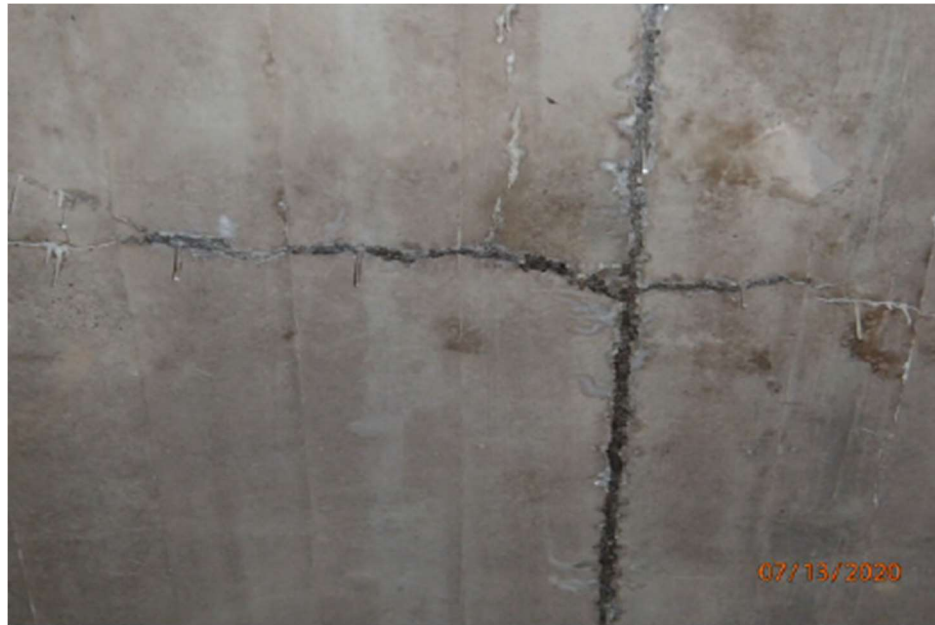
**Figure 261 – Bridge 241-0016-0 Deck Cracking Underside (GDOT, 2020)**

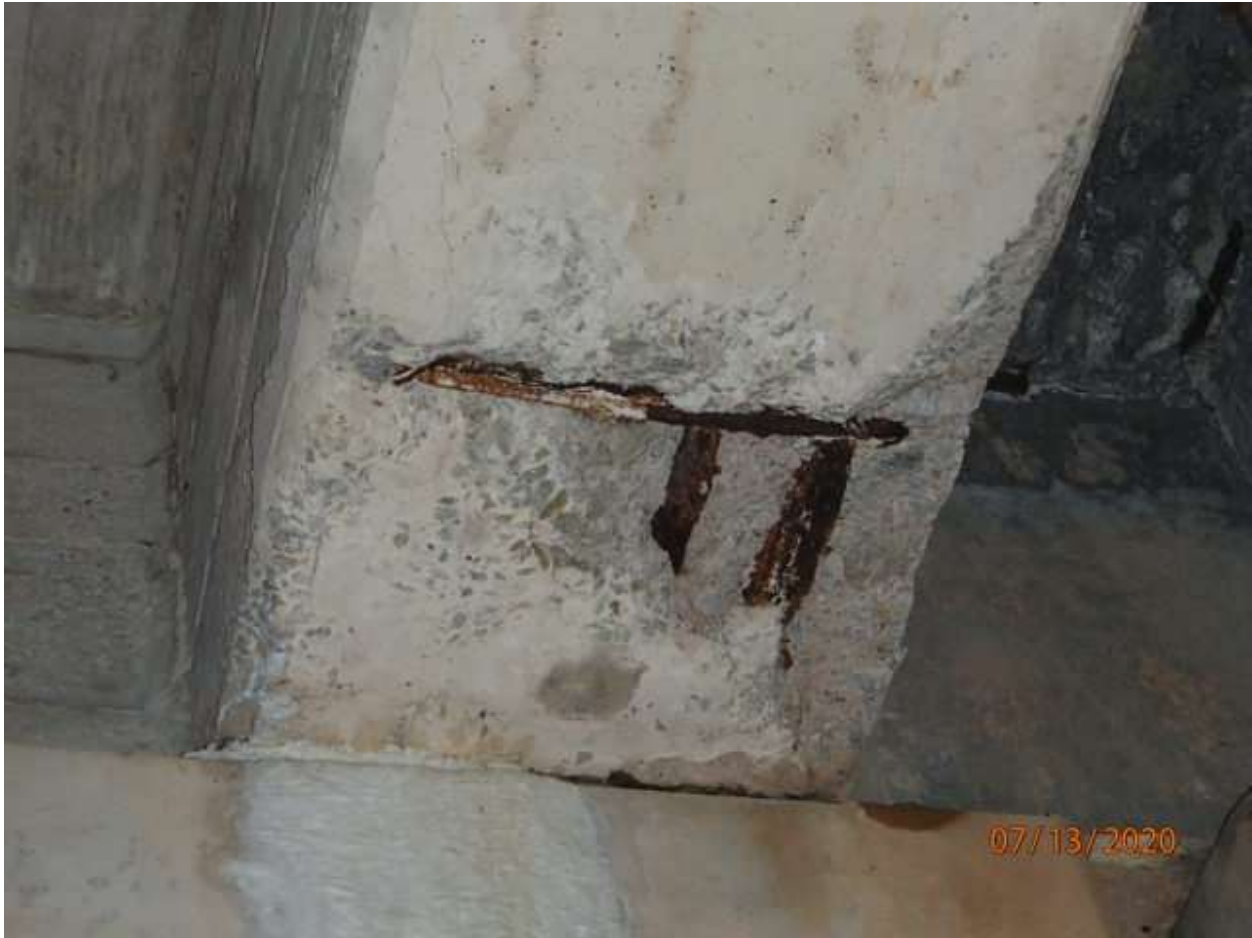
**Figure 262 – Bridge 241-0016-0 Beam 9 Concrete Spalling 2016 (Top) vs 2020 (Bottom)**

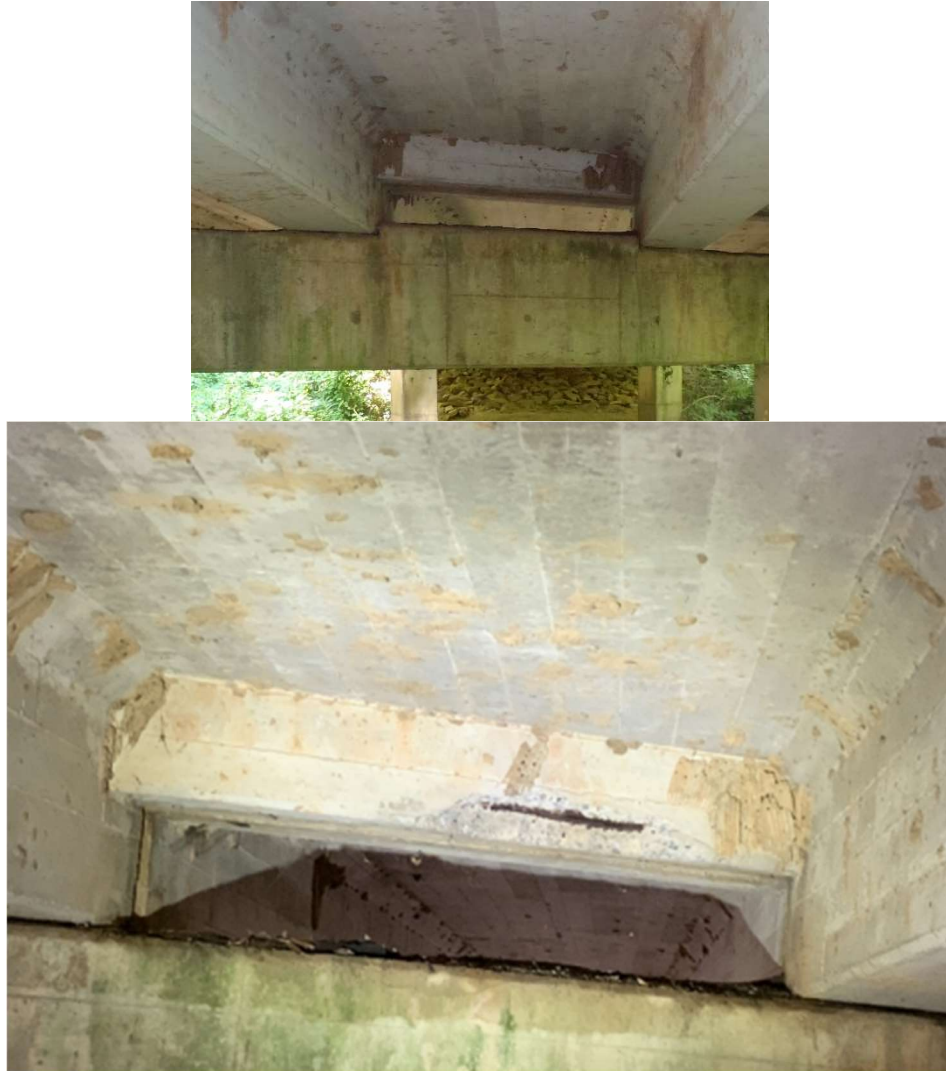
**Figure 263 – Bridge 157-5046-0 Reinforced Concrete Top Flange Concrete Spall 2014 (Top) vs 2022 (Bottom)**

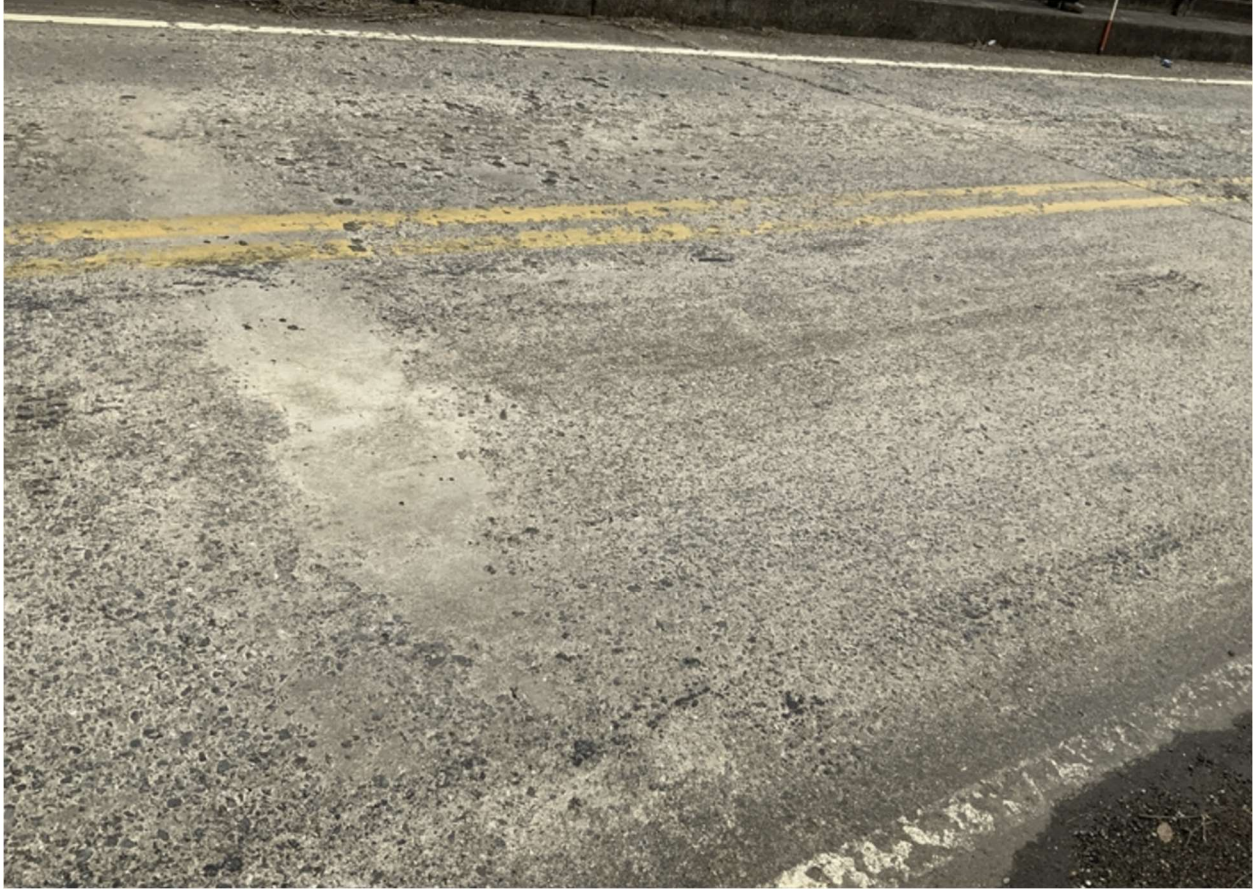
**Figure 264 – Bridge 157-5046-0 Reinforced Concrete Top Flange Concrete Spall with Loose Aggregates (GDOT, 2022)**

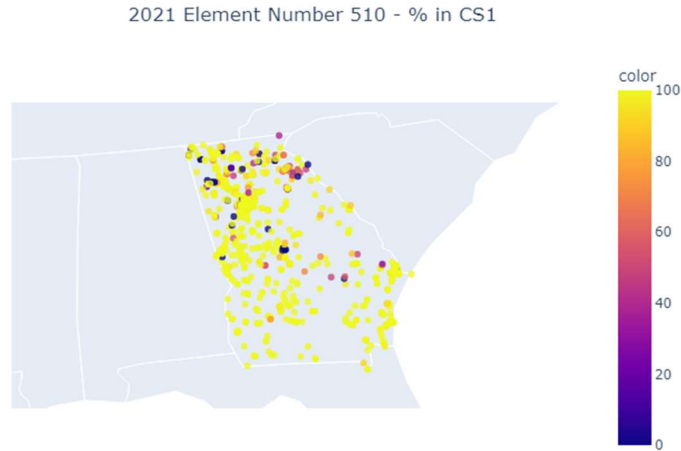
**Figure 265: Percent of EN510 in Condition State One by Location, 2021. County-Owned (Top) vs State-Owned (Bottom)**

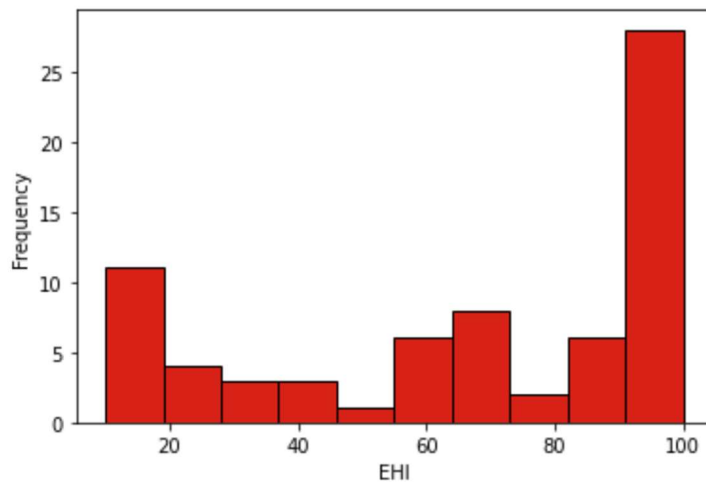
Once this element was identified, a further analysis into the condition of these elements in snow counties versus other Georgia counties was completed. The average EHI of this element in counties other than the snow counties was calculated to be 89.79 and the average EHI in snow counties was calculated to be 67.01. Next, distribution plots were generated showing that in snow counties there was a higher distribution of low EHIs than in non-snow counties. These can be seen in **Figure 266**.

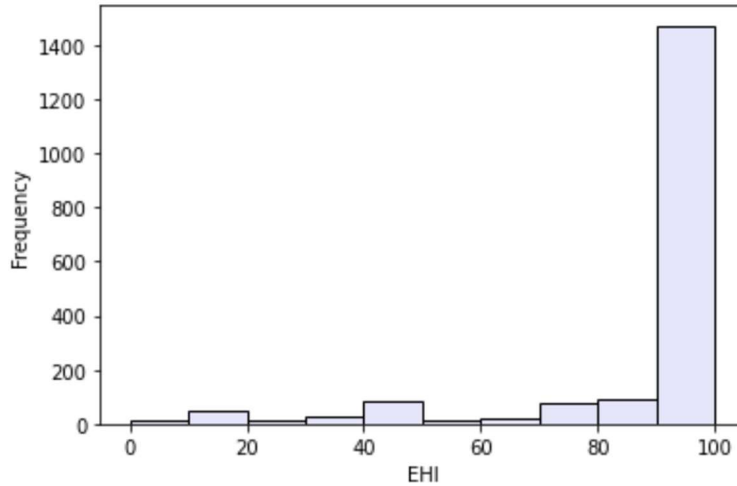
**Figure 266 – EHI of EN510 Snow Counties (Top) vs Non Snow Counties (Bottom)**

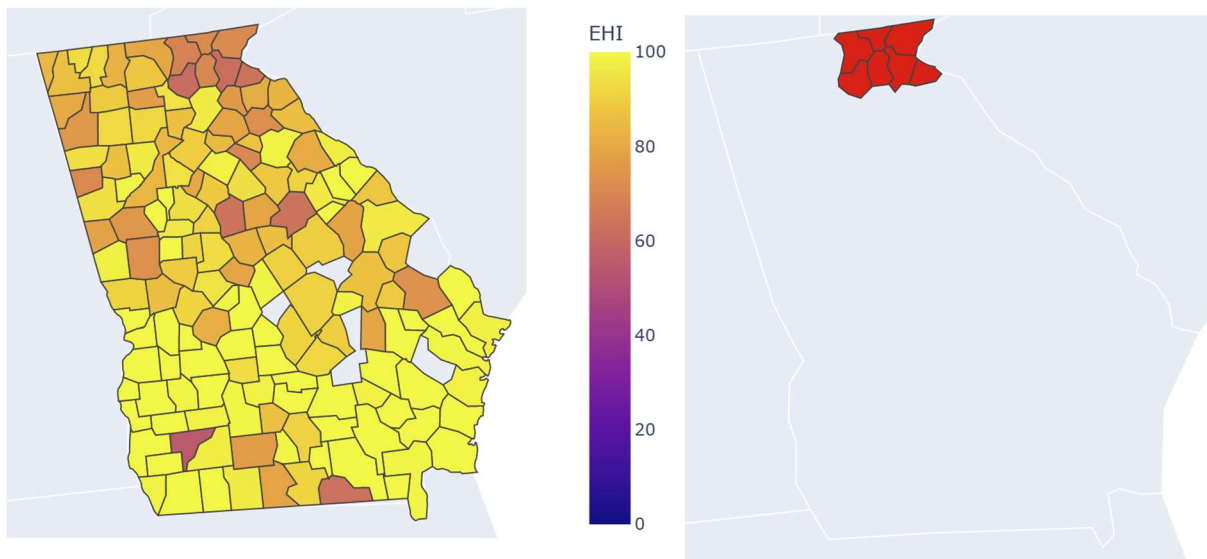
**Figure 267 – EHI of EN510 by County (Left) vs Snow Counties (Right)**

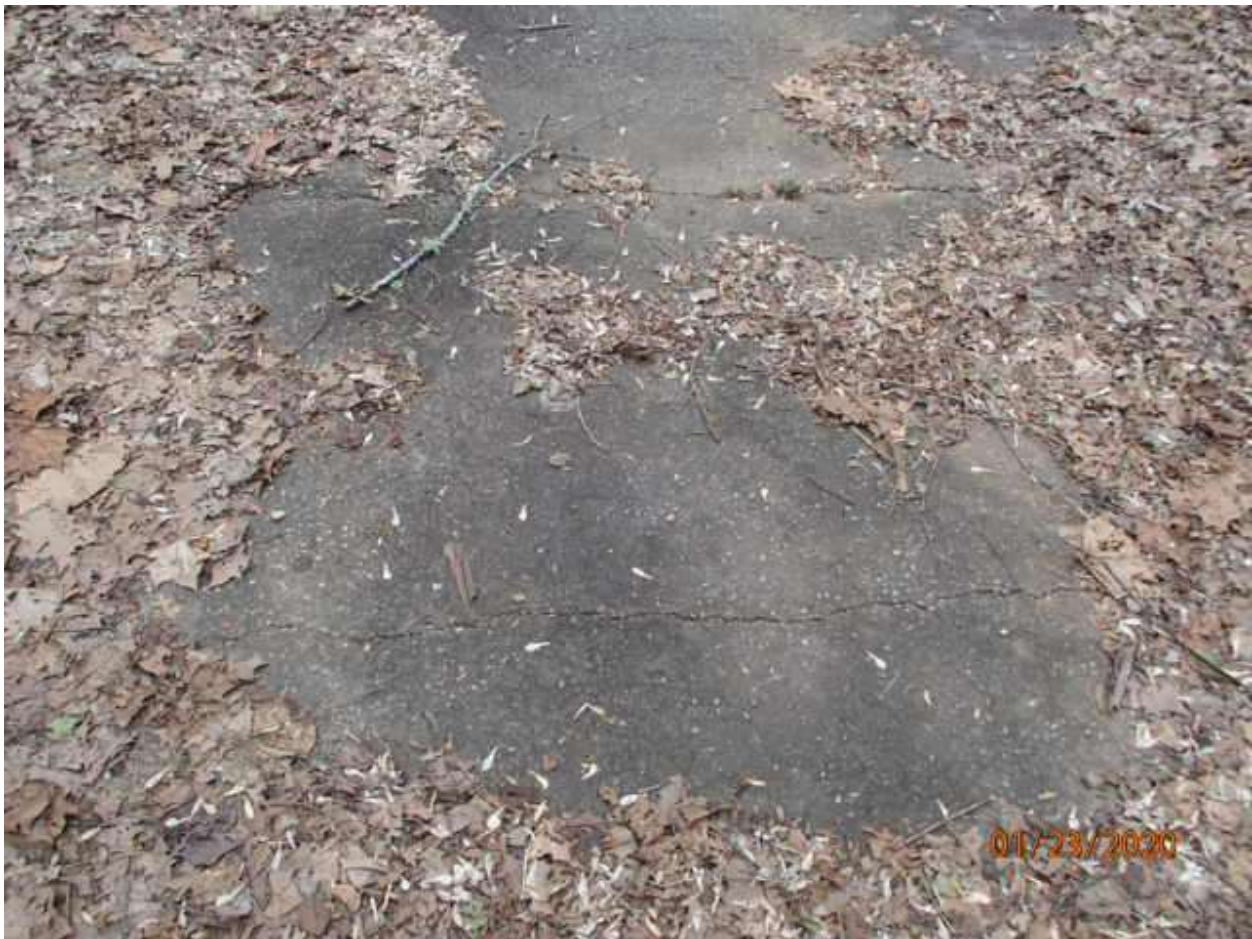
**Figure 269 – Bridge 311-5047-0 Transverse Cracking (GDOT, 2020)**

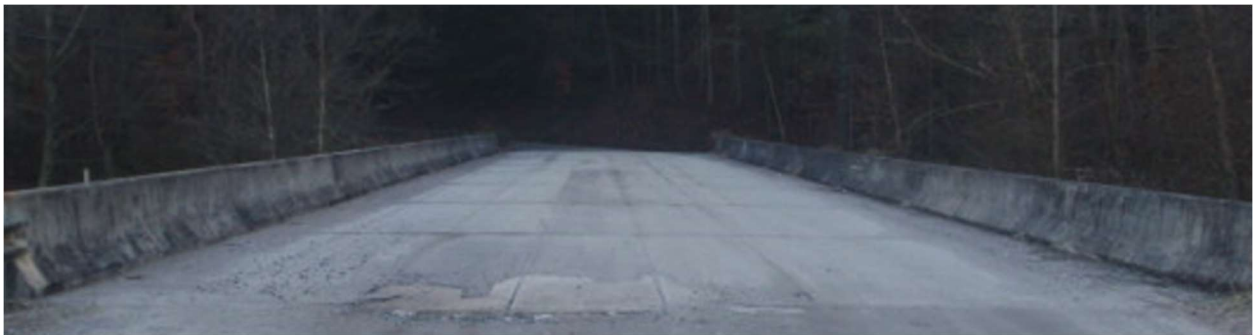
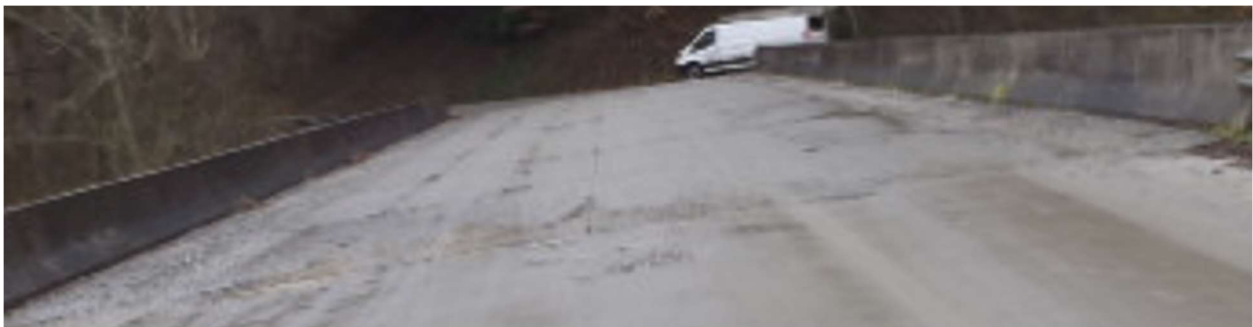
**Figure 270 – Bridge 311-5012-0 Deck Condition 2014 (Top) vs 2022 (Bottom)**

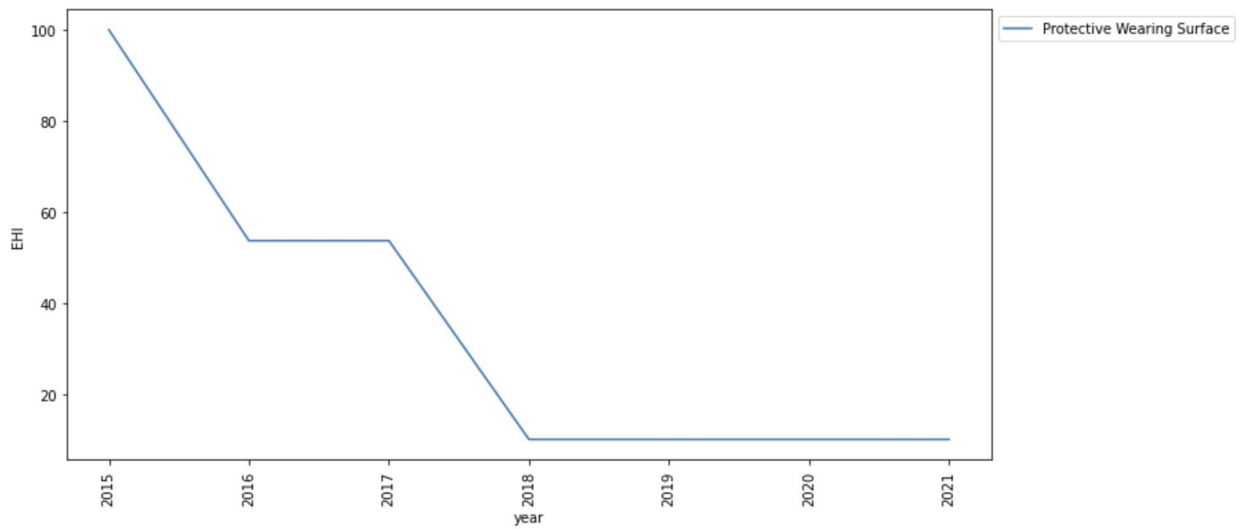
**Figure 271 – Bridge 137-0029-0 EN510 EHI by Year**

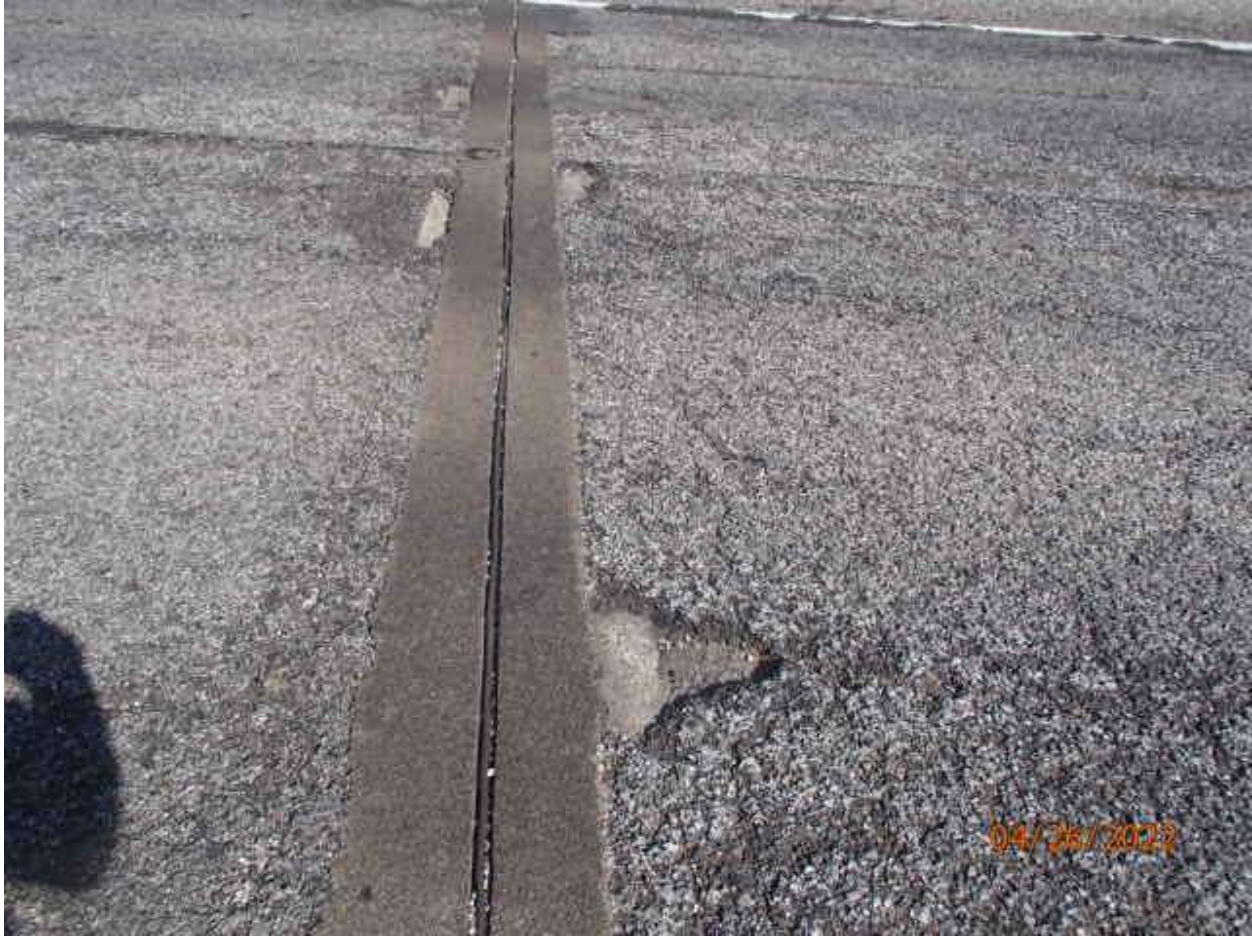
**Figure 272 – Bridge 137-0029-0 Protective Wearing Surface at Bent 2 Condition 2014 (Top)  
vs 2022 (Bottom)**
