IMPACT OF WEATHER STRESSORS TO IDENTIFY VULNERABLE BRIDGE ELEMENTS  
IN GEORGIA TOWARDS DATA DRIVEN ASSEST MANAGEMENT

by SPENCER KOPF

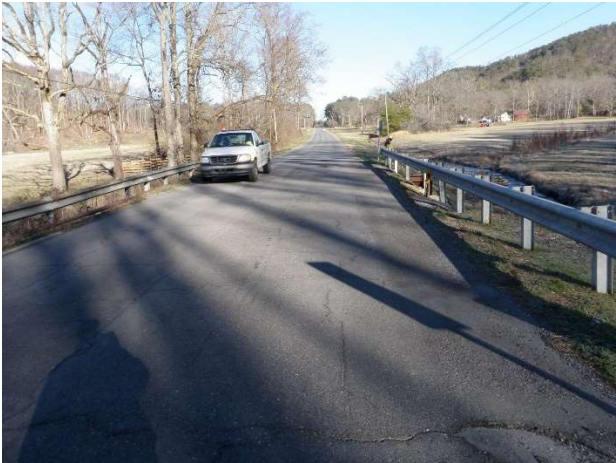
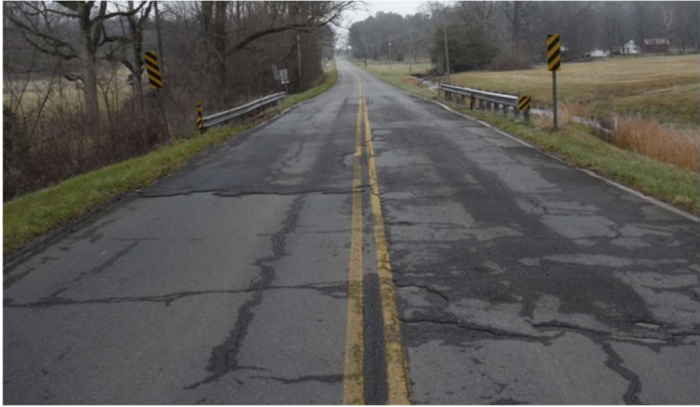
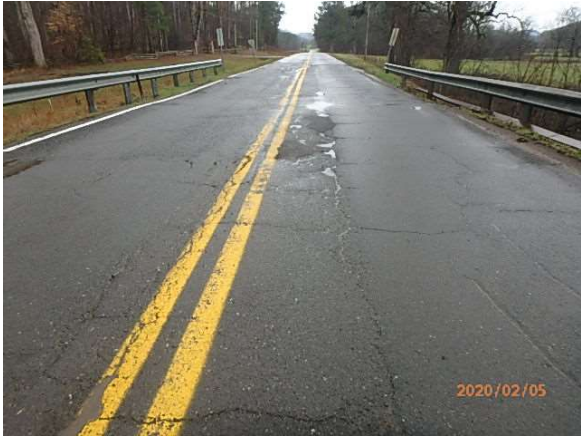
**Figure 273 – Bridge 213-0044-0 Deck Condition 2014 (Top) vs 2016 (Middle) vs 2020 (Bottom)**

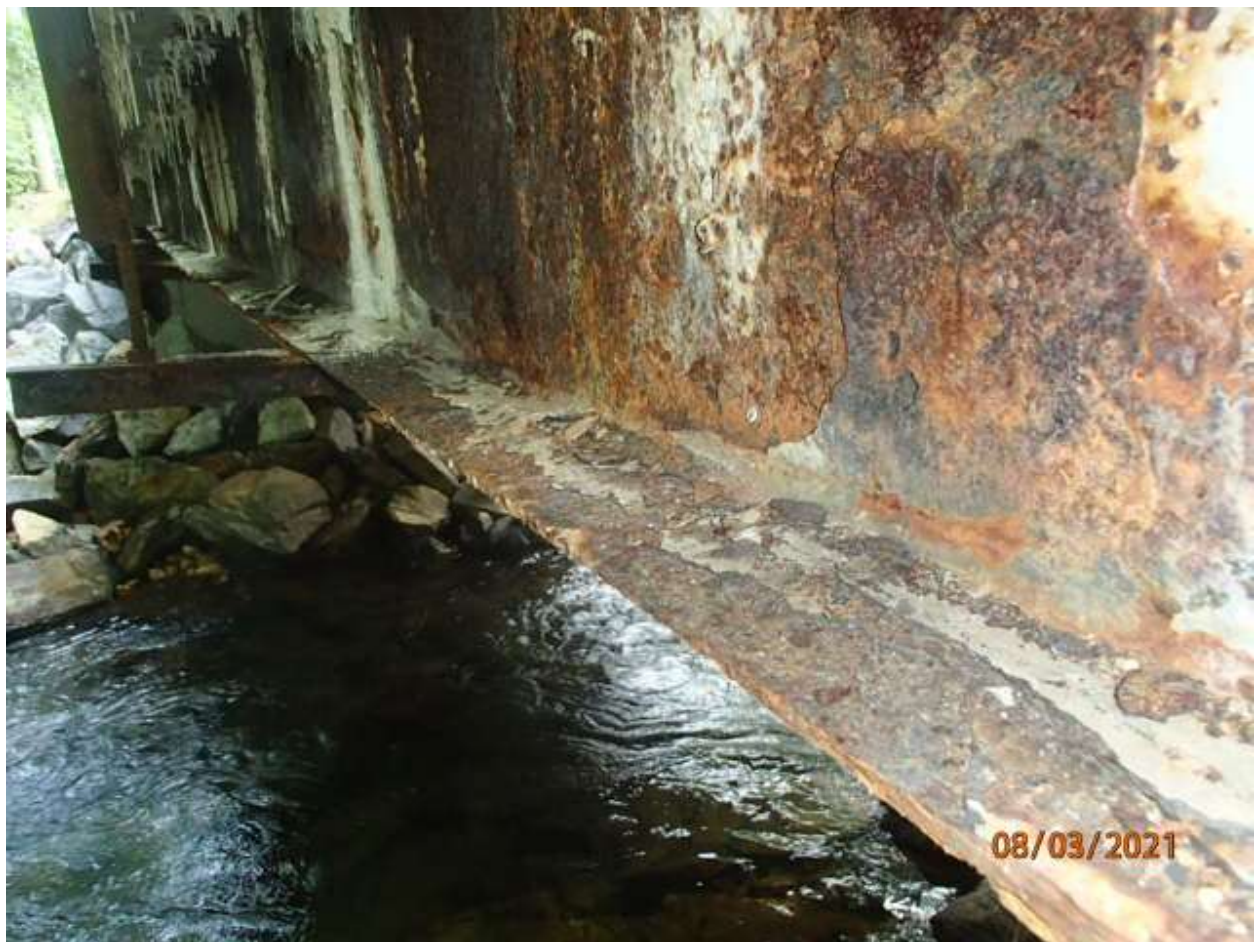
**Figure 274 – Bridge 291-5044-0 Steel Beam Corrosion (GDOT, 2021)**

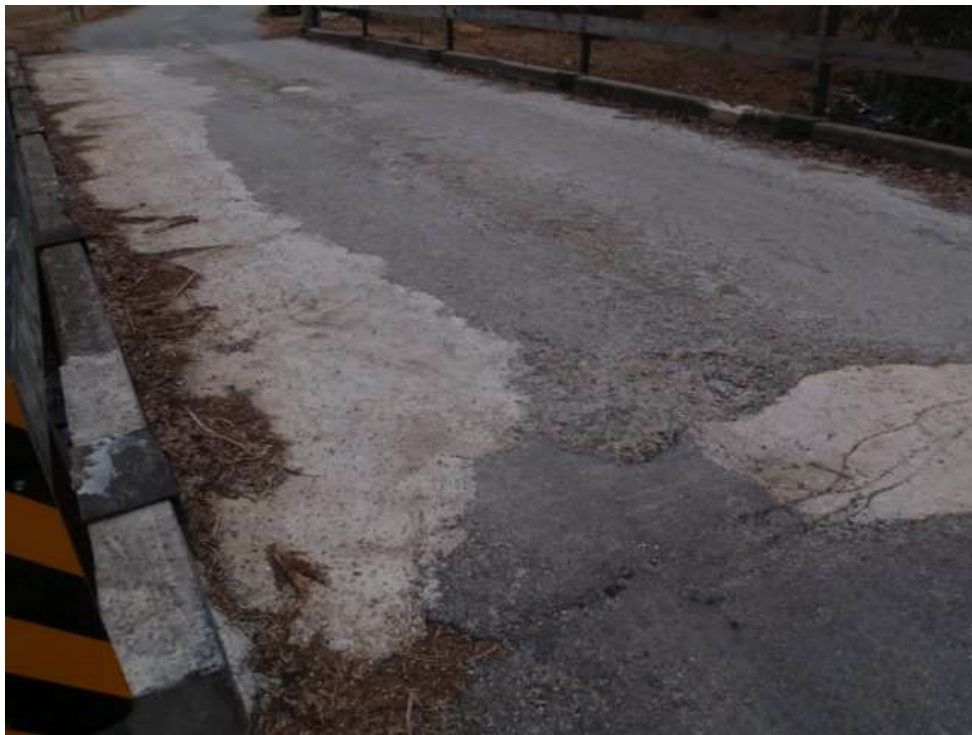
**Figure 275- Bridge 291-5044-0 Deck Condition (GDOT, 2014)**

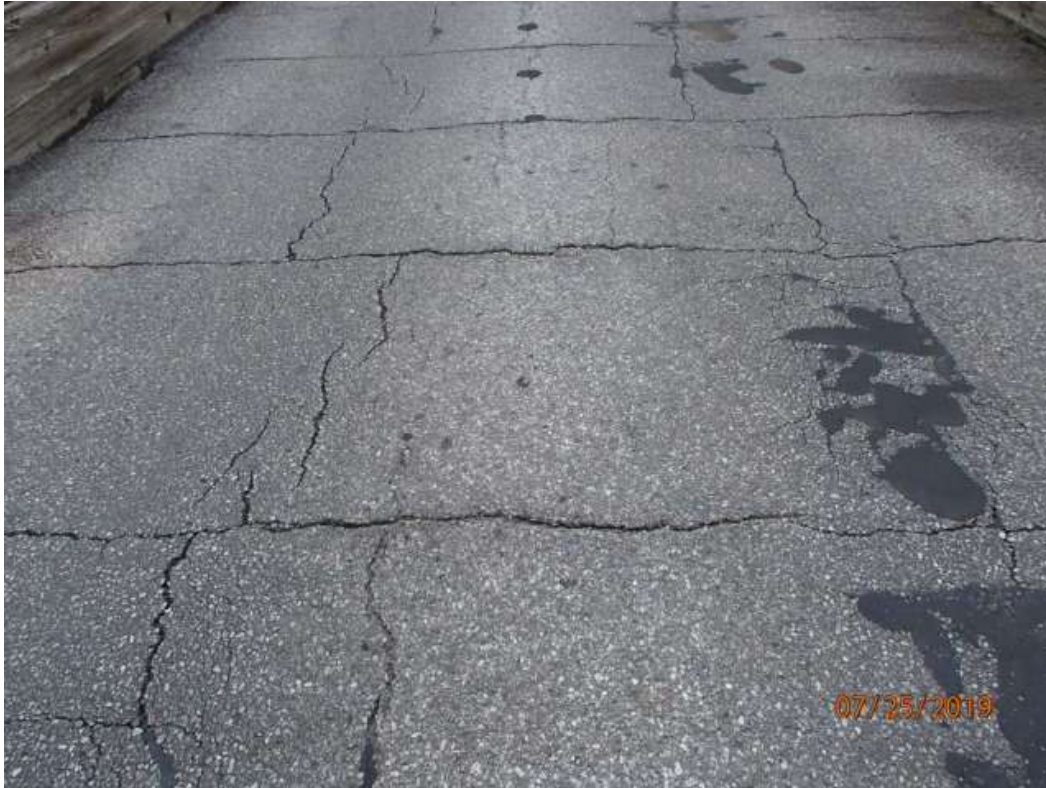
**Figure 276 – Bridge 291-5048-0 Asphalt Cracking (GDOT, 2019)**

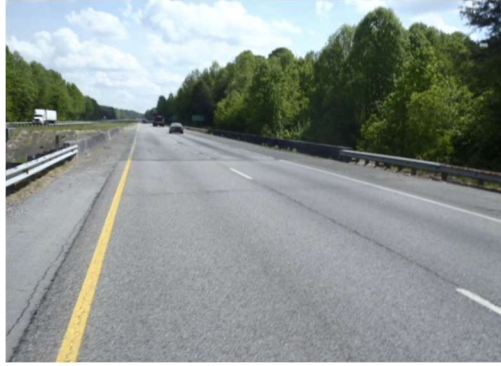
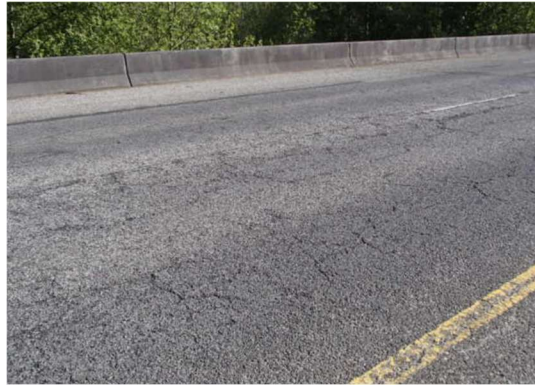
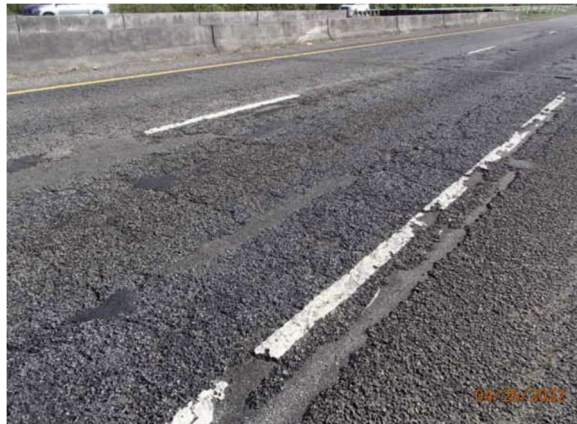
**Figure 277 – Bridge 137-0028-0 Deck Condition 2016 (Top) vs 2018 (Middle) vs 2022  
(Bottom)**

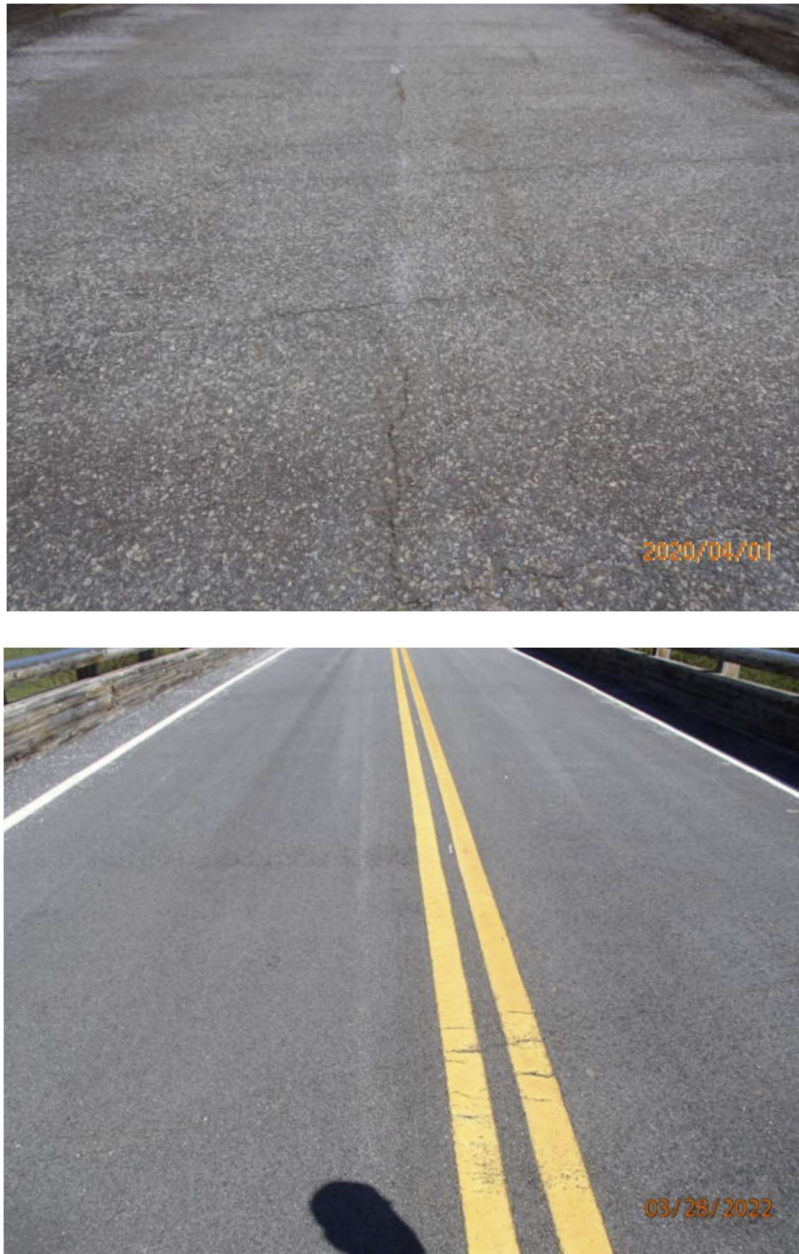
**Figure 278 – Bridge 137-5064-0 Deck Condition 2020 (Top)) vs 2022 (Bottom)**

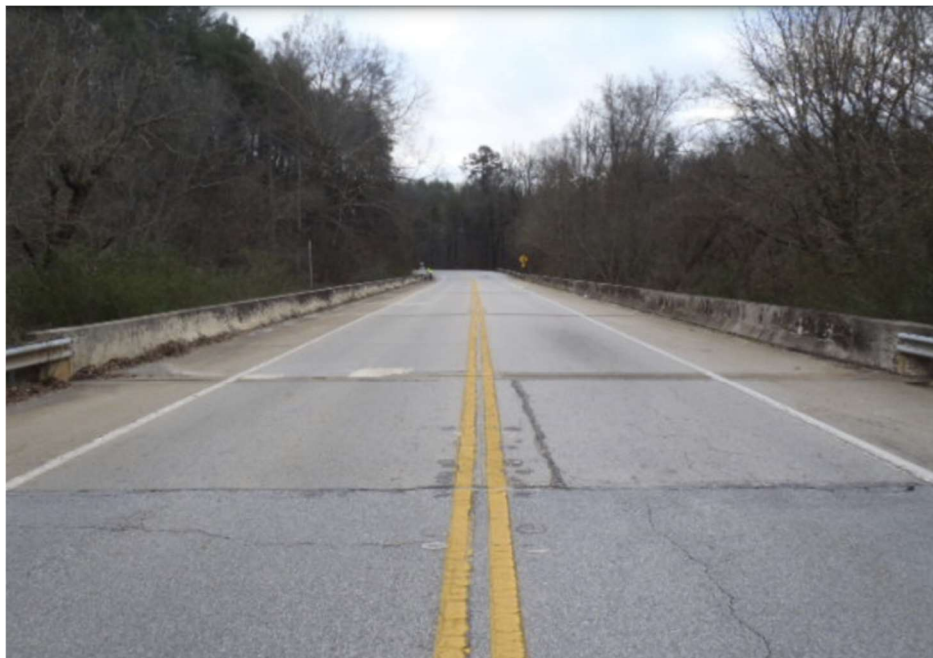
Bridge 187-0011-0 is a state owned and maintained bridge located in Lumpkin County. The bridge was originally constructed in 1937, but was widened in 1985. The bridge was identified because of the low EHI of the protective asphalt surface over the reinforced concrete deck. Throughout the bridge there is spalling, transverse and longitudinal cracking in the asphalt overlay. There are patchwork repairs to patch the spalling of the asphalt around the joints. Inspectors also note that the original side of the concrete deck has heavy deterioration from age and salts, making it likely that snow and freezing temperatures played a role in the deterioration of this bridge deck.

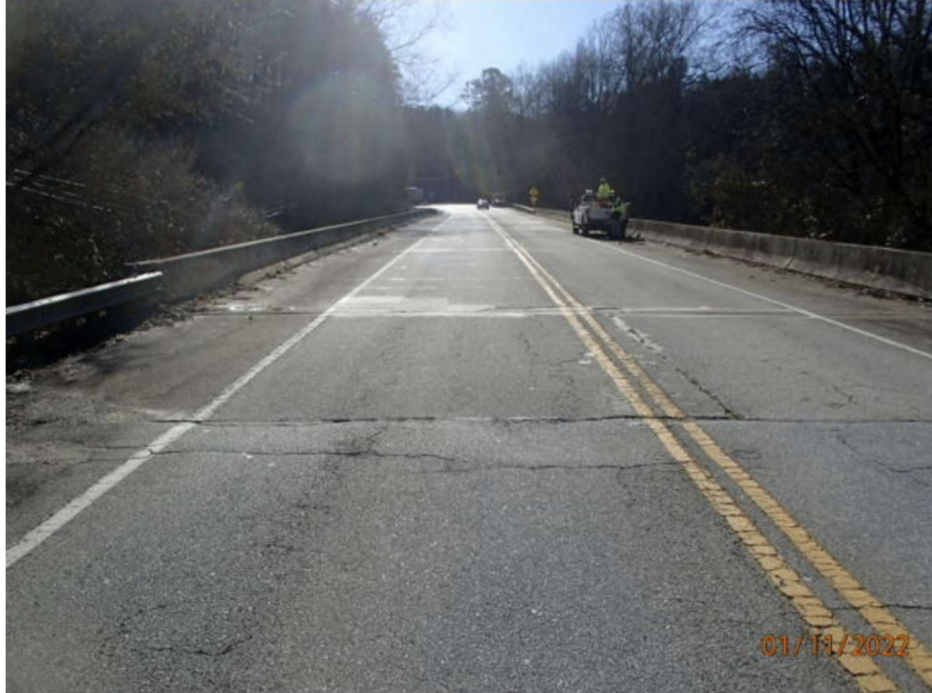
**Figure 279 – Bridge 187-0011-0 Deck Condition 2016 (Top) vs 2022 (Bottom)**

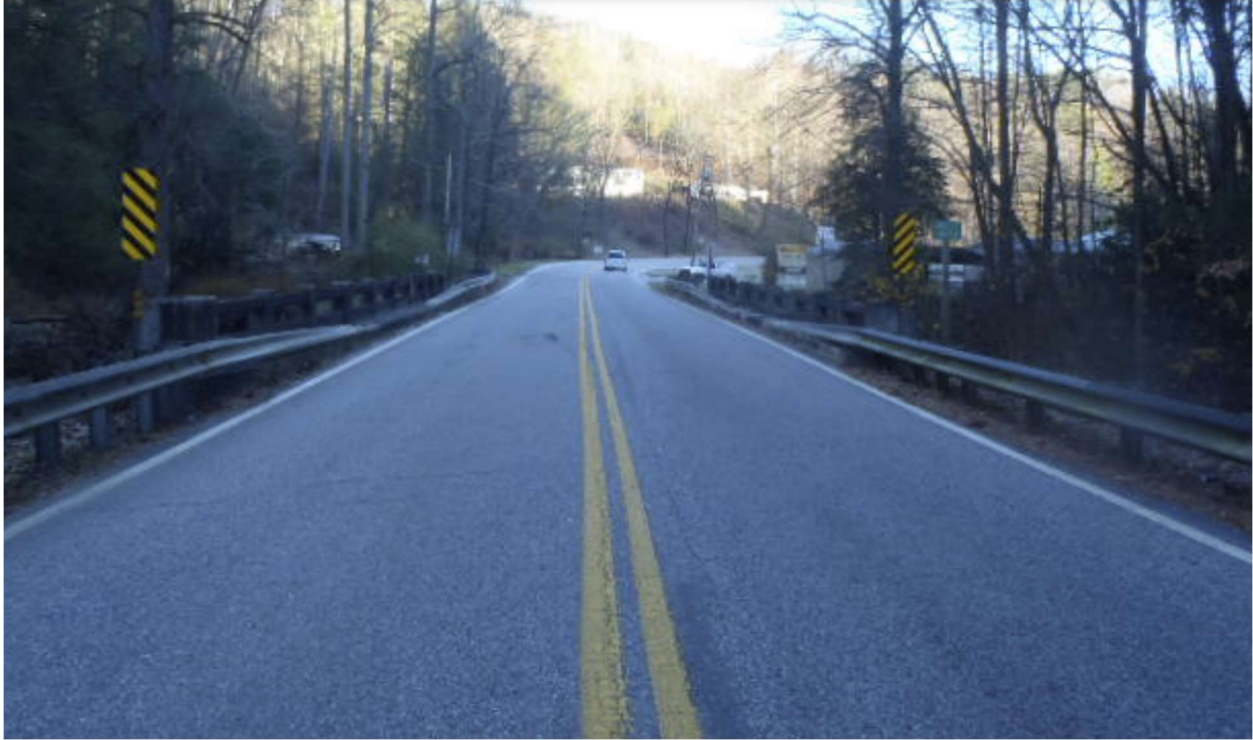
**Figure 280 – Bridge 187-0007-0 Deck Condition 2015 (Top) vs 2021 (Bottom)**

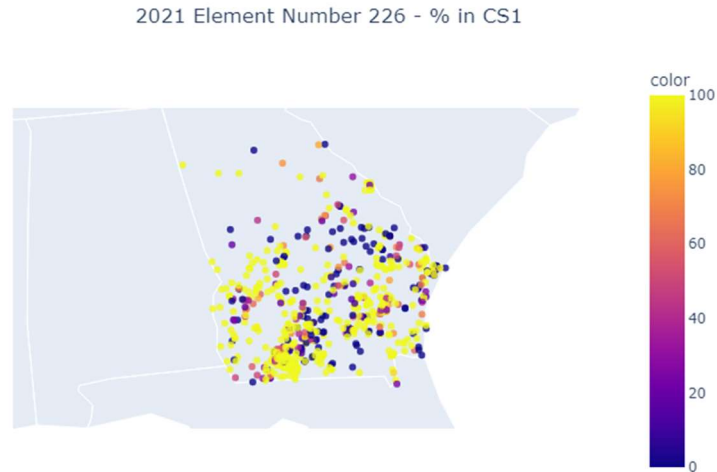
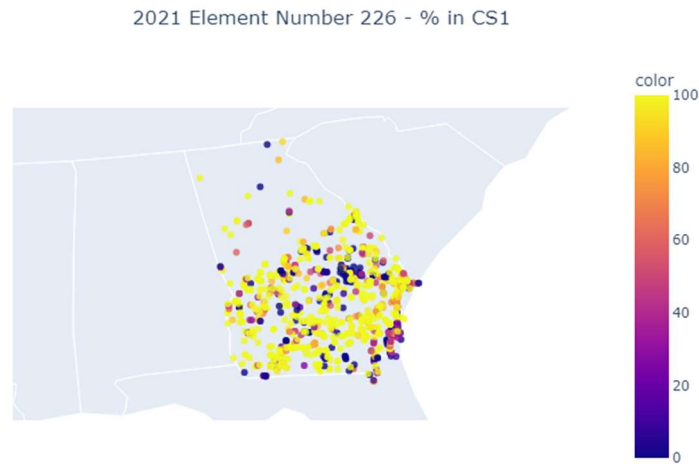
**Figure 281: Percent of EN226 in Condition State One by Location, 2021. County-Owned (Top) vs State-Owned (Bottom)**

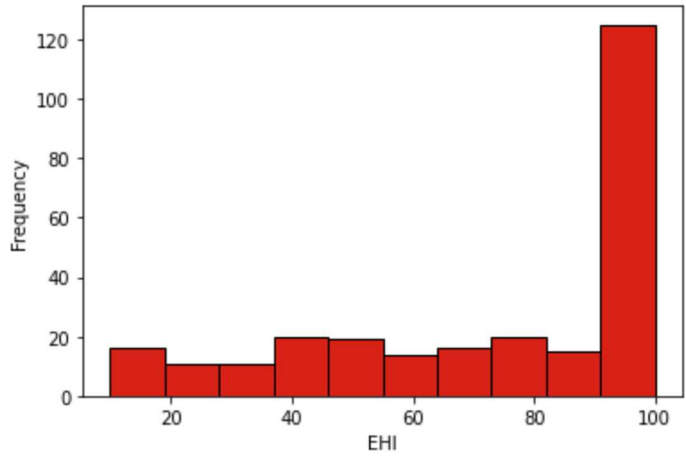
**Figure 282 – EN226 EHI Distribution Across Coastal Counties**

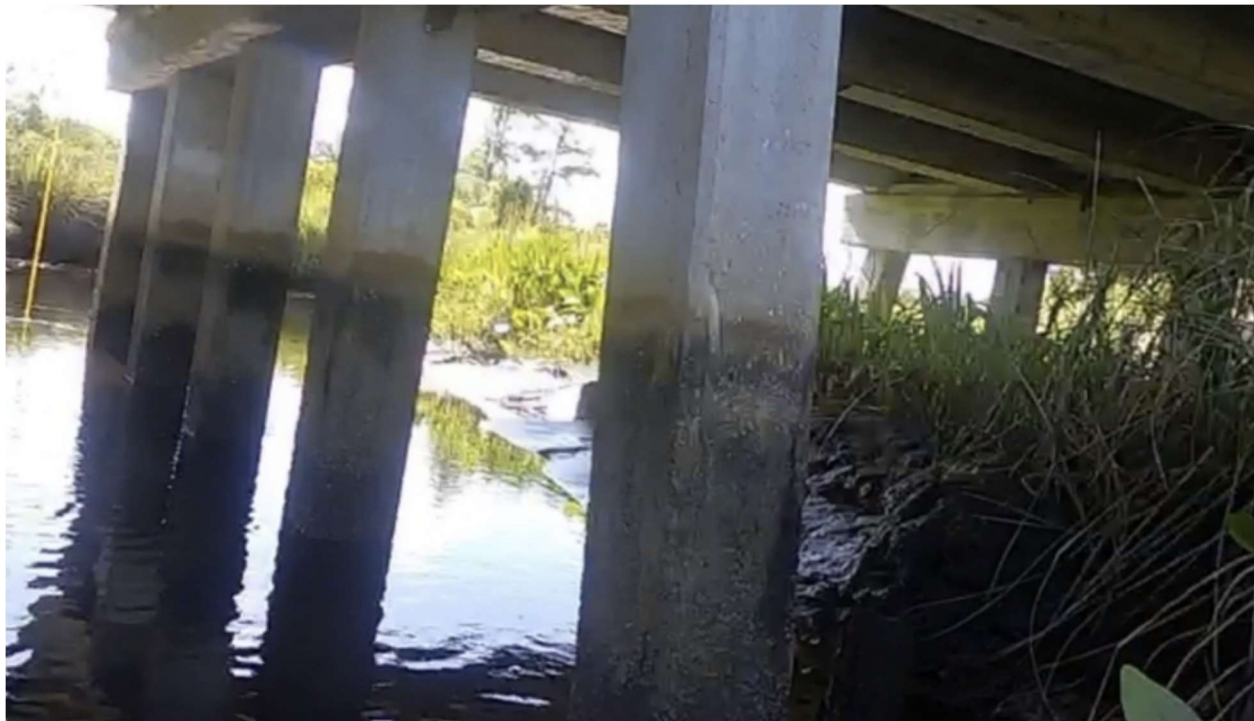
**Figure 285 – Bridge 039-0001-0 Prestressed Concrete Piles Typical Condition (GDOT, 2021)**

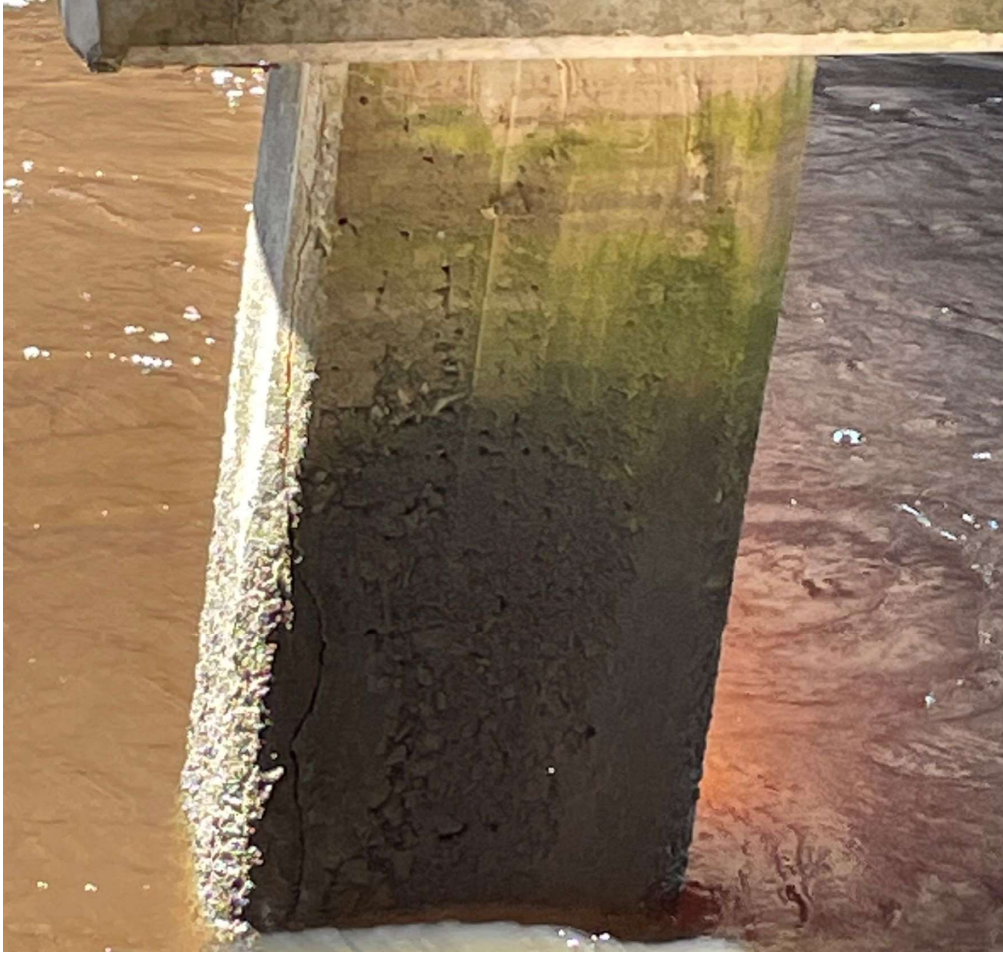
**Figure 286 – Bridge 039-0009-0 Prestressed Concrete Pile Typical Cracking and Abrasion (GDOT, 2021)**

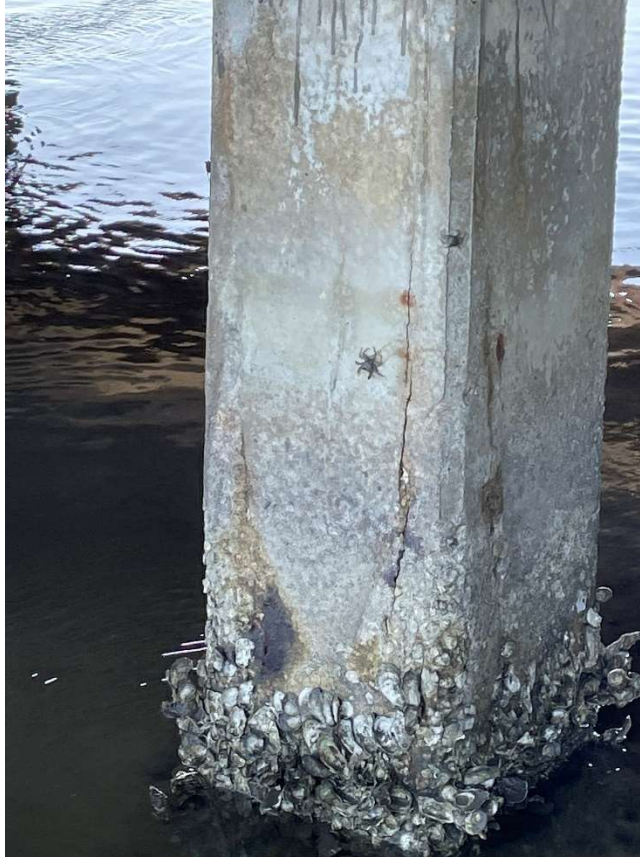
**Figure 288 – Bridge 039-0049-0 Prestressed Concrete Piles Typical Condition (GDOT, 2021)**

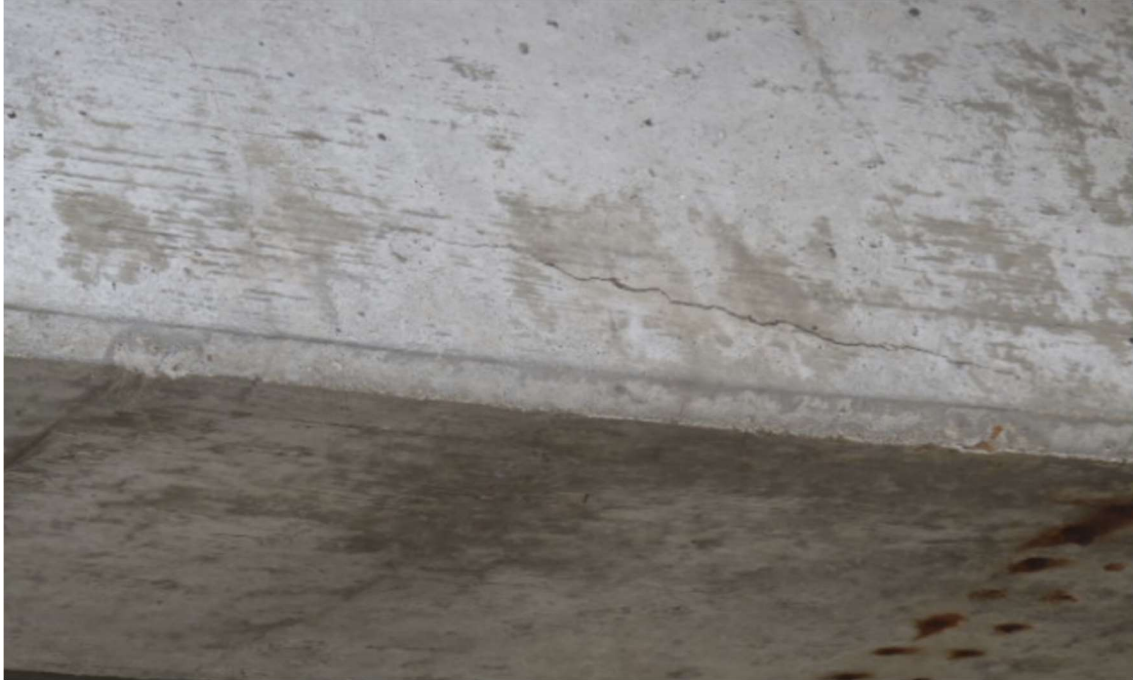
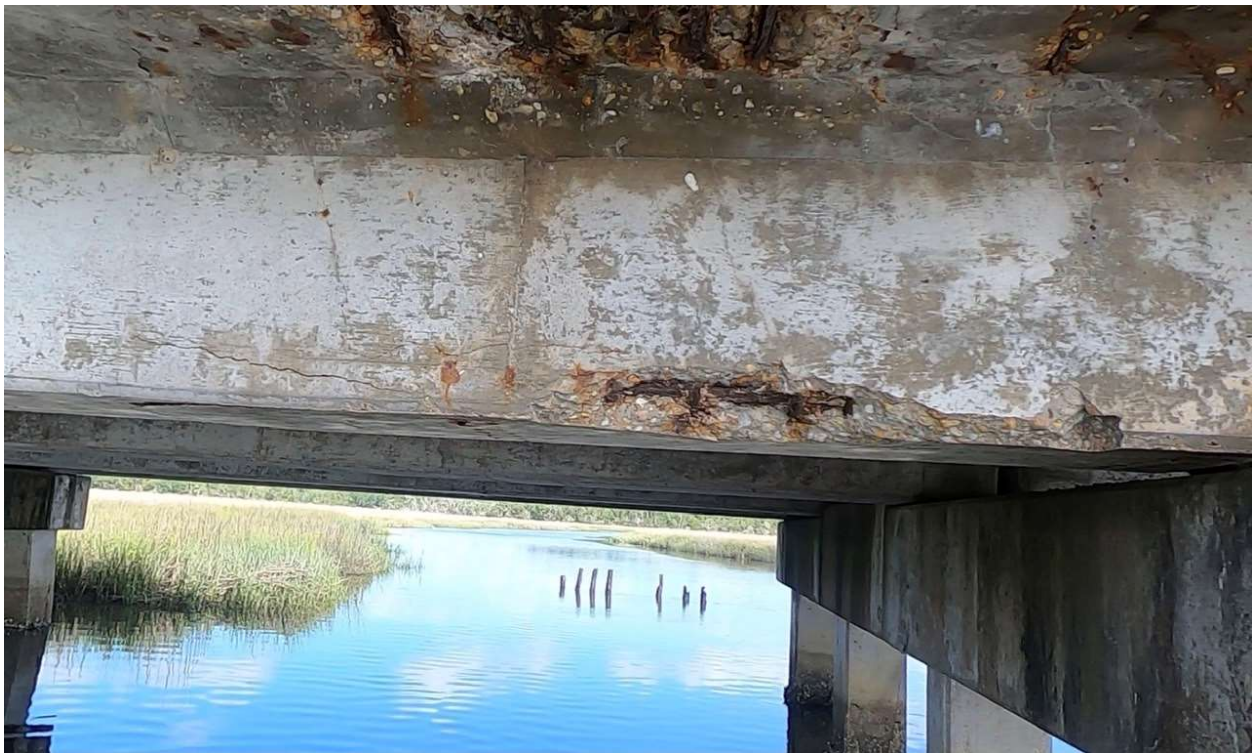
**Figure 289 – Bridge 039-0049-0 Reinforced Concrete Girder Condition 2017 (Top) vs 2021 (Bottom)**

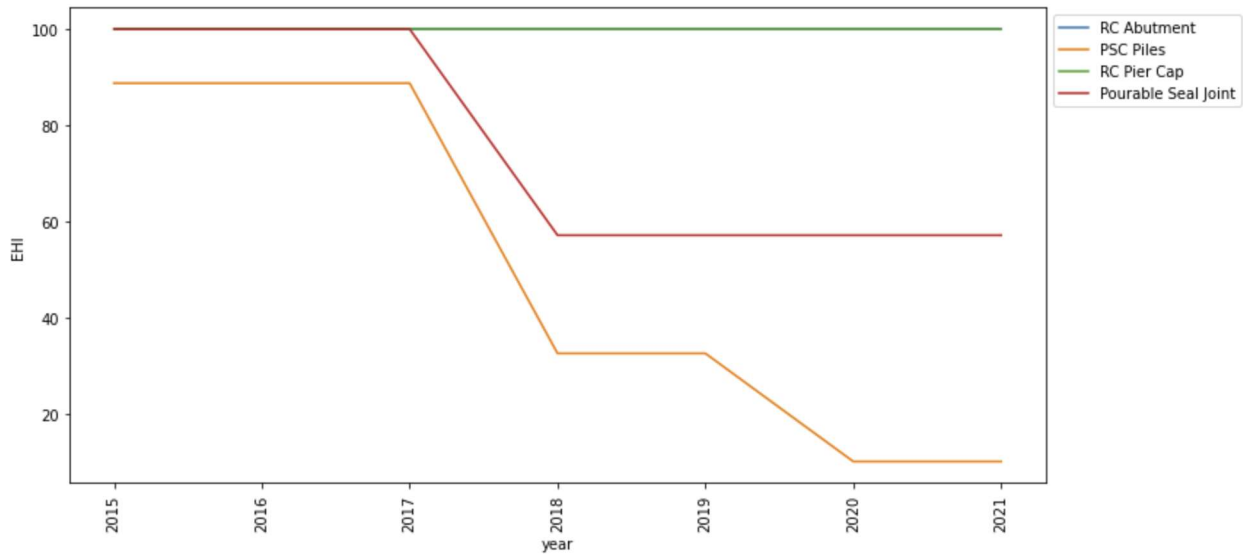
**Figure 290 – Bridge 127-0029-0 EHI by Year**

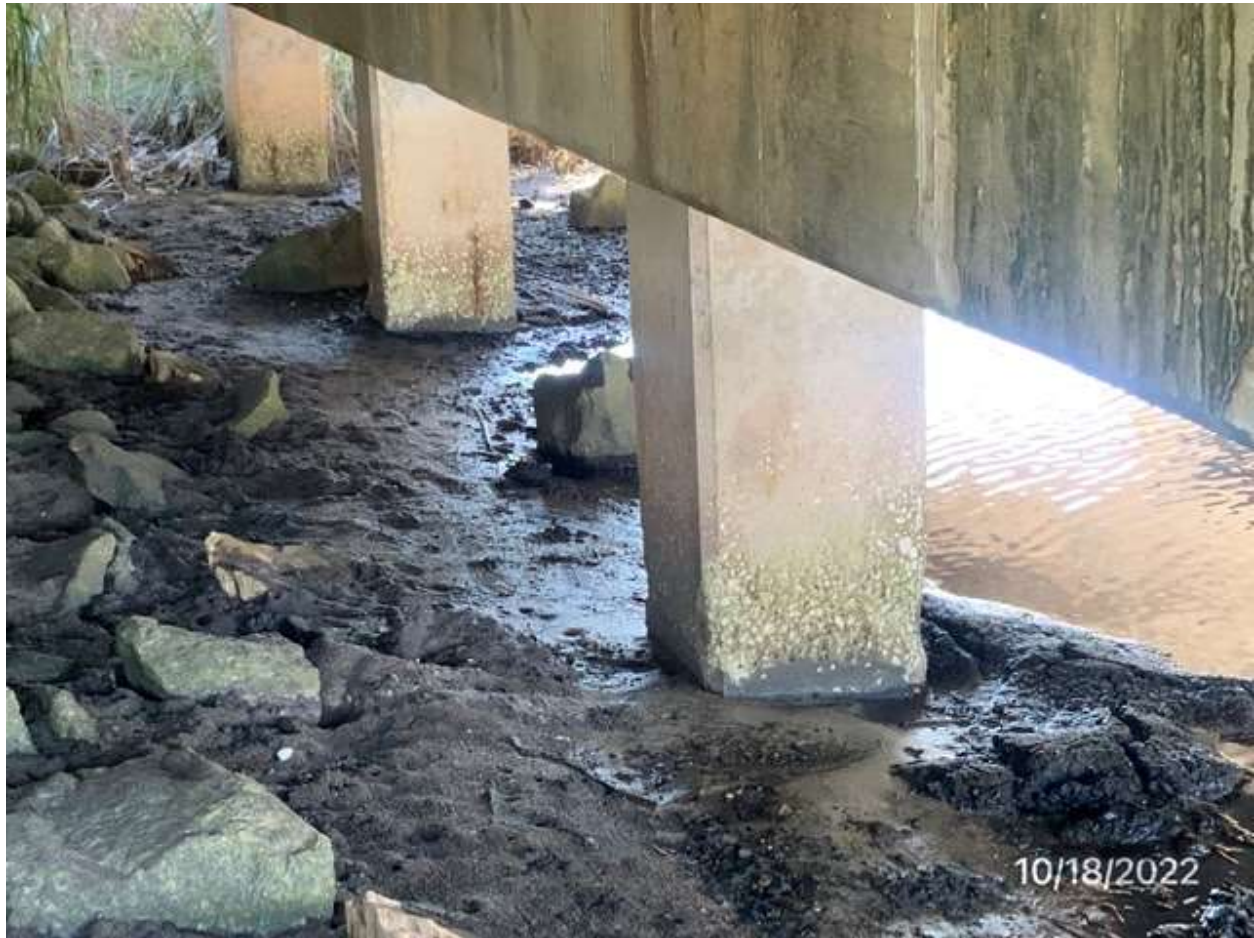
**Figure 291 – Bridge 127-0029-0 Typical Pile Cracking (GDOT, 2022)**

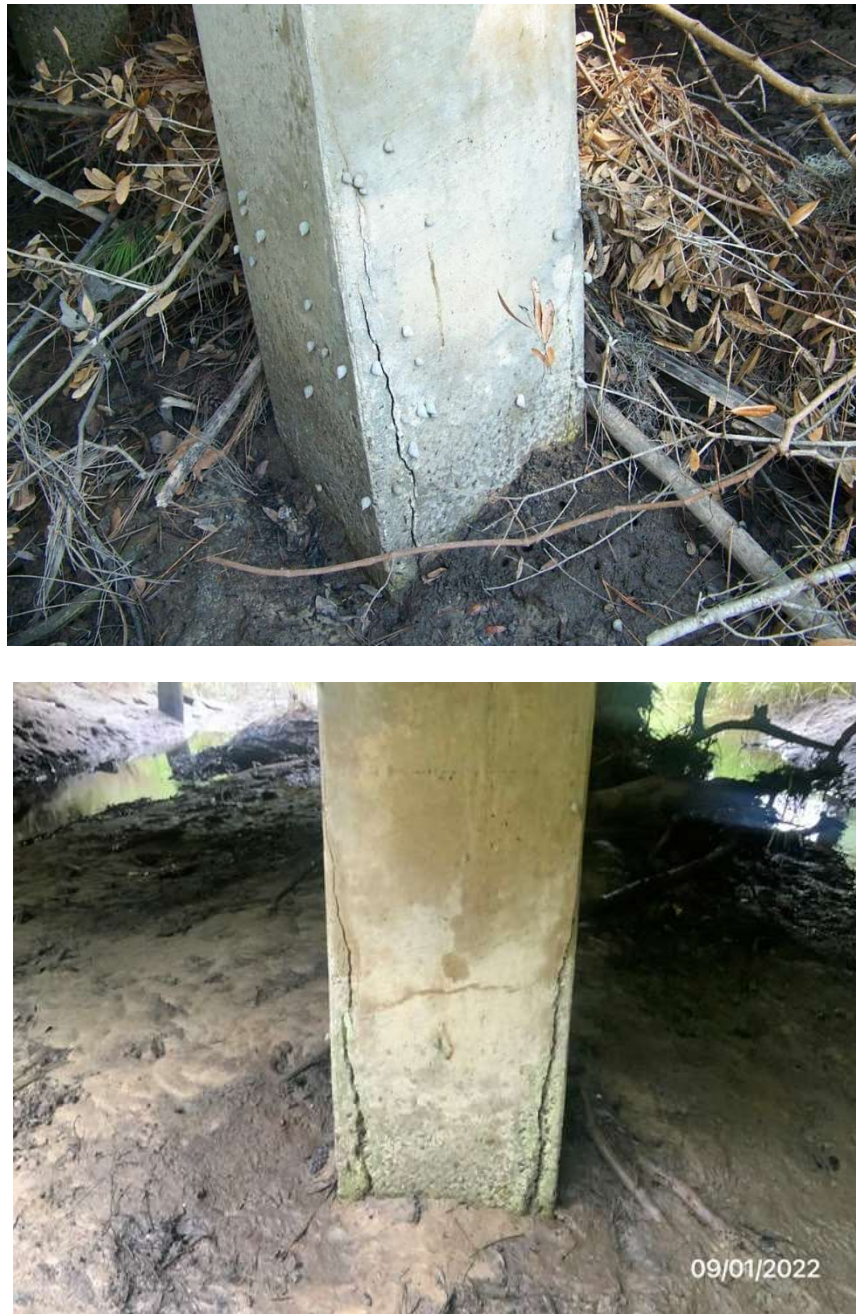
**Figure 292 – Bridge 051-0142-0 Pile Cracking 2014 (Top) vs 2022 (Bottom)**

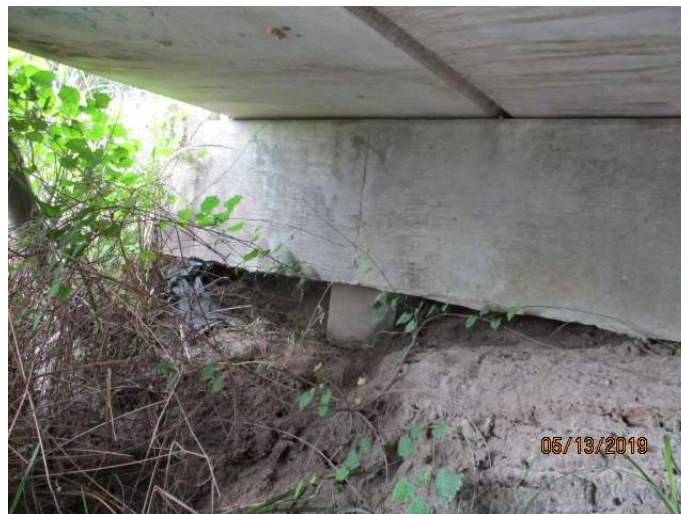
**Figure 293 – Bridge 039-0051-0 Abutment Undermining (GDOT, 2019)**

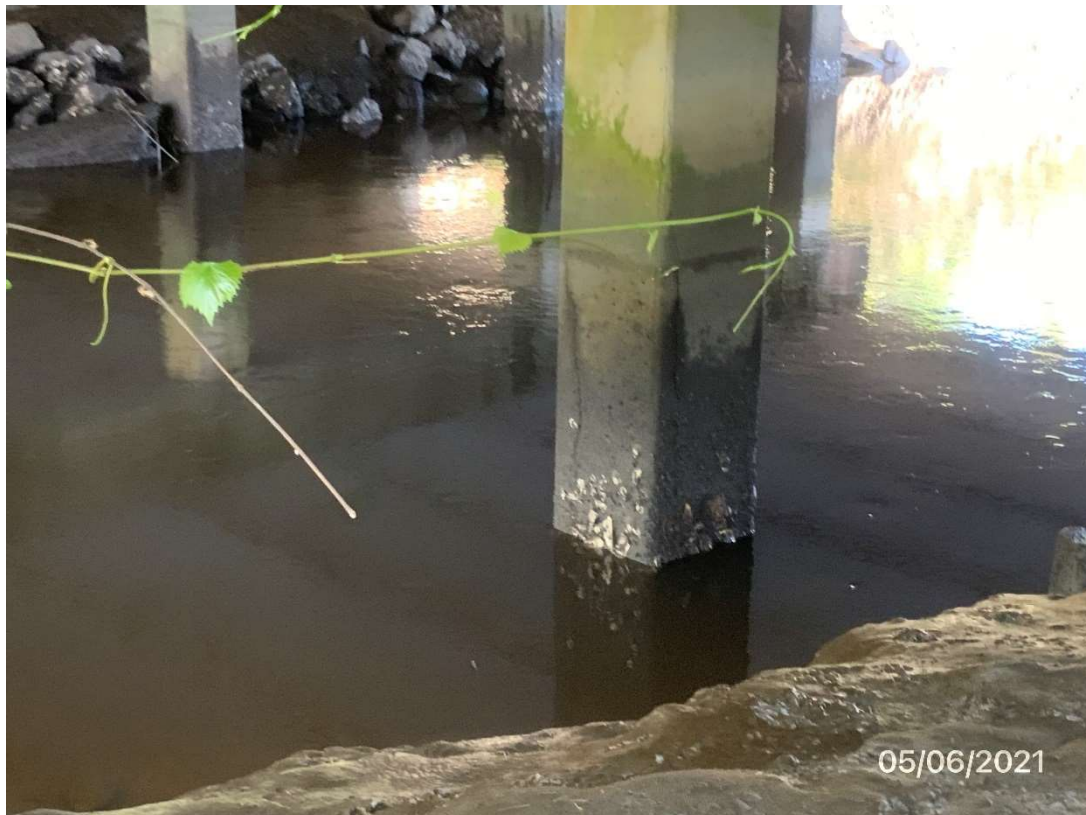
**Figure 294 – Bridge 039-0051-0 Typical Prestressed Concrete Pile Cracking (GDOT, 2021)**

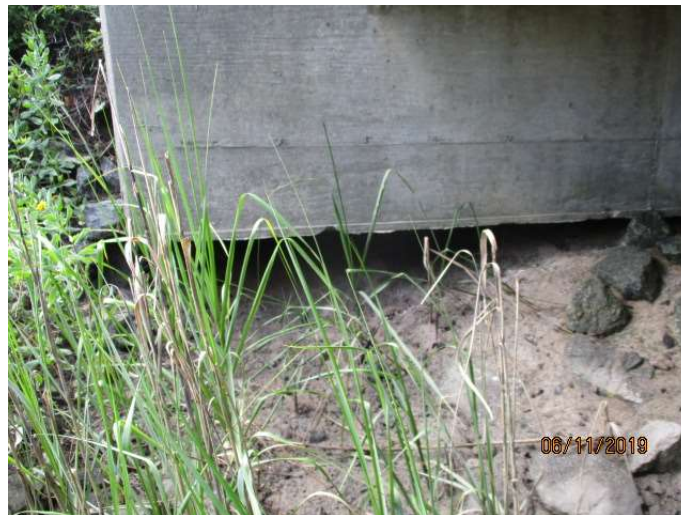
**Figure 295- Bridge 039-5029-0 Abutment Undermining (GDOT, 2019)**

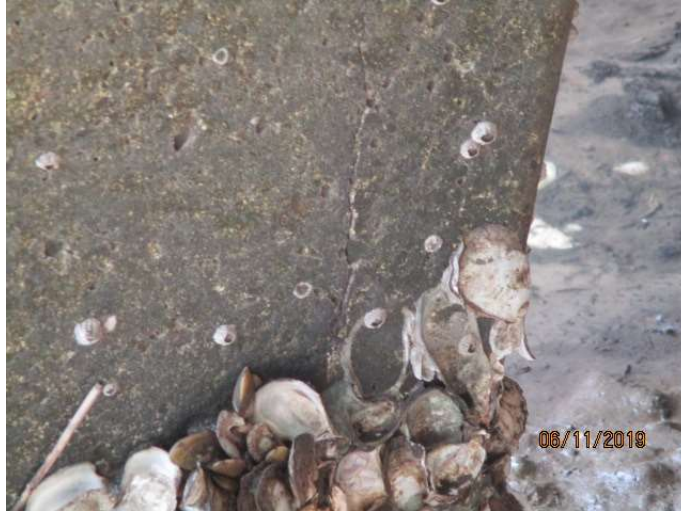
**Figure 297- Bridge 039-5029-0 Pile Cracking (GDOT, 2019)**

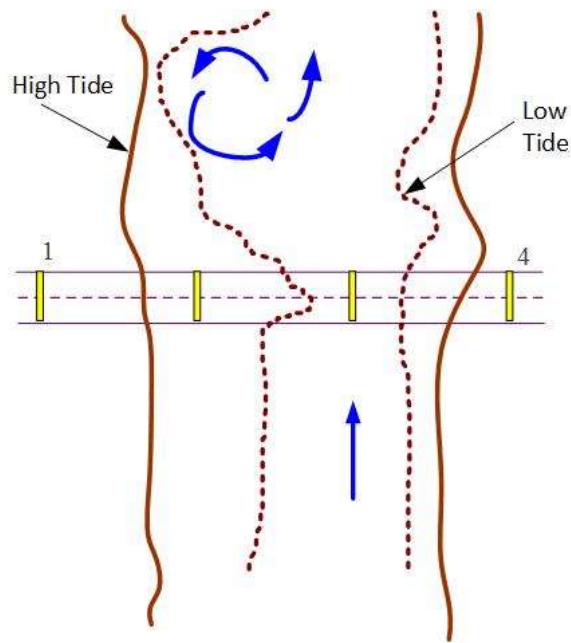
**Figure 298- Bridge 127-0034-0 Plan View (GDOT, 2022)**

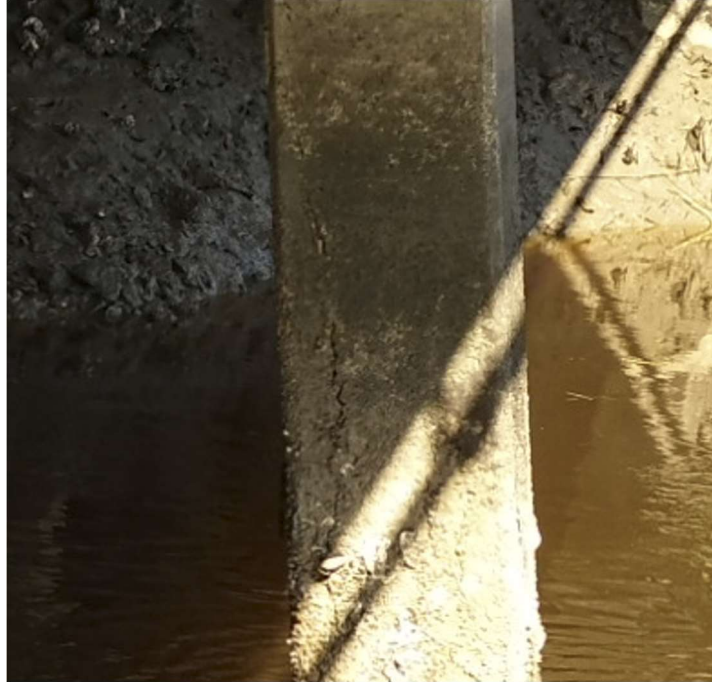
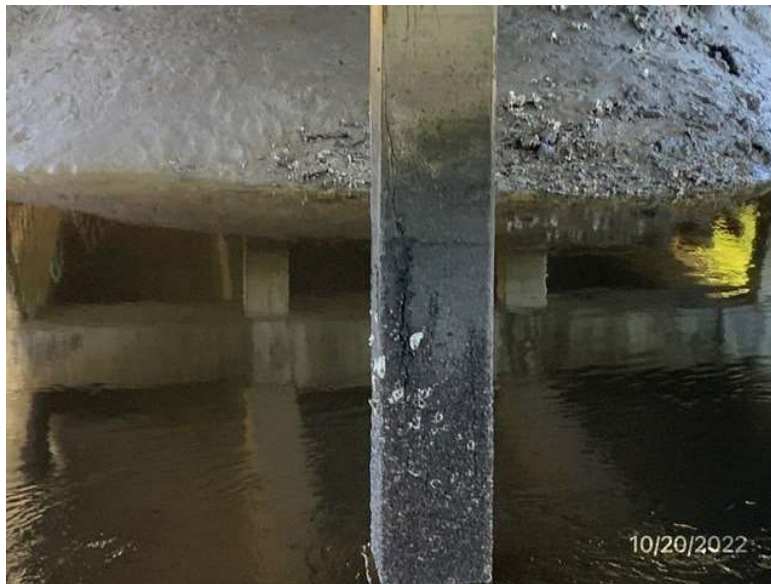
**Figure 299- Bridge 127-0034-0 Bent 3 Pile 2 Cracking 2014 (Top) vs 2022 (Bottom)**

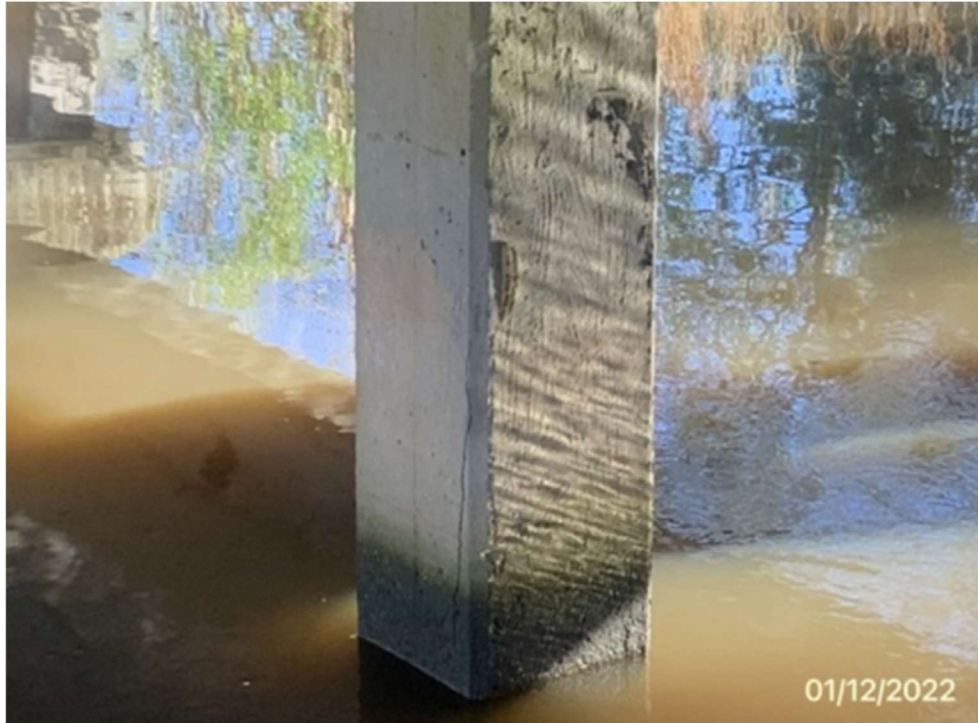
**Figure 300 – Bridge 170-0006-0 Typical Cracking in PSC Piles (GDOT, 2022)**

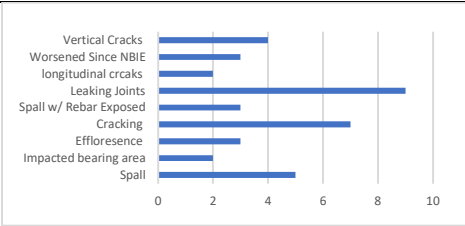
<p>RC Connecting Component - Joints/Cracking/Spalling</p>	<p>2 bridges showed impact of DT32.</p> <p>Impacts of unsealed joints were observed on 8 bridges.</p>
				<p>RC Abutment <i>EN215</i></p>

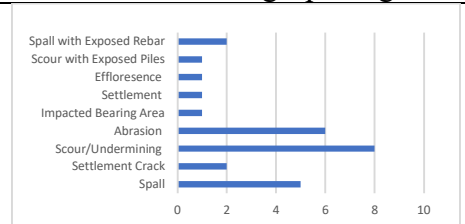
<p>RC Substructure – Scour/Abrasion by Rainfall/Spalling</p>	<p>In addition to the 10 bridges studied, 16 additional bridges were observed with deteriorated abutments.</p> <p>22/26 bridges were impacted by rainfall.</p>
				<p>RC Pier Wall <i>EN210</i></p>

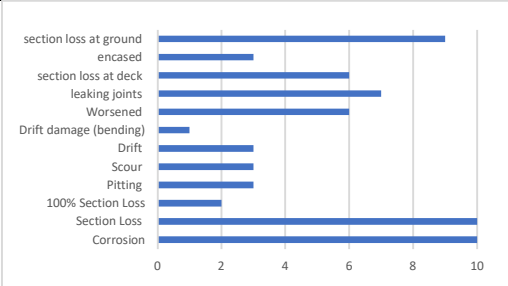
<p>Steel Substructure - Section Loss and Corrosion</p>	<p>9 bridges showed impact of a DP10 environment</p>

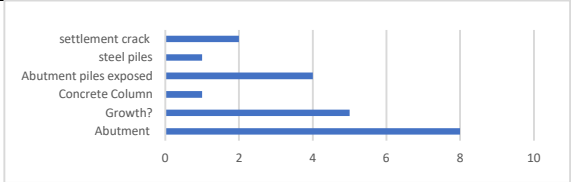
<p><b>Abutment/Scour/Erosion</b></p>	<p>All 10 bridges showed signs of weather impact.</p> <p>Half of the bridges showed rapid scouring/erosion</p>

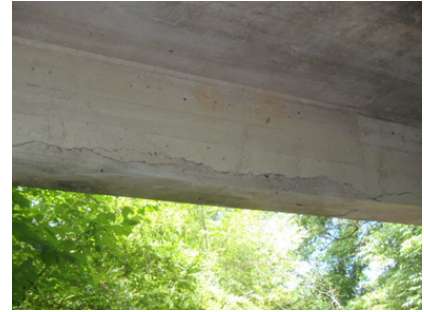
Concrete Spalling – Concrete Spalling is the flaking/chipping of the surface of a concrete surface. This leads to loss of material, and the potential for reinforcing steel to be exposed

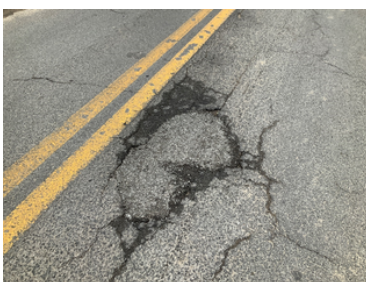
Freeze-Thaw Cycle – A freeze-thaw cycle is water's repeated freezing and thawing. When water freezes, it expands which can lead to cracking, spalling, and degradation of concrete bridge elements and can lead to the settlement of bridge abutments.

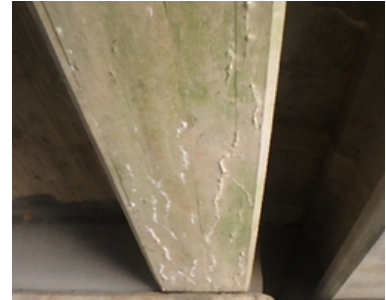
Scour - the erosion of soil around the foundation of a bridge caused by water.

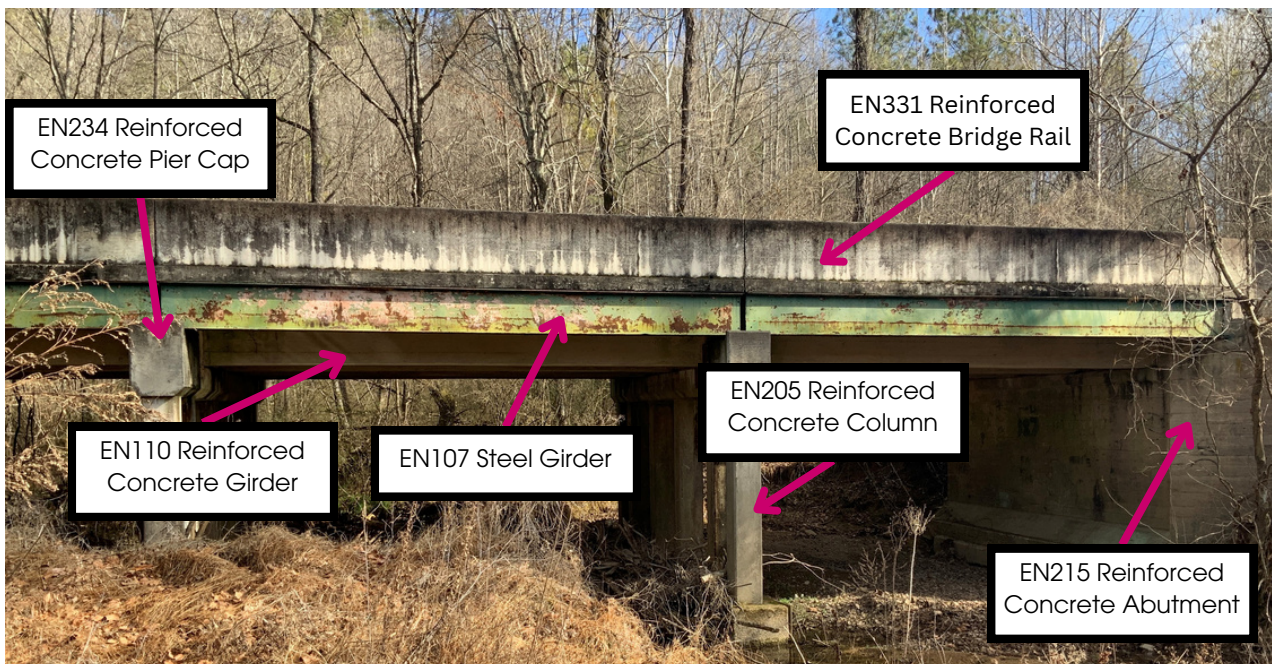
An example of a bridge broken down element by element is shown below:

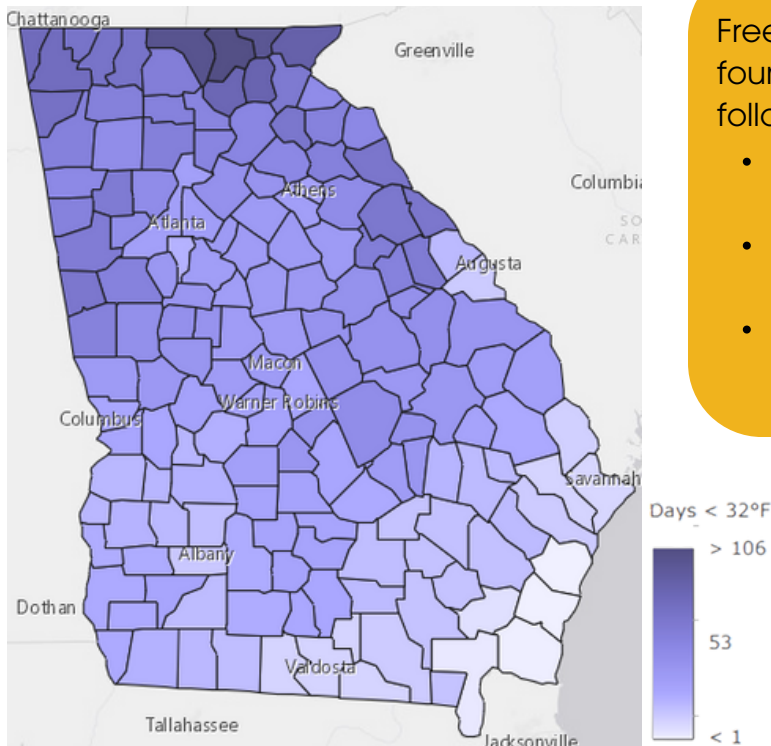
Freezing temperatures are found to impact the following bridge elements:

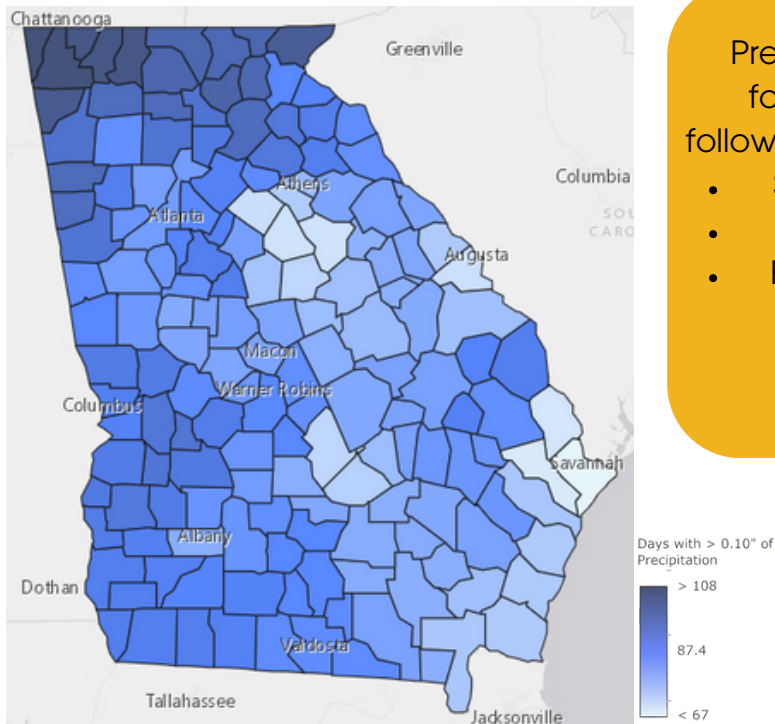
Precipitation has been found to impact the following bridge elements.
