IMPACT OF WEATHER STRESSORS TO IDENTIFY VULNERABLE BRIDGE ELEMENTS  
IN GEORGIA TOWARDS DATA DRIVEN ASSEST MANAGEMENT

by SPENCER KOPF

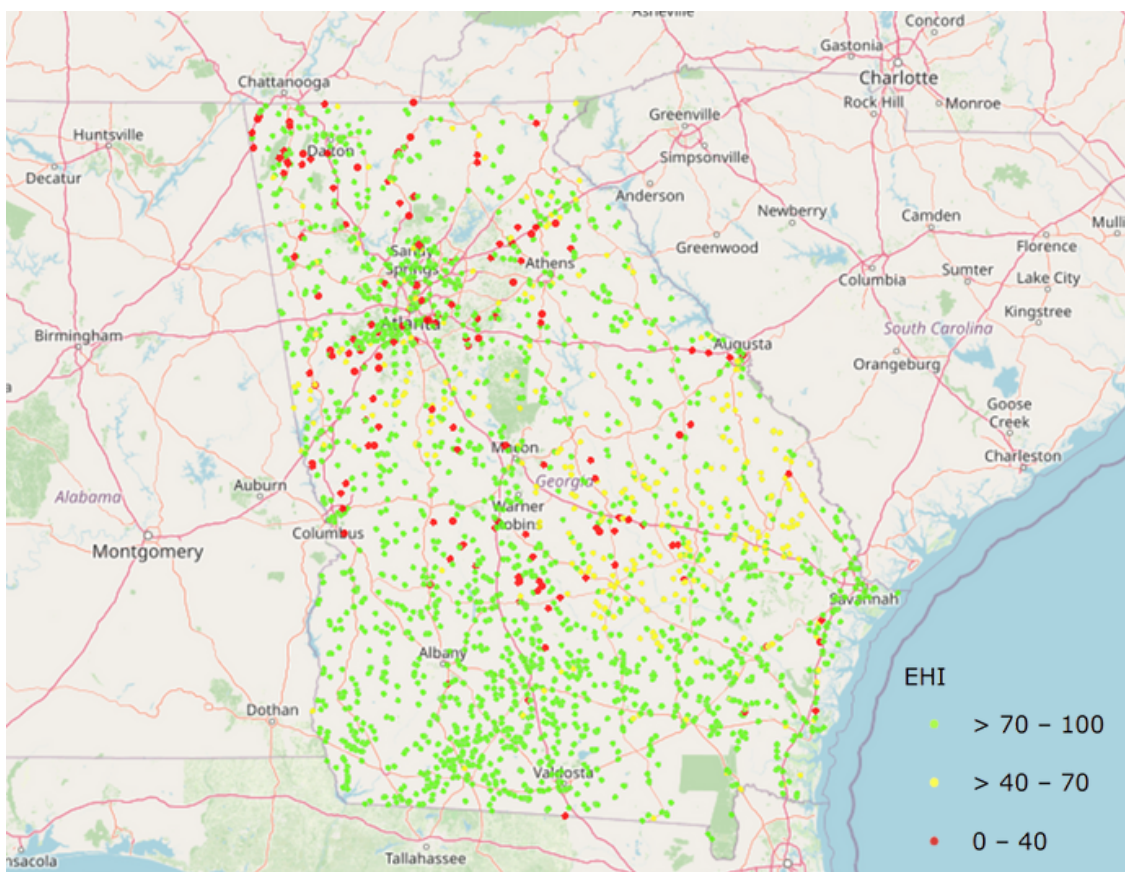
*Reinforced Concrete Top Flange EHI by Location*

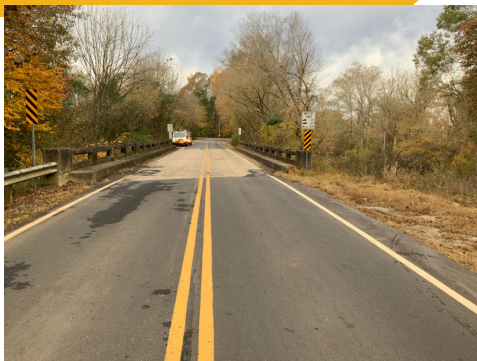
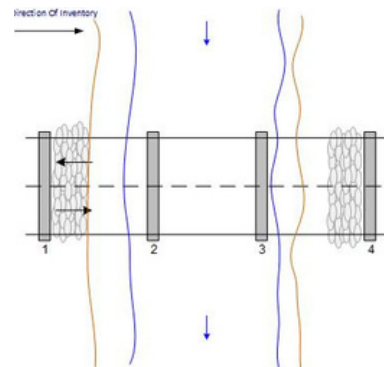
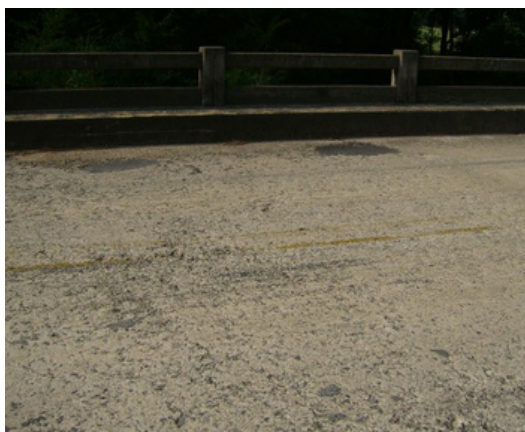
In this time, the county tried to mitigate the impacts by patching spalls. However, a better course of action for this bridge would have been a protective overlay to protect the whole deck. The patching did not improve the deck condition or help stop the weather impact. Although more expensive up front, an overlay would have improved the condition of this bridge.

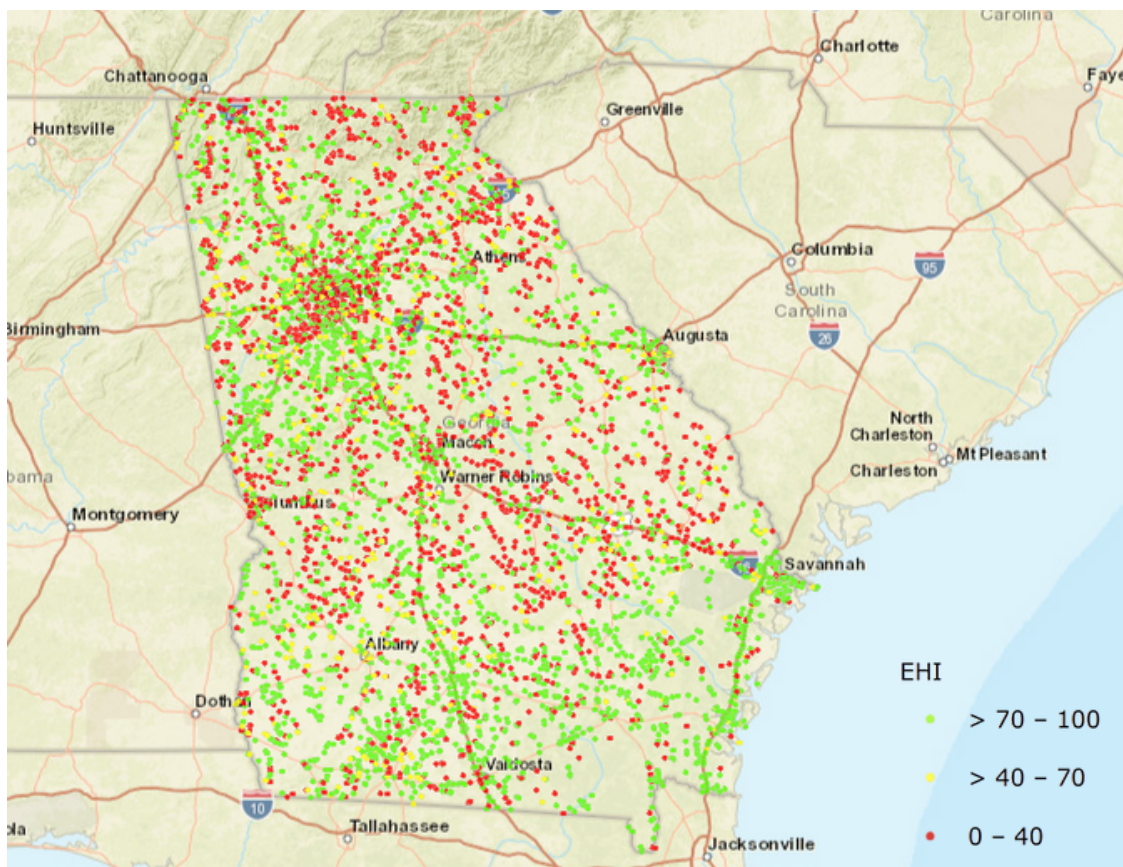
*Pourable Joint Seal by EHI*

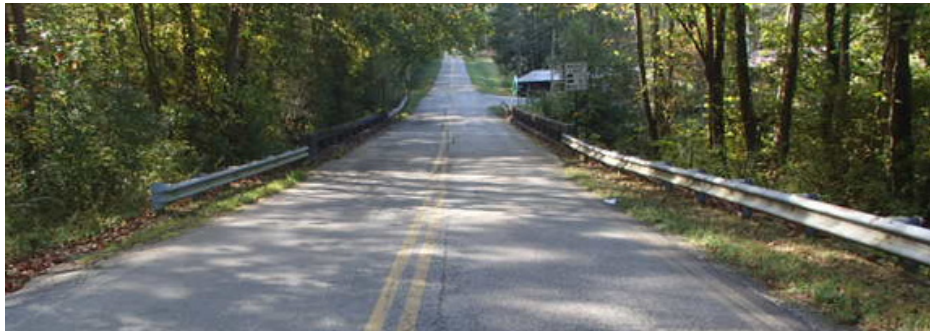
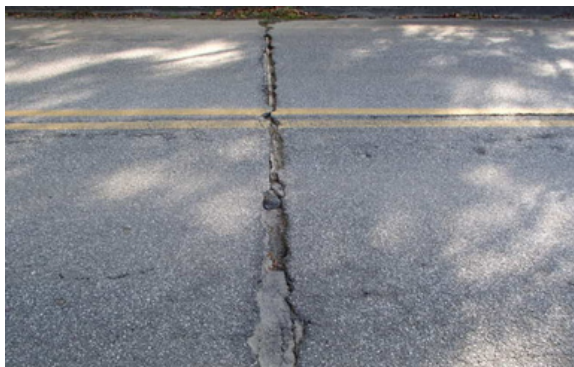
Sealing piles is a small cost that can protect the condition of bridge elements

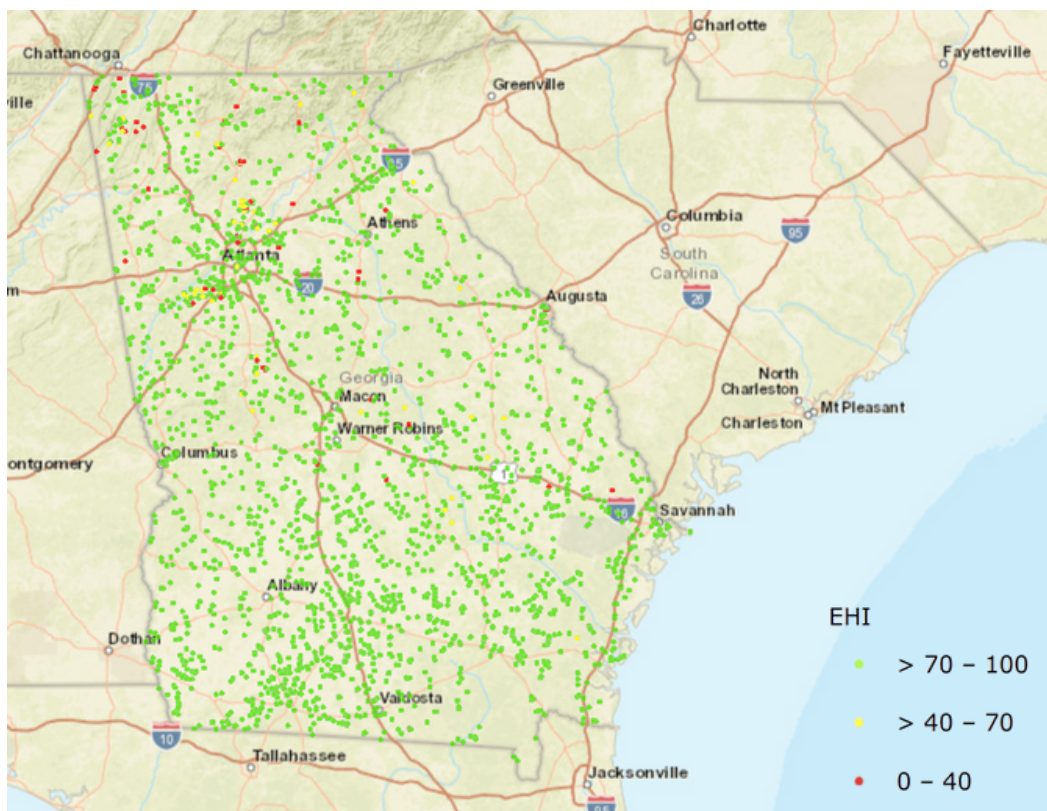
*Reinforced Concrete Girder EHI by Location*

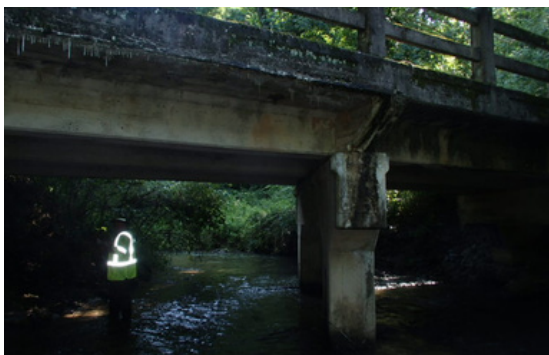
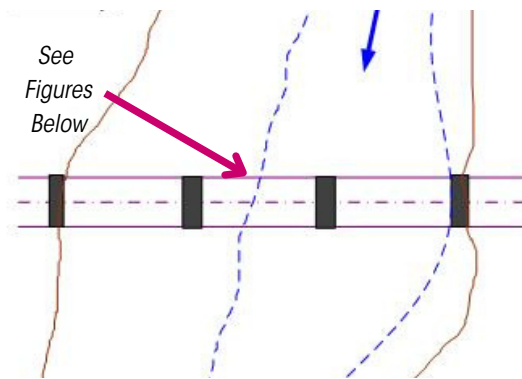
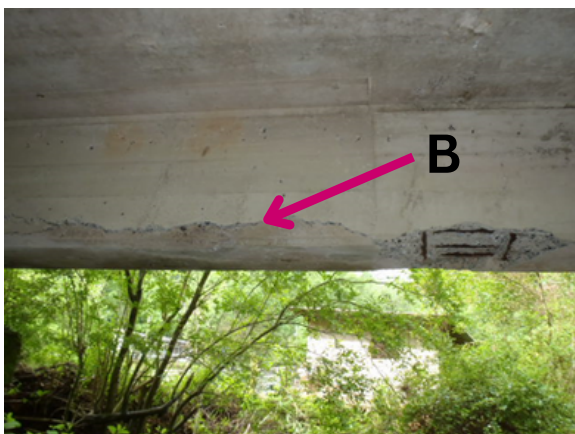
The estimated cost of repairing these overhead cracks in 2014 might have been around \$2,000. Because of the age of the structure and this deteriorating condition, this bridge will have to be replaced in the near future.

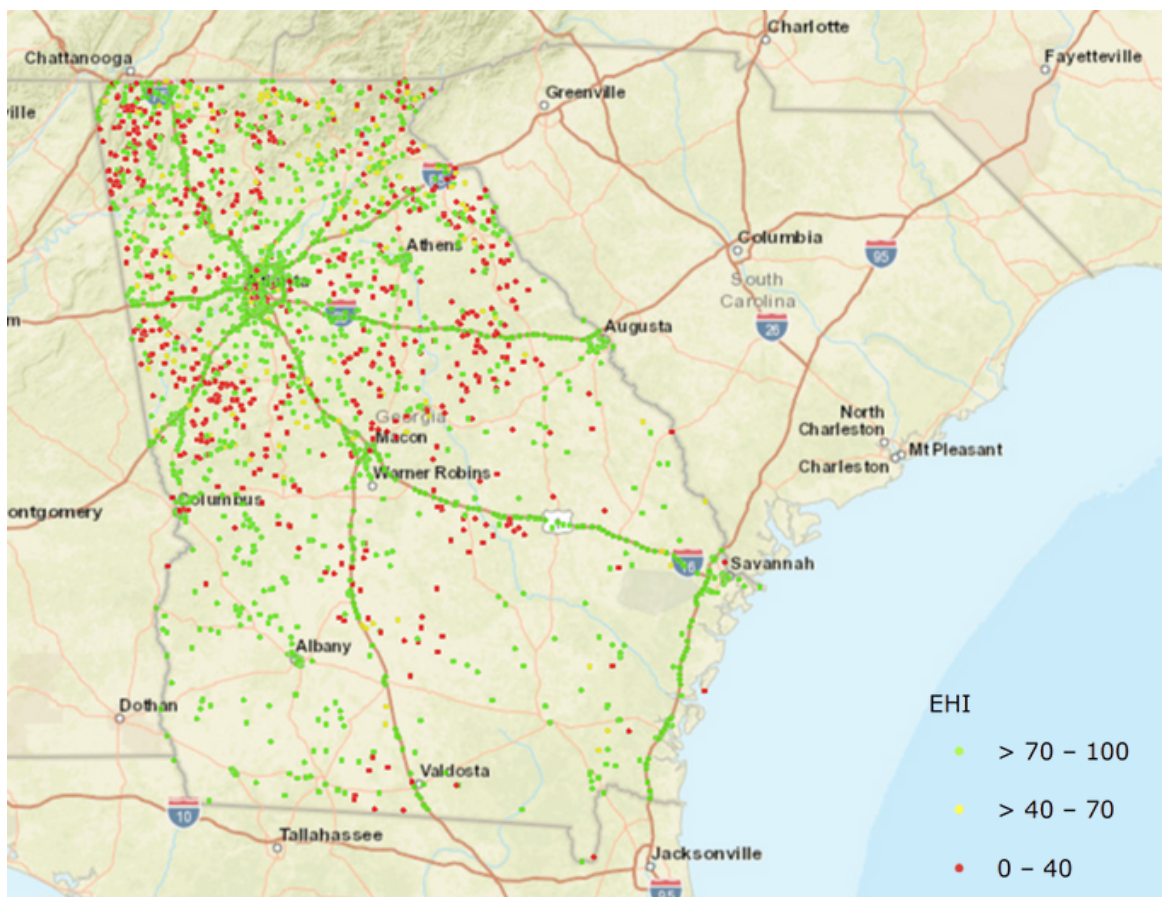
*Steel Girder EHI by Location*

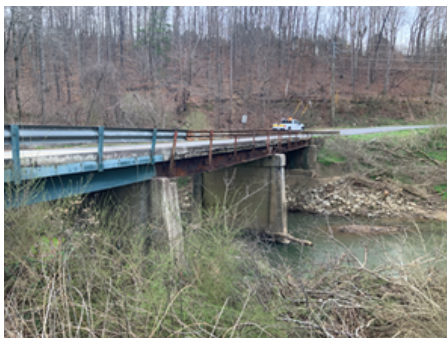
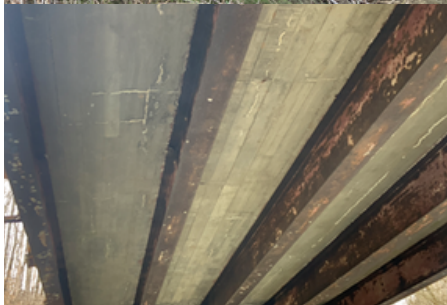
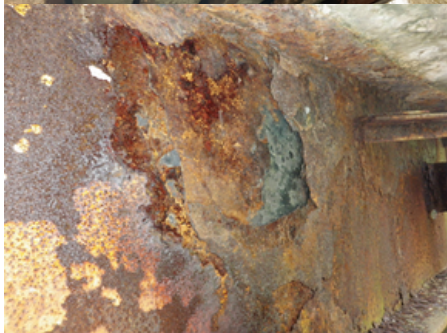
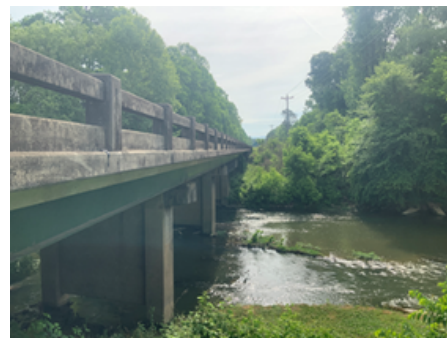
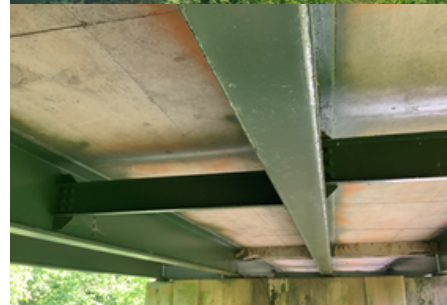
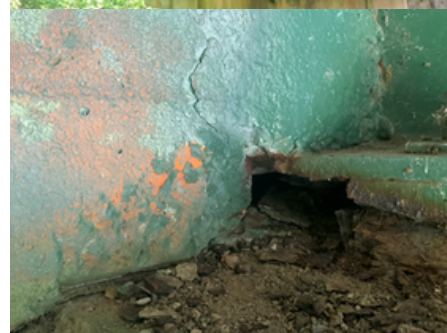
# VULNERABLE ELEMENTS

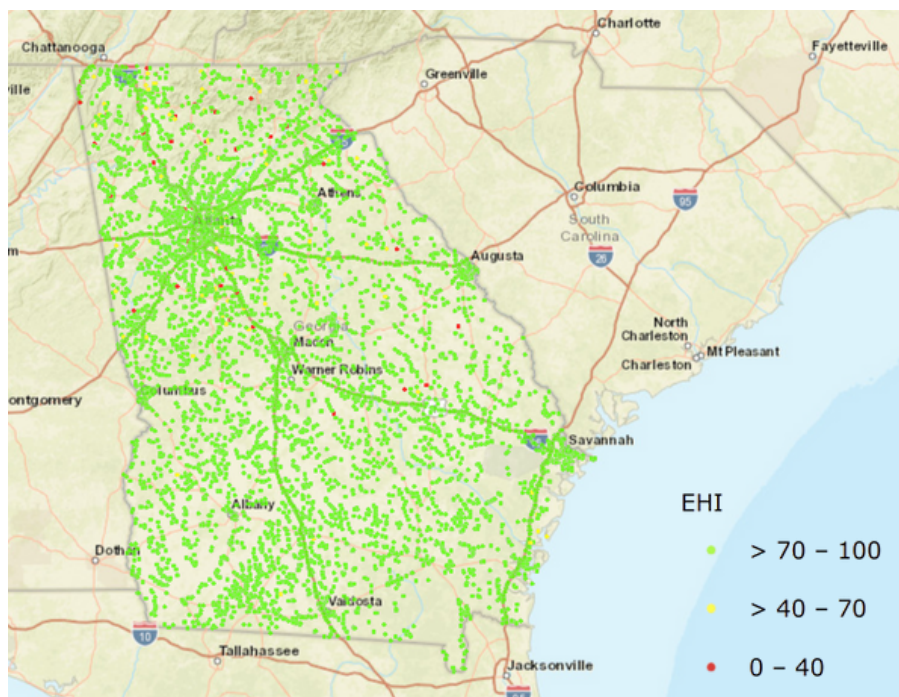
*Reinforced Concrete Pier Cap EHI by Location*

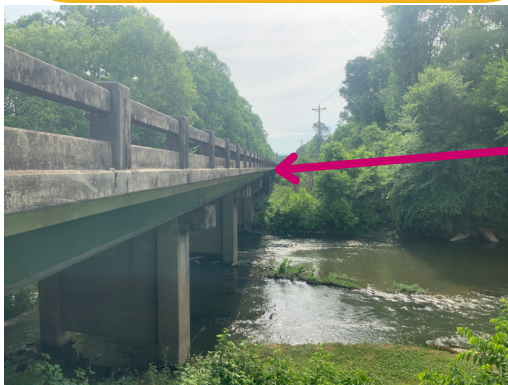
To repair the new spalling 6 years later in the pier cap alone will cost ~\$2,000, and the joints will still need to be sealed (>\$3,900). If these spalls are left unaddressed, it will likely result in a load posting on this bridge.

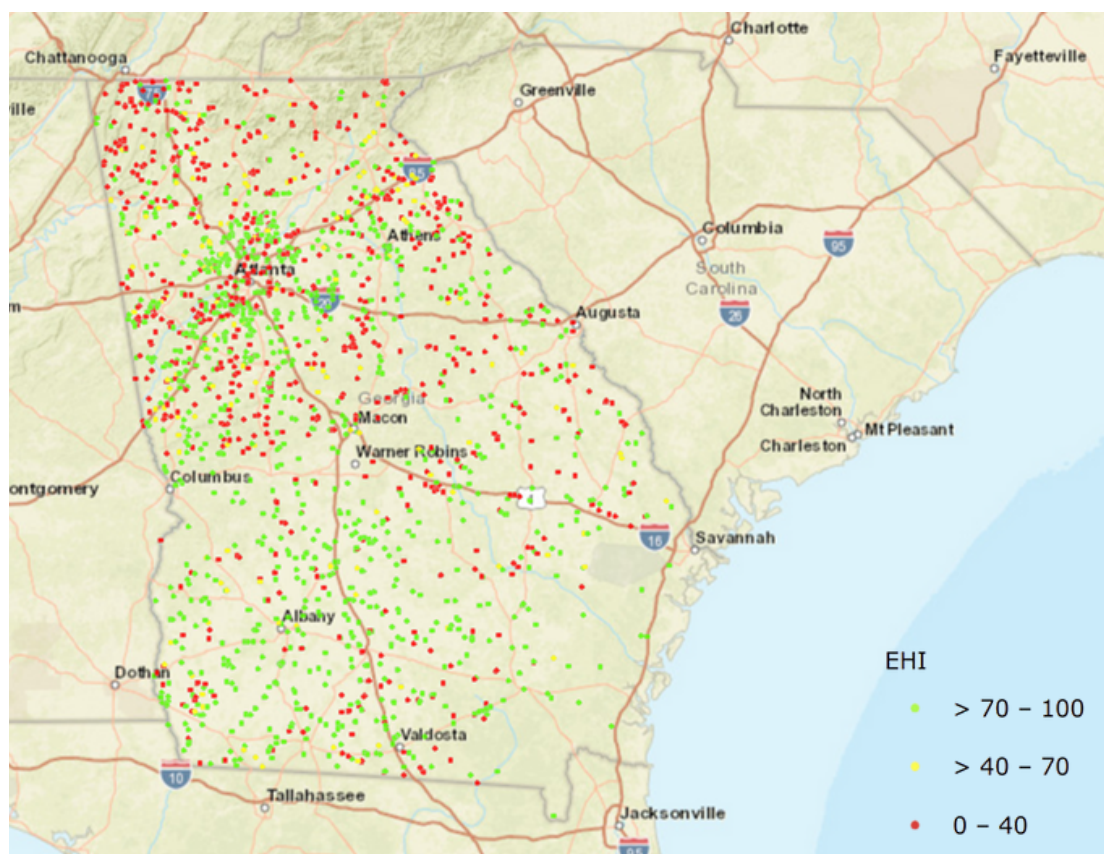
*Steel Pile EHI by Location*

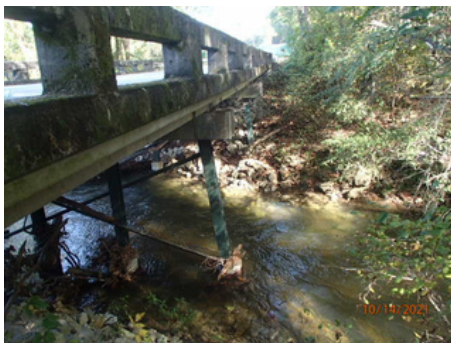
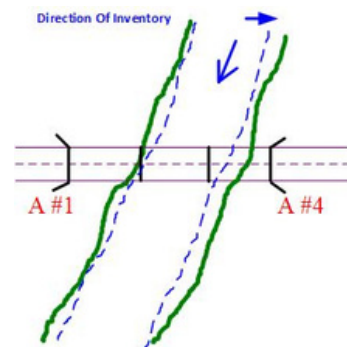
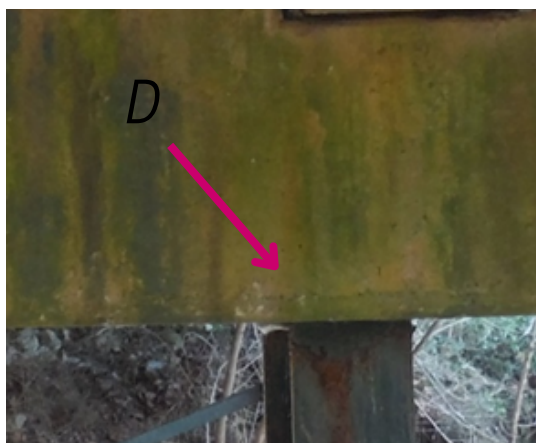
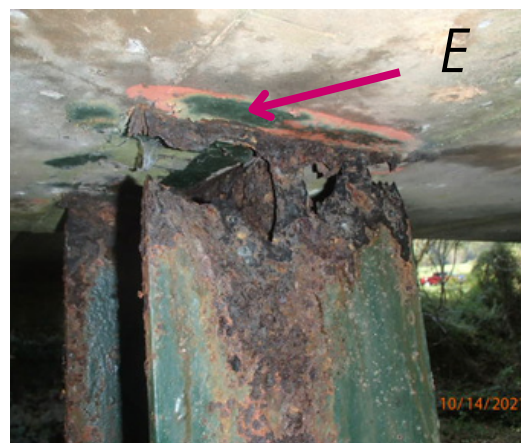
The bridge closure could have been avoided if the piles had been cleaned and painted. This would have only cost ~\$6,000.

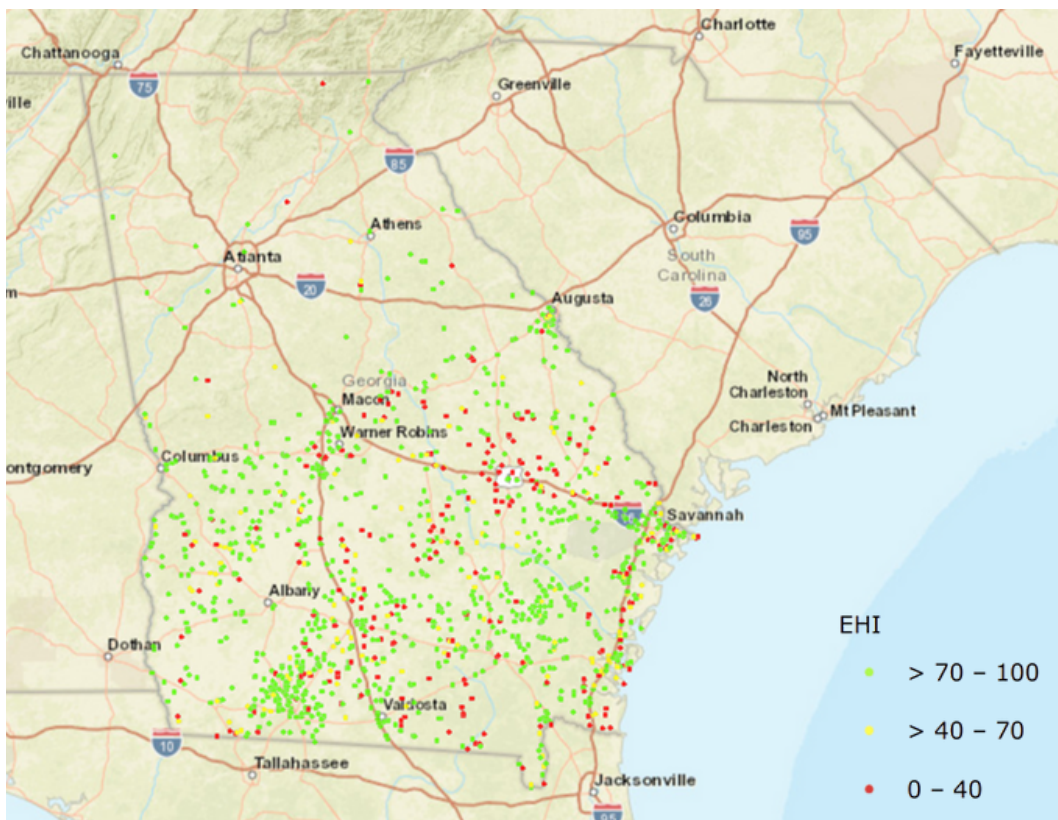
*Prestressed Concrete Pile EHI by Location*

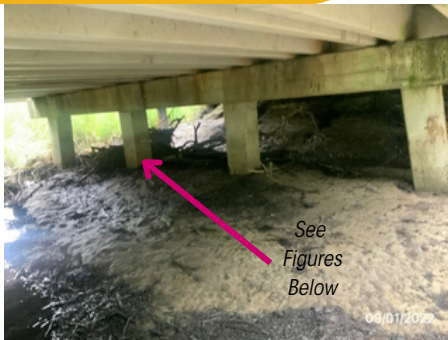
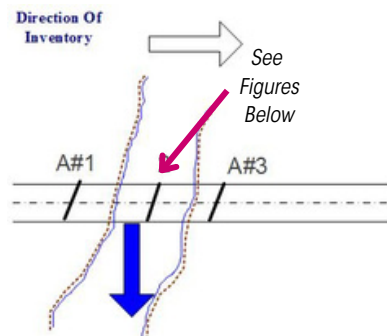
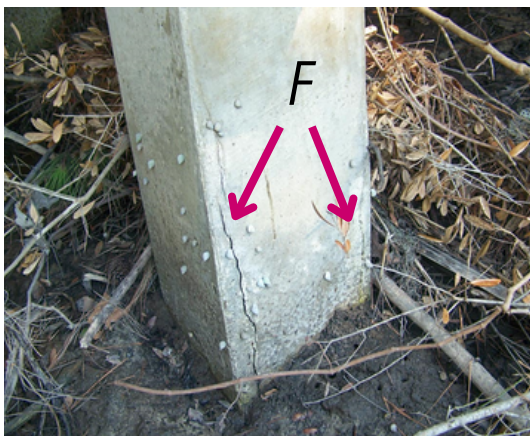
Repairing cracks by means of a crack injection and/or sealing in 2014 would have been ~\$200. However, the pile will likely need repair and a jacket wrap to support the superstructure. Leading to an increased cost in repair costs.

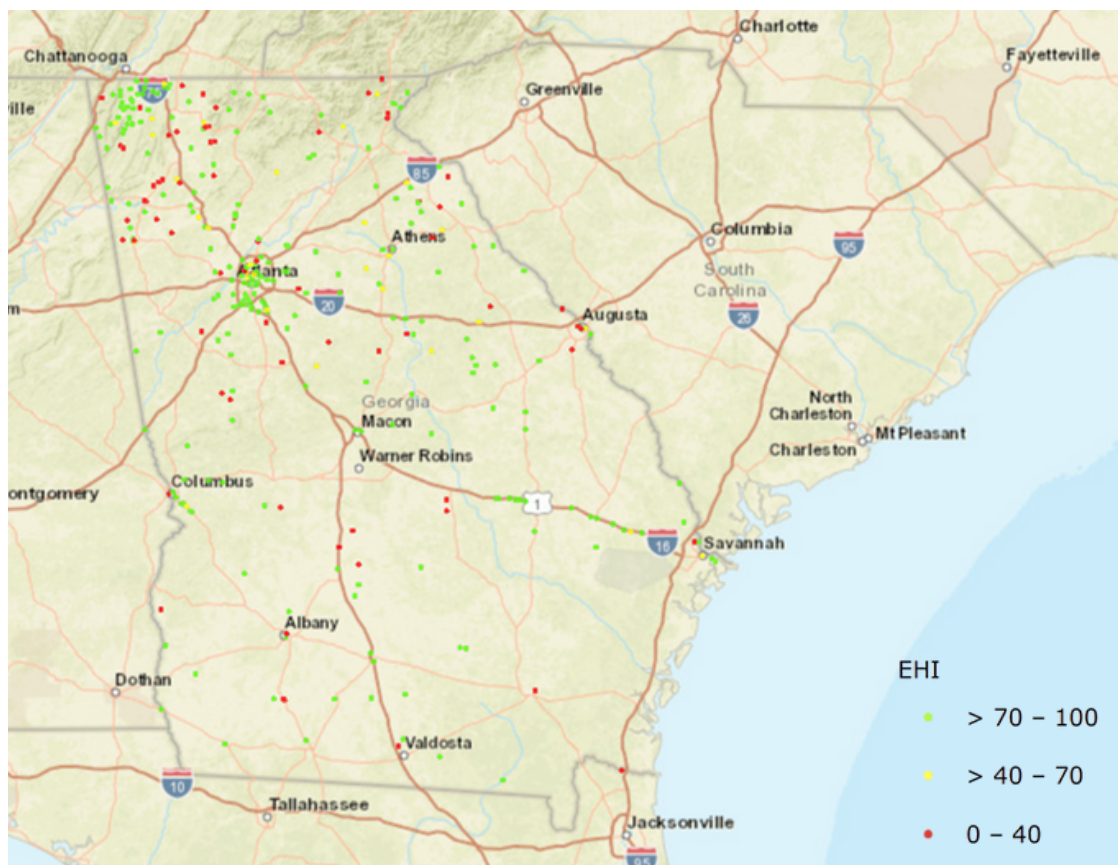
*Reinforced Concrete Pier Wall EHI by Location*

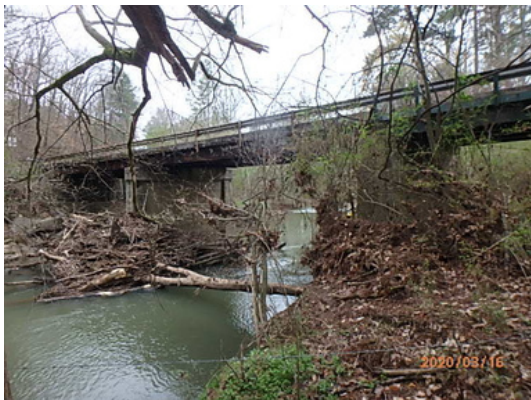
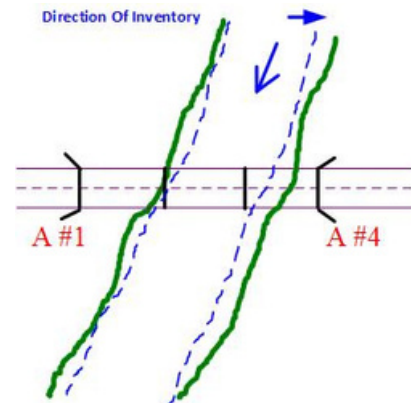
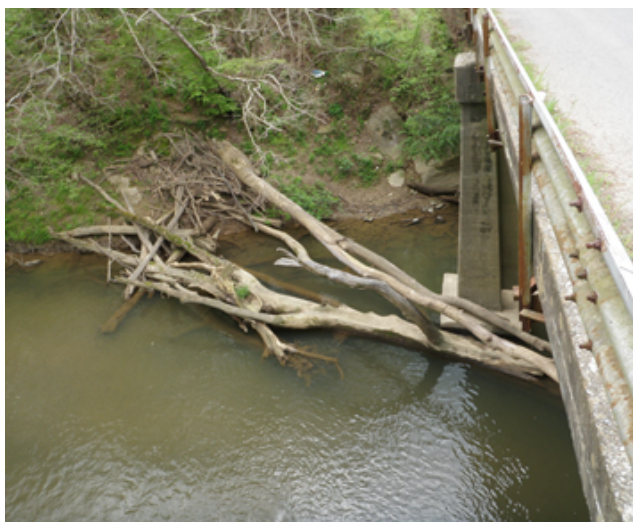
Drift can cause scouring or potentially damage other substructure elements.

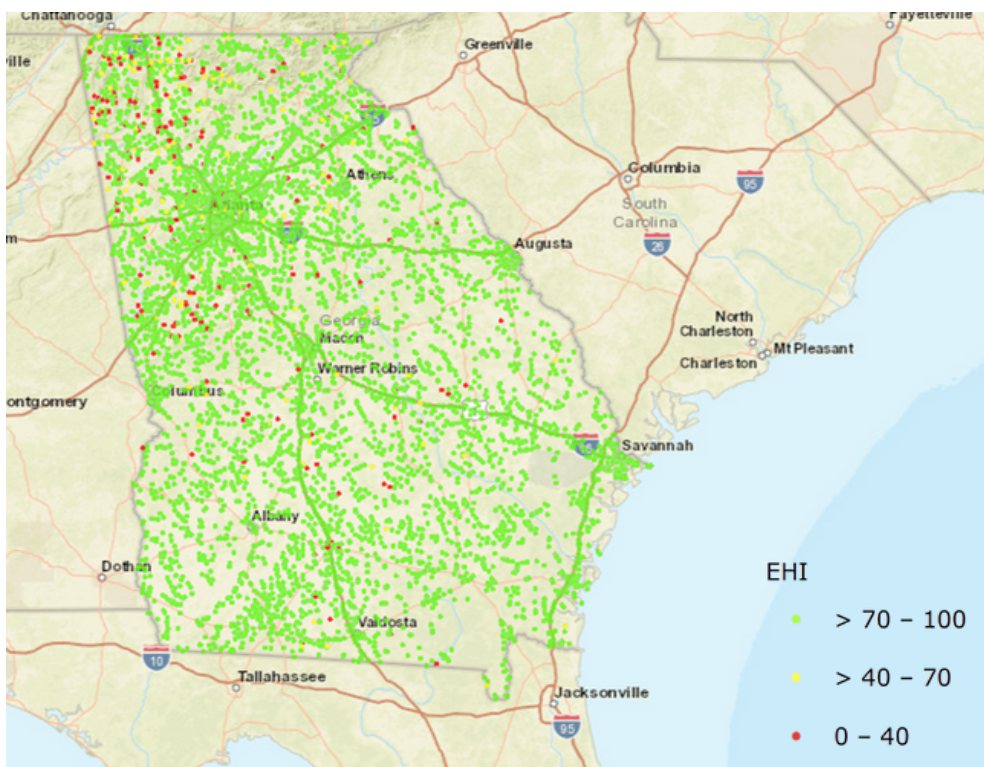
*Reinforced Concrete Abutment EHI by Location*

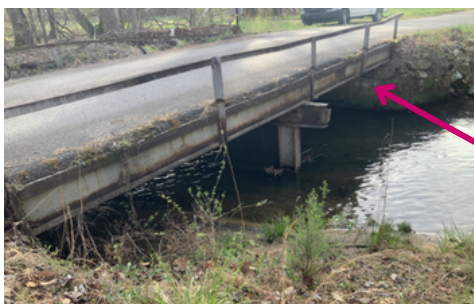
Due to the location of the spall (see G), under a bearing area, the bridge's load capacity was also impacted by the deterioration.

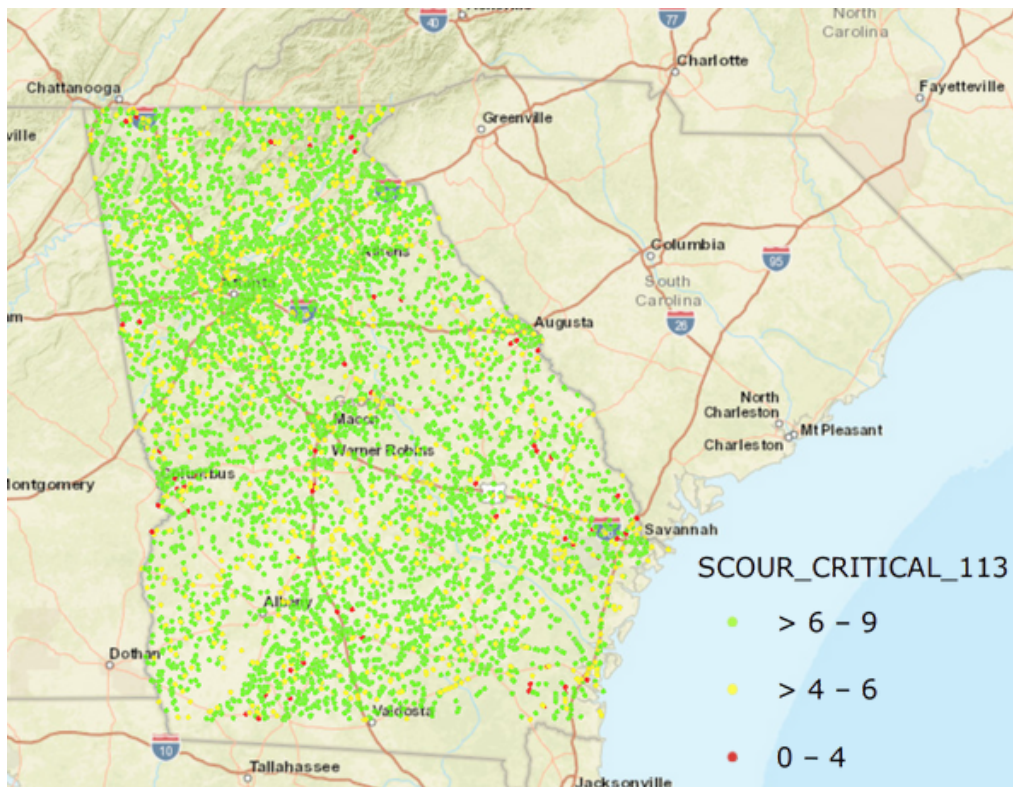
*Scour Critical Assets by Location*

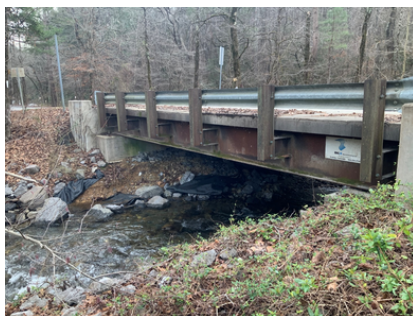
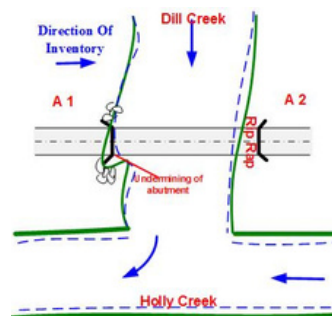
This scour also dropped the NBI substructure rating of the bridge from a 9 to a 5. This is a perfect example of how an earlier repair would save money.
