EVALUATING THE PERFORMANCE OF GEORGIA'S CRCPs USING
GROUND PENETRATION RADAR (GPR)

INDEX WORDS: Continuously Reinforced Concrete Pavement, Ground Penetration Radar, Eddy Current Technique, Condition Assessment

A Thesis Submitted to the Graduate Faculty of The University of Georgia in Partial Fulfillment
of the Requirements for the Degree

MASTER OF SCIENCE

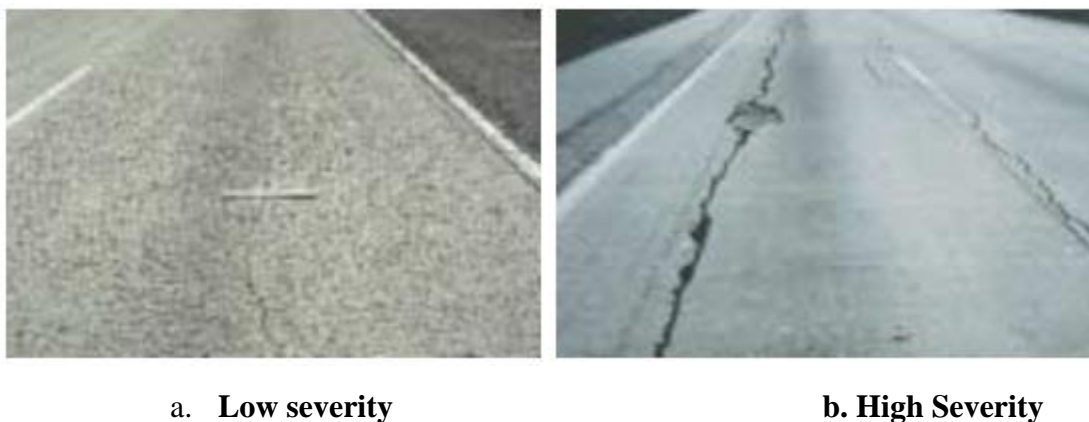
Figure 3.5- The examples of severity levels of longitudinal cracks (FHWA 2003)

Longitudinal cracks have three different severity levels (low, moderate, and high) (FHWA 2003). These cracks at low severity have no spalling or faulting and crack widths are less than 0.12 in (3 mm). At moderate severity level, the cracks ranged from 0.12 in (3 mm) to 0.52 in (13 mm) in width have spalling or faulting, which are less than 3 in (75 mm) and 0.52 in (13 mm), respectively. The cracks at the high severity are more than 0.5 in (13 mm) in width; with spalling formed more than 2.95 in (75 mm) or with faulting formed more than 0.5 in (13 mm) as is seen from Figure 3.5.

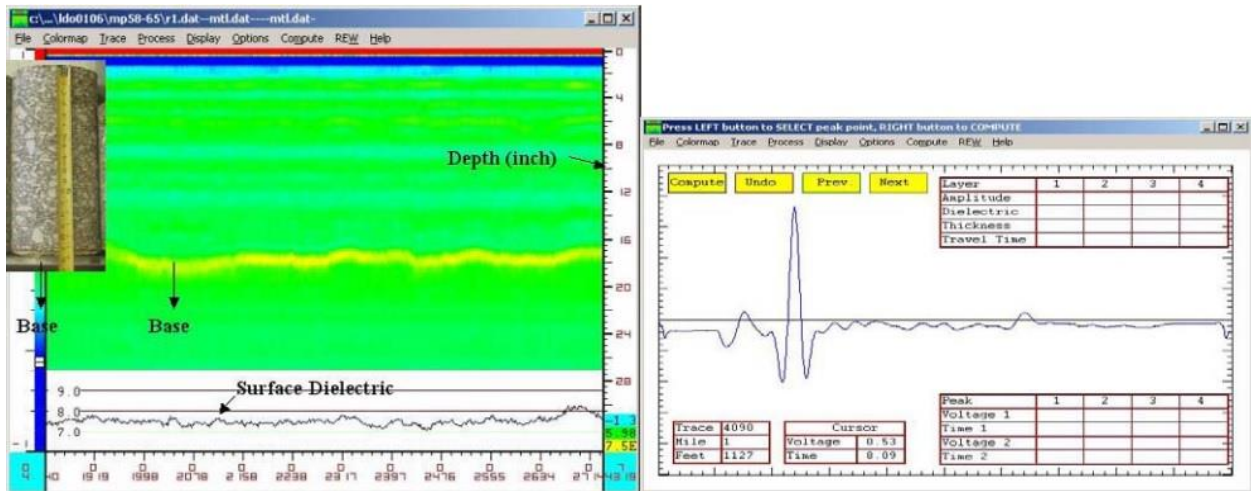
Figure 3.12 – 18 inches (450 mm) depth pavement with no defects in thick asphalt pavements (Chen and Scullion 2008)

In a forensic investigation performed by Chen and Scullion (2008), GPR was used for pavement evaluation with a 1.0 GHz antenna through approximately the top 24 in (610 mm) of the pavement. The team notes that GPR has become a practical test method to explore cracks through asphalt layers and has been found to provide comprehensive results of underground conditions. Due to having a large number of GPR traces for each GPR test, a color coding scheme was used to convert the variations of dielectric signals from these traces to subsurface images. An example of the color coding for a hot-mix asphalt pavements is presented in Figure 3.12 and Figure 3.13. Figure 3.12 represents the reflections of well-compacted pavement without defects. GPR reflection indicates that the two reflections in the color-map are a red line at the top of the figure that is the pavement surface and a yellow area located between 16 and 17 in (400 mm and 425 mm) depth that is the top of the base layer. The right and bottom axes show the depth and distance scales, respectively. When the pavement section has a weak structure, a GPR unit registers strong reflections (blue and red signs) as shown in Figure 3.13. The primary aim of a study conducted by Chen and Scullion (2008) was to evaluate the rehabilitation for pavements with stripping. One of the sections investigated was approximately 18 miles (29 km) of US281. This site has 6 in (150 mm) of AC and 12 in (300 mm) of granular caliche base. Many locations were determined to have stripping problems at various depths by using GPR. In addition, FWD test results showed that the structure of the pavement was inadequate. Based on both test results, the bases were found to be wet and very weak. The other objective conducted by the team was to determine causes of distress. The selected area was US69. A porous layer causing debonding was detected at 2-4 in (50-100 mm) by GPR, FWD, and coring. The results showed that the presence of the porous layer caused the surface distress.

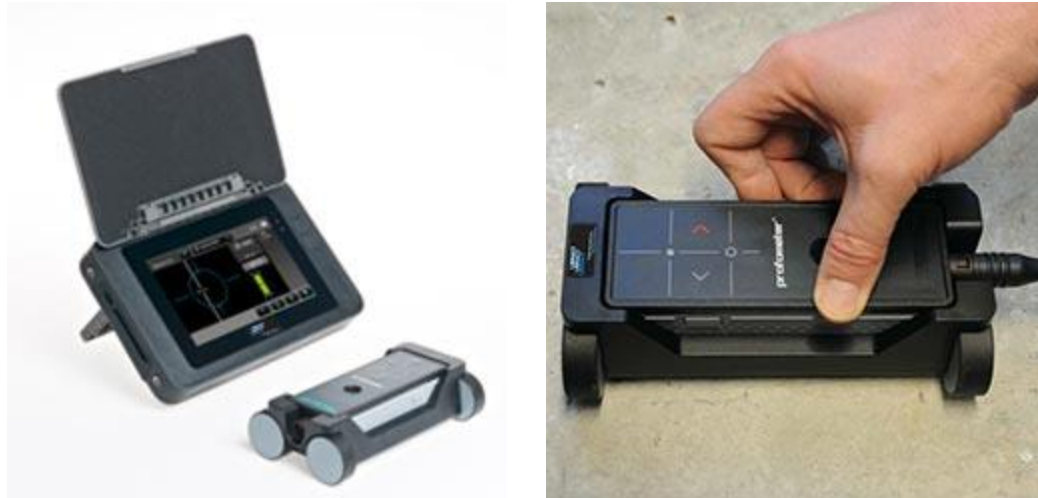
Figure 3.14 – The Covermeter - Profometer 600 (Impact Test Equipment 2017)

The Profometer, one of the eddy current techniques, is known as a rebar locator (Figure 3.14). The working principle of this instrument is on detection of the change in the electromagnetic field in the reinforced concrete. The device is easy and handy to use. To be able to get accurate data, this unit shall be calibrated before beginning the applications. The accuracy of the calibration is checked by using a test block including reinforcement. The location and size of reinforcement in the test block is measured at different sections on the block. Then, it is scanned by Profometer. The results should overlap (Lokesh et. al 2014).

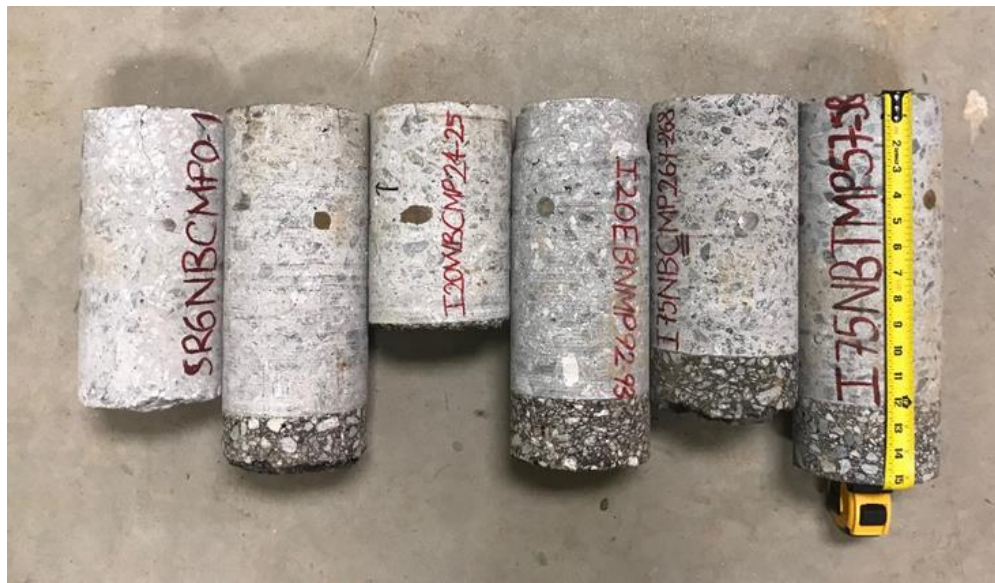
Figure 6.1– Core Specimens taken from Site Investigations

The NDT methods, GPR and Profometer, were used at each site survey. The GPR unit was moved over the wheel path, which was close to the shoulder, on the outside lane of each site to collect data in longitudinal direction. A 6-inch (152 mm) core was taken on the centerline of slab of each site to measure the depth and size of longitudinal and transverse reinforcements and concrete layer thickness (Figure 6.1). The length of cores varied by depending on the CRC thickness of the sites. The lengths of core specimens were 15 in (381 mm) for Site 2, 4, and 6. It was 15 in (381 mm) for Site 1, as well. However, it looks like 12 in (305 mm) in Figure 6.1 because the core was damaged during the process of taking it. Likewise, the core length for Site 3 looks like 9 in (229 mm). A core 12 in (305 mm) in length was taken from Site 5.

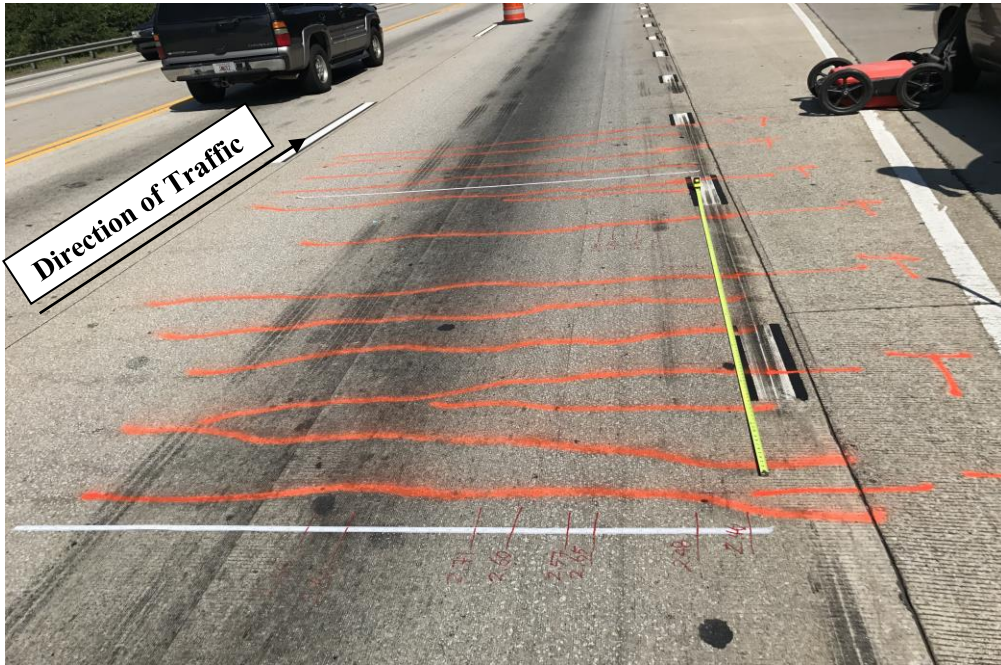
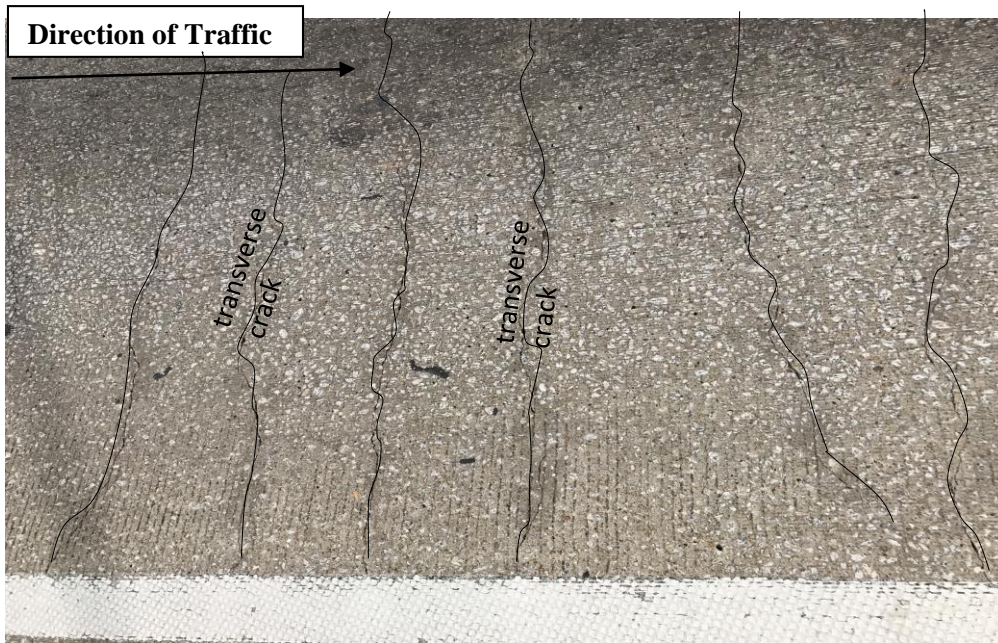
Figure 6.4 – Typical Cluster Transverse Cracks Pattern at S1-a and S1-b

The site had the cluster transverse cracks as showed in Figure 6.4. Transverse rebars and cracks were marked as ‘TC’ and ‘T’ in the clusters, which indicate ‘crack on transverse rebar’ and ‘transverse rebar’, respectively (Figure 6.4). The minimum and maximum distance between the clusters of transverse cracks were measured as approximately 46 ft. (1402 cm). The single transverse cracks were spaced at the range of approximately 1 ft. and 4 ft. (30.5 and 122 cm) as it is shown in Figure 5.6. The typical transverse crack width varied in the range of 0.04 in and 0.14 in (1.02 and 3.56 mm) (Figure 6.5). There was no visible longitudinal crack.

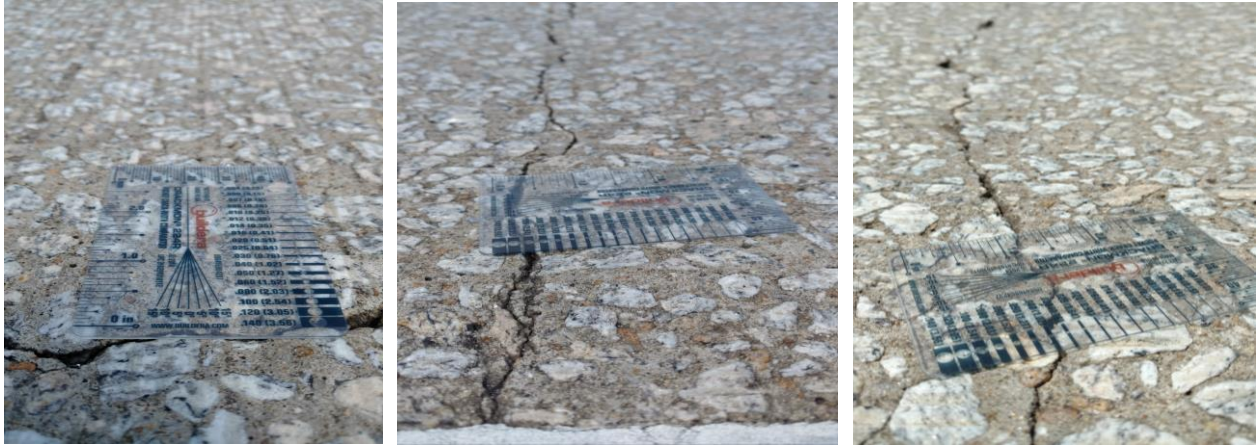
Figure 6.5 – The Measurement of Crack Widths at S1-b, S1-c, and S1-d

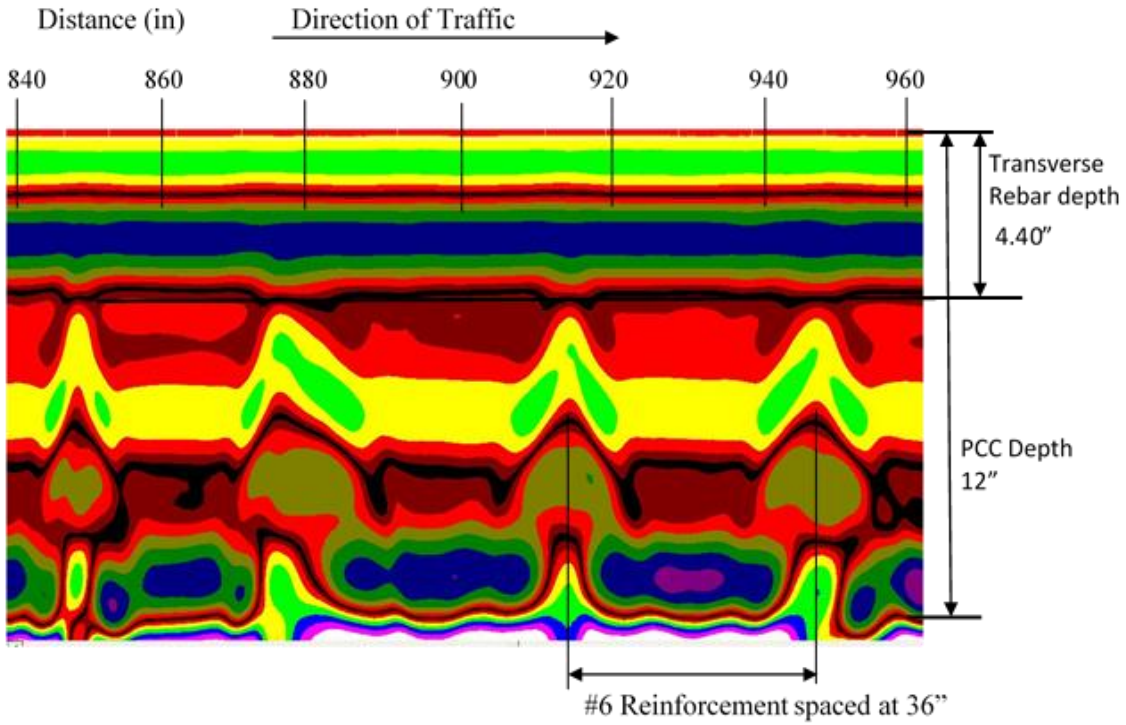
Figure 6.6 – GPR Scan in the Longitudinal Direction (S1-b)

The GPR unit scans were visualized in RadView software. Figure 6.6 clearly shows the location of four transverse reinforcements and concrete layer thickness. Based on findings, the sections for which cracks formed were over the steel transverse reinforcements. The site did not show significant depth change of transverse and longitudinal reinforcements across the section scanned. Figure 6.7 indicates the depth of longitudinal reinforcement and CRC thickness in the transverse direction. The longitudinal reinforcements' depth lowered toward the inside lane.

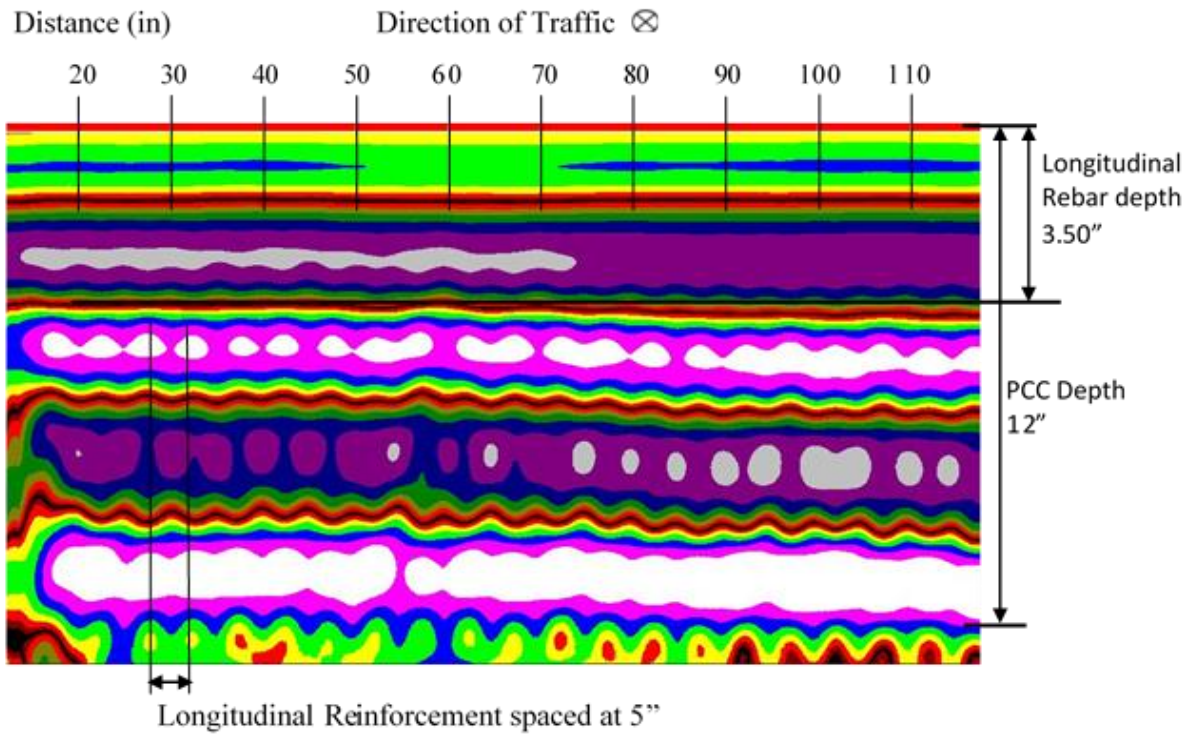
Figure 6.7 – GPR Scan in the Transverse Direction (S1-b)

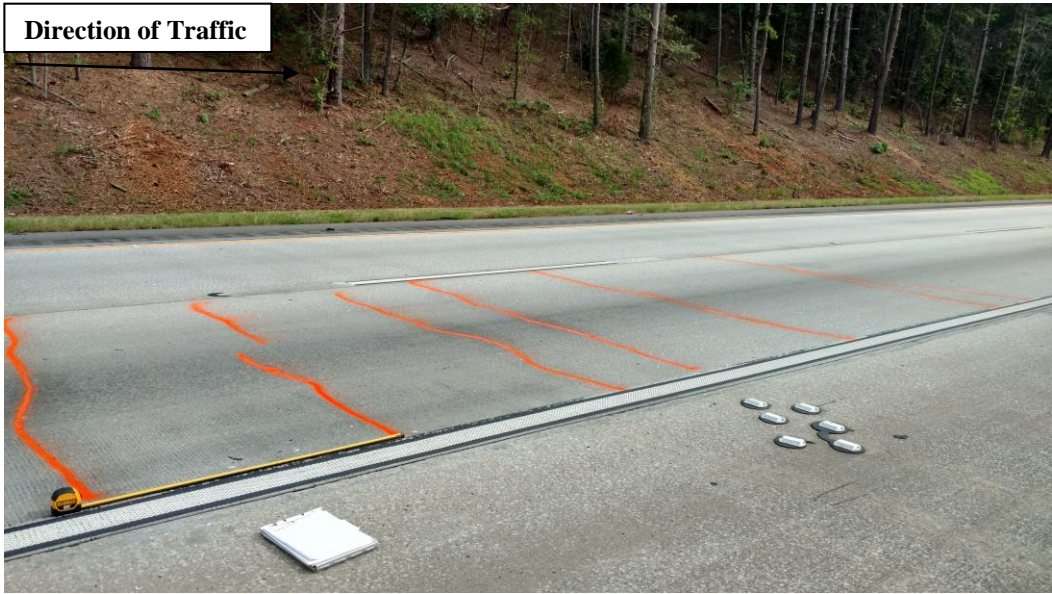
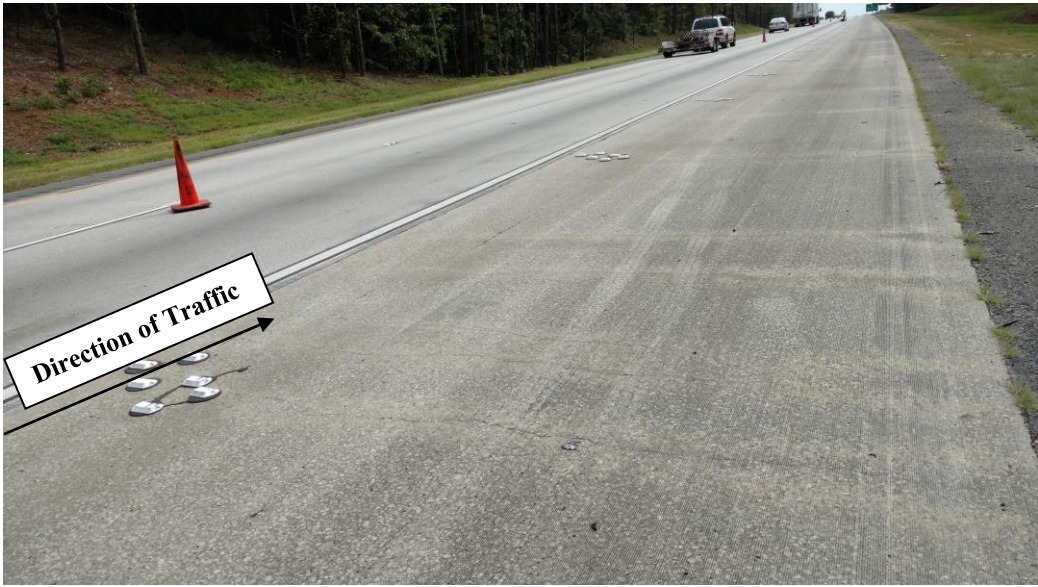
Figure 6.13 – Typical Cluster Transverse Cracks Pattern at S2-a and S2-c

The site had the cluster transverse cracks as showed in Figure 6.13. Transverse cracks were marked in the clusters (Figure 6.13). The distance between the clusters of transverse cracks was measured approximately 24 ft. (732 cm). The single transverse cracks were spaced at the range of approximately 1.8 ft. and 4.0 ft. (55 and 122 cm) as it is shown in Figure 6.12. The typical transverse crack width varied in the range of 0.03 in and 0.10 in (0.76 and 2.54 mm). The site had many visible holes on the pavement by sizing maximum 1.5 in x 3 in (38 mm x 76 mm) (Figure 6.14). The longitudinal cracks were not noticed visibly.

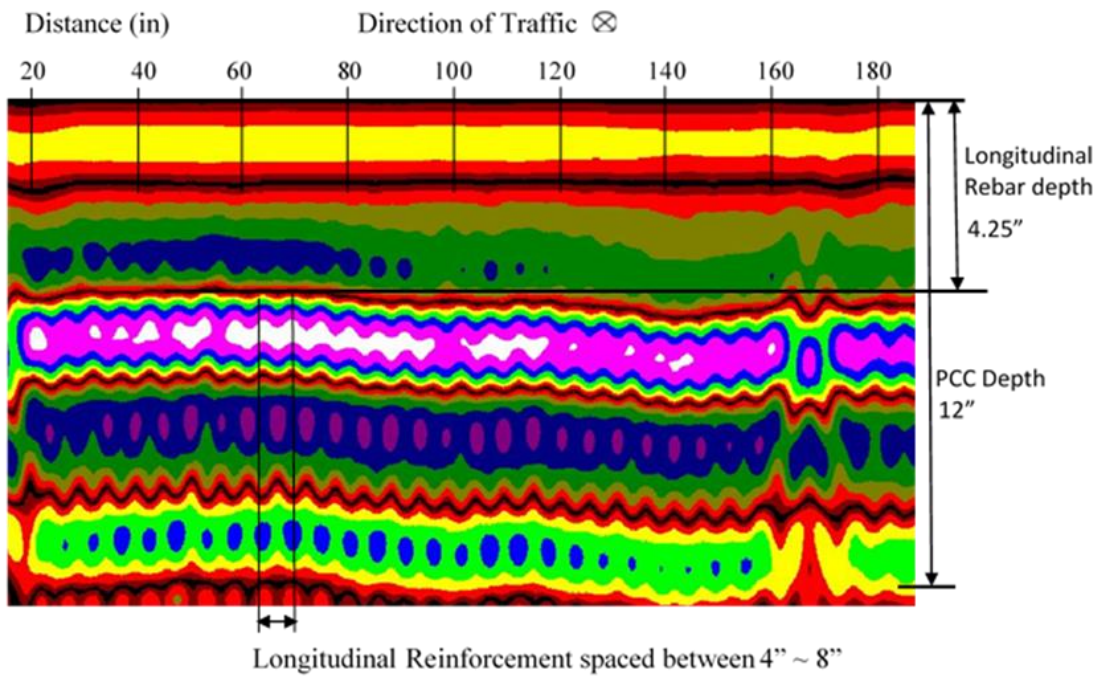
Figure 6.16 – GPR Scan in the Transverse Direction (S2-c)

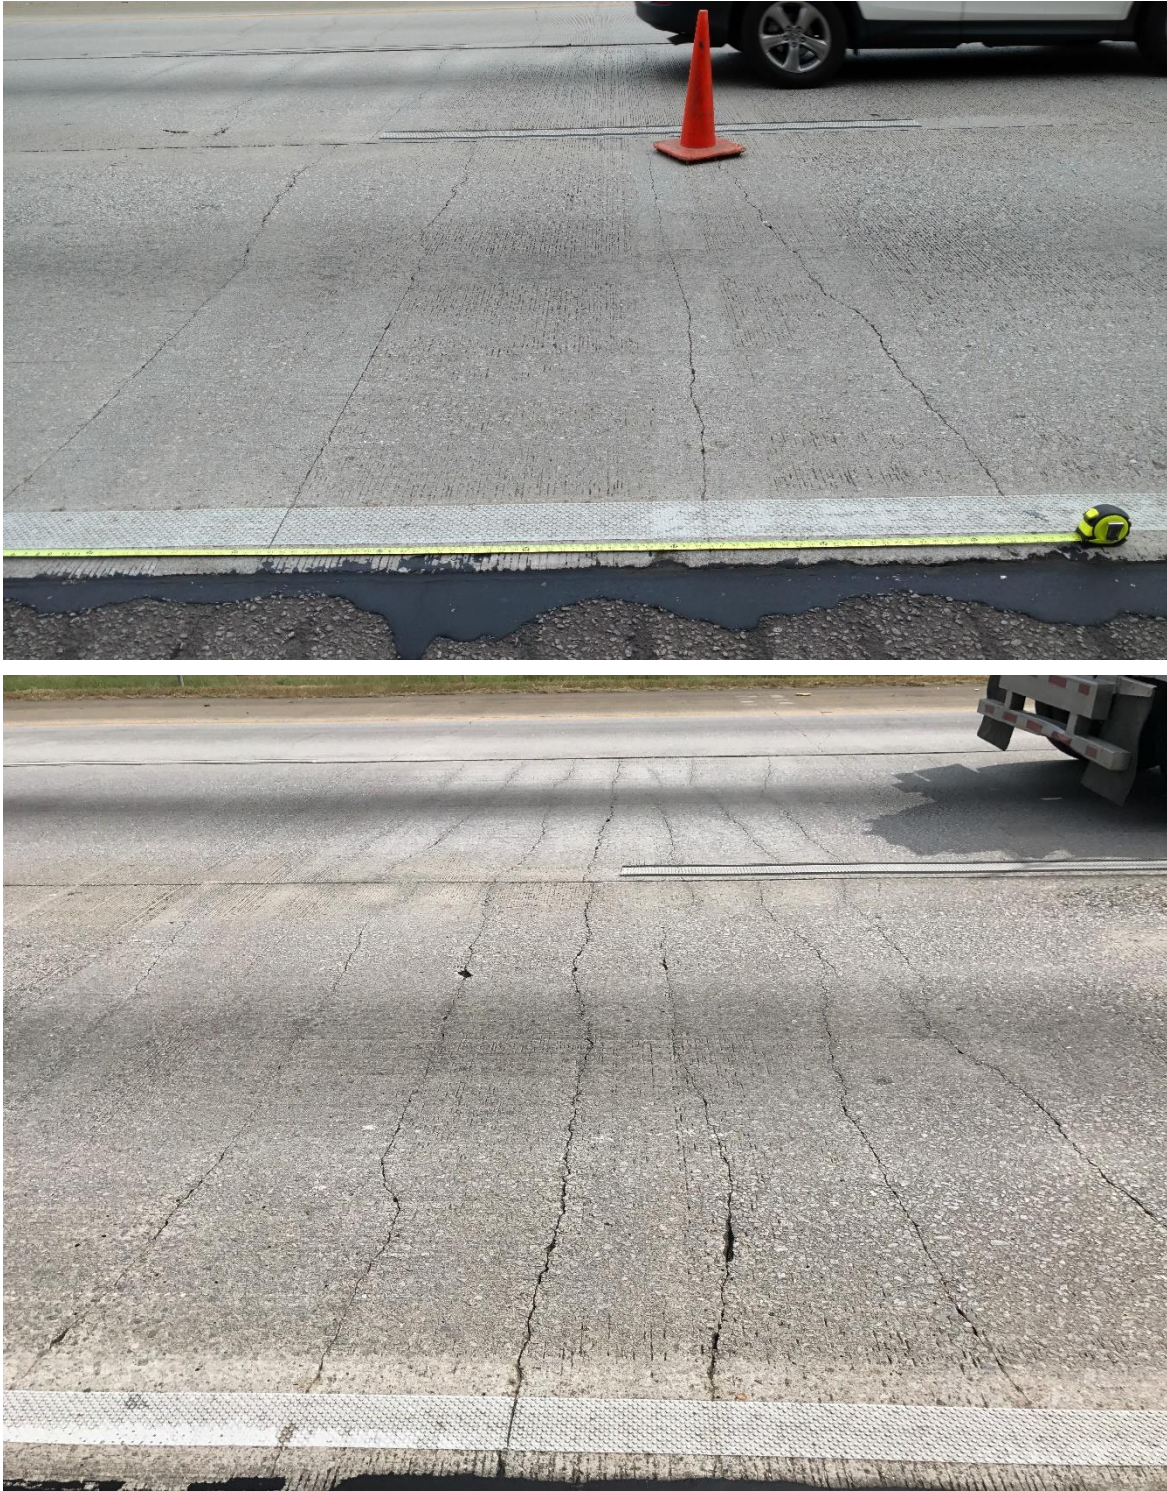
Figure 6.21 – Typical Cluster Transverse Cracks Pattern at S3-a and S3-c

The site had a considerable number of cluster transverse cracks as showed in Figure 6.21. The minimum and maximum distance between the clusters of transverse cracks were measured to range from 10 ft. to 20 ft. (305 and 610 cm). The single transverse cracks were spaced at the range of approximately 5 ft. and 6.5 ft. (152 and 198 cm) as it is shown in Figure 6.20. It was detected that the site had the punchouts at the location of the cluster transverse cracks (Figure 6.21). The crack width varied in the range of 0.06 in and 0.12 in (1.5 and 3 mm) indicated in Figure 6.22.

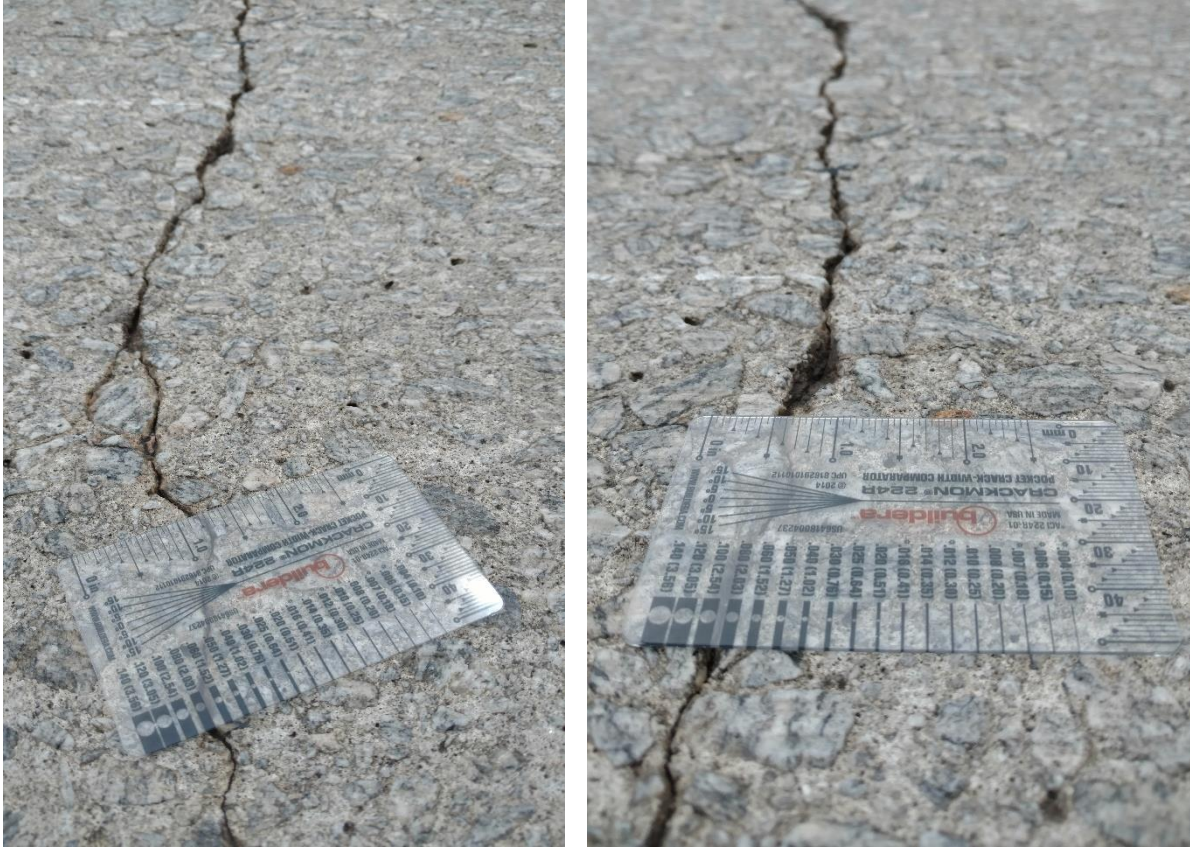
Figure 6.22 – The Measurement of Crack Widths at S3-a

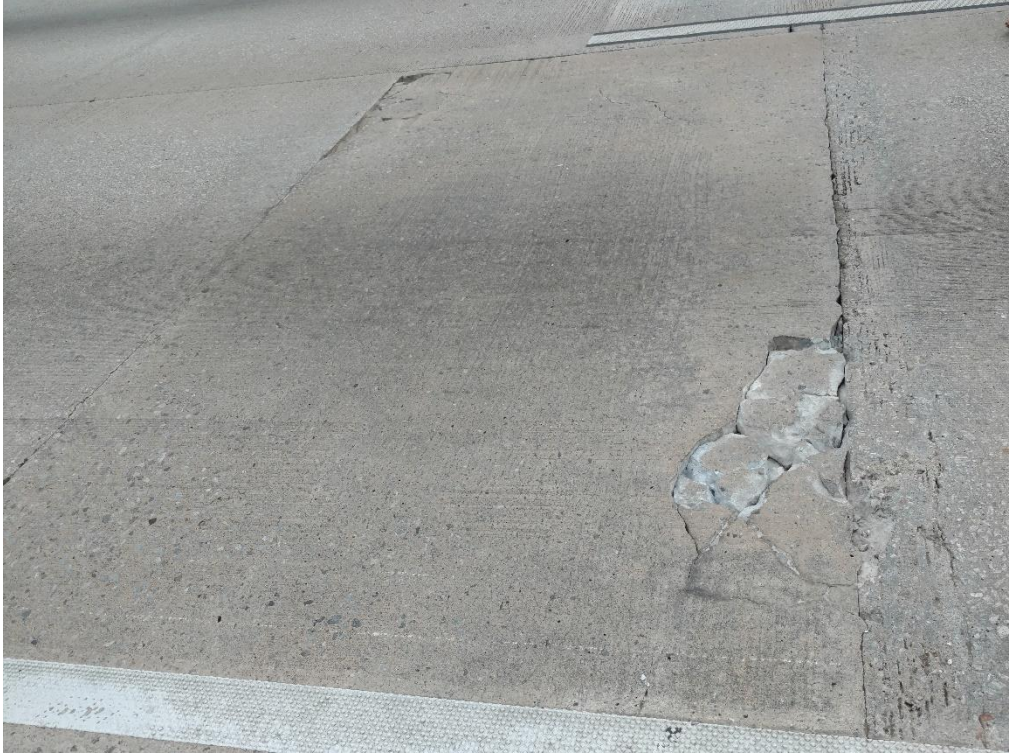
Figure 6.23 – A Patched Area at Outside Lane at S3-b

A few patched areas observed in this project were examined using GPR and Profometer. It should be noted that while the punchout areas had been previously patched, the repairs had become severely distressed again with significant punchouts observed during the field investigation. Figures 6.23-24 show the patched area with punchout at S3-b during investigation. Another problem area was located near MP 24 WB. This area had a few punchouts on the wheel-path which was on the patched area near the inside lane (S3-d), as seen in Figures 6.25-26.

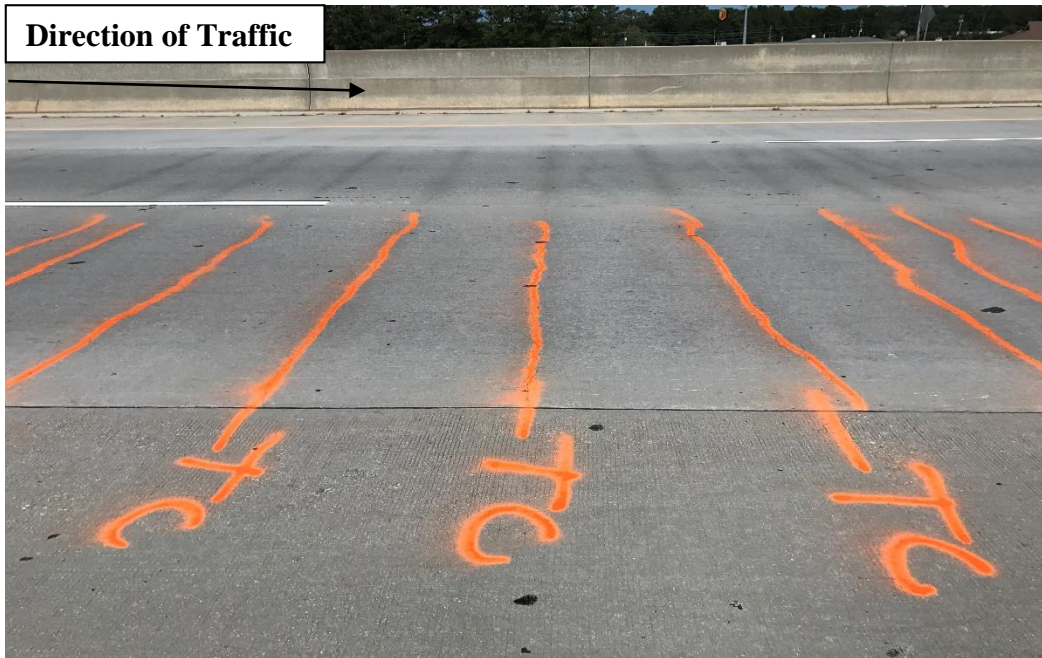
Figure 6.35 – Typical Cluster Transverse Cracks Pattern at S4-b and S4-d

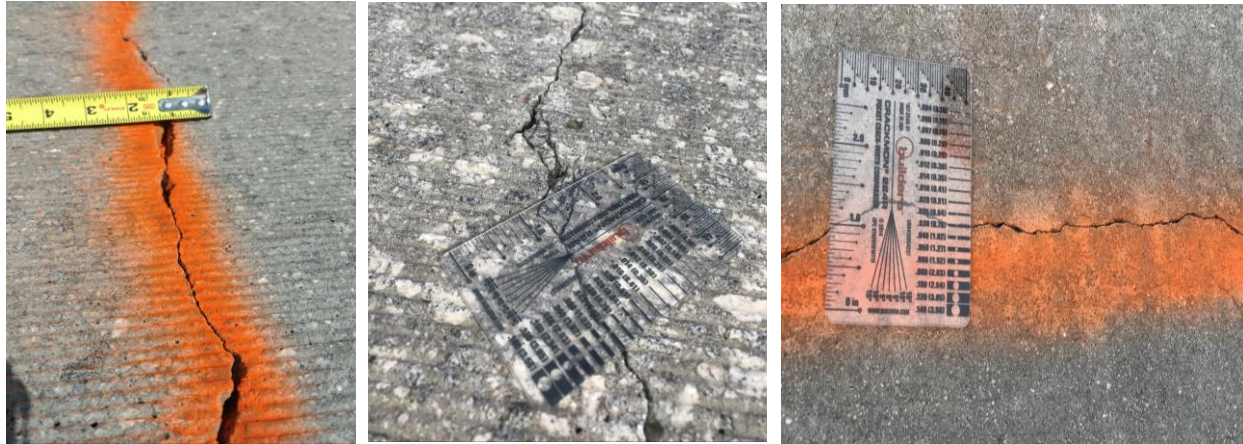
Figure 6.36 – The Measurement of Crack Widths at S4-a and S4-c

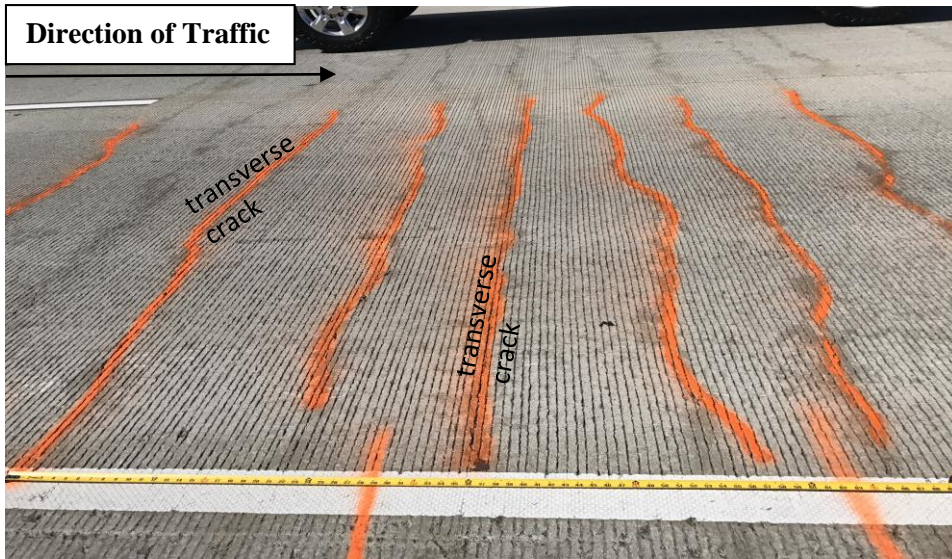
Figure 6.54 – Typical Cluster Transverse Cracks Pattern at S6-a and S6-c

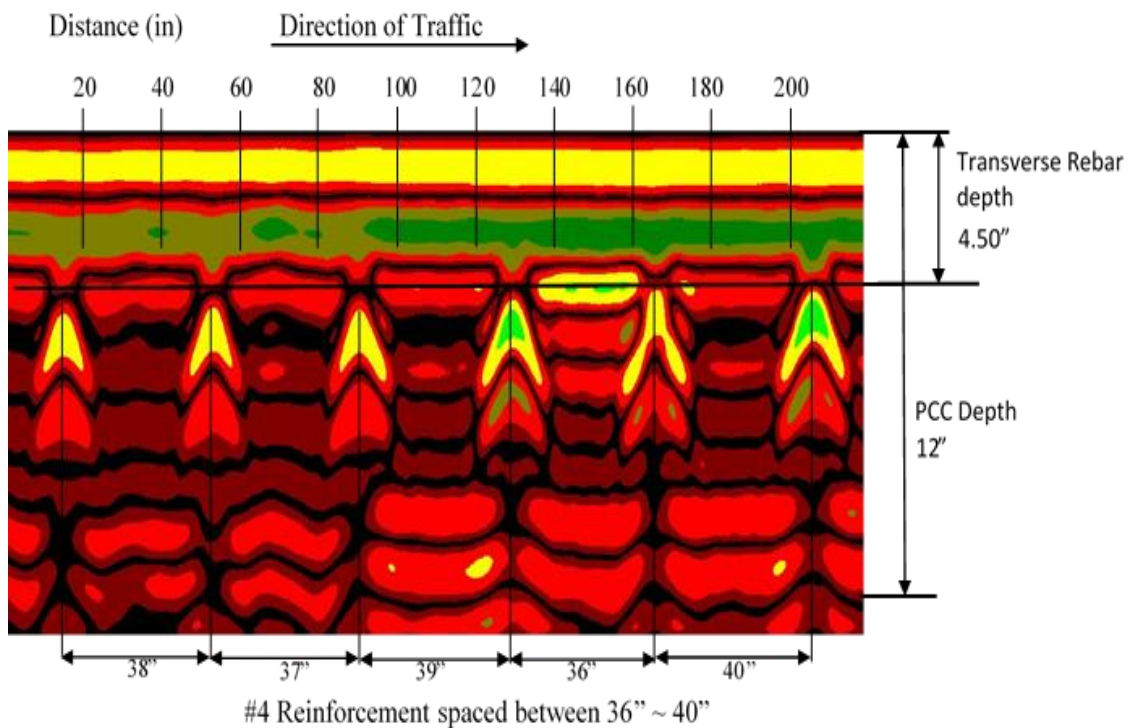
Figure 6.57 – GPR Scan in the Longitudinal Direction (S6-a)

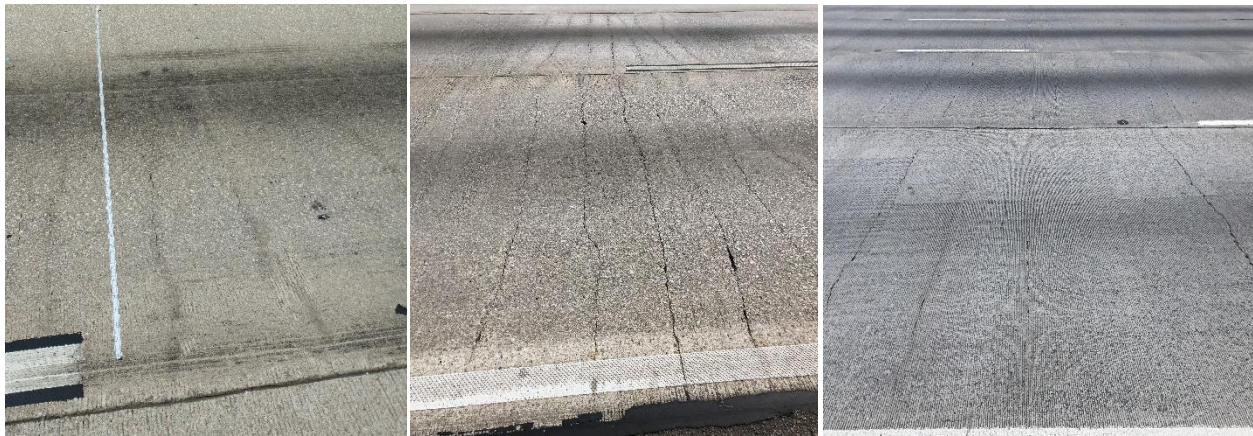
Figure 6.61 – The Density of Transverse Cracks in Sites 1, 3, and 5, respectively

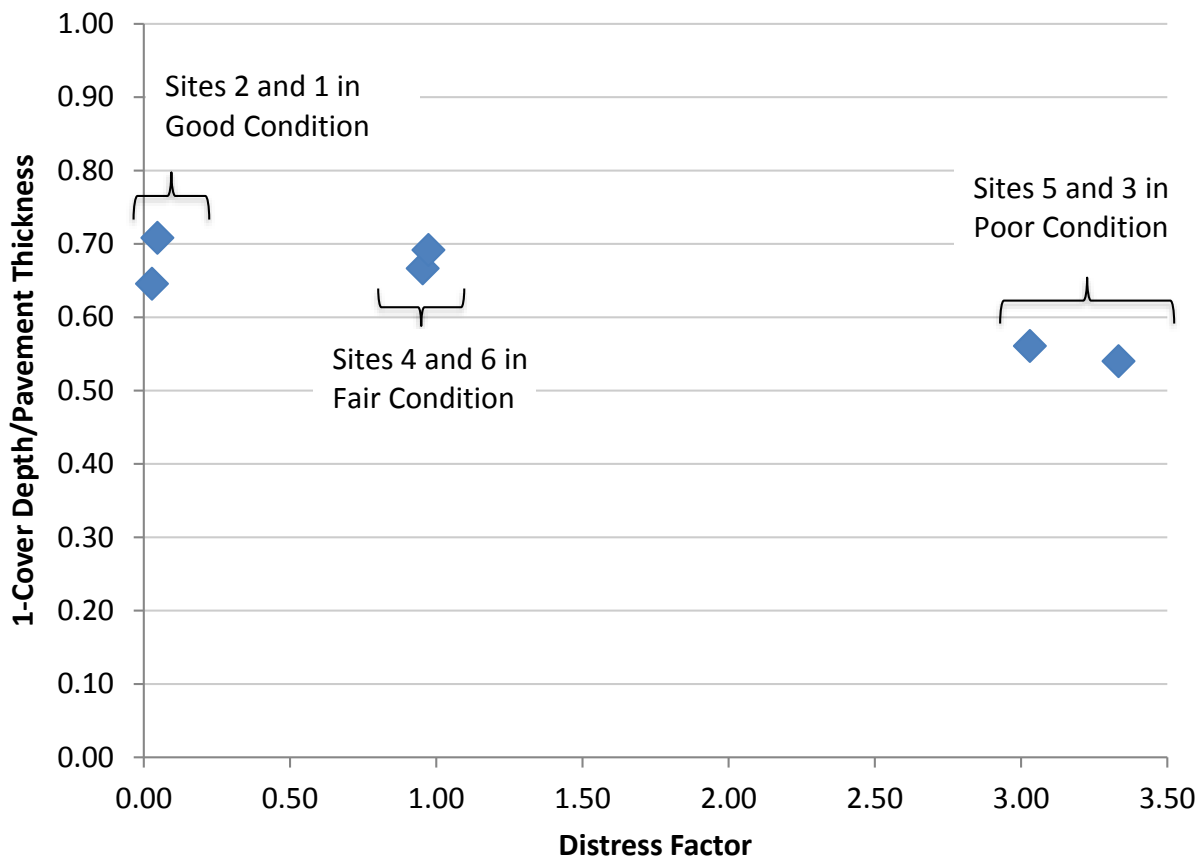
Figure 6.66 – The Comparison of the Normalized Ratio and Distress Factors
