TIDAL MARSH MITIGATION IN THE OGEECHEE RIVER ESTUARY, GA: SHORT AND LONG TERM CHANGES

A Thesis Submitted to the Graduate Faculty of The University of Georgia in Partial Fulfillment
of the Requirements for the Degree

2004

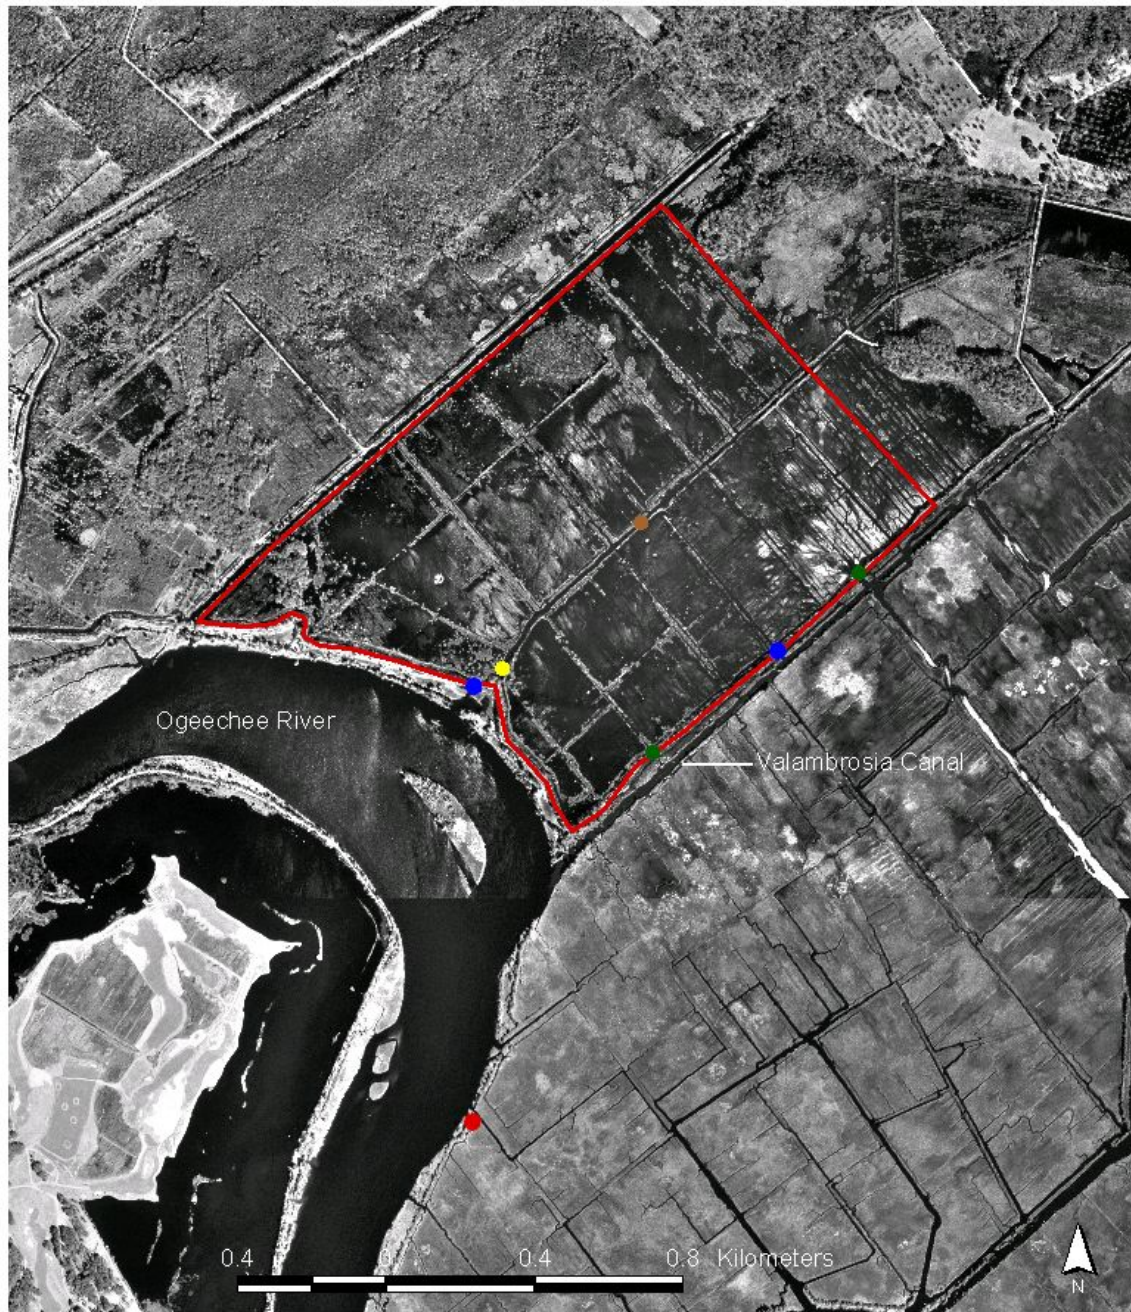
Figure 1. Study Sites at the Tucker Mitigation Site. This figure depicts the Tucker Mitigation site and the three study sites (Reference Site, Outer Impoundment Site, and the Inner Impoundment Site) where monitoring measurements were taken.

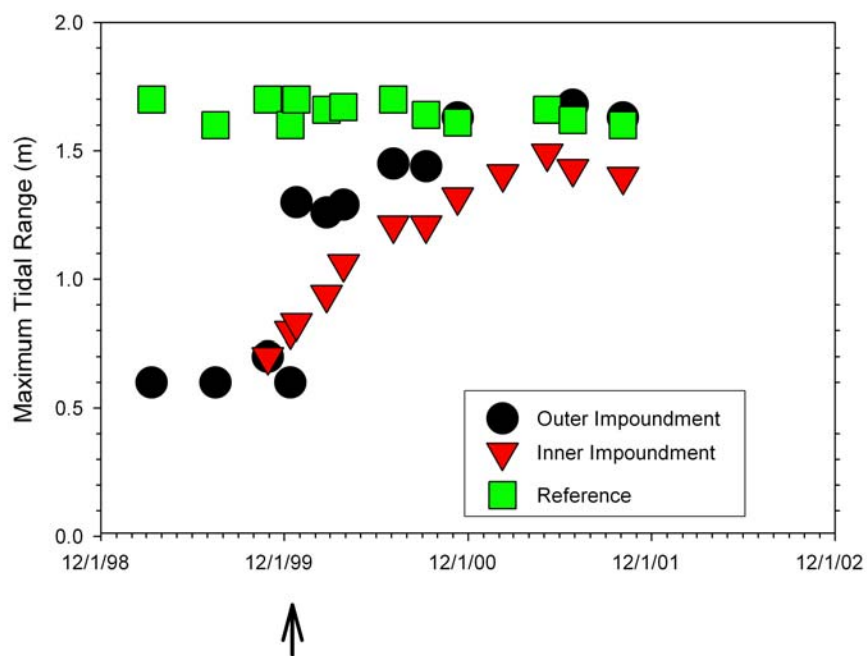
Figure 4. Comparison of Tidal Ranges at the Outer Impoundment, Inner Impoundment, and Reference sites.

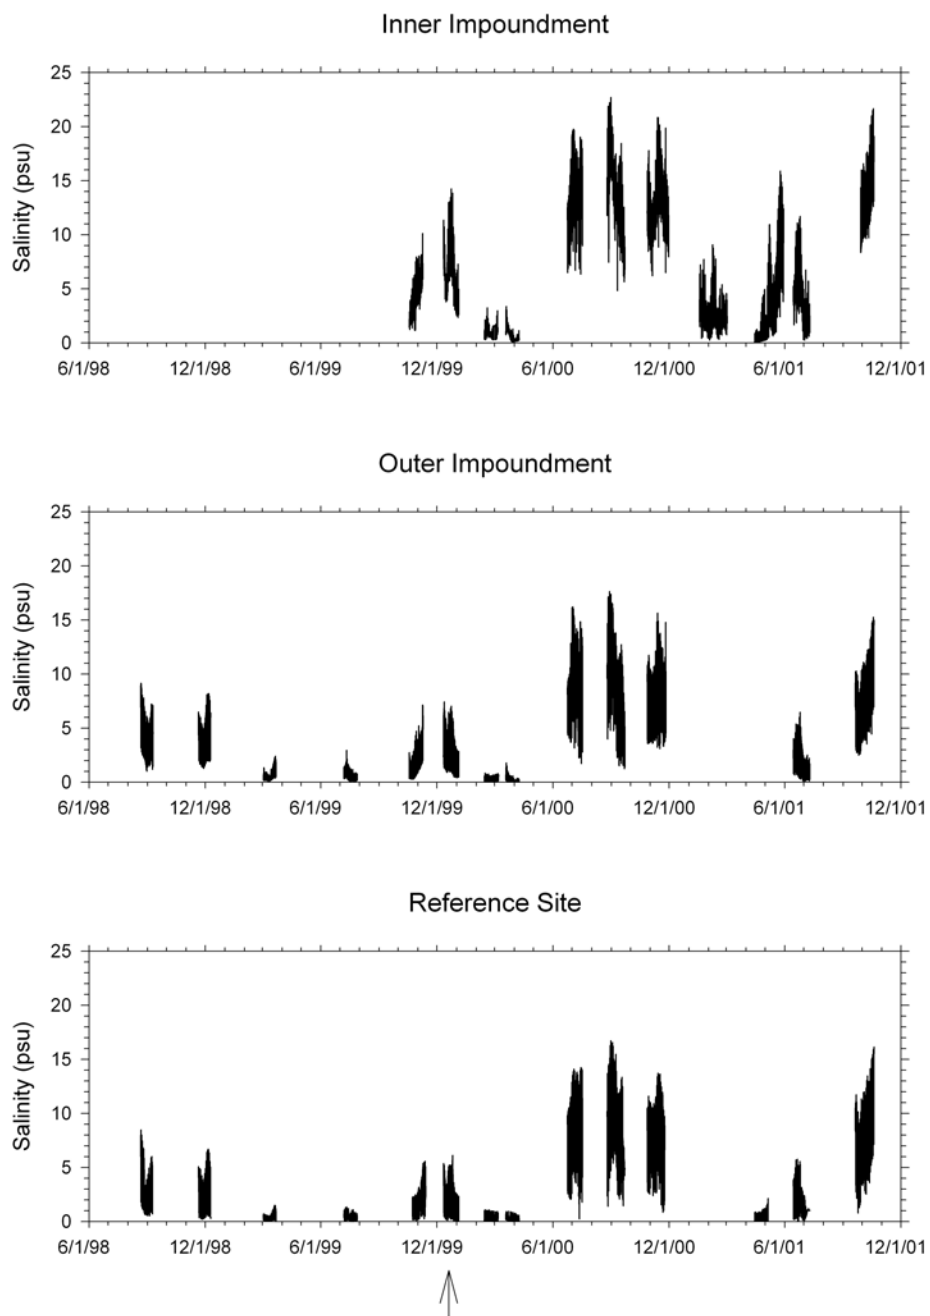
Figure 5. Comparison of Salinity at the Outer Impoundment, Inner Impoundment, and Reference sites.

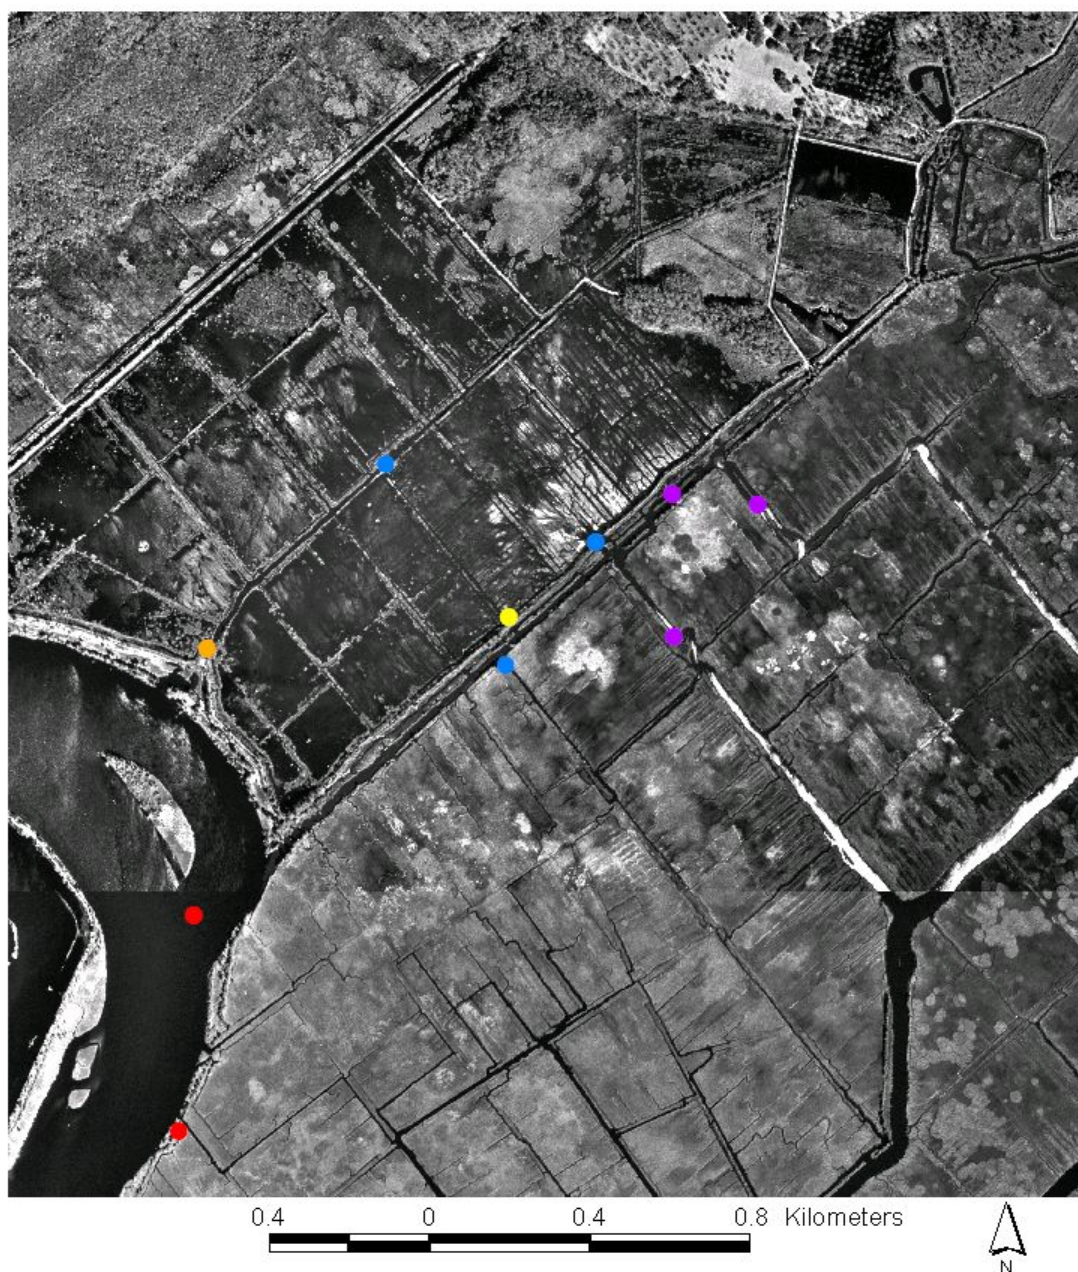
Figure 7. Salinity Survey of Tidal Creeks Surrounding the Tucker Mitigation site. Salinity measurements were taken at stations in the Ogeechee River, inside the impoundment, and in the surrounding canals to determine salinity influences inside the impoundment from the Ogeechee and Little Ogeechee Rivers.

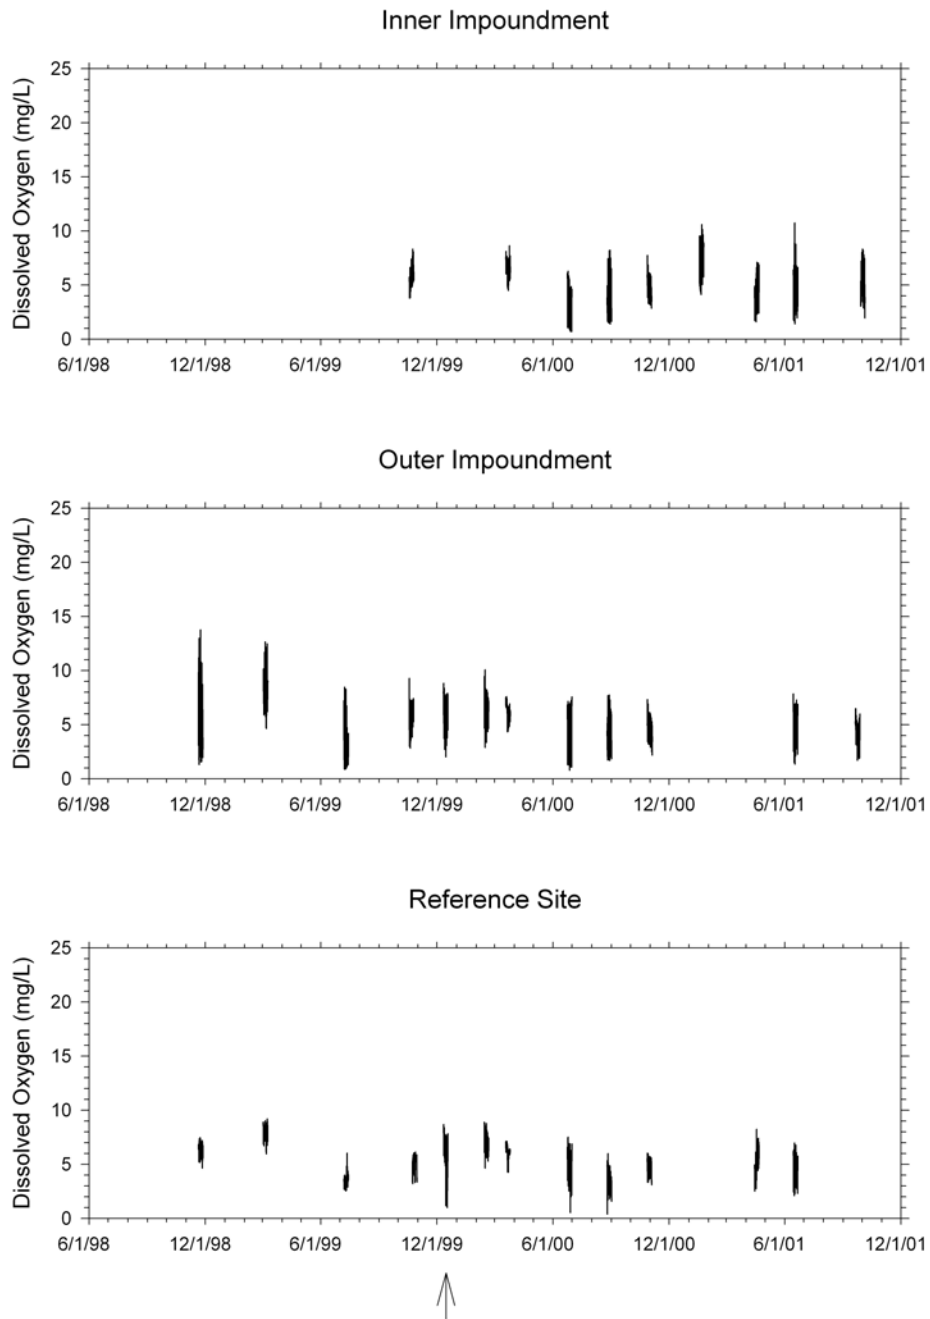
Figure 11. Comparison of Dissolved Oxygen at the Outer Impoundment, Inner Impoundment, and Reference sites. Only the first week of each three week deployment is shown here, as the sensors would tend to foul after a week and produce unreliable data.

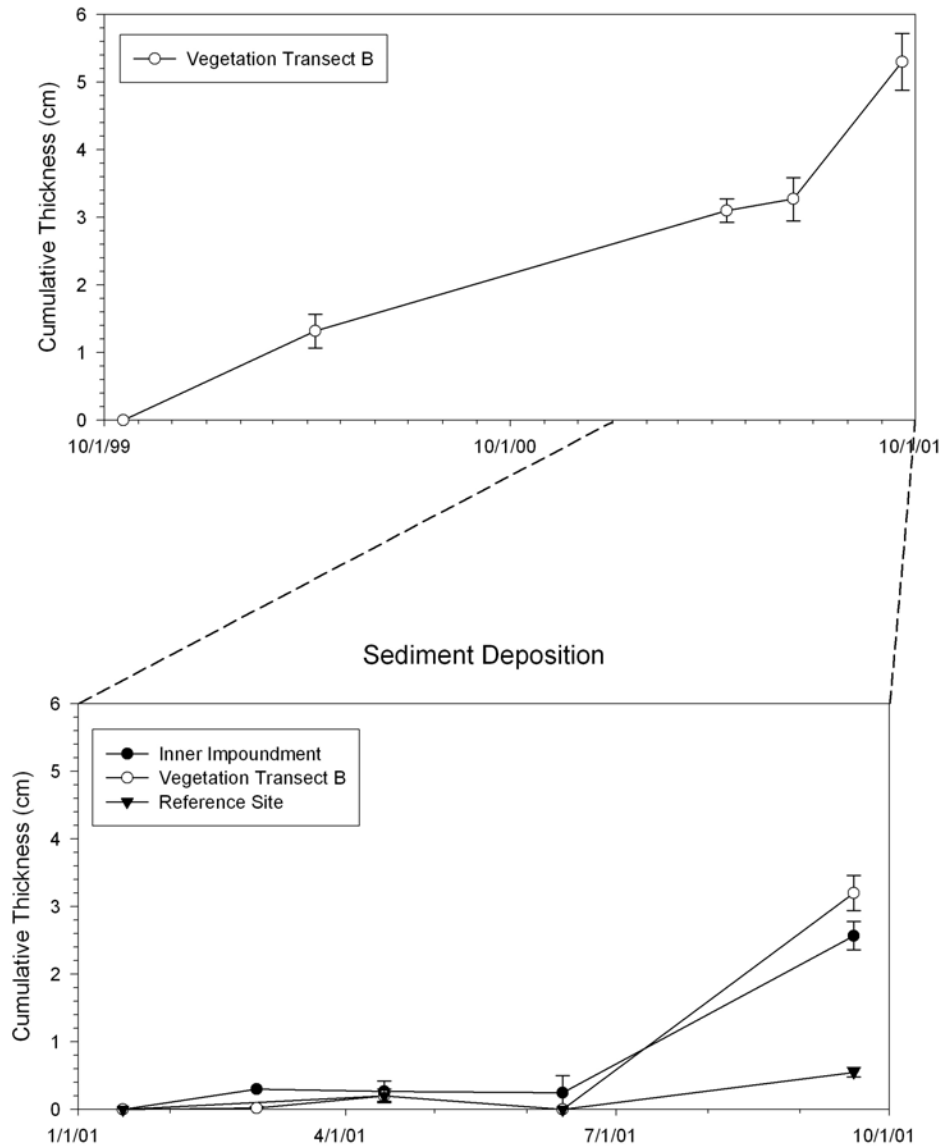
Figure 15. Comparison of Sediment Cumulative Thickness at the Outer Impoundment, Inner Impoundment, and Reference sites. Sedimentation rates were quantified by placing three unglazed ceramic plates (15 cm x 15 cm) at the marsh surface. Plates were initially placed at Vegetation Transect B in October 1999 to gain long-term information on impoundment sedimentation. In January 2001, plates were placed at Vegetation Transect B, Inner Impoundment, and the Reference Site for comparative studies.

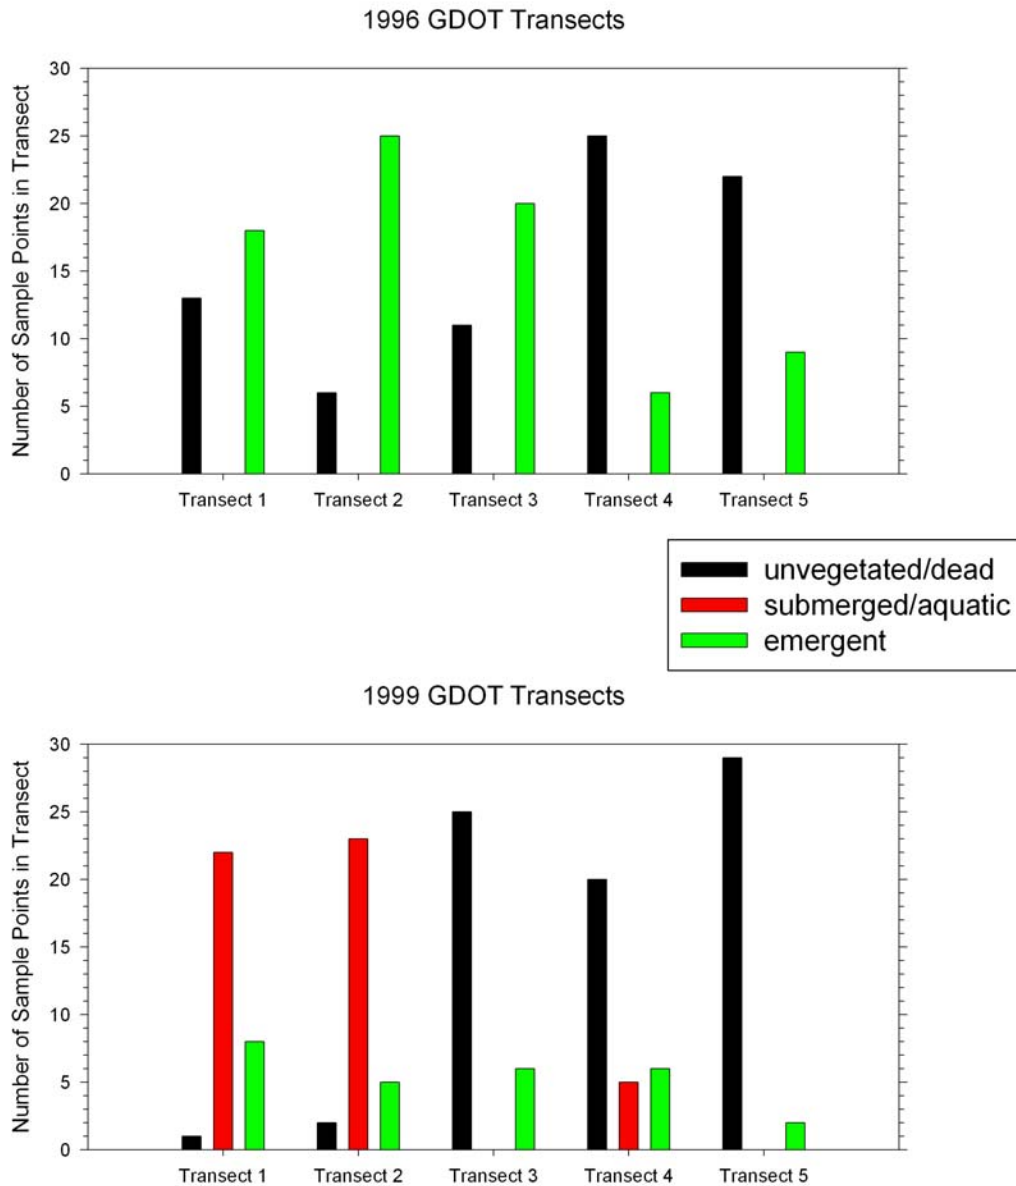
Figure 16. GDOT Vegetation Transects. Vegetation transects completed inside the impoundment by Georgia Department of Transportation in August of 1996 and 1999. See Figure 2 for transect locations.

emergent vegetation was stressed and in this three year period emergent vegetation was replaced by floating and aquatic species (Fig. 16). Transects 1 and 2 have the highest occurrence of submerged vegetation, which is in accordance with GDOT observations that these transects were completely under water even at extreme low tides. Because these two transects are farthest away from tidal exchange and therefore sediment input, this area may be lower in elevation, which would result in greater water depths. The other three transects do not show as much of an increase in submerged/aquatic vegetation but still show decreased emergent vegetation over the three year period.

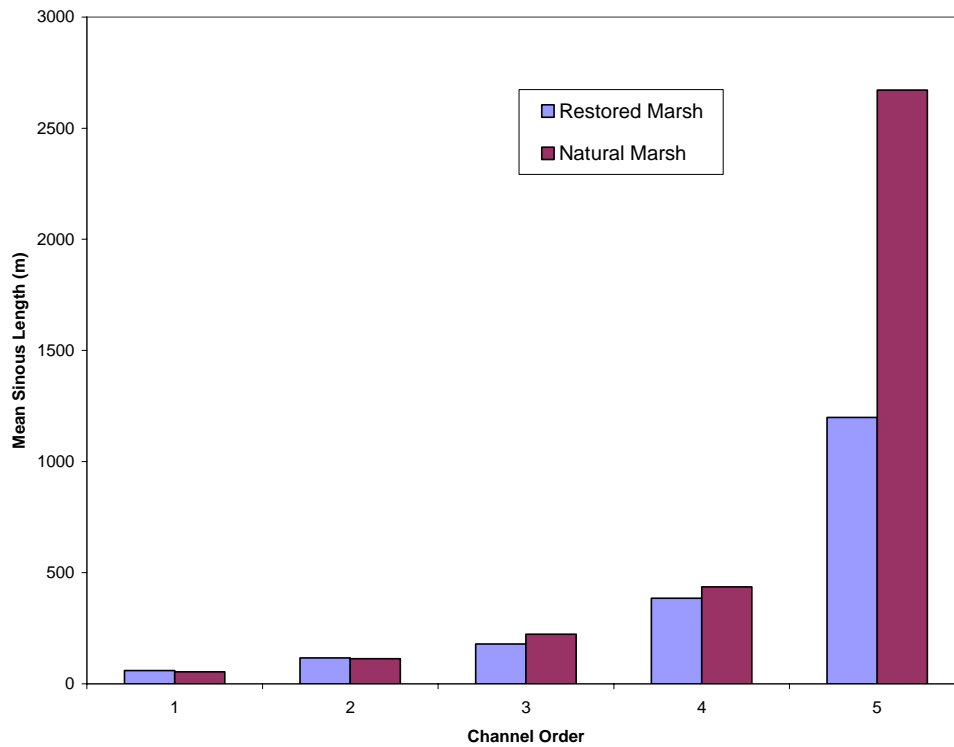
Figure 24. Mean Sinuous Length Plotted by Channel Order for the Restored and Natural Marsh. The mean sinuous length is calculated by dividing the total sinuous channel length for each order by the number of channels for that order.

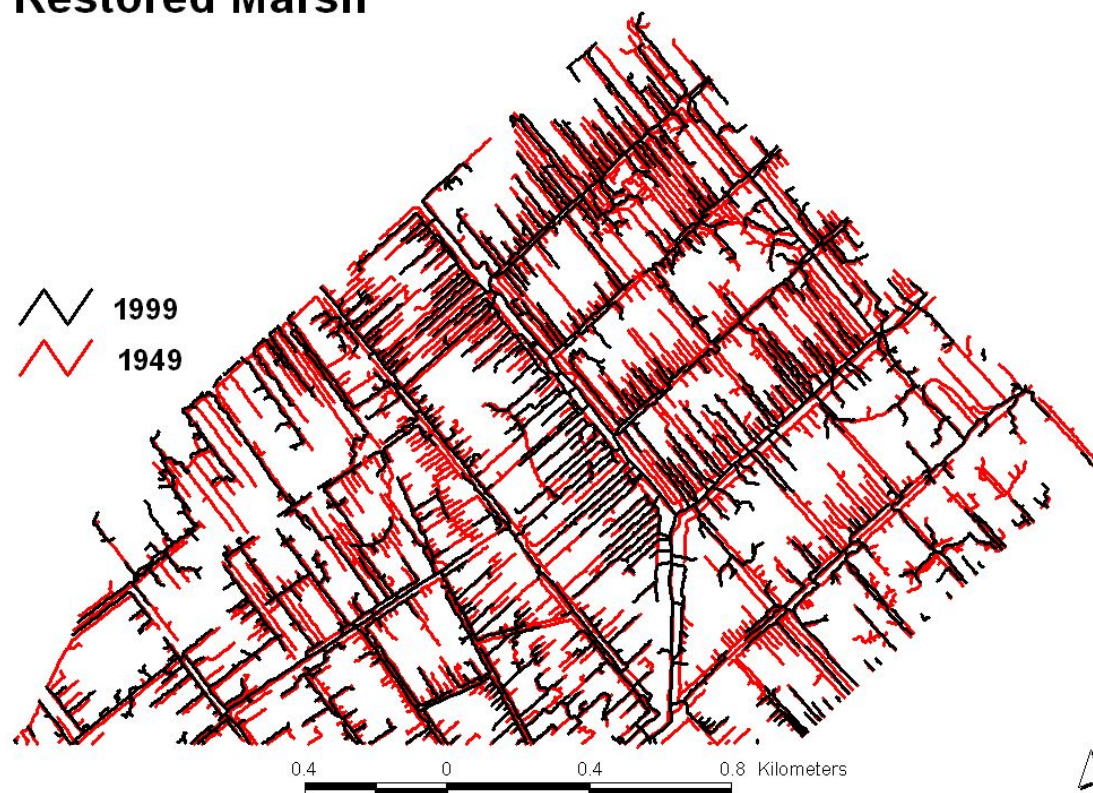
Figure 25. Overlay of the Centerline Digitizations of the 1949 and 1999 Restored Marsh.

25). The lower order channels, particularly the first and second order channels have increased in sinuosity over fifty years (Fig. 23). However, little to no sinuosity increase was found in the third and fourth order channels.
