A COMPARISON OF HISTORIC AND MODERN SCHOOL FACILITIES IN RURAL
NORTH EAST GEORGIA ACCORDING TO HENRY BARNARDS'S PRINCIPLES OF
SCHOOL ARCHITECTURE

A Dissertation Submitted to the Graduate Faculty of The University of Georgia in Partial
Fulfillment of the Requirements for the Degree
DOCTOR OF EDUCATION

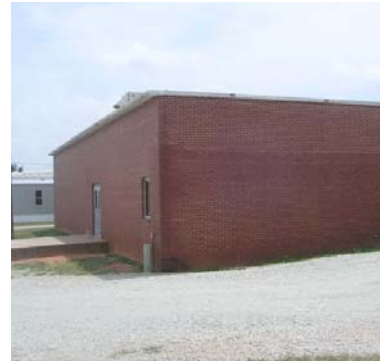
Figure 2: Example of Brick Detail

The brick facility (Figure 2) is located just outside of Carnesville, Georgia in a quiet, rural surrounding. The site is well drained with no water standing for long periods of time, even during inclement weather. The facility is built on a slab. The plot on which the school was located consists of 37 acres. There was a well for drinking water, with bathrooms located inside the building. The facility was designed to serve students of all ages and grade levels.

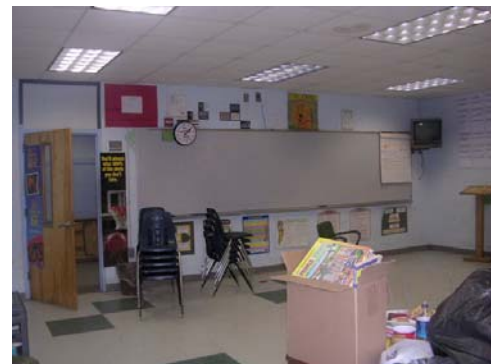
Figure 3: Surveyed Classroom at Franklin County Trade School

The size of an average classroom (Figure 3) in the facility is 625 square feet. The classrooms were standard for their time period. The exterior wall in each classroom had a bank of slide out windows 5'8" tall which ran the length of the classroom. Transom windows were on the hall (interior) wall of the classroom. Each classroom was lighted by six hanging incandescent fixtures which contained one 300 watt bulb per fixture.

Classroom ventilation was achieved through opening the slide out windows, transom windows and classroom door. During the winter, there was no dedicated ventilation for classrooms.

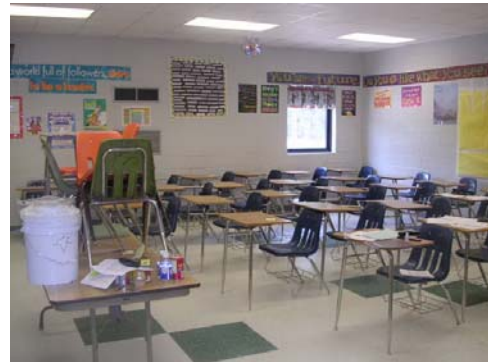
Figure 5: Surveyed Modern Classroom at FCMS.

A standard classroom in the facility (Figure 5) contains a floor area of 720 square feet.

Florescent lighting is used in addition to one small window located in each classroom. Though the natural lighting was not measured in intensity by the author, the effect of lighting provided by the window

would be estimated as having a minimal impact at best. The push out style window doubles as a fire exit, according to the Georgia Fire Marshal's Office.

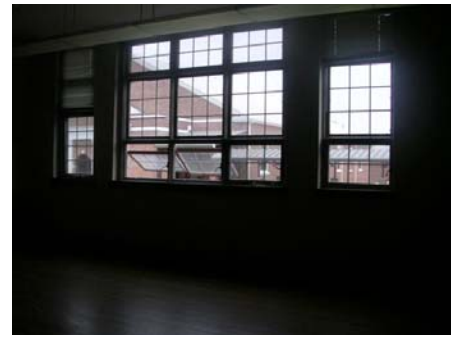
Figure 7. Window Bank @ Hartwell Elementary

lighting in all classrooms. There is one chimney in the facility, which served the original coal burning and natural gas boiler for the steam heating system. Controlling the steam radiators was a mechanical process achieved through using a manual valve to curtail or increase the flow of water through the radiators. Presently the school is served by HVAC for heating and cooling. There is a thermometer in each classroom for controlling the HVAC system; however, there was no historical evidence that classrooms used a thermometer to control the steam system.

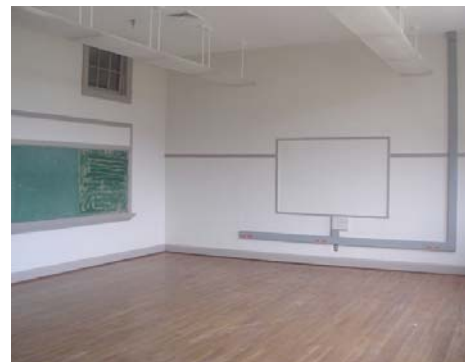
Figure 8. Surveyed Classroom at Hartwell Elementary.

The average classroom at Hartwell Elementary (Figure 8) consists of a floor area of 609 square feet. The surveyed classroom had a cubic airspace of 7,308 feet of air for students. The walls were covered with plaster. Lighting had been changed from incandescent to florescent at some time in the past, however the writer

was unable to determine when the change was made. There were no desks, which would have been original to 1934 in the classrooms to survey; however, based on the size of the classrooms a conservative estimation can be made that students had sufficient seat space and teachers could observe the entire class and move about without causing disruptions.

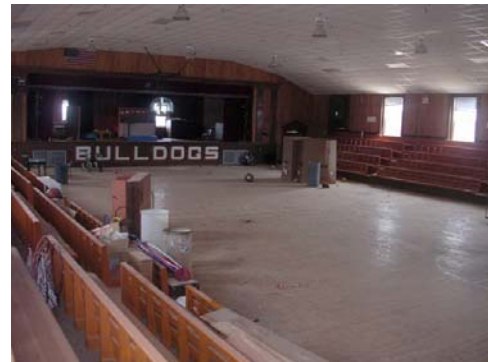
Figure 9. Gym at Hartwell Elementary.

The gym at Hartwell Elementary School (Figure 9) easily seated seven hundred students and parents for athletic events. The gym also had a large stage, which could be used for assemblies, plays or town meetings. Dressings rooms were available in the split-level down stairs under the stage and there are also stage right and left storage rooms for the stage

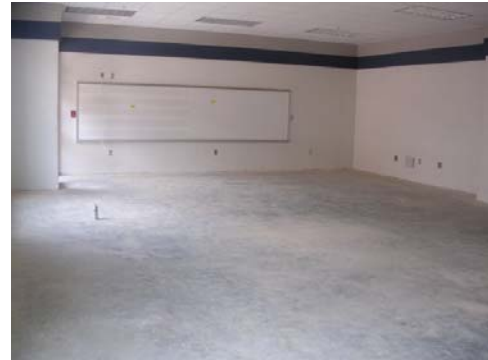
Figure 11. Modern Classroom at Hartwell Elementary School.

Although the new facility will not be occupied until the fall of 2004, the facility's director for Hart County Schools granted the author permission to visit and survey the site. In contrast to the historic facility, each classroom in the new construction area will have only one three foot by three foot window for natural light. There is also an exterior exit door with an

additional three by three window. Classroom illumination will be provided almost entirely by florescent lighting. It is a huge change from the 1934 construction. Classrooms in the new section (Figure 11) contain 838 square feet of instructional space. Classrooms will have suitable space for students and teachers and will provide for ease of movement for both.

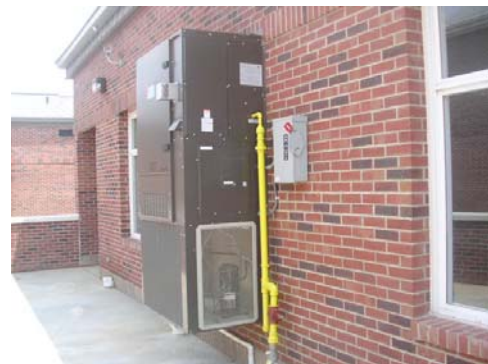
Figure 12. HVAC Unit at Hartwell Elementary

Ventilation in the facility will be provided exclusively by the HVAC system (Figure 12). The windows in each classroom are sealed. The heating side of the HVAC unit uses natural gas to provide combustion for heating purposes. Individual room controls are present in each classroom.

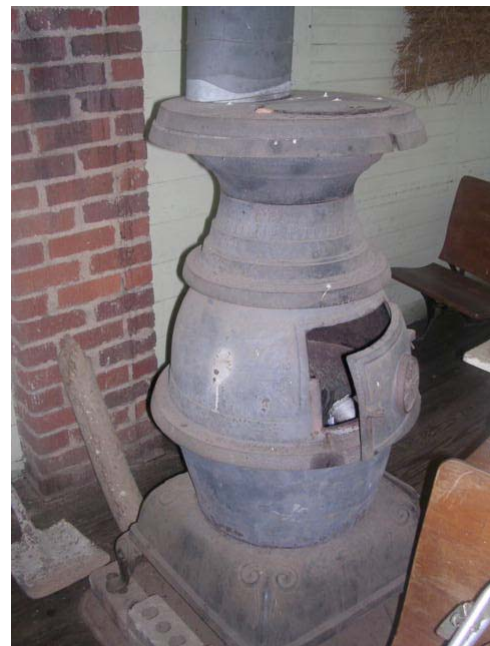
Figure 15. Classroom Stove at Bonds Academy.

Heating of the facility was accomplished by individual coal burning stoves in each classroom (Figure 15). The stoves were ventilated through a system of flues connected to two chimneys in the facility. The last principal of the school, who also served as a teacher in her first year of service to students in Madison County, recalled a morning when a student bumped the stove and the pipe fell from the ceiling to the floor. She recalled the rest of the lessons of the day concerned cleanliness. Memories of students in the school do support the idea of humidity being controlled in the classroom by having a pan of water on the stove in a classroom. In the summer ventilation was accomplished using the large double hung windows in each classroom and the

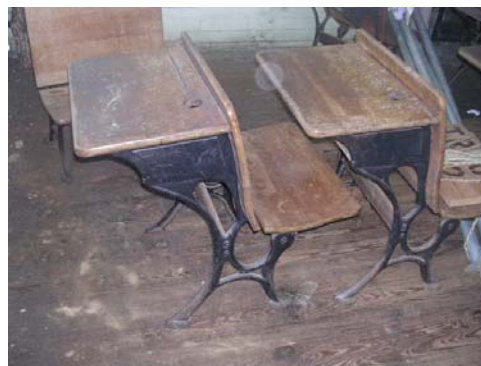
Figure 16. Desk at Bonds Academy School.

Classroom furniture was available to measurement and document at Bond's Academy. Turn of the century desks were found in the facility, which matched up, in likeness with desks in the Madison Graded School (Figure 51), which is described later in this chapter. While the community coordinator did not know if desks (Figure 16) were original to the opening day of the facility, they were well worn and well preserved. The tops of the desks did slope at the rate of one inch per foot as recommended by Barnard and they did have a dedicated storage area for students.

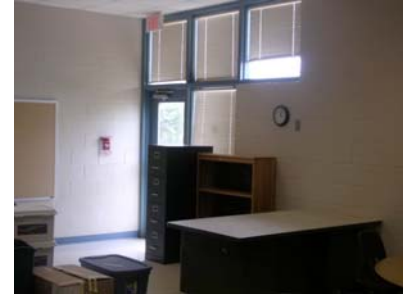
Figure 18. Danielsville Elementary Classroom

Grade levels within the facility are arranged in a pod layout. They are grouped together in common areas of the facility. The classroom surveyed (Figure 18) covered an area of 864 square feet and contained 8,510 cubic feet of air space. A fifth grade classroom with 30 students would accommodate each student with 283 cubic feet of individual

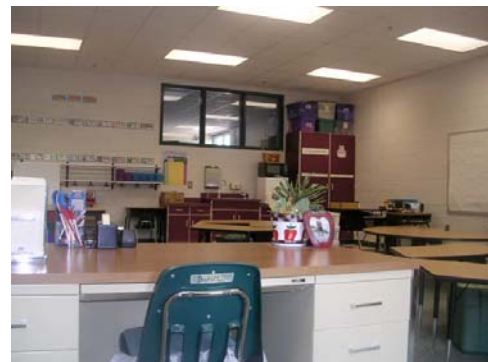
Figure 19. Danielsville Elementary Interior Window

Florescent and natural lighting enhancement, provide lighting in the classrooms. A majority of classroom's exterior walls are windowed (Figure 19) with a bank of windows located toward the ceiling of each classroom. Barnard recommended that the bottom of windows be located a minimum of four feet from the floor. The windows in Danielsville

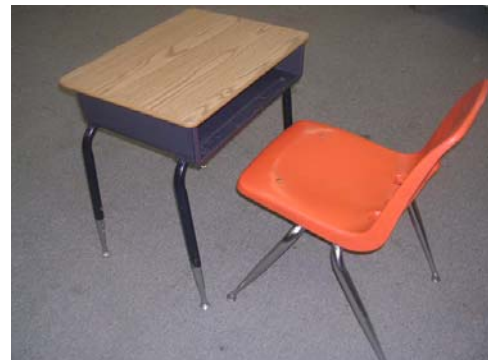
Figure 20. Desk at Danielsville Elementary.

Student furniture in classrooms varies in style depending on the grade level being taught. Desktops (Figure 20) for students are not sloped at the one inch per one-foot ratio recommended by Barnard. Teacher arrangements are suitable and teachers are able to view the entire classroom from any area. Normal teaching apparatus such as marker boards and trays, maps, globes, science specimens and critical discipline materials are observable throughout the building.

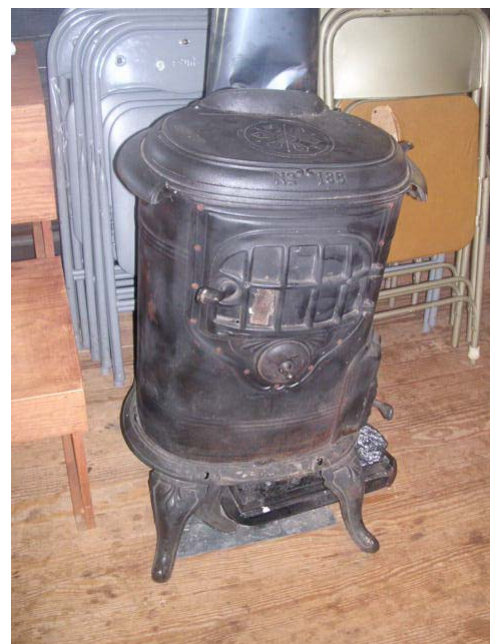
Figure 22. Stove at Chestnut School.

A wood burning pot-bellied heater (Figure 22) was used to warm the un-insulated building. Later the school used coal to fire the stove. Six double hung windows were used to give light and provide ventilation to the students in the single classroom in the structure. Handmade shutters original to the opening of the facility remain today. A student who

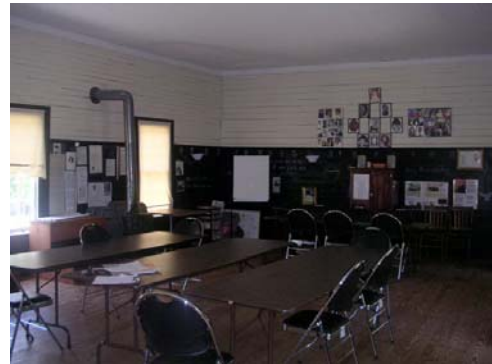
Figure 23. Chestnut Grove Classroom.

The single classroom (Figure 23) at Chestnut Grove was served by one suspended chimney, located in the center of the building. The chimney was removed and placed on the south side of the facility when church members restored the school.

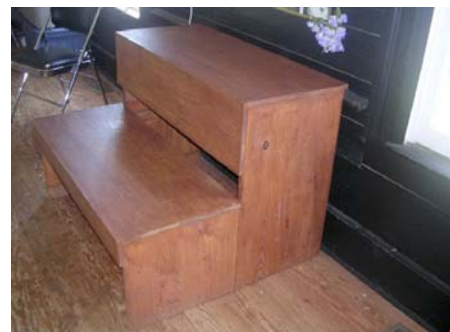
Figure 24. Recreation of Desk at Chestnut Grove.

There were no original student desks on display in the schoolhouse. There were two replicas of desks (Figure 24), built to specifications dictated by former

students on display. The desks were not sloped as recommended by Barnard. As can be seen in the photograph, the back of the seat had the desktop of the desks immediately behind attached. Judging by the size of the desks, young students would have no problem functioning in them; however, there was no record of age appropriate desks being available for students use. The desk (if used by one student) would have provided students with sufficient workspace. Based on the dimensions of the classroom, the author's judgment would be that a teacher could function in the classroom and move about without causing student disturbances.

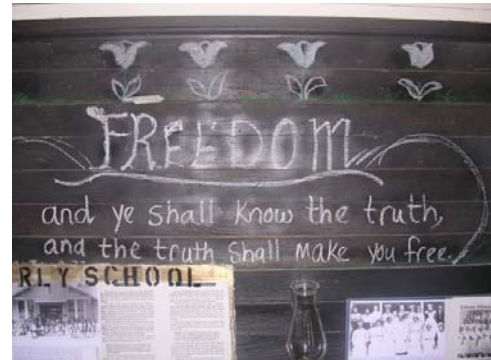
Figure 25. Recreation of Chalkboard Painted on Classroom Wall.

There was no evidence of a teacher's desk, however the former student interviewed recalled there was a teacher desk and bookcases and other basic furniture available. Students around 1934 did not use slates for written work. Only the chalkboard was used according to the student. The author was not able to determine if slates had been used early on in the history of the school. There were no chalkboards or trays for erasers and chalk. The

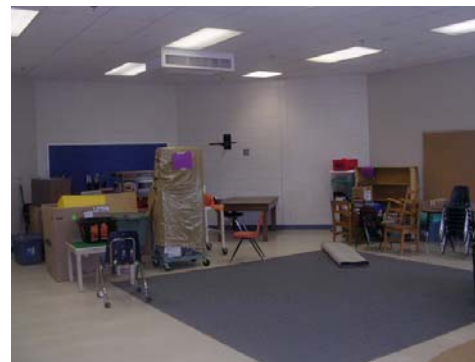
Figure 27. Classroom at Hull Sanford School.

The typical classroom (Figure 27) size in the

school is 783 square feet of floor space. All ceilings in the building are 9' 10" above the floor. This area allows in a classroom of 30 for students to have a dedicated area of 26 square feet each. The 9' 10" ceilings create an air space of 7,712 cubic feet within the classroom allowing airspace of 257 cubic feet of airspace per student, which exceeds Barnard's recommendation of 150 cubic feet per student. The size of the classroom does allow for unrestricted movement of students and the teacher in the classroom.

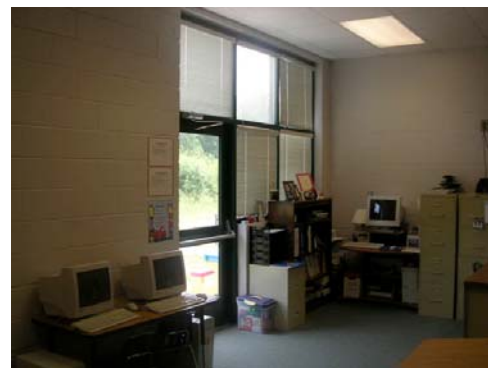
Figure 28. Classroom Windows at Hull Sanford Elementary.

Florescent lights serve each classroom and lighting is enhanced by windows (Figure 28) located in the top two feet of wall space in each room. The window bank is 16 feet long. The windows are sealed. Ventilation to classrooms is provided by a total electric HVAC system. Each classroom does have a dedicated HVAC unit, which is controlled in the classroom by individual teachers. The walls of the facility are insulated. 64% of the classrooms have exterior doors.

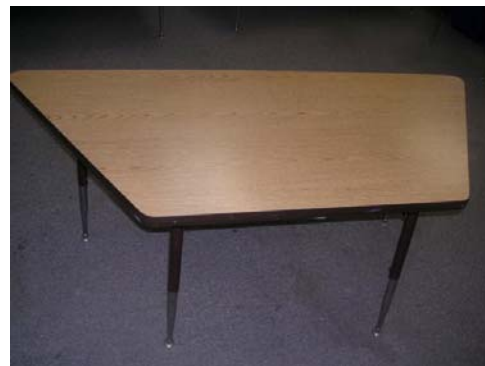
Figure 29. Tables at Hull Sanford School

tables(Figure 29) are of an appropriate size for students, however the recommended slope by Barnard in his 1848 publication is not followed. The students and teachers do have the ability to move around the room without creating a disruption and most classes visited had multiple activities going on simultaneously. The teacher was able to view any area of the classroom from her desk without any problem. Standard discipline specific teaching apparatus was apparent in the facility.

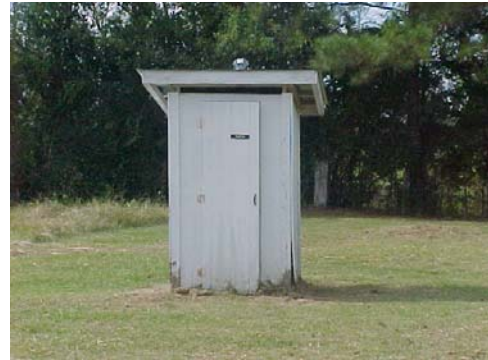
Figure 31. New Smyrna Outhouse

The exterior of the Smyrna School facility is clapboard siding. The building is set on piers, as was most construction of its time period. Restrooms (Figure 31) were located on the exterior of the building and replicas have been reconstructed on the site. It could not be determined if the original site was dry, however considering the condition of the facility a reasonable assumption can be made that the location was dry and quiet (based on the rural nature of Wilkes County in the late 1890's).

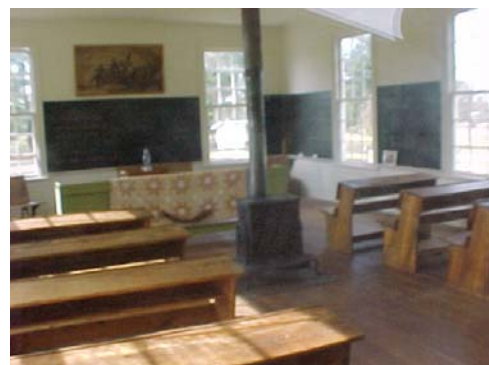
Figure 32. Surveyed Classroom at New Smyrna School

The one-room schoolhouse (Figure 32) has a total square footage of 693 feet and a cubic airspace of 6,930 cubic feet. A 189 square foot covered porch is attached at the entrance.

The classroom appears to be set up in an orderly manner with the teacher desk located at the front of the room in front of the blackboard. Desks from different periods were present ranging from all wood to cast legs with wood tops and sheet metal bottoms with wood tops. The majority of seating was a bench with backs, which also served as the desktop to the next row of students (Figure 32). The desktop's slope was less than one inch per foot and there was a storage area for books. The benches were all built one size, not accommodating large or small students well. The teachers' desk seemed small by today's standards, however it probably served the teacher well. Directly in front of the teacher's desk (Figure 32) is the original recitation bench where students would sit when reciting their work. Movement by the teacher in the classroom could take place without disrupting the class. Students had adequate space when seated in their assigned areas, if classmates surrounding them were not large. One drawback of bench seating was if a student in the middle of the row needed to exit the row, they would disrupt at least half the scholars on the row.

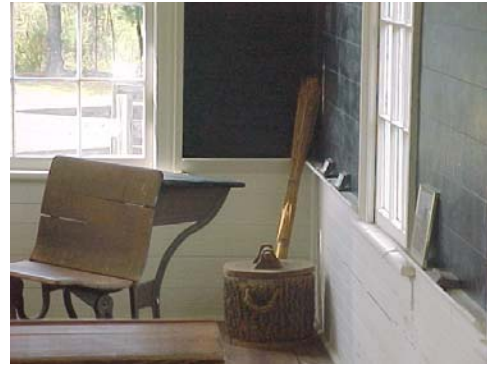
Figure 33. Wooden Water Crock at New Smyrna School

There were historic pictures, books, and maps available for student use in the facility. There was also a wood water crock (Figure 33) in the classroom, however the age of the storage unit could not be determined. There was playground equipment in the yard, but the authenticity of the equipment could not be verified.

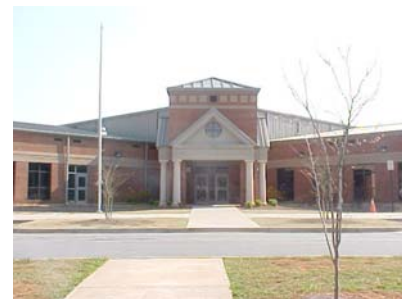
Figure 34. Jefferson City Middle School

The brick veneered structure is located on 10 acres. Adjacent to the school is Pendergrass Road, the Jefferson City Elementary School and single-family dwellings. Water and sewer services are provided by the city. The building is built on a slab.

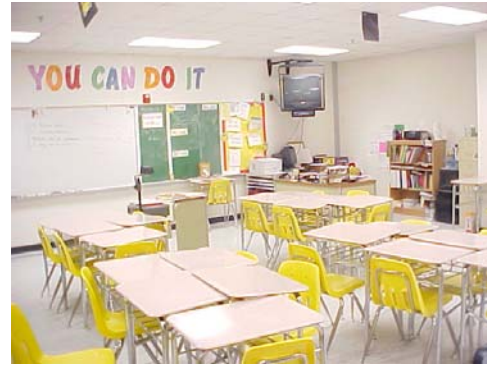
Figure 35. Jefferson City Middle School

Classrooms in the building (Figure 35) adhere to the standards established by Barnard in the requirement that each student have an allotment of 150 cubic feet of airspace. Airspace in a typical classroom at Jefferson allots students 195 cubic feet of airspace each. The classroom measured is a standard classroom in the facility and is 650 square feet, which

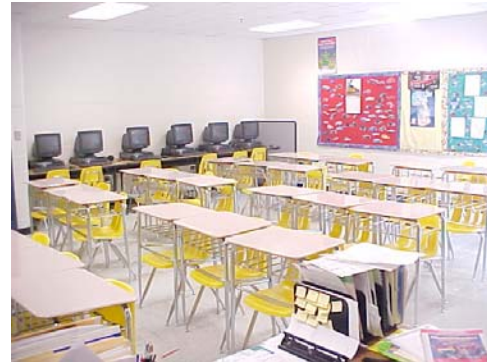
Figure 36. Computers as Teaching Apparatus

student use in the school. Jefferson City Middle School has made a commitment to technology as a teaching apparatus (Figure 36). In the facility there are 1.4 students per computer. Also in the school there are many teaching aids, which are readily available. Maps, globes, Internet, marker boards, clocks, dedicated science equipment and specimens are available for use depending on the discipline uses in specific classrooms.

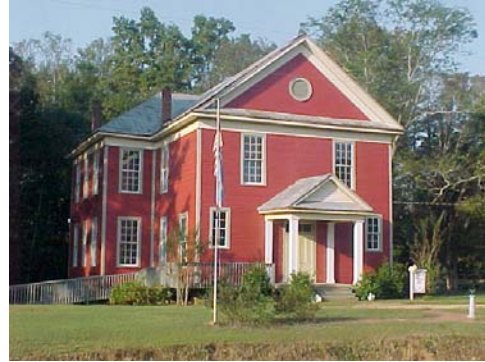
Figure 37. Apalachee School

The town of Apalachee in Morgan County is the home of the Apalachee Schoolhouse (Figure 37), (Figure C11), (Figure C12). According to Board of Education minutes on display at the facility, the school was completed in 90 days after the bid was let to Mr. E.W. Knott for the amount of \$2,590. The structure is built of yellow pine and the roof is covered

with tin. The foundation of the structure is comprised of bricks. Originally, the restroom facilities were located outside the structure. There is no record of a water source for the school, however it would be a safe assumption to suggest that a well served the school. The site of the school is a well-drained location and the school is located approximately one quarter of a mile east of Georgia Highway 441.

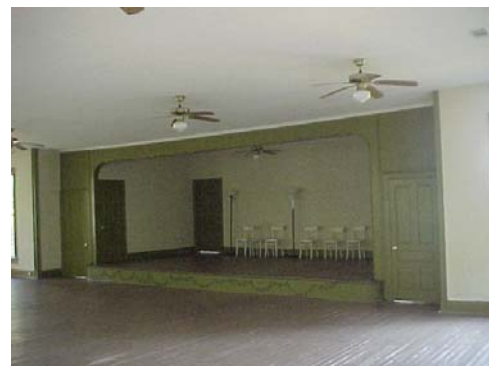
Figure 38. Auditorium at Apalachee

When opened, the school served students in the Apalachee community for grades one through eleven. The two-story facility contained three classrooms and a storage closet on the first floor. The entire second floor is an auditorium (Figure 38) and storage areas. The building originally was fitted with a fire escape, which has since been removed. The location was quiet; however just across the

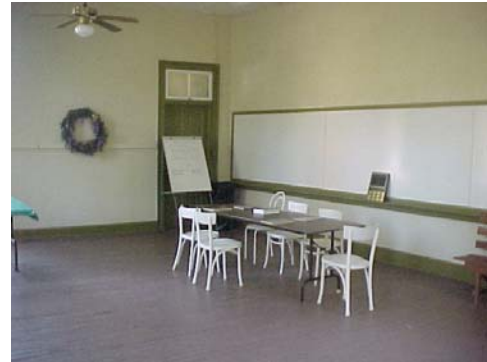
Figure 39. Surveyed Classroom at Apalachee

The largest classroom (Figure 39) in the Apalachee School is 551 square feet and has a ceiling height of 12'3". The total cubic feet in the classroom is 6,750. A classroom of 30 students would have had 225 cubic feet of airspace per student, which met the standard set by Henry Barnard. A classroom was not in place, however there were several historic desks original to the facility. It would be safe to assume that there would have been an ease of movement for students in the classroom and given the type of original desks on display, students would have had unrestricted movement while in their desk. Aside from the classrooms there were several storage closets and the aforementioned auditorium on the second floor.

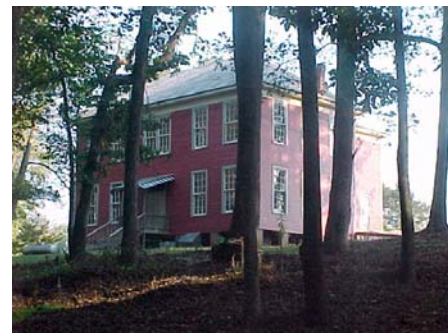
Figure 40. Natural Light was in Abundance at Apalachee

There was an abundance of natural light available in the classrooms (Figure 40). Lighting was

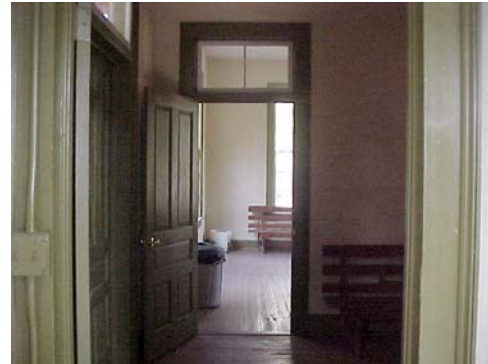
Figure 41. Transom Windows

There was no dedicated ventilation other than the double hung windows in the classrooms and transom windows (Figure 41) above the doors and the long hall, which bisected the first floor of the facility. The hallway, often referred to in southern architecture as a shotgun structure or a dog-run provided for ventilation, as it was open at each end to the outside with double doors. There was no

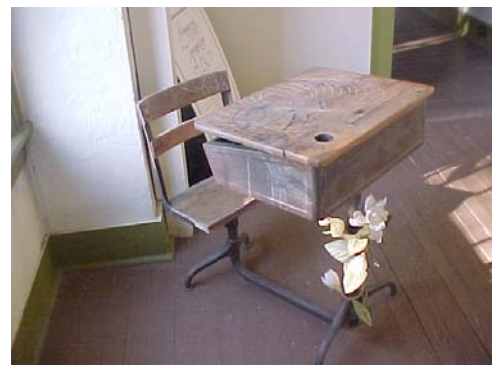
Figure 42. Student Desk

Student desks on display (Figure 42) were not a shared seating arrangement as seen in other buildings. Each seating unit was totally self-contained. The top of the desk had a slope greater than 1" per foot and the top of the desk raised to allow students to store books and personal effects in the desk. There were also several benches located in the

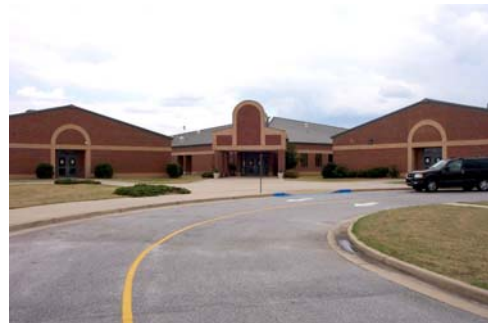
Figure 43. Malcom Bridge Middle School

Students in 1997 first occupied the campus of Malcom Bridge Middle School (Figure 43), (Figure C13), located just out of Watkinsville, Georgia. The total facility is comprised of six wings, which are interconnected. The facility was built from the proceeds of a bond referendum passed in November 1995, by the citizens of Oconee County on a 25-acre plot.

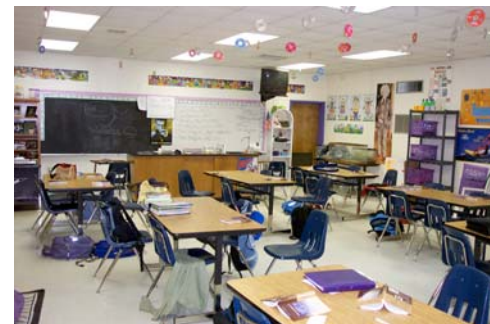
Figure 45. Classroom at Malcom Bridge Middle School

The classroom surveyed (Figure 45) in the facility measures 27.5' x 29' which equals a square footage area of 797.5'. With ceilings 10' high a calculation of classroom air displacement of 7,975 cubic feet was attained. The specified classroom is standard for the instruction of math, language arts and social studies. These classrooms well exceed the standards set forth by Barnard and the committee formed to give input to school leaders. According to

the teacher interviewed there are no problems with student overcrowding nor is there a problem with student supervision whether the teacher is at his/her desk or moving about a classroom.

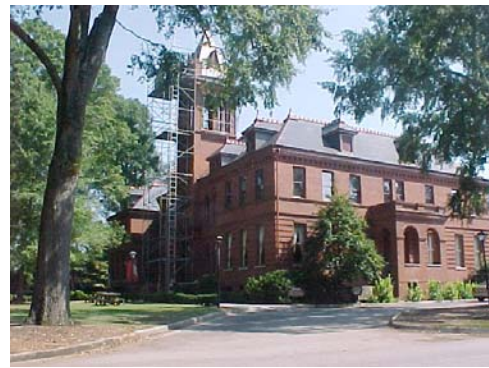
Figure 46. Madison Graded School

Built in 1895, the Madison Graded School (Figure 46, (Figure C14), (Figure C15) is believed to be the first brick schoolhouse built on the railway between Augusta and Atlanta. Madison, a community, which is known in folklore as the town General William Tecumseh Sherman, found too beautiful too burn in his march to the sea during the Civil War, is a town full of unique architecture. The Madison Graded School is no exception to the architecture of the town. The school was built in the architectural style of Romanesque Revival. The roof of the facility is slate (Figure 47) and the interior walls are plaster. Electricity provided the lighting in classrooms. While most students of the time period were housed in classrooms where students were mixed by grade, the students in Madison were “graded” or separated into specific groups by grade. Later, grades eight through eleven were added (in a separate facility) along with a lunchroom and gym. The facility served the community as a schoolhouse until county schools were consolidated 1957. Destruction of the building was a

On opening, the school consisted of 13 classrooms and was built on a foundation and also is situated on pillars. The site is well drained and is located in a quiet neighborhood on approximately 4 acres of land. There are very large trees located today on the grounds of the facility. Original photos of the school show the building towering over the trees on the plot. Grades originally taught at the Madison Grade School were first through seventh. It is not clear how water for students was supplied.

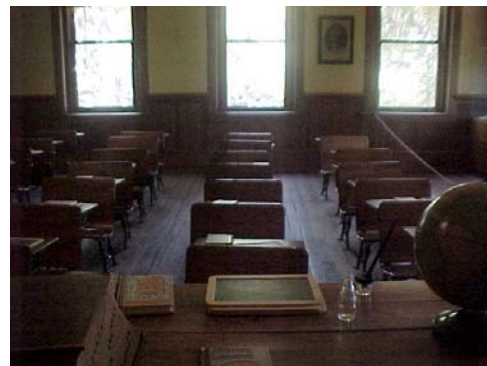
Figure 49. View of Classroom From Teachers Desk

Classrooms (Figure 49) on first appearance seem to be quite spacious, however after measuring they were found to be 22' x 28'. The height of the ceiling was the highest surveyed at 13'. The height of the ceiling in each classroom creates the illusion that the rooms are much larger than reality. Each classroom at the Madison Graded School contained

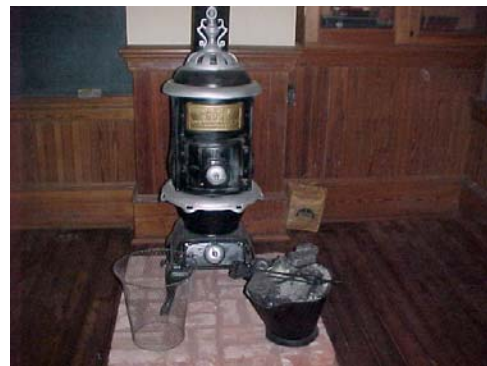
Figure 50. Madison Graded School Classroom Stove

The heating of the facility was accomplished on a room-to-room basis. Each classroom had a coal-burning stove (Figure 50), which was lighted each day by the school janitor. The pollutants were removed from the building by an extensive system of chimneys. There was no evidence of a thermometer in the classroom, nor dedicated humidity controls.

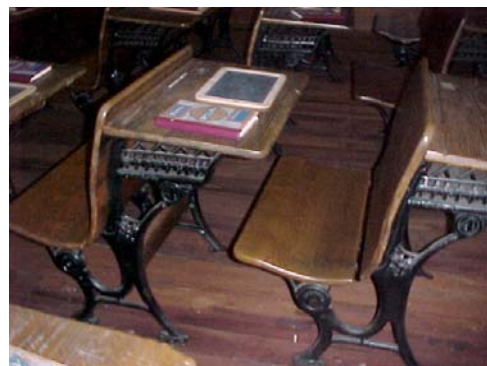
Figure 51. Madison Graded School Desk

Desks in the facility's classrooms (Figure 51) were what could be considered at the time as state of the art. In the model of a historic classroom arrangement there were 23 individual desks arranged in the room. The desks were the type where the backrest was attached to the desktop behind the pupil. Desks throughout the facility were found in a variety of sizes. Desks were well suited to the size of the students. The tops of the desks were sloped at one

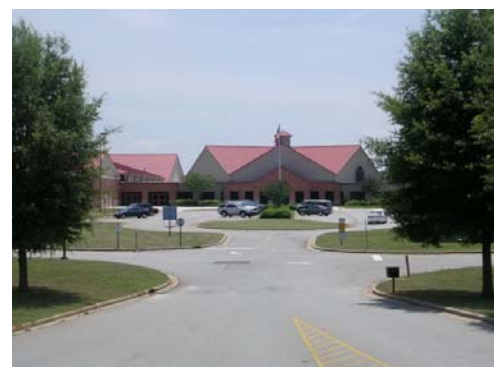
Figure 53. Oconee County High School, Main Entrance

Occupied in 1992, Oconee County High (Figure 53), (Figure C16) School is located just outside Watkinsville, Georgia and houses 1,600 high school students. Presently it is the only high school located in Oconee County, however a new high school is due to open in the fall of 2004, which will house ninth and tenth grade students. The new high school

will relieve the student population pressure found today at Oconee County High School. The brick veneer structure was constructed on a slab and is located on a plot containing 84.49 acres. The county provides water for student use in the facility. The facility site is in a quiet area and during inclement weather there is no standing water around the school.

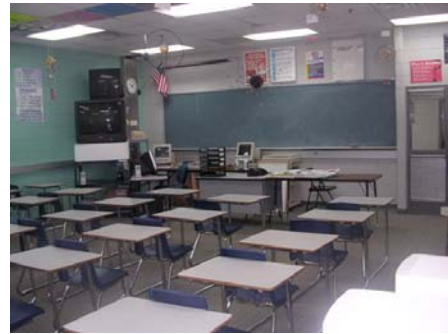
Figure 54. Oconee County High School Classroom

Standard classrooms (Figure 54) at Oconee County High School are 24' x 30' which covers a floor area of 720 square feet. The ceiling height in the surveyed classroom measures 132.5" (11.04'). The surveyed classroom contains 7,949 cubic feet of air

space, which will allot an individual student in a classroom of 30 students 265 cubic feet of air space. The walls of the classroom are constructed of concrete block and carpet covers the floors of most classrooms.

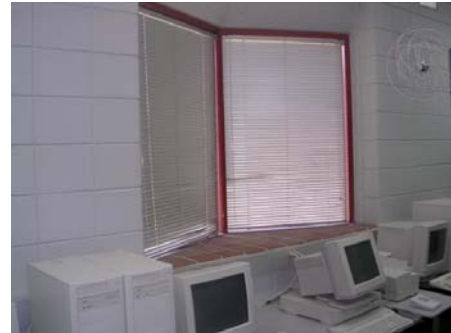
Figure 55. Interior Window

Lighting is provided from florescent fixtures in the classroom. In each classroom there are two 3' x 4' windows which provide natural light (Figure 55). The windows are sealed and provide no ventilation from the outside.

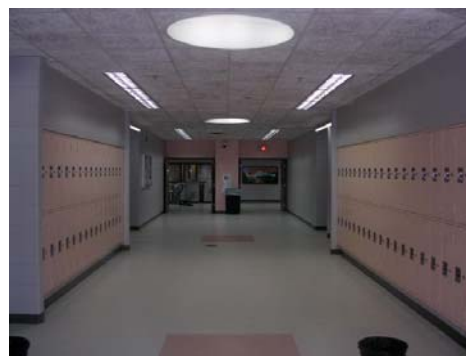
Figure 56. Oconee County High School Hall

In the interview with faculty members at Oconee County High School, the researcher posed the question, what is the best aspect of your facility and classroom spaces. Both faculty members responded the hall width (Figure 56) was a great design aspect of the school. Measuring the halls they were found to be 14' in width. The educators interviewed felt the width of the halls provided students easier access and movement between classes and eliminated

student conflict due to the fact students were not tightly packed together. Asking if they knew of any study, which would support their hypothesis, they responded their thoughts were based on their professional opinion. Regardless, both the teachers interviewed listed the width of the halls as an important design element at Oconee County High School.

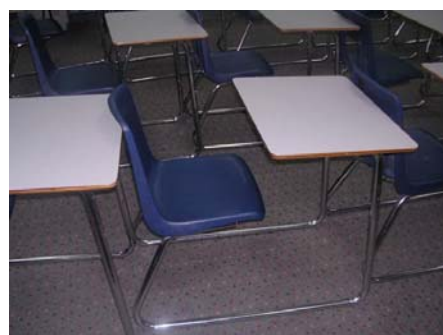
Figure 57. Bi-Entry Desk at Oconee County High School

The teachers interviewed when the survey was conducted also had comments concerning classroom furniture for students. The age appropriate desk used at Oconee County High School is a bi-entry desk (Figure 57). Students can enter from either side of the desk. The teachers interviewed found this to be a great positive for student movement and classroom management. The slope of the desktops varies throughout the building depending when the desks were purchased. Desks original to the school were not sloped as Henry Barnard recommended, however replacement bi-entry desks purchased as replacements do have the recommended one-inch of slope per one inch of desktop. All desks in the building have a storage area for textbooks.

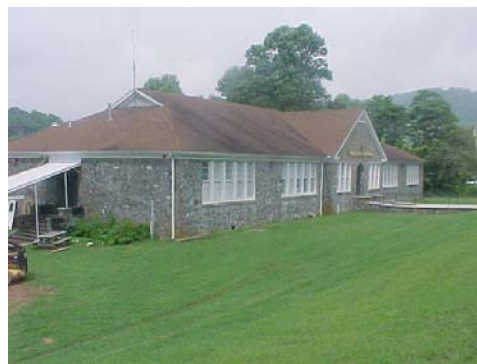
Figure 58. Woody Gap School

The Woody Gap School, (Figure 58), (Figure C17) located in Suches, Georgia, is unique in many ways including its facility. Built in 1940 on the site of the home place of Georgia's Confederate Governor, Joe Brown, the exterior of the building is constructed of granite quarried from within the city limits of the city. Several teachers were working there in the school when the survey was completed and were very knowledgeable in the history of the facility. The school was used to consolidate five one and two teacher schools, which had met in churches throughout the surrounding countryside.

The school is located just up a small hill from a mountain stream and the site of the building is well drained. The school is built on piers with a crawl space under the building and a full basement located under the center of the building. At one time the basement served as the lunchroom, however a separate building has been built for serving students today. The facility is also in a quiet location.

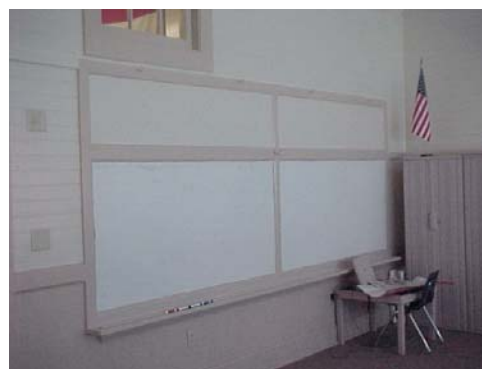
Figure 59. Elementary Classroom at Woody Gap

The classroom surveyed (Figure 59) at Woody Gap measured 29' x 23' which computes to a square footage of 667 square feet. A ceiling height of 12' results in a classroom containing 8,004 cubic feet of air space. Applying a standard class size of 30 to the given classroom would allow students 267 cubic feet of air per student. The average class size at Woody

Gap is 15 students so Barnard's standards are easily exceeded. The grade structure within classrooms at Woody Gap is also unique in that multiple grades meet simultaneously in classrooms supervised by a single teacher. The kindergarten students are in a classroom to themselves. First and second, third and fourth, fifth and sixth and seventh and eighth grade students meet in the same classrooms. All high school academic classes are segregated by grade. Even in multiple grade classrooms there appeared to be opportunity for easy movement by the instructor and the students around the classroom and in their seats. It was also noted that observation of the entire classroom could easily be attained from any point in the classroom.

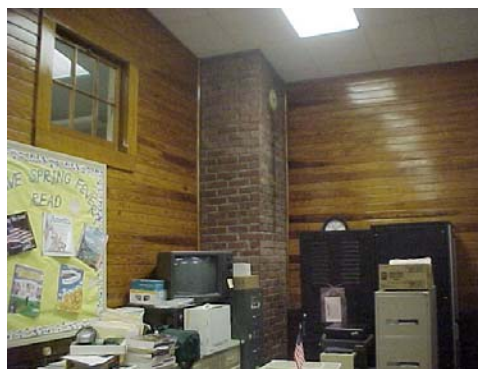
Figure 61. Chimney and Flues

The building was originally heated by wood burning stoves in each classroom. As time passed the school also used coal, fuel oil, liquefied gas and electricity for heating purposes. Covered flues are visible in classrooms today (Figure 61). The exhaust from the heaters was ventilated through five chimneys, which were back to back (serving two classrooms with each other). In warmer times of the years the double hung windows could be opened for cooling purposes. There are transoms built into the walls and doors (Figure 62) of each classroom, which still function. There was no evidence of humidity controls or a classroom thermometer in the original classrooms.

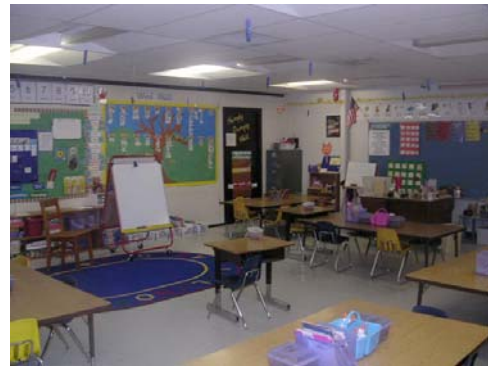
Figure 64. Banks County Primary Kindergarten Classroom

Classrooms at Banks Primary were standard from one to the other in size. The classroom surveyed (Figure 64) measures 31' x 24' and had a ceiling 96" above the level of the floor. The calculations show a total area in a classroom at Banks Primary of 744 square feet. Multiplying the area times the ceiling height of eight feet gave a cubic area of 5,952 cubic feet of air space. Using the student constant of the study shows that each student in a classroom of 30 would have 198.4 cubic feet of unique air space, which exceeds Barnard's recommendation of 150 cubic feet per student.

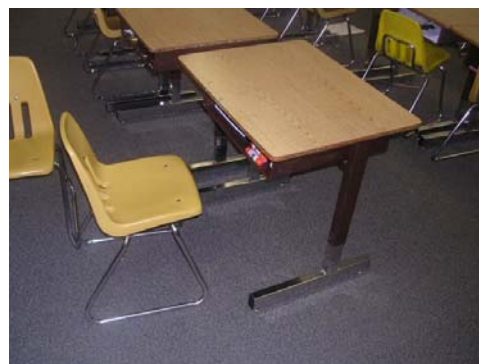
Figure 65. Banks County Primary Student Desk

The student furniture in classrooms is age appropriate. A majority of the students have an individual table and chair (Figure 65). The table provides a storage area for books, however it is a flat surface, which Barnard would have discouraged. The principal pointed out that students could reconfigure their desks into tables for group work with little effort.

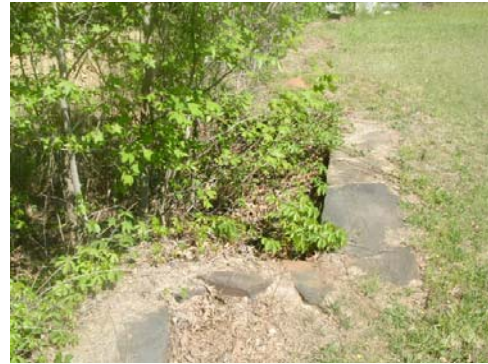
Figure 68. Surviving Rock Wall

The Ashland School House is located in the Bold Springs Community in northwest Franklin County. According to community members interviewed, the original facility was a two-story structure built CIRCA 1908. The downstairs consisted of classroom space while the upstairs was an auditorium. The original structure burned in 1933 and the Ashland School House, (Figure 67), (Figure C19) which is located just across the road from the original schoolhouse, opened for classes in 1934. The four-room schoolhouse stands at the top of a knoll and is immediately behind the Ashland Masonic Lodge. The location of the facility on the knoll eliminates any problem, which might occur from water standing around the well-drained site. The schoolhouse was built on pillars made of mortar and stone, which was collected at the site. The exterior of the building was clapboard siding and was recovered in 2002 with vinyl siding. When the facility opened, grades one through seven were taught according to a member of the community, whose husband attended the school. Classrooms were multi-grade with first and second meeting in a classroom together while third through fifth grades shared a classroom, as did sixth and seventh grade students. The school site also had a remaining area dedicated to pupil transportation services. A surviving rock wall (Figure 68) and

steps are still located on the site today where pupils loaded and unloaded school buses. There were no documents showing the date the wall was built, however one of the community members interviewed remembered that student transportation was not an option when the school reopened. Most students were transported to school on foot.

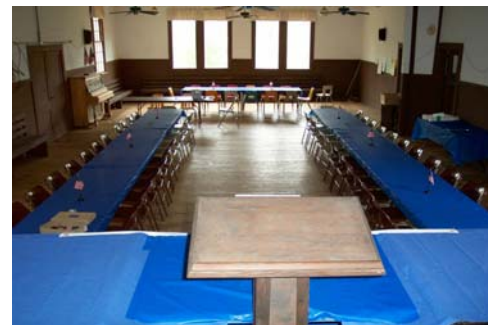
Figure 69. Community Room at Ashland School

The surviving classroom which was surveyed measured 28' 5" x 22' 9". The 646 square feet of

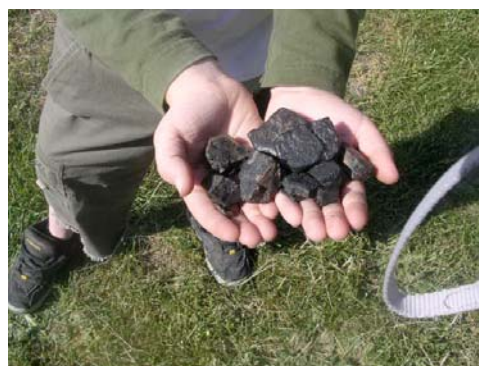
Figure 70. Coal found on the Ashland School Site

In the winter the un-insulated facility was heated by coal burning stoves (Figure 70). Ventilation of the structure was attained in the warmer months by opening windows and exterior doors. There were no fresh air vents in the ceiling or floor to provide fresh air for students in the winter as Barnard prescribed. Considering the wood construction of the school and

lack of insulation an assumption could be made that a buildup of stale air, with which Barnard was concerned, would not be a problem. The community member interviewed did have a recollection of teachers keeping a container of water on the stove to maintain sufficient moisture in the air in the winter, however there was no reallocation of a thermometer being in a classroom.

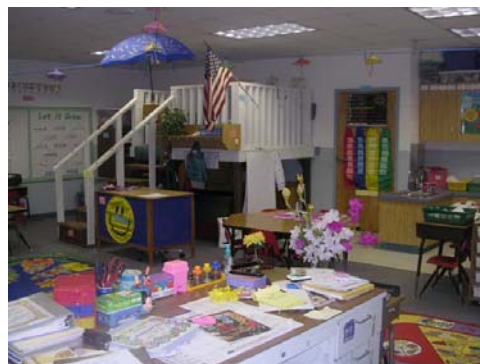
Figure 72. Kindergarten Classroom at Lavonia Elementary

The specific classroom surveyed (Figure 72) serves kindergarten students. The ceiling height in the classroom is 10'. The dimensions of the room are 28' x 28' which computes to a total area of 784 square

feet. With a classroom of 30 students the kindergarten classroom at Lavonia Elementary exceeded the standard of 150 cubic feet of air space per student by 111'. The classroom at Lavonia contains 284 cubic feet of air space per student. The classroom surveyed has no wasted space, in fact there was a reading loft constructed of two by fours so part of the room was two stories. It appeared to the author that there was sufficient room for children to move about the room and the teacher would have easy visual access to students anywhere in the classroom. A storage closet was available for storage in the classroom and additional storage is also available throughout the school.

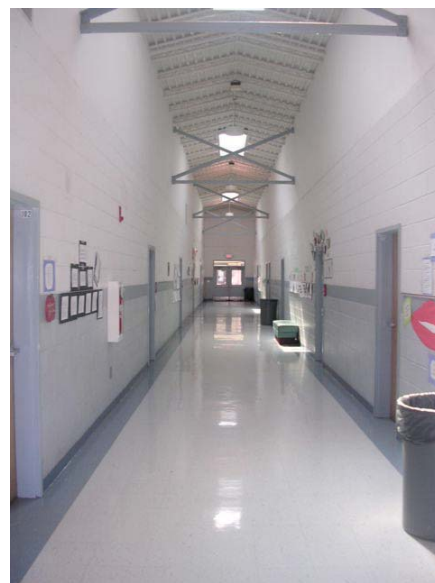
Figure 73. Hall Skylights at Lavonia Elementary

windows on the exterior walls (surrounding the courtyard). The hall area around the courtyard is very well lit and is visible from the main entrance into the facility. Another unusual lighting feature is in the hallways, which project away from the core of the building. The ceiling in the halls reach a height of 20' and are lighted by skylights as well as man-made lighting (Figure 73). The hallways presented a challenge to the school leadership during inclement weather. The Georgia Emergency Management Agency (GEMA) was called into consultation with school officials to evaluate procedures to follow in case a tornado warning was issued. GEMA officials instructed system personal to not follow standard tornado procedures during drills or warnings but to sit students against the interior walls of classrooms instead of hallways. These procedures were developed due to the hallway skylights.

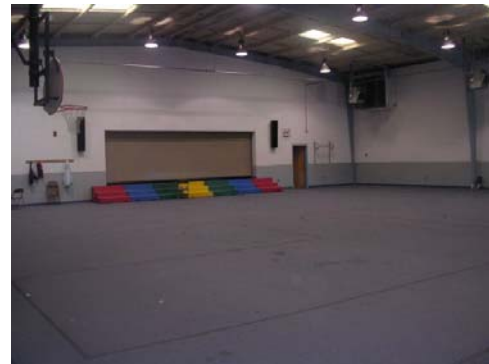
Figure 75. Gym at Lavonia Elementary

Lavonia Elementary has four separate areas dedicated to physical activities. A gymnasium is built into the main building (Figure 75). The gym appeared to be very spacious and there was a stage in the gym so it could double as an auditorium. There were no bleachers in the gym. Seating for assemblies would consist of students sitting on the floor for special

activities and for more formal activities, such as promotion ceremonies at the end of the year, chairs would be arranged in the room for seating of students and parents. The gym at Lavonia Elementary was insulated with a type of insulation not seen in any other facility. The insulation was sprayed onto the roof of the structure and was used to dampen noise and retain warm air in the winter. The gym was not air-conditioned. Also at Lavonia Elementary there were three outdoor areas dedicated to physical activities. There were two playgrounds, one for lower grades (K-2) and another for students in the third through fifth grades. There was also a walking track, which was completed in the 2003-2004 school year, and measured one quarter of a mile in length.

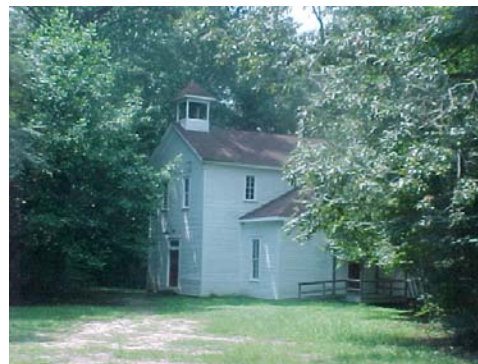
Figure 76. Hebron School

The school, (Figure 76), (Figure C21), (Figure C22) built in 1909, was located on a flat area just down a hill from the Hebron Church. The lay of the plot provided drainage into two wooded hollows. The foundation of the structure is built of mortar and stones, which were probably collected at the site. The date of August 1909 is inscribed in the mortar of one of the pillars. According to the student interviewed, who attended the school in the late 1920's, the school was in a peaceful location.

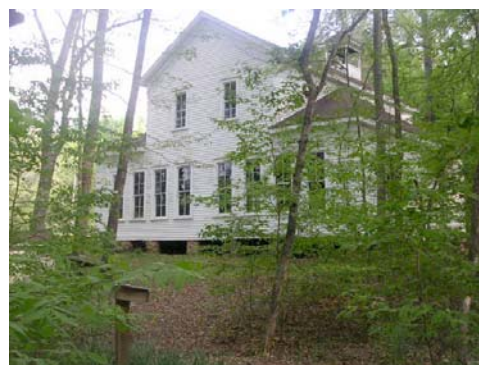
Figure 79. Windows at Hebron School

The windows in the facility (Figure 79) were double hung which allowed them to be opened at both the top and bottom to create a draft. The walls of the building were not insulated, however were tight in their construction as were the floors and ceilings. All interior surfaces were tongue and groove wood. There was neither dedicated ventilation nor transom

windows as Barnard devised in his plans for schools in the facility. Heating in the building was accomplished by a wood-burning stove, on which a pan of water sat in the winter months to assist in moisturizing the air. There was no thermometer in the building so temperature changes were never recorded.

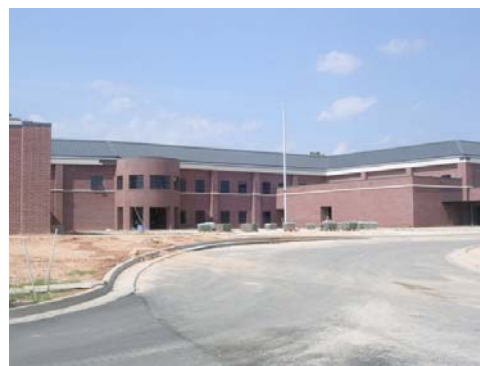
Figure 80. Stephens County Middle School

The Stephens County Middle School (Figure 80), (Figure C23), (Figure C24) facility is being built with proceeds from a Special Purpose Local Option Sales Tax (SPLOST), which was approved by the voters in 1998. The cost of the facility is expected to be in the neighborhood of 18.5 million dollars and is to be occupied in the fall of 2004 housing a projected

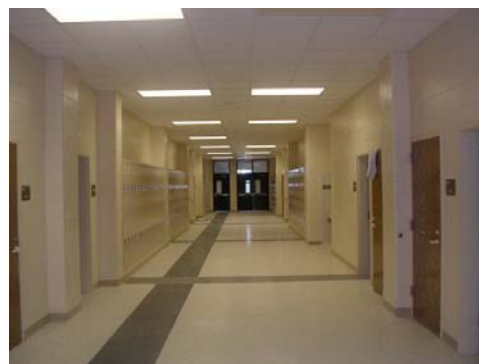
Figure 81. Stephens County Middle School Hall

Entering the facility from the main entrance students will find themselves in a large commons area that connects with hallways. This will then disperse students to their designated areas of study. The floors in the hallways of the first floor are terrazzo, with ceramic tiled load bearing columns supporting the floor above. The main hallway leading into the facility was 26' wide. The halls narrow down to 14' (Figure 81) when entering areas of the building

where classrooms are present. Fire suppression sprinklers guard the entire structure. Access was gained to the main mechanical room of the facility and was quite impressive.

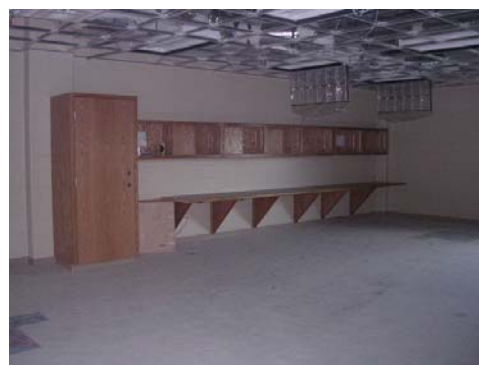
Figure 82. Stephens County Middle School Classroom

The social studies classroom surveyed (Figure 82) measured 26' x 34' and ceiling height in all classrooms are ten feet. The classroom covers an area of 884 square feet and contains 8,840 cubic feet of air space. Applying the constant of 30 students per classroom to the measure reveals each student is provided with 294 cubic feet of air space. This measure almost doubles Barnard's recommendation of 150 cubic feet per student.

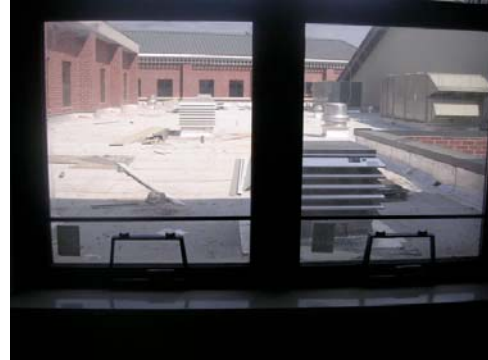
Figure 83. Stephens County Middle School Classroom View

Florescent fixtures provide illumination in the facility. Each standard size classroom has a minimum of 2 windows measuring 6' x 6' 8". While Stephens County Middle School classrooms are well lighted, the windows were somewhat of a distraction in some second floor classrooms. Some classrooms on the second floor overlook the roof of single story parts of

the building, which created quite an unsightly view of a tarred roof scape (Figure 83). Windows, whose bottoms were located higher on the walls of the classroom, might have been more suitable in these given classrooms.

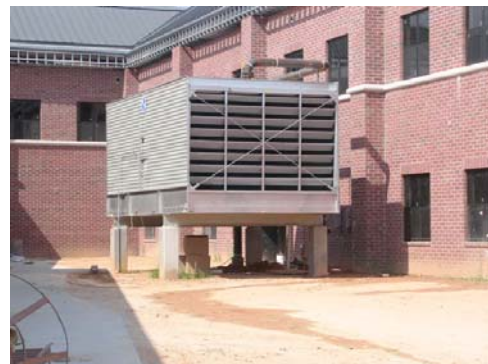
Figure 84. HVAC Water Cooling Tower

There is dedicated ventilation in individual classrooms s required by industry standards for HVAC manufactures. The air conditioning system made use of a large water-cooling tower (Figure 84), which aids in the economics of cooling the facility. The windows are sealed however there is a small screened 32 square inch opening at the bottom of each window. Heating

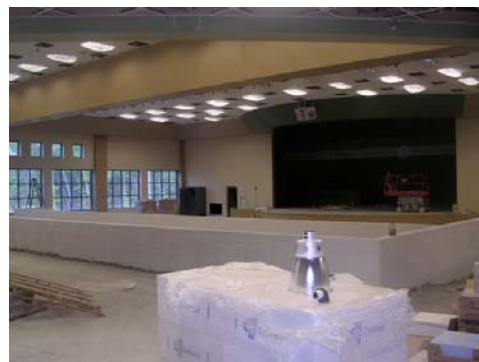
Figure 85. Auditorium at Stephens County Middle School

Teaching apparatus include lab tables with overhead mirrors, which will provide students with a bird's eye view of science experiments and specimens, and an area dedicated to computer workstations which contain five network drops in each classroom in the building according to a school official. Also other needed discipline specific tools for teachers will be provided in this new facility. An extensive library is also part on the building with study room built into two walls of the area. An auditorium with a complete stage and backdrop area is built into the school (Figure 85). The sloped seating area will accommodate 1,200 parents or students for plays, concerts or civic and community meetings.
