Phase I Historic Resources Survey

South Bainbridge-Climax Transmission Study

December 2012

The University of Georgia
College of Environment + Design
Center for Community Design & Preservation
Historic Resources Survey Report

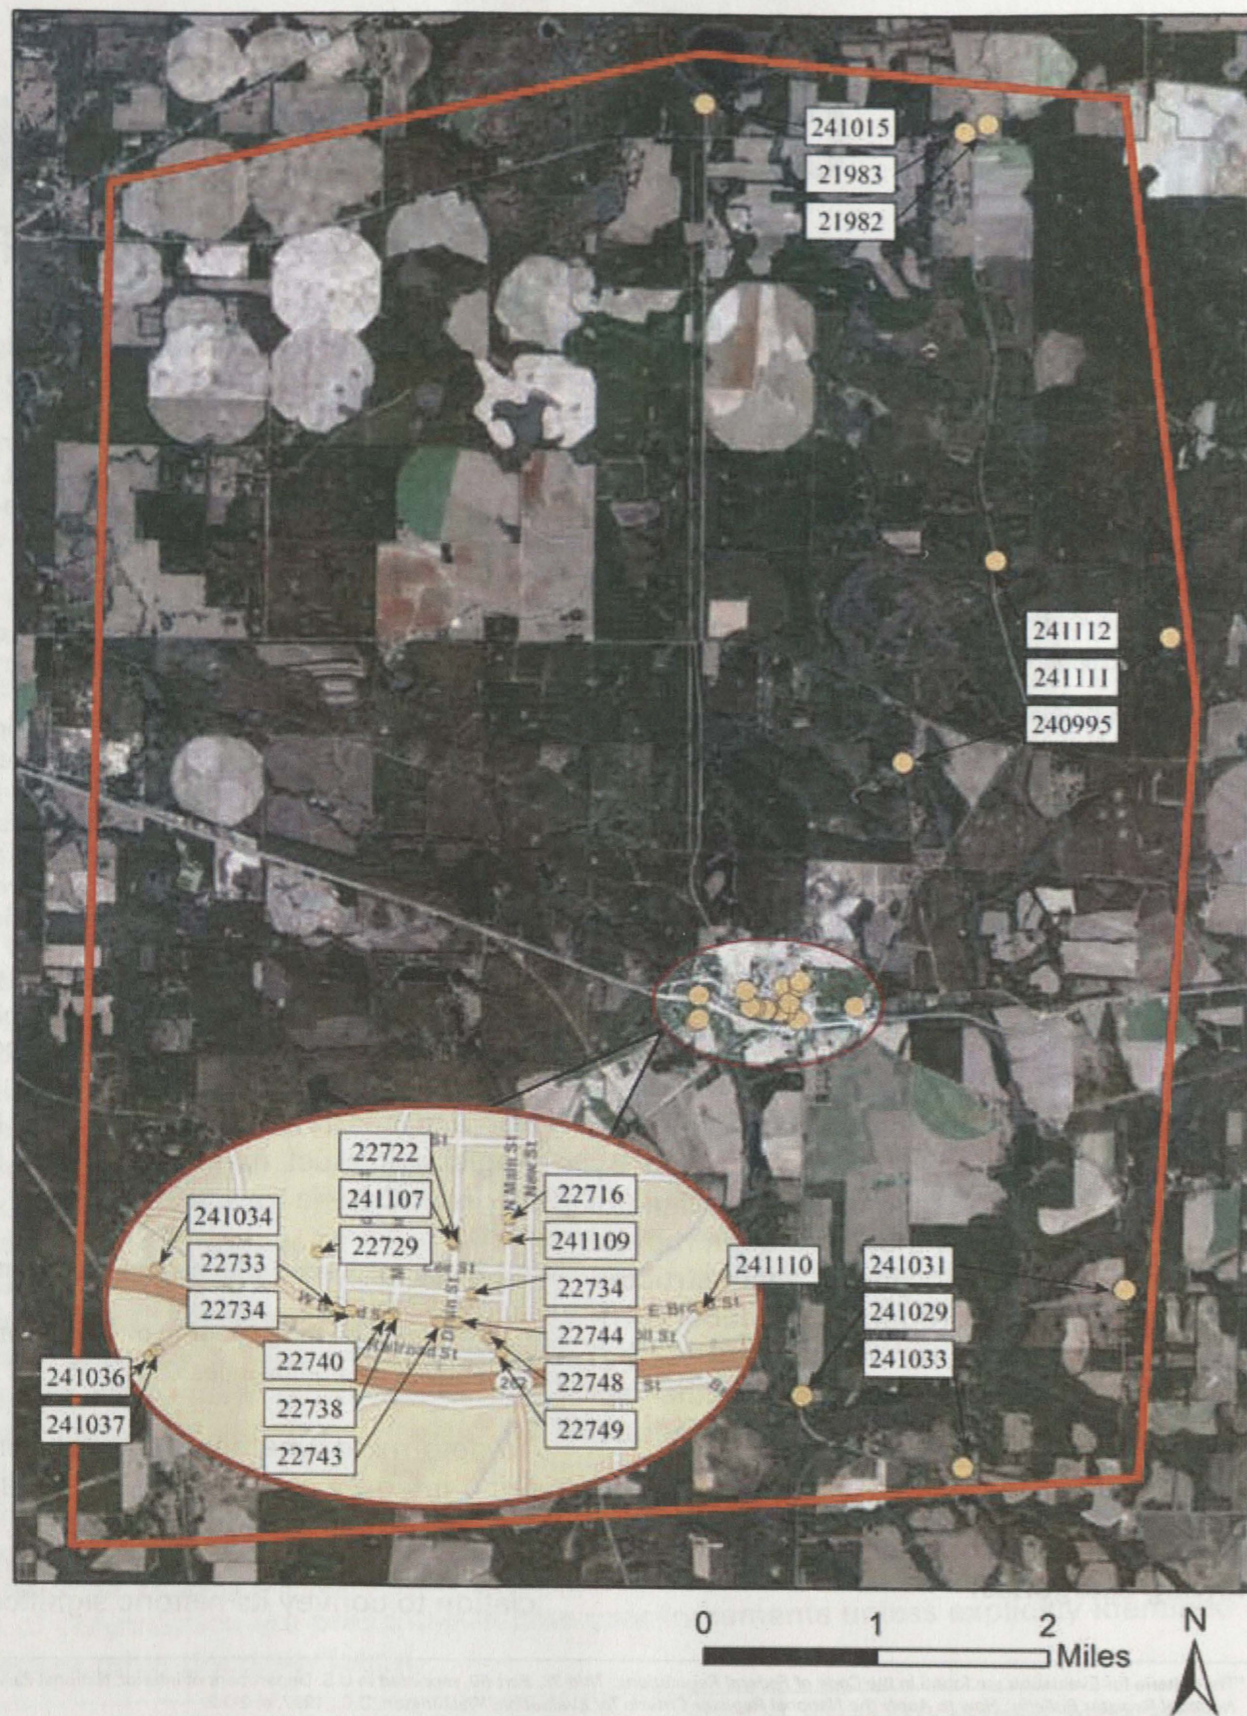
Figure 3. Recorded Historic Resources within the Studied Area

A total of twenty seven (27) resources are currently extant within the S. Bainbridge-Climax survey area, and maintain a minimum level of age, integrity and significance. The construction date of all resources ranged from the mid-1840s to the late 1940s. The majority of resources date to the turn of the 20th Century; thirteen resources (48%) are believed to have been constructed between 1900 and 1915.

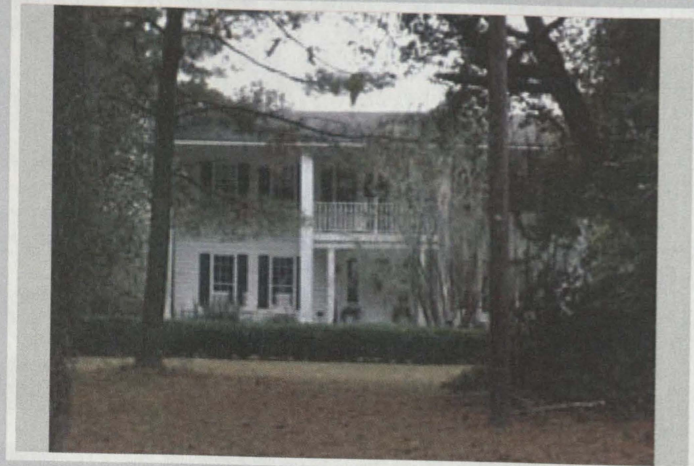
Resource ID DR-01
Address 261 Earl Hester Rd
County Decatur

Resource Type Building
Resource Use Single Family Residence
Date of Construction 1900-1909
House Type Georgian House
Barn Type
Church Type
Commercial Type
School Type
Structural System Balloon Frame
Style Colonial Revival
Roof Gable: side
Exterior Cladding Synthetic: Vinyl Siding
Foundation Pier with Infill: Concrete Block
Porch Verandah, Wrap-around, Balcony
Windows Double Hung Sash: 9/9
Chimney Both Gable Ends: Brick
Alterations Replacement materials

Preliminary Assessment
Not Eligible

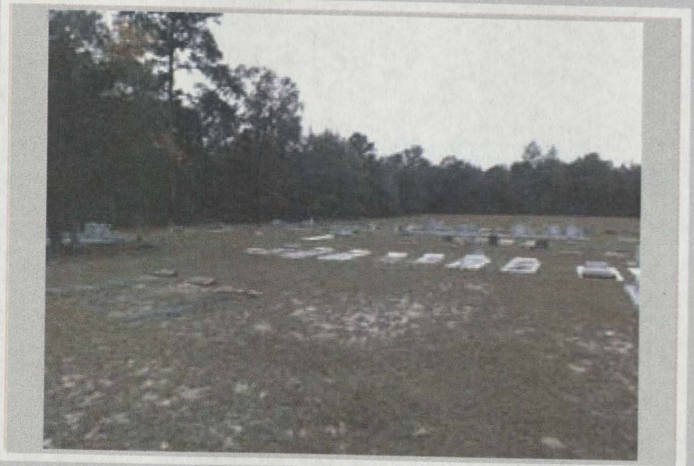
Resource ID DR-02
Address 119 Salem Church Rd
County Decatur

Resource Type Site
Resource Use Funerary: Cemetery
Date of Construction 1847
House Type
Barn Type
Church Type
Commercial Type
School Type
Structural System
Style
Roof
Exterior Cladding
Foundation
Porch
Windows
Chimney
Alterations

Preliminary Assessment
Not Eligible

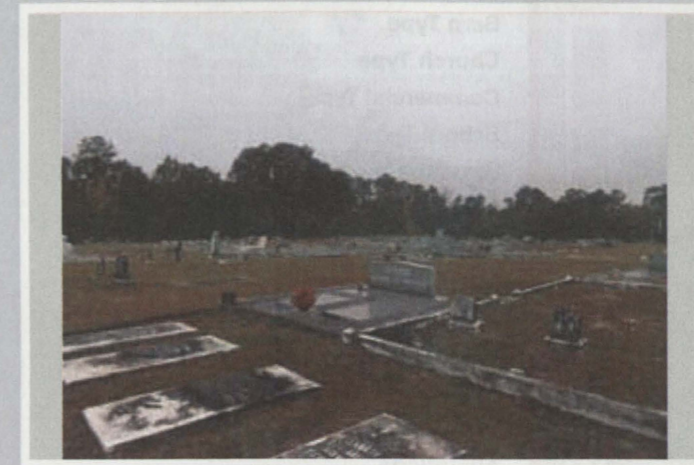
Resource ID DR-03
Address 535 GA-262
County Decatur

Resource Type Site
Resource Use Funerary: Cemetery
Date of Construction 1870
House Type
Barn Type
Church Type
Commercial Type
School Type
Structural System
Style
Roof
Exterior Cladding
Foundation
Porch
Windows
Chimney
Alterations

Preliminary Assessment
Not Eligible

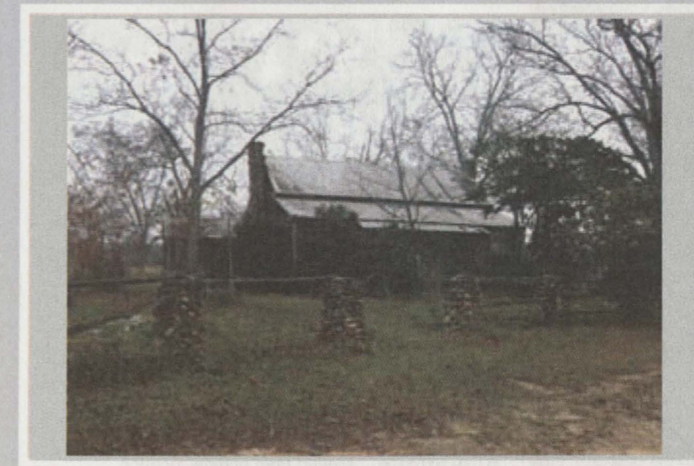
Resource ID DR-04
Address Meredith Jones Rd @ 353 Jones Rd
County Decatur

Resource Type Building
Resource Use Single Family Residence
Date of Construction 1885-1894
House Type Central Hallway
Barn Type
Church Type
Commercial Type
School Type
Structural System Balloon Frame
Style No Academic Style
Roof Gable: side
Exterior Cladding Wood: Weatherboard
Foundation Unknown
Porch Verandah
Windows Double Hung Sash: 6/6
Chimney Both Gable Ends: Stone
Alterations Enclosed Verandah

Preliminary Assessment
Not Eligible

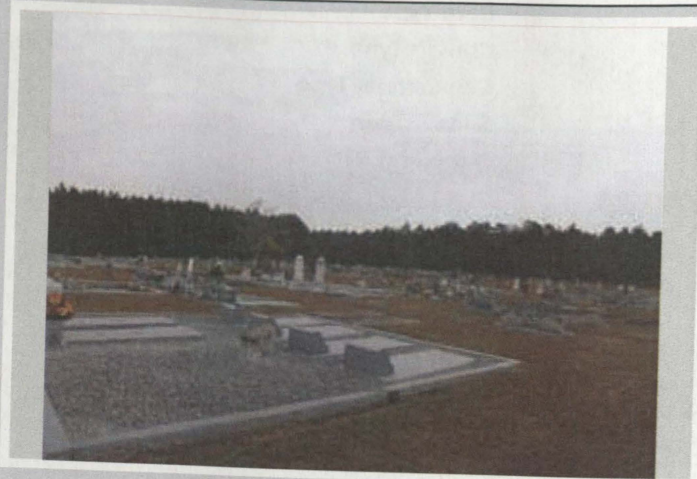
Resource ID DR-05
Address 760 GA-262
County Decatur

Resource Type Site
Resource Use Funerary: Cemetery
Date of Construction 1876
House Type
Barn Type
Church Type
Commercial Type
School Type
Structural System
Style
Roof
Exterior Cladding
Foundation
Porch
Windows
Chimney
Alterations

Preliminary Assessment
Not Eligible

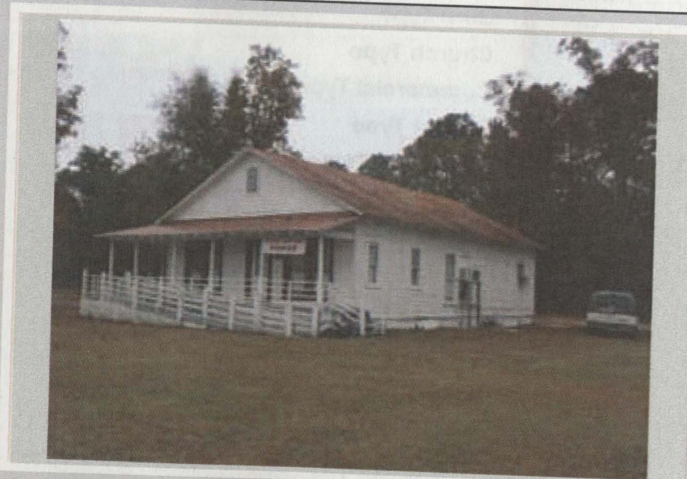
Resource ID DR-06
Address 3653 Thomasville Hwy
County Decatur

Resource Type Building
Resource Use Religious: Church
Date of Construction 1930-1939
House Type Bungalow: Front Gable
Barn Type
Church Type
Commercial Type
School Type
Structural System Balloon Frame
Style Craftsman
Roof Gable: front
Exterior Cladding Shiplap
Foundation Continuous: Concrete block
Porch Verandah
Windows Double Hung Sash: 6.1
Chimney No chimney observed
Alterations Moved from original location

Preliminary Assessment
Not Eligible

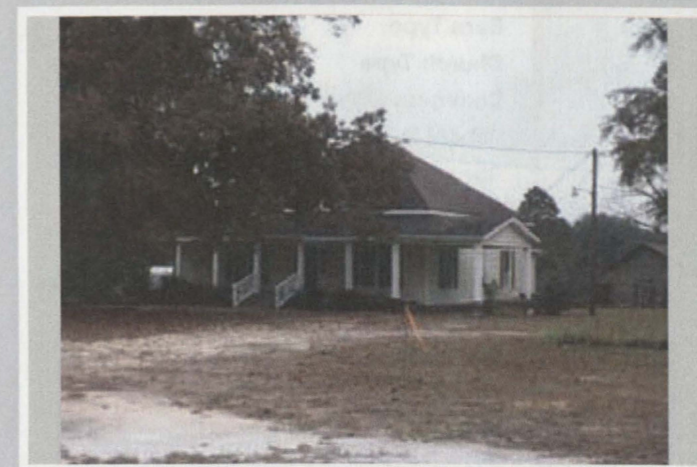
Resource ID DR-07
Address 149 Attapulugus-Climax Rd
County Decatur

Resource Type Building
Resource Use Single Family Residence
Date of Construction 1900-1909
House Type Georgian cottage
Barn Type Machinery
Church Type
Commercial Type
School Type
Structural System Balloon frame
Style No Academic Style
Roof Hip
Exterior Cladding Synthetics: Vinyl Siding
Foundation Pier with Infill: Brick
Porch Verandah
Windows Double Hung Sash: 2/2
Chimney Gable end interior: Brick
Alterations Material replacements; Altered verandah

Preliminary Assessment
Not Eligible

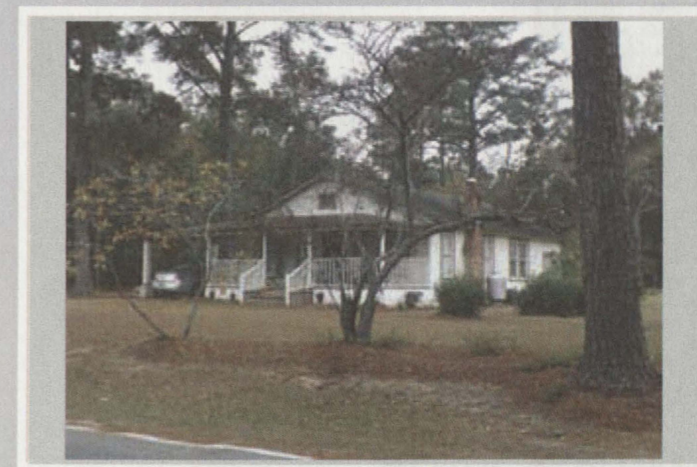
Resource ID DR-08
Address 146 Attapulugus-Climax Rd
County Decatur

Resource Type Building
Resource Use Single Family Residence
Date of Construction 1930-1939
House Type Bungalow: Front Gable
Barn Type
Church Type
Commercial Type
School Type
Structural System Balloon Frame
Style Craftsman
Roof Gable: front
Exterior Cladding Shiplap
Foundation Unknown
Porch Verandah
Windows Double Hung Sash: 4/1
Chimney Lateral exterior: Brick
Alterations Rear shed addition

Preliminary Assessment
May meet criteria

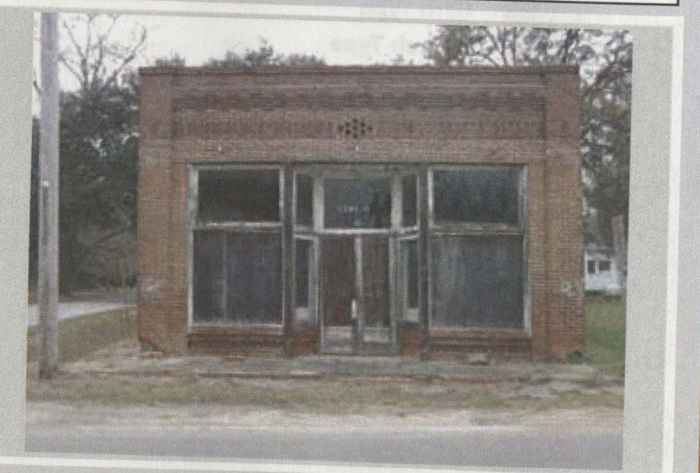
Resource ID DR-CX-10
Address 101 Main St
County Decatur

Resource Type Building
Resource Use Vacant
Date of Construction 1885-1894
House Type
Barn Type
Church Type
Commercial Type Single retail
School Type
Structural System Balloon Frame
Style No academic style
Roof Flat
Exterior Cladding Brick: common bond
Foundation Continuous: brick
Porch Recessed
Windows Fixed: rectangular
Chimney Lateral interior: Brick
Alterations

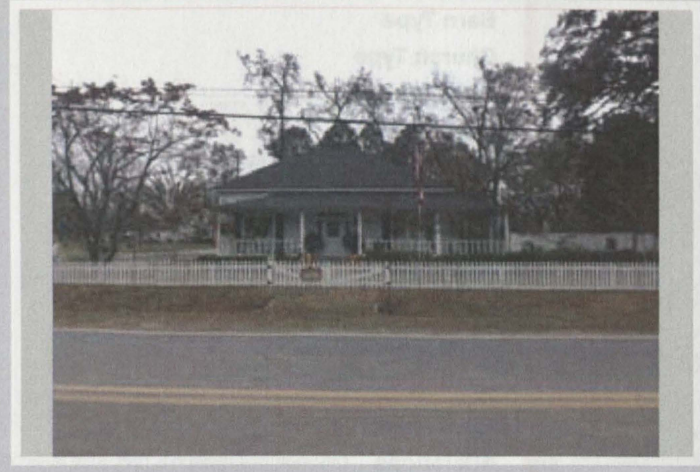
Resource ID DR-CX-11
Address 114 West Broad St
County Decatur

Resource Type Building
Resource Use Single Family Residence
Date of Construction 1905-1914
House Type Georgian cottage
Barn Type
Church Type
Commercial Type
School Type
Structural System Balloon frame
Style Greek Revival: elements
Roof Hip
Exterior Cladding Synthetics: Vinyl siding
Foundation Unknown
Porch Wrap-around
Windows Double hung sash: 1/1
Chimney No chimney observed
Alterations Multiple rear additions

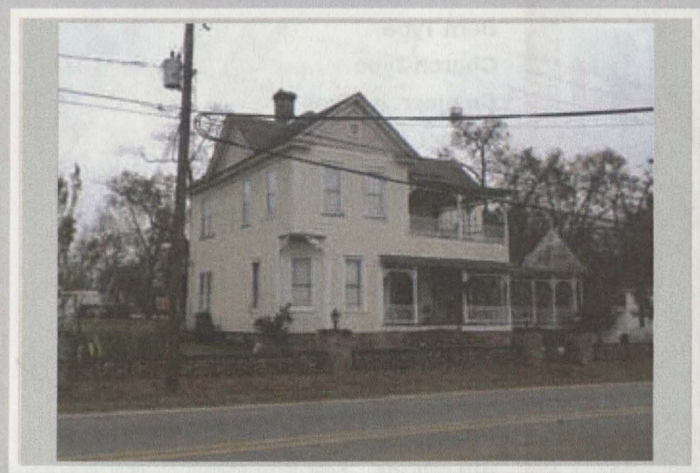
Resource ID DR-CX-12
Address 202 West Broad St
County Decatur

Resource Type Building
Resource Use Single Family Residence
Date of Construction 1905-1914
House Type Queen Anne House
Barn Type
Church Type
Commercial Type
School Type
Structural System Balloon Frame
Style Folk Victorian
Roof Complex
Exterior Cladding Weatherboard; Drop Shingle
Foundation Pier with infill: brick
Porch Wrap-around; balcony
Windows Double hung sash: 1/1
Chimney Off Center within roof surface: brick
Alterations Replacement materials, rear additions

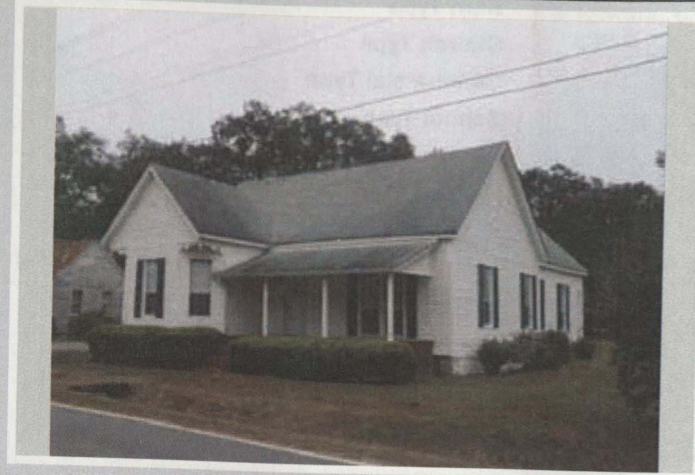
Resource ID DR-CX-13
Address 216 West Broad St
County Decatur

Resource Type Building
Resource Use Single Family Residence
Date of Construction 1905-1914
House Type Gabled ell cottage
Barn Type
Church Type
Commercial Type
School Type
Structural System Balloon frame
Style Folk Victorian
Roof Gable: cross
Exterior Cladding Synthetics: Vinyl siding
Foundation Pier with infill: brick
Porch Verandah
Windows Double hung sash: 9/6
Chimney No chimney observed
Alterations Replacement materials; rear shed addition

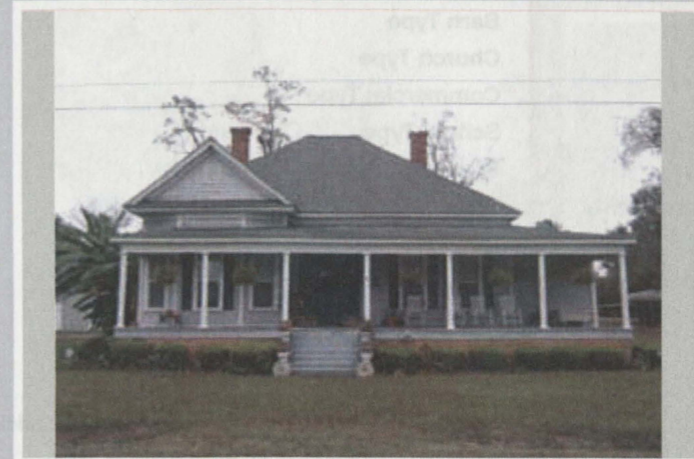
Resource ID DR-CX-15
Address 314 West Broad St
County Decatur

Resource Type Building
Resource Use Single Family Residence
Date of Construction 1905-1914
House Type New South cottage
Barn Type
Church Type
Commercial Type
School Type
Structural System Balloon frame
Style Queen Anne, Colonial Revival
Roof Complex
Exterior Cladding Shiplap
Foundation Pier with infill: brick
Porch Wrap-around
Windows Double hung sash: 1/1
Chimney Multiple random
Alterations Enclosed porch

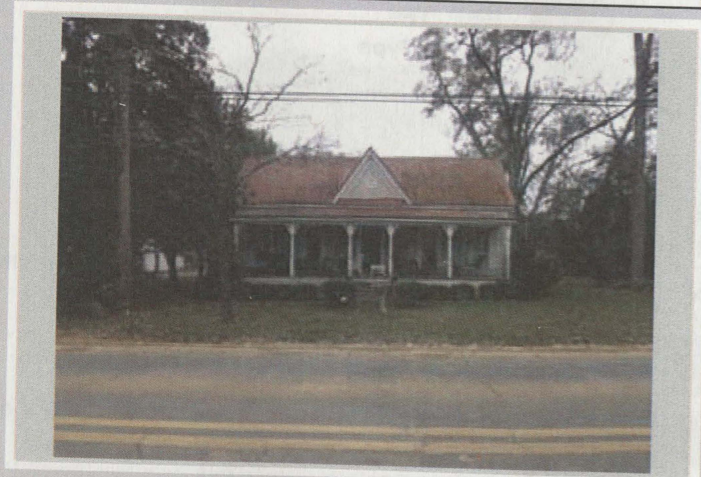
Resource ID DR-CX-14
Address 301 West Broad St
County Decatur

Resource Type Building
Resource Use Single Family Residence
Date of Construction 1900-1909
House Type Central hallway
Barn Type
Church Type
Commercial Type
School Type
Structural System Balloon Frame
Style Folk Victorian
Roof Gable: cross
Exterior Cladding Synthetics: vinyl siding
Foundation Pier: brick
Porch Verandah
Windows Double hung sash: 1/1
Chimney Gable end exterior: brick
Alterations Rear gable addition, material replacements

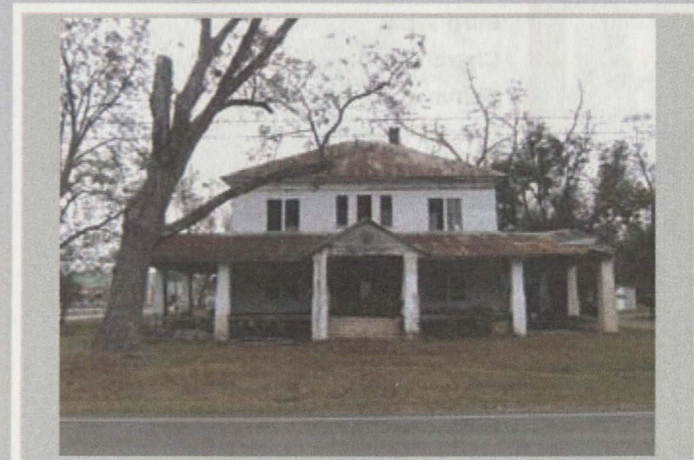
Resource ID DR-CX-16
Address Peabody St at West Broad St.
County Decatur

Resource Type Building
Resource Use Vacant
Date of Construction 1885-1894
House Type Georgian House
Barn Type
Church Type
Commercial Type
School Type
Structural System Balloon Frame
Style Colonial revival
Roof Hip
Exterior Cladding Synthetics: vinyl siding
Foundation Pier: brick
Porch Verandah
Windows Double hung sash: 2/2
Chimney Off center within roof: brick
Alterations Late 19th century alterations

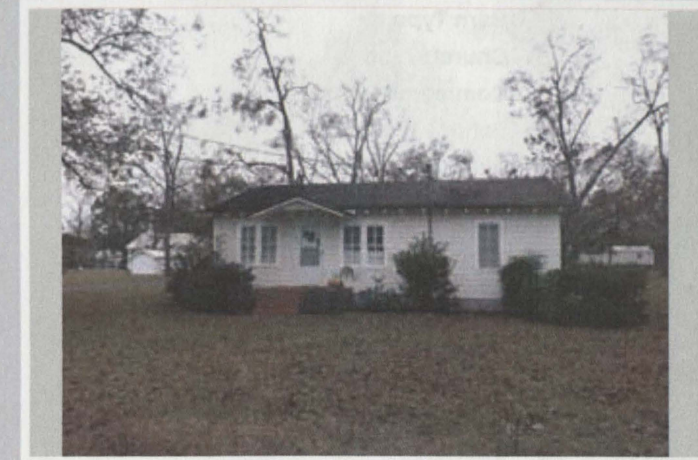
Resource ID DR-CX-19
Address 301 Drane Street
County Decatur

Resource Type Building
Resource Use Single Family Residence
Date of Construction 1940-1949
House Type Bungalow: side gable
Barn Type
Church Type
Commercial Type
School Type
Structural System Post-and-beam
Style Craftsman
Roof Gable:side
Exterior Cladding Shiplap
Foundation Continuous: concrete
Porch Stoop
Windows Double hung sash: 4/4
Chimney No chimney observed
Alterations Material replacement; rear addition

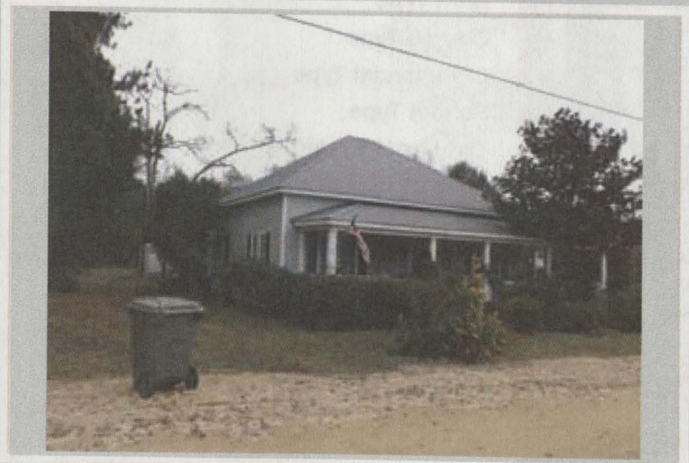
Resource ID DR-CX-18
Address 404 Drane Street
County Decatur

Resource Type Building
Resource Use Single Family Residence
Date of Construction 1905-1914
House Type Georgian cottage
Barn Type
Church Type
Commercial Type
School Type
Structural System Balloon Frame
Style No academic style
Roof Hip
Exterior Cladding Shiplap
Foundation Unknown
Porch Wrap-around
Windows Double hung sash: 2/2
Chimney No chimney observed
Alterations Rear shed addition, replacement materials

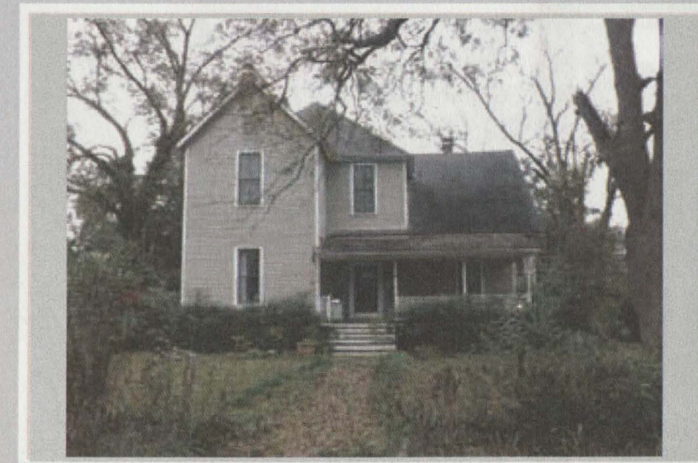
Resource ID DR-CX-20
Address 110 Church Street
County Decatur

Resource Type Building
Resource Use Single Family Residence
Date of Construction 1910-1919
House Type Gabled ell house
Barn Type
Church Type
Commercial Type
School Type
Structural System Balloon Frame
Style No academic style
Roof Irregular
Exterior Cladding Weatherboard; vinyl siding
Foundation Unknown
Porch Verandah
Windows Double hung sash: 4/4
Chimney Off center within roof surface: brick
Alterations Multiple alterations; material replacements; additions

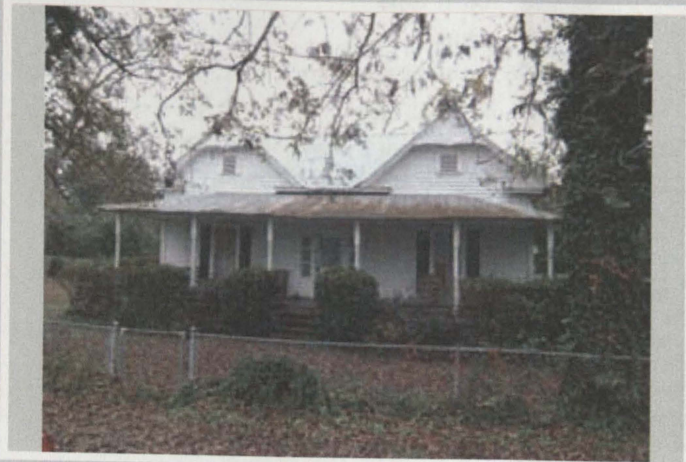
Resource ID DR-CX-21
Address 412 Main Street
County Decatur

Resource Type Building
Resource Use Single Family Residence
Date of Construction 1900-1909
House Type Georgian cottage
Barn Type
Church Type
Commercial Type
School Type
Structural System Balloon frame
Style Folk Victorian
Roof Hip; Gable:front
Exterior Cladding Shiplap
Foundation Pier: brick
Porch Verandah
Windows Double hung sash: 2/2
Chimney No chimney observed
Alterations

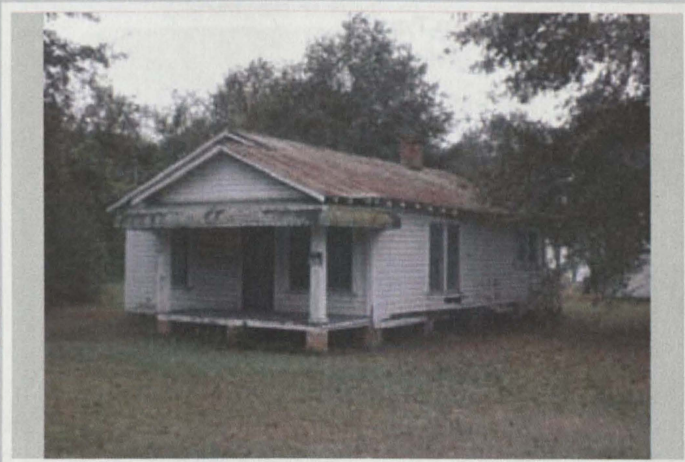
Resource ID DR-CX-23
Address Burt Phillips Rd at Hwy 262 S
County Decatur

Resource Type Building
Resource Use Single Family Residence
Date of Construction 1935-1944
House Type Bungalow: front gable
Barn Type
Church Type
Commercial Type
School Type
Structural System Balloon frame
Style Craftsman
Roof Gable: front
Exterior Cladding Shiplap
Foundation Pier: brick
Porch Verandah
Windows Double hung sash: 2/2
Chimney Off center, ridgeline: brick
Alterations

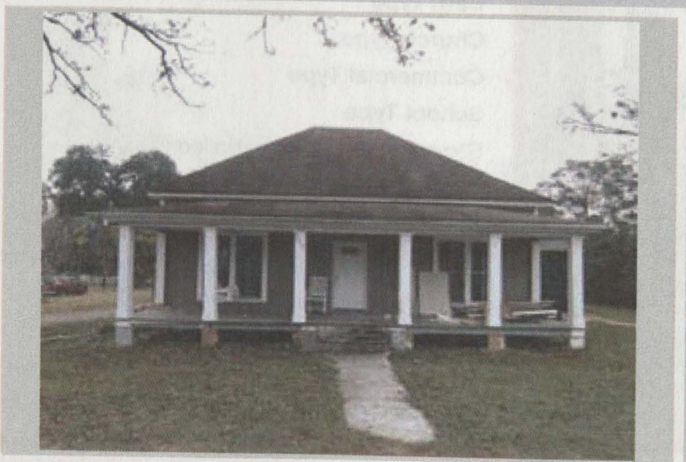
Resource ID DR-CX-22
Address 418 Main Street
County Decatur

Resource Type Building
Resource Use Single Family Residence
Date of Construction 1900-1909
House Type Georgian cottage
Barn Type
Church Type
Commercial Type
School Type
Structural System Balloon Frame
Style No academic style
Roof Hip
Exterior Cladding Shiplap
Foundation Pier: brick
Porch Verandah
Windows Double hung sash: 2/2
Chimney No chimney observed
Alterations Side shed addition; Replacement materials

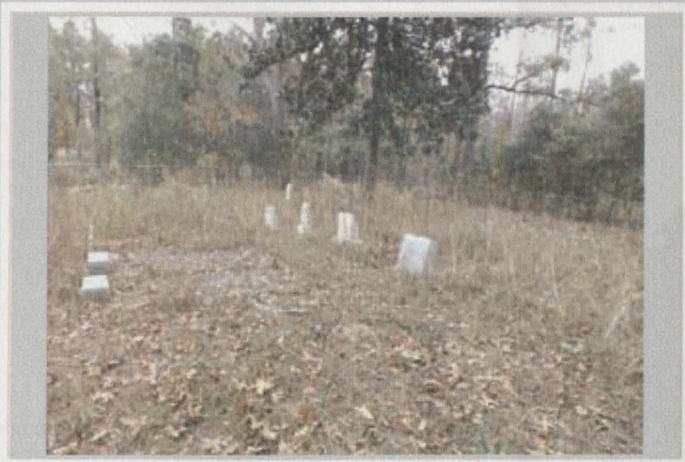
Resource ID DR-CX-24, Arline Cemetery
Address End of Arline Cemetery Rd.
County Decatur

Resource Type Site
Resource Use Funerary: cemetery
Date of Construction 1874
House Type
Barn Type
Church Type
Commercial Type
School Type
Structural System
Style
Roof
Exterior Cladding
Foundation
Porch
Windows
Chimney
Alterations

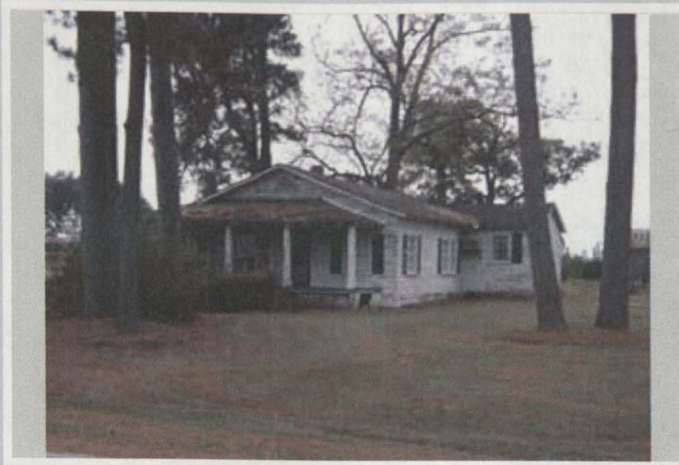
Resource ID DR-25
Address Open Pond Rd. at Pelham Rd.
County Decatur

Resource Type Building
Resource Use Single Family Residence
Date of Construction 1920-1929
House Type Bungalow: front gable
Barn Type
Church Type
Commercial Type
School Type
Structural System Balloon frame
Style Craftsman
Roof Gable: front
Exterior Cladding Shiplap
Foundation Pier with infill: brick
Porch Verandah
Windows Double hung sash: 6/6
Chimney Off center within roof surface: brick
Alterations Historic wing addition

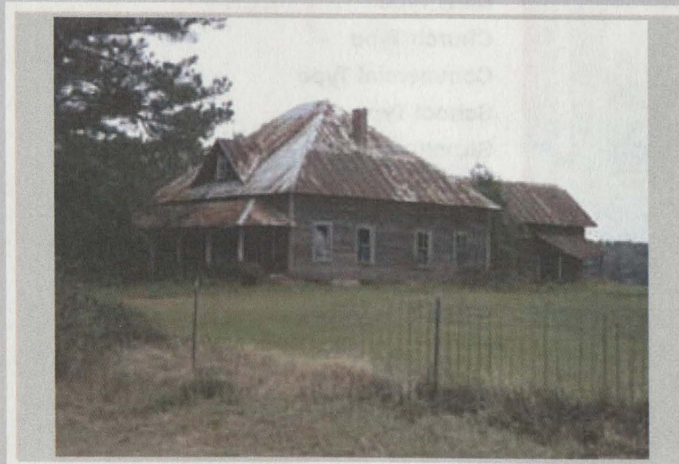
Resource ID DR-26
Address Old Pond Rd, 100 yards east of Pelham Rd.
County Decatur

Resource Type Building
Resource Use Vacant
Date of Construction 1900-1909
House Type Georgian cottage
Barn Type
Church Type
Commercial Type
School Type
Structural System Balloon frame
Style No academic style
Roof Hip
Exterior Cladding Weatherboard
Foundation Unknown
Porch Verandah
Windows Double hung sash: 4/4
Chimney Off center within roof surface: brick
Alterations Historic gable rear addition

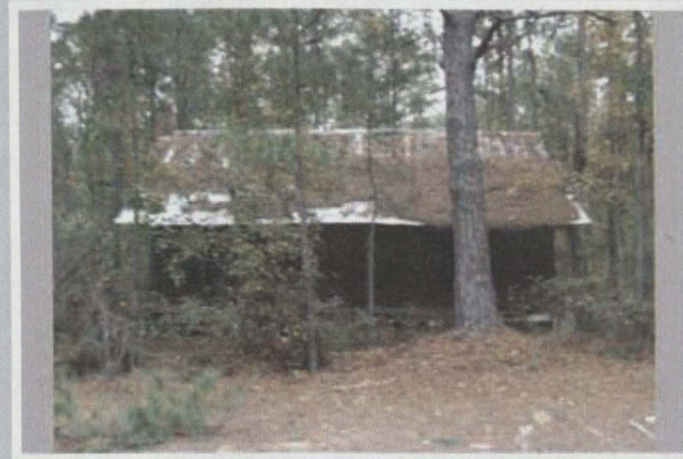
Resource ID DR-27
Address Mile marker 18 on Pelham Rd.
County Decatur

Resource Type Building
Resource Use Vacant
Date of Construction 1900-1909
House Type Hall-parlor
Barn Type
Church Type
Commercial Type
School Type
Structural System Balloon frame
Style No academic style
Roof Gable: side
Exterior Cladding Weatherboard
Foundation Pier: brick
Porch Verandah
Windows N/A
Chimney Both gable ends: brick
Alterations
