Oglethorpe County farm study by Rural Preservation Class

CJ Howard Farm

## C.J. Howard Farm, 1872

## McCannon Homeplace (OG-434)

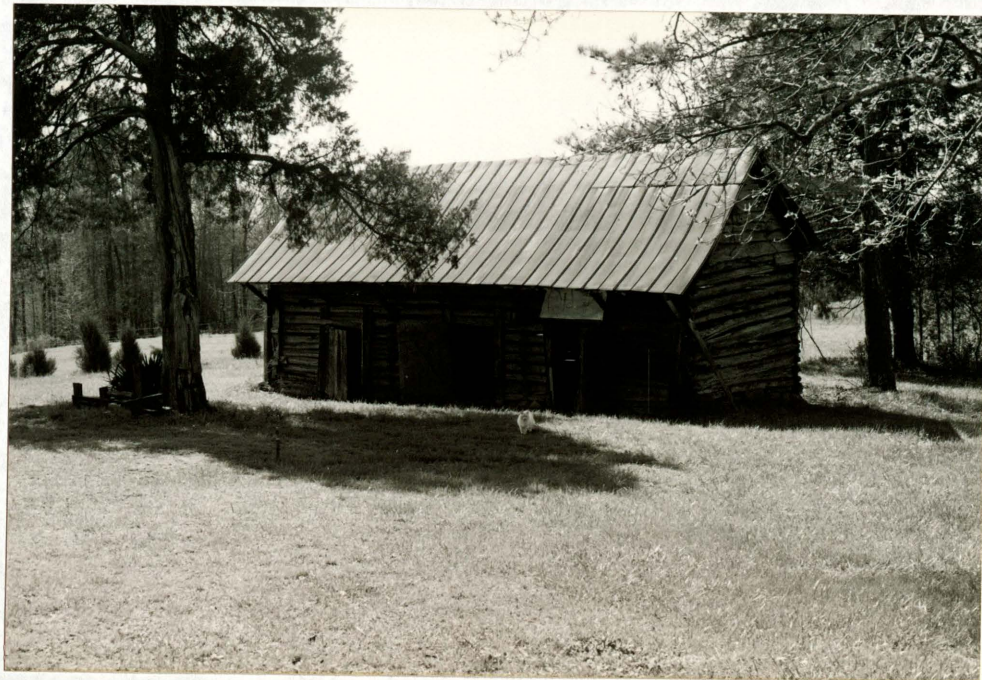
**The log structure, now empty and about to be demolished.**

*Hog Shed/Hay Barn* – This structure sits to the northwest of the farmhouse. It is in fairly good condition though sagging in places. There are no collar ties supporting the roof. The owner is worried about the structural soundness and plans to demolish it in the next several months. He is willing to give it to anyone who would move it. The owner's daughter was using the structure as a playhouse until recently, now it is empty.

Based on this pseudo-preservationist outlook, I would conclude that the historic outbuildings on this property are threatened. The log structure is in immediate danger and the others will probably also be endangered at a later date. The present owners have no plans to leave the property, and so have the capacity to do a great deal of damage to the farm over their life spans.

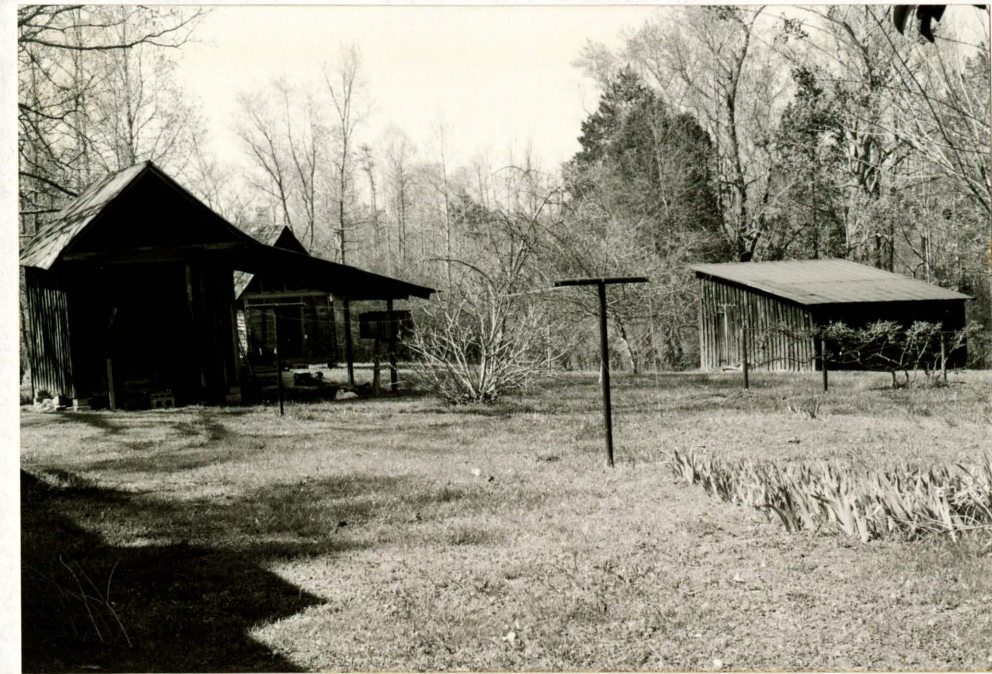
*Corn Crib, Smokehouse, Mule Barn/Shed* – All these buildings are still standing in the same location as in the 1996 survey. These buildings are all in good repair and are being used for storage. Tongue and groove flooring has been added in the smokehouse which was on the floor in the kitchen.

**The Smokehouse, Storage Shed, and Mule Barn, 2002.**

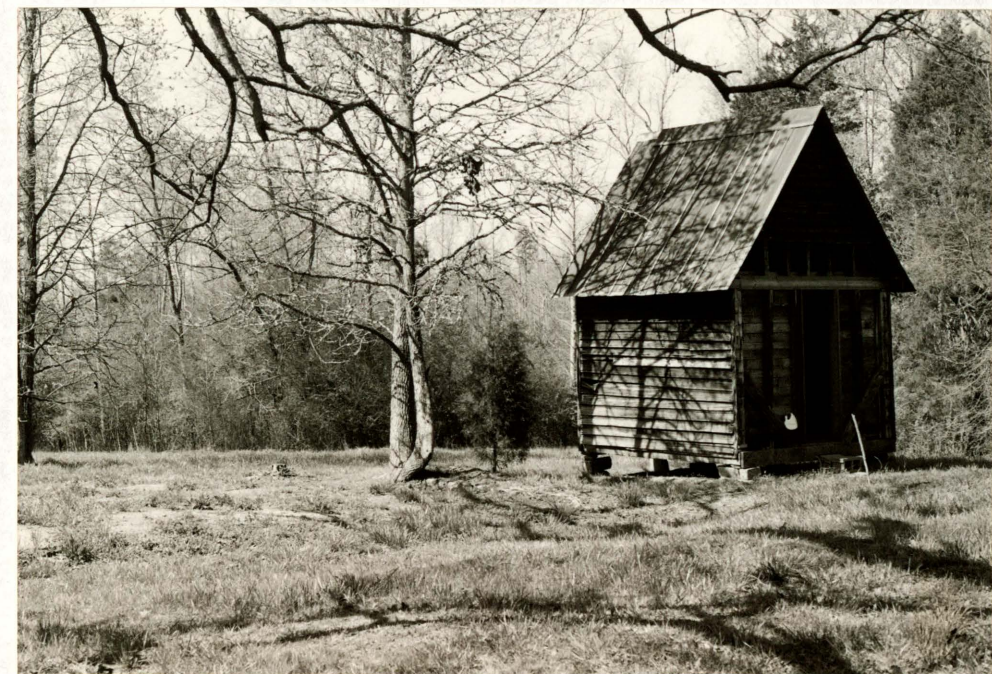
*Storage Shed*- Some minor structural repairs have been made to this building. The weatherboard has been removed and bracing has been added. The weatherboard is currently stored in the mule barn and will be reapplied. The building is now being used as a playhouse by the owner's daughter.

**The location of the demolished Milking Shed and the Storage Shed. Note the missing weatherboard and new bracing.**

*Dairy Shed* – The owner demolished the dairy shed in 2000. He was worried that it would collapse.

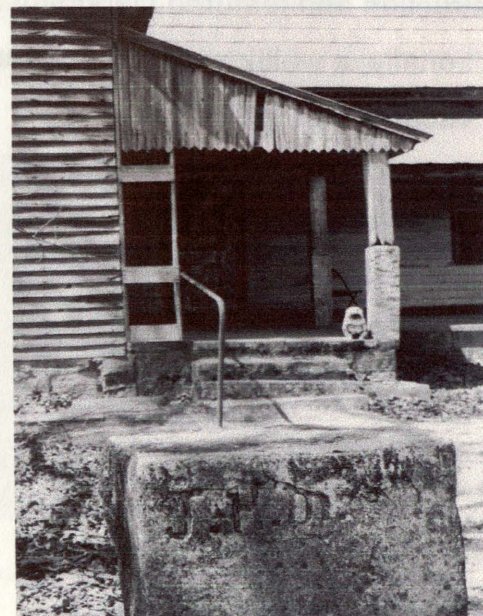
Fig. 1 – Initials “J.H.M.” on pier flanking the walk.

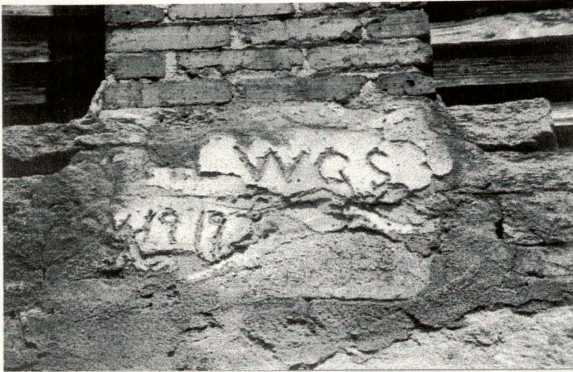
Fig. 2 – Initials and date etched in base of chimney, south elevation.

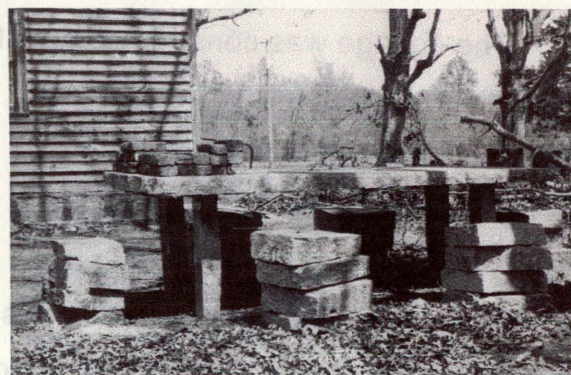
Today the site remains unoccupied although there is evidence of occasional visits by Mr. Lamar Cofer (or his family), who continues to own the property; a large granite table (Fig. 3) is now

Fig. 3 – Large granite “picnic” table.

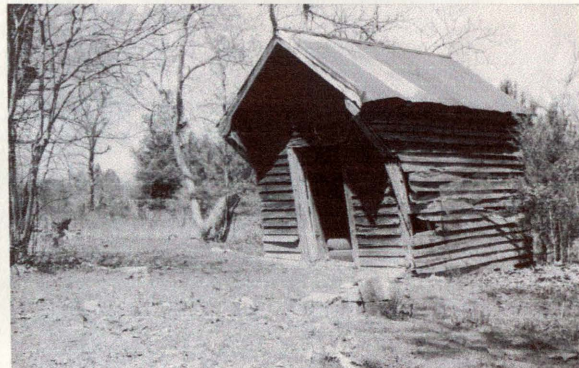
The outbuildings have suffered somewhat more than the house. The small storage shed to the north (Fig. 4) is settling and skewed off its foundation. The weatherboards are exhausted and large holes are visible along the walls. Of the three barns, one is now

Fig. 4 – Small storage shed, showing signs of neglect.

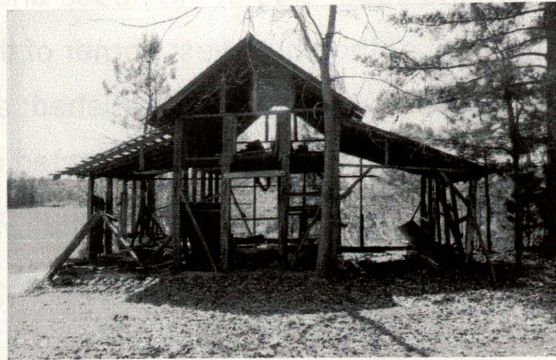
completely missing all of its clapboard siding (Fig. 5) as well as some of its roof material on its eastern shed. The other two (Figs. 6 and 7) are in somewhat better shape, although they, too, are apparently no longer in use. Again, there is evidence of the attendant problems of long-term neglect: missing weatherboards, sagging doorframes, and the like.

Fig. 5 – Barn at southwest corner of property; all siding has been removed.

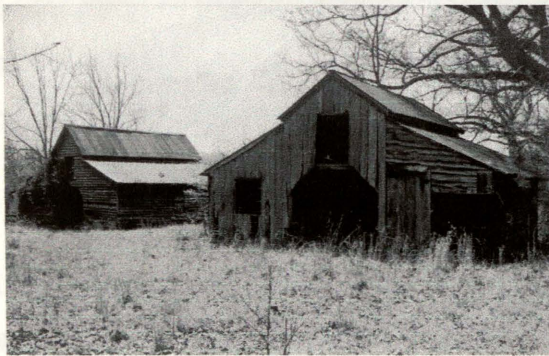
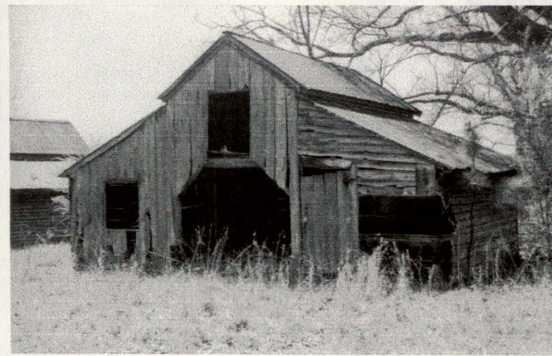
Figs. 6 and 7 – Two barns, almost identical, at the western edge of the property.

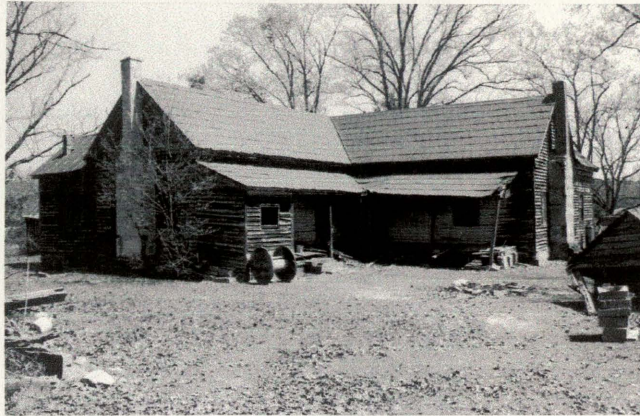
adjacent to and south of the flower pit (these two features are reversed on the 1996 site plan)(Fig. 8). The privy and the chicken coops remain, but are similarly dilapidated.

Fig. 8 – The house viewed from southwest. The collapsed smokehouse is visible at lower left; the well shed roof at the right. Note collapsed rear porch and broken window in the addition.

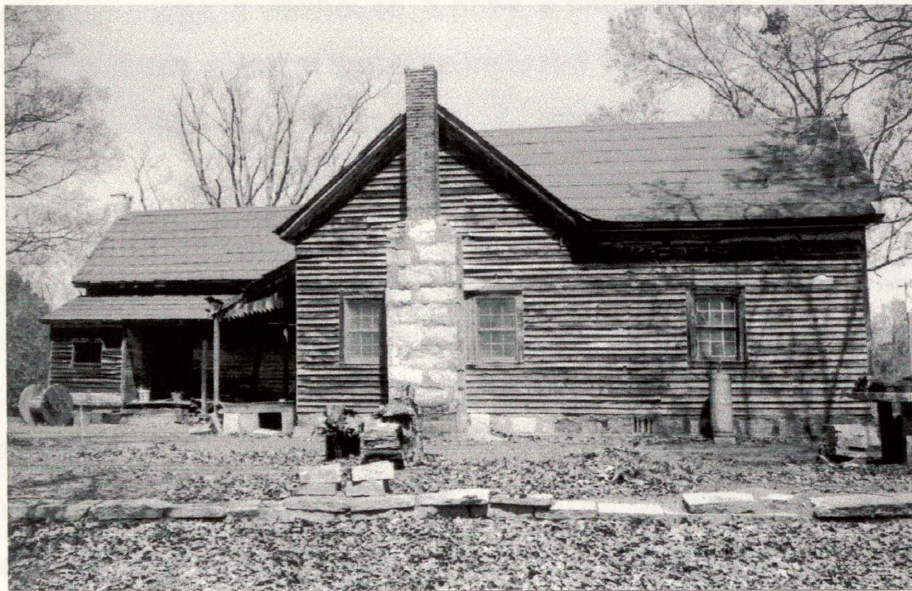
View of the cottage from the west, showing pressed metal roof, original windows and siding.

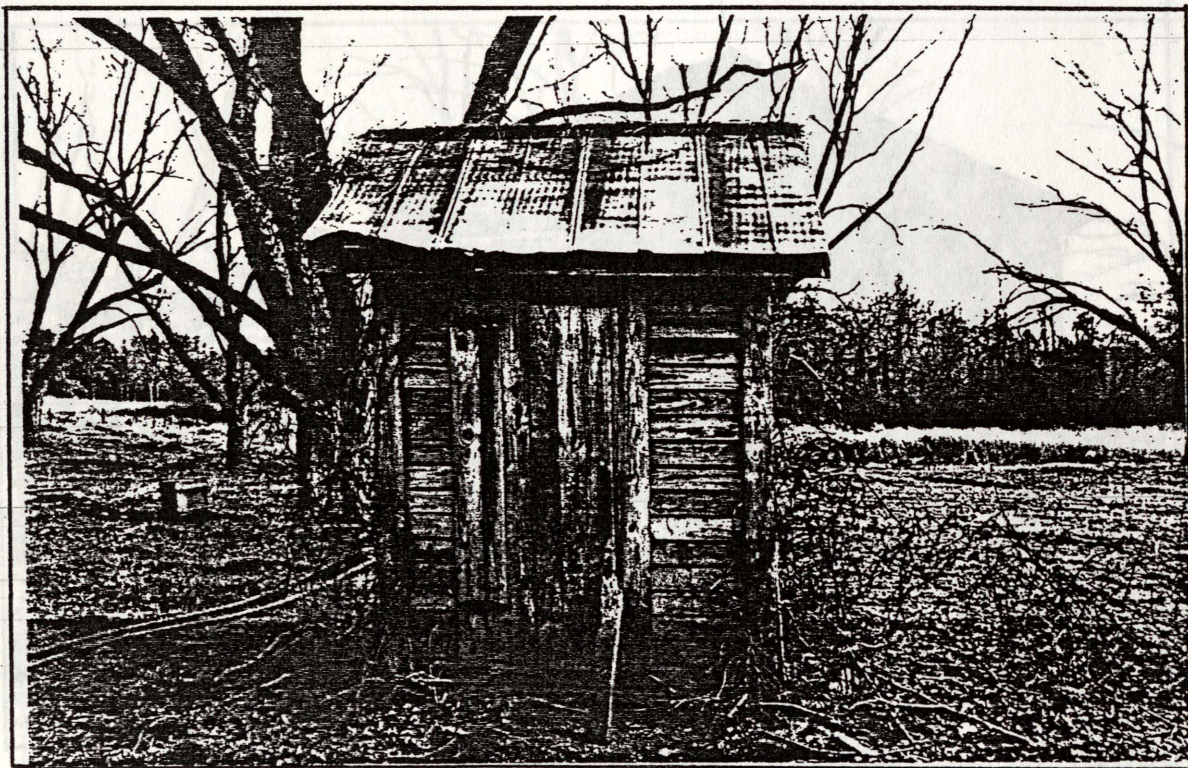
DIRECTION FACING: South  
FRAME#: 7

NOTES: This building was moved from its original location on the north side of the road.
