# Historic Resources Survey Report

City of Johns Creek, Georgia

September 2012

The University of Georgia  
College of Environment + Design  
Center for Community Design & Preservation  
Historic Resources Survey Report  
City of Johns Creek, Georgia

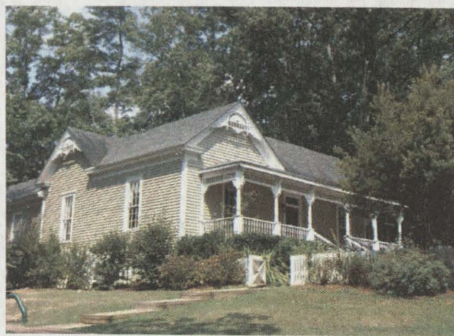
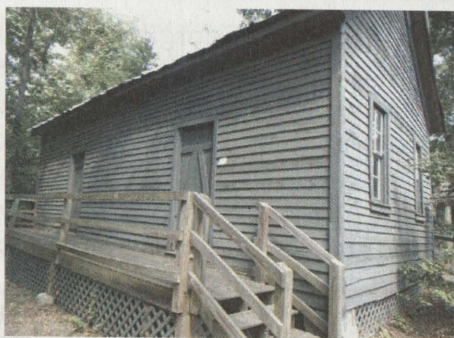
Built circa 1882, the one-story Georgian cottage is currently used as an educational facility. The asymmetric front façade has a full-width verandah with Folk Victorian detailing, and the entry door has a full-width lit transom. The entire exterior is clad with weatherboard siding, and the cottage retains its historic 9/9 double hung sash windows. The well-maintained yard plantings obscure the foundation, and no chimney was observed. This structure has multiple rear shed additions that do not adversely affect the historically preserved front façade.

A circa 1880 tenant house outbuilding is located adjacent to the primary structure. The side gabled double pen has a partial verandah porch, 4/4 double hung sash windows, and a standing seam metal roof. The exterior is clad in historic weatherboard which has been painted a pale blue at the time of this survey. The date of construction of the tenant house and the primary residence was taken from information gathered at the Autrey Mill Heritage Center.

Resource FU-CoJC-01 was evaluated under Criterion C for architecture and design and is recommended **not eligible** for the listing in the National Register of Historic Places. These resources maintain good integrity in location, but the changes to the historic landscape setting is so altered that they are unable to convey a sense of historic workmanship or feeling and aesthetic of the period of construction.

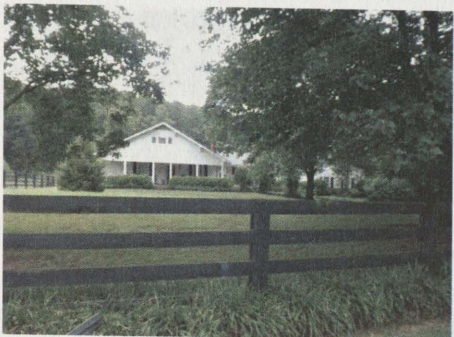
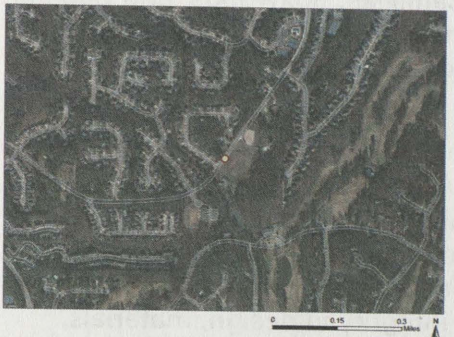
Resource FU-CoJC-07 is a circa 1924 Front Gable Bungalow in the Craftsman style. The structure was built as a single family residence, which is its current primary use. The symmetric façade supports wide overhanging eaves with knee braces, and contains a tripartite diamond patterned fixed window. A single brick chimney is located off-center within the asphalt shingled roof. Two large single-hung sash windows have a diamond pattern in the upper sash, which mirrors the transom above the entry door. The entire weatherboard clad façade is recessed from square post porch supports which create a full width verandah. The structure has a far set back from Brumbelow Road, and is located on a partially wooded lot.

Resource FU-CoJC-07 is recommended **eligible** for listing in the National Register under Criterion C for its significance in architecture. Resource FU-CoJC-07 represents a type identified in *Georgia's Living Places* as significant to Georgia's architectural history, and the house retains the integrity to convey this significance. FU-CoJC-07 has been determined to retain its historic location, design, setting, materials, workmanship and feeling. The house has not been altered; the building contains its historic materials and remains in its original location. The house is able to convey a sense of historic workmanship and aesthetics because of its unaltered state. There are no known associations between this resource and any important person or event. The non-historic secondary dwelling and pump house located on the site should not be considered for nomination.

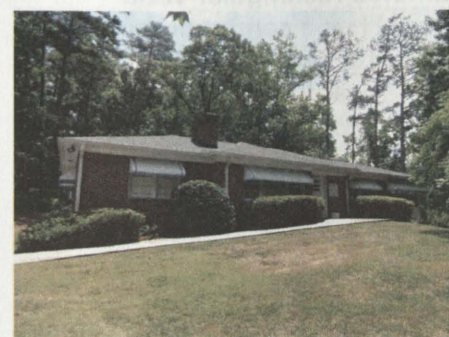
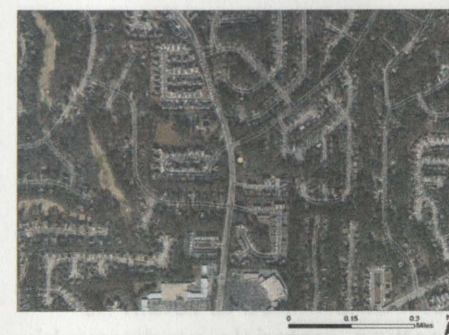
This circa 1953 linear Ranch house was constructed as a single family dwelling and was converted into a veterinary office in the late 1990s. The asymmetric façade is encased in brick veneer and is beneath an asphalt shingle roof with a large off-center brick chimney. The 2/2 paired double hung sash windows have horizontal muntins, and are located on the front façade by the central Chicago window. All windows on the front façade have typical mid-century aluminum awnings. A continuous concrete masonry unit foundation supports the structure which is integrated into the sloping topography. This resource retains its original mid-century three horizontally orientated lit entry door. A full width verandah is located on the right façade and is enclosed by glass; the current occupant indicated it was altered in the 1960s.

Resource FU-CoJC-08 was evaluated under Criterion C for significance in architecture, but is recommended **not eligible** for listing in the National Register. Although identified as a type significant to Georgia's architectural history, this Ranch house is unable to convey its historic significance due to non-historic alterations. The structure maintains integrity in location and setting, but lacks integrity in design, materials, workmanship, and feeling. The current occupant claims that the alterations to the verandah on the right façade occurred in the 1960s; these alterations may gain historic significance in time and contribute to the overall integrity of the resource. FU-CoJC-08 is not known to be associated with any important person or event.

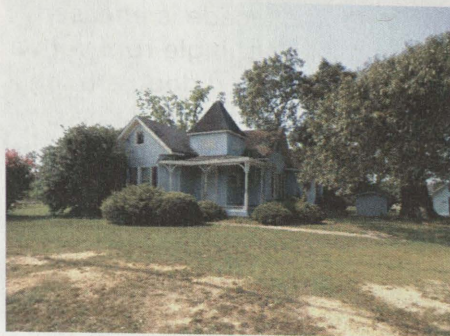
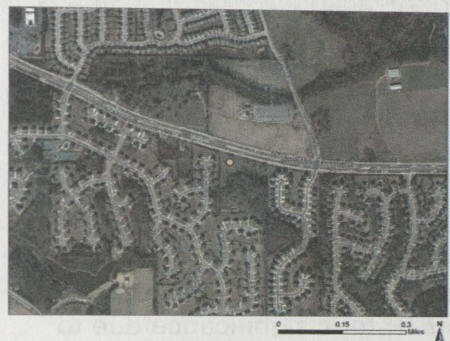
This circa 1907 single family dwelling is an asymmetrical Queen Anne Cottage with a pronounced central turret containing a horizontally orientated rectangular vent. The complex asphalt shingle roof has a central hip with protruding gable sections in all directions. An exterior single brick chimney is located on a rear gable end. Folk Victorian detailing is evident on the partial width front verandah supported by turned post porch supports with ornately carved brackets. The single pane lit entry door is located beneath the main turret, adjacent to paired 6/6 double hung sash windows. The primary façade has a single fixed window in the front facing gable. Located on the site are two historic outbuildings; one well house, and one storage shed, both potentially built in the 1930s.

Resource FU-CoJC-09 was evaluated under Criterion C for significance in architecture and is recommended **eligible** for listing in the National Register. This resource has been identified as a type significant to Georgia's architectural history and retains the integrity to convey this significance. Resource FU-CoJC-09 has been determined to retain its integrity in location, design, setting, materials, workmanship, and feeling. The house and outbuildings remain in their original locations, and the setting of the site has not been altered. The house retains its historic design and materials and is able to convey a sense of historic workmanship through its architectural detailing which possess the feeling and aesthetic of its period of significance. There is no known association between this resource and any important person or event. Extant outbuildings appear historic and should be considered along with the primary structure in any potential listing.

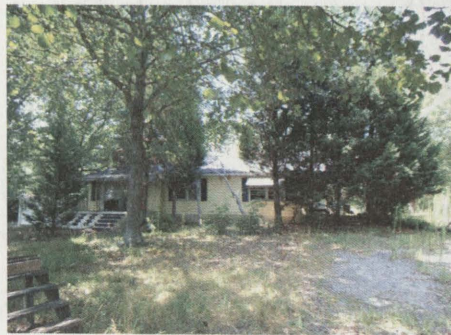
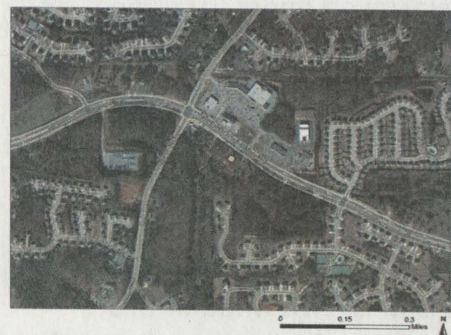
This circa 1955 structure is an asymmetric linear Ranch house with no academic style. A partial width verandah is located on the left portion of the front façade and is supported by decorative metal supports. The façade has paired 2/2 double hung sash windows with horizontal muntins, covered by mid-century aluminum awnings. A mid-century two pane lit entry door is located atop polychromatic concrete stairs which contribute to the overall continuous concrete foundation. The roof is hipped with asphalt shingles, and contains no chimney. Vinyl siding with shiplap detailing serves as the exterior material.

Resource FU-CoJC-11 was evaluated under Criterion C for significance in architecture and is recommended **not eligible** for listing in the National Register. This resource retains its original historic location, and the setting remains partially wooded. FU-CoJC-11 lacks integrity in design, materials, workmanship, feeling, or association. The design and materials of the house have been altered by the application of vinyl siding. The design and material change prevent this resource from conveying a sense of historic workmanship, and lacks the feeling and aesthetics of the period of construction. There are no known associations between this resource and any important person or event.

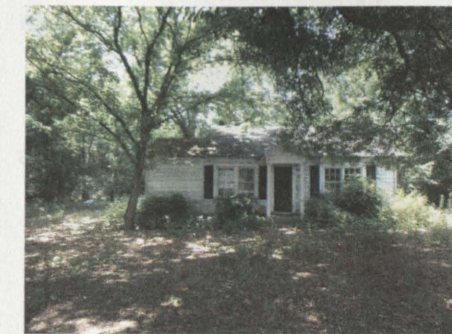
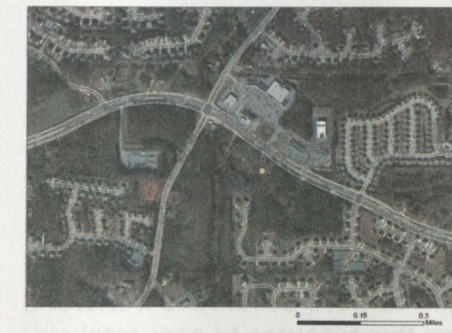
This American Small House, constructed circa 1945, is a single family residential dwelling that is currently vacant. The asphalt shingle, side gable roof is flanked by metal chimneys. Elements of Craftsman style are apparent in the exposed rafter tails in the roof eaves. The front portico spans the width of the door, has wood box column supports, concrete stoop, and front gable roof. The windows are predominantly flat headed, rectangular, double hung sash with a 6/6 pattern. There is a single fixed pane hexagonal window on the rear of the house. The house appears to have two non-historic additions: one located on the rear, and one on the right facade. An historic well house and shed are present near the rear addition of the house. The landscape setting is characterized as informal/picturesque with large mature trees, ornamental shrubs, designed drives and a large hibiscus tree.

Resource FU-CoJC-12 was evaluated under Criterion C for significance in architecture and is recommended **not eligible** for listing on the National Register. The resource retains integrity in location and setting; however, multiple non-historic alterations affect its integrity of materials and design. The prominent addition to the right façade prevents this resource from conveying a sense of historic workmanship and lacks the feeling or aesthetic of the period of construction. There is no known association between this resource and any important person or event.

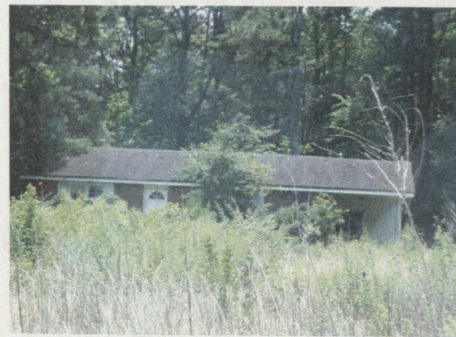
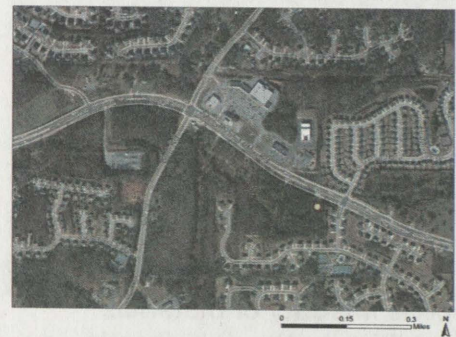
This circa 1965 Ranch house is a single family residential dwelling that is currently vacant. The building has an asphalt shingle, side gable roof, with no apparent chimney. The exterior cladding is brick veneer in a running bond which sits atop a concrete foundation. The windows are flat-headed double hung sash, with a 2/2 pattern. There is a soldier course of bricks under the overhanging roof eaves, and decorative ironwork over all windows. The Ranch House has single entry stoop and an integrated carport. The original mid-century inset fanlight door is extant. The yardscape is casual, and there are pine and sweet gum trees present. The surrounding area is characterized as a mixed use suburban area.

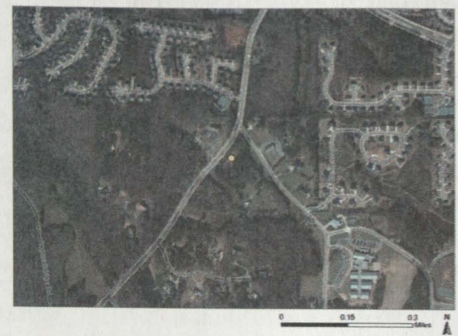
This mid-1960s Ranch House is an asymmetrical structure with a stepped side gable roof. The roof material is comprised of asphalt shingle and a non-fire chimney is located off-center on the ridgeline. A one-story verandah is located on the front façade; it is a partial width porch comprised of wood and concrete. The flat-headed windows are double hung with a 6/6 pattern and are rectangular. The landscape is characterized as casual with a designed drive. The house is located in a mixed use suburban area.

FU-CoJC-15 was evaluated under Criterion C for significance in architecture and is recommended **eligible** for listing in the National Register, if the minimum age requirement is met. The structure maintains its original location and setting, and retains good integrity of original materials and design. The retention of mid-century features accurately depicts the feeling of the period of construction and showcases the historic workmanship of the era. The exact date of construction of this resource is unknown; when it has surpassed 50 years in age it can be considered eligible for nomination.

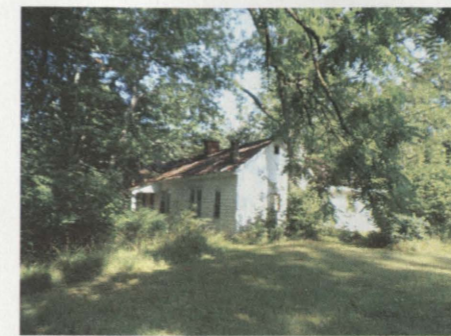
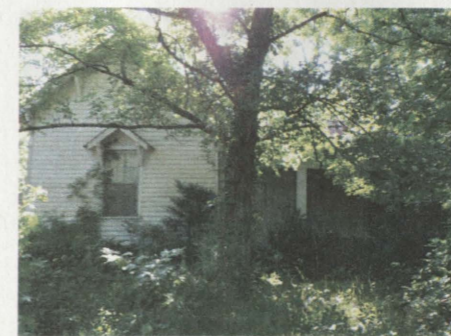
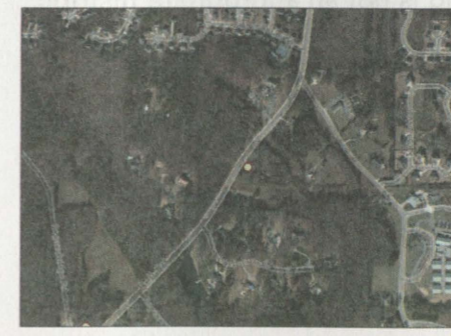
FU-CoJC-16 is circa 1850s single family residence which is currently vacant. The Gabled Ell Cottage incorporates stylistic elements from both Colonial Revival and Craftsman styles. The façade of the house is asymmetrical and the multi-gable roof is comprised of a combination of asphalt shingle, standing seam metal and corrugated sheet metal. The foundation is multi-material, primarily stone and concrete piers. A number of additions have occurred on the rear of the structure; however, dates for these alterations are not available. A verandah is located on the front façade spanning half width and has a shed roof. There are several historic outbuildings on the property: including a barn and a well house and an implement shed. The landscape setting is classified as informal, with many mature trees: black walnut, apple, pear, post oak, hemlock, Southern sugar maple, and beech. Also on the property are boxwoods, variegated canicum and wisteria.

Resource FU-CoJC-16 was evaluated under Criterion C for significance in architecture and is recommended **eligible** for listing in the National register. This house type and corresponding architectural styles are identified as significant to Georgia's architectural history. The resource maintains its original location; however, the overgrowth of the site adversely affects the integrity of setting. Rear additions do not diminish the integrity of design or materials, as they appear over 50 years of age and contribute to the architectural evolution of the resource. There is no known association between Resource FU-CoJC-16 and any significant event or person.

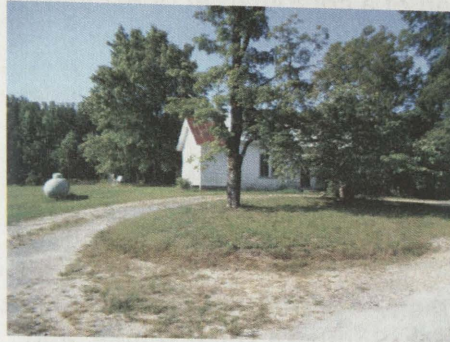
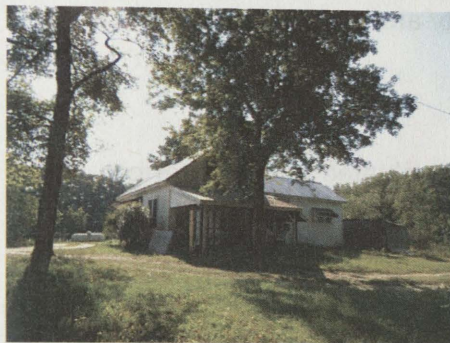
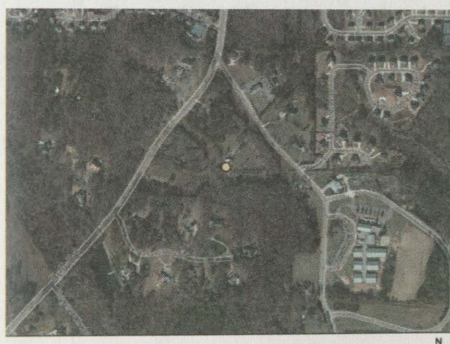
This one-story circa 1915 Saddle Bag Cottage has an asymmetrical façade which includes a mid-century integrated one vehicle carport. Paired, flat-headed double-hung sash windows with a 4/4 pattern are located on the front façade. The side gable roof is comprised of standing seam metal and has a brick chimney along the center ridgeline of the roof. The front stoop is comprised of concrete and has a small attached hood roof. The exterior material of the structure is a combination of original weatherboard and replacement vinyl siding. The structure has multiple rear additions, but the dates of construction are undetermined. The landscape setting is informal and includes agricultural fields and natural woods. The house is located in a heavily developed, suburban area of Johns Creek.

Resource FU-CoJC-17 was evaluated under Criterion C for architecture and is recommended **not eligible** for listing in the National Register. This resource maintains its historic location and has fair integrity in setting. Multiple alterations in exterior materials and additions adversely affect the resources integrity of design and materials; a large integrated carport changes the overall footprint of the structure, and vinyl siding is not an appropriate historic material. FU-CoJC-17 is unable to convey a sense of historic workmanship and does not express the feeling of the era of construction. It is unknown if this resource has any association with any important person or event.

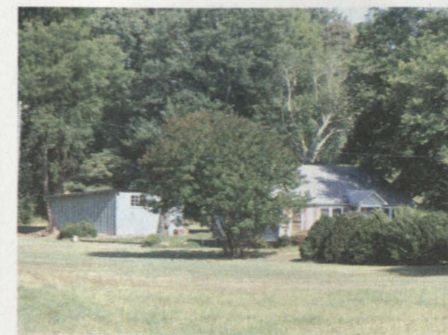
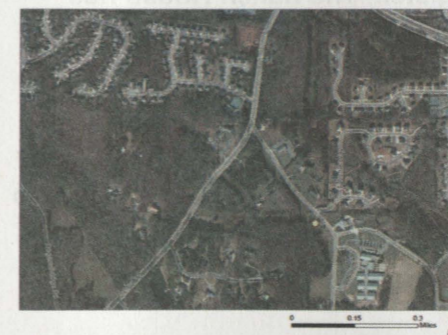
This circa 1948 American Small House is a single family dwelling with an asymmetrical façade and asphalt shingle side gable roof. The portico on the façade is partial width, spanning the width of the front entry door and a pronounced gable. The exterior material is vinyl siding and no chimney was observed. The windows are flat, double hung sash with a 6/6 pattern, and one set of paired windows is located adjacent to the 9 pane lit entry door. An implement shed was documented and is located behind the house. The landscape setting is informal and contains agricultural fields and forests. The surrounding environment is suburban with both historic and non-historic resources.

Resource FU-CoJC-18 was evaluated under Criterion C for design and significance to architecture and is recommended **not eligible** for listing in the National Register. Although this house type has been identified as significant to Georgia's architectural history, this resource does not retain the integrity to express this significance. The structure retains its historic location and setting, but has poor integrity in design and materials. The inclusion of vinyl siding as the exterior cladding precludes this resource from expressing historic workmanship or the feeling of the period of construction. It is unknown whether this resource is associated with an important person or event.

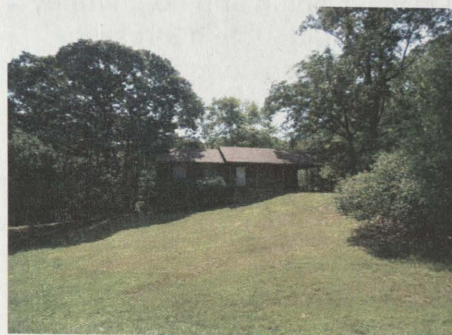
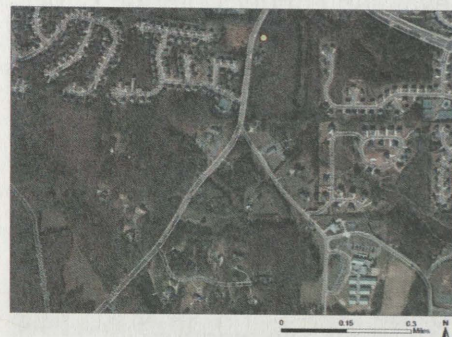
This circa 1955 Ranch house is a single family dwelling that is currently vacant. The asymmetrical structure has a side gable asphalt shingle roof and no chimney. The exterior material is weatherboard and the foundation is a combination of concrete block and stucco. All windows on the front façade are obscured by boards. The landscape is characterized as informal with contouring and natural woods present. The surrounding environment is suburban and contains a mixture of old and new structures.

FU-CoJC-19 was evaluated under Criterion C for significance in architecture and design and is recommended **eligible** for listing in the National Register. The Ranch House has been identified as significant to Georgia's architectural history, and this resource maintains its original location and setting. FU-CoJC-19 exhibits excellent integrity in its design and materials; through these components the resource expresses the feeling and aesthetic of the period of construction and displays historic workmanship. There is no known association between this resource and any important person or event.

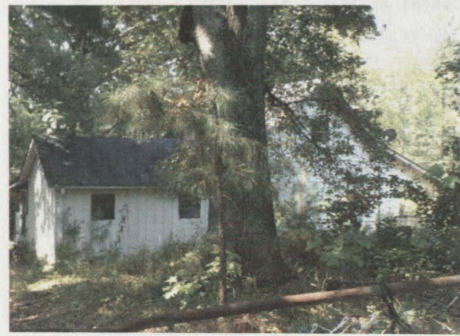
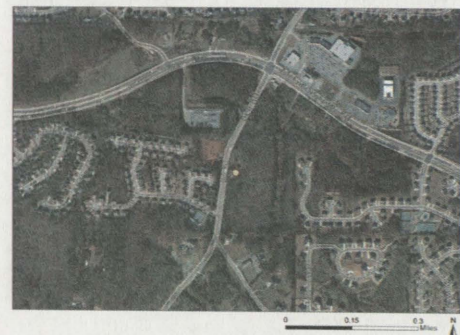
Resource FU-CoJC-21 is a single family, Side Gable Bungalow, constructed circa 1960, that is currently vacant. The asymmetrical structure is clad in asbestos siding and has an asphalt shingle roof with no visible chimney. There are two lit dormers in the upper half story. The partial width front verandah has a shed roof with a Flemish eave, and a side stair with metal balustrades. The single entry door has an inset fanlight. A port-cochere extends from the right façade. The observed windows are 1/1 double hung sash, and a large Chicago window is present. The structure is sited within a wooded lot, surrounded by chain link fencing. The resource is located in a suburban area with mixed old and new resources.

Resource FU-CoJC-21 was evaluated under Criterion C for significance in architecture and design and is recommended **not eligible** for listing in the National Register. The structure maintains its historic location but lacks integrity in setting due to extreme overgrowth of vegetation and surrounding developments. The alteration of exterior cladding to asbestos siding adversely affects the original material and design of the structure. This resource is unable to express the feeling and aesthetics of the period of construction, and does not exhibit historic workmanship. There is no known association between this resource and any important person or event.

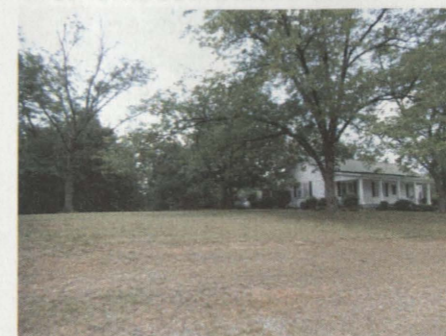
Resource FU-CoJC-22 is an asymmetrical, single family Extended Hall-parlor dwelling, built circa 1875. The structure is side gabled with a standing seam metal roof, and has two stuccoed masonry chimneys located on the exterior gable end and off center along the roof's ridgeline. The façade's exterior material has been replaced and is currently clad in vinyl siding. There is a single entry door is located under the shed roof of the full width verandah. The porch supports are non-decorative tapered columns. Double hung sash windows with 3/1 and 3/3 patterns are located on the front façade. A large non-historic, rear addition was documented. The structure is sited within a wooded lot, which also contains an implement shed. The lot is located in a suburban area with mixed old and new resources.

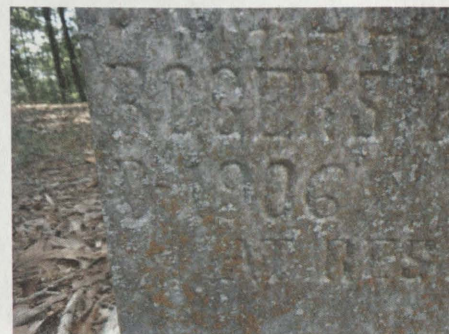
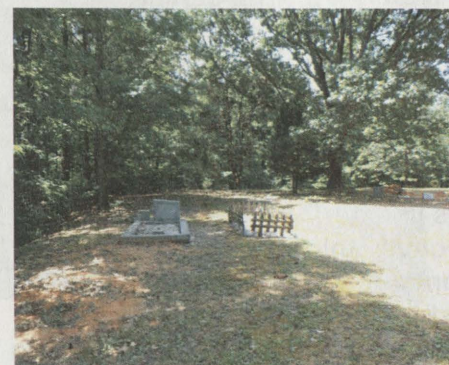
This cemetery has approximately 50 graves and the oldest graves observed were 1905 and 1907. Servicemen from the Army and Navy, veterans of World War II were documented. Common names found in the cemetery include Rogers and Smith. The 1996 Georgia Historic Resources Survey indicated that this site is predominately an African American cemetery and may contain graves of slaves and freedmen in addition to residents of the Shakerag community. The cemetery is located in an environment with both historic and non-historic resources.

Resource FU-CoJC-23 was evaluated under Criterion C for design and landscape architecture and Criterion D for information potential and is recommended **not eligible** for listing in the National Register. This resource maintains its original location; however, it is an active cemetery and the inclusion of contemporary markers adversely impacts the site's integrity of design, setting, materials, workmanship, and feeling. This resource cannot be related to a particular time period or cultural group and therefore lacks a historic context to be nominated under Criterion D. There is no known association between FU-CoJC-23 and any important person or event.

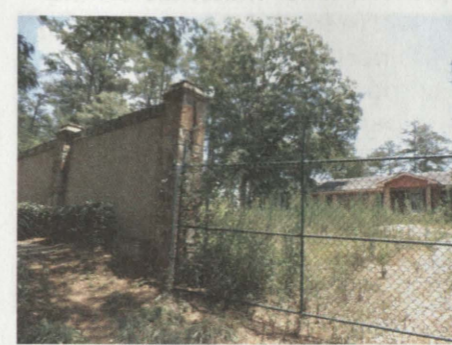
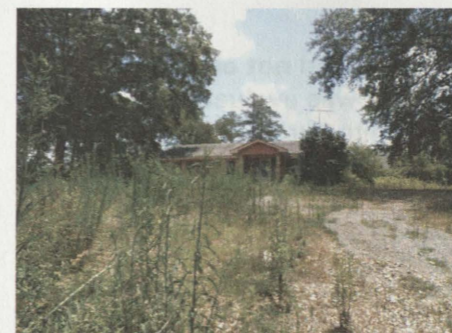
This 1960s era Ranch House is a one-story single family dwelling that is currently vacant. The asymmetrical house has a side gable roof comprised of asphalt shingles, and a gable end exterior brick chimney. The home is constructed by post and beam wood framing and has polychromatic exterior. The flat headed double hung sash windows are a 2/2 pattern and have horizontal muntins. The front entry door is a perfect example of a mid-century design with three inset horizontally orientated lights. A front portico with a vertical board gable and designed scrolled metal supports was documented. The landscape setting is casual and overgrown; the property is heavily gated.

Resource FU-CoJC-26 is recommended **eligible** for listing in the National Register. This resource was evaluated under Criterion C for significance in architecture and design and retains the integrity to express this significance. The structure remains on its historic construction site and has minimal alterations to its historic landscape setting. Key materials of the Ranch House type remains extant including the polychromatic brick, horizontally oriented windows, and original entry door, which allow the structure to represent this historic workmanship and feeling and aesthetic of the period of significance. There is no known association between Resource FU-CoJC-26 and any person or event.

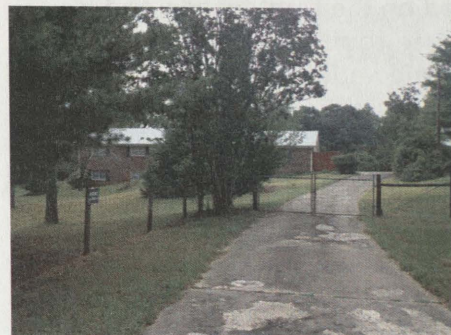
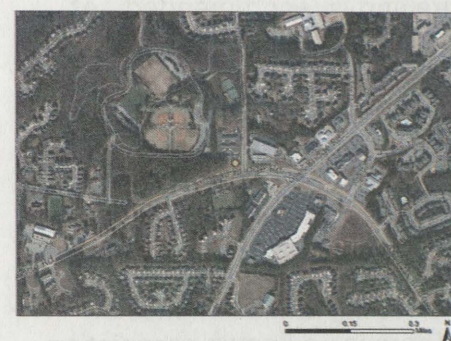
This late 1960s, asymmetrical Ranch house has a side gable roof comprised of asphalt shingles with no evident chimney. The exterior materials are common bond brick and vinyl siding and the foundation is composed of concrete with brick veneer. Two Chicago windows are located on the porch, partial width recessed porch; and the remainder of the windows are flat headed double hung sash with a 6/6 pattern. Several outbuildings were documented on the property including a barn, implement shed, and a secondary dwelling. The view of the house is obstructed by large trees and shrubs, and the landscape setting is casual. The house is located in a suburban area of Johns Creek and the majority of surrounding resources are younger than fifty years old.

Resource FU-CoJC-29 is recommended **not eligible** for listing in the National Register. This resource was evaluated under Criterion C in the area of architecture. Although the house type represents a type that has been identified as important to Georgia's architectural history, Resource FU-CoJC-29 lacks the character defining features to serve as a good or representative example, and has experienced alterations to original historic materials. The house remains at its historic construction site, and retains elements of its historic setting. This resource is unable to express the feeling or aesthetic of the period of construction, or historic workmanship through use of synthetic siding. There is no known association between this structure and any important figure or event.

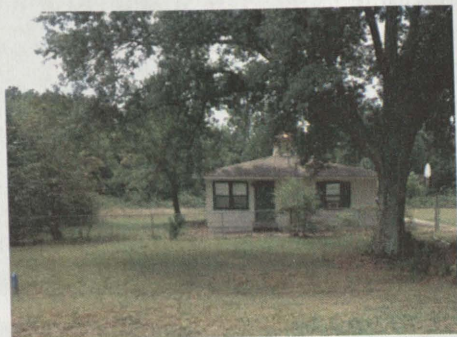
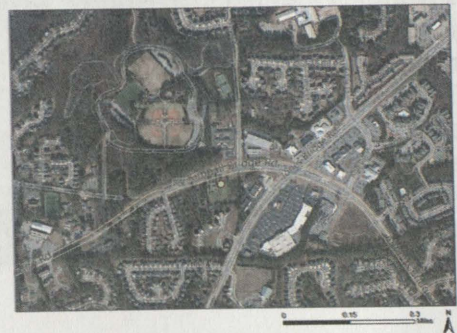
Resource FU-CoJC-31 is a Pyramidal Cottage located in a suburban area with mixed old and new resources. This single family dwelling, built circa 1930, is located on a naturally wooded lot, surrounded by a fence with a designed driveway. The façade is asymmetrical with an off center single entry door and is clad with Masonite siding. A concrete stoop with no covering serves as the primary entry point. The windows are 1/1 double hung sash, paired to the left of the door. The pyramidal roof has asphalt shingles and a center brick chimney enclosed by synthetic siding.

Resource FU-CoJC-31 is recommended **not eligible** for listing in the National Register and was evaluated under Criterion C for architecture and design. Although this type is recognized as significant to the architectural history of Georgia, this structure does not retain enough integrity to convey this significance. FU-CoJC-31 is located on its historic construction site and has undergone few changes to its landscape setting. The structure is unable to express integrity in design and materials due to the multiple exterior alterations made to the exterior materials. These alterations preclude FU-CoJC-31 from expressing the feelings and aesthetics of the period of construction, and the sense of historic workmanship. There is no known association between this resource and any significant person or event.

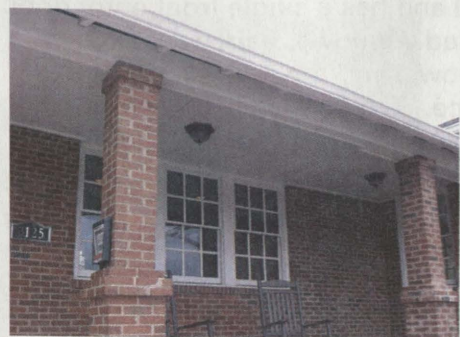
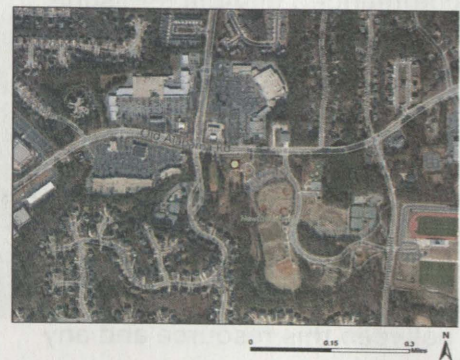
Resource Fu-CoJC-33 is an H-shaped school building circa 1929. This symmetrical school house has a recessed front porch with large brick post porch supports and double door entry with a 6 pane lit transom. Tripartite 6/6 DHS windows are located on both sides of the building and horizontally oriented vents are within both gable wings. The picturesque landscape includes designed planting beds, designed drives, and walks. An extensive renovation of the building began approximately in 2010 and the facility is now named 'Park Place at NewTown School' and is a center for active senior adults. The 1929 schoolhouse is listed on the National Register of Historic Places.

Resource FU-CoJC-33 was evaluated under Criterion C for architecture and design and recommended **eligible** for listing in the National Register of Historic Places. This resource remains at its historic location and maintains excellent integrity in design, materials and workmanship. FU-CoJC-33 has undergone alterations to its historic landscape setting; however, the alterations do not adversely affect the historic feeling of the school. It is unknown whether this resource is associated with an important event or person.

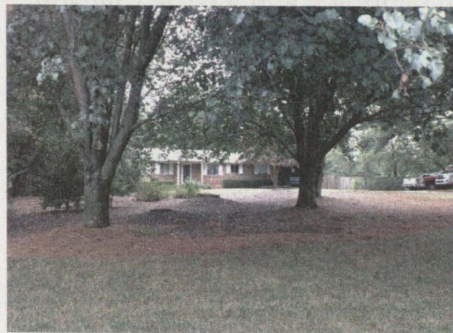
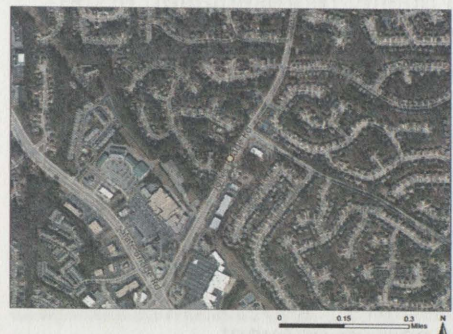
Resource FU-CoJC-37 is a side gabled, polychromatic brick Ranch House with a continuous brick foundation. This circa 1955 asymmetrical structure has a partial width front portico with a gable roof. The façade contains a single front door and paired single hung sash windows. The roof has asphalt shingles, and no visible chimney was observed. An original carport is integrated into the right façade of the structure. Designed fencing and a designed drive were observed in the informal landscape of the site.

Resource FU-CoJC-37 was evaluated under Criterion C for architecture and design and is recommended **eligible** for listing in the National Register. This resource remains in its original location and maintains good integrity in its historic landscape setting. Resource FU-CoJC-37 is an excellent example of this significant house type in Georgia, and displays excellent integrity in design, materials, workmanship, and feeling. This resource contains several elements which are vital to the integrity of the Ranch House type. There is no known association between this resource and any important person or event.
