# ENHANCING STREAM FUNCTION IN WESTERN NORTH CAROLINA PASTURES

This thesis evaluated the application of Natural Channel Design (NCD) and Best Management Practices (BMPs) in enhancing stream function on a cattle pasture in Buncombe County, North Carolina. Potential reductions in sediment, nutrient, and *E. coli* specific enhancement measures were quantified. Applying NCD principles and Rosgen's stream classification, the study addresses impacts from cattle access and historical land modifications, offering a scalable model for sustainable agriculture and ecological health. Key measures, including exclusion fencing, riparian buffers, bank stabilization, and alternative water sources, were implemented to reduce erosion and pollutants. Adaptive strategies tailored to each stream section integrate BMPs with NCD techniques, balancing stream health and pasture use. The results suggest improvements in water quality and stream stability, with implications for extending this BMP-NCD approach across Western North Carolina to support water quality in the French Broad River Basin.

MASTER OF LANDSCAPE ARCHITECTURE

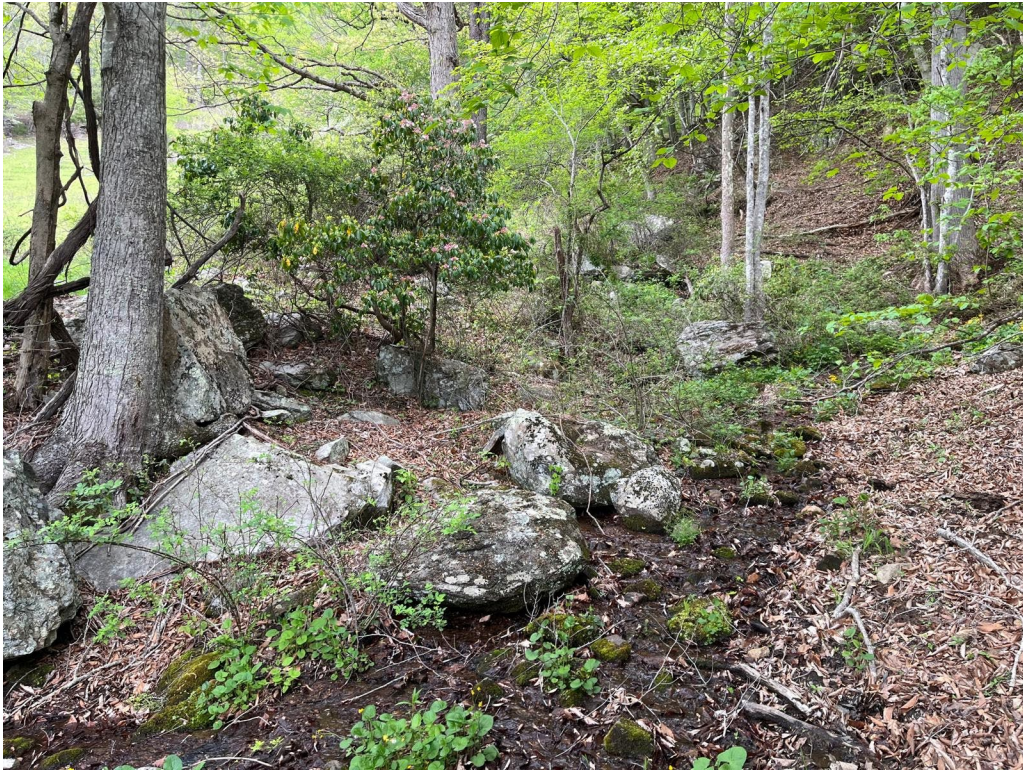
Figure 5. The stream surrounded by rocky terrain and sparse brush, with the absence of typical riparian vegetation contributing to the destabilization of streambanks. Note the steep gradient visible in the background.

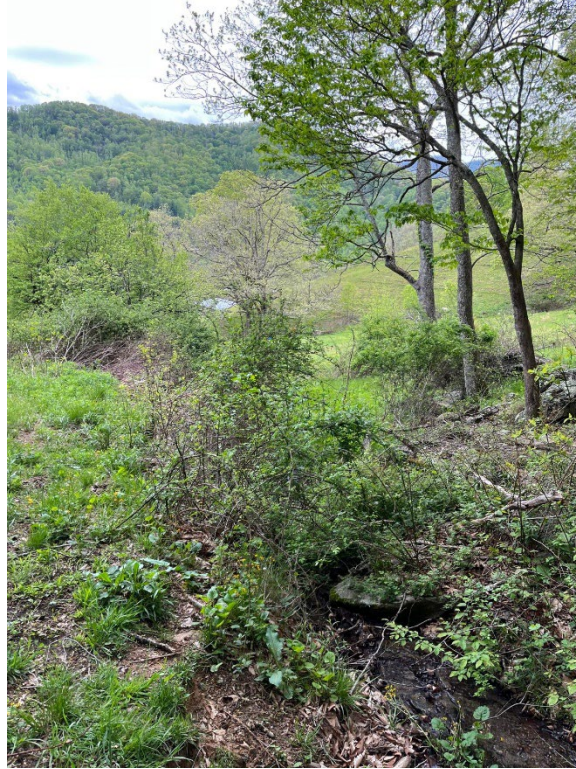
Figure 6. Streamside vegetation in the upper pasture, with blackberry bushes and scattered brush, with little to no typical riparian vegetation contributing to streambank destabilization. Photo by author, April 29, 2023.

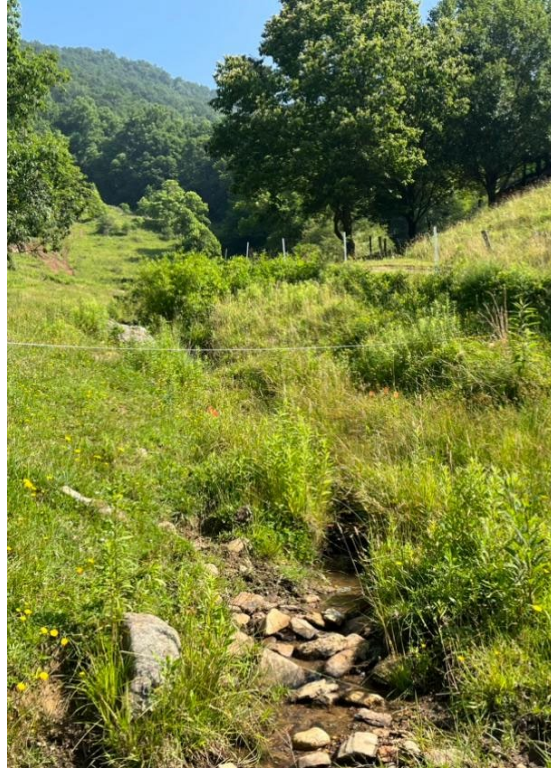
Figure 7. The stream running through the lower pasture, surrounded by grasses and minimal brush. The lack of dense riparian vegetation and the steep gradient in the background contribute to erosion and streambank instability. Photo by author, July 29, 2023.

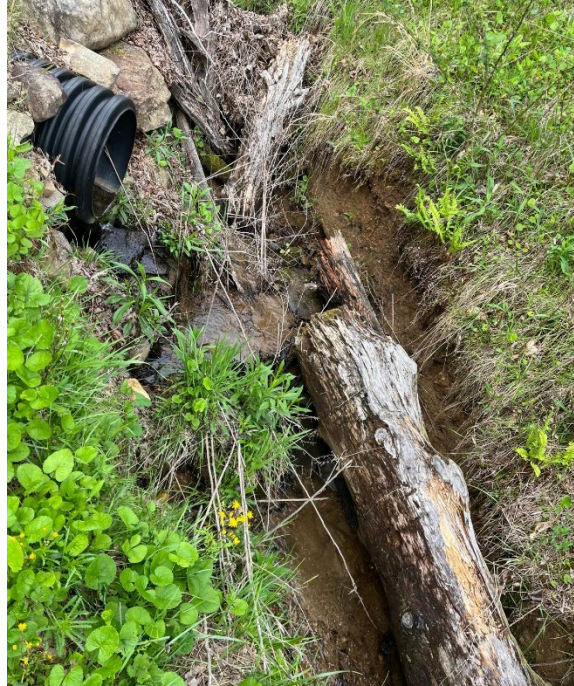
Figure 8. Stream section showing human modifications, including a log obstruction and a plastic corrugated pipe directing water into the stream. Photo by author, April 29, 2023.

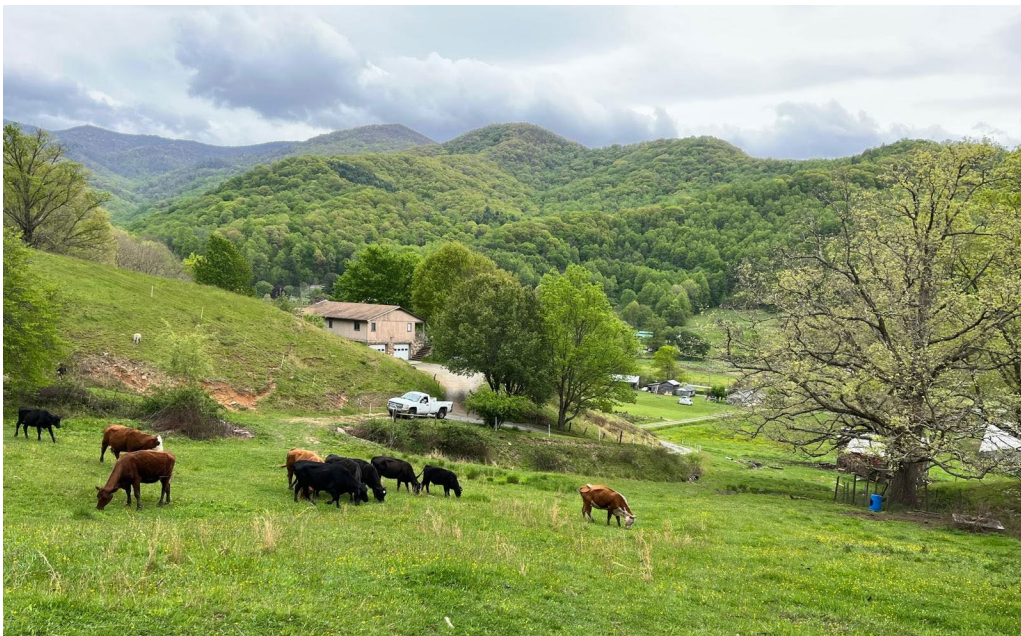
Figure 9. Cattle grazing above stream with full access to waterway. Photo by author, April 19, 2024.

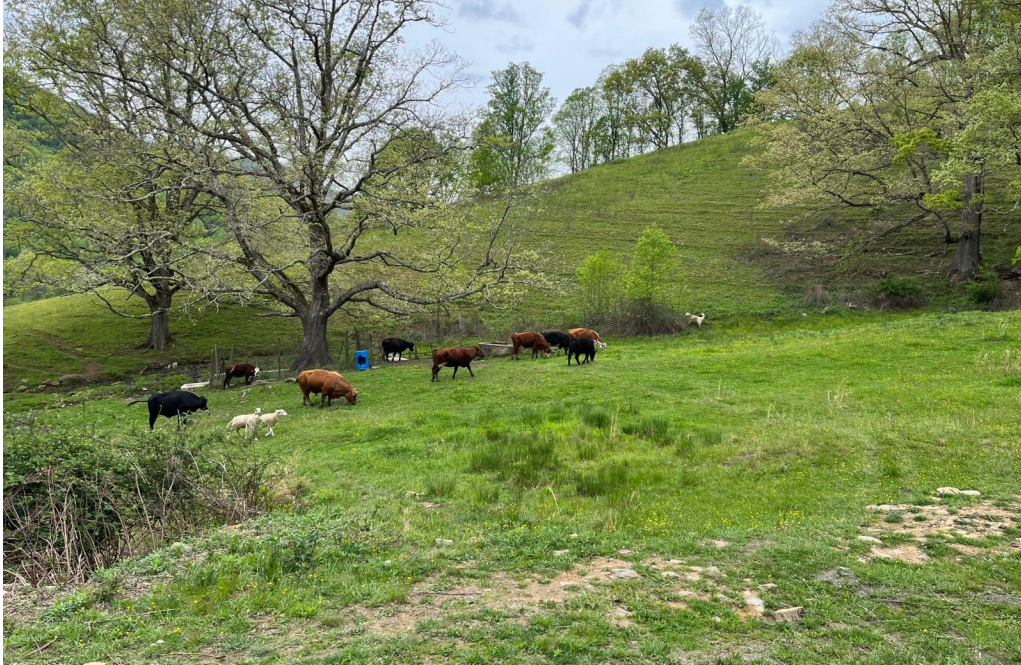
Figure 10. Cattle grazing in pasture with foreground showing erosion above stream from heavy use due to cattle crossing and access road. Photo by author, April 29, 2023.

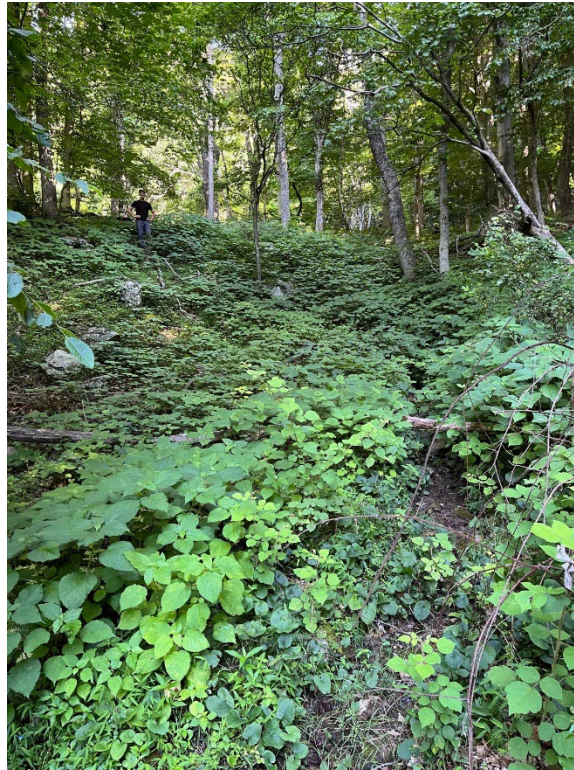
Figure 11. Headwaters of the stream where the spring emerges from the ground. Photo by author, July 12, 2023.

Figure 9 and Figure 10 capture the natural features and land use influences in Section W's upper reaches. Figure 9 shows the stream's headwaters emerging from a spring in a forested area, while Figure 10 highlights vegetation and debris within the channel, bordered by a deciduous forest on one side and pastureland on the other. These images illustrate the contrasting environments around the stream that impact its condition and flow.

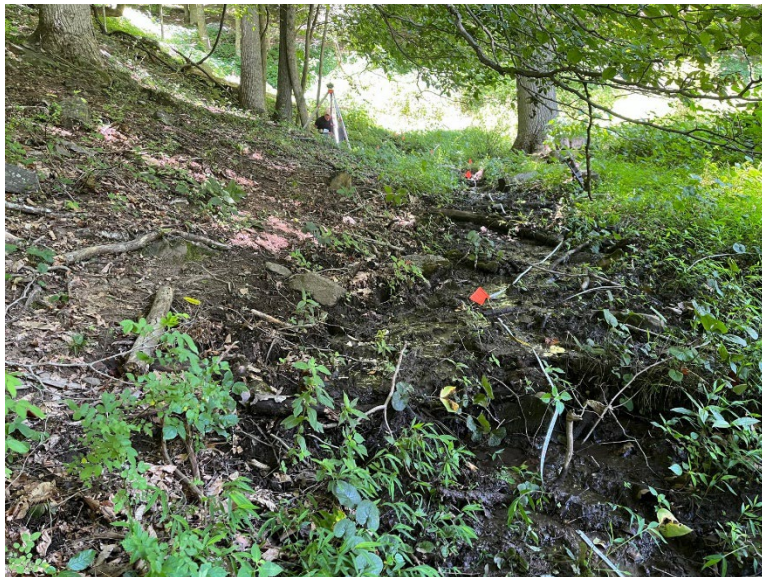
Figure 12. Vegetation and debris accumulating in the stream channel, with a deciduous forest floor visible on the left side and pastureland on the right. Photo by author, July 12, 2023.

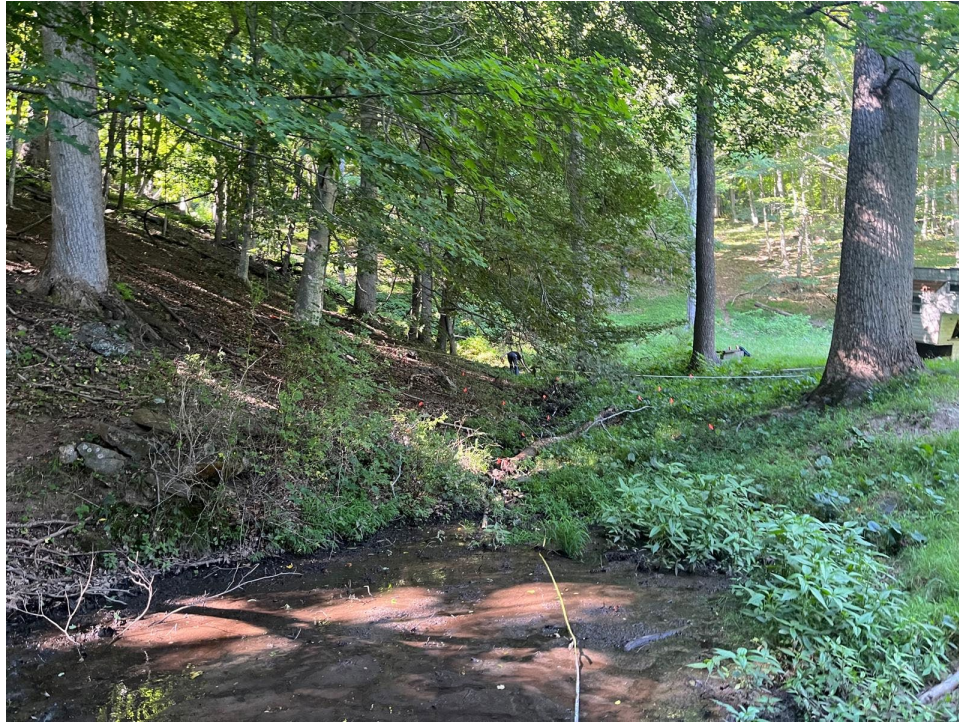
Figure 14. Mud pond formed due to cattle activity and road impoundment, with a view of deciduous forest on the right side of the stream and pastureland on the left. Photo by author, July 12, 2023.

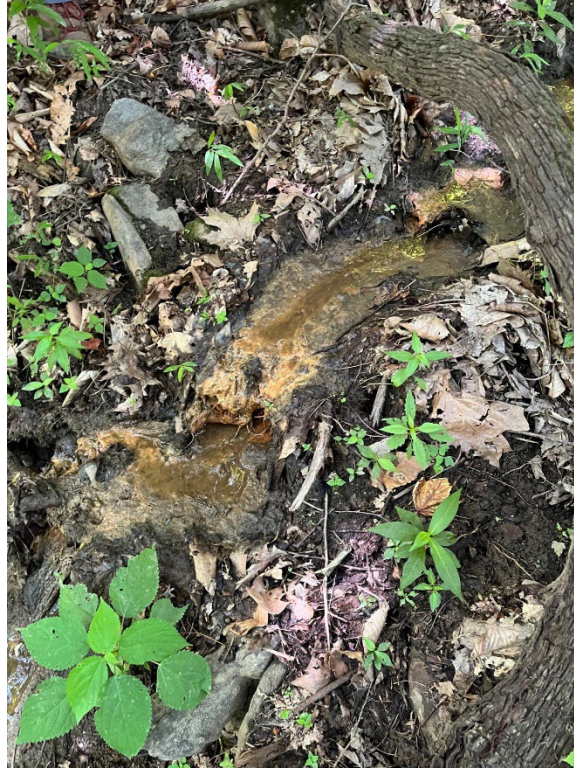
Figure 15. Evidence of iron-oxide bacteria likely from excess nutrient load from cattle manure.

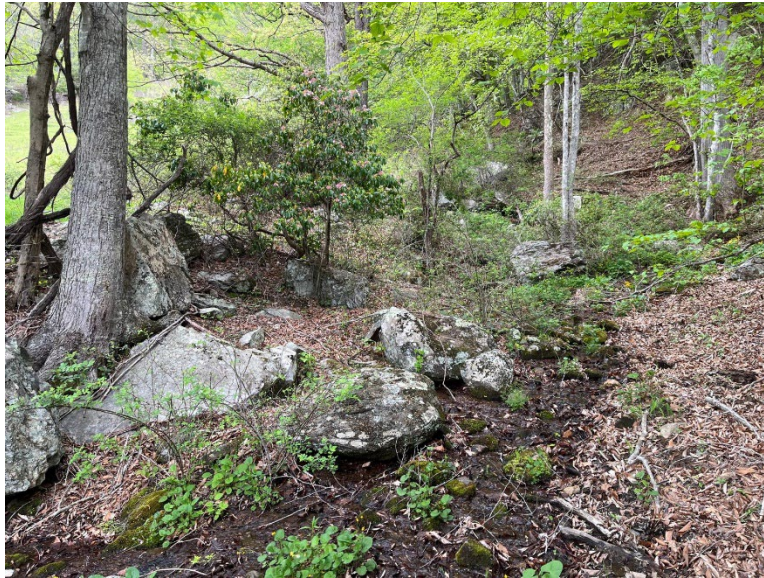
Figure 21. Section X topography includes a steep slope and boulders. It is enclosed in a deciduous forest. Photo by author, July 12, 2023.

Section X is situated on a steep, boulder-strewn slope within a deciduous forest, as seen in Figure 19. This rugged terrain contributes to erosion and poses challenges for stream stability. Observations, as seen in Figure 20, reveal signs of bank erosion and the presence of invasive species along the stream's edges, with debris accumulating in the streambed

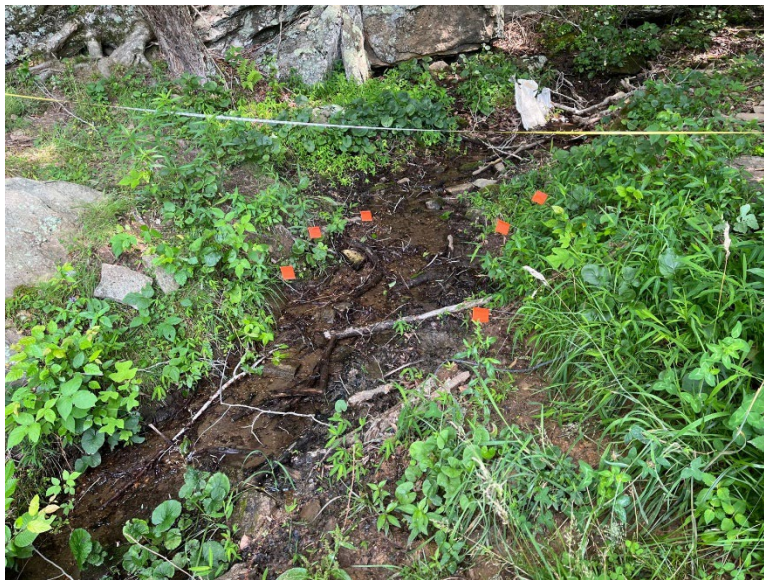
Figure 22. The stream shows signs of erosion and invasive species along its sides. The streambed is full of debris. Photo by author July 12, 2023.

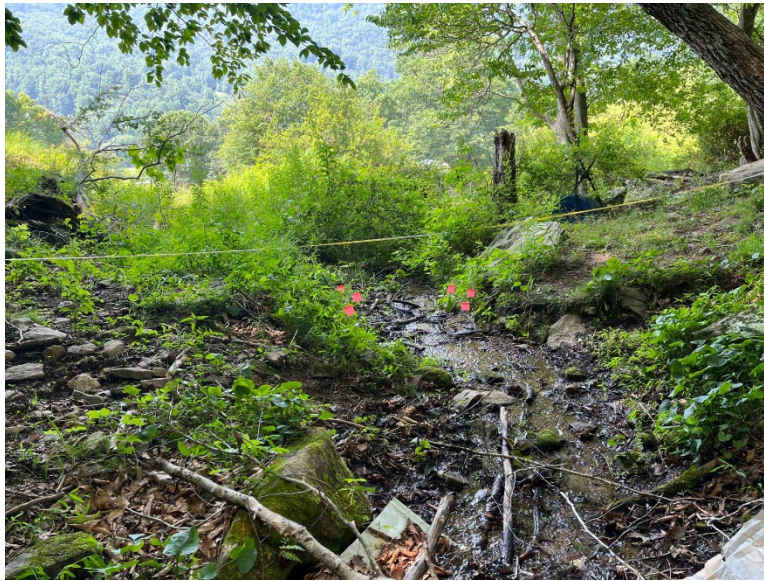
Figure 23. The stream continues through a rocky and debris-filled channel before entering into a transition zone before reaching the wetland. Photo by author July 12, 2023.

Section X transitions from a rocky, debris-filled stream channel into a wetland area, as illustrated in Figure 21Figure 22. In Figure 21, the stream flows through a channel laden with rocks and debris, leading into a transition zone before reaching the wetland. Figure 22 shows the wetland area, where the stream passes through dense herbaceous cover and grasses before rechanneling downstream. This transition highlights the need for careful management to support wetland function, control sediment, and maintain channel stability as the stream flows from upland areas into this sensitive zone.

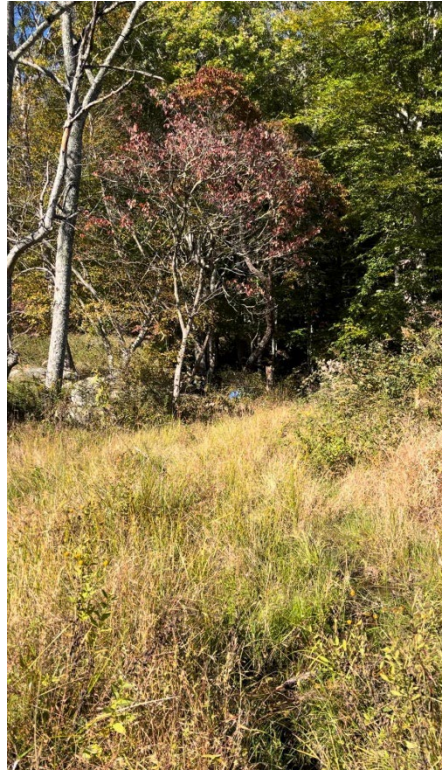
Figure 24. Wetland area of the stream section passes through herbaceous cover and grasses before rechanneling downstream. Photo by author, September 3, 2023.

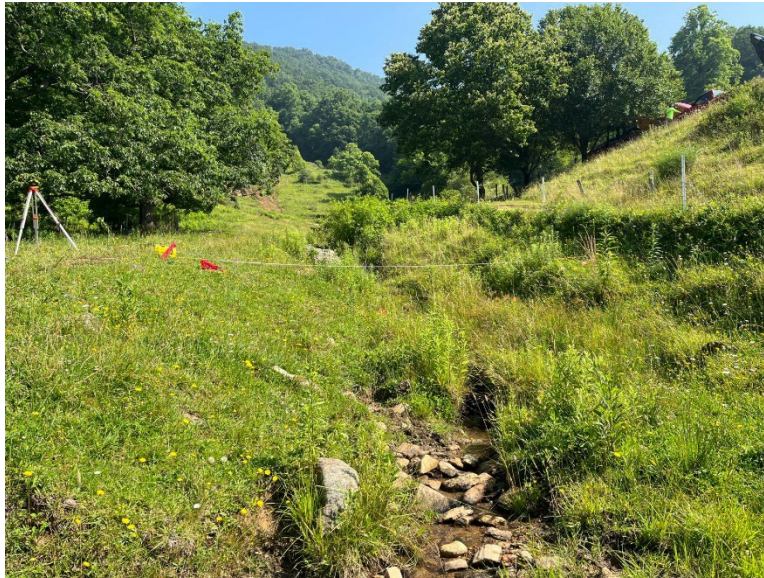
Figure 30. Section Y begins at a 36" culvert beneath the pasture access road. Fencing lines the left side of the stream, adjacent to a gravel road. Photo by author, July 13, 2023.

Figure 28 through Figure 30 provide a visual overview of Section Y, highlighting the impacts of livestock access and the surrounding infrastructure on the stream. Figure 28 shows the beginning of Section Y at a 36" culvert beneath the pasture access road, with fencing along the left side adjacent to a gravel road. Moving downstream, Figure 29 illustrates the end of Section Y, located about 60 feet before the barn, where cattle have unrestricted access, resulting in trampled vegetation and well-worn access points. Figure 30 captures a heavy-use area marked by uneven banks and dried manure. The stream channel throughout Section Y contains rocks and cobble but primarily consists of sand, illustrating the combined effects of cattle activity and natural sediment composition on stream stability.

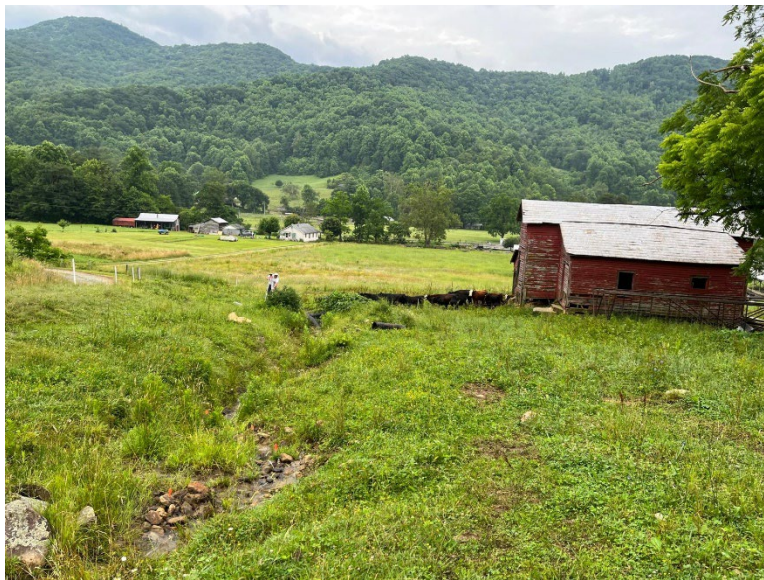
Figure 31, Section Y ends approximately 60 feet before the barn, with cattle having full access to the stream. Trampled vegetation and heavily used access points are evident throughout. Photo by author, July 13, 2023.

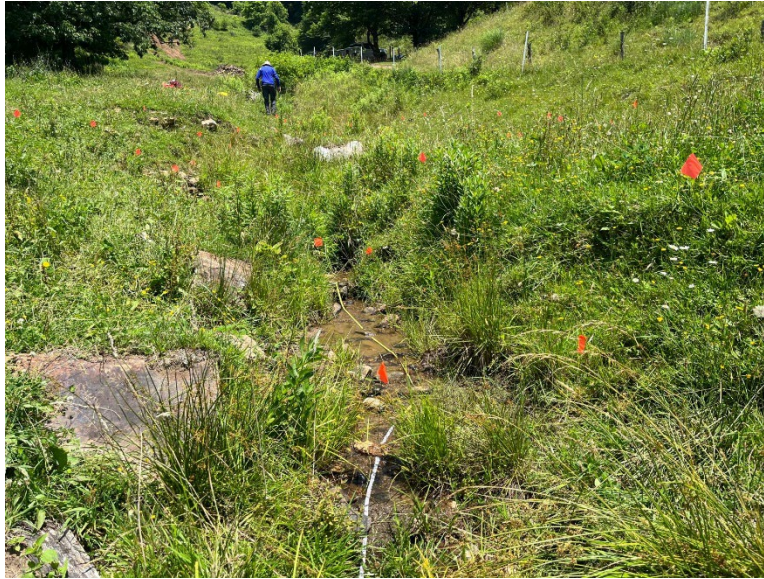
Figure 32. Heavy-use access area indicated by uneven banks and dried manure. The stream channel features rocks and cobble but is primarily sand. Photo by author, July 13, 2023.

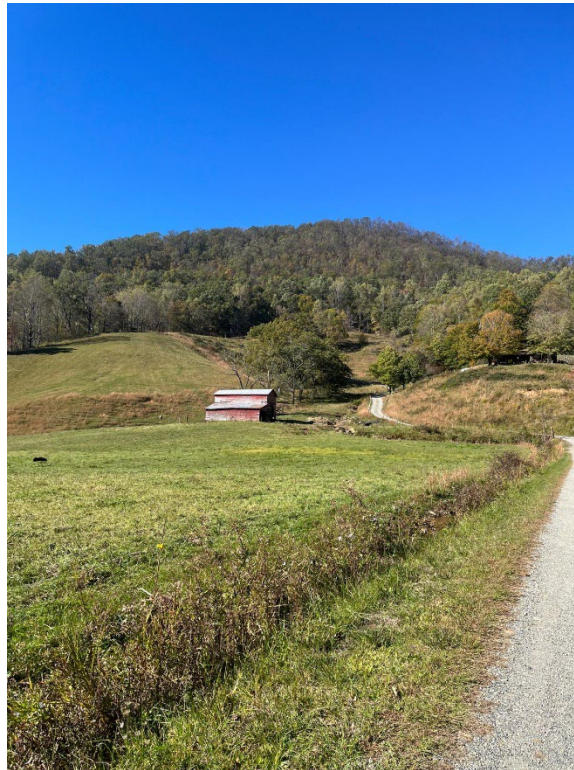
Figure 38. Section Z runs alongside the road, showing clear anthropogenic alterations from the straightening of the stream channel. Photo by author, September 3, 2023.

Figure 36 through Figure 38 provide a visual assessment of Section Z, illustrating the impacts of anthropogenic modifications and livestock access on the stream and surrounding pastureland. Figure 36 shows the straightened stream channel running alongside the road, highlighting the clear anthropogenic changes in this section. Figure 37 reveals wetland characteristics in the pasture, where vegetation shifts from pasture grasses to water-tolerant species like rushes, with cattle having unrestricted access to both the stream and wetland areas. In Figure 38, the entrenched stream channel in Section Z demonstrates increased water velocity due to straightening, with fallen streamside vegetation following a recent rain event underscoring the impacts of this channel modification on stream stability and bank resilience.

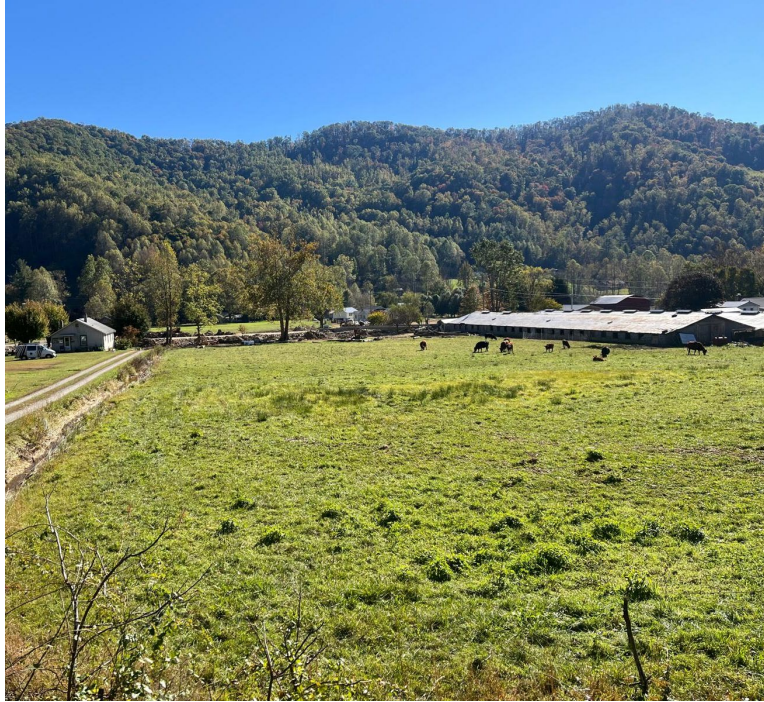
Figure 39. Stream on the left next to road, with wetland indicators in the pastureland shown by a shift from pasture grasses to rushes and other water-tolerant species. Cattle have direct access to both the stream and wetland areas. Photo by author, September 3, 2023.

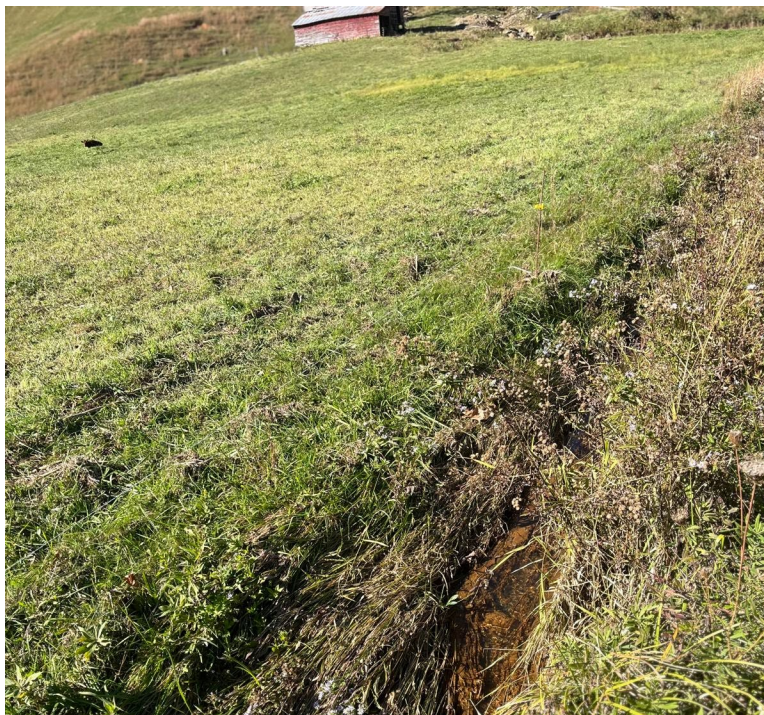
Figure 40. The stream channel in Section Z is highly entrenched, with increased water velocity from channel straightening, evidenced by fallen streamside vegetation following a recent rain event. Photo by author, September 3, 2023.

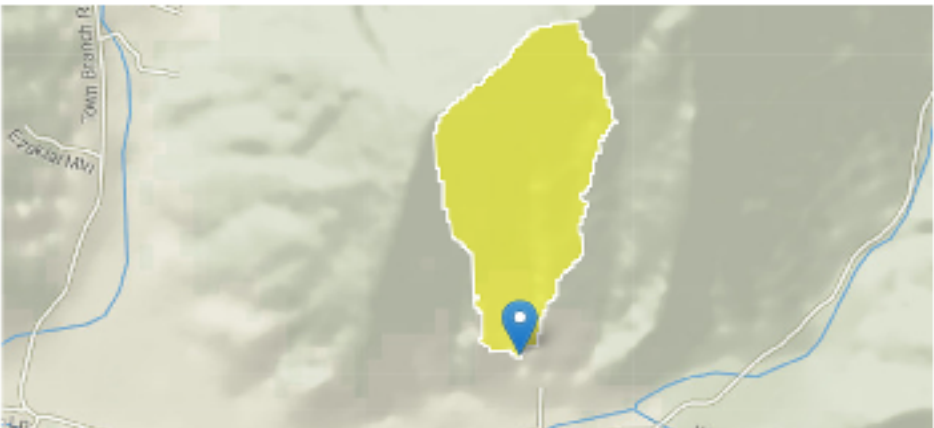
| SECTION W<br>STREAMSTATS | | | SECTION Y<br>STREAMSTATS | | |
|---|---|---|---|---|---|
| Delineation of watershed draining to Section W | | | Delineation of watershed draining to Section Y | | |
