ASSESSING LONG-TERM AND SHORT-TERM SHORELINE CHANGE OF COCKSPUR  
ISLAND IN THE SAVANNAH RIVER ESTUARY

The shorelines of Cockspur Island, GA are constantly responding to natural and anthropogenic forces. In the fall of 2015, dredge spoil was placed on the north shore to protect cultural resources from rapid erosion. This study assessed both long-term and short-term shoreline change trends occurring on the island and at the experimental beneficial-use dredge spoil site, using GIS and sUAV surveying, to inform adaptive management strategies. The north and south shorelines were dominantly erosional over 85 years, at rates of  $-0.47 \text{ m yr}^{-1}$  and  $-0.2 \text{ m yr}^{-1}$ , respectively, and the east shoreline was accretionary at  $+3.79 \text{ m yr}^{-1}$ . Based on a 0.5% per month volume loss rate over the 40-month period, the lifetime of dredge spoil placement is 14 years. However, because the elevation of the berm is decreasing as the deposit erodes landward, a shorter effective lifespan of 8 years is more likely.

A Thesis Submitted to the Graduate Faculty of The University of Georgia in Partial Fulfillment  
of the Requirements for the Degree

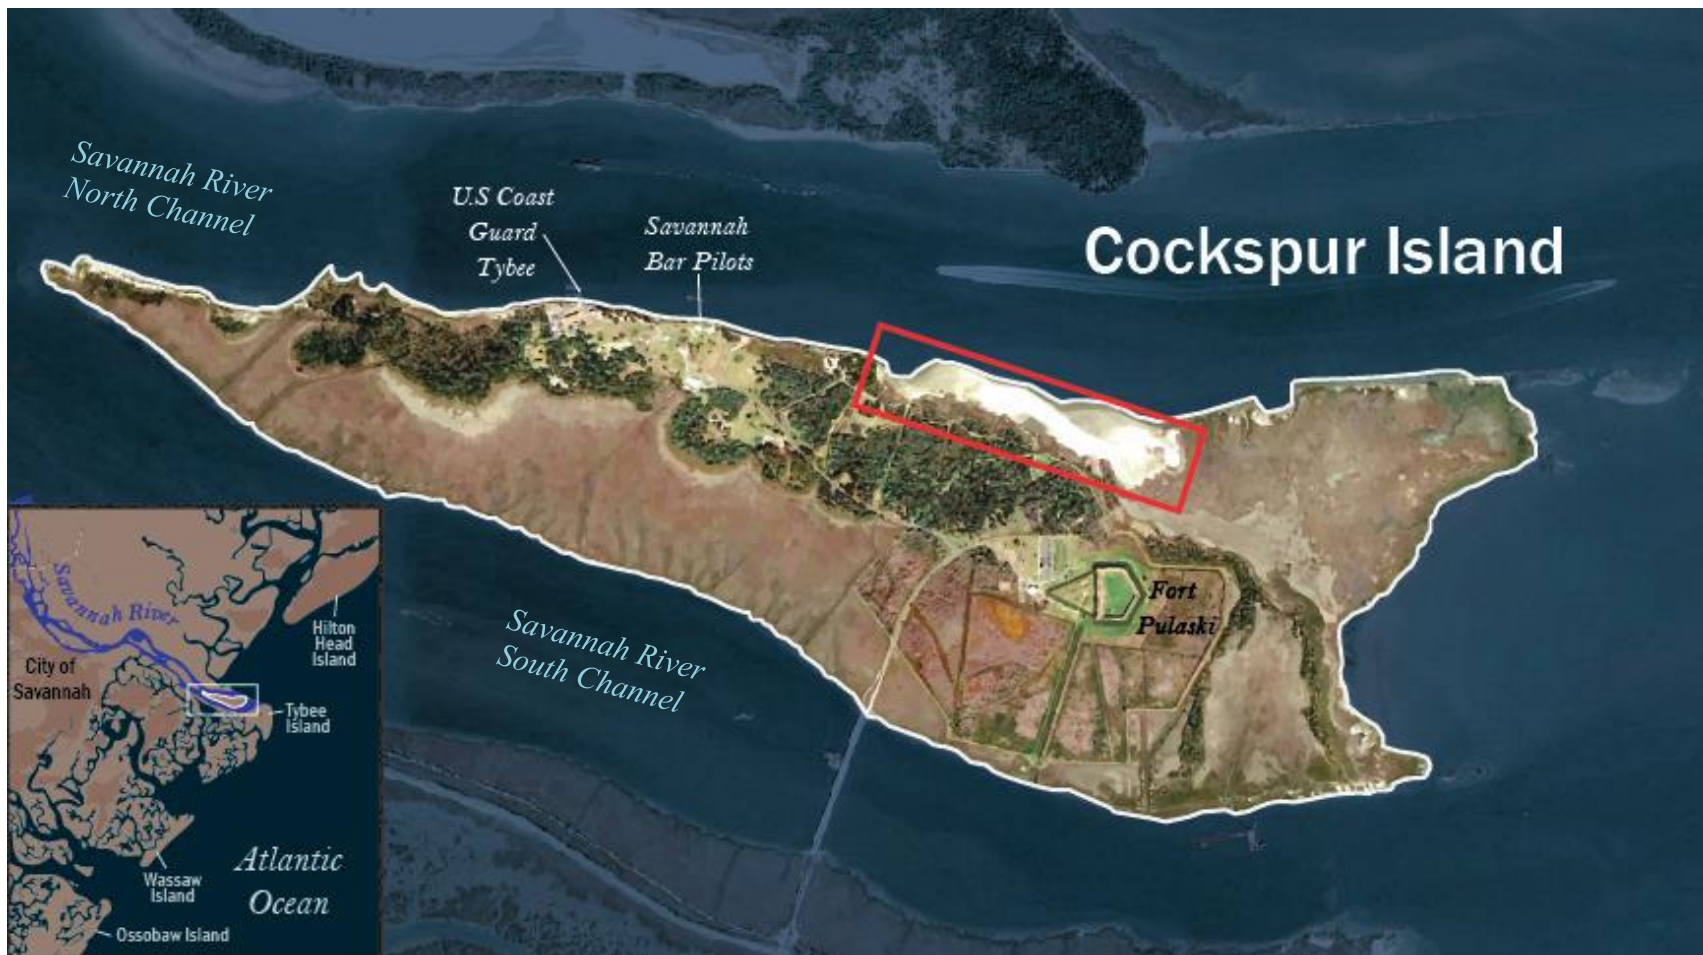
Figure 1. Map of Cockspur Island. Inset map (bottom left) shows relative location of Cockspur Island (white box) to Georgia coast. The red box on the northern shoreline of Cockspur Island indicates the nourished region of the shoreline.

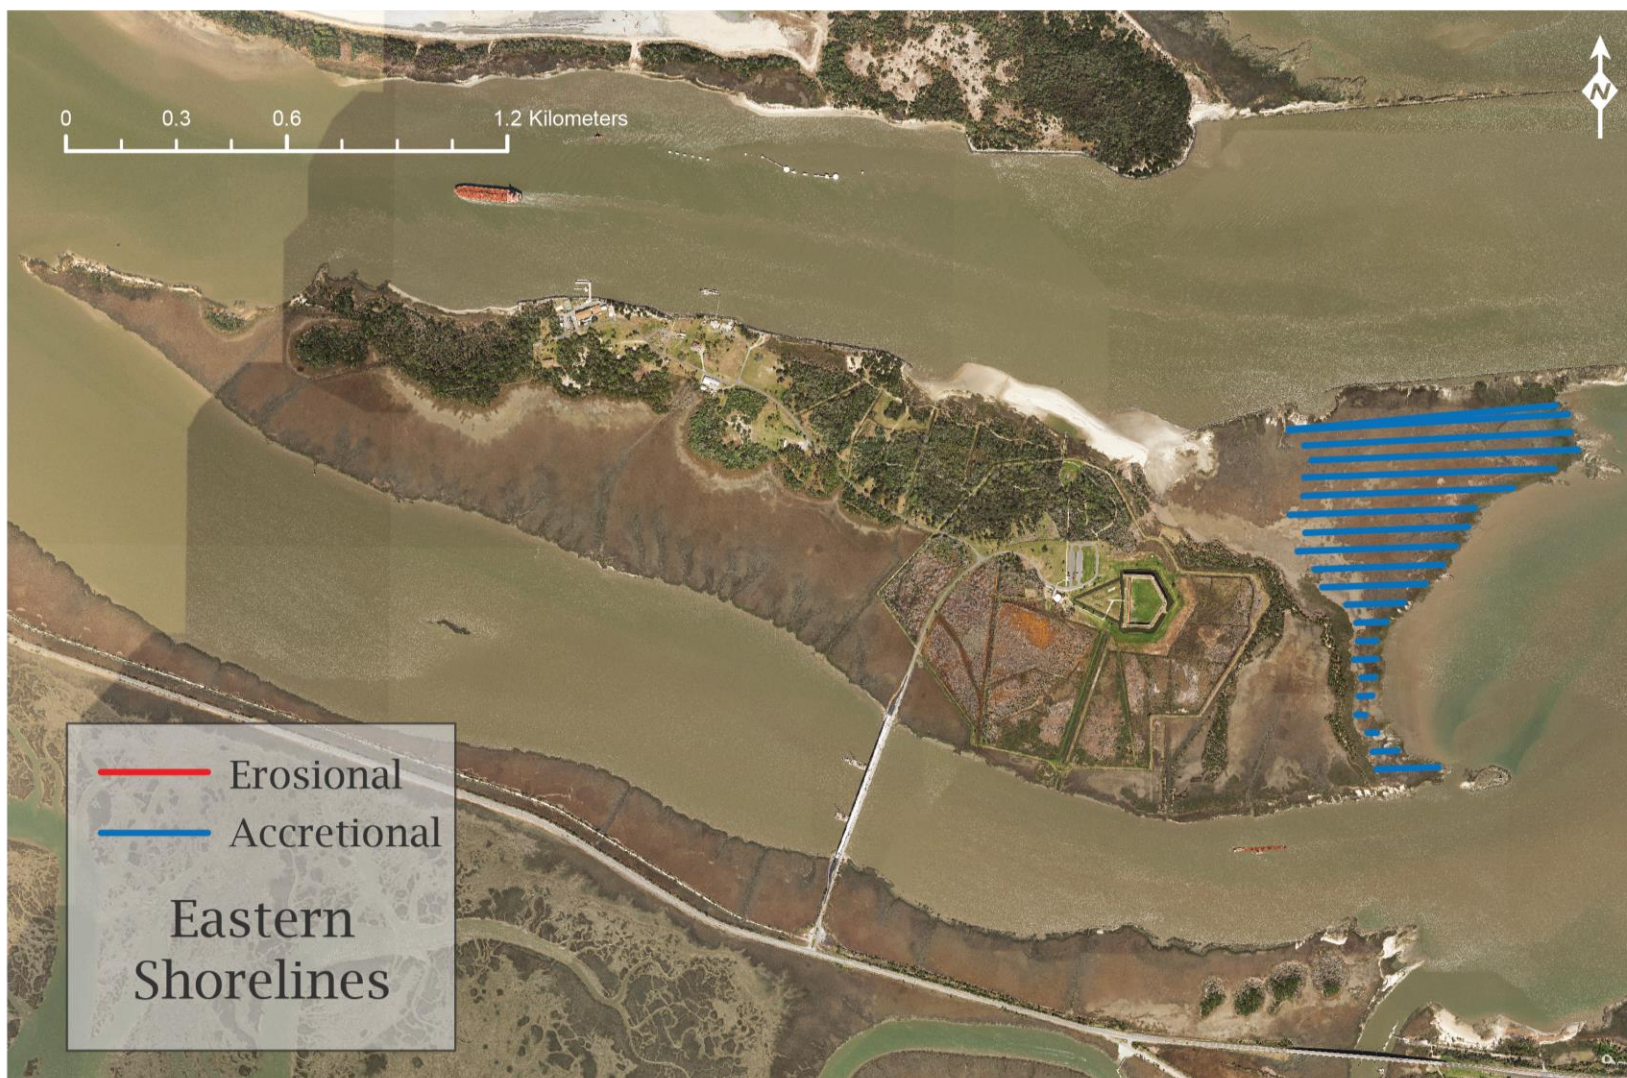
Figure 8. AMBUR produced transects of Cockspur Island eastern shoreline. Length of transects represent the magnitude of change. Analysis performed with all shoreline transects, from 1933 to 2018. Blue transects indicate net accretion, there are no erosional transects.

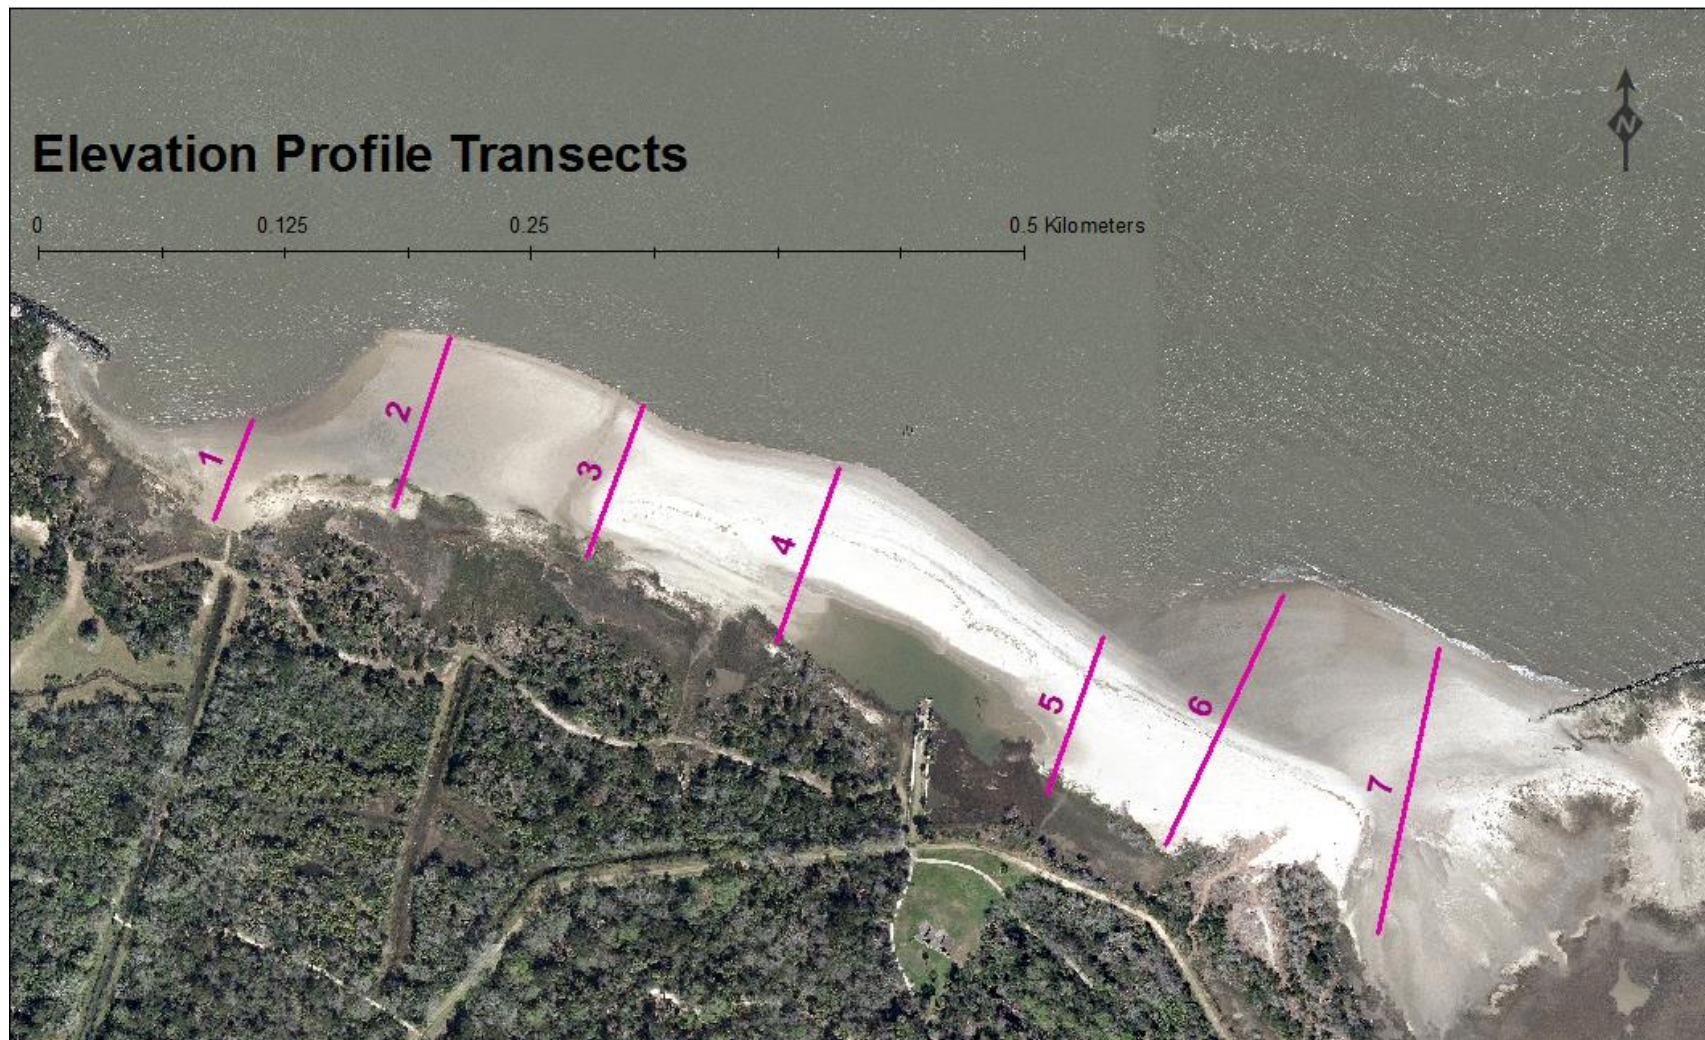
Figure 20. Map of transect locations for elevation profile comparisons on Cockspur Island's nourished northern shoreline. Transects are labeled from the western end to the eastern end of the shoreline. Transects are measured from the channelward edge to the landward edge.

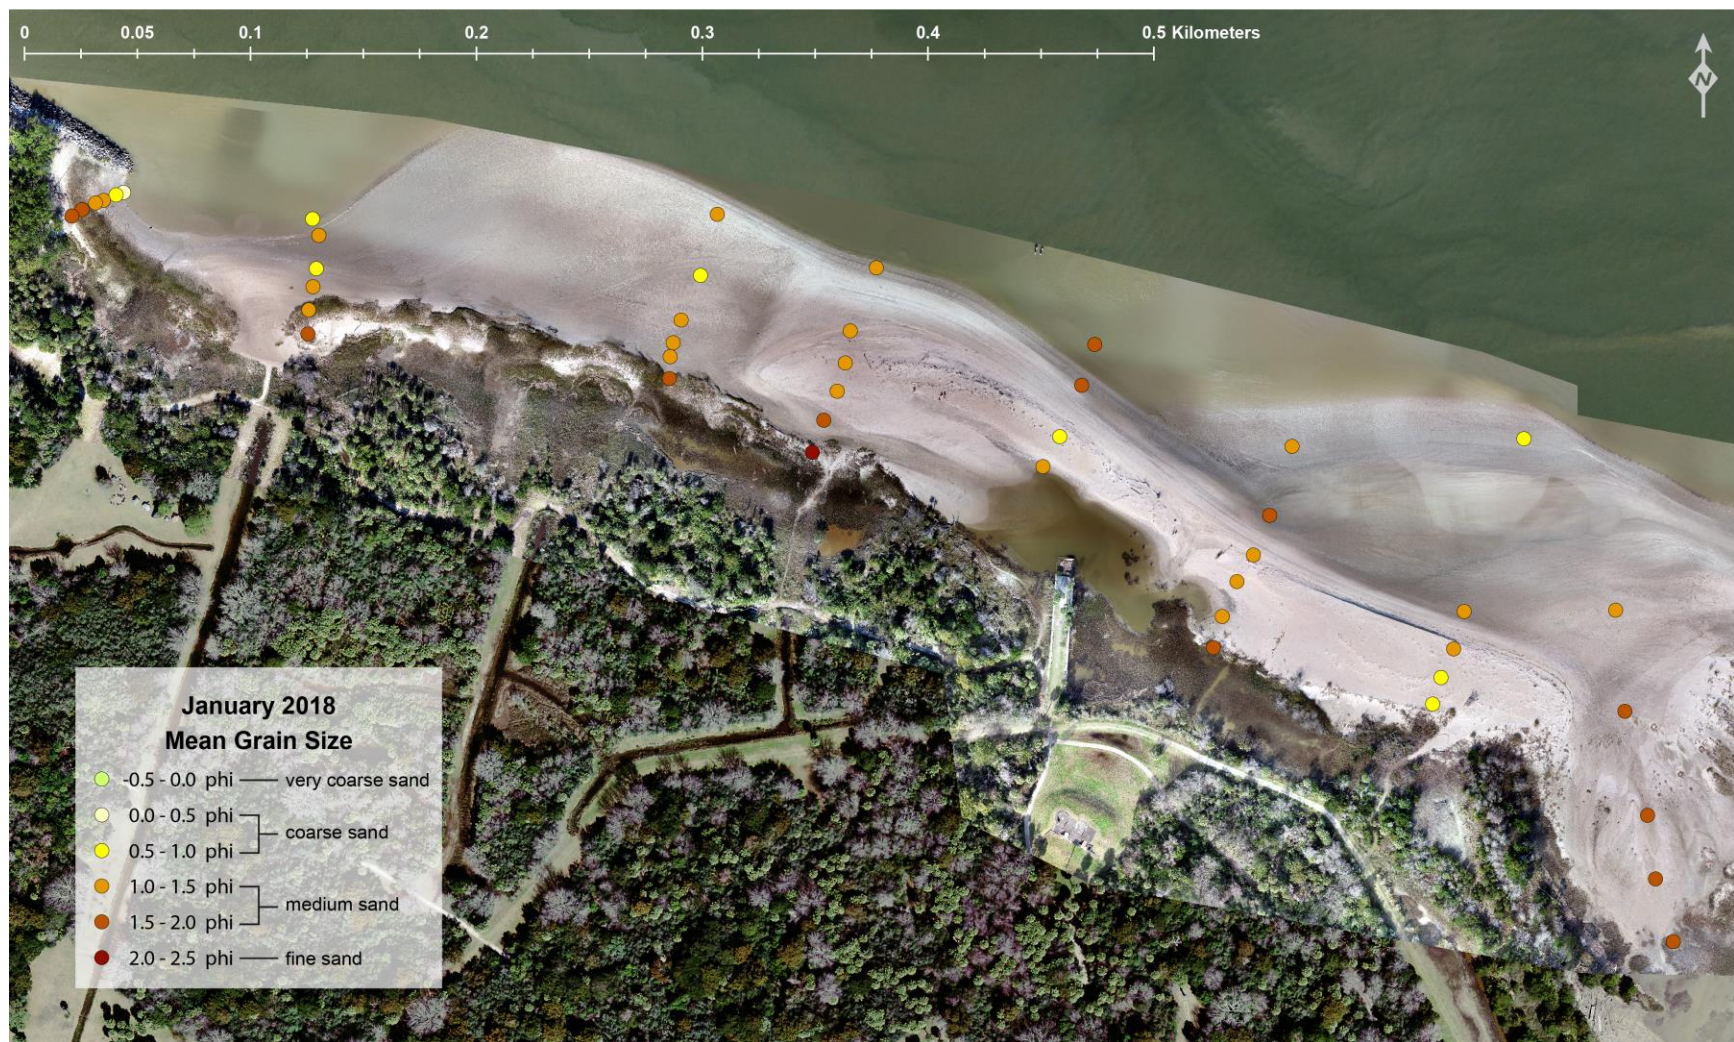
Figure 28. Map of mean grain size, in phi, of the nourished northern shoreline on Cockspur Island, for January 2018. Light hues indicate finer sediment grain size; darker hues indicate coarser sediment grain size.

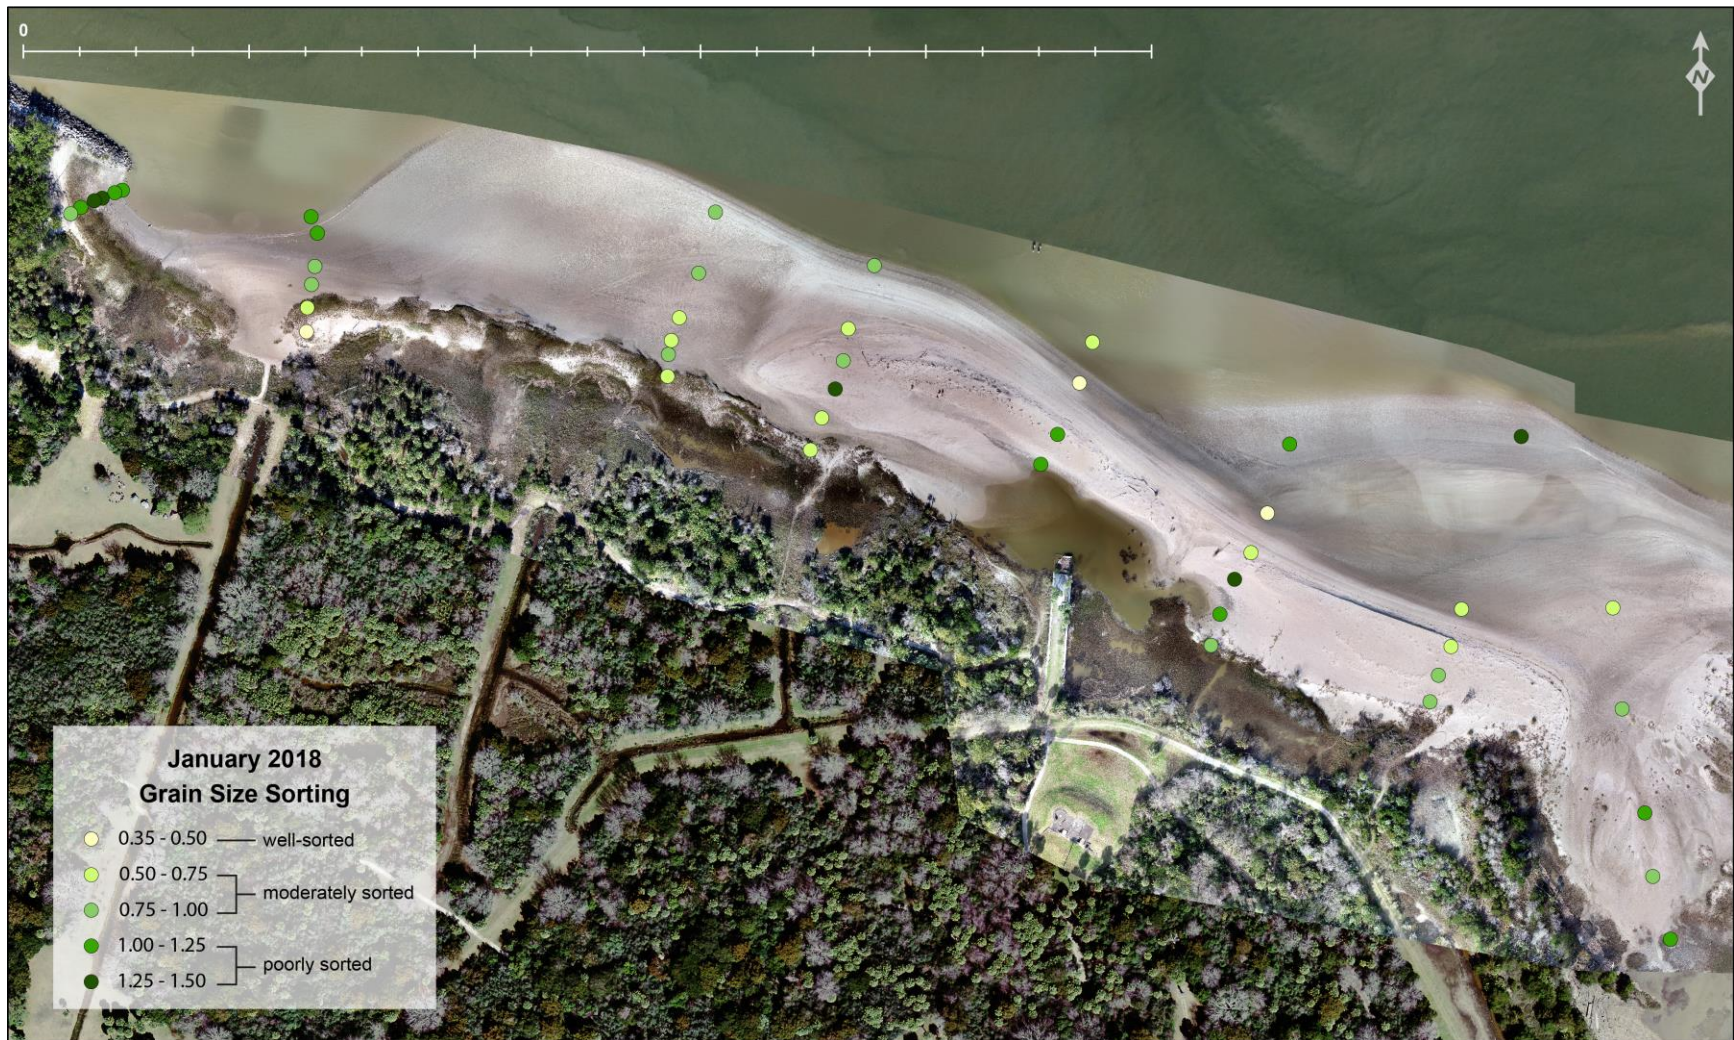
*Figure 29. Map of grain size sorting of the nourished northern shoreline on Cockspur Island, for January 2018. Light hues indicate poorer sediment grain size sorting; darker hues indicate more well-sorted sediment grain size*

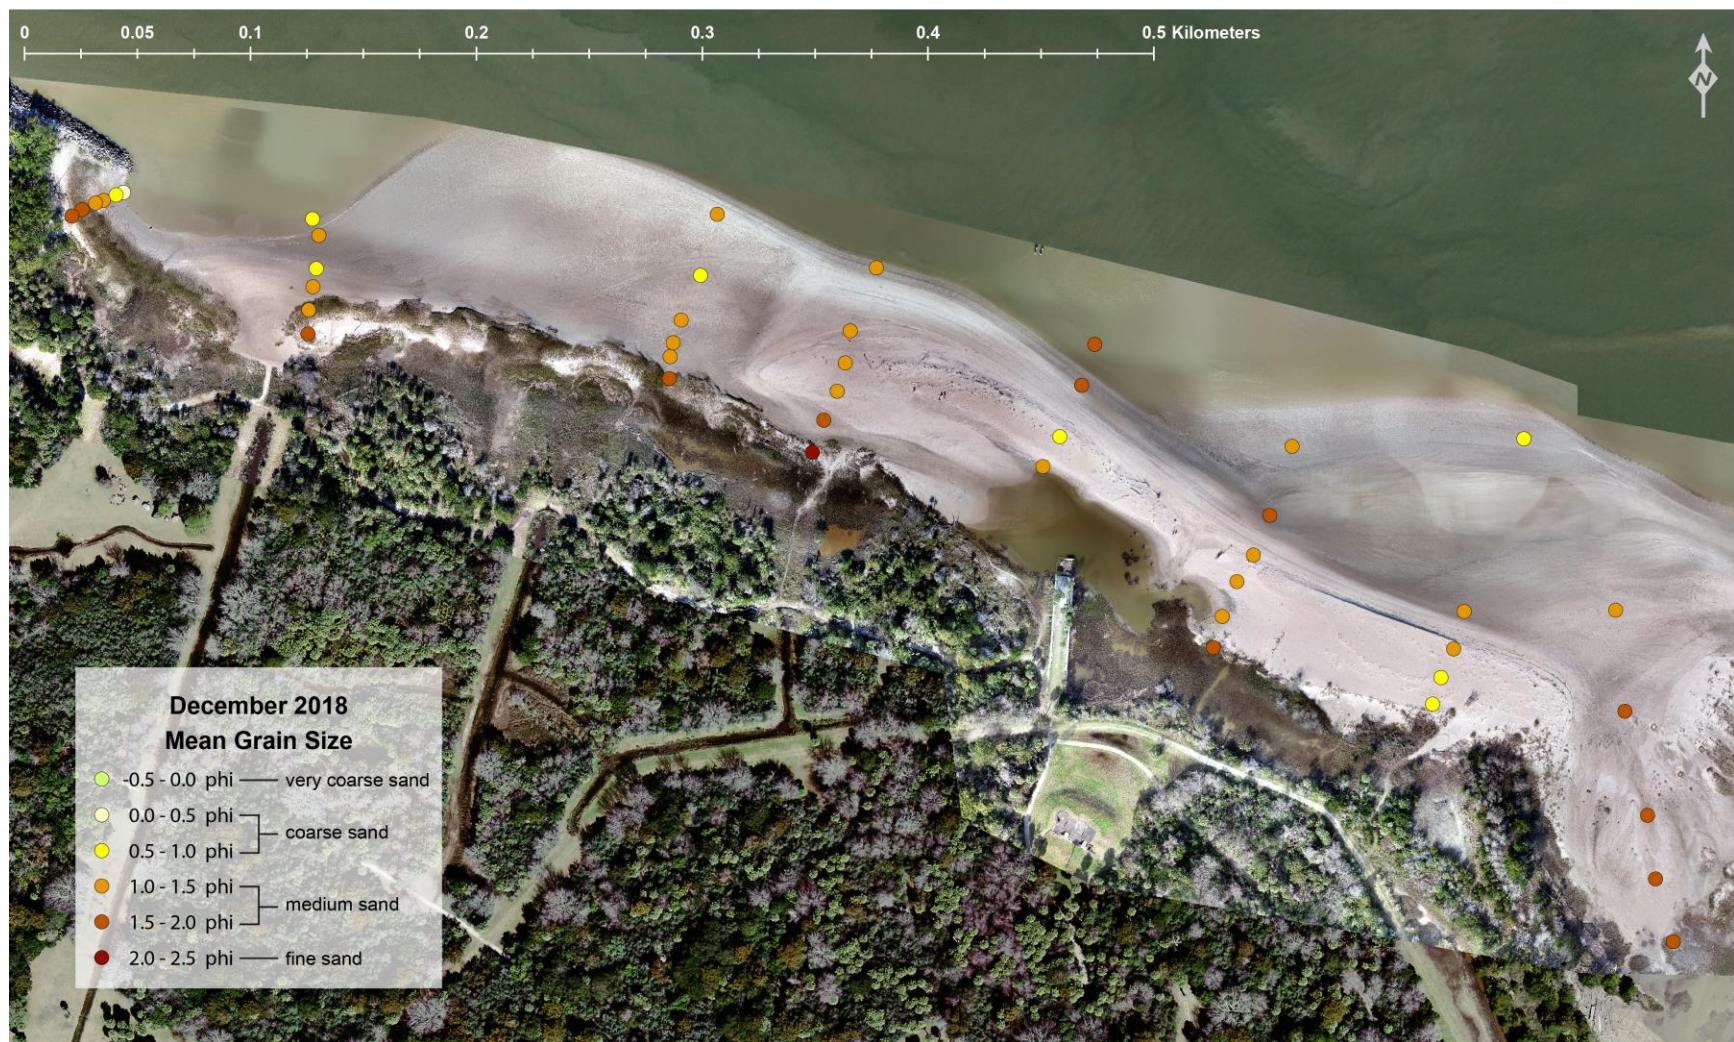
Figure 30. Map of mean grain size, in phi, of the nourished northern shoreline on Cockspur Island, for December 2018. Light hues indicate finer sediment grain size; darker hues indicate coarser sediment grain size.

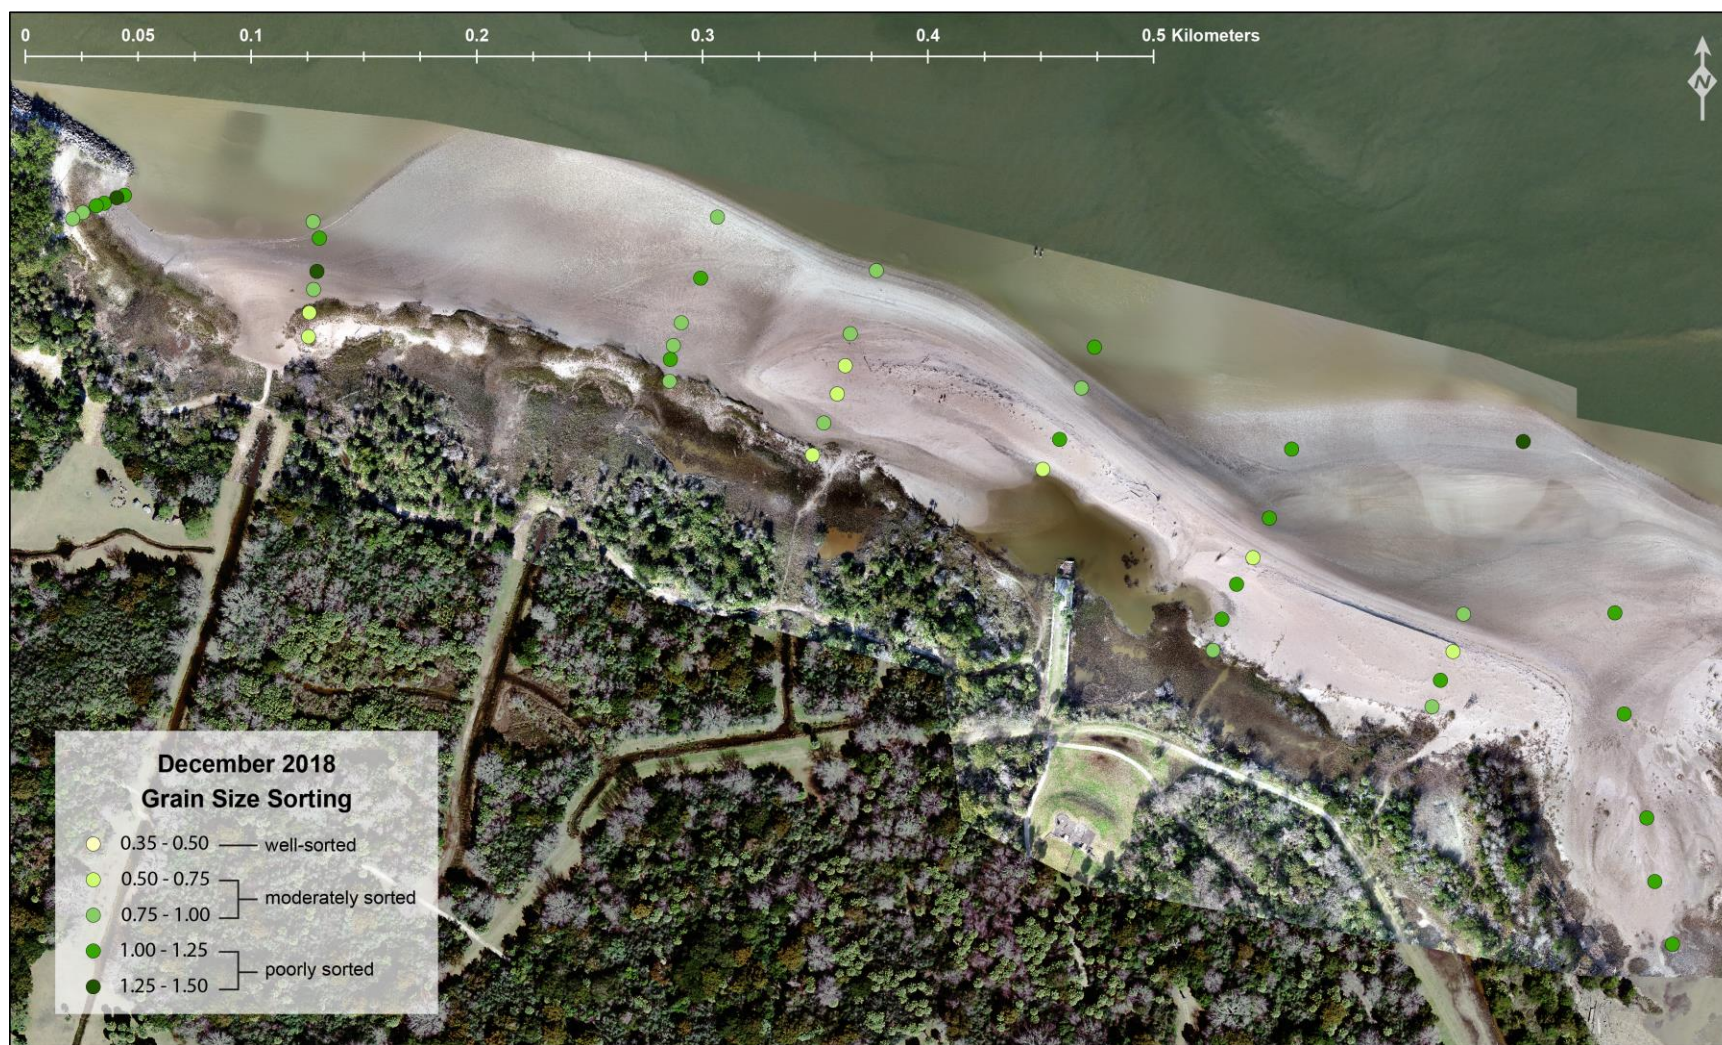
*Figure 31. Map of grain size sorting of the nourished northern shoreline on Cockspur Island, for December 2018. Light hues indicate poorer sediment grain size sorting; darker hues indicate more well-sorted sediment grain size.*

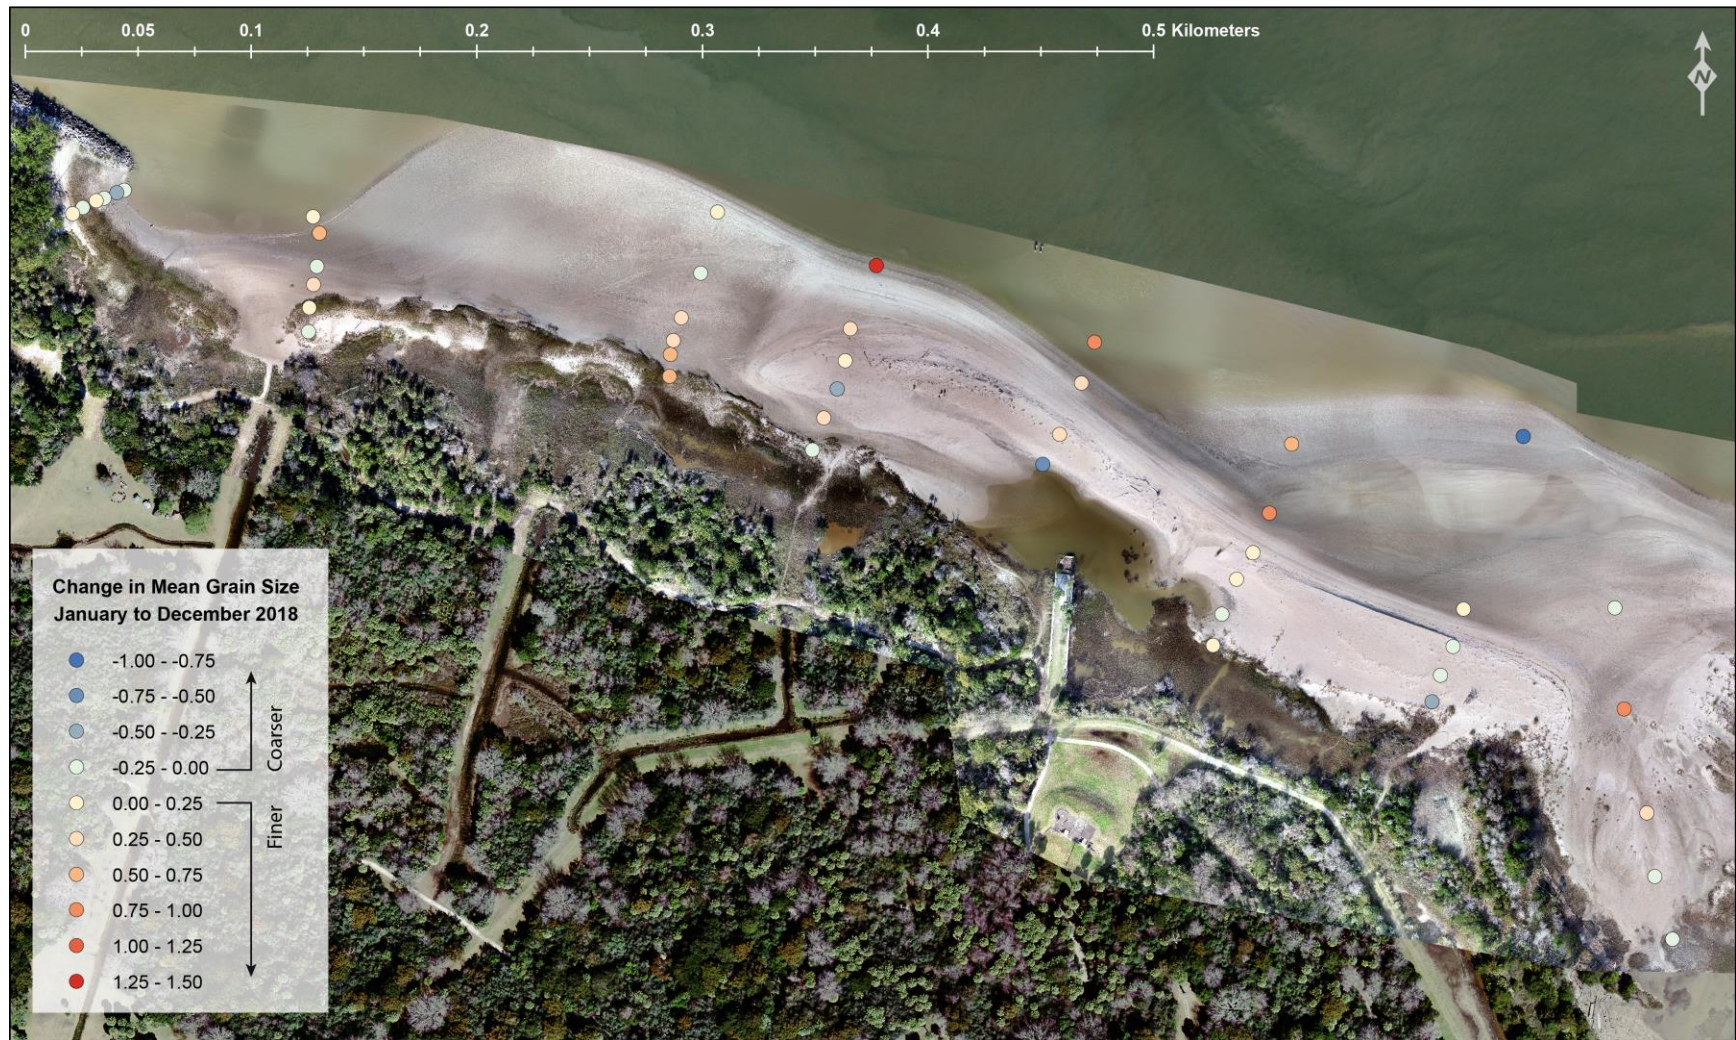
Figure 33. Map of change in Mean Grain Size, in phi, on Cockspur Island, on the nourished northern shoreline. Cool colors indicate mean grain size becoming finer, warm colors indicate mean grain size becoming coarser.

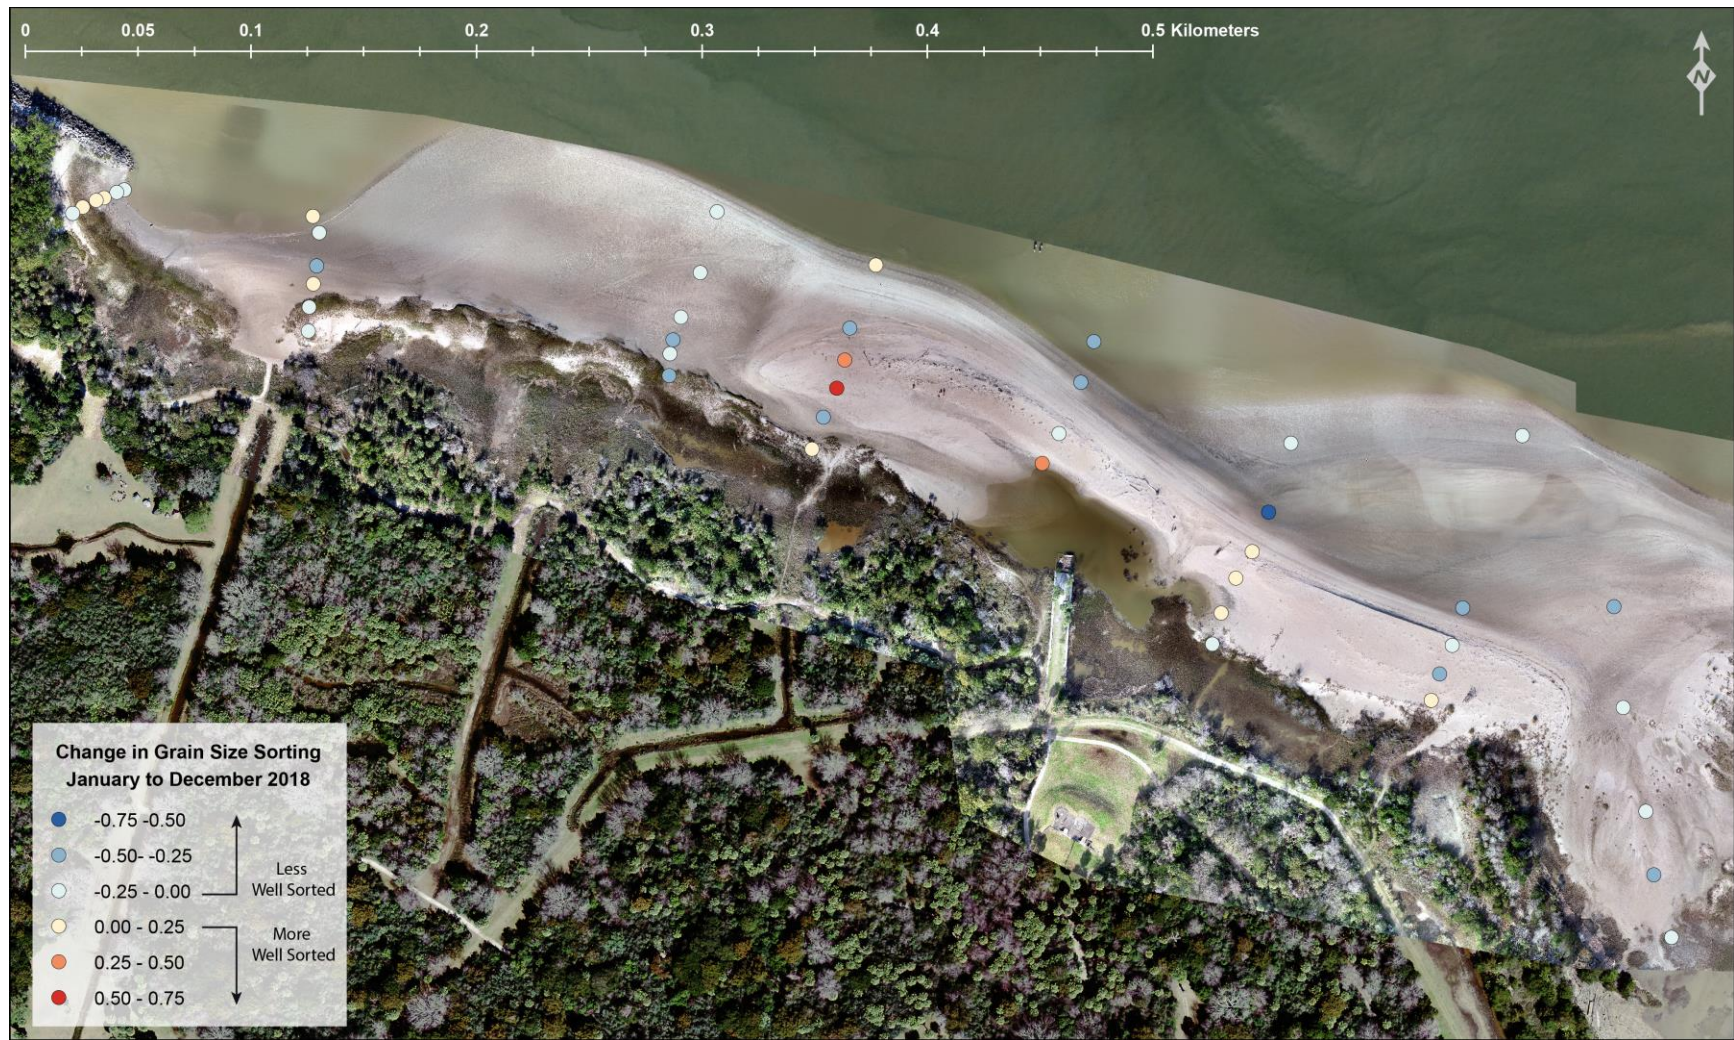
Figure 34. Map of change in Grain Size Sorting on Cockspur Island, on the nourished northern shoreline. Cool colors indicate grain size becoming less well-sorted, warm colors indicate grain size becoming more well-sorted.
