THE CULTURE OF ARCHITECTURE IN THE SANTA FE TRAIL REGION OF
SOUTHEASTERN COLORADO

A Thesis Submitted to the Graduate Faculty of The University of Georgia in
Partial Fulfillment of the Requirements for the Degree

MASTER'S OF HISTORIC PRESERVATION

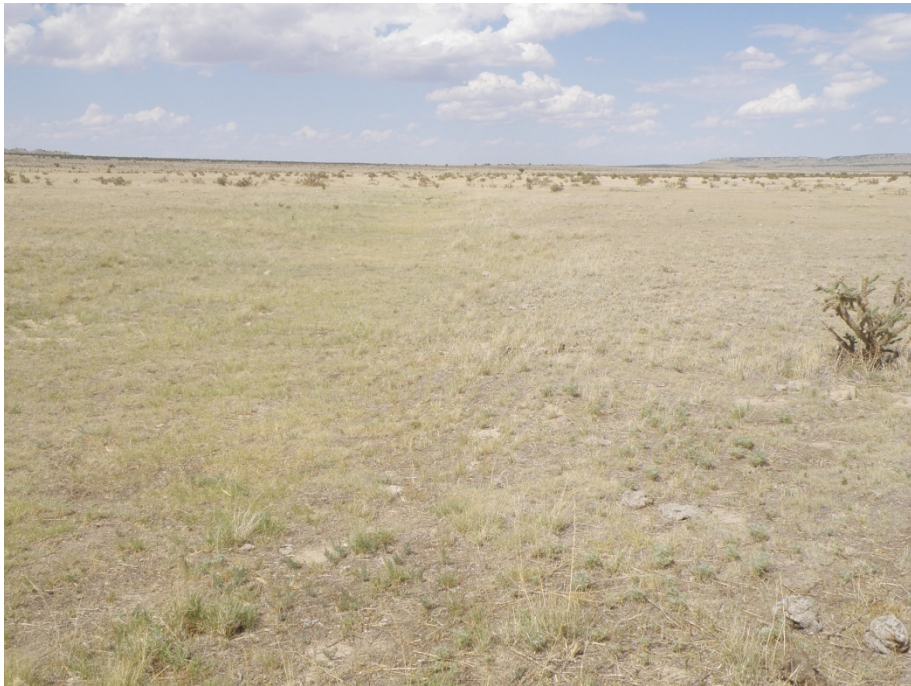
Figure 5: *Mountain Branch of the Santa Fe Trail, remaining trail bed*¹⁵

Many of the trail beds of the Santa Fe Trail are still visible, faded reminders of the track that guided many pioneers on their adventures westward. The Purgatoire Valley and surrounding countryside became a land of discovery during the days of travel by the Santa Fe Trail, with the first boom towns and business developing as a result of the increased migration across the middle United States.

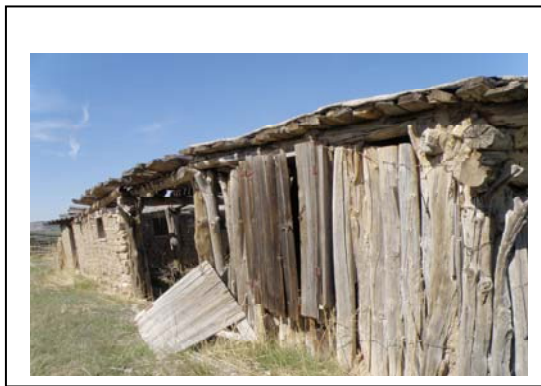
IMAGE C: *Jacal* Structure

Additions were often constructed as *jacals*, a Native American form of architecture adopted by New Mexicans consisting of a wall of closely spaced wood posts tied together, with adobe filling any spaces; small timbers (often piñon) were placed into the earth and tied with wire (Figure 9, Image C). Flat roofs were most typical of New Mexican design, with large, equally spaced, vertical logs (*vigas*) covered by smaller horizontal timbers (*latillas*). The *vigas*, typically hand-hewn ponderosa or cottonwood, usually extend beyond the structural walls, with the horizontally laid *latillas* forming the surface of the roof, covered with mud and stone (Figure 9, Image D).

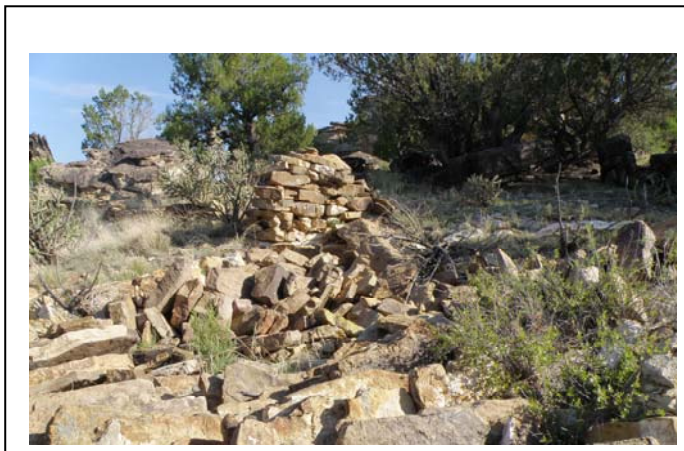
Figure 11: *Images of Survey Site LA091*⁶⁸

IMAGE A: South Entrance and Adobe Wall

IMAGE B: Outbuilding Foundations

Two square foundations are located directly south of the main dwelling, Features B and D, each of sandstone with bits of remaining adobe mortar (Figure 11, Image B). Only the fallen walls of these structures remain, with the earth roof, timbers covered by packed mud, having eroded and melted with the natural elements. The foundations are arranged facing west, with the front entrance located on the western wall. The smaller foundation, immediately north of the second foundation, measures 18 feet by 12.8 feet; the larger foundation measures 20.10 feet by 16.10 feet, and each has a square plan with no evident additions. Being that these were relatively simple structures with no evident window frames or room divisions, these foundations were most likely outbuildings at one time, used for storage or agricultural needs.

Evident from the six small pen enclosures, corral area and outbuilding foundations are a former livestock operation, most likely raising sheep. The adobe wall, large *viga* roof beam, garden terracing, and overall use of the natural landscape are features of the built environment most closely attributed to New Mexican settlers. Although not a plaza system, homestead site LA091 includes many features of New Mexican architecture and indicates a former sheep operation, a common New Mexican way of life in the late nineteenth century Santa Fe Trail region. Furthermore, the land patent information confirms the New Mexican analysis, as the land was patented on January 15, 1885 by Nicolas

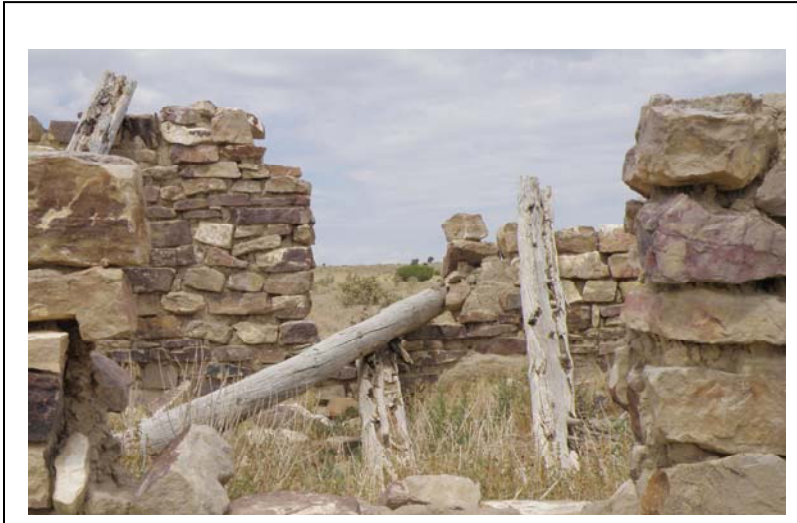
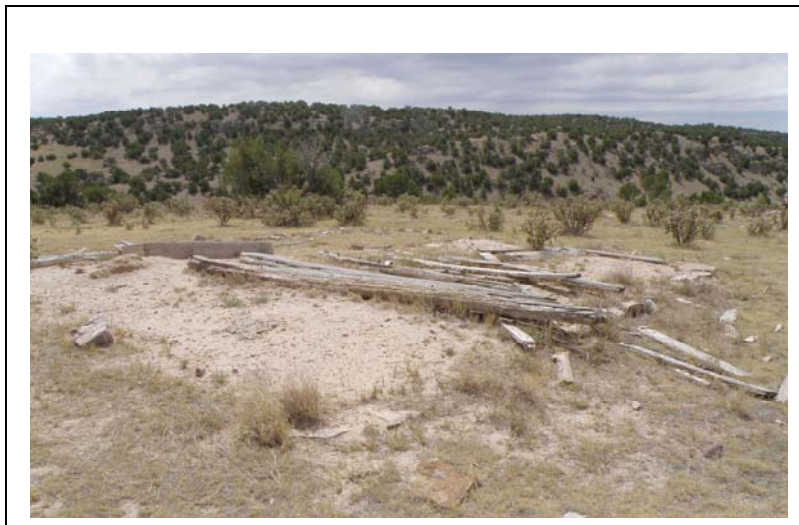
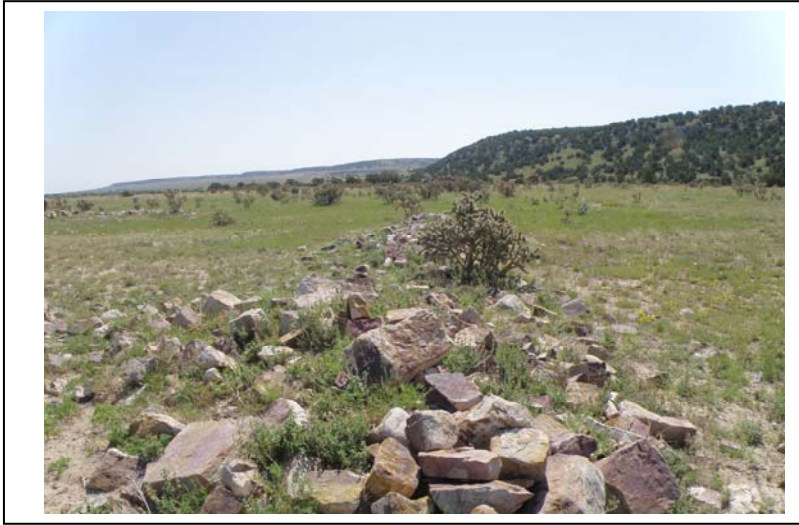
Figure 13: *Images of Survey Site LA100*

IMAGE A: Central Structures with Remaining Walls

IMAGE B: Central Dwelling with Stone Foundation, No Remaining Walls

IMAGE C: Stone Corrals

An additional central dwelling is evident just north of the aforementioned structures; however, unlike the other central structures, this dwelling, marked as Feature L, has no remaining walls, only the outline of the stone foundation (Figure 13, Image B). The foundation tells the story of many additions and alterations to the original dwelling. A rectangular plan, measuring 26.6 feet by 16 feet, is evident, and this is thought to be the original structure. Surrounding this section, at a distance of 22 feet on all sides is another faint stone foundation, signaling an extension to the original square-plan dwelling. The entire structure appears to have been adobe, as mounds of earth now lie beside the stone foundation without any remains of stone wall construction. Within the original square plan are both fallen milled and hand-hewn timbers, cut and wire nails, and several large log beams; the lumber could have been used for window and door construction, with the wire nails attributed to the alterations, and the large beams as roof support,

To the west of the central stone structures are stone corrals, identified as Feature C (Figure 13, Image C). The rough cut sandstone was rubble laid in an L-plan, with wood posts in the center and the remains of a tack room to the north of the corral system. The L-plan of the stone corral measures 62 feet by 68 feet, with wings on either side measuring 53 feet and 20 feet. The associated tack room foundation off the corner of the north wall and east wall of the corral is a rectangular plan, measuring 38 feet by 14 feet. Because few fallen stones remain, the tack room was most likely constructed of adobe with the remaining stone foundation still evident. The interior log posts were connected as part of a corral system for sheep.

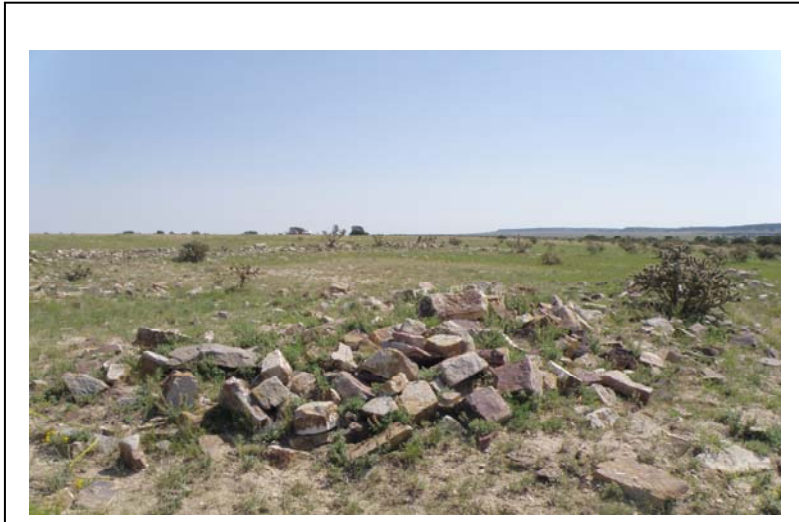
IMAGE D: Loafing Shed and Stone Corral

A loafing shed foundation, Feature M, is located on the eastern edge of the site, opposite from the corral location (Figure 13, Image D). A place to store hay, the loafing shed is identified by its remaining three wall foundation. The shed was constructed of rough sandstone and three sided, in a U-shape plan facing east. Corrals extended eastward from the east wall of the shed and were also constructed of rubble-laid stone, almost 100 feet in length. Only the stone remains of the shed and corrals are still evident, with no other fencing, roof structure or outbuildings connected to the structure. However, found near the loafing shed during survey were sheep shears (Figure 11, Image E), furthering the idea that

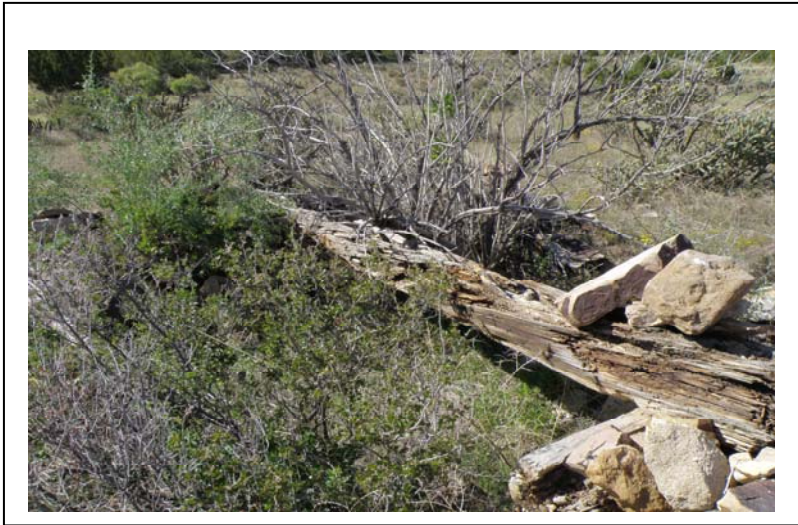
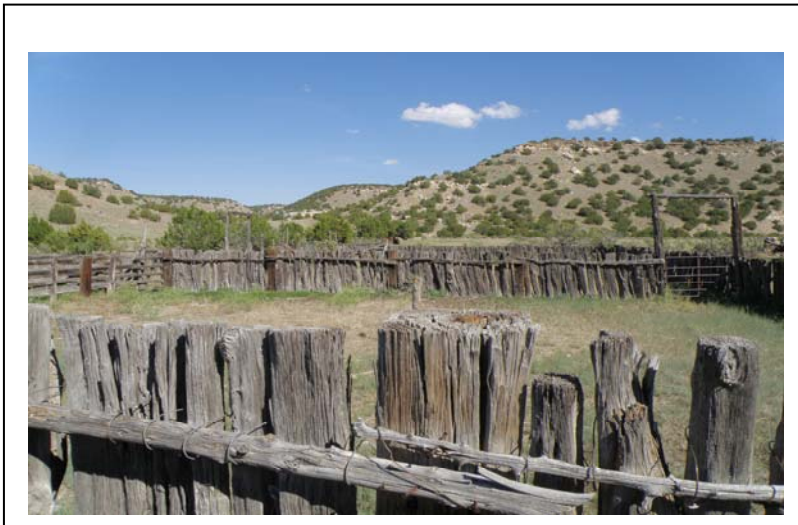
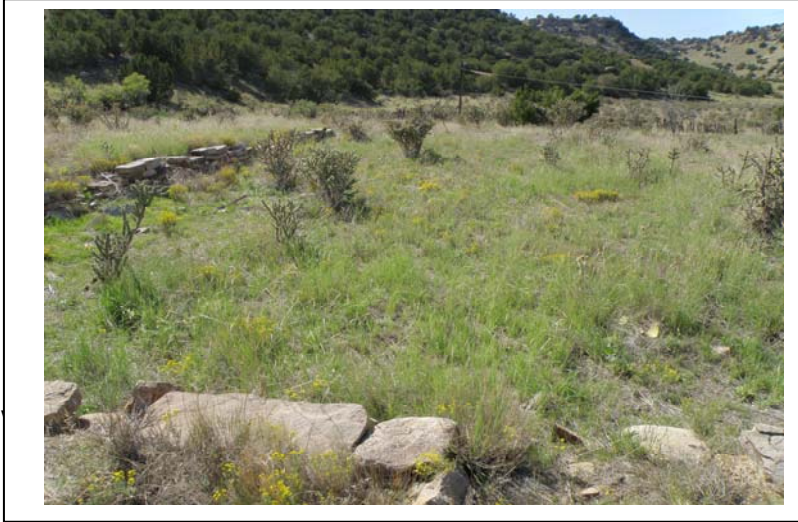
Figure 15: *Images of Survey Site LA158*

IMAGE B: Dugout Remains with *Vigas*

IMAGE C: Corral System

IMAGE D: Foundation of Possible Church

The main dwelling, Feature 1A, has a rectangular plan, with all four stone walls standing, although largely in ruins, oriented north to south, with the entrance facing north (Figure 15, Image A). The dwelling plan measures approximately 53 feet by 16 ½ feet. The foundation and walls are of double-laid sandstone with adobe mortar, with some concrete patching at the south corner. Multiple entries, separated by windows, are located on the north wall, although no interior divisions are evident; the south wall likely included windows, although the south walls ruins make this hard to determine. A fireplace, also constructed of sandstone, is located at the corner of the south and west walls. Hewn log *vigas* stretch across the north and south walls, exposing the roof structure skeleton, as the smaller timbers and earth-based roof covering are no longer evident. A rectangular foundation of an

The site also includes a large central rectangular foundation, Feature 5, identified by a historical archaeologist as possible remains of a church (Figure 15,

Image D). Regional churches would often be located within plazas, with traveling priests visiting the place of worship once every season. The remaining stone walls measure 54 ½ feet by 27 feet and are of sandstone. The large size of the foundation leads one to believe it could have been the site of a church; such large structures, unless remains of corral systems, are fairly uncommon in a region dependent on the labor of settlers and nearby construction materials. A community church would often be located in the center of the plaza, where this particular foundation is situated. Features of historical archaeology surround the site. Evidence of ornate broken glass, rather than kitchen supplies like crockery or earthenware, may reveal the use of the former structure as a religious space rather than domestic. However, with only a stone foundation remaining, no definite determination regarding the architecture and use of the former structure can be provided.

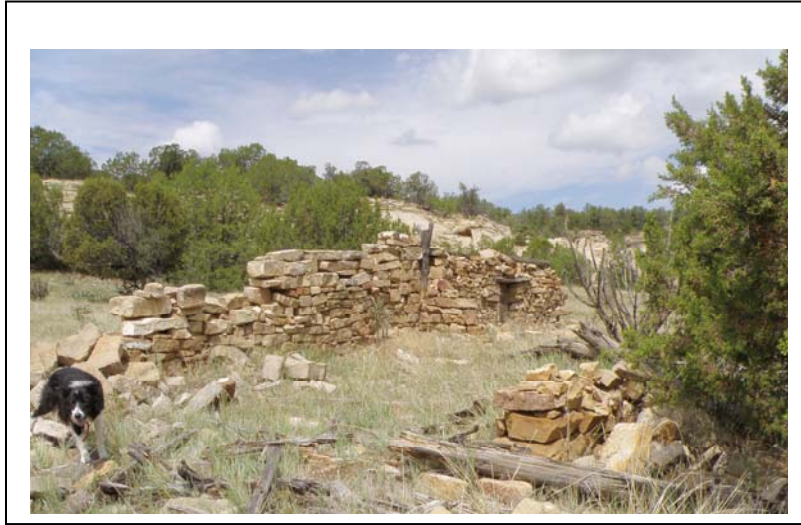
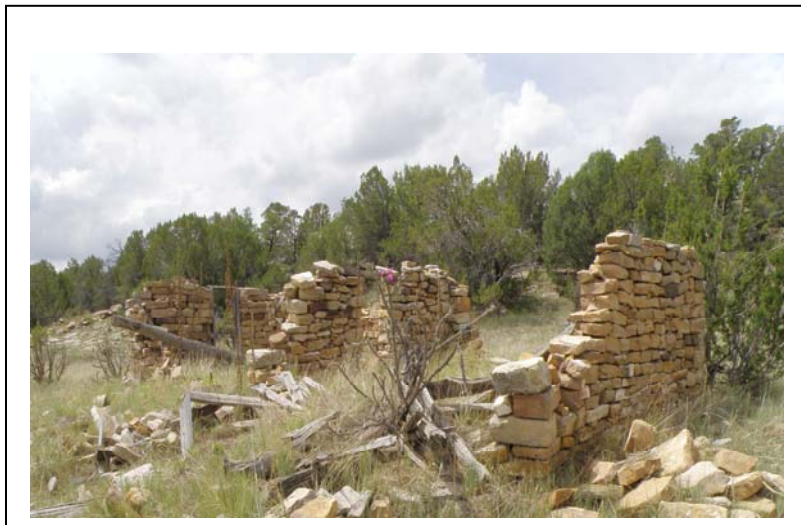
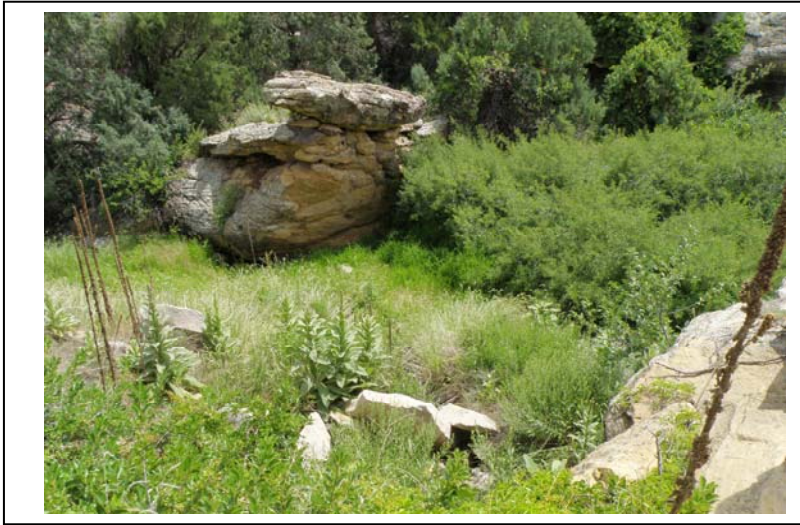
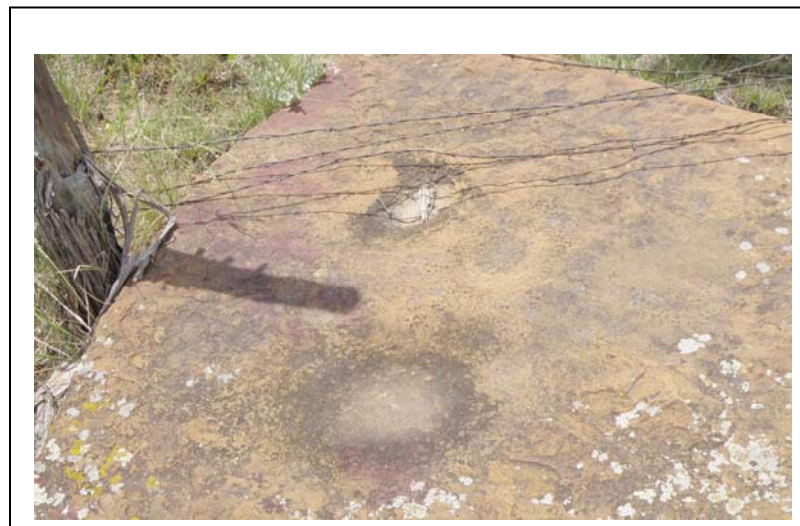
Figure 17: *Images of Survey Site LA040*

IMAGE A: Stone Dwelling with Central Fireplace

IMAGE B: Stone Dwelling with Interior Walls

IMAGE C: Stone Pens

IMAGE D: Milling Slick

along the southern edge of the plan, contrasting the central dwellings of plaza system of decades prior. The larger of the two stone dwellings, Feature 2, has a rectangular plan with a stone fireplace and wood lintel, constructed of milled lumber (Figure 17, Image A); the remaining stone foundation shows a division of two rooms, although the interior walls are no longer standing. The second stone dwelling, Feature B, includes interior and exterior walls, all of rough dry-laid sandstone, and has remains of windows, all framed with milled lumber and wire nails (Figure 17, Image B). *Vigas*, hewn logs, stretch the north and south walls of the second dwelling, a reminder of the New Mexican flat roof construction shown in the previous case studies as well. These stone dwellings are similar to those of the previous case studies, constructed of rough sandstone and, now eroded, adobe mortar. The milled lumber, wire nails and central fireplace of the dwellings, as well as the standing interior room divisions, however, suggest a later homestead.

The site includes other stone foundations, largely rectangular, and considered to be the remains of outbuildings of a farming operation. Small pens are located on the peripheries of the site and blend with the natural landscape, incorporating outcropping and slopes to create burro and goat pens (Figure 17, Image C). The stone corrals, Feature 12, are typical of earlier New Mexican construction, as wire was previously unavailable. Milling slicks (Feature 14), rock faces used to grind grain with stones, are evident on rocks surrounding the site (Figure 17, Image D), adding to the understanding of this homestead as related to

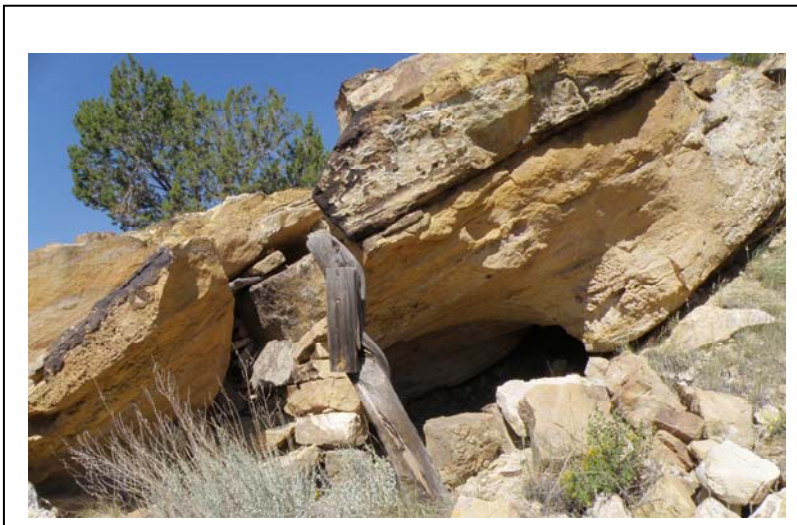
IMAGE D: Chicken Coop in Outcropping

natural stone outcroppings, the two chicken coops are placed within natural stone outcroppings, with sandstone and adobe mortar infill and a small frame door (Figure 19, Images C & D). Incorporating the natural landscape into outbuildings saved time on construction and lessened the need for construction materials. Stone walls divide the chicken coops from the spring below, and remains of wood posts for corrals lie on the east boundary of the site. Stone terracing is evident to the south of the front entry. As shown, many elements on site LA152 reveal the molding of the natural terrain and slope to form a landscape suitable for a homestead and farming operations.

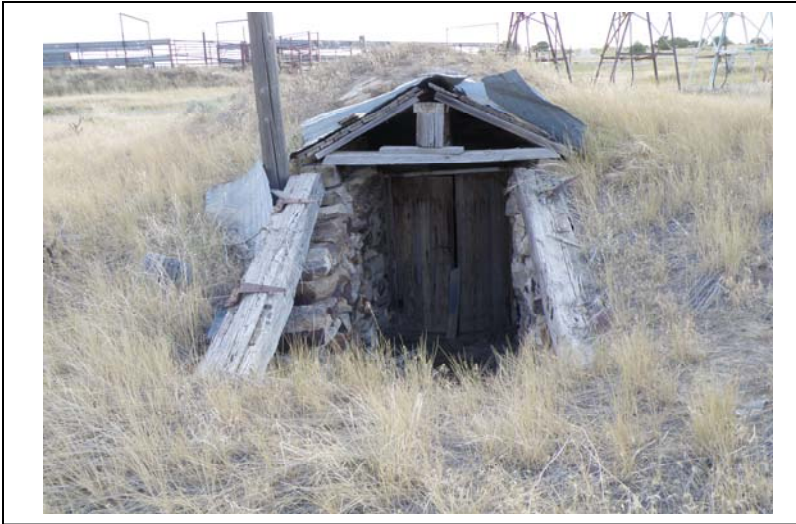
IMAGE A: Dugout Construction

As wood was scarce and fuel required to fire bricks was rarely distributed, regional stone or sod became primary building materials.⁸⁶ In southeastern Colorado, dirt and sod were commonly used in the construction of dugouts, buildings sunken a few feet below earth with packed dirt walls and dirt floors (Figure 15, Image A). Dugouts were usually rectangular in plan, with roofs supported by log beams and covered with smaller timbers. More elaborate dugouts would be lined with sandstone or include superstructures of stone or log.

Dugout: A type of dwelling sunken into the earth, usually a few feet deep, with earth walls and a dirt floor. Interior walls were dampened with water and packed hard to help prevent the dirt from flaking. More elaborate dugouts were lined with stone walls and might have superstructures of stone or log. Roofs were often also earthen, with log beams supporting packed dirt and smaller branches. Dugouts were usually the first structures constructed by homesteaders venturing to the region of southeast Colorado; after a year or two, more substantial dwellings would be constructed, either in addition or separate from the original dugout.

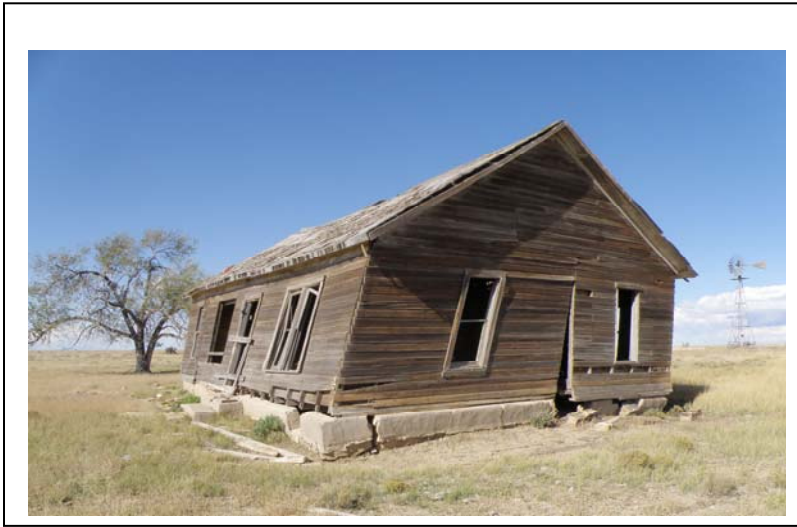
IMAGE C: Massed-Plan Side-Gabled Anglo-American Dwelling

The late nineteenth century also brought the railroad, furthering the availability of manufactured materials for homesteads. Anglo-American houses began to follow a national model, incorporating light framing techniques into regional architecture. The smaller rectangular plan was extended to double-pen, square one-story hipped roof dwellings, and even two-story square plans, as homesteaders knowledgeable of National building styles and able to purchase framing materials through railroad supply (Figure 15, Image C).⁹⁰ Milled lumber was commonly used in roof construction, thereby replacing the earth and sod

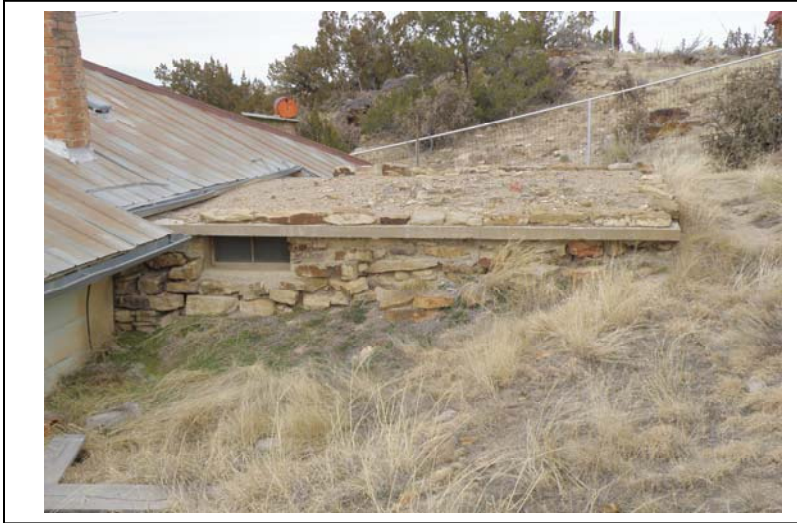
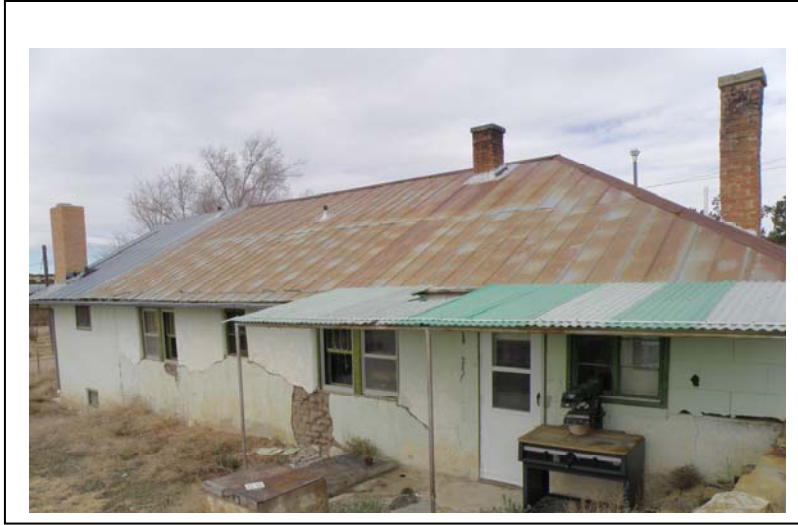
Figure 22: *Images of Survey Site OT073*

IMAGE A: Original Dugout Dwelling

IMAGE C: Main Dwelling

Shown through Mollett's homestead is the evolution of the homestead site; as settlers needed immediate housing, simple dugouts were often the first option, with larger dwellings constructed later. The linear site and numerous additions shows the development and continuation of the homestead site through the years of occupation. Furthermore, site OT073 also reflects the methods of adaptive reuse, thereby creating homes and outbuildings with found objects and materials. The linear site plan and architecture, including gabled roofs, frame windows and doors, an outhouse, and the use of railroad ties in construction, combined with the census information, seem to confirm the Mollett site as an example of early twentieth century Anglo-American homestead design.

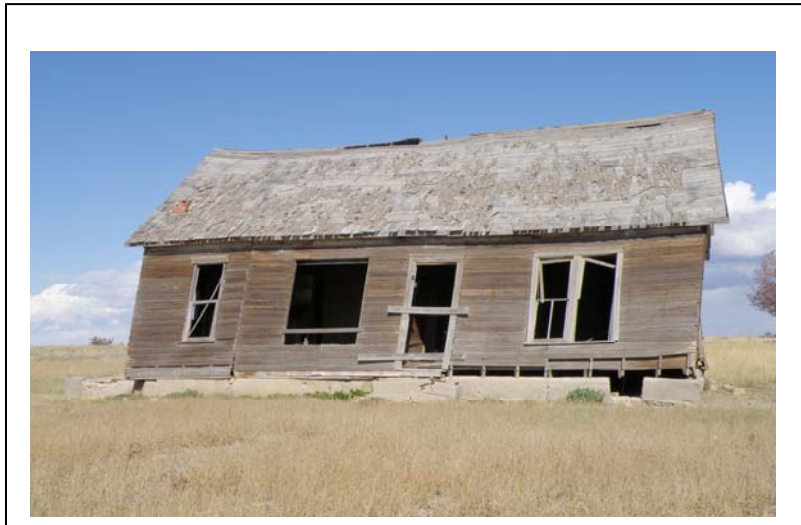
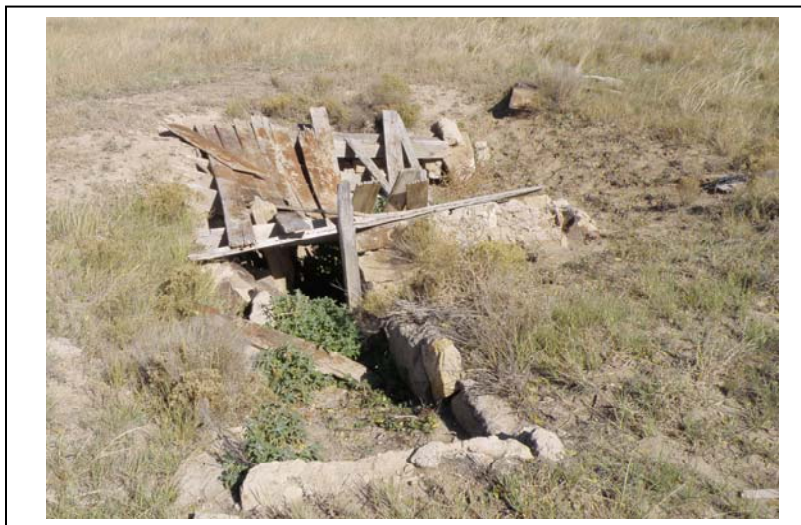
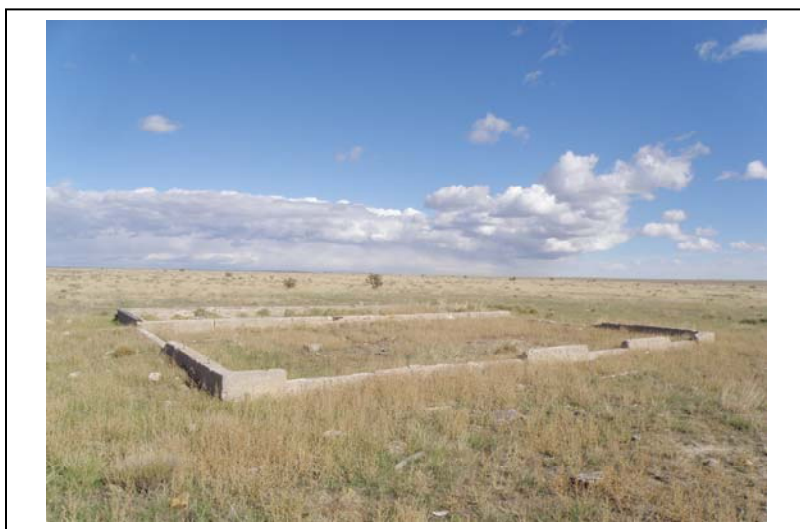
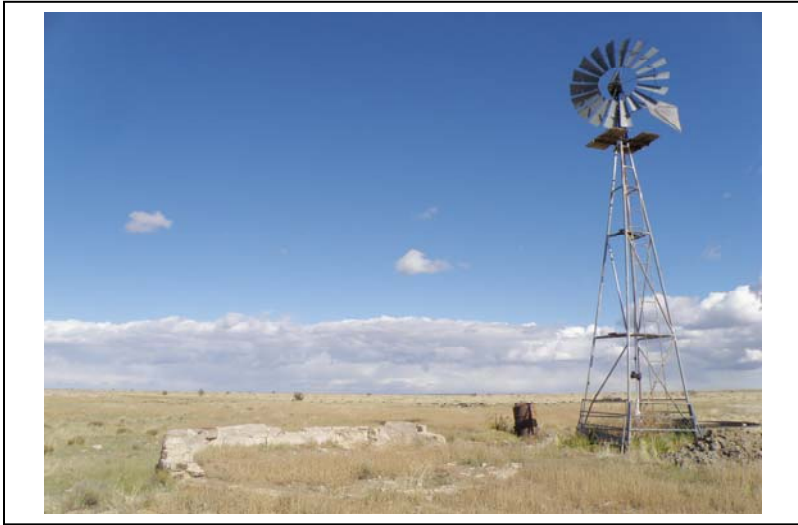
Figure 24: *Images of Survey Site LA250*

IMAGE A: Frame Dwelling

IMAGE B: Cellar

IMAGE C: Concrete Foundation of Possible Barn

IMAGE D: Windmill and Stock Tank

outbuildings more familiar to the Midwestern regions of the United States. Indeed, site LA250 differs from the more typical regional architecture of stone and adobe previously identified; rather, this case study reveals the entry of Anglo-American settlement into the region. An entirely frame house, concrete barn foundation, metal windmill and stock tank, and boom-town location along the high plains are features representative of Anglo-American homesteaders in southeastern Colorado.

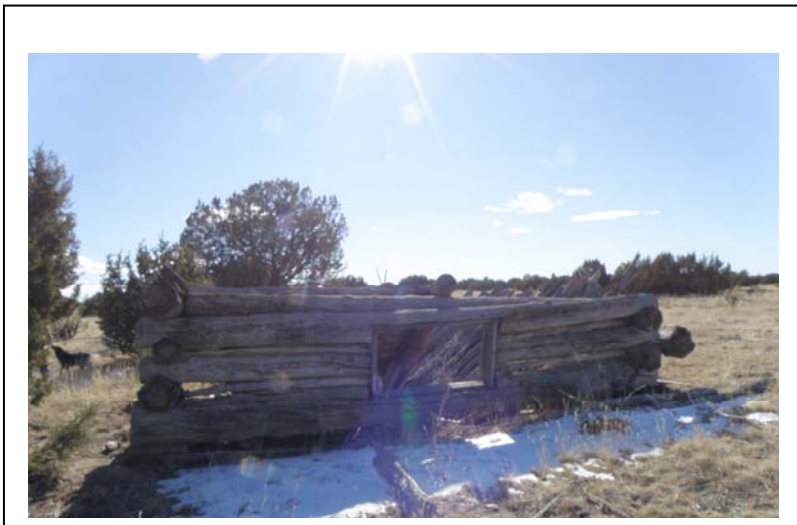
IMAGE A: Dugout with Log Superstructure

The Dorsey Homestead reflects the Anglo-American settlement patterns and construction methods, with the remains of a log superstructure combined dugout dwelling and small homestead site, including animal pens and fencing with barbed wire. According to the United States Census of 1920, Converse J. Dorsey was born about 1884 in Missouri; in 1920, he was the head of the household, married, had a son and daughter, spoke English and was white. This site was patented in 1924, amidst the homestead boom of the 1920's. The architecture reflects Anglo-American, rather than New Mexican, construction techniques; prior

to the homestead movement, few dwellings were constructed of log, as such architectural design was largely confined to the neighboring plains and Midwestern states. However, settlers such as Dorsey brought with them the Anglo-American, plains region, culture of design. The use of a dugout dwelling reflects the requirement for immediate housing, the lack of construction materials, and the need for a dwelling before the harsh winter set in. The combination of a log superstructure and dugout is a vernacular architectural design tied to the social history of the Homestead Era in southeastern Colorado and the entry of Anglo-Americans to a region previously settled by New Mexicans.

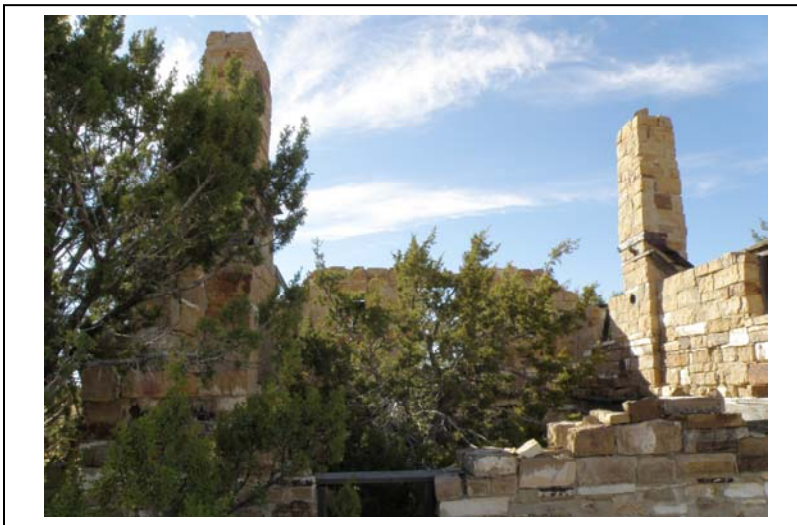
IMAGE A: Stone Dwelling

Unlike the regionally common dugouts or simple small houses (typically one story with one rectangular room) the main dwelling of the McDaniel Homestead is two-story, constructed of finished, regular laid sandstone, the work of an experienced mason (Figure 28, Image A). The four remaining stone walls are sloped at the corners, evidence of a former gable roof. Concrete with large aggregate forms the building foundation. The dwelling is oriented east to west, with two main entrances on the east wall. The first floor is sunken of dirt, with no remains of flooring. The south wall includes a double fireplace on each story, with built in wood shelving to the west of the fireplaces. (Figure 28, Image B). A wood mantel is over the first story fireplace. The north wall also includes a chimney, once connected to a stove on the first floor. The frame windows on all walls are sunken into the wall 16 inches. A large wood beam tops the interior walls, forming lintels over the interior doors and windows. A wood plank lintel is on the second

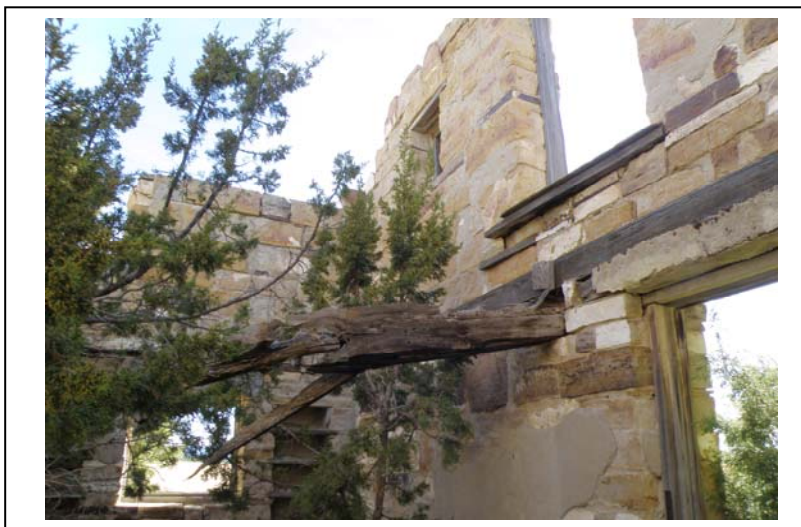
Figure 28: *Images of Survey Site LA201 [continued from previous page]*

IMAGE C: Second Story Floor Beams

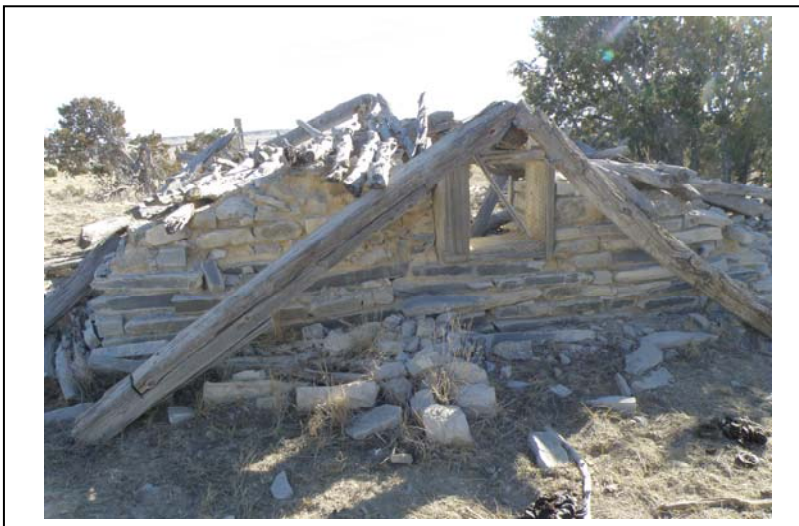
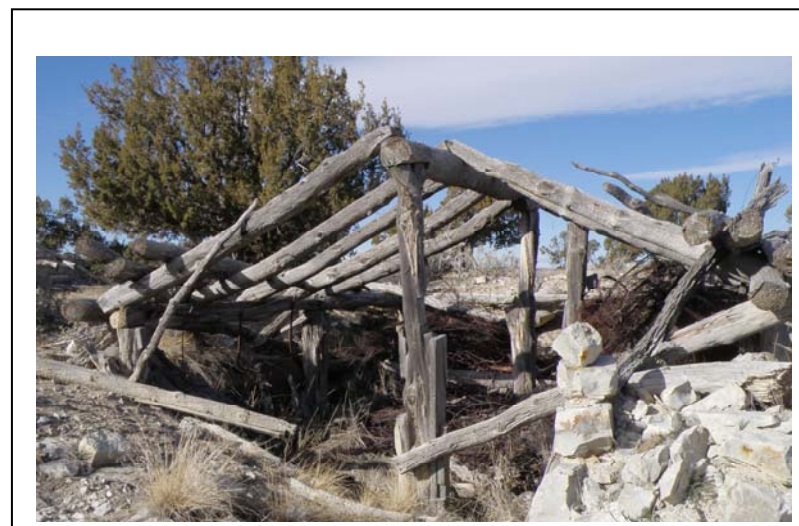
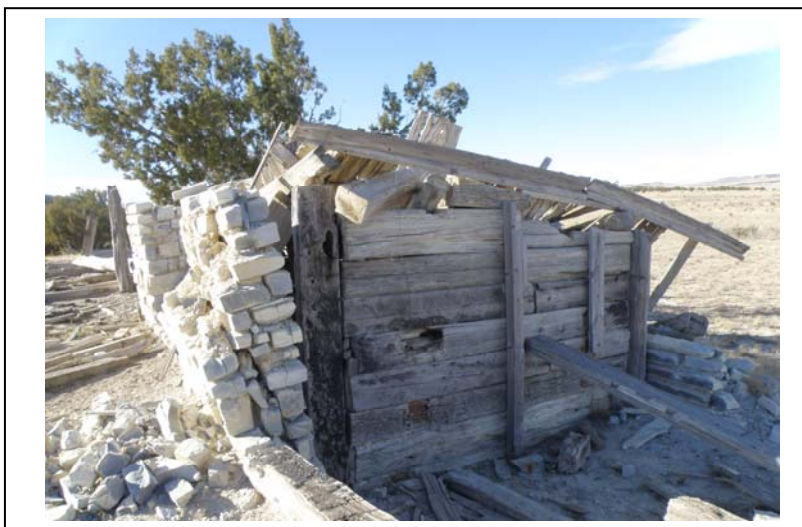
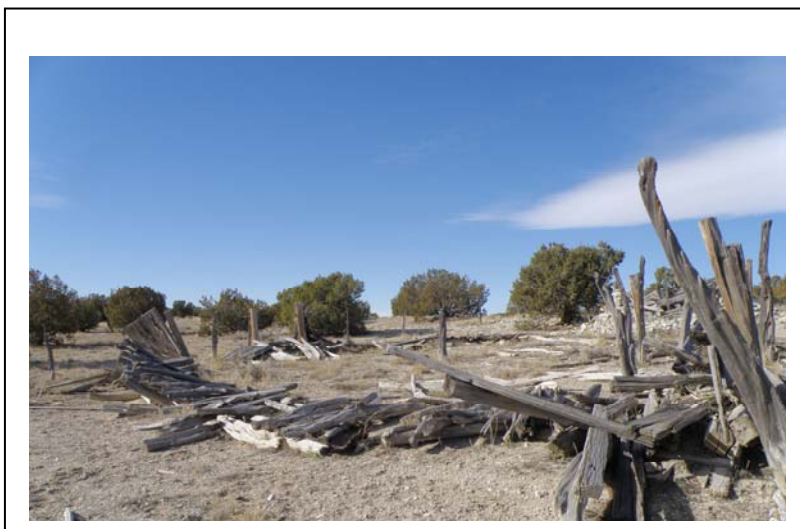
Figure 30: *Images of Survey Site LA360*

IMAGE A: Main Dugout Dwelling

IMAGE B: Dugout, east of Main Dwelling

IMAGE C: Small Shed

IMAGE D: Corral Area, East of Main Dugout Dwelling

interesting architecture, incorporating both the natural environment, with limestone as a primary construction material, and the adaptive reuse of railroad ties for structural support.

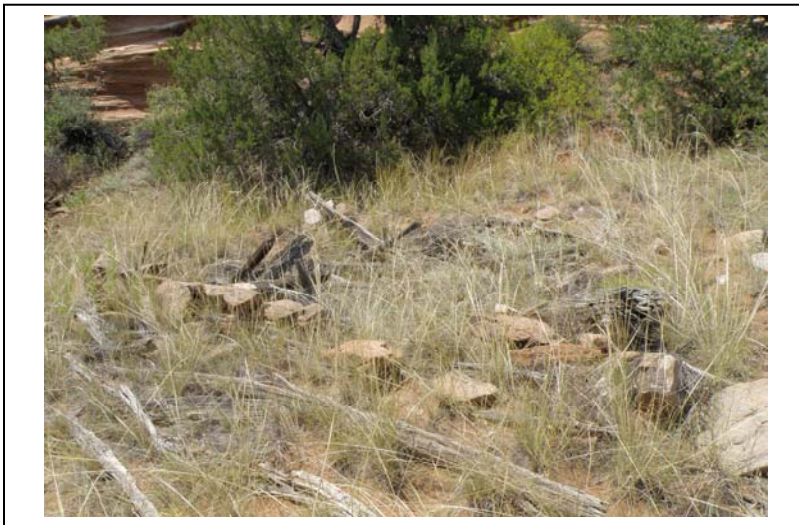
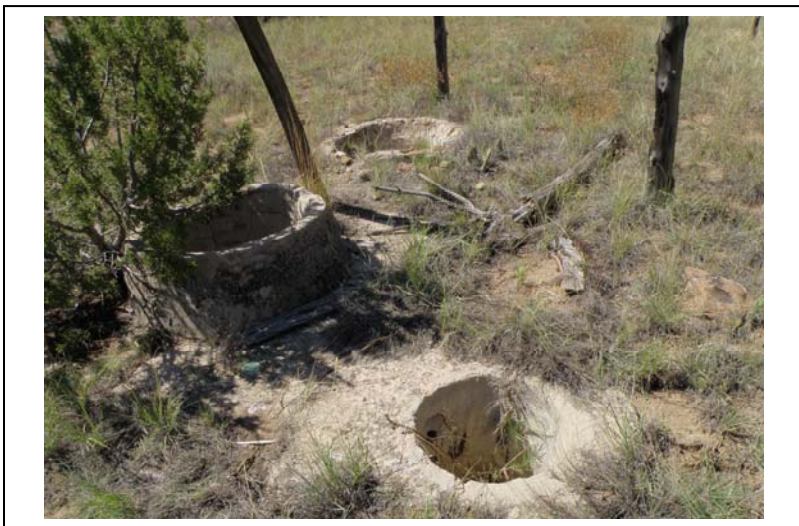
Figure 32: *Images of Survey Site LA175 [continued from previous page]*

IMAGE C: Stone-Lined Dugout

IMAGE D: Concrete Cisterns and Filter

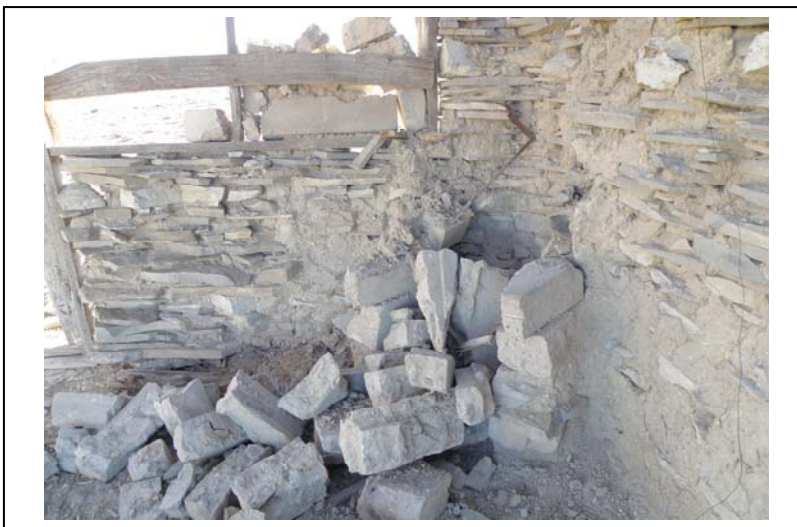
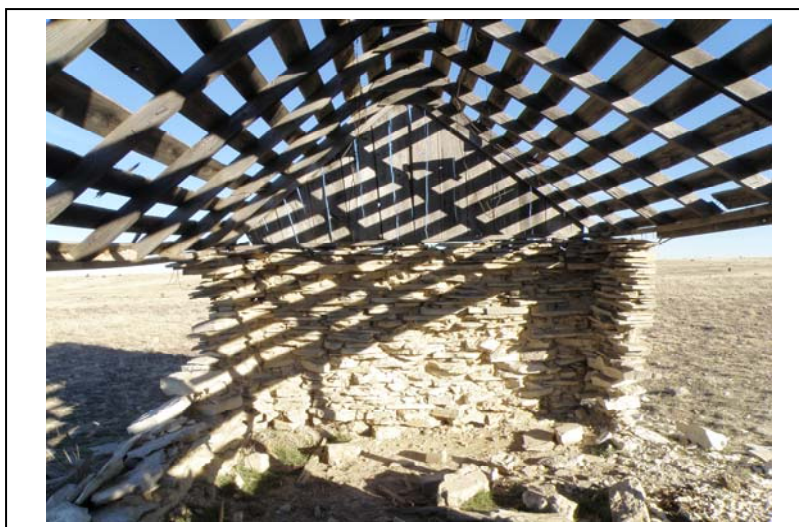
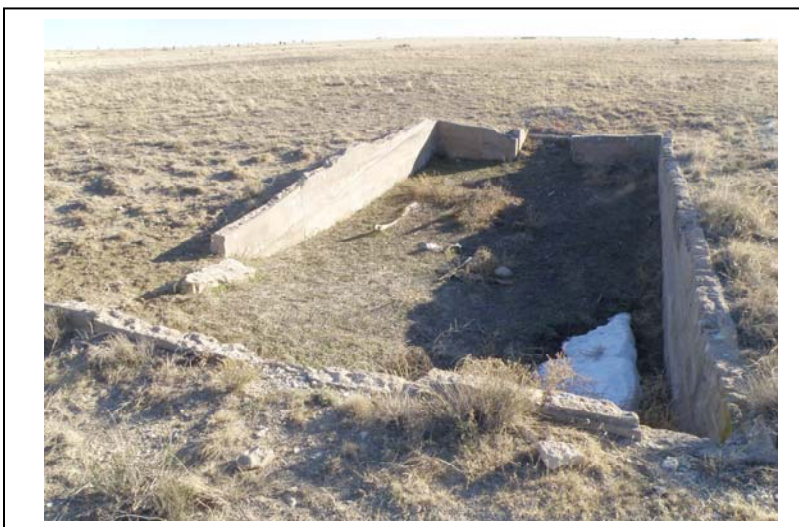
Figure 34: *Images of Survey Site OT057 [continued from previous page]*

IMAGE B: Corner Fireplace of Main Dwelling

IMAGE C: Frame Roof on Main Dwelling

IMAGE D: Concrete-Lined Dugout

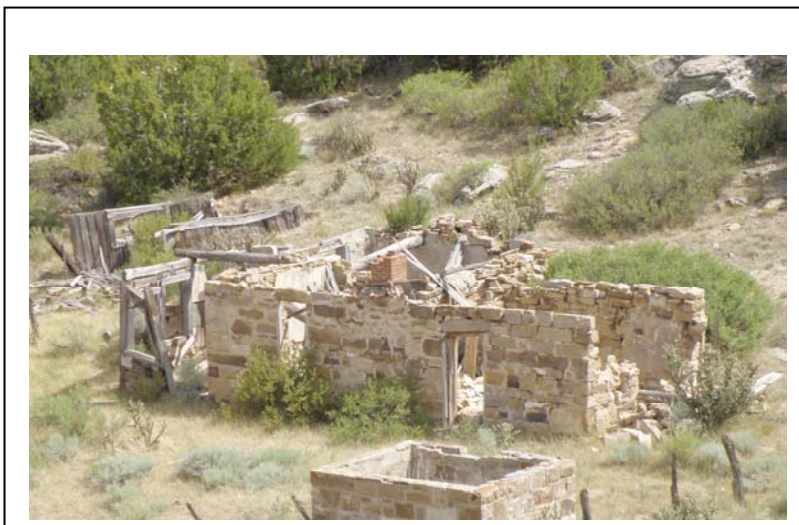
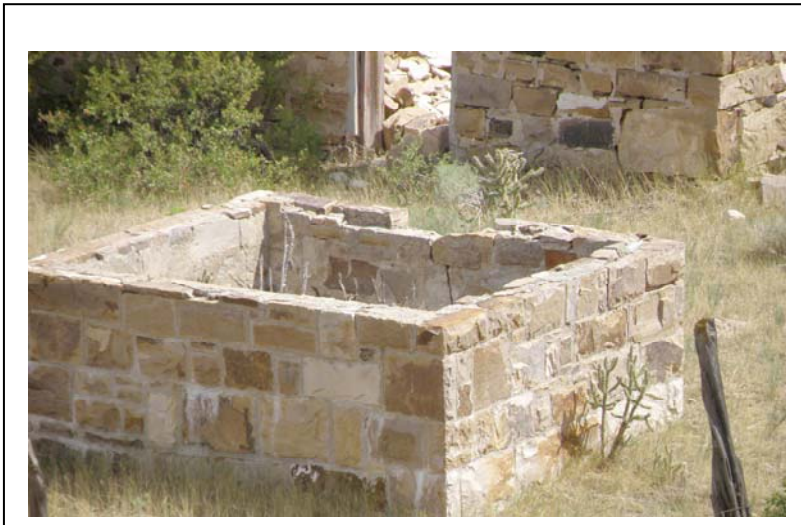
Figure 37: *Images of Survey Site LA054*

IMAGE A: Main Dwelling

IMAGE B: Fireplace of Main Dwelling

IMAGE C: Shed

IMAGE D: Cistern

Mexican design and construction techniques the dwelling and surrounding features display.

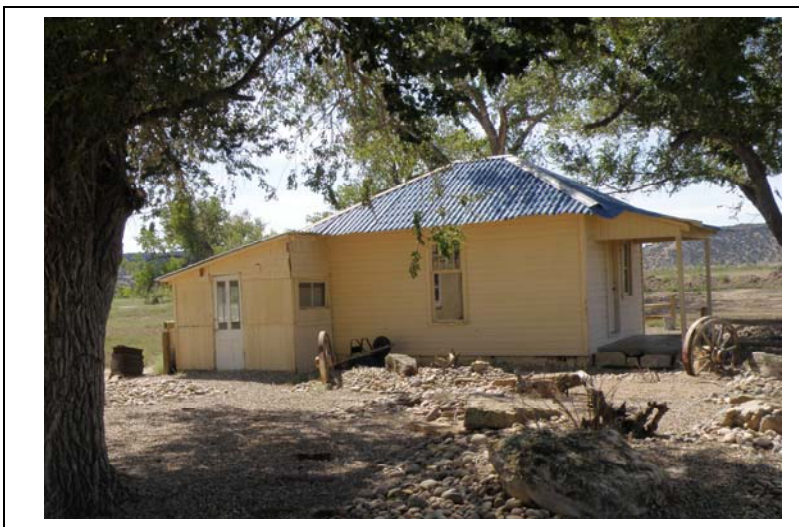
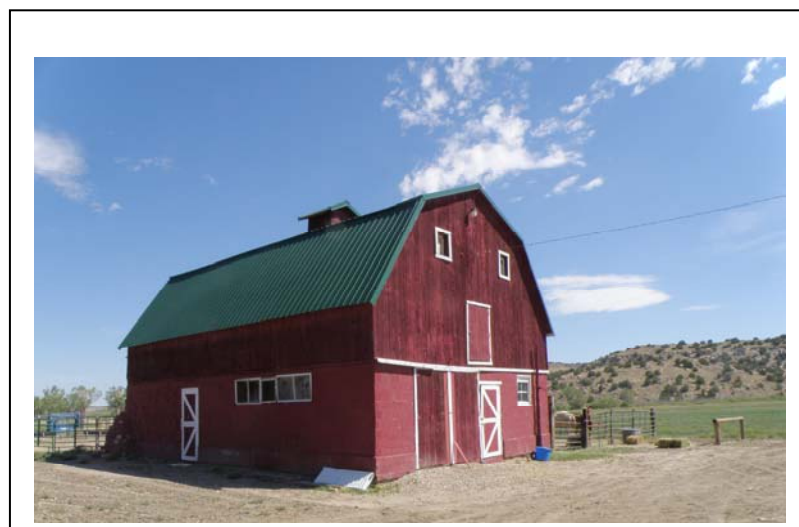
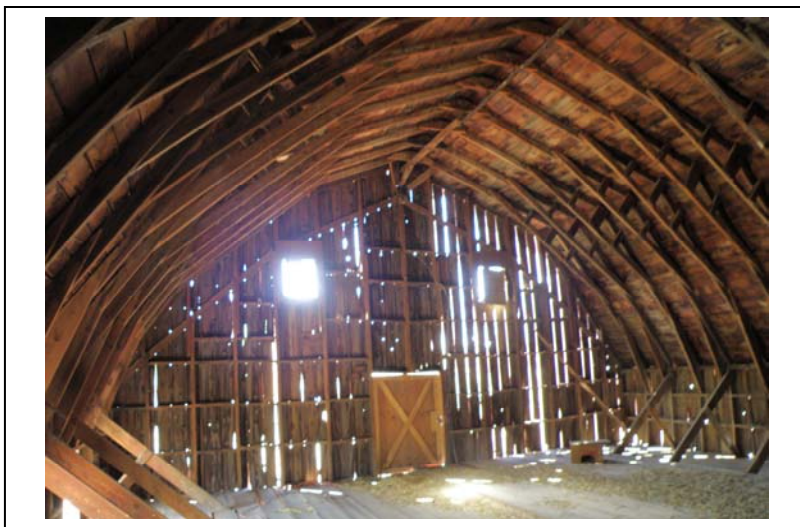
Figure 39: *Images of Survey Site OT016 [continued from previous page]*

IMAGE C: Bunkhouse

IMAGE D: Barn

IMAGE E: Roof Truss System

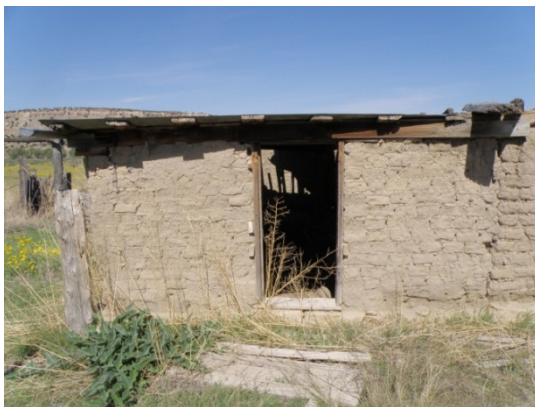
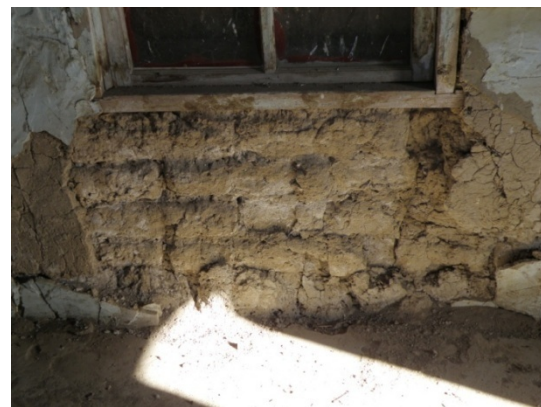
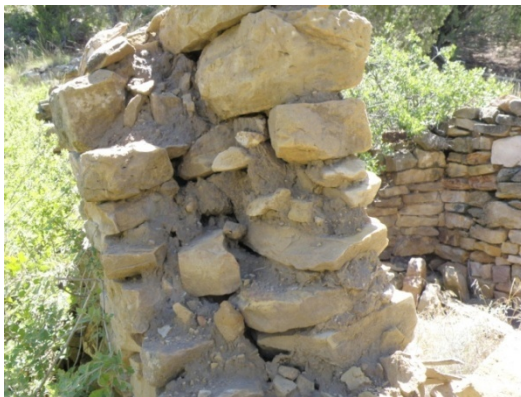
Adobe: A primary construction material in southeastern Colorado, adobe consists of clay, sand and water, often with other natural material (often straw or twigs) mixed in to serve as a key. Either used as mortar for stone buildings, applied as stucco, or shaped into blocks and dried under the sun, adobe is one of the most prominent construction material types throughout the region. The availability, durability and warmth of adobe structures made adobe a likely choice for settlers. If poorly maintained or neglected, adobe will melt and deteriorate, leaving many entirely adobe dwellings as only mounds of dirt.

Adobe Bricks

Adobe Mortar
