THE CULTURE OF ARCHITECTURE IN THE SANTA FE TRAIL REGION OF
SOUTHEASTERN COLORADO

A Thesis Submitted to the Graduate Faculty of The University of Georgia in
Partial Fulfillment of the Requirements for the Degree

MASTER'S OF HISTORIC PRESERVATION

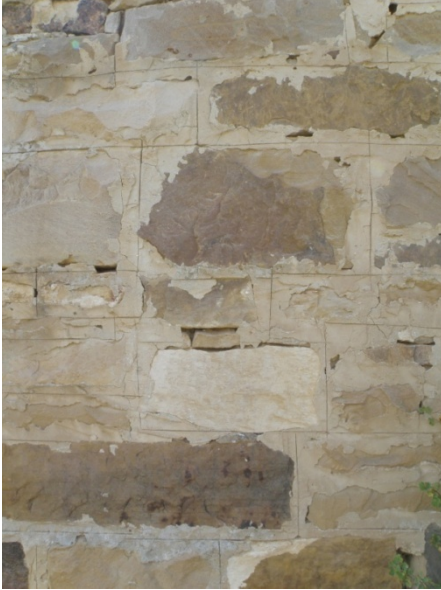
Concrete: A construction material comprised of cement and aggregate, concrete gained popularity in the twentieth century, substituting for southeastern Colorado's traditional use of sandstone and adobe as primary building materials. As the availability of cement increased with new railroad and town infrastructure throughout the region, settlers found concrete to be a welcomed alternative to the slower drying adobe. The homesteaders of early twentieth century combined sandstone construction with concrete mortar and concrete foundations for durability and longevity; the appeal of concrete led some settlers to build entire structures from the material, including cisterns, outbuildings and even houses.

Scored concrete mortar

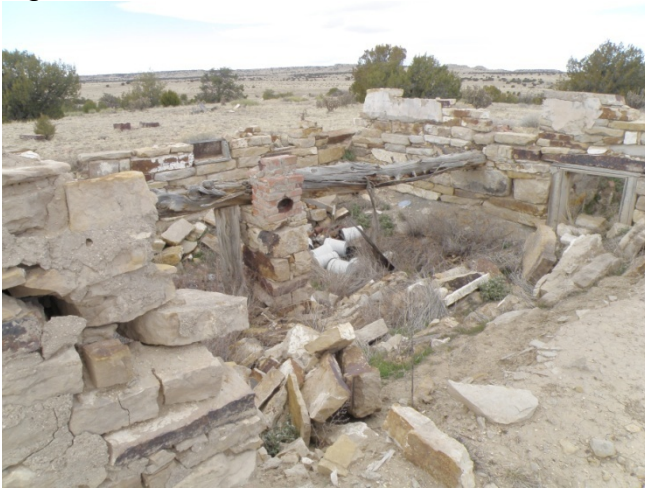
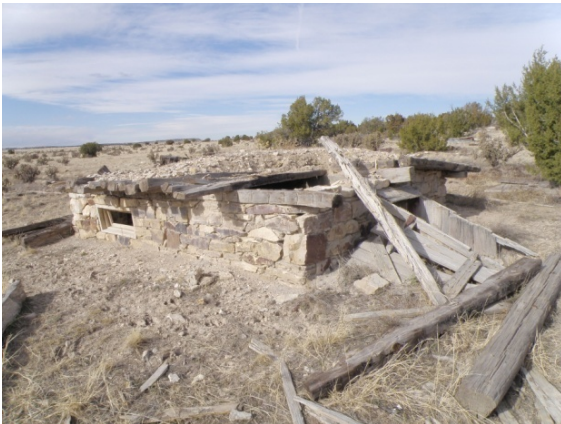
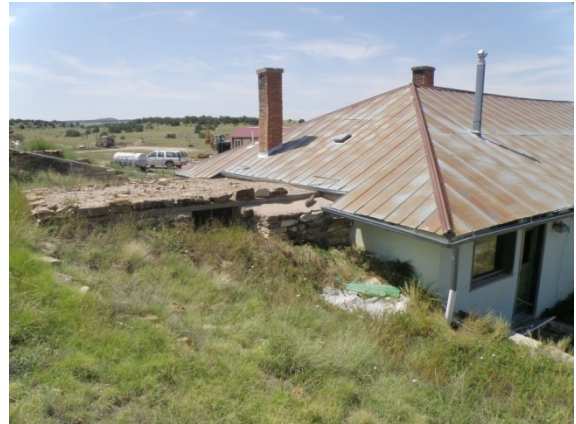
Dugout: A type of dwelling sunken into the earth, usually a few feet deep, with earth walls and a dirt floor. Interior walls were dampened with water and packed hard to help prevent the dirt from flaking. More elaborate dugouts were lined with stone walls and might have superstructures of stone or log. Roofs were often also earthen, with log beams supporting packed dirt and smaller branches. Dugouts were usually the first structures constructed by homesteaders venturing to the region of southeast Colorado; after a year or two, more substantial dwellings would be constructed, either in addition or separate from the original dugout.

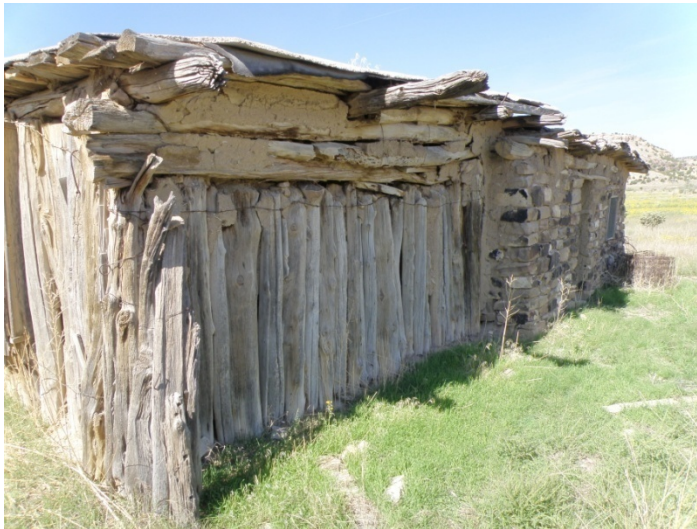
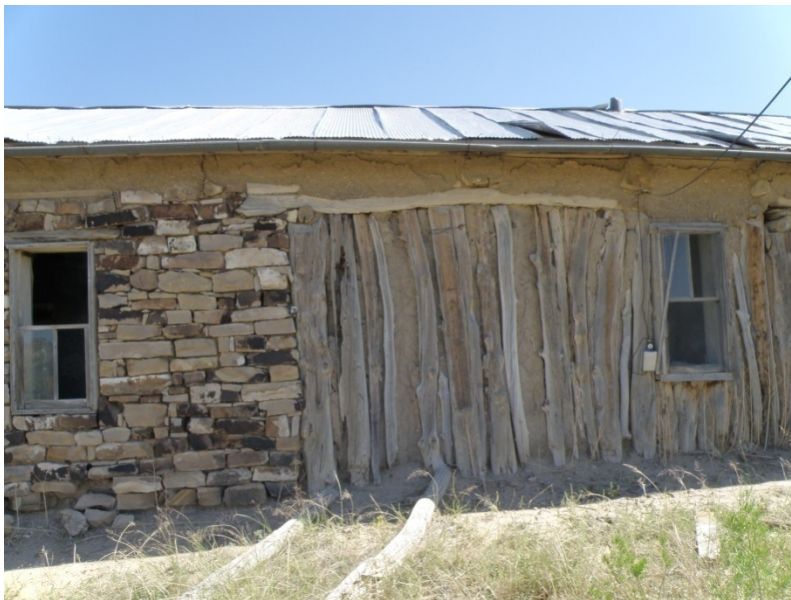
Jacal: A Native American form of architecture adopted by New Mexicans and Anglo-Americans in southern Colorado, consisting of a wall of closely spaced wood posts tied together with adobe with adobe filling any spaces. Slender posts (often piñon) were placed into the earth and tied with wire are common of the jacal construction among the homesteads of southeastern Colorado. Simple to construct, jacals were often the first structures built on a homestead. Jacals are found in combination with stone and adobe architecture, either as the original structure or as an easy addition.

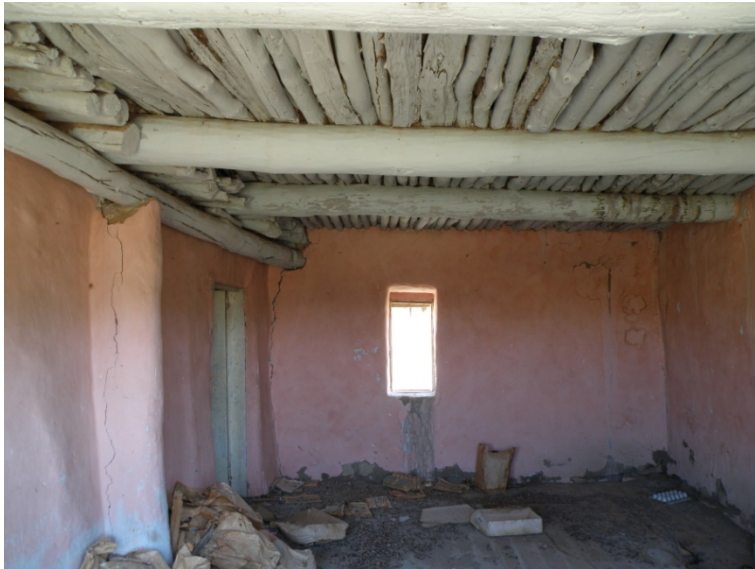
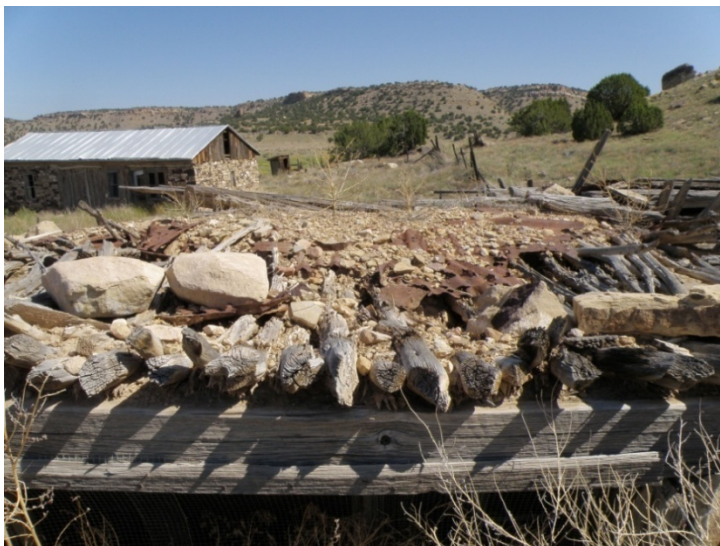
Vigas and Latillas: The New Mexican style of architecture included a flat roof composed of vigas and latillas; large, equally spaced, vertical logs (vigas) were covered by smaller horizontal timbers (latillas). The vigas, typically hand-hewn ponderosa or cottonwood, usually extend beyond the structural walls. The horizontally laid latillas form the surface of the roof and were commonly covered with mud and stone. The relatively simple construction, as compared to gable roof types, made this New Mexican roof type a common feature among southeastern Colorado architecture.

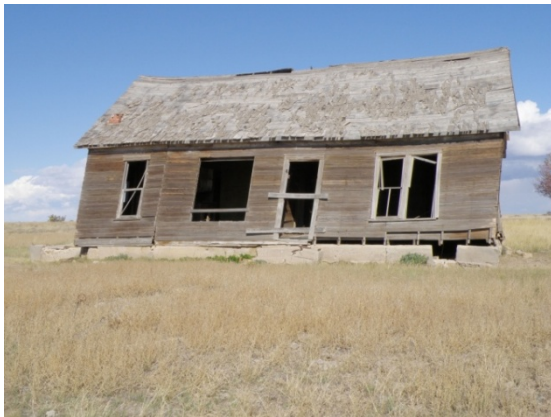
Wood: A construction material incorporated in much of the architecture across southeastern Colorado, wood served many uses, when available. Common throughout the region were hand-hewn timbers and logs. Large timbers, usually ponderosa or cottonwood, could only be found within canyons, and these large members were frequently constructed as roof beams. However, the scarcity of large timbers made entire log buildings rare to this region, and when large timbers were unavailable, settlers also adaptively reused railroad ties, even constructing entire homes and outbuildings with railroad ties. Smaller timbers, often piñon, were used for corrals and fencing, jacal-designs, and horizontal roof surfaces (latillas). With the railroads, milled lumber was easier to obtain. Milled lumber became widely used for door and window frames, flooring and roof construction. As milled lumber increased in availability and popularity, frame houses also offered appeal to homesteaders; although lacking the warmth and resiliency of native masonry, frame houses could serve as a status symbol, comparable to the modern houses of the eastern United States.

Frame House

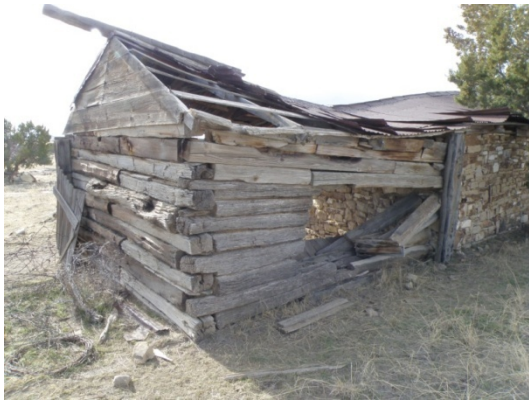
Railroad ties

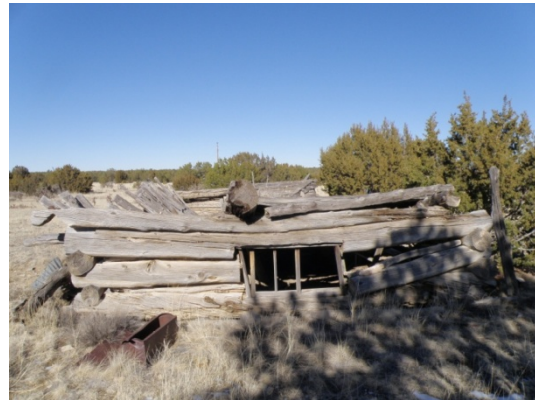
Hand-hewn red cedar logs
