AN INVESTIGATION OF DISTRESSES FOUND IN CONCRETE AND ASPHALT  
PAVEMENTS FOR GEORGIA FORENSIC GUIDE RECOMMENDATION

CATHERINE ELIZABETH JOHNSON

A Thesis Submitted to the Graduate Faculty of The University of Georgia in Partial Fulfillment  
of the Requirements for the Degree

2016

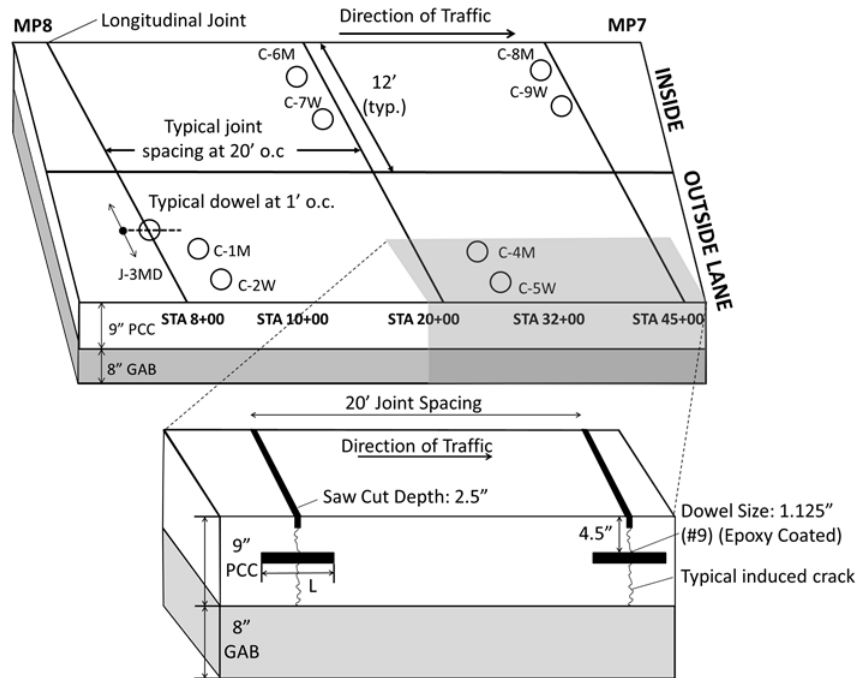
Figure 6.7 - 3D View of Coring Locations and JPCP details for SR 22 (good condition).

Typical cores and crack depths at joint locations, as well as photos of cores retrieved from joint locations are shown in Figure 6.6. Figures 6.7 and 6.8 illustrate coring locations for the two

JPCP sections. Pavement cores were extracted in order to confirm the existing pavement thickness, dowel size, joint design, and crack depth. Based on the recommendations in the NCHRP 747 report, the cores were taken on the centerline of the slab, wheel paths on outside and inside lanes, and cracks to document the crack depth. Further, the non-destructive test data and visual inspection were reviewed to determine the coring locations for both sites as shown in Figures 6.7 and 6.8. For I-75, a 4-inch core drill was used for laboratory tests, although a 6-inch core bit was utilized to observe dowel locations. For SR-22, a 4-inch core drill was used for all extractions. Photos of all cores extracted are shown in Figure 6.9. As shown in Figure 6.9, cores show consistent compaction and few voids.

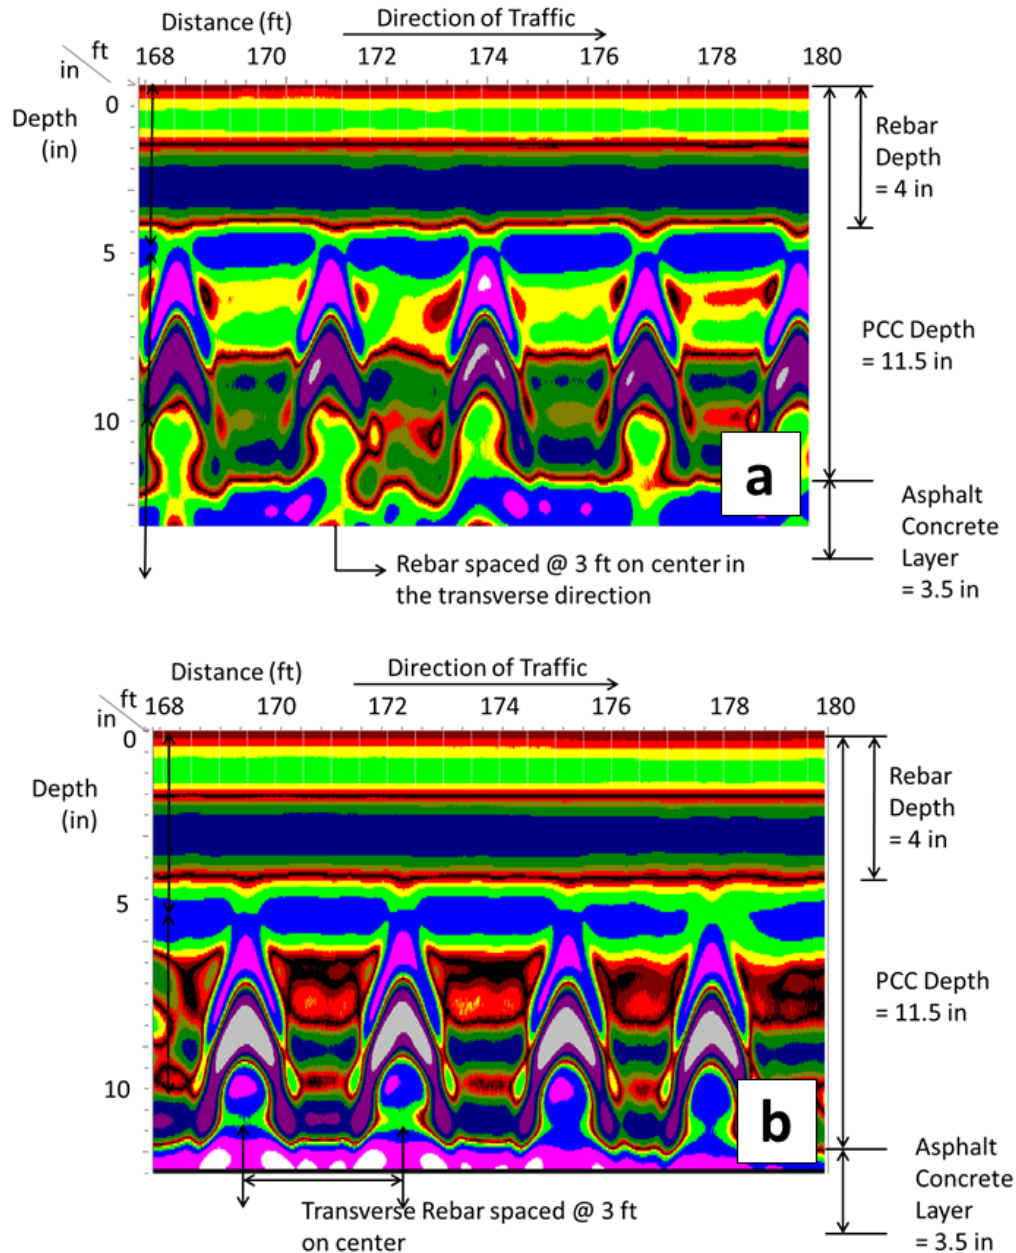
Figure 7.4 - GPR scans in the direction of traffic:  
 (a) I-85 MP 55-54 - Inside Lane; (b) I-85 MP 45-44 - Inside Lane;

Non-destructive testing was carried out by using a Falling Weight Deflectometer (FWD) and Ground Penetration Radar (GPR). More information on these technologies is included in Section 3.3 - Review of Pavement Forensic Technologies – Non-destructive. A summary of information acquired from NDT testing is shown in Table 7.2. The GPR data showed consistently level pavement layers. In addition, transverse rebar spacing was identified as 3 feet on center, as shown in Figure 7.4. When the GPR machine scans metal rebar, the resulting image is slightly distorted. This results in arrow-like shapes seen below the rebar in Figure 7.4.

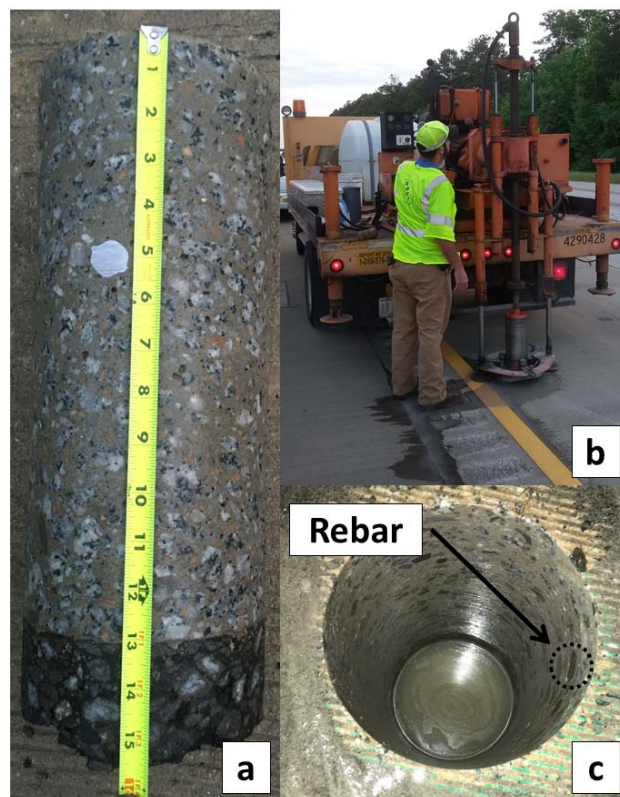
Figure 7.6 - Typical Cores at Rebar Locations  
(a) Core sample; (b) Coring machine; (c) Inside view of a cored pavement.

The coring process, including the machine used to drill cores, is shown in Figure 7.6. For both sites on I-85, a 4-inch core drill was used for laboratory tests and a 6-inch core bit was utilized to observe existing pavement thickness, and reinforcement size & location. Based on the recommendations in the NCHRP 747 report, the cores were taken at the centerline of the slab, wheel paths on the inside and outside lanes, and cracks to document the crack depth (Rada, 2013). Additionally, the coring locations for both sites were reviewed from the non-destructive test data and visual inspection information. The locations of cored specimens are shown in Figures 7.7 and 7.8 which provide a 3D schematic of the pavement section.

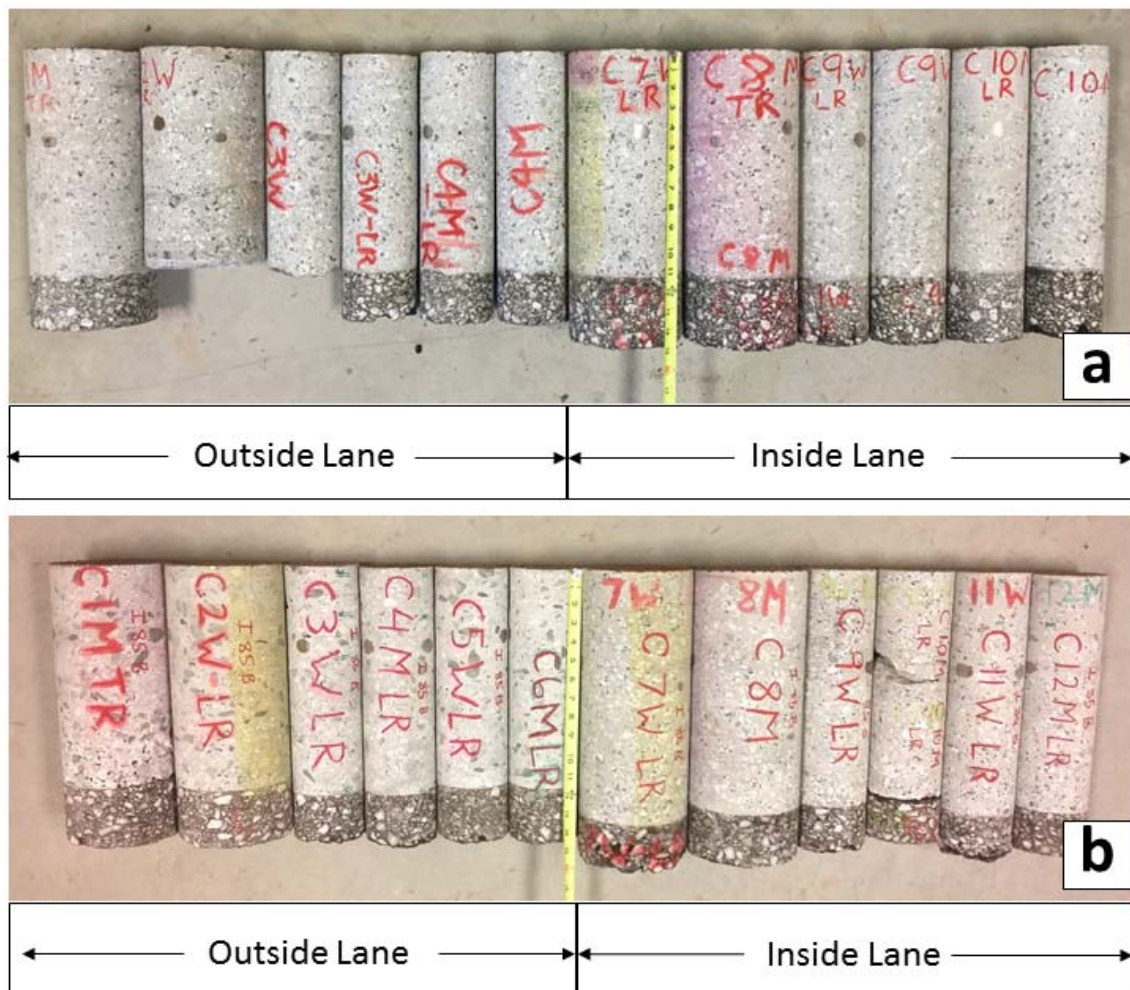
Figure 7.9 - All cores extracted  
(a) Fair CRC (I-85 MP 55-54) (b) Poor CRC (I-85 MP 45-44)

Photos of all cores extracted are shown in Figure 7.9. As seen in the figure, the reinforcement depth varied by  $\pm 0.5$  inches. MP 45 showed relatively consistent compaction with few voids. MP 55 had compaction problems in the outside lane, more specifically, sample C1MTR (Figure 7.9(b) far left). A visible difference was seen when comparing the concrete from the

outside and inside lanes from MP 55. More details on these two material differences are provided in section 7.6 - Petrographic Examination.

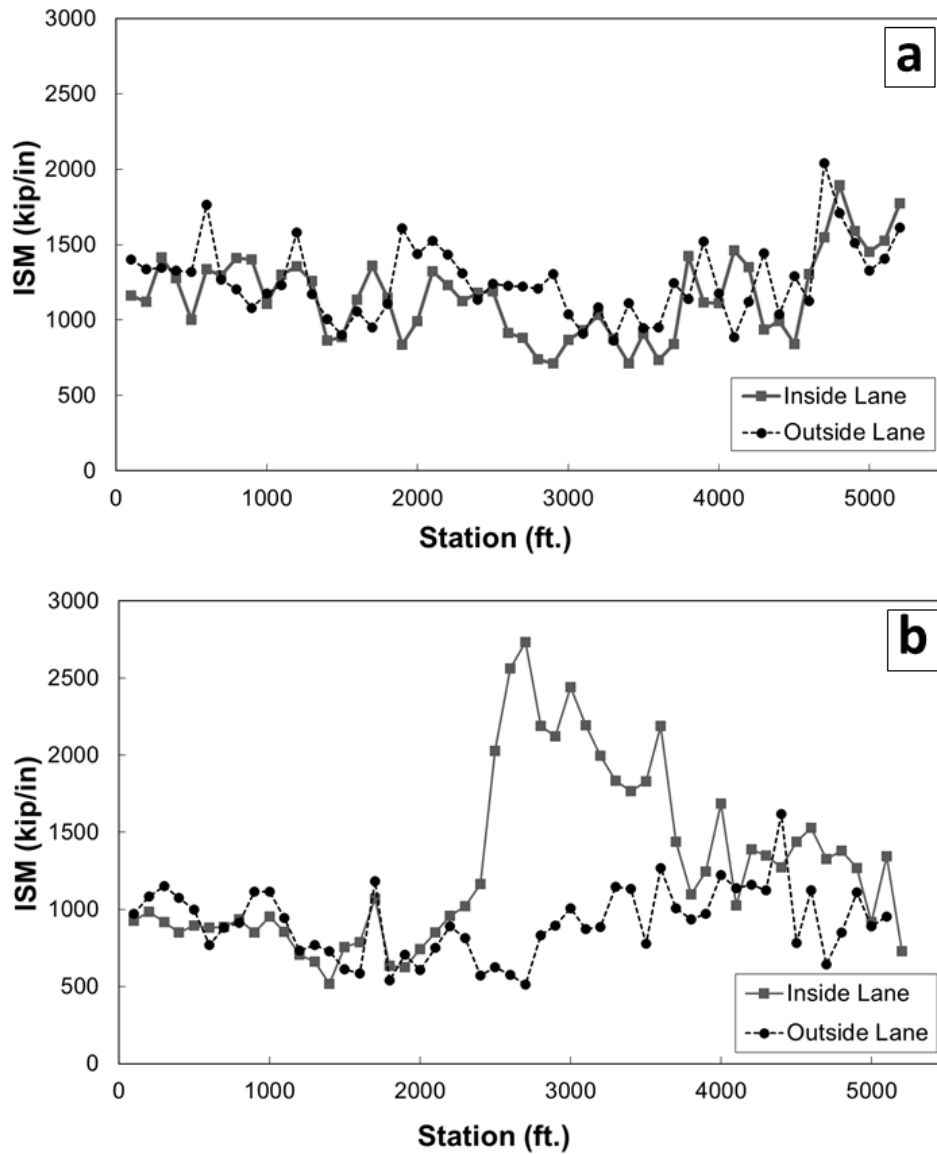
Figure 8.5 - ISM Plots for AC pavements  
(a) SR-38 and (b) SR-54

The ISM plots for SR-38 and SR-54 are shown in Figure 8.5. The ISM plot of SR-38 has an average ISM value of 1100 and 1200 kip/in for the inside and outside lane, respectively. The ISM plot of SR-54 shows an irregular trend in the inside lane (Figure 8.5(b)). The ISM value is steady around 1100, but rapidly increases to a value close to 3000. Three coring samples were taken within this irregular area. It was discovered that the total length of the extracted cores varied

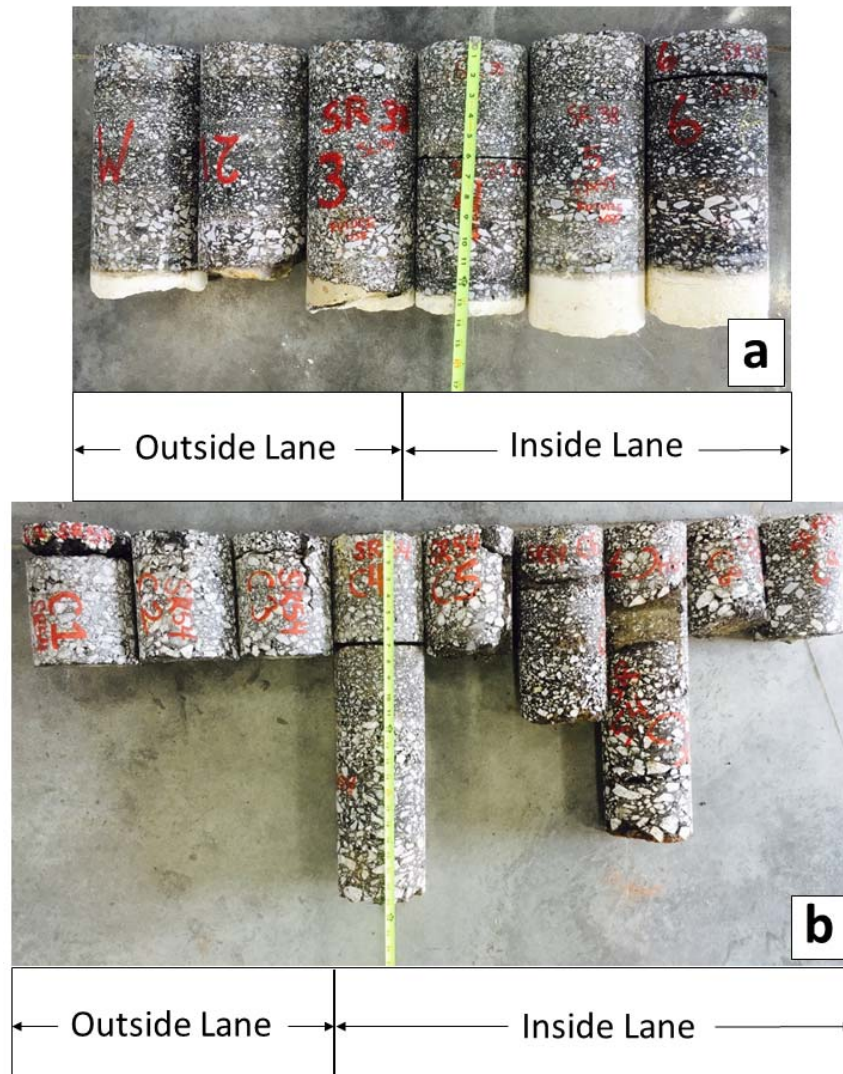
Figure 8.8 - All Cores (Superpave Pavement)  
(a) SR 38 and (b) SR 54

The cores samples from SR-38 contained compacted soil cement below their respective AC layer. The use of soil cement was typical in South Georgia to save GAB material and haul costs as most of quarries for GAB were located in North Georgia. Figure 8.6 shows typical cores taken at joints from SR-38. Figures 8.6(a) and 8.6(b) show a core sample before and after extraction. As shown in Figure 8.6(c), there were several AC lifts within the cored specimen. This could be attributed to a series of milling and overlay rehabilitation. All cores extracted from SR-38 and SR-54 are shown in Figure 8.8. Cores from SR-38 (Figure 8.8(a)) appeared very similar in length and layer density.

All of the SR-54 coring samples taken contained large cracks. Many cracks initiated from either the bottom or top, and several samples were extracted in pieces. Figure 8.7 shows images from the coring process on SR-54. A large, irregularly shaped void was discovered when coring sample C-7 (Figure 8.7(b)). The void was also part of the extracted sample, as seen in Figure 8.7(c). The void was assumed to be the result of an organic material (e.g. wood) displaced during construction. All cores extracted from SR-38 and SR-54 are shown in Figure 8.8. The core samples from SR-54 had a consistent thickness in the outside lane. However, cores from the inside lane had irregular lengths (Figure 8.7(c)). As mentioned previously, the 4<sup>th</sup>, 6<sup>th</sup>, and 7<sup>th</sup> samples in

Figure 8.8(b) show full depth asphalt composed entirely of asphalt mixes. No GAB was found underneath these samples.

Design drawings were not available for SR-54. The irregular length of coring samples from the inside lane of SR-54 lead to the conclusion that, the inside lane was composed of an existing pavement that contained an asphalt base (Figure 8.7c). The existing road underwent a full-depth rehabilitation on partial sections of the road. The two pavements are joined at the wheel path locations in the pavement. The large cracks shown in Figure 8.3 (b) initiated from the two pavement layers.
