The Rock House

Historic Structure Report
Fall 2011

Forward

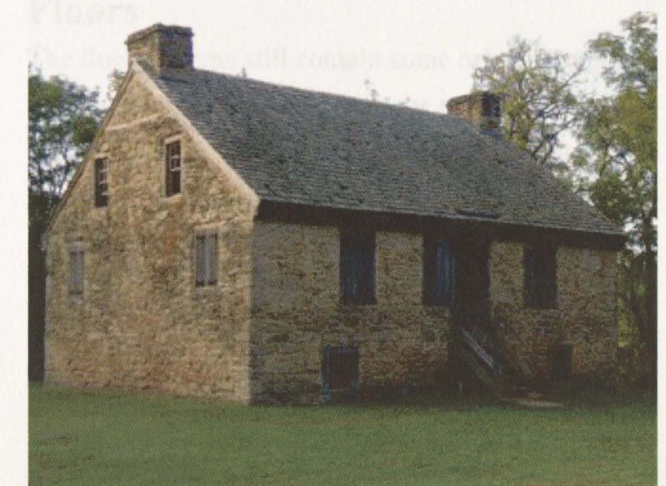
Foundation

The load bearing masonry foundation ranges from 10-14" thick walls made of varying sizes of rough-faced fieldstone of gneiss and granite with a high lime mortar mix on top of original red clay mortar.

There are slightly darker colored ashlar stone quoins on each corner. The footing system is simply placed on the ground 24 inches under ground level. The original stones are structurally sound with minor cracks and mold issues.

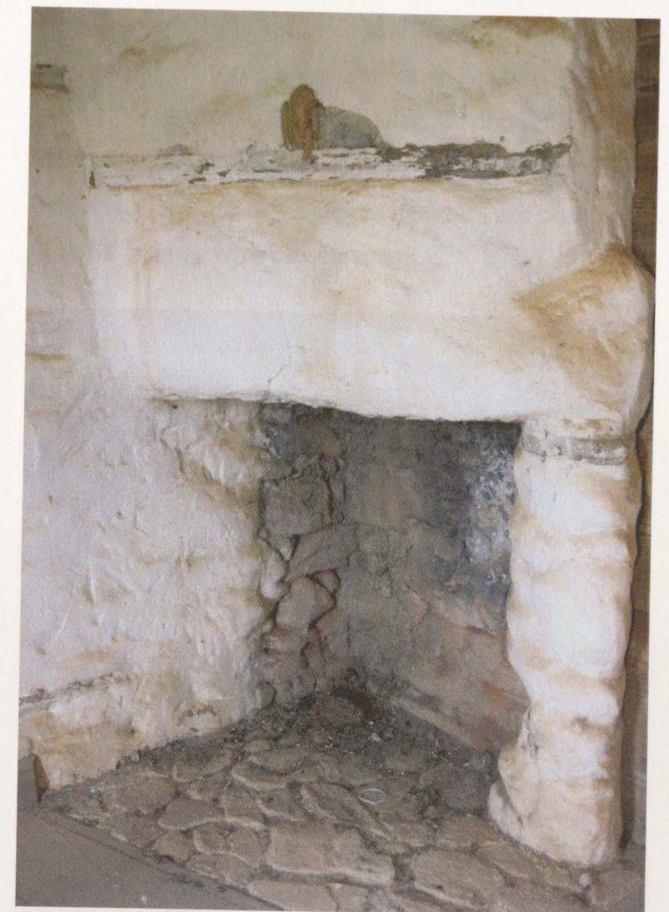
Fireplaces and Chimneys

There are two interior end chimneys flush with the east and west elevations. There is a stone hearth, previous to the 1979-1981 reconstruction under modern poured concrete. The east chimney shares three fireboxes, one in the cellar, and two on the main floor in Room 1 and 2 (see floor plan on page 40). The corner fireplace is located in the southeast corner of Room 1 and finished with plaster. The chimney in Room 2, is 8' wide and 2' deep and is constructed with two, possibly original, horizontal timber lintels spanning the full breadth of the chimney mass which resemble the nailer blocks in the basement in size. The chimney on the west elevation has a firebox on the lower lever and in Room 3 of the main floor. Both chimneys have been partially rebuilt, which is indicated by the minimal

evidence of use in the firebox. The exterior of the chimneys is granite ashlar, both lacking a cap with an open flue.

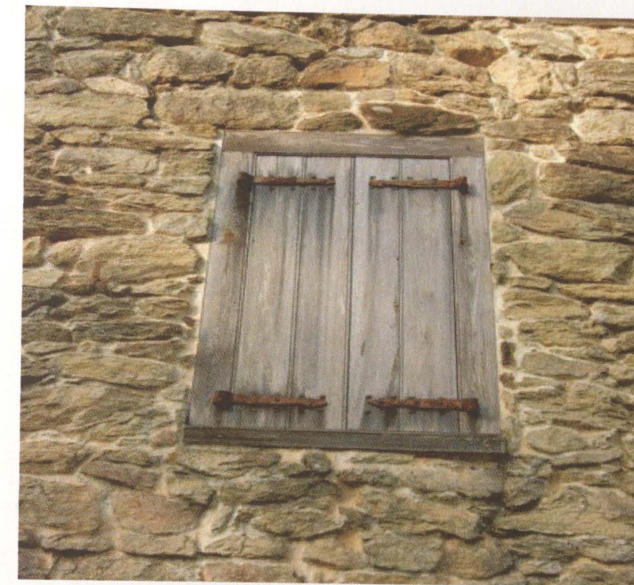
Shutters

There are shutters on all windows on the main floor with recreated wrought iron hardware. None of the shutters are original. Shutter are missing on both north and south façade windows.
