SAFETY ANALYSIS OF EMBANKMENT DAMS AND ALTERNATIVE ECONOMICAL DESIGN

This research evaluates cost effective rehabilitation options for an existing earthen dam located in Grayson, Georgia. The case study dam did not meet Georgia dam safety requirements and therefore required an engineered intervention minimizing risk for downstream receptors. The solution implemented included a roller compacted concrete lining on the dam face, which increased stability enough to meet regulatory standards. This work focuses on evaluating alternative design options to determine an effective and cost efficient solution for similar dam rehabilitation. Using numeric modeling, we evaluated the existing dam configuration to confirm that it did not meet dam safety standards. We evaluated the implemented rehabilitation design to show if it improved reliability of the dam structure to meet regulatory standards. Finally, we evaluated an additional design option to determine if other intervention designs would be as robust. An economic evaluation of expected construction costs for engineering design options led to a recommendations for rehabilitation of similar earthen embankment dams.

A Thesis Submitted to t

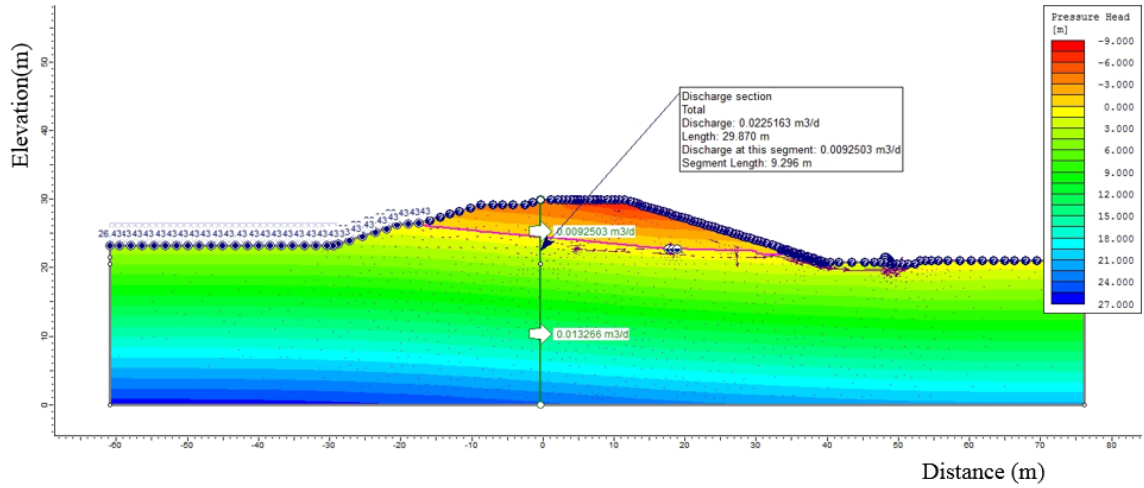
Figure 10: SSS analysis of improved dam at normal pool water level elevation

Following the same geotechnical analysis procedures to evaluate the stability of the original dam, a new analysis was performed for the improved condition. This effort began with evaluating seepage through the dam and its foundation. Figure 9 and Figure 10 represents the SSS analysis for normal and maximum lake water level elevations.

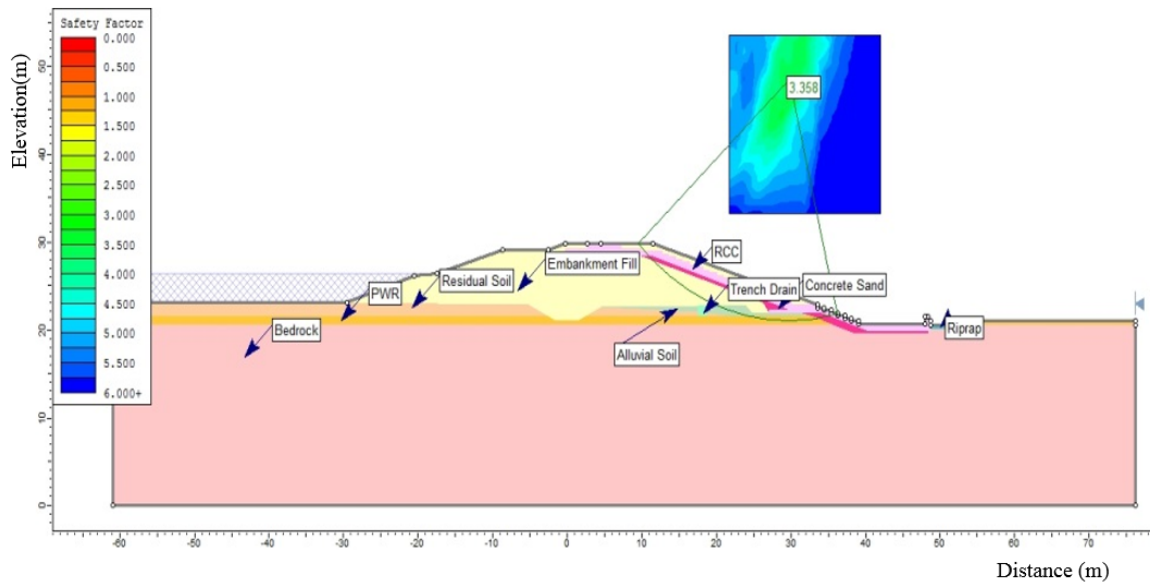
Figure 12: Slope stability analysis of improved dam at normal pool water elevation

Water tables were found for normal and maximum pool elevations. They were used to calculate slope stability for all geotechnical conditions. Figures 11 and 12 represent the slope stability analyses at the normal and maximum pool water elevations, respectively.

This revised analysis showed estimated factors of safety of 3.358 and 3.357 at normal and maximum pool water level elevations. According to Georgia the Rules for Dam Safety criteria, the factor of safety should be 1.5 or higher under static loading. Therefore, the slope stability of the improved dam met regulatory requirements under static loading.
