EMBRACING THE HISTORIC AND TOXIC LEGACIES OF A SVOCS-CONTAMINATED BROWNFIELD: USING LANDSCAPE INTERPRETATION TO EXPAND THE REDEVELOPMENT OF BOULEVARD CROSSING PARK

MASTER OF LANDSCAPE ARCHITECTURE

2015

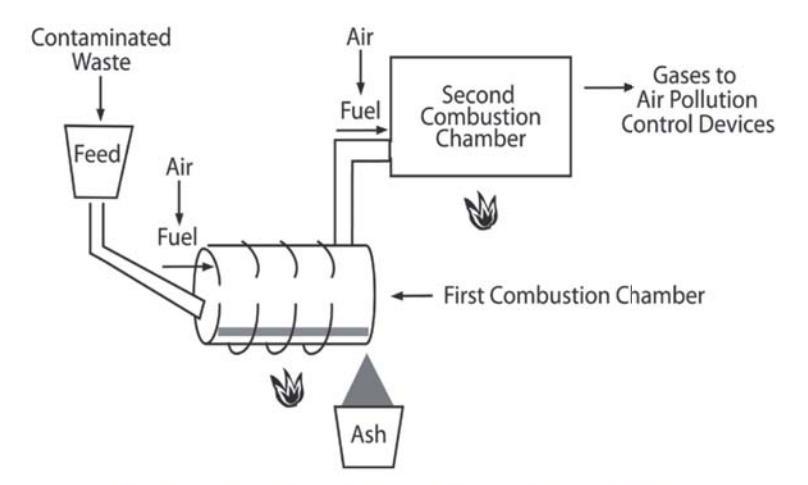
Incineration (Figure 7) is defined as the burning of harmful materials, like polluted soil, at a controlled temperature that is high enough to demolish hazardous contaminants (Hollander, Kirkwood, Gold, 2010). Several types of contaminants can be treated by incineration, including soil, sludge, liquids, and gases (U.S. EPA, 2012). During this process, materials are heated inside of an incinerator, at various temperatures for different periods of time, depending on the amount and type of harmful chemicals present (U.S. EPA, 2012). After the chemicals are heated up, they transform into gases, eventually combining with oxygen to become less hazardous gases and steam (Hollander, Kirkwood, Gold, 2010). Following this process, the modified gases are treated by air-pollution-control devices, which produce waste that must be collected and disposed of in a licensed landfill (Hollander, Kirkwood, Gold, 2010).

How an incinerator converts waste into ash and gases.

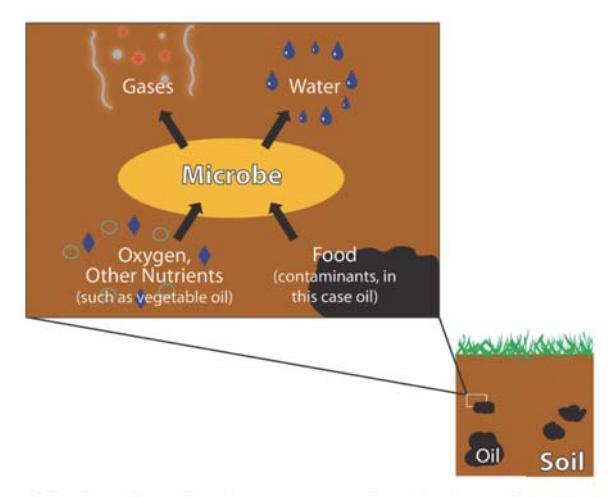
Bioremediation (Figure 8) is the process of using biological agents, such as microorganisms or plants, to degrade or eliminate harmful materials in contaminated soil or water (Hollander, Kirkwood, Gold, 2010). These microorganisms can absorb toxic organic contaminants like fuels or solvents, and break them into safe products, including carbon dioxide and water (U.S. EPA, 2012). Meanwhile, the contaminants provide enough energy to stimulate the growth of microbes (U.S. EPA, 2012). Although bioremediation is a non-intrusive, sustainable cleanup technique it requires time, which pose an obstacle for brownfields that require instant remediation. (Hollander, Kirkwood, Gold, 2010). However, bioremediation could be used in the context of landscape intervention because mature landscapes require a long period of time. On-site bioremediation treatment is advantageous for several reasons, as it does not require excavation, it produces less dust, it releases fewer contaminants, and is more cost effective (U.S. EPA, 1996). Furthermore, the EPA emphasizes in situ bioremediation as a treatment that could potentially have the best performance on permeable soil according (U.S. EPA, 1996).

Microbe takes in oil, oxygen, and nutrients and releases gases and water.

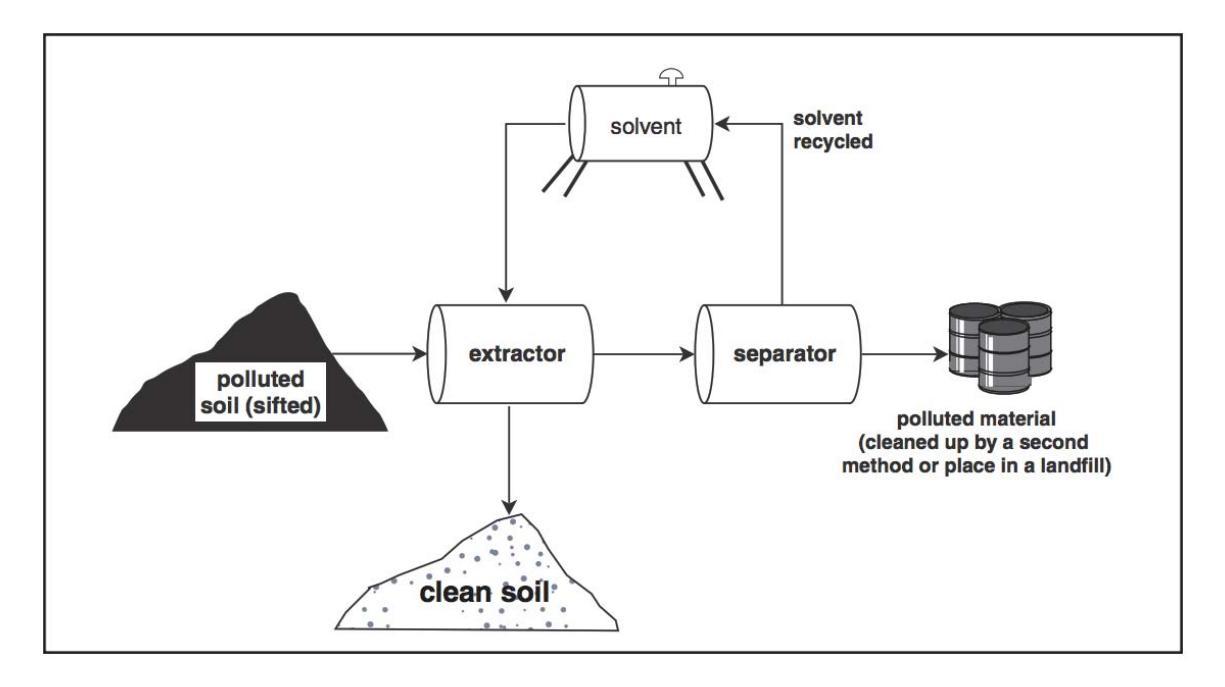
Figure 9: Schematic diagram of solvent extraction

Solvent extraction (Figure 9) is a chemical approach that uses solvents to remove hazardous contaminants (U.S. EPA, 2001). First, soil is dug out and sifted to remove rocks and debris for solvent extraction. Then, the soil is placed in an extractor and mixed with solvent for treatment (U.S. EPA, 2001). The chemicals dissolved by solvent are then diverted into a separator where they can be separated from the solvent. Lastly, the resulting solvent is reused or disposed of in a licensed landfill (U.S. EPA, 2001).

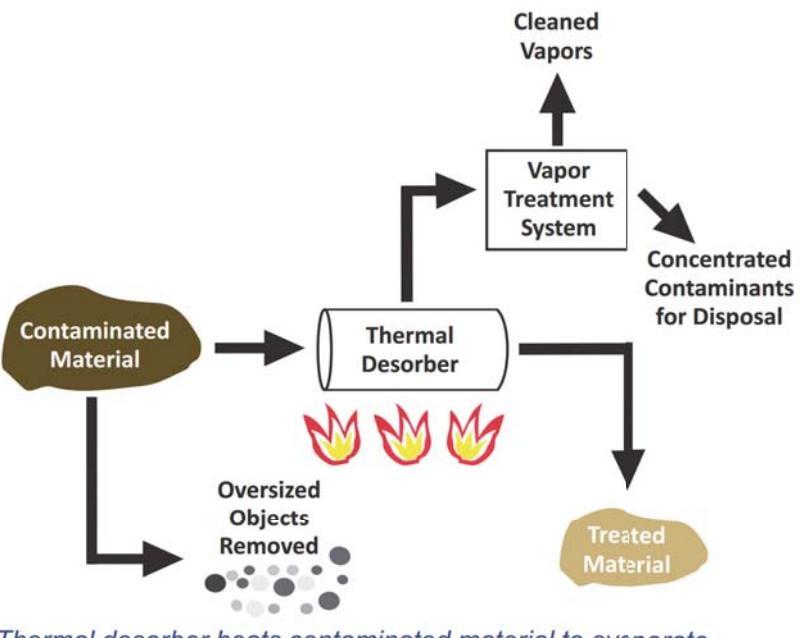
Thermal desorption (Figure 10) is a physical technology approach that has demonstrated effectiveness in treating organic-contaminated solid mediums by heating them to a certain high temperature, which changes them into gases and separates the organic contaminants from the solid medium. This process can remove both volatile and semi volatile contaminants (Marks, Wujcik, & Loncar, 1994). The excavated and prepared soil is then placed into a thermal desorber that heats the contents to a specifically designated high temperature, based on the properties of the contaminants For example, a temperature between 600 and 1000°F may be used to treat SVOCs contaminated soil (U.S EPA, 2012). Thermal desorption, when combined with other technologies, could more effectively treat contaminants. For example, off-gas treatment could be integrated with thermal desorption on sites where waste has less than 10 percent organics (Marks, Wujcik, & Loncar, 1994). Rather than destructing organic contaminants through a process, such as incineration, thermal desorption volatilizes contaminants and collects the off-gas for further destruction or discharge (Hollander, Kirkwood, Gold, 2010).

Thermal desorber heats contaminated material to evaporate contaminants.

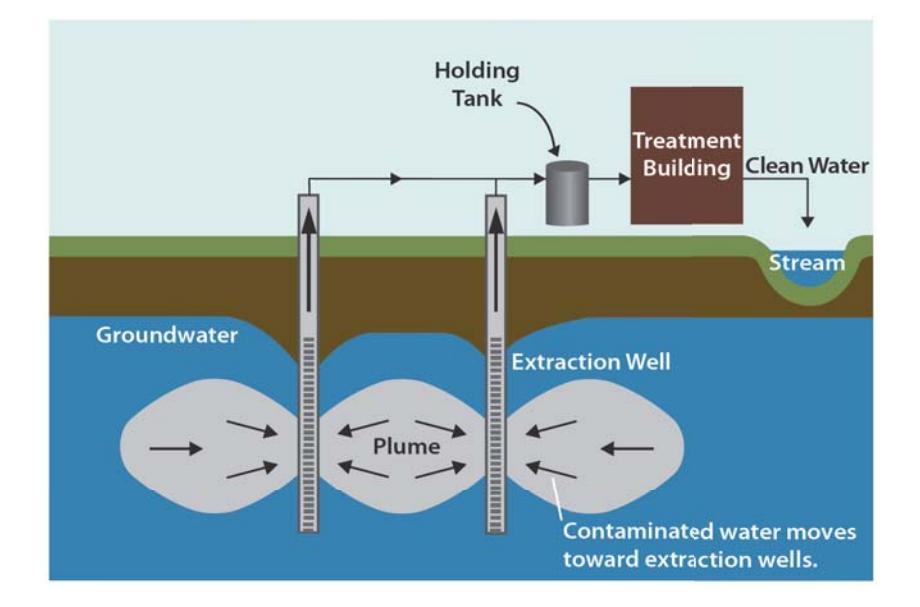
Pump and treat (Figure 11) is a method that pumps groundwater through recovery wells or trenches, sending it to an aboveground treatment system where contaminants are treated by cleanup techniques, using a biological reactor or carbon adsorption (U.S. EPA, 2012).

Figure 11: Working principle of pump and treat system (Source: Image from U.S. EPA, 2012)

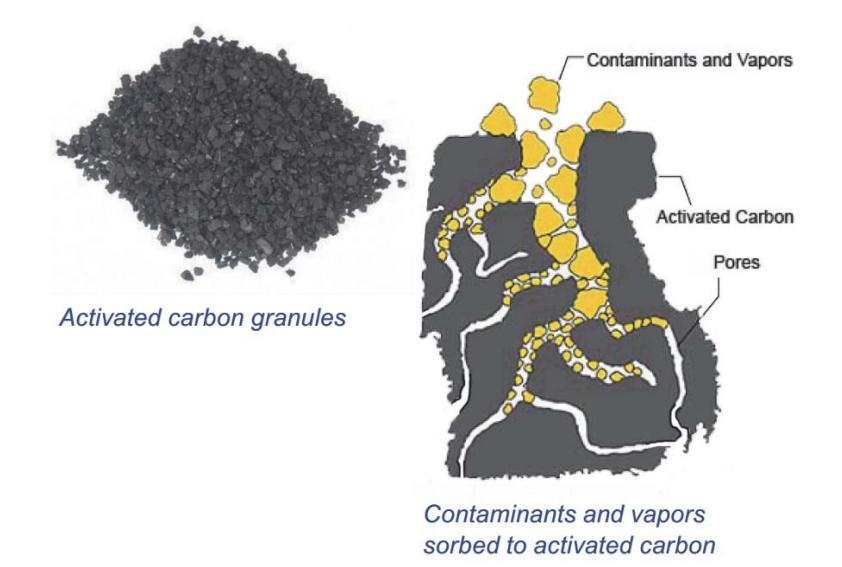
In this method, the groundwater would be pumped through columns or tanks that contain GAC (Figure 12) in order to sorb the contaminants from the surfaces of granules (U.S. EPA, 2012). After this process, the exiting water and air will need to be tested to judge whether the contaminants are completely treated or not. If not, they will be processed again until reaching the treatment requirement (U.S. EPA, 2012). Regular replacement or regeneration of GAC is needed to keep the system working (U.S. EPA, 2012).

Figure 12: Working principle of carbon adsorption/ granulated activated carbon (GAC) (Source: Image from U.S. EPA, 2012)

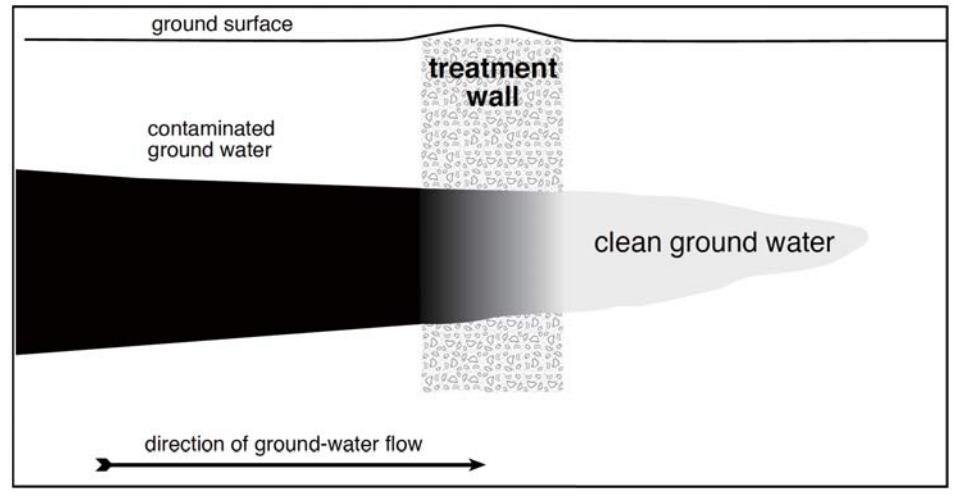
Figure 13: Schematic diagram of passive treatment wall

including cost effectiveness, energy efficiency, and the ability for modification to treat different types of contaminants. These walls are energy efficient because they do not depend on mechanical equipment or an energy source to pump out contaminated water. Moreover, the property can retain a productive function, while undergoing treatment (U.S. EPA, 1996).

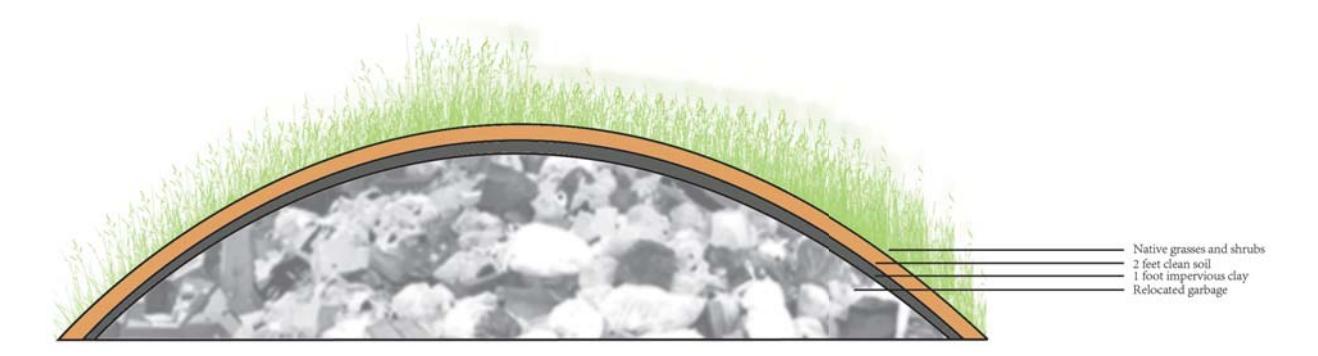
Figure 16: Diagram of capping

The site was historically used as a landfill, but was closed in 1980 (Figure 15). Notably, there are numerous adjacent landfills around the Bay area, some of which have been converted into parks, while others continue to operate in their original capacity. The site's previous use as a landfill resulted in contamination originating from existing tons of garbage stored on site. The landfill also presented a threat to water quality (Fred, & Jones, 1991). When waste was saturated with water or received artificial irrigation, it had the capacity to produce leachate and methane gas, which could result in potential ground water pollution that would harm human health (Pedersen, & Johnson, 1997). In order to address these threatening factors, hills and mounds of waste were creatively constructed on site. The hills consisted of 60 feet of garbage, covered by a one-foot thick impervious clay layer with two feet of soil on top (Hargreaves Associates, 2015). They were then covered with native grasses, wild flowers and small shrubs instead of tall trees in order to keep the clay cap from being disturbed or broken (Figure 16). No irrigation was provided, in order to prevent groundwater from being polluted by the leachates from the landfill.

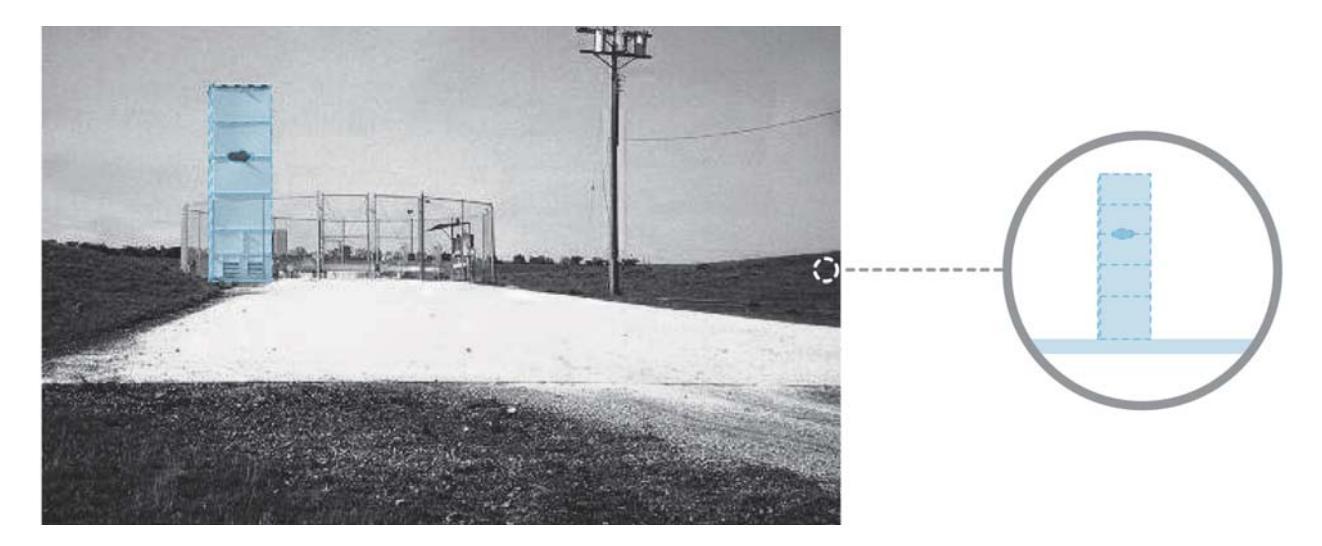
Garbage under the hills produced methane gas for decades, which negatively impacted the environment, as many greenhouse gases do (Horii, 2000). However, designers decided to make use of the methane, rather than ignore it. A keyhole-shaped waste gas burner (Figure 17) was

added on site to address problems associated with the methane gas. This project was named "Keyhole" (Horii, 2000).

Figure 17: Methane gas burnoff facility "Keyhole"

Landscape can be utilized both in the remediation and redesign processes to improve brownfield redevelopment and enhance remediation processes and effects. For example, the methane gas burn-off facility in Byxbee Park, Chapter 3, successfully combined the remedial process with landscape design. Similarly, contamination treatment technologies like bioremediation and phytoremediation that utilize plants and microbes as a media to treat contaminants on site could be more extensively utilized during remediation processes. Landscape interventions like those not only help the treatment process achieve better remediation performances, but also improve the landscape with a sensual experience of brownfield redevelopment (Sleegers, 2010). And, the Alumnae Valley project used wetlands to infiltrate the runoffs and installed monitoring wells under the marsh to treat toxicity and prevent leaching (Michael Van Valkenburgh Associates, 2015).

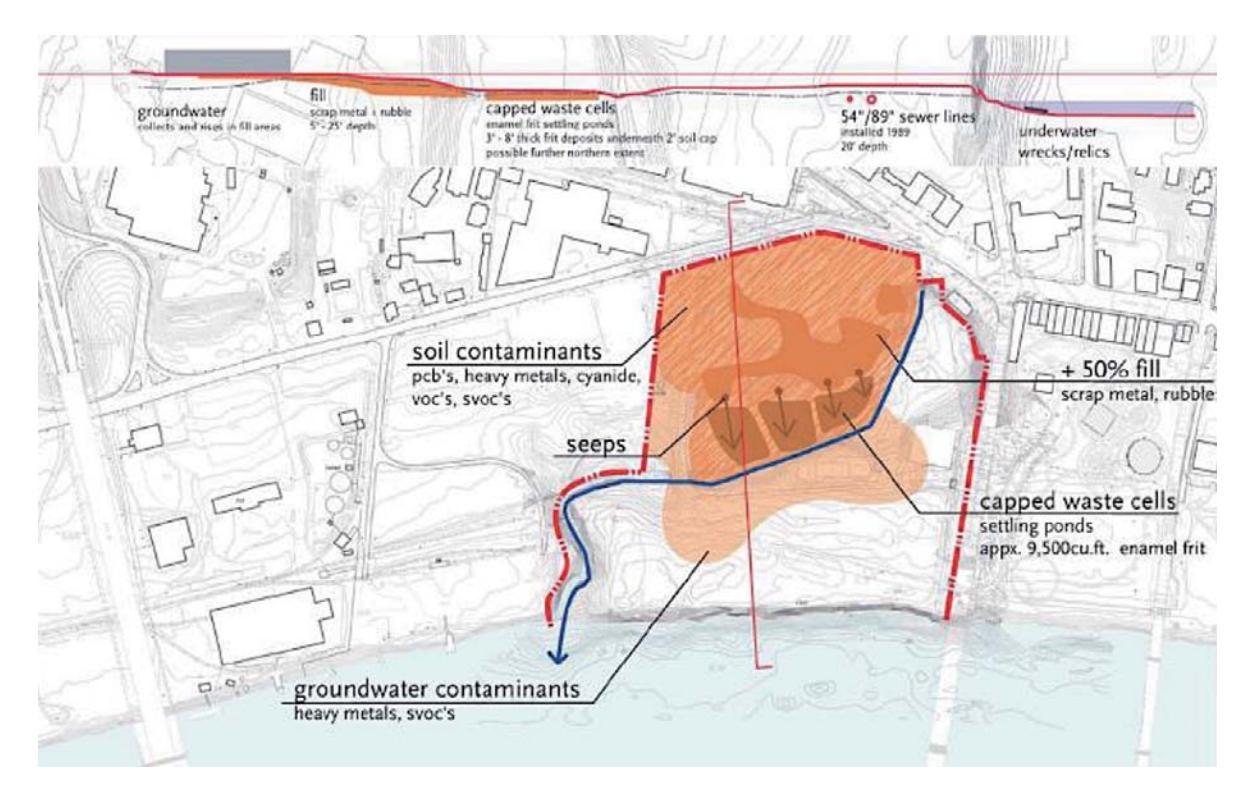
Figure 25: Site contamination study

contaminants that were leaching from the capped waste cells (Collett, & Taylor, 2014). The effluent polluted groundwater and the surrounding environment would threaten the environmental and public health.

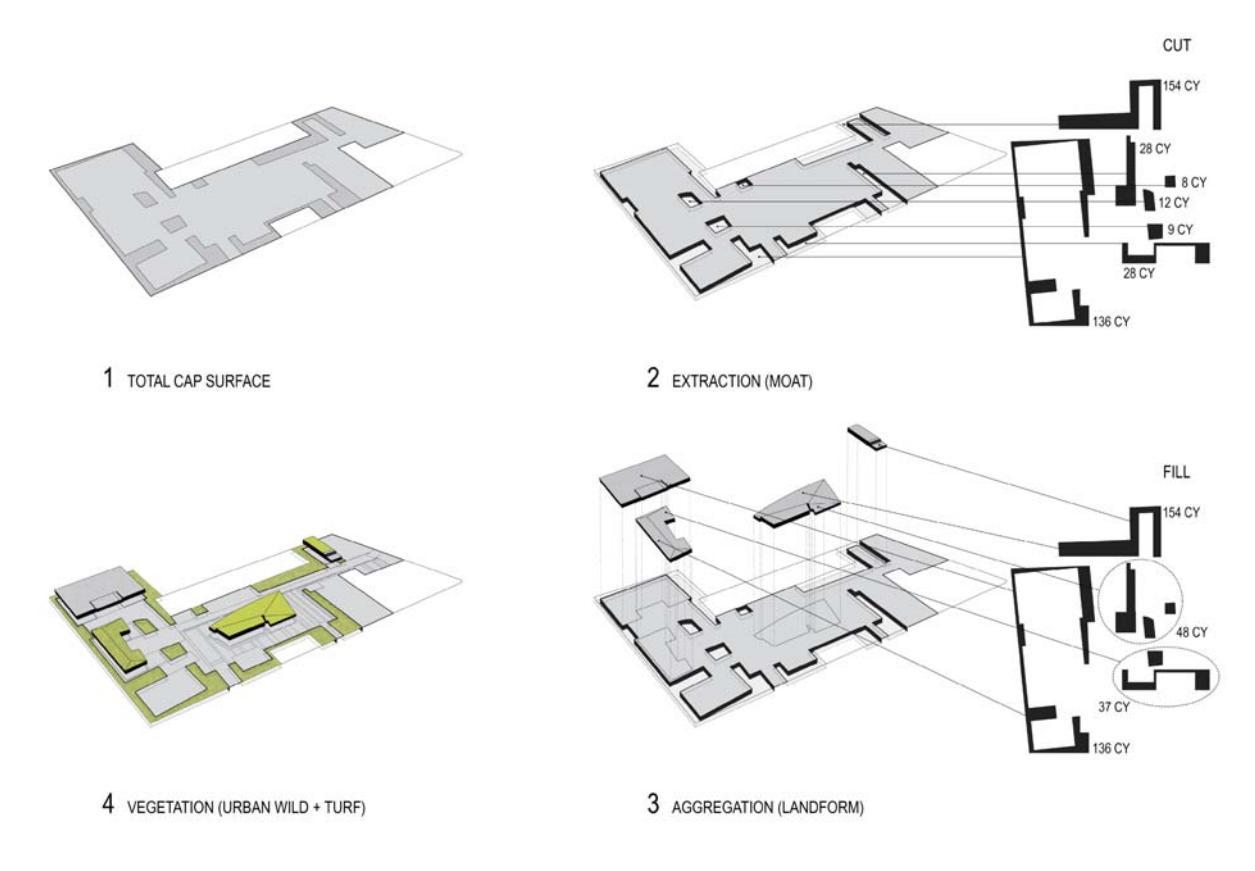
Figure 34: Remediation strategy

Between 1902 and 1934, a steel shop called the Providence Steel and Iron Company, occupied the site. A painting company, PS&I, was involved with painting outdoor beams on site and allegedly polluted soils by overspraying lead-based paint (Hollander, Kirkwood, & Gold, 2010). According to environmental remediation standards, soil with lead contamination higher than 10,000 ppm was required to be excavated and treated by licensed facility, while soil with lead contamination from 4,000 ppm to 10,000 ppm was treated on site and then placed back on site for further use, like building landforms. Designers also decided to cap 12 inches of clean soil or pavements for the entire site (Hollander, Kirkwood, & Gold, 2010) (Figure 34).

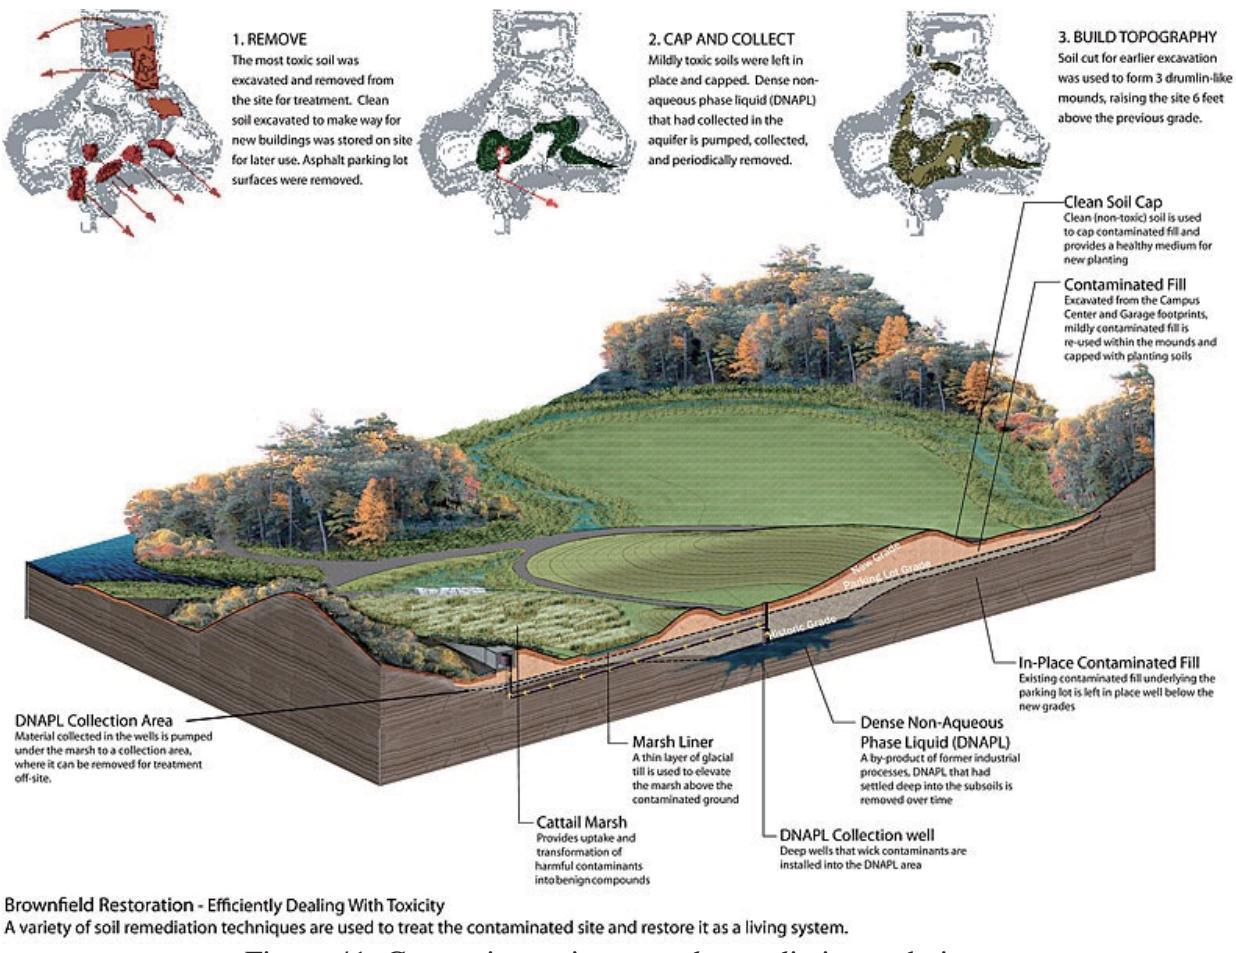
Polluted soils found underneath the parking lot and dense non-aqueous phase liquid beneath the aquifer layer, caused by former industry activities, presented challenges for redevelopment. This project relied on both off-site and on-site treatment of contaminants. Heavily contaminated soil was excavated and removed off-site for treatment; the mildly contaminated soil was capped with clean fill on site and used as fill material for meadow-planted and drumlin-like mounds (Michael Van Valkenburgh Associates, 2015). Newly constructed deep wells and a pumping infrastructure collected and pumped out dense non-aqueous phase liquid left by former industrial processes, periodically removing it off site for further treatment (Michael Van Valkenburgh Associates, 2015) (Figure 41).

Figure 41: Contaminants issues and remediation techniques

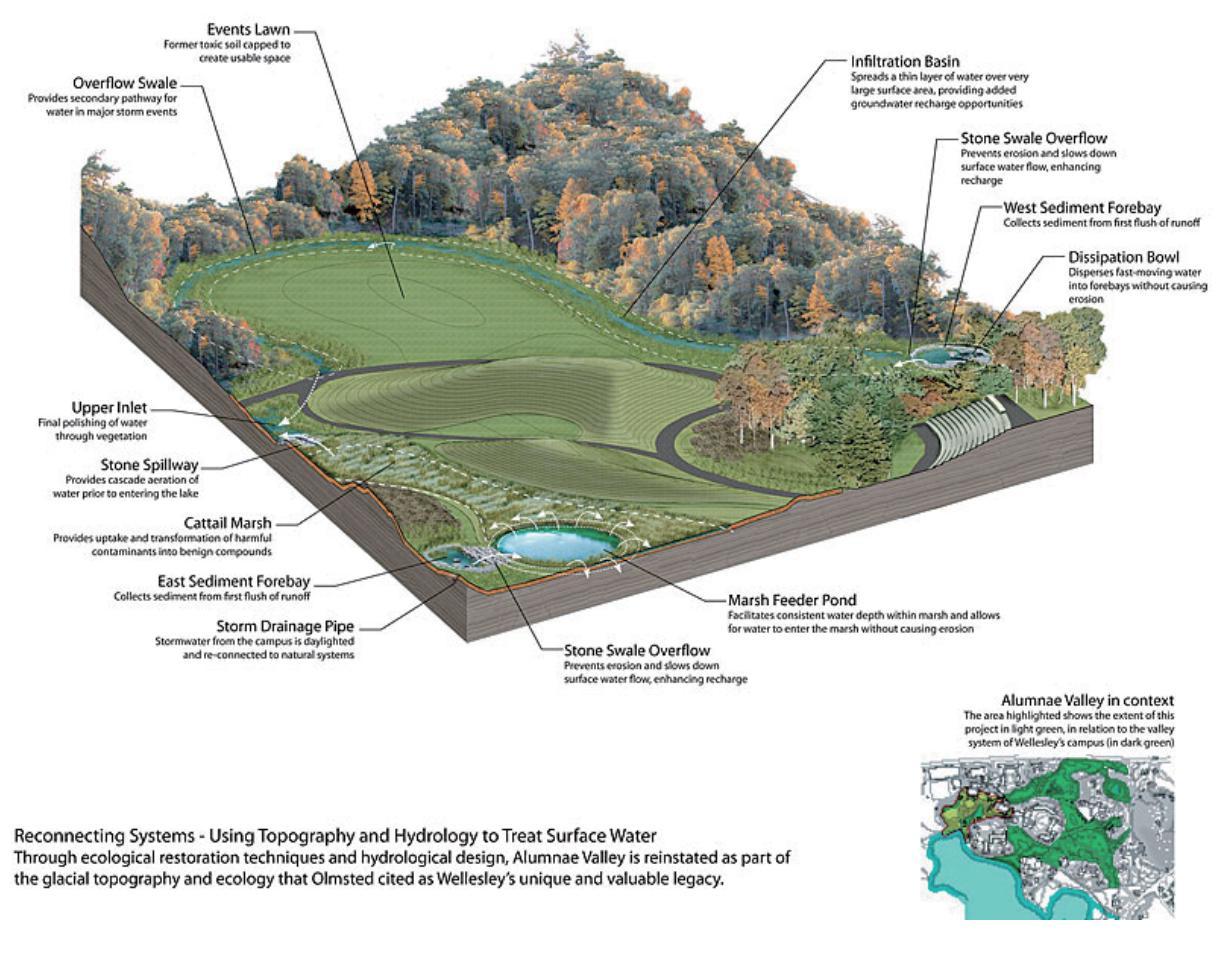
The site's historical functions include a glacial valley, industrial ground, and a parking lot (Michael Van Valkenburgh Associates, 2015). However, the original glacial valley landscape was severely damaged as a result of the site's later use as an industrial ground and parking lot. The site's most precious features are contained in the glacial valley, which, unfortunately, suffered the greatest destruction. In order to strengthen this valuable site character, designers tried to recover it through various techniques: confronting the pollution history and treating the contaminants with proper techniques; restoring the original glacial valley landscape and

enhancing the landscape experience by taking advantages of topography and the hydrology system (Figure 42).

Figure 42: The Valley's hydrologic system

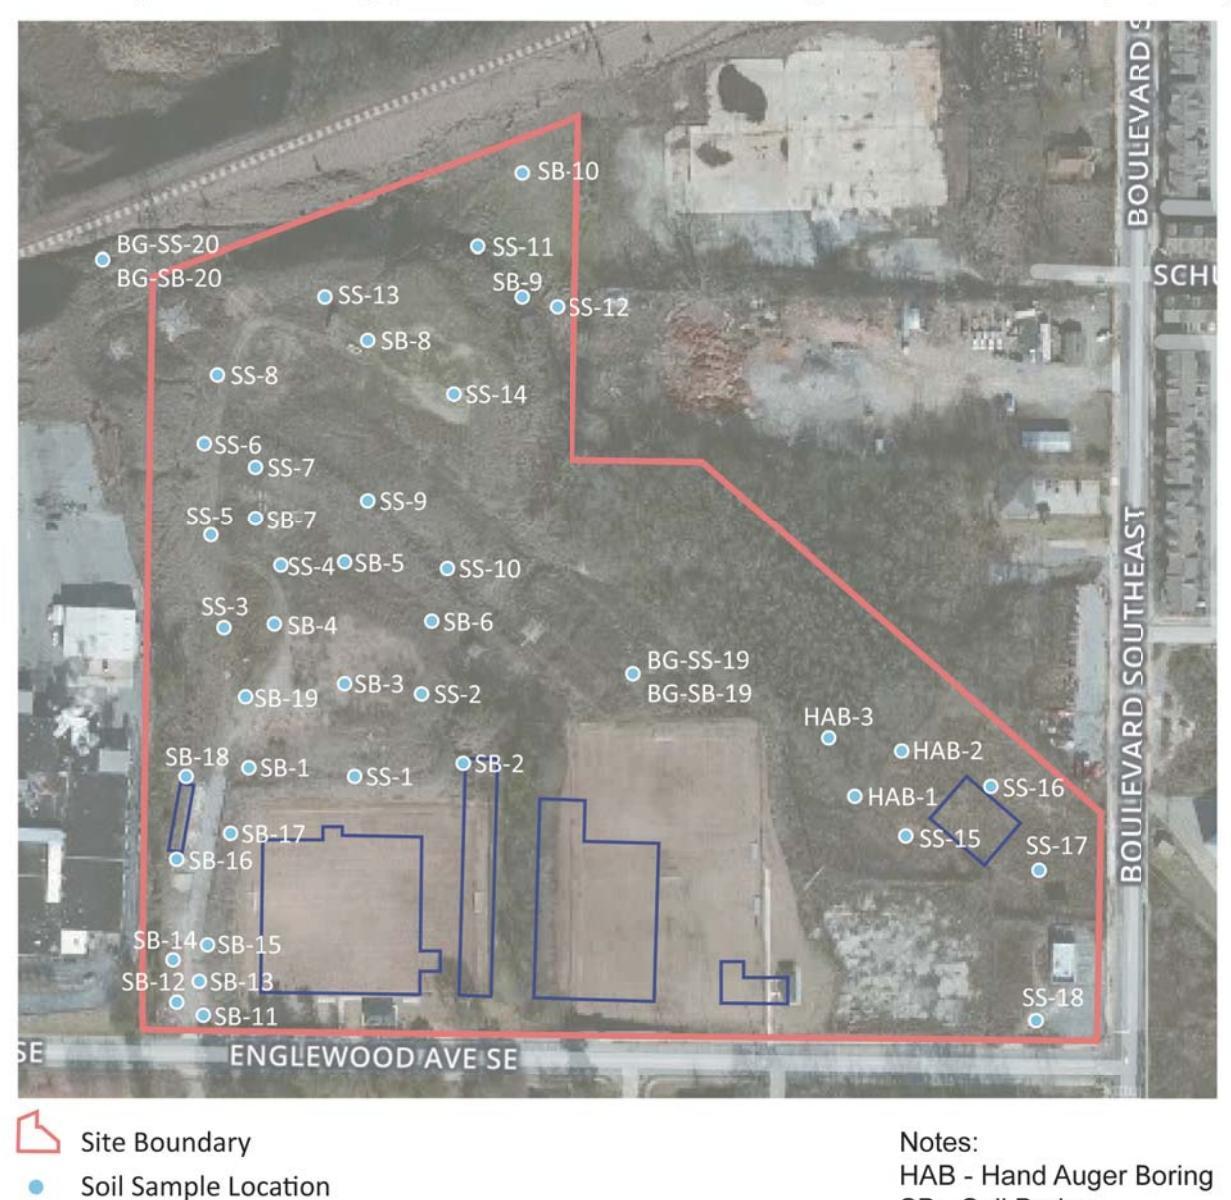
Soil Sample Locations Map (Data Sources Boulevard Crossing Park Phase II ESA Report, 2013)

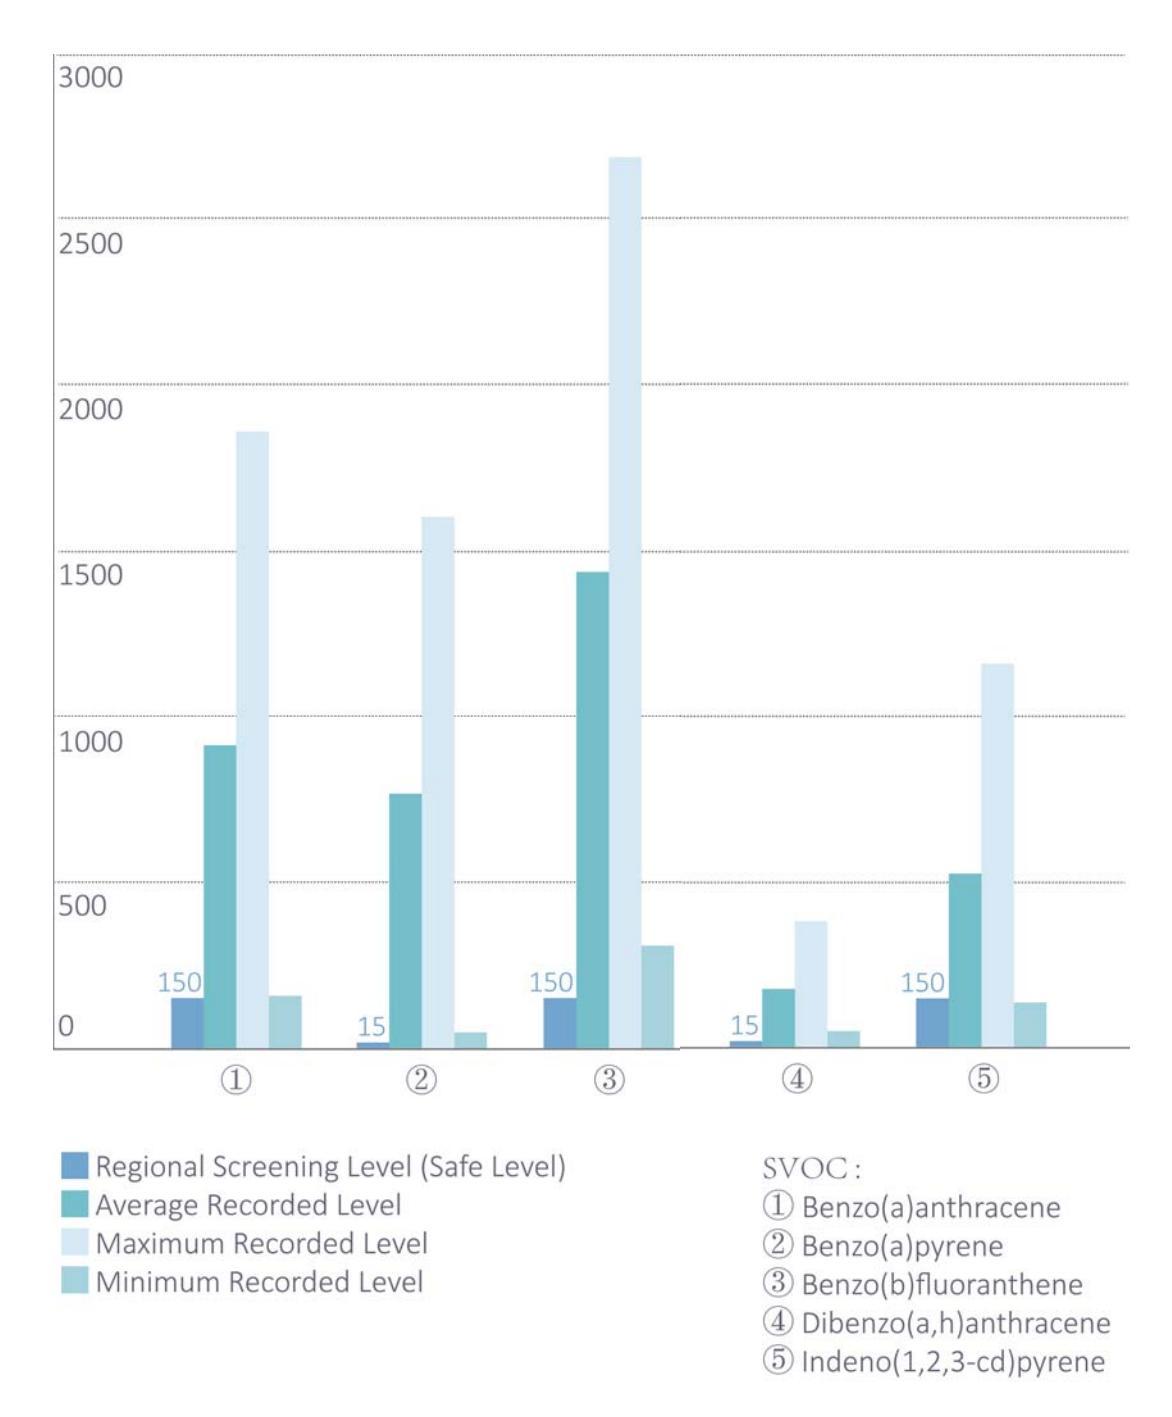
Figure 65: Comparison of the sample recorded level and the RSL level

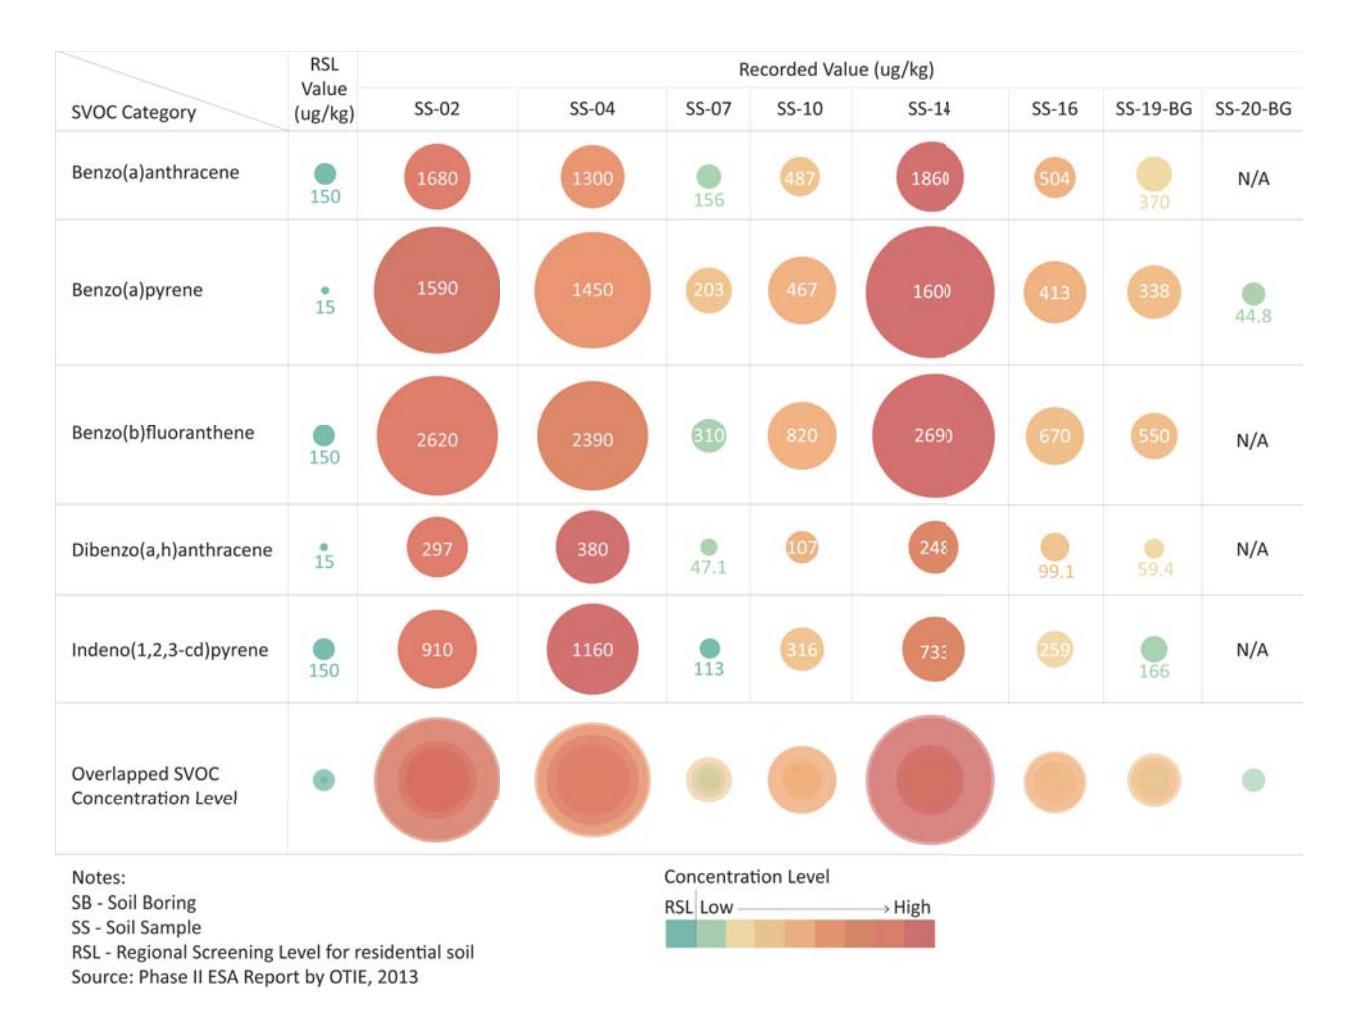
Table 11: Summary of SVOCs Concentration Level (Image drawn by the author) This chart (Table 11) uses green circles to represent the RSL value of SVOCs. The recorded values of the SVOC contaminated soil samples are represented as colors ranging from yellow, to green, and red. The sizes and redness of these circles are determined by the recorded values of the samples: the bigger the recorded value is, the larger the circle is and the darker the color is.
SVOCs Concentration Level Map

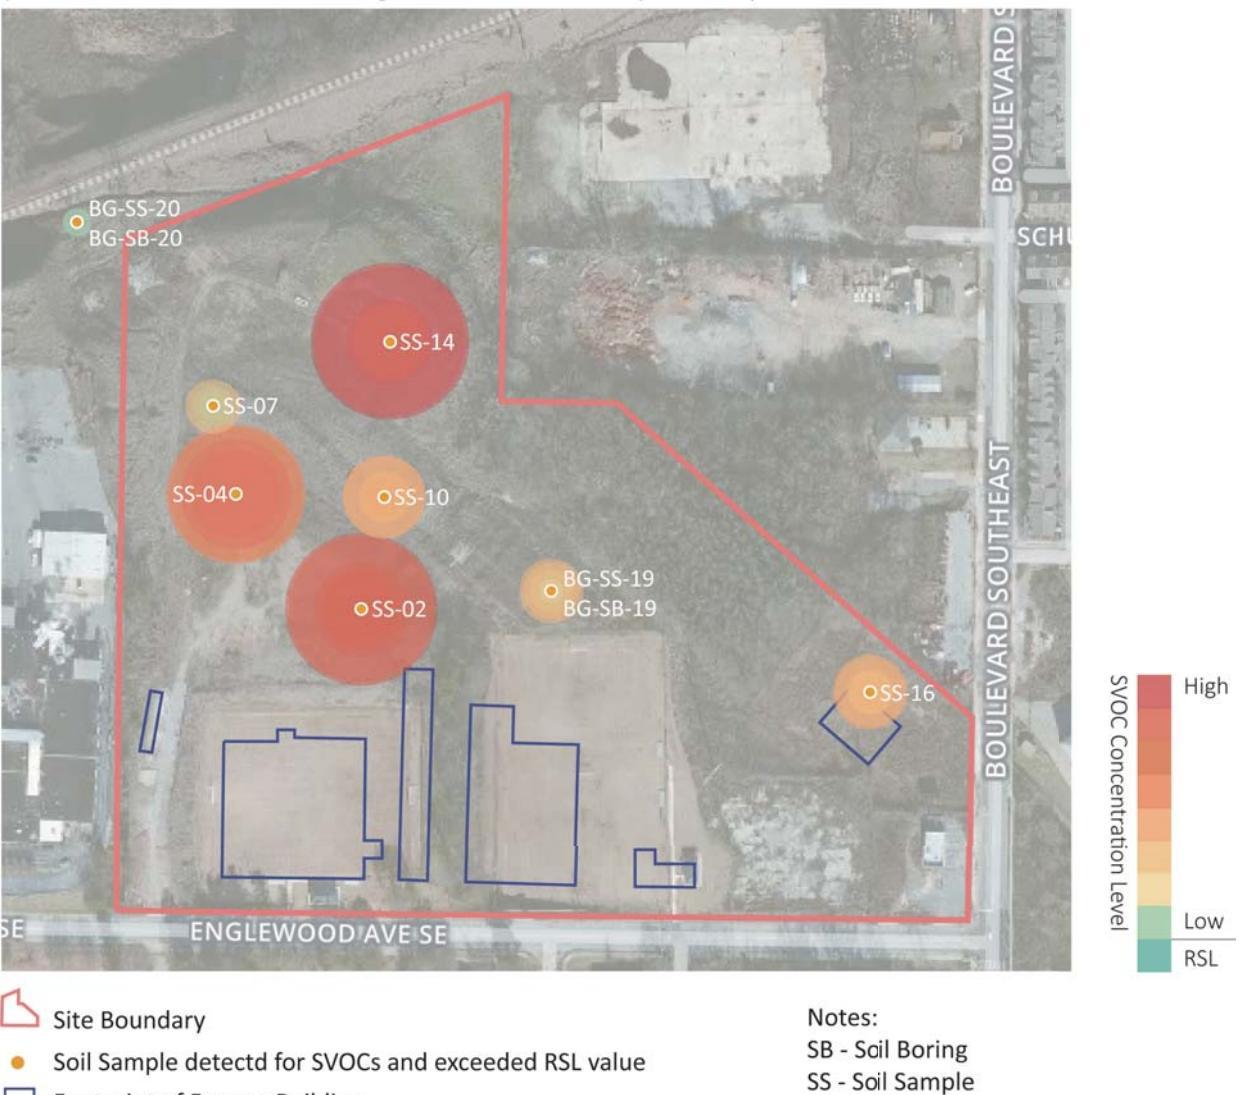
Figure 66: SVOCs concentration map (Image drawn by the author)
